**Re: Approval of Capital Expenditures Supplemental to Newfoundland Power Inc.'s  
(the "Company") 2017 Capital Budget Application – Rose Blanche Hydroelectric  
Plant**

6. Schedule C to this Application is a report titled *Rose Blanche Hydro Plant Turbine No.1 Refurbishment*, which details the results of the assessment of the damage to Turbine No. 1 and provides estimates of the expenditures necessary to return the turbine to service.

8. Schedule D to this Application is a report titled *Rose Blanche Hydro Plant Rockfall Remediation*, which provides a detailed assessment of the results of the rockfall and provides estimates of the expenditures necessary to return the Plant site to a safe condition.

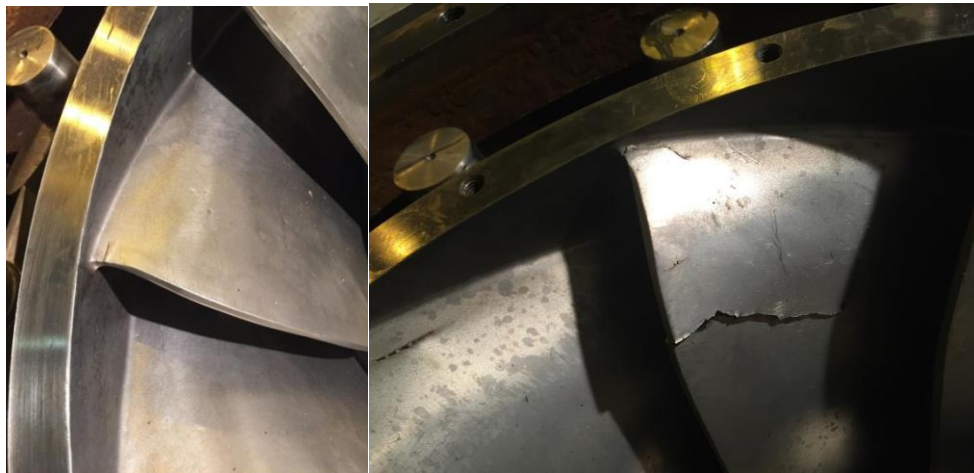
**Figure 1 – T1 Turbine Runner Showing Blade Cracks**

the runner material, fatigue cracks formed during the relatively short period of time between the reinstallation of T1 in June 2016 and its failure in mid-December.<sup>7</sup> These cracks would have been caused by normal loading on the runner blades while T1 was operating, and would have made the runner susceptible to the failure and damage that occurred in December 2016.

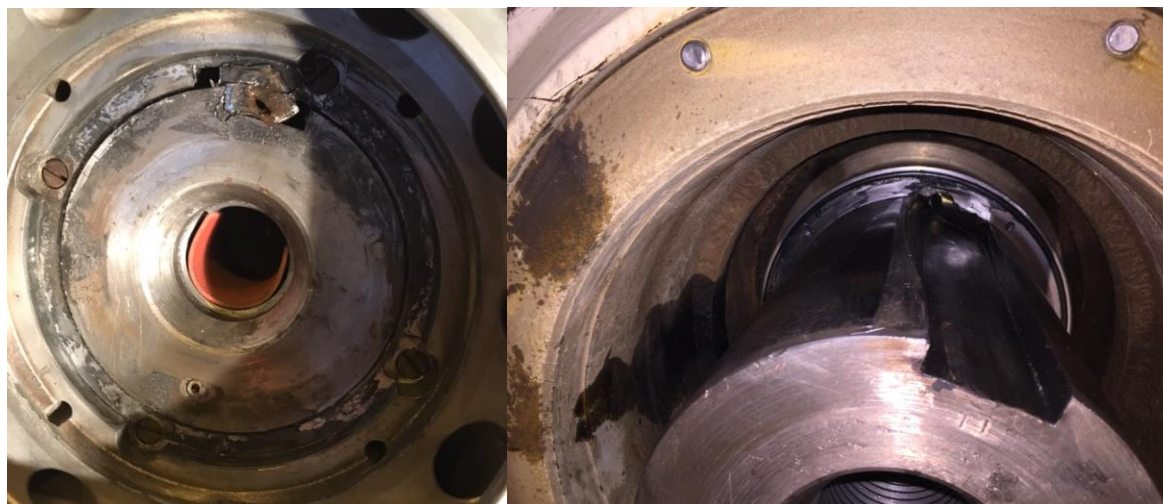
**Figure 2 – Rolled Key and Shaft Keyway Damage**

The indications from the onsite testing are that the shaft end has a bend of 0.017”. It is also likely, based on the deformation of the runner key and keyway, that the shaft was also twisted and plastically deformed, although this cannot be definitively established without destructive testing. Although no cracks in the shaft were found using magnetic particle, ultrasonic and liquid penetrant inspection methods, American Hydro are of the opinion that the stress to which the shaft was exposed in the December 2016 incident has drastically reduced the fatigue life of the shaft, and have recommended that the shaft be replaced.

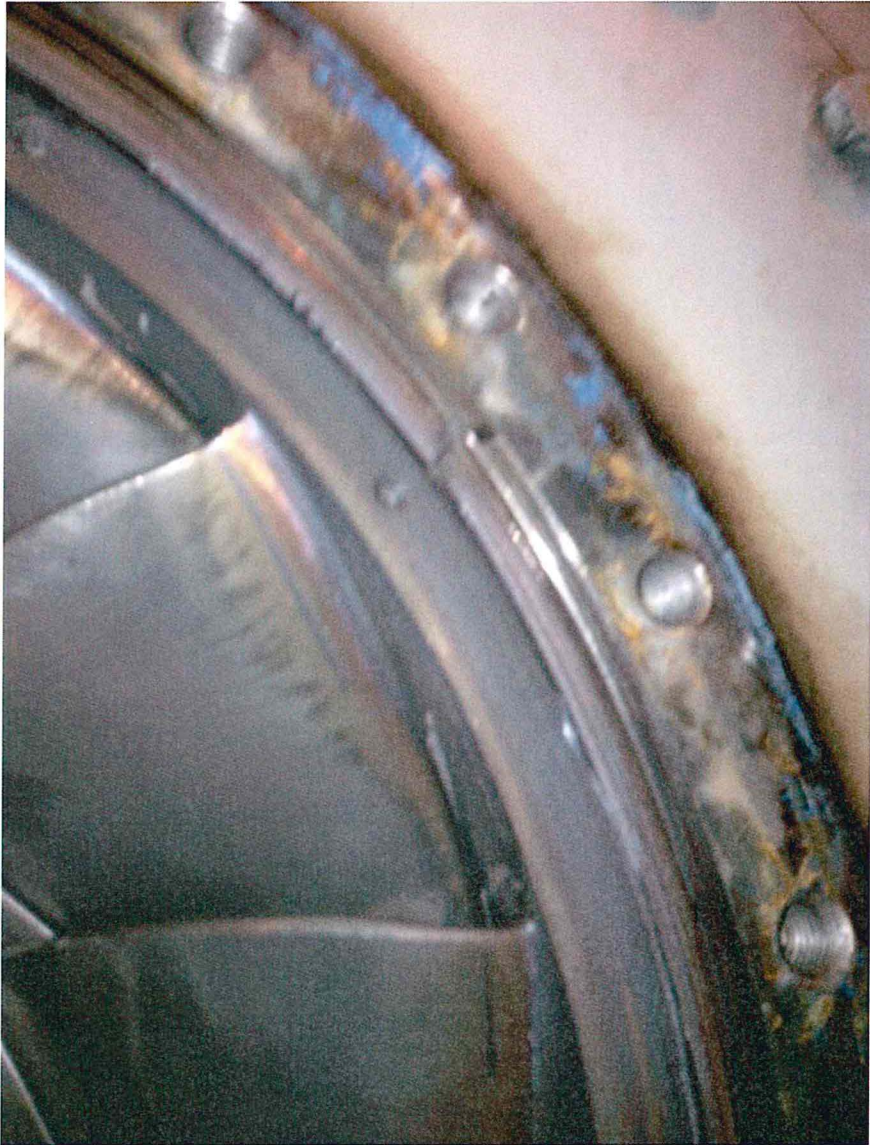
**FIGURE 3 – RUNNER HEAT DAMAGE DURING THE FIRST INCIDENT**

The colors shown in the photo below (Figure 3) accurately capture the temperatures involved in the first incident. Colors such as pale or straw yellow indicate heating in the area of 600 F (316 C). Blue or dark blue is 1,150 F (621 C) to 1,200 F (649 C) and grey or darker areas are even higher. Locations that have any scale formation indicate a temperature of 1,580 F (860 C). Where the material experiences the most distress is the cooling from these temperatures which will typically have two effects. One, if the material is not cooled slowly cracking may occur prior to any physical stresses being applied. Or two, if no cracking occurs the material will likely form un-tempered martensite. This then presents a microstructure that exhibits a brittle characteristic. With a brittle structure in place, once load and fatigue come back into play the cracking that we observe on this runner will typically occur.

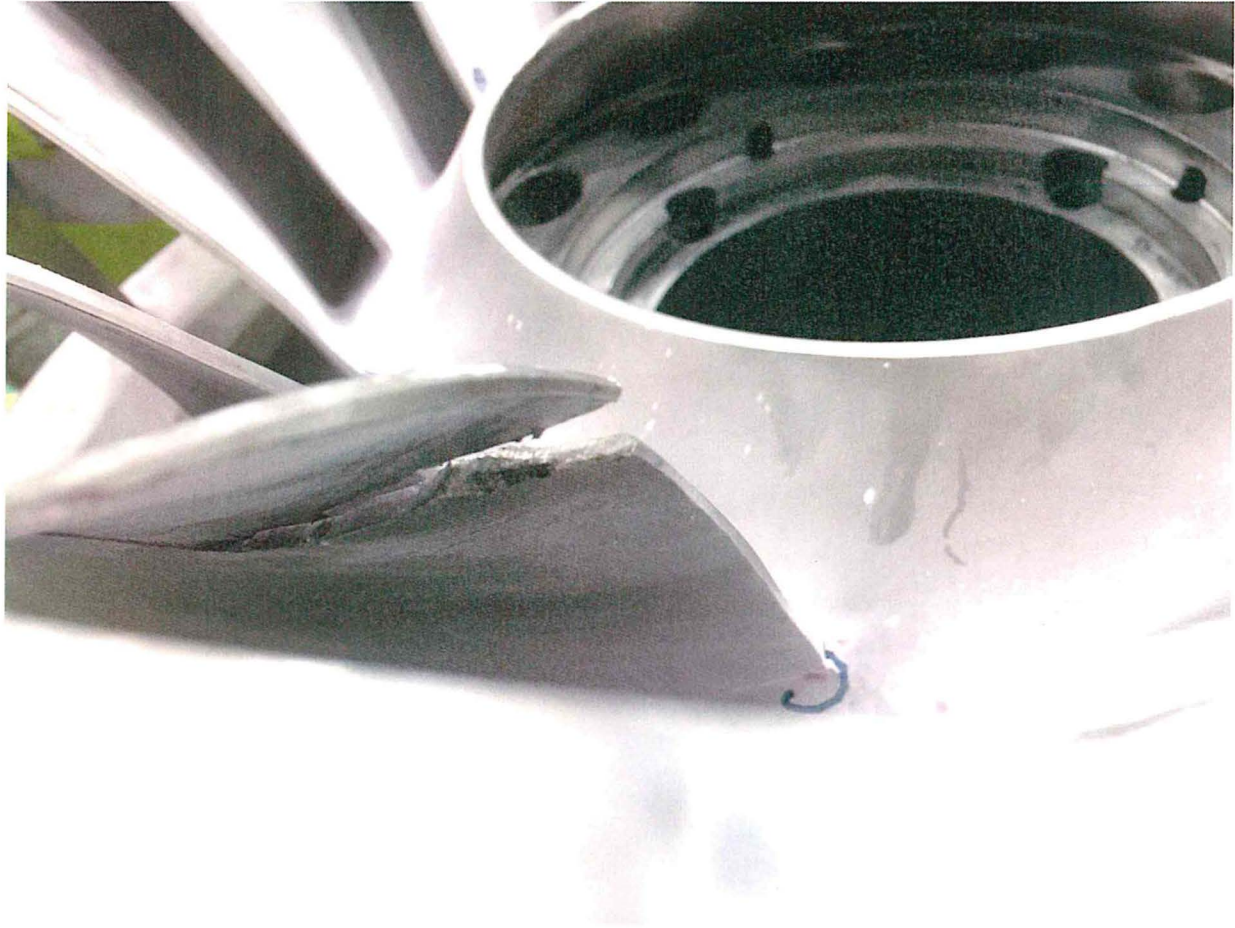
**FIGURE 4 – BUCKET #4 PRESSURE SIDE**

The cracking seen at the intersection of the blade discharge edges and the crown is typical of Francis runners. This location is usually the highest stressed area in a runner, and fatigue cracks may begin to form as a result of the start/stop cycles of the unit. The cracking seen at the intersections of the blade discharge edges and the band can occur on high specific speed Francis runners where the acute angle between the blade discharge edge and band forms a stress concentration. The stresses seen in this area typically result from the rotational speed of the unit (operating and runaway). The crack on blade 4 is not in a location that typically sees high stress. The first 1 inch of this crack length shows a smooth texture typical of fatigue crack propagation with some smearing of the surface that corresponds to shearing between the crack faces. This smearing most likely occurred after the brittle fracture. The remaining 3.5 inches of crack length shows a grainy texture typical of brittle fracture, which would have occurred after the crack propagated beyond the slow growth region. The most probable cause of a crack initiating in this abnormal location is a localized impact causing a crack initiation site. However, there is not a clear indication of such an impact on this blade. Given that, we think that once this blade had cracked and separated from the band, this allowed the blade to repeatedly flex at the now-cracked location. This caused a fatigue crack to form and propagate for the first 1 inch, then transition to fast growth and fracture for the remaining crack length.

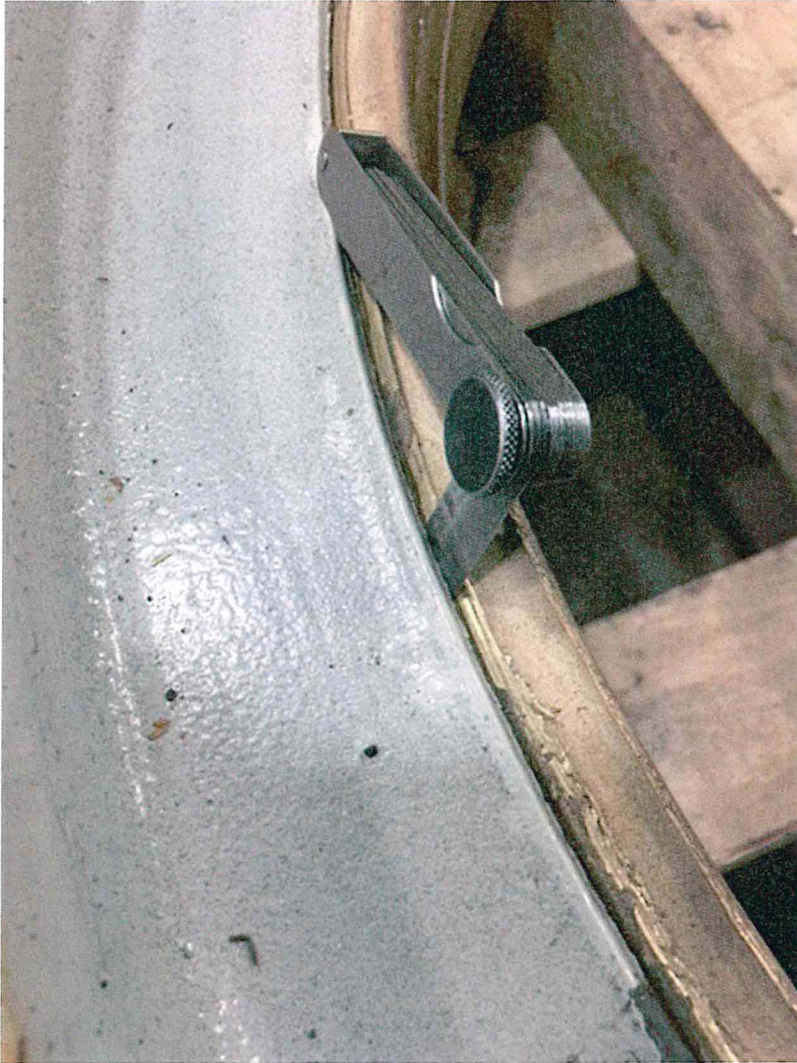
**FIGURE 8 - .010" (.25mm) FEELER GAUGE INSERTED BEHIND SEAL**

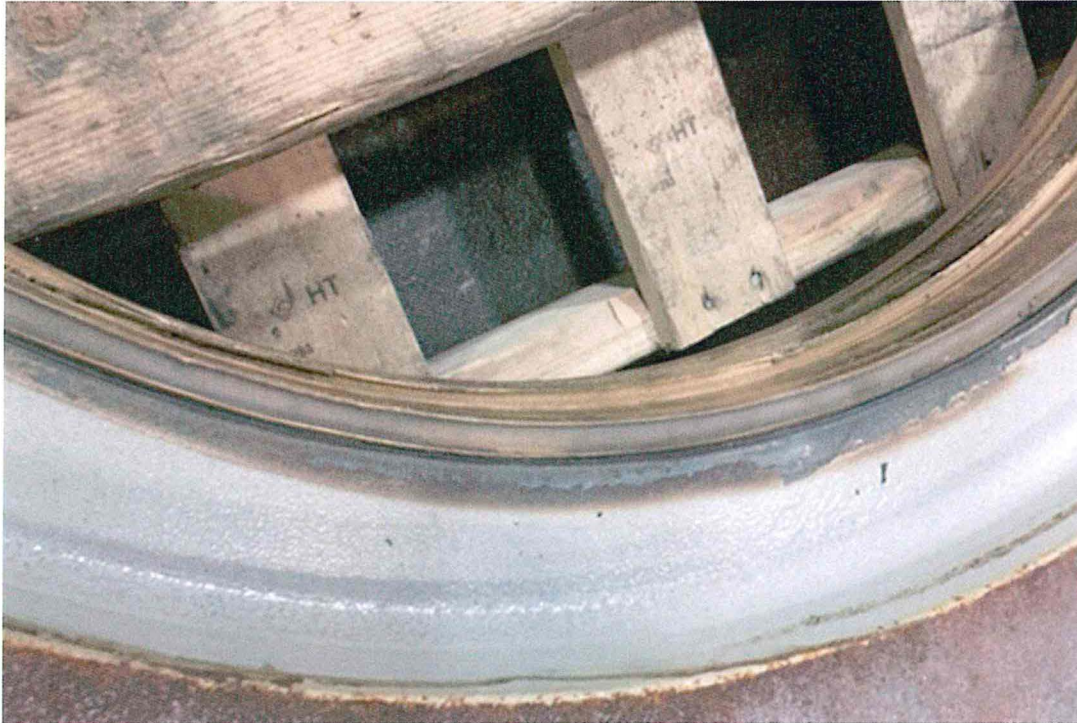
**FIGURE 9 – BURRS ON ID AND OD OF THE WEARING RING AND BLISTERED PAINT**

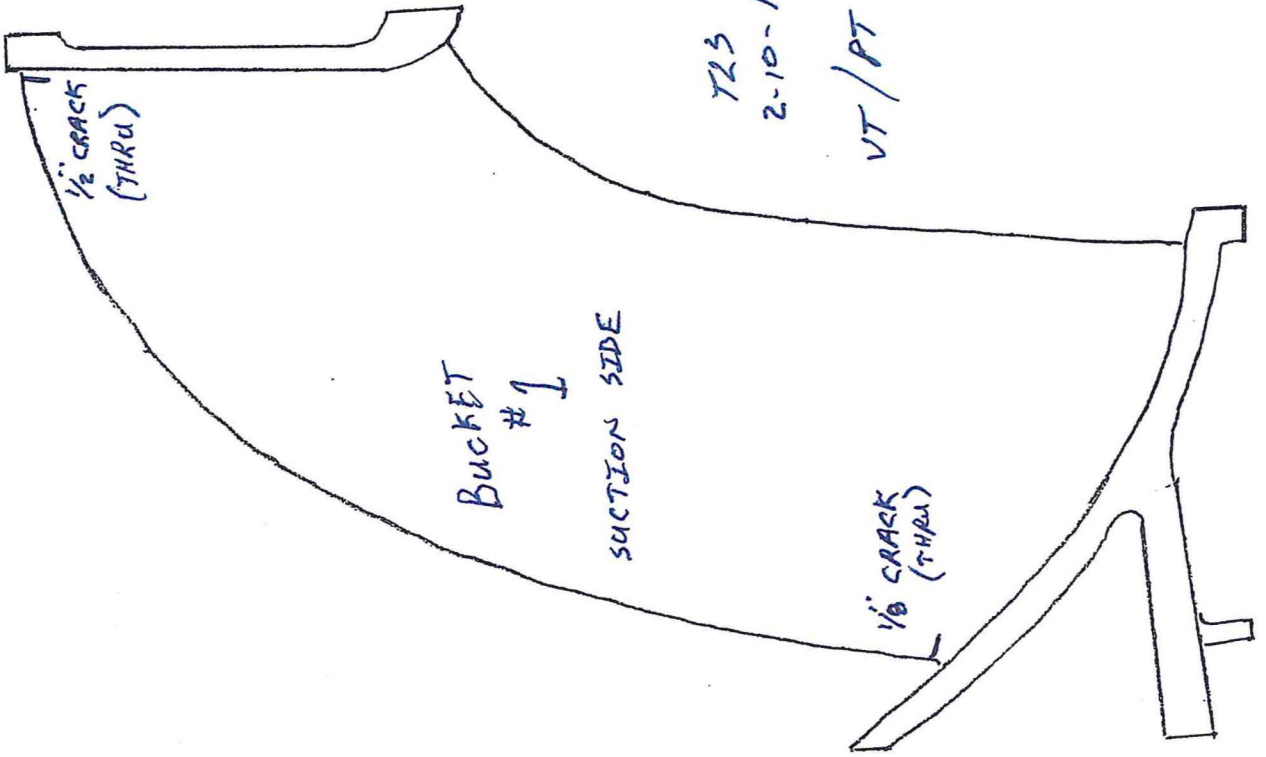
BUCKET  
#1

1/2" CRACK  
(THRU)

VT/PT REJECTS

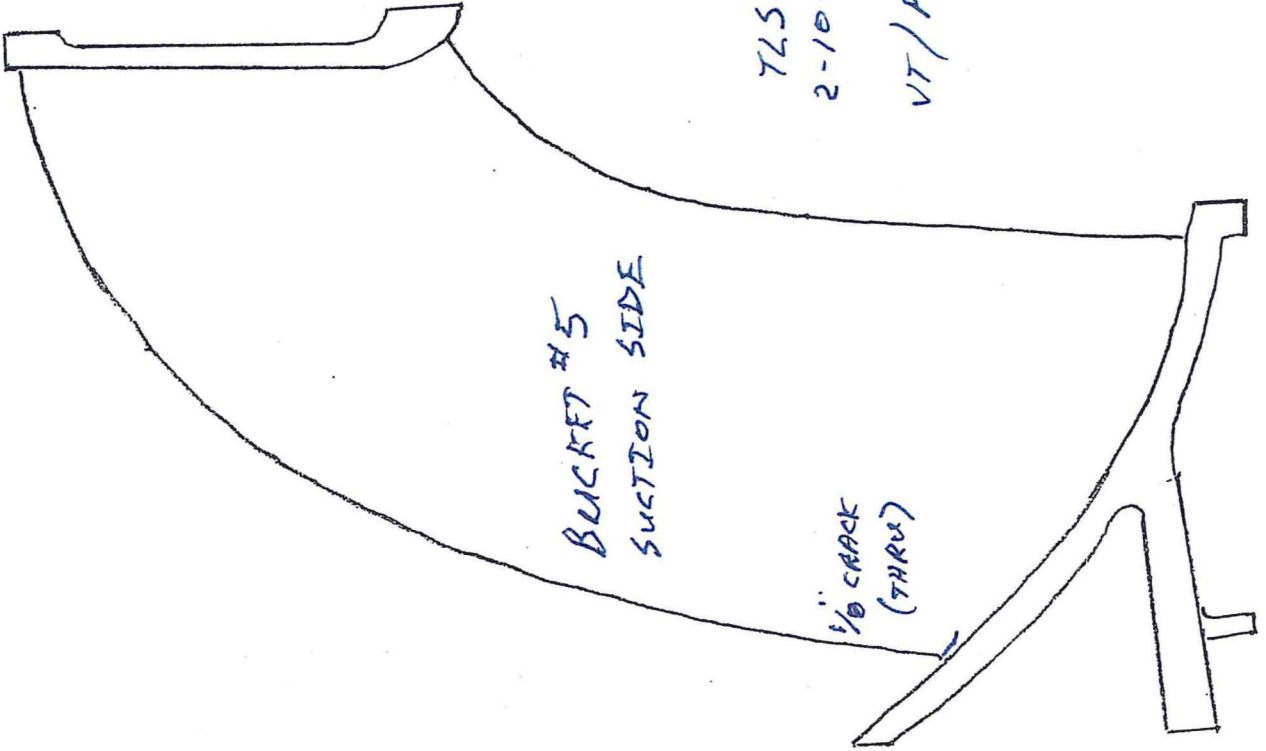
BUCKET #5  
SUCTION SIDE

1/8" CRACK  
(THRU)

725  
2-10-17  
VT/PT REJECTS

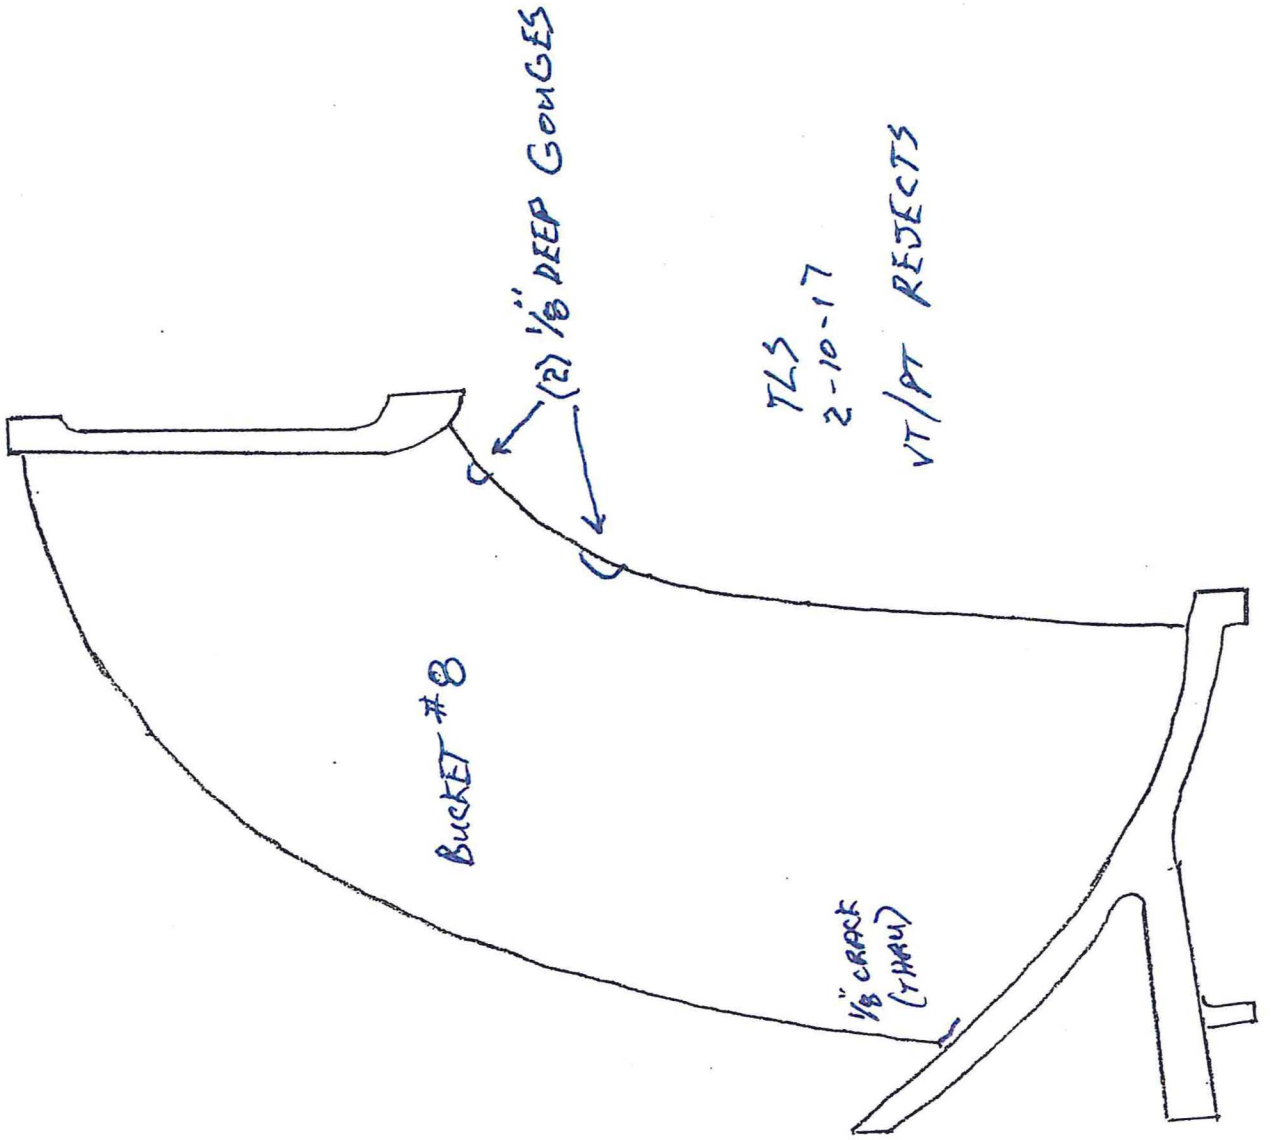
VT/PT REJECTS

1/8" CRACK  
(YHAW)

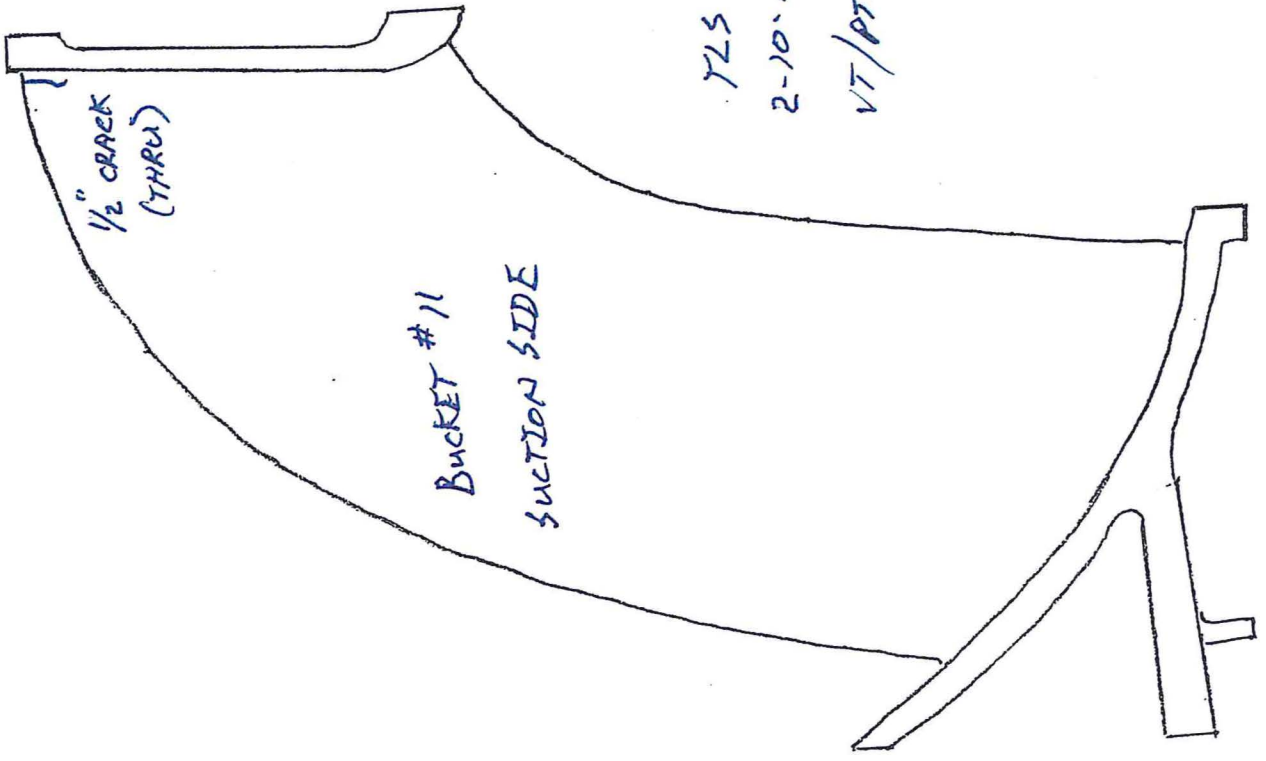
BUCKET #11  
SUCTION SIDE

1/2" CRACK  
(THRU)

VT/PT REJECTS

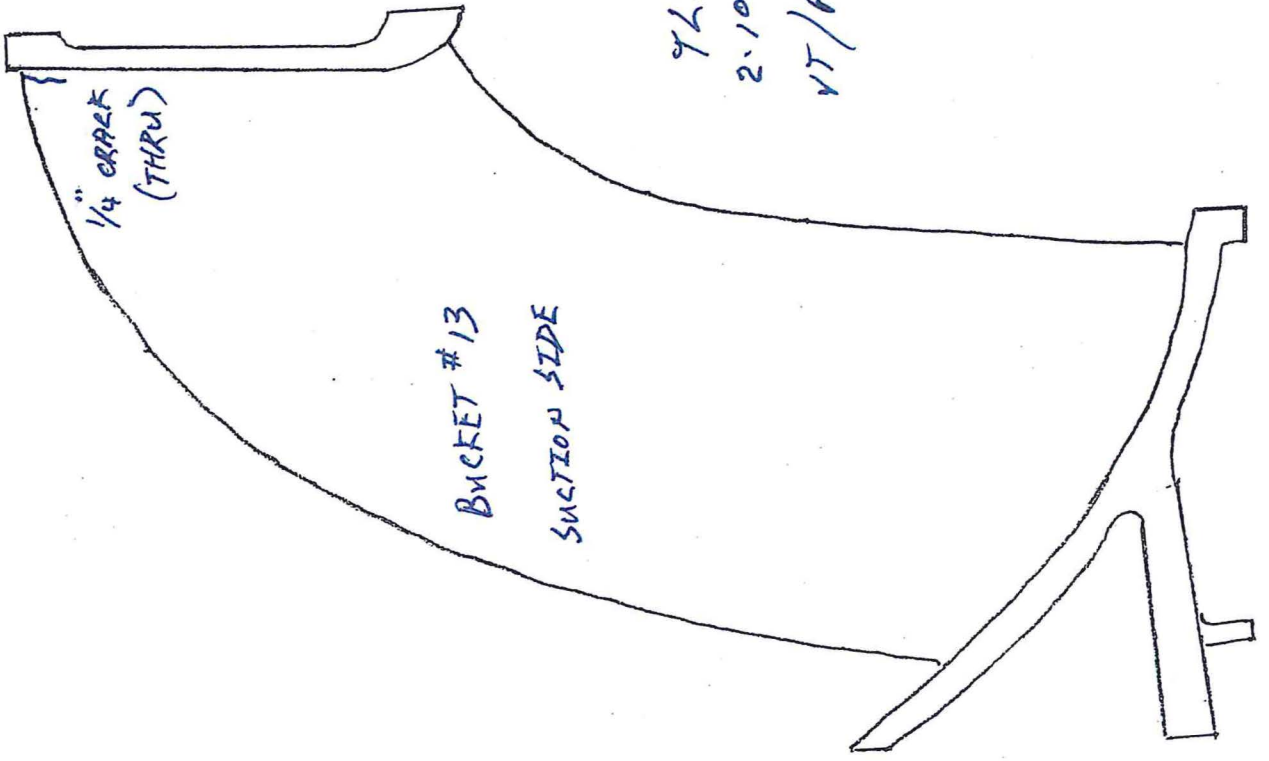
BUCKET #13  
SUCTION SIDE

1/4 CRACK  
(THRU)

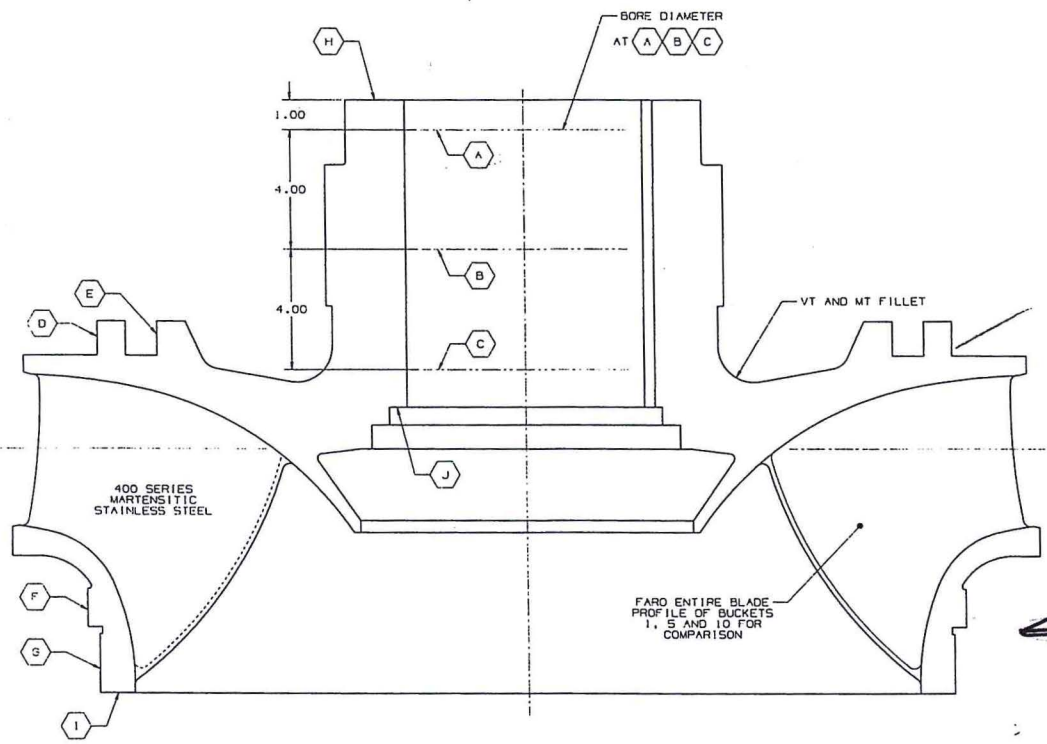
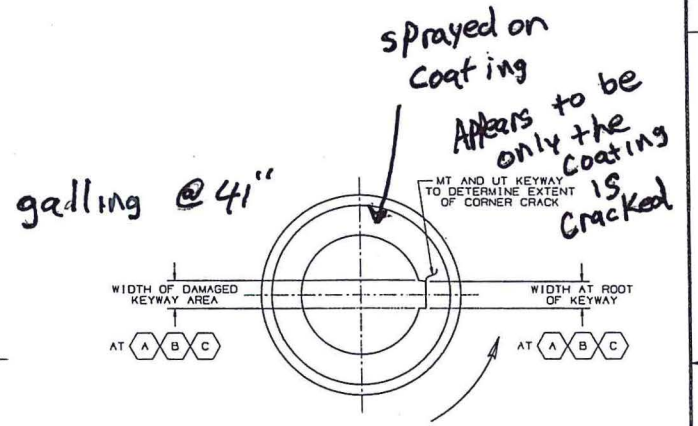
← VT  
 Alum bronze 360°  
 galled to  
 Band seal

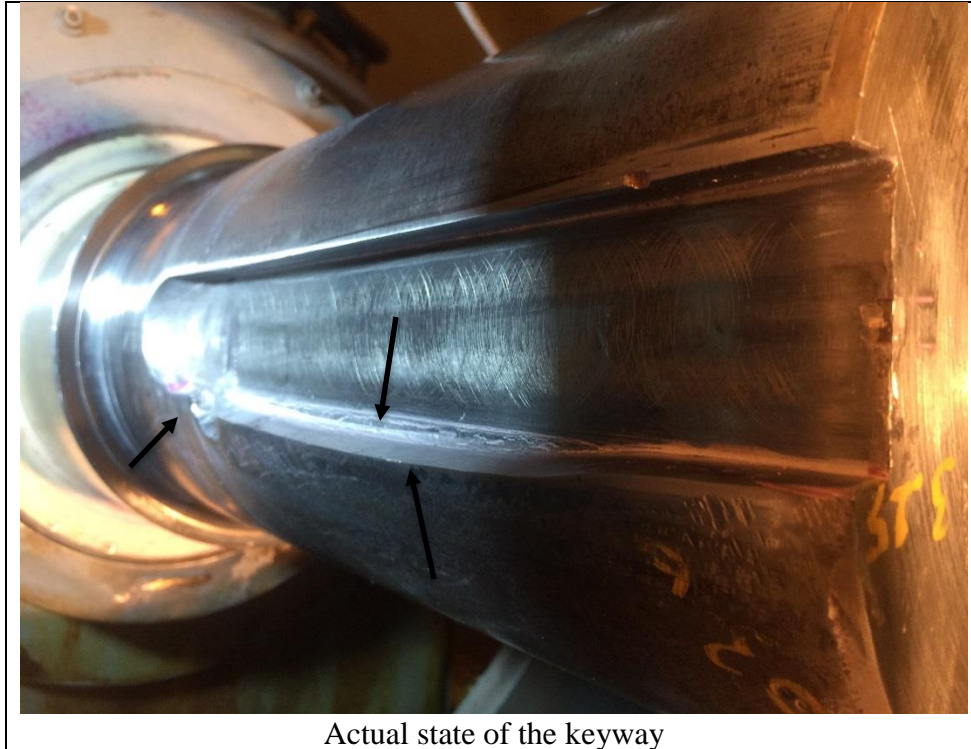
The following picture show the shaft keyway damaged areas.

In the keyway area, we performed a dye penetrant inspection to verify if surface cracking could be detected. We also performed an ultrasonic inspection that confirmed that the key area was free of reportable defects.

We estimate that if we have to machine a keyway oversize free from stress riser, the value C will need to be increased from 1.772 (original) to approximately 2.250. The depth will also need to be slightly increased.

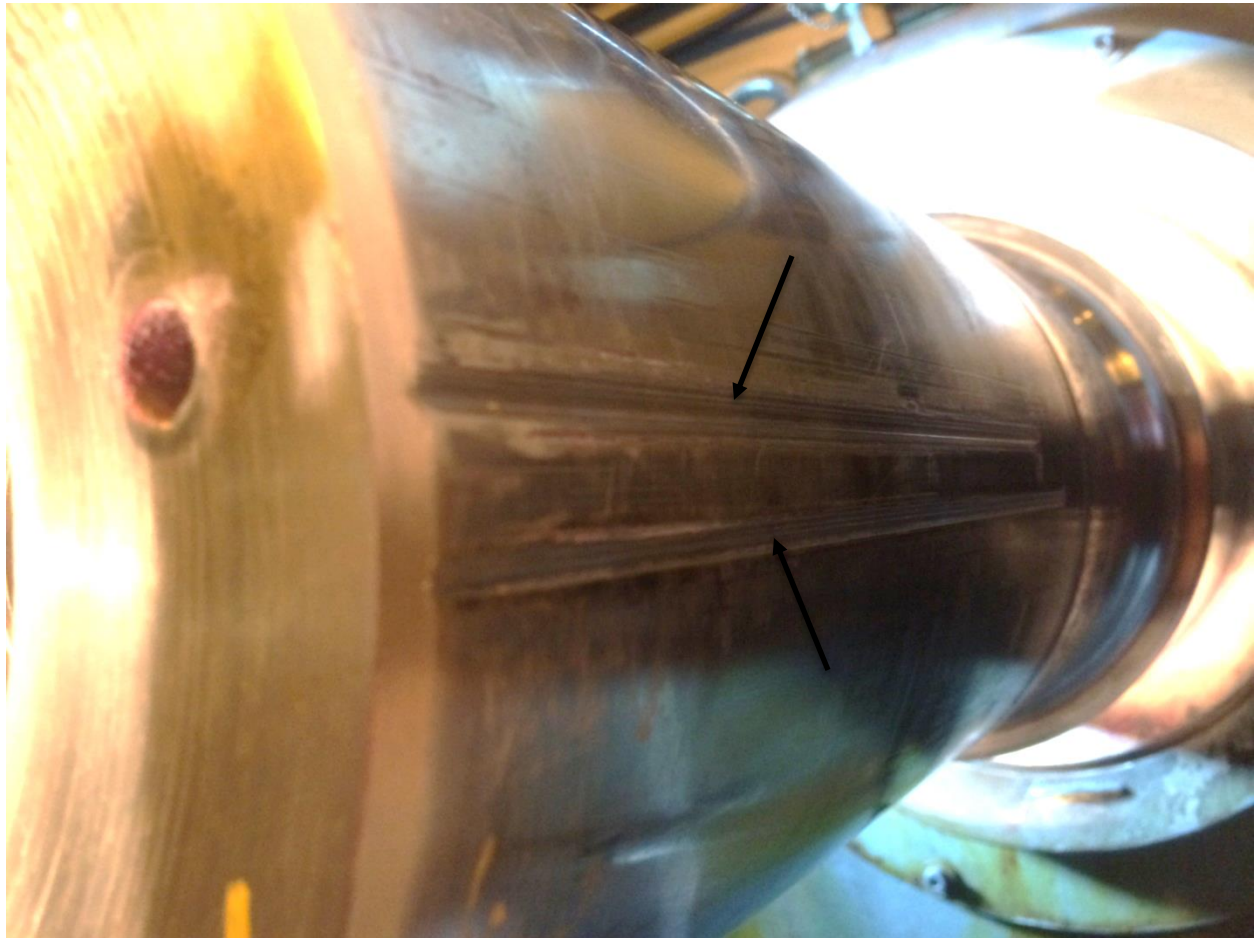
We observed two scratches on the runner fit that possibly originated from the runner removal operation.

Two scratches of approximately 0.0625" depth x 9" long

We perform an NDT inspection that confirmed the runner fit was free from reportable indications.

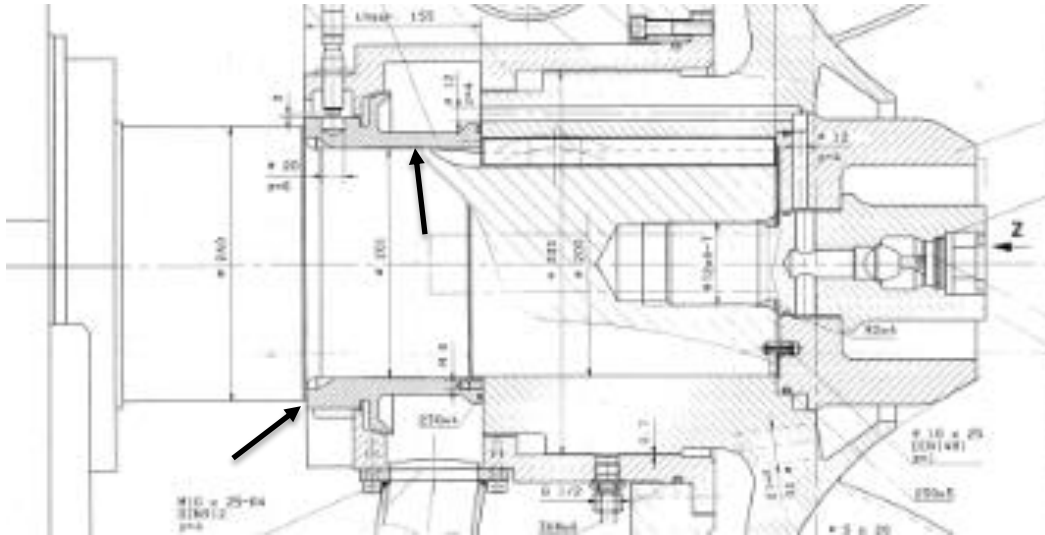
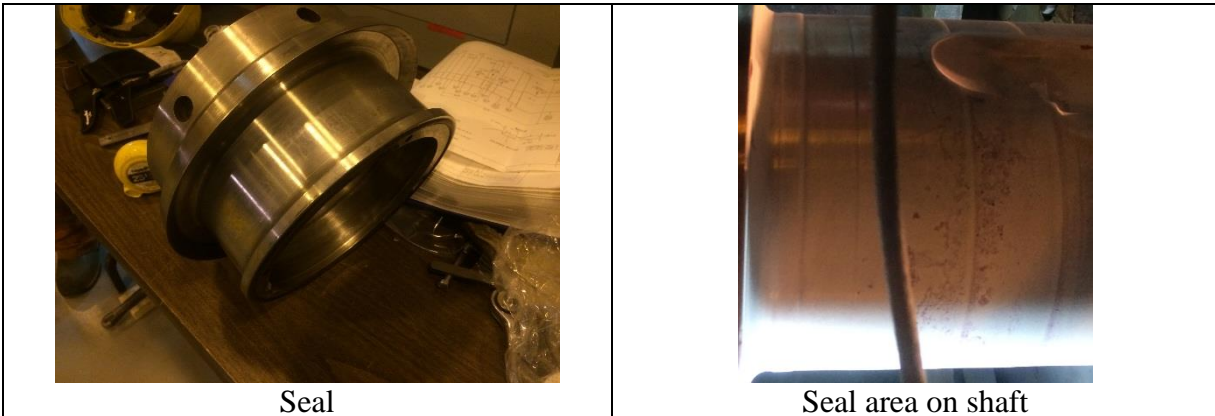
The following cross section of the shaft end indicates damage where the shaft is in contact with the seal bushing.

The NDT inspection report confirmed that the surface was not cracked but does have some indications of fretting and wear.

Shaft measured 7.914” towards thrust bearing for a small area on the shaft, and 7.901” towards the runner side. General shaft drawing shows 7.913”.

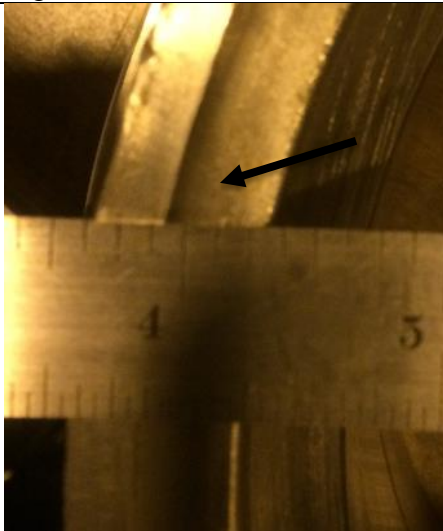
Worn area on the bushing

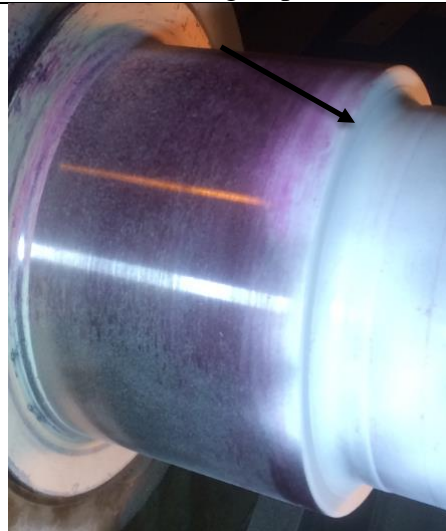
Worn area on the shaft shoulder

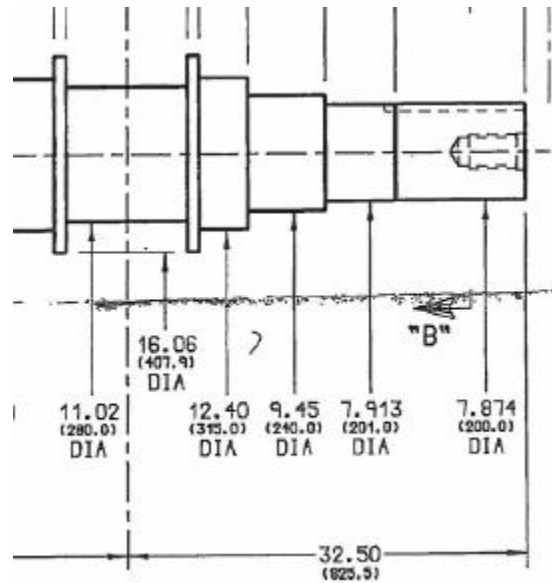
The total indicator runout measured on the seal fit was 0.004 mils and at the end of the shaft was 0.017 mils.

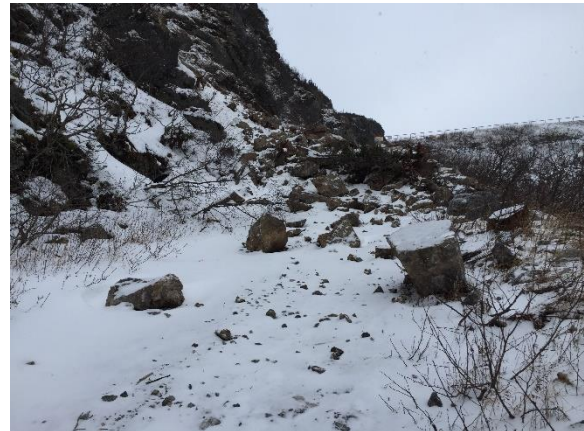
**Figure 3 - Road Blockage**

The rockfall has completely obstructed vehicle access to the main dam. As shown in the photograph in Figure 3, a significant portion of the rock debris came to rest in a mound on the road. Due to the instability of the slope, MECO recommended that removal of the material blocking the road should not be immediately undertaken and that the dam be accessed only from the opposite side of the valley. Access is currently limited to pedestrian traffic. Due to the steep rocky slopes of the valley, vehicular access cannot be established without major capital works.

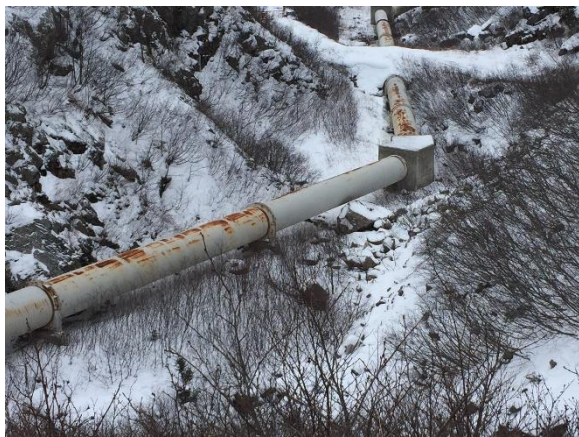
**Figure 4 – Overview of Damaged Area**

The Penstock was struck by rock in 4 locations resulting in dents in the penstock and damage to the paint.<sup>2</sup> The largest boulder to strike the penstock was estimated to weigh approximately 5 tonnes. The location of some of the impacts also indicates that the boulders were bouncing significantly at the time of the impact. All welds appear to be intact, and the penstock does not appear to have been displaced. MECO has advised that the penstock may be expected to operate without incident in the near term; however, in light of the damage sustained, further assessment will be undertaken to confirm the long-term integrity of the penstock.

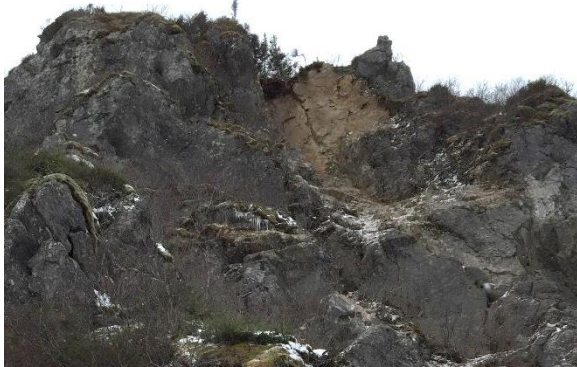
Figure 6 – Unstable Rock Slope

Vehicular access to the main dam is essential to the safe, reliable operation of the Plant. Staff must be able to access the dam with vehicles and equipment to perform routine maintenance, such as trashrack debris removal.<sup>3</sup> Access is also required to provide response in the event of a dam safety, public safety or employee safety emergency.<sup>4</sup> Due to the instability of the rock slope, MECO has recommended avoiding work in the area until summer. With access currently limited, the Company's ability to respond to normal operational and maintenance requirements is also limited. The associated risk is acceptable in the short term; however, remediation of the rockfall site and the access road must be undertaken as soon as it is safe to do so. The photographs in Figures 6 and 7 show the unstable rock slope.

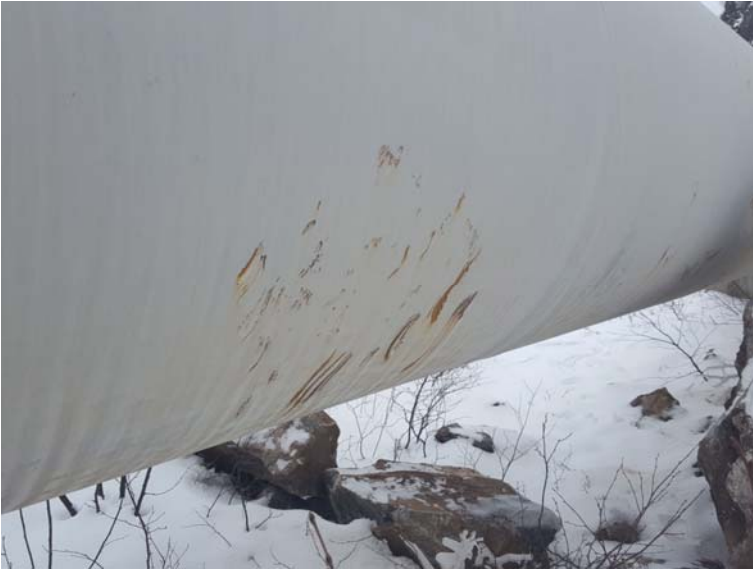
**Photo 15** – Impact Area 2, paint damage, steel indented.

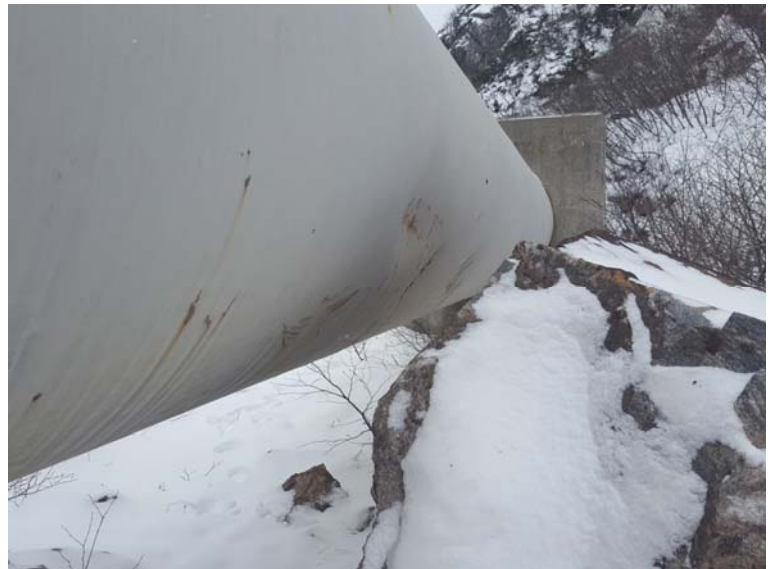
**Photo 16** – Impact Area 3. Approximate 5 tonne boulder impact.

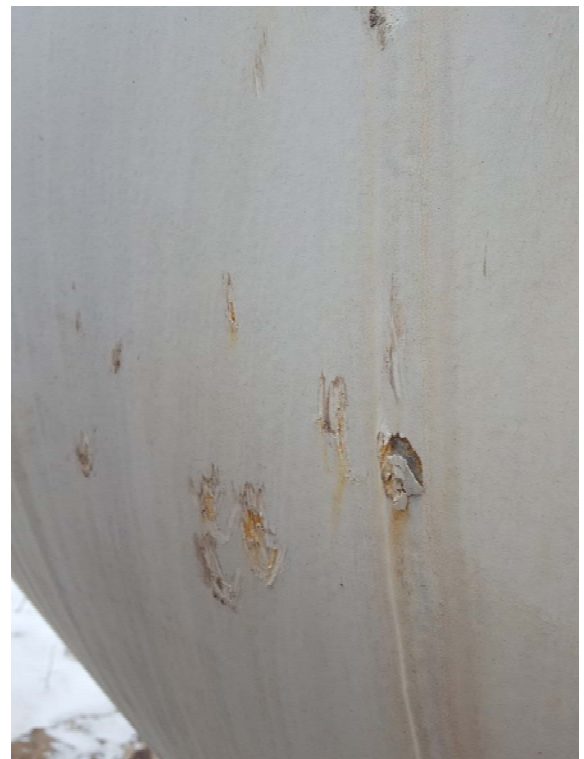
**Photo 22** – Paint Damage.

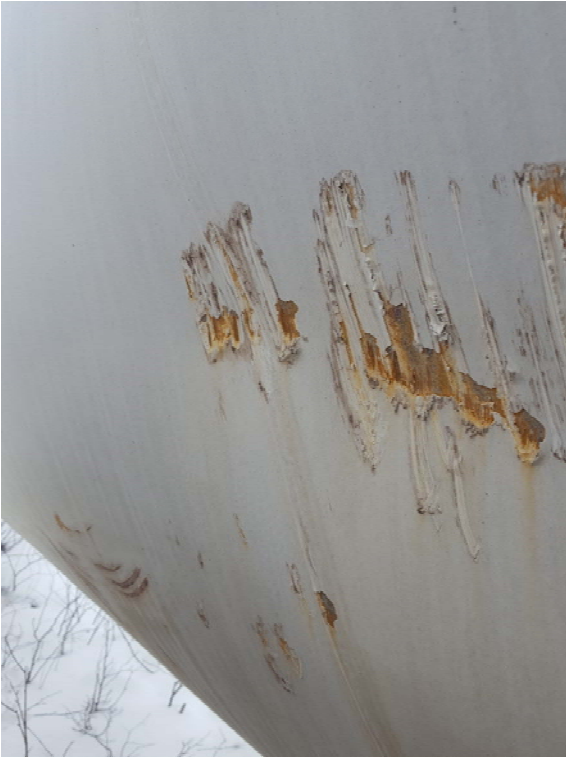
**Photo 23** – Paint Damage.

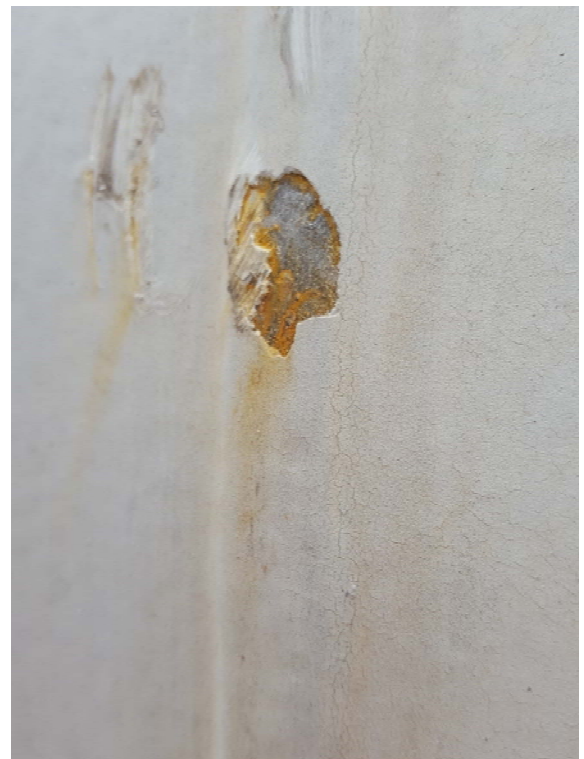
**Photo 24** – Paint Damage.
