Distribution Rebuild Update

June 2012

Byron Chubbs, P.Eng.

4.4 *Rebuild Distribution Lines Update*

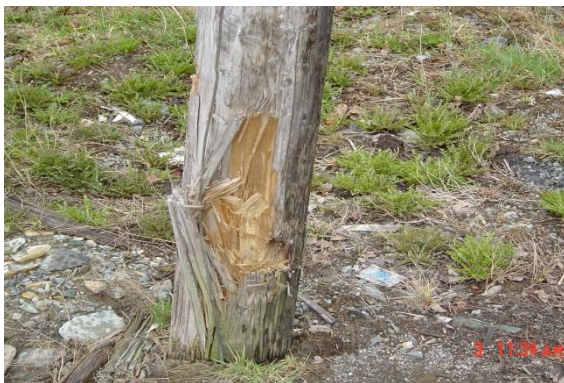
Figure 1: Damaged Wooden Pole

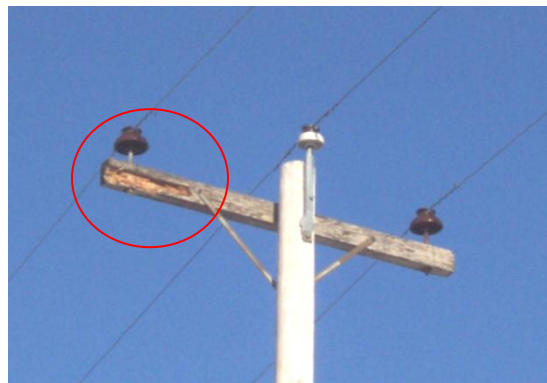
Figure 2: Rotten Crossarm

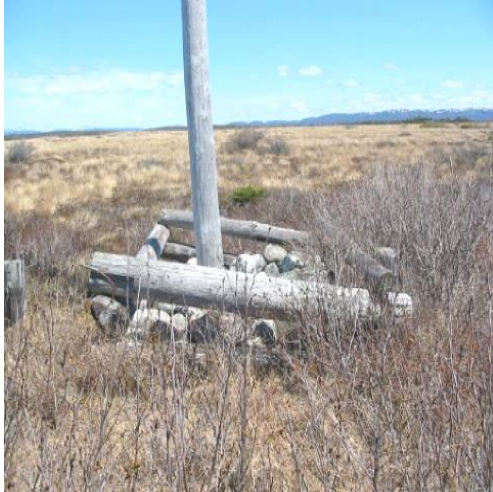
Figure 3: Pole Crib Requiring Repairs

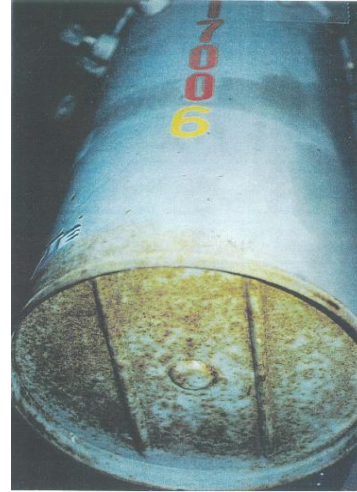
Figure 4: Rusted Transformer

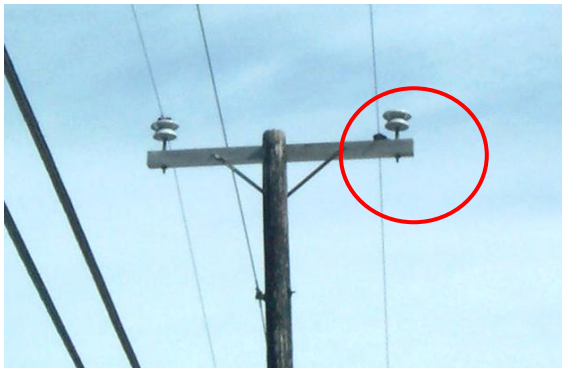
Premature failure of porcelain insulators due to “cement growth” is a known problem through the utility industry.¹² Newfoundland Power began to experience abnormal failures of porcelain insulation in the early 1980s.¹³ Since that time, the Company has replaced a significant number of defective CP8080 suspension insulators and 2-Piece pin-type insulators.¹⁴

Figure 6: Broken Insulator In Service

¹² Since the early 1960s the term "cement growth" has been used to categorize a problem for premature failure of porcelain insulators. The volume expansion of the cement occurs in the presence of moisture and is attributed to a chemical change in the cement that occurs with age. The expansion typically occurs over 10 or more years. As the cement expands it produces stress on the porcelain that fails in tension by cracking.

¹⁴ CP8080 suspension insulators fail by radial cracks, which are sometimes contained inside the metal cap and are not visible. The crack causes a current path between the metal cap and pin and shorts out the insulator. Pin type and pin cap type (2-Piece) insulators fail by circumferential cracks. Failure is usually mechanical; the top shears off the insulator causing the conductor to float clear of the structure.

- *Locations where CP8080 and 2-Piece insulators remain in service.* In the year following the inspection, insulators identified for replacement are included as part of the *Rebuild Distribution Lines* project.

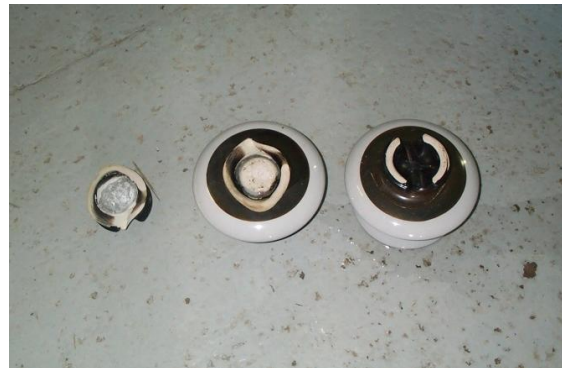
Figure 7: Broken Insulator Removed From Service

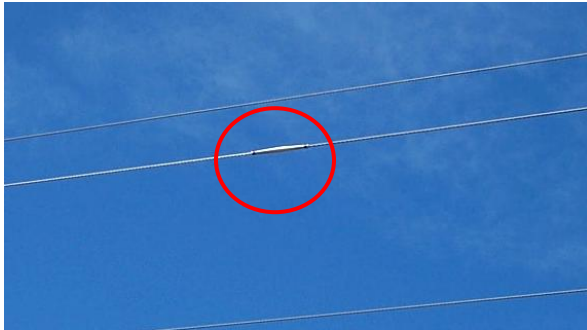
nine years in service these automatic sleeves began showing signs of premature deterioration, in large part due to our severe environmental conditions.¹⁹

Figure 9: Automatic Sleeve In Service

First indications of a problem surfaced in early 2002 when an automatic sleeve failed. An investigation followed which showed a high percentage of sleeves were experiencing signs of water ingress and internal corrosion.²⁰ The potential risks to public and employee safety, as well as system reliability prompted the Company to discontinue the use of automatic sleeves by the fall of 2002.²¹

²⁰ In the Fall of 2002, a total of 35 sleeves were removed from various areas throughout the Company and inspected. The results indicated widespread internal deterioration of automatic sleeves. 71% of the sleeves removed showed at least some corrosion with 37% being severely corroded.

²¹ Mechanical failure of a corroded automatic sleeve would result in line separation and the potential of an energized line dropping to the ground, presenting a public safety hazard. This hazard would also exist for line personnel performing energized work. In addition to mechanical failure, there is the risk of electrical failure of the sleeve creating an open circuit. This is particularly hazardous if a sleeve is on a neutral conductor. Voltage differences could be present across an electrically open sleeve on a neutral conductor that would be hazardous to line personnel. Mechanical or electrical failure of automatic sleeves can each result in customer outages.

- *Locations where automatic sleeves remain in service.* In the year following the inspection, automatic sleeves identified for replacement are removed as part of the *Rebuild Distribution Lines* project.

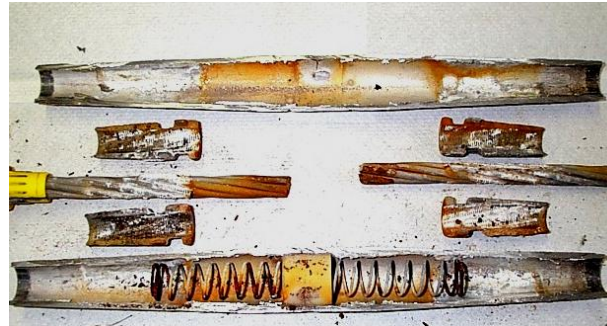
Figure 10: Disassembled Automatic Sleeve Showing Corrosion

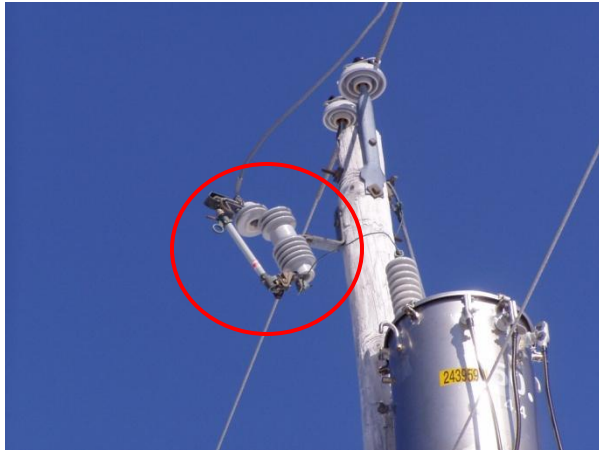
Porcelain insulated cutouts have been in use in the electrical industry for many decades.²² Throughout that time, design and manufacturing processes have changed somewhat, but porcelain remained as the basic insulating material. In 2000 and 2001, the Company began to experience incidents of failed porcelain cutouts. Through 2002 and into 2003, hundreds of cutout failures were reported, and line personnel became increasingly concerned with the safety hazards associated with cutout failures.²³

²³ Throughout the Company cutouts are opened and closed as part of regular system operations. This is typically done by line personnel positioned in the pole or the bucket of a line truck using a 10' long *hotstick*. Operating a cutout that is close to failure while it is energized may result in the cutout breaking, placing line personnel in an unsafe situation.

Figure 11: Broken Porcelain Cutout In Service

In 2003, as a result of the increasing rate of failures, the Company decided to discontinue the use of porcelain insulated cutouts and adopt the polymer insulated cutout as its new standard.²⁴

Porcelain cutout failures continued to increase after 2003, and since that time, the Company has expanded the replacement program to all porcelain cutouts on the main trunk of distribution feeders, as well as lateral taps and large customers.

- *Locations where porcelain cutouts remain in service on the main trunk of distribution feeders, as well as lateral taps and large customers.* In the following year porcelain cutouts identified for replacement are removed as part of the *Rebuild Distribution Lines* project.

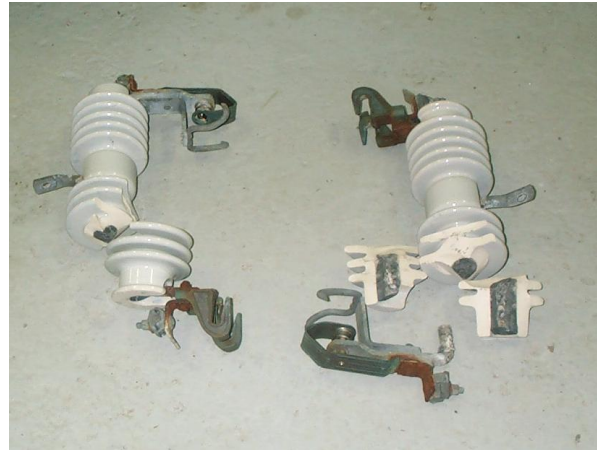
Figure 12: Two Broken Porcelain Cutouts Removed From Service

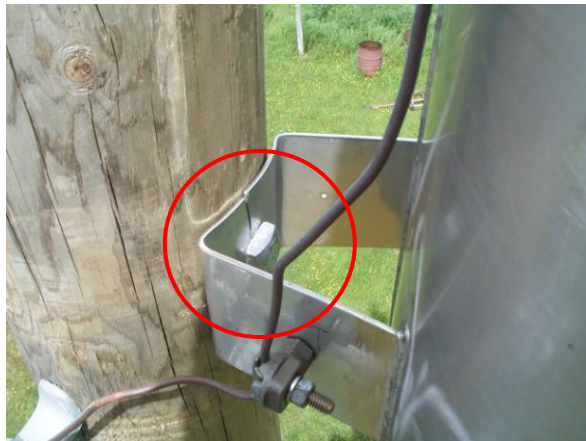
The Company began purchasing pole mounted transformers manufactured with 316L stainless steel in 2001. This was done as a result of numerous failures due to rusting transformer tanks, largely due to higher levels of salt contamination in Newfoundland. After several years of using the new stainless steel tank design, the issue of broken hanging brackets began to surface on 25 kVA and 50 kVA transformers.²⁶

Following discussions with the manufacturer it was determined that the hanging brackets were not sufficient for the mechanical forces exerted by higher wind conditions in the Newfoundland environment. To address this issue, the Company changed its specification for stainless steel transformers in 2007, requiring a hanging bracket made of a thicker gauge stainless steel.

Figure 14: Broken Stainless Steel Transformer Hanging Bracket

²⁶ The first reported bracket failure occurred in 2003 when a lower bracket split after being in service for several months. A second reported bracket failure occurred in February 2006.

²⁷ Of the reported failures, 19 were 50 kVA units, 7 were 25 kVA units and 2 others did not have the size reported.

In total there have been 27 transformer bracket failures reported on stainless steel transformers manufactured from 2001 to 2006, inclusive.²⁷ As a result, the Company has worked with the manufacturer to develop a reinforcing bracket that can be installed on in-service transformers. Beginning in 2013, 25 kVA and 50 kVA transformers manufactured between 2001 and 2006 will be identified and retrofitted with a reinforcing bracket as part of the *Rebuild Distribution Lines* project.

- *Locations of stainless steel transformers manufactured from 2001 to 2006.* In the year following the inspection, transformers identified to be retrofitted with a reinforcing bracket will be included as part of the *Rebuild Distribution Lines* project.
