1 Q. **Refurbishment of Tank 2.**

Newfoundland and Labrador Hydro Holyrood, NL

Fuel Oil Tank No.2

Inspection Interval Extension Report

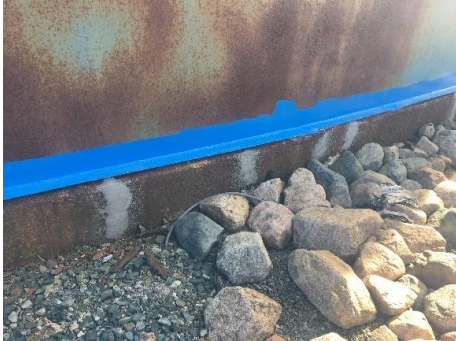
1. Cracking and spalling of concrete ring beam (2017)
2. Corrosion and possible delamination of chine area (2017)
3. Corrosion concerns with floor (2008)

Figure 1: View of concrete ring beam repairs.

1. Repair cracked and spalling areas of concrete ring beam
2. Seal chine and ring wall interface following repair of ring beam
3. Reapply coatings to the tank chine area
4. Install tank nameplate in accordance with API 650
5. Complete all recommendations from the 2016 inspection report

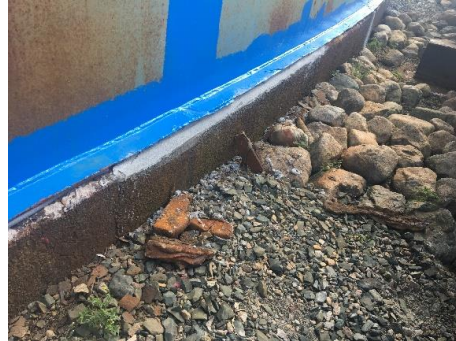
Figure 2: View of concrete ring beam repairs.

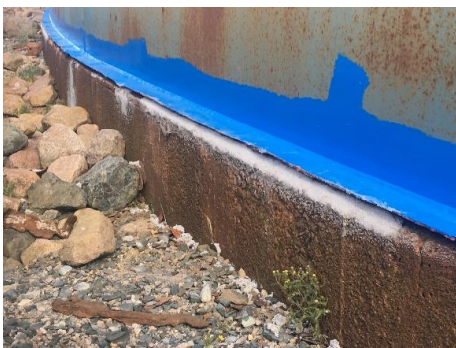
Figure 3: View of concrete ring beam repairs.

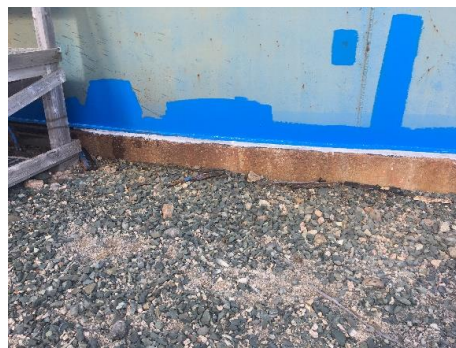
Figure 4: View of sealant applied to tank chine and ring beam interface.

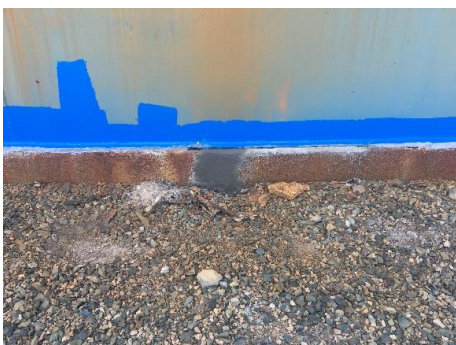
Figure 5: View of concrete repair and sealant applied to tank chine and ring beam interface.

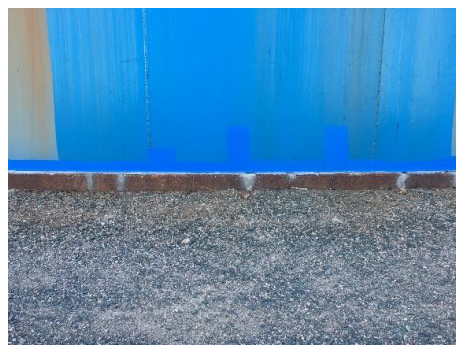
Figure 6: View of concrete repair and sealant applied to tank chine and ring beam interface.

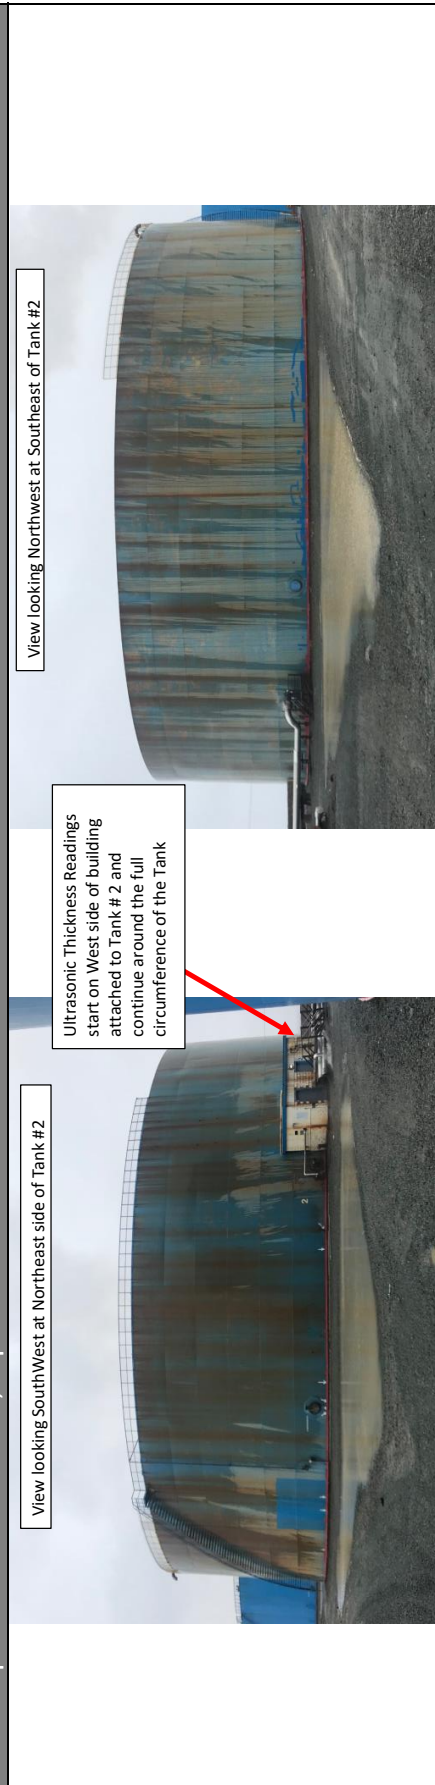
4. The UT inspection commenced concurrently with the MPI inspection. The data indicated that there are no issues with the chine area with the exception of one (1) hole as shown on the reports in Appendix B. The area around the hole showed no signs of corrosion or stress.

Tank # 2													
Readings are taken starting at North of Tank on West side of Shack (Facing Plant) around the circumference													
0.347	0.242	0.347	0.305	0.316	0.334	0.316	0.268	0.233	0.292	0.353	0.364	0.345	0.328

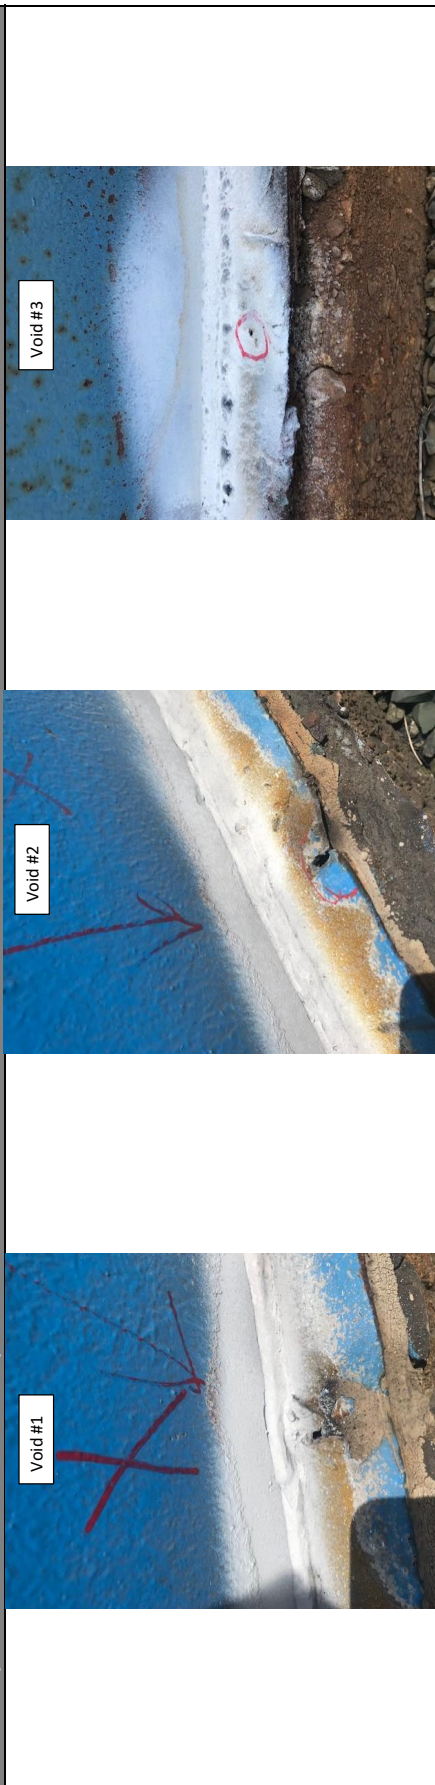
Tank #1		Tank #2	
Void #1	Void #2	Void #3	Void #3
0.266	0.288	0.291	0.304
0.277	0.291	0.331	0.289
0.314	0.301	0.325	0.305
			0.311
			0.286
			0.280
			0.313
			0.310
			0.279
