**Re: Allowance for Unforeseen Items Account – TL219 and TL203 Storm Damage Repairs –
Final Report**

TL219 and TL203 Storm Damage Recovery

Final Report

March 10, 2022

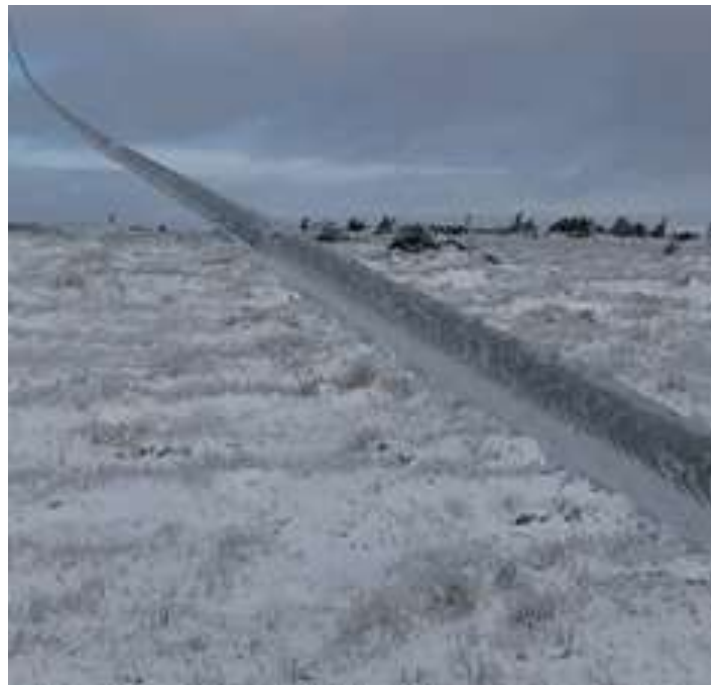
Figure 2: Ice Accumulation on TL219 Conductor

1 On the morning of February 5, 2022, Hydro’s TL203 and TL219 tripped while heavy freezing rain was
2 observed in the region. Freezing rain persisted for several hours, resulting in accumulation of variable
3 amounts of ice on transmission lines and structures (Figure 2) and causing damage to TL219 and TL203
4 conductor and structures. Due to transmission redundancy serving the region, there was no immediate
5 customer impact as a result of the trip; however, to ensure reliable service to customers and ensure
6 damaged structures did not pose a risk to public safety, Hydro had to execute required repairs
7 immediately to mitigate the risk of further damage and restore the system.

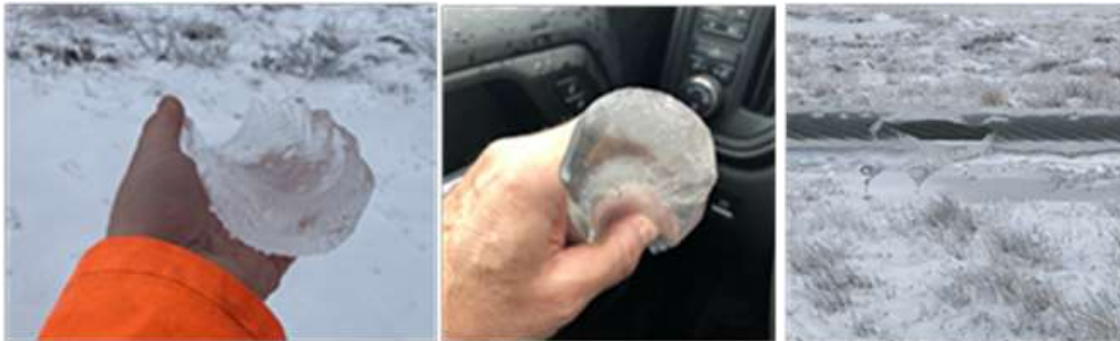
Figure 4: Ice Accumulation on TL219 and TL203

4 The extended weather event resulted in significant, variable ice accumulation on the transmission lines
5 in the area. Figure 4 shows examples of ice accumulation in the area of the failures.

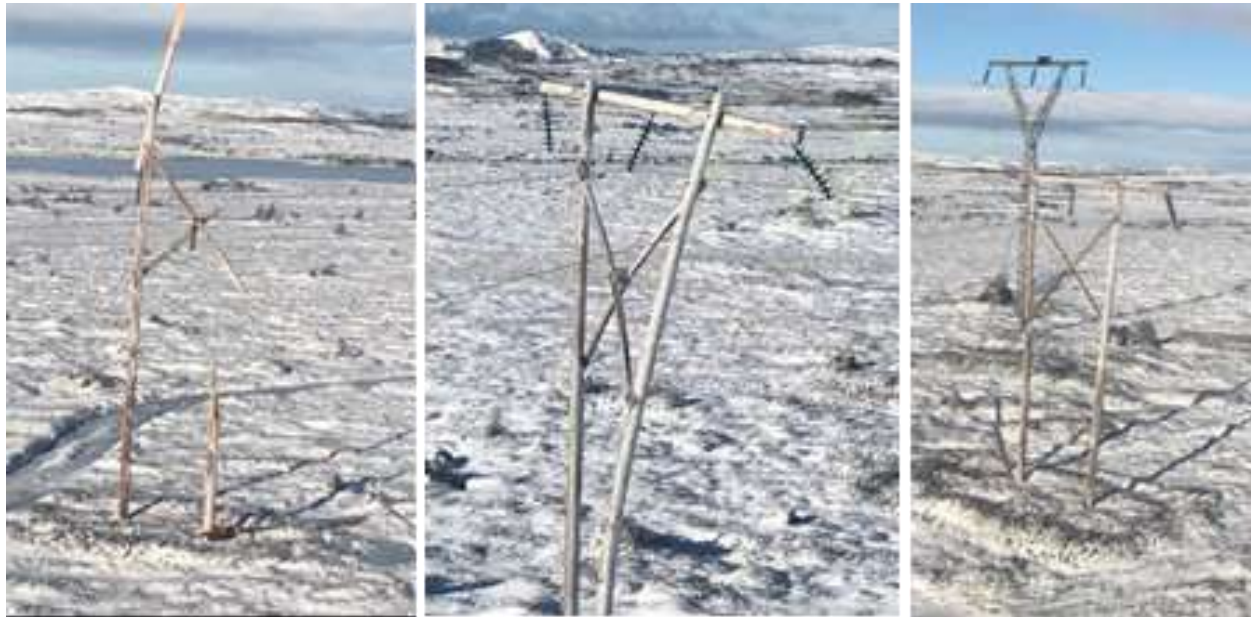
Figure 6: TL219 Structure Failures and Mechanical Bending

2 The damages experienced on TL219 included the structural failure of four consecutive Tangent H-frame
3 structures (Structures 392–395) in the Terrenceville area as shown in Figure 5. The damage included
4 broken conductor, poles, crossarms, and cross braces as shown in Figure 6.

5 Based on observations at site, it appears that ice accumulation on the conductor began to shed off as
6 the temperatures began to increase (refer to Figure 7), resulting in a longitudinal load that caused the
7 conductor and structure to pull in one direction. Due to the vintage of this line, it was not designed for
8 such longitudinal loading and resulted in mechanical bending of the crossarms and structures as shown
9 in Figure 6. The loading experienced had the potential to result in a significant cascade type of failure,
10 similar to a domino effect. As seen in Figure 8, the failure on TL219 was located on a short section of line
11 between two dead end structures,¹ which likely prevented the cascade failure of additional structures.

10 On February 4, 2022, an extreme weather event resulted in variable ice accumulation on sections of
11 TL219 and TL203. This ice accumulation, in conjunction with the age of the assets, was significant
12 enough to overload the capacity of the structure components resulting in a system failure. For TL219
13 specifically, it is suspected that ice shedding from the conductor resulted in unbalanced loading of the
14 structures⁴ causing the structures to bend longitudinally and eventually fail.

3 The scope of work for TL219 included the full replacement of four Tagent H-frame structures. This
4 includes the following work tasks:

- 5 • Remove and dispose existing damaged structures;
- 6 • Splice broken conductor;
- 7 • Install new poles;
- 8 • Install new crossarms and cross bracing; and
- 9 • Install insulators.

10 The existing tangent structures were designed using a single dimensional wood crossarm configuration
11 supported by class 4 poles. As Hydro no longer uses class 4 poles for transmission infrastructure, the
12 existing structures were replaced with class 2 poles, increasing reliability of the structures as per current
13 standards. In addition, a double dimensional wood crossarm was utilized instead of a single crossarm to
14 increase the structures ability to resist future unbalanced loading. Figure 11 illustrates the design
15 difference between the existing structure and the new structure. The more robust material components
16 utilized during the repair effort provide a significant increase in structure capacity. Refer to Figure 12–
17 Figure 14 for photos showing repair work.

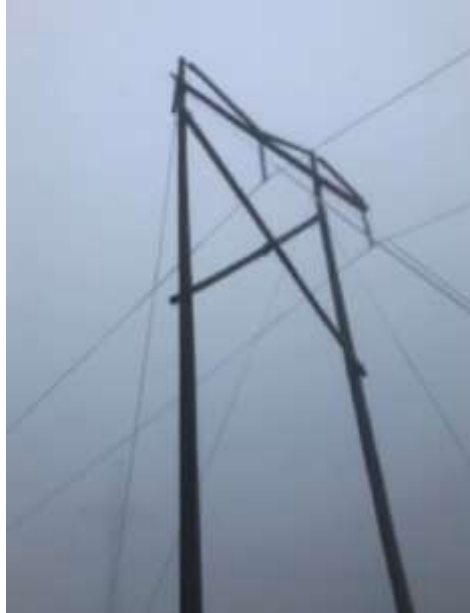
Figure 9: Broken Crossarm on TL203 – Structure 77

- 2 The damage experienced on TL203 included the structural failure of a crossarm on Structure 77 as
3 shown in Figure 9 near the isthmus on the Avalon Peninsula (Figure 10).

2 The scope of work for TL203 included the replacement of a single wood pole crossarm on Structure 77
3 as shown in Figure 9. This was replaced as per the original design.
