Re: Application for Approval for Rotor Rim Shrinking and Stator Recentering at the Upper Salmon Hydroelectric Generating Station

Upper Salmon Hydroelectric Generating Station Rotor Rim Shrink and Stator Recentering

April 26, 2022

A report to the Board of Commissioners of Public Utilities

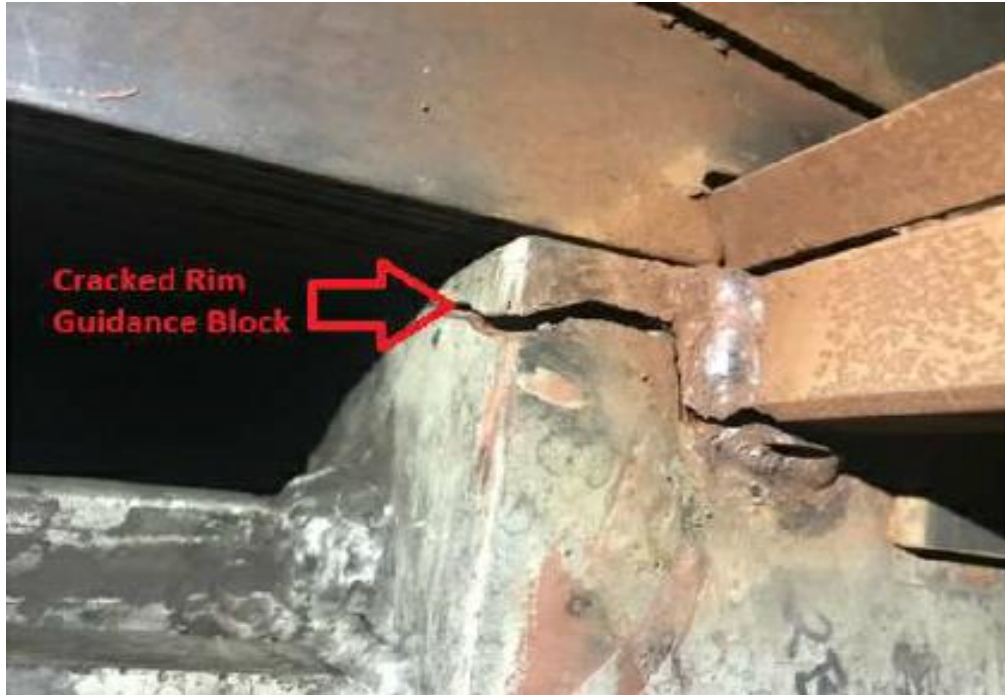
Figure 4: Rotor Rim Guidance Block #10 Crack

17 During the planned annual preventive maintenance checks and inspections in August 2021, a significant
18 crack on rim guidance block #10 (Figure 4) was discovered along with two drive key assemblies, #5 and
19 #6, which had shifted upward within their slots (Figure 5 and Figure 6, respectively). This was the first
20 occurrence of cracking identified on the rotor rim guidance blocks and the first time that a whole
21 assembly had shifted. It was also noted that the rotor rim guidance assembly was close to hitting the
22 shrouds on the unit, as can be seen in Figure 5.

7 A failed rotor rim guidance key and a corner of one of the blocks that had failed were removed and sent
8 to Wayland Engineering’s metallurgy testing facility for failure analysis. The analysis indicated fatigue as
9 the failure mode for the guidance block sample provided.

10 With these results, Hydro, in consultation with the OEM, attempted to gouge the cracks to determine if
11 the guide blocks could be refurbished. Due to the depth of the cracks, Hydro determined that
12 refurbishment was not possible on all of the blocks and keys. It was also determined that it was not
13 possible to implement the long-term solution of a rotor rim shrink and stator recentering at that time
14 due to the commitment to have the Upper Salmon unit in service for the 2021–2022 winter availability
15 period. The long-term solution requires finite element analysis (“FEA”) to confirm design details and
16 procurement of specialty items such as stator sole plate keys, which have long lead times of up to six
17 months. Therefore it was determined that the Upper Salmon unit would have all the rotor rim guidance

1 keys welded and all blocks replaced as a short-term fix in 2021 under the Hydraulic In-Service Failures
2 project,⁴ and Hydro would seek approval to implement the long-term solution of rotor rim shrink and
3 stator recentering in 2022.

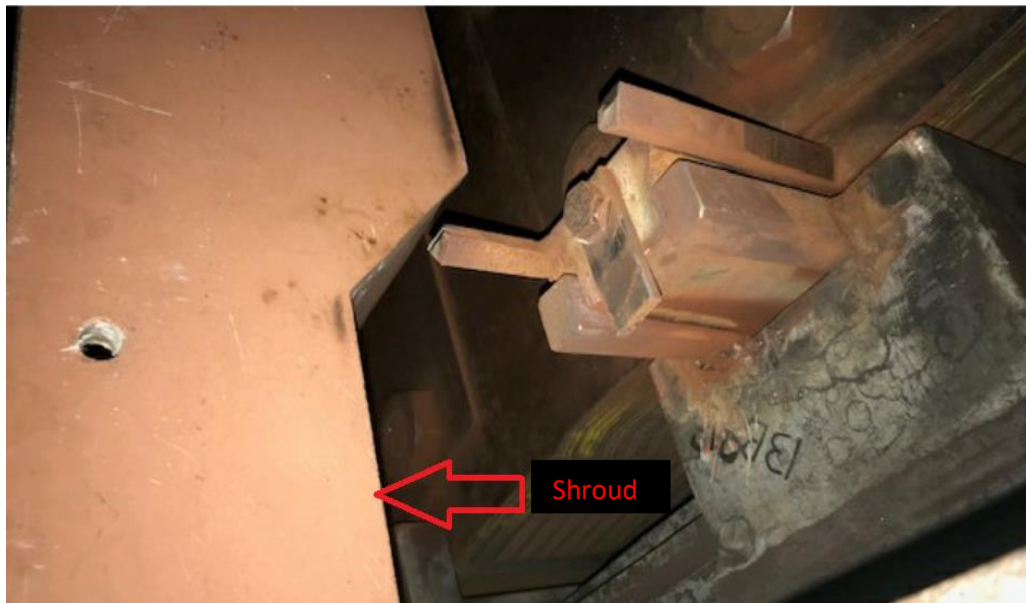
Figure 5: Raised Key Assembly #5

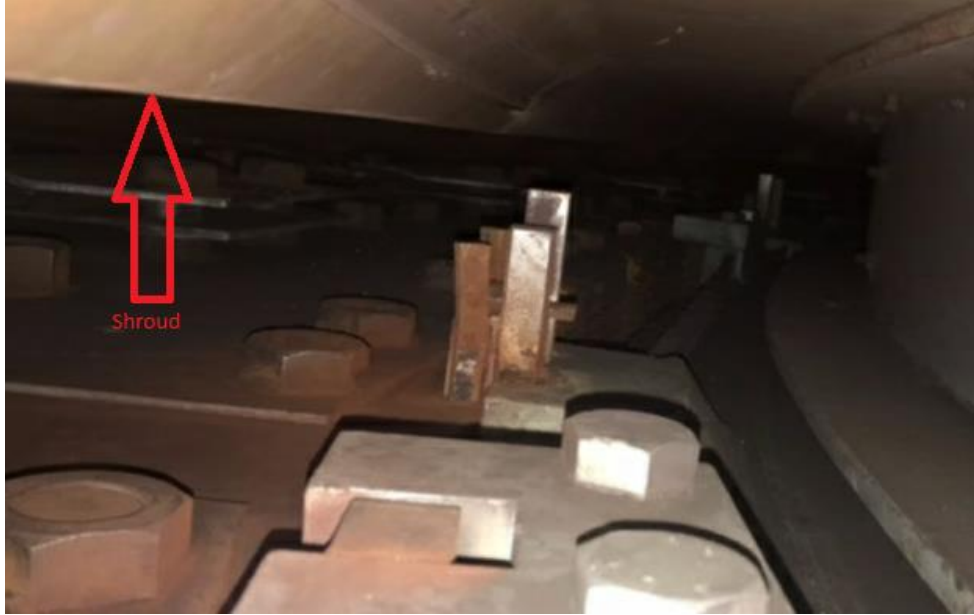
Figure 6: Raised Key Assembly #6
