Q. Re: Rocky Pond Plant Refurbishment (p. 2 of 81, Schedule B) - Provide for the last five years:

2005 Dam Safety Inspection Report

**Tors Cove /
Rocky Pond
Developments**

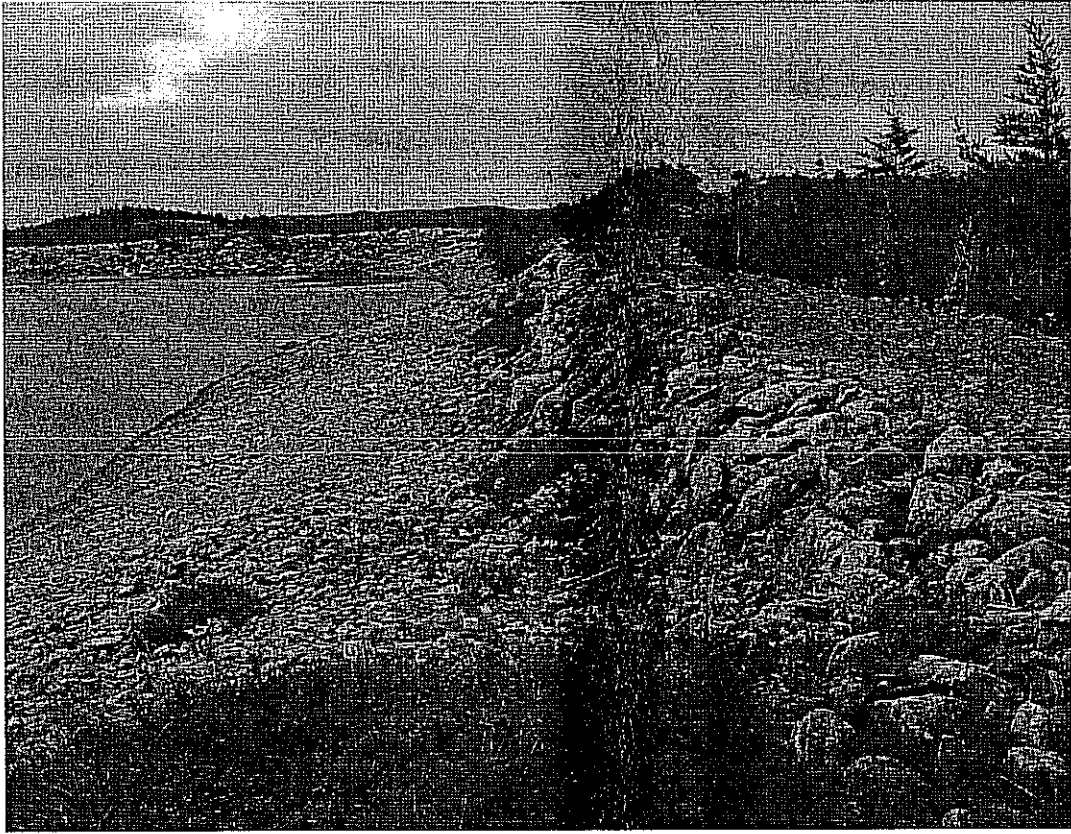
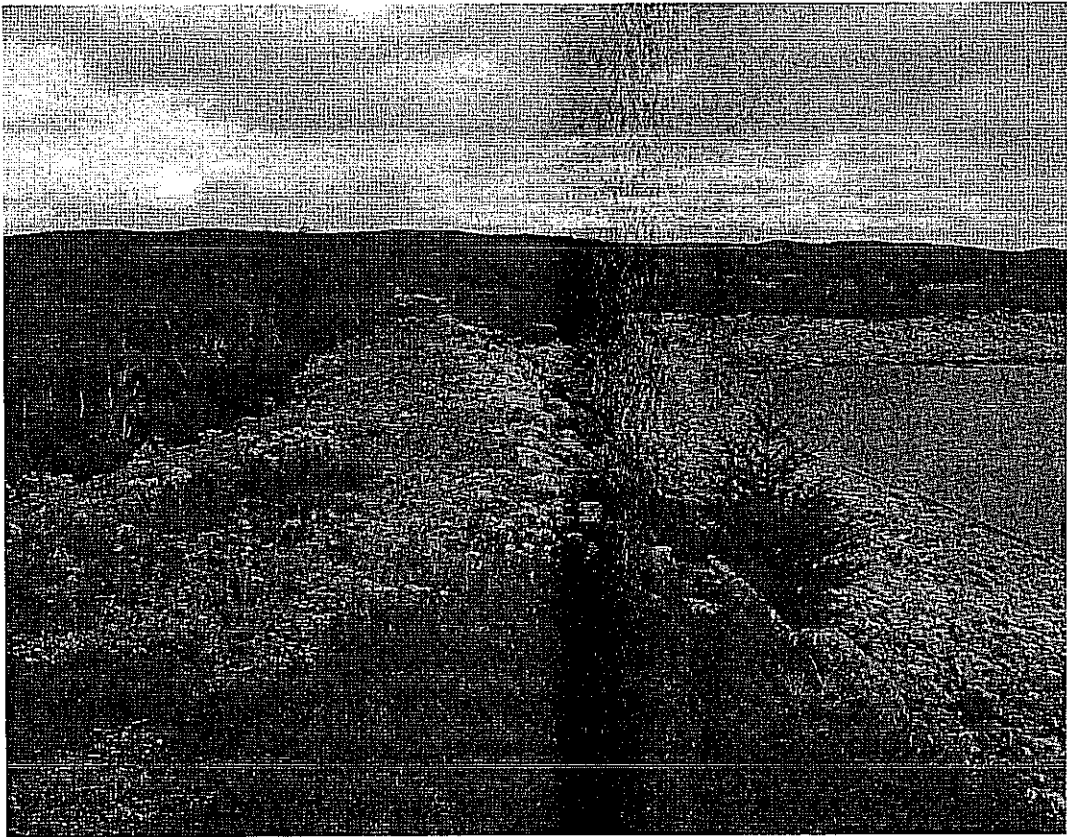
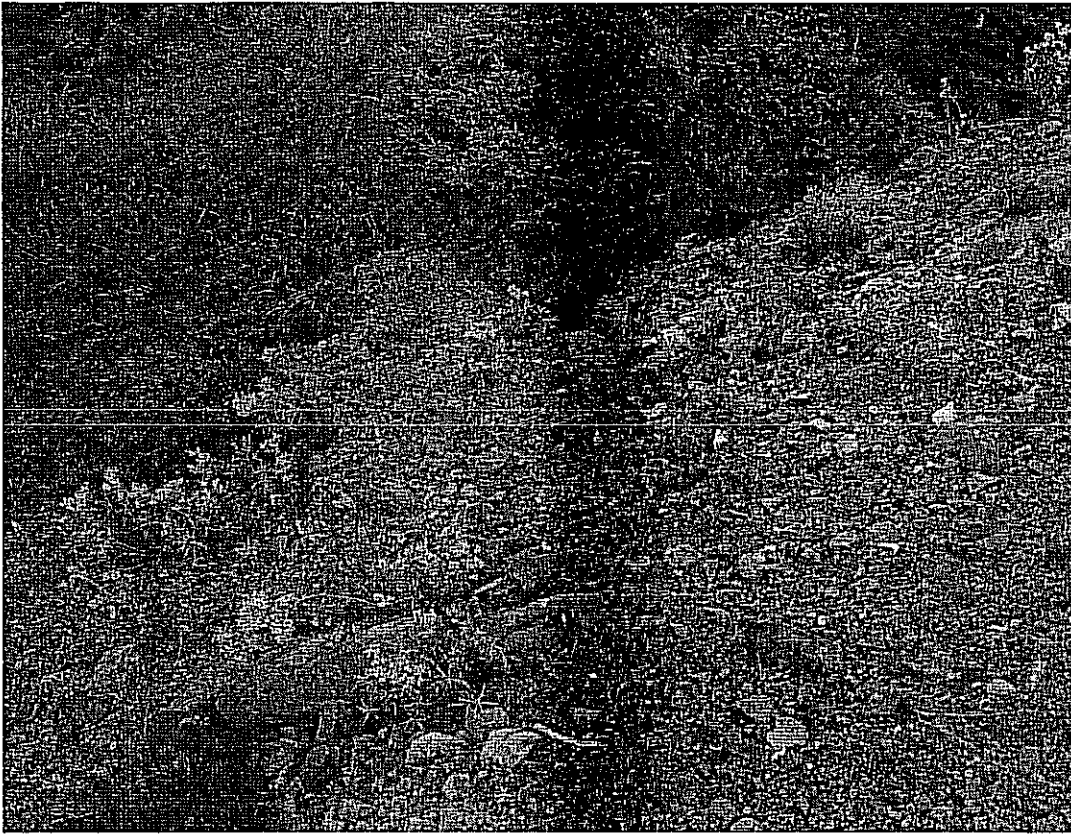
Erosion observed on D/S slope near mid dam.

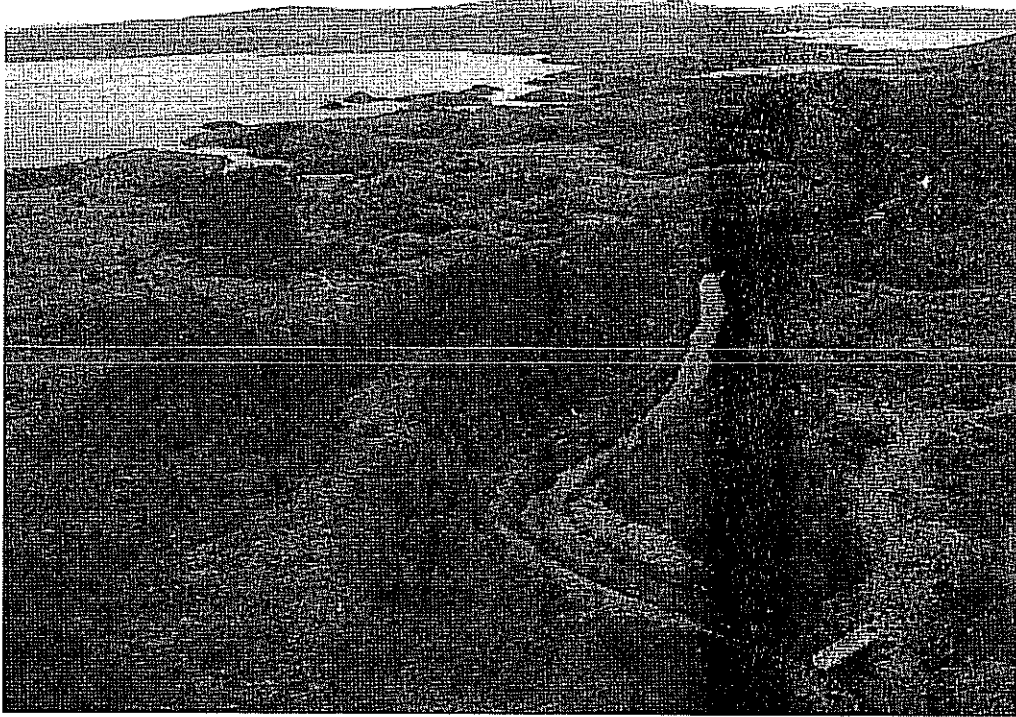
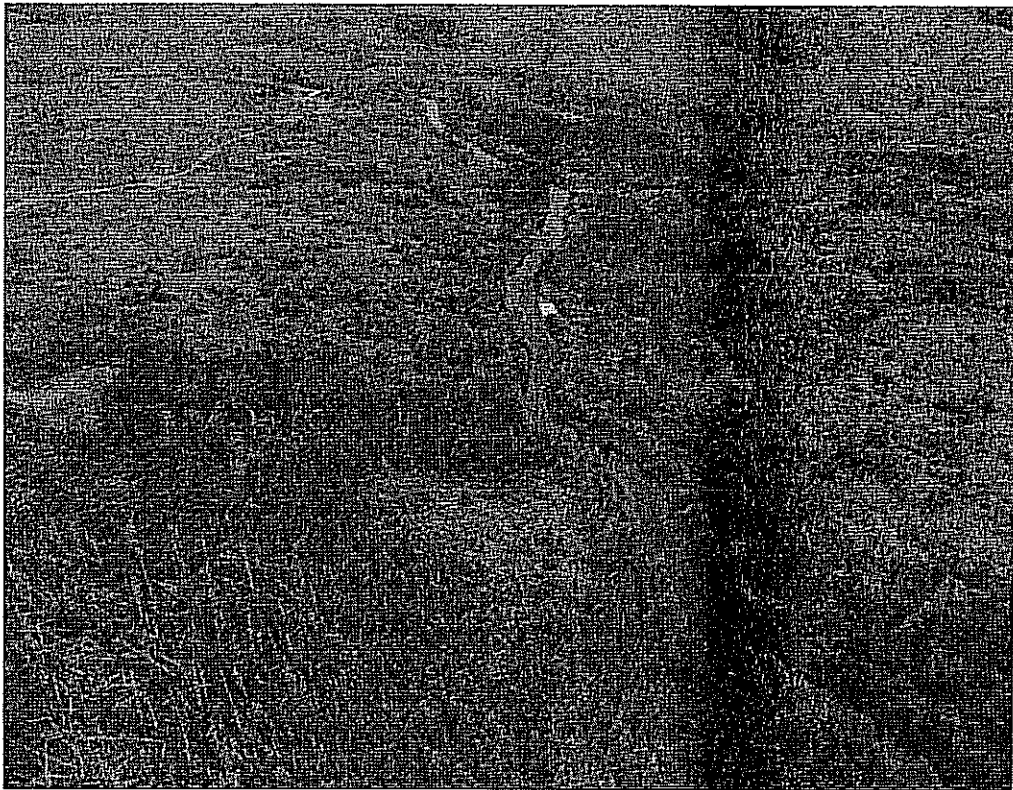
Canal embankment near bridge crossing deteriorated due to ATV use.

Warning signs should be placed on bridge. This is a public safety issue.

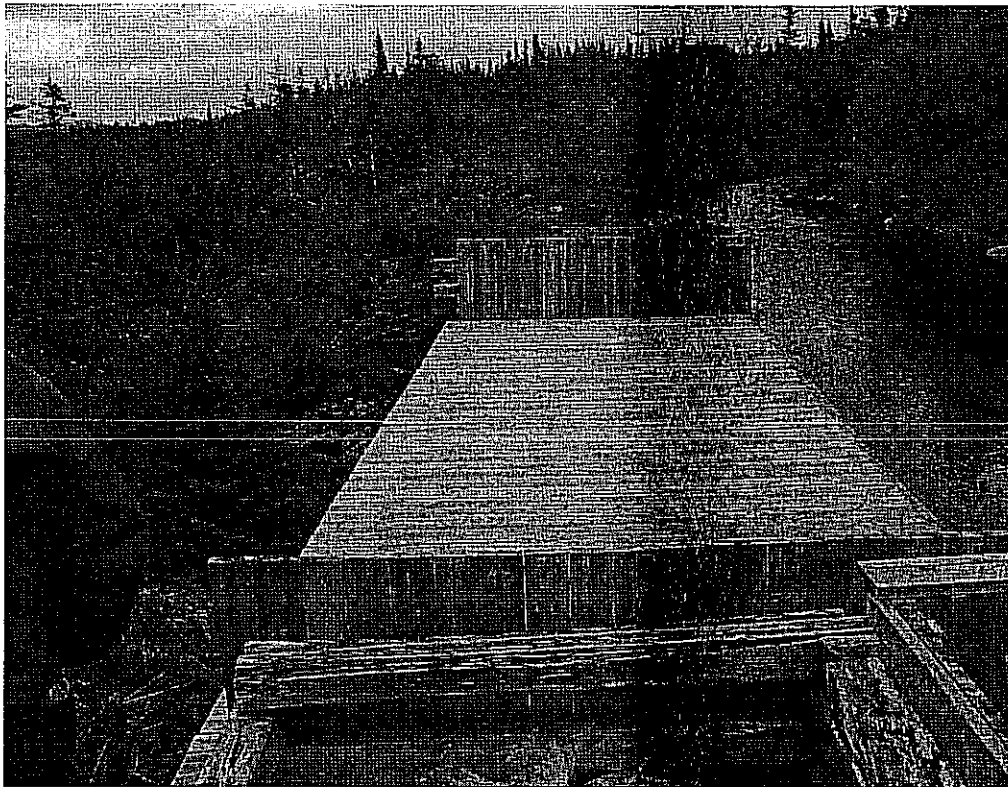
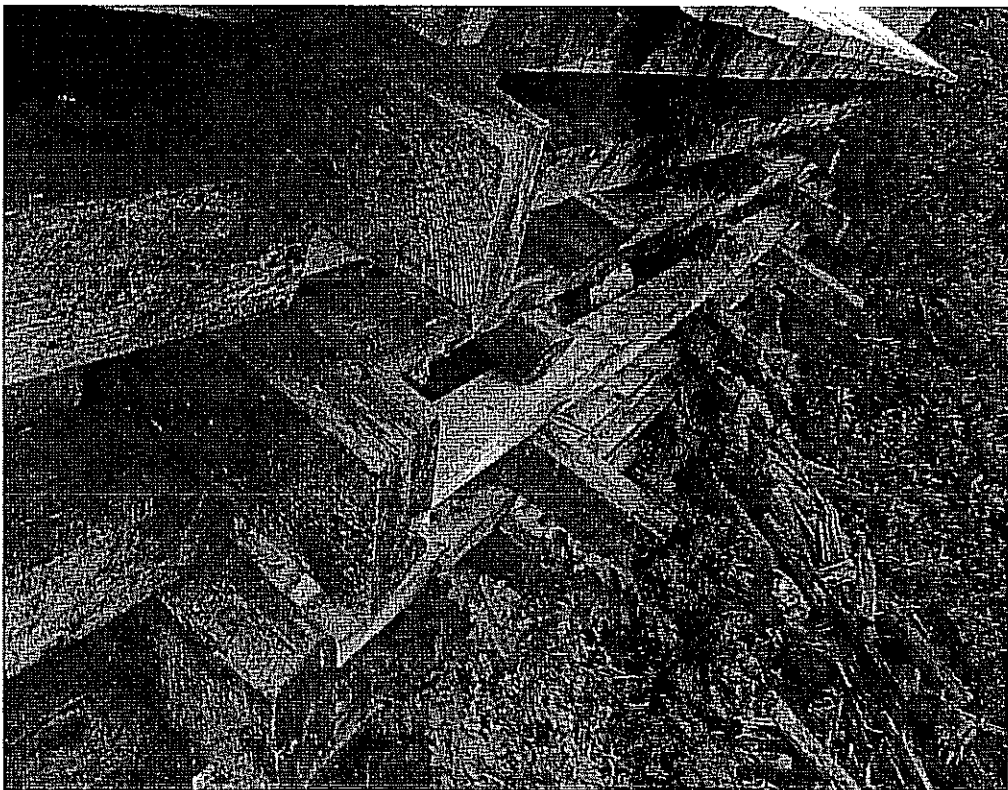
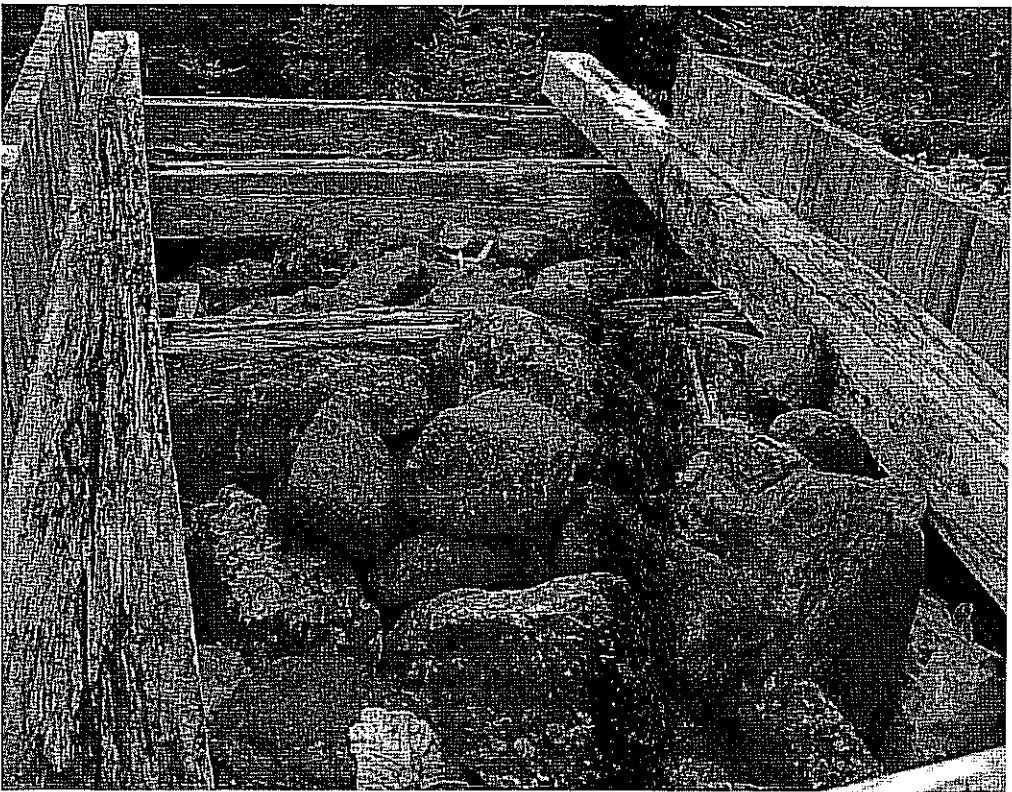
Deterioration/rot of structural timber members is evident, particularly at the abutments.

Remnants of beaver house/dam near spillway U/S. Obstruction should be removed.

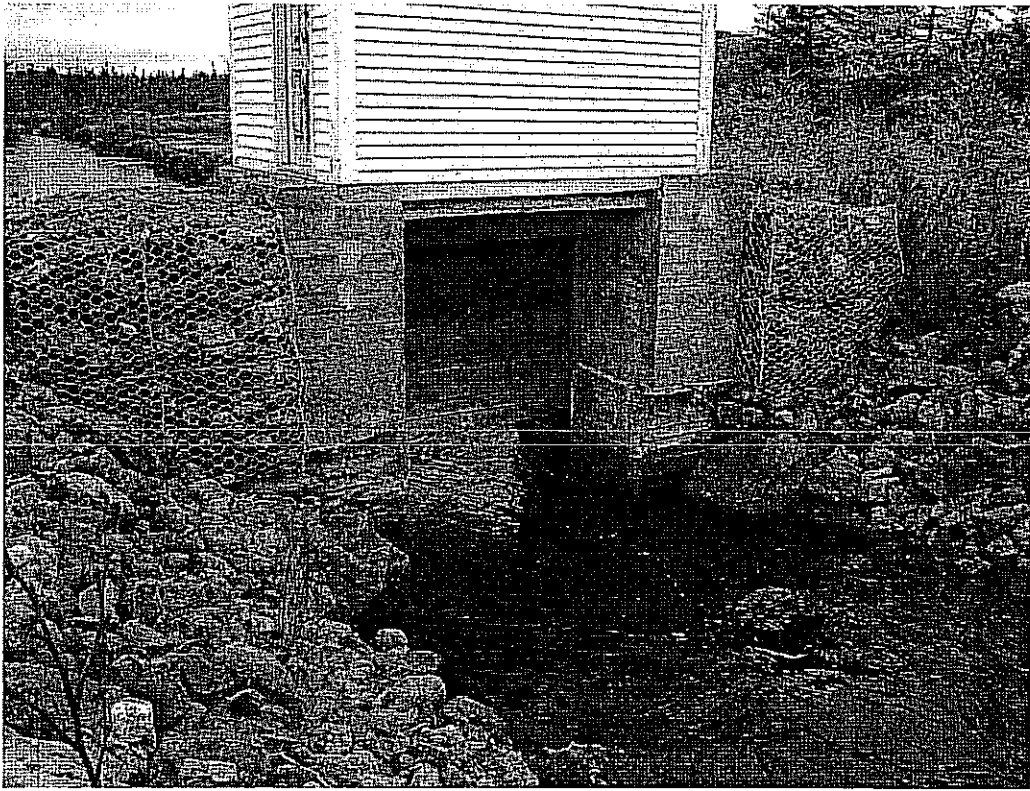
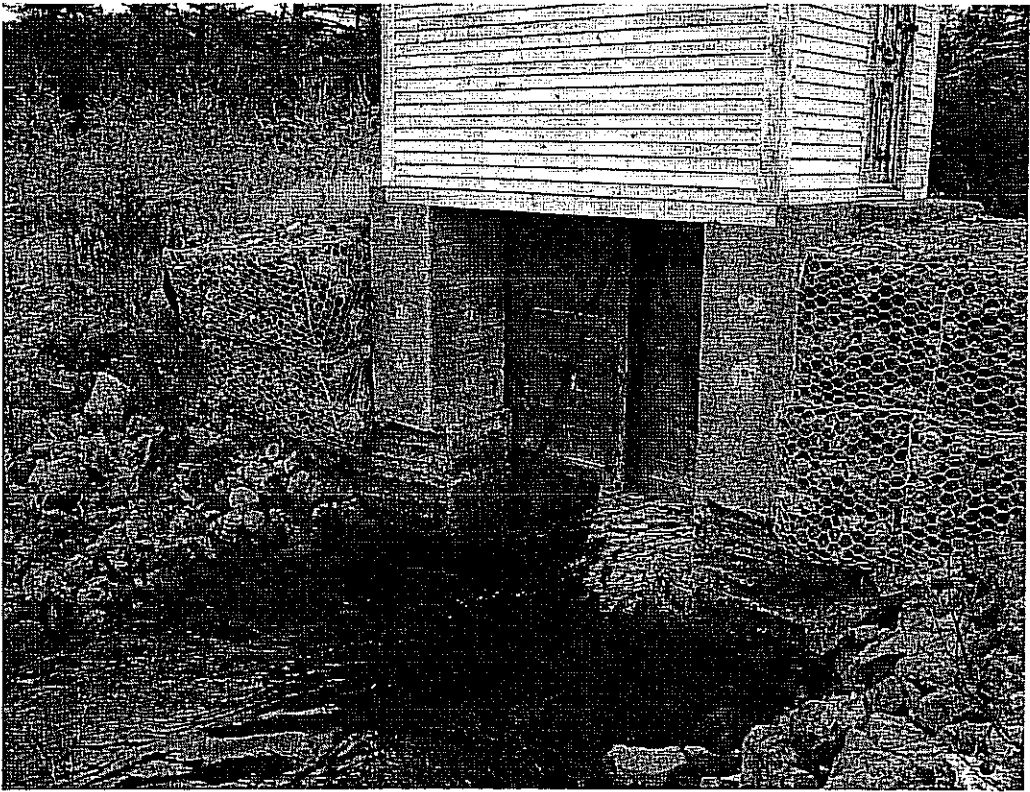
Gabion abutments are leaned and buckling – should be repaired or removed.

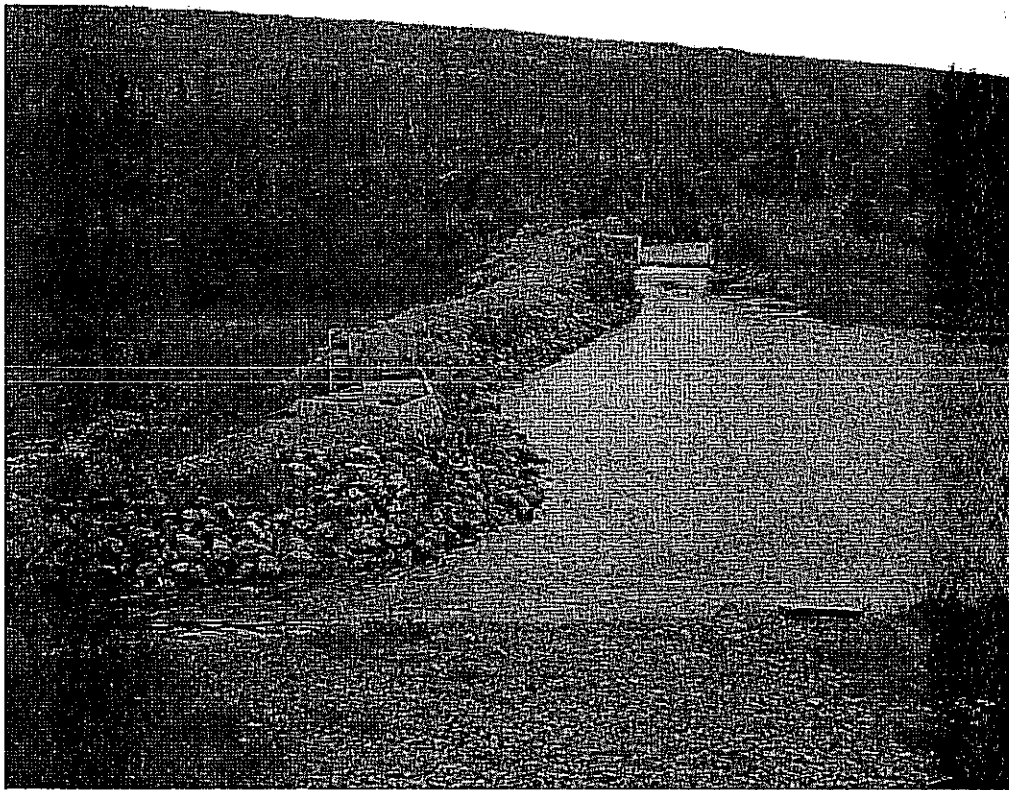
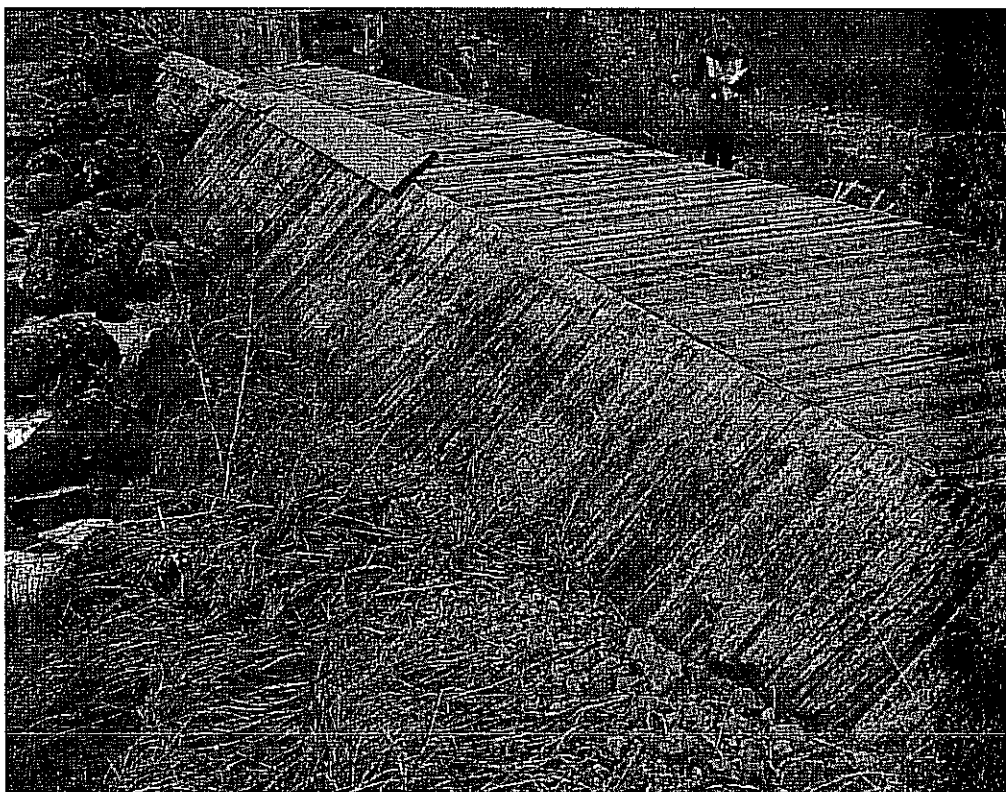
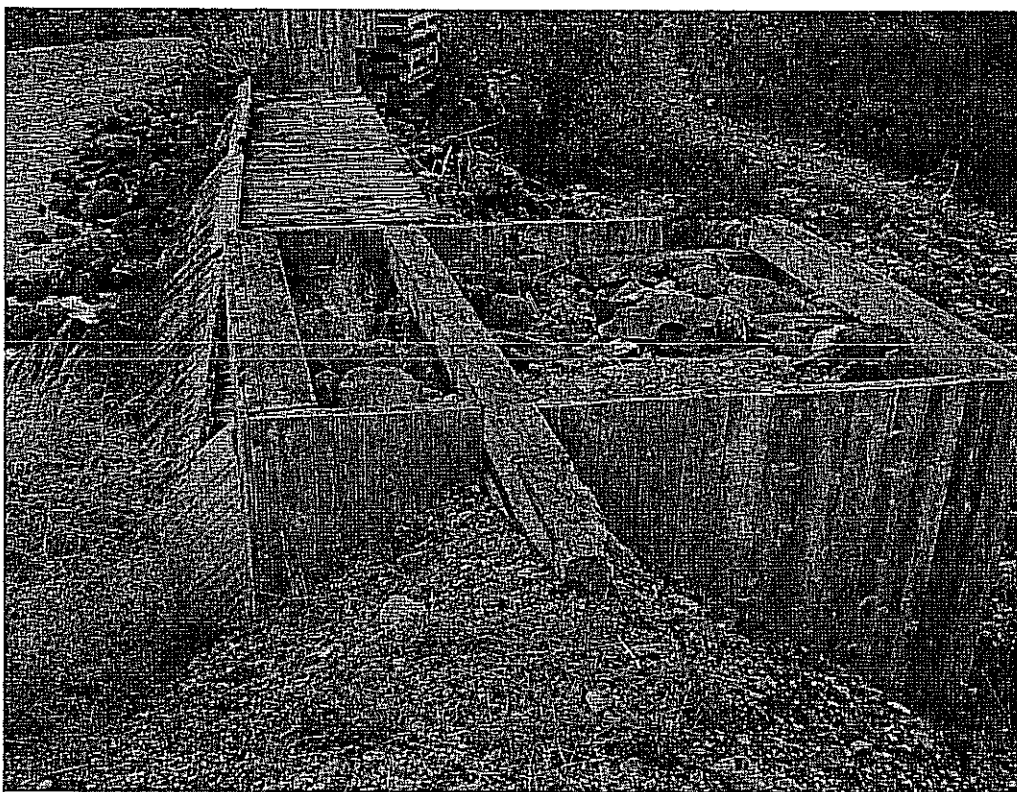
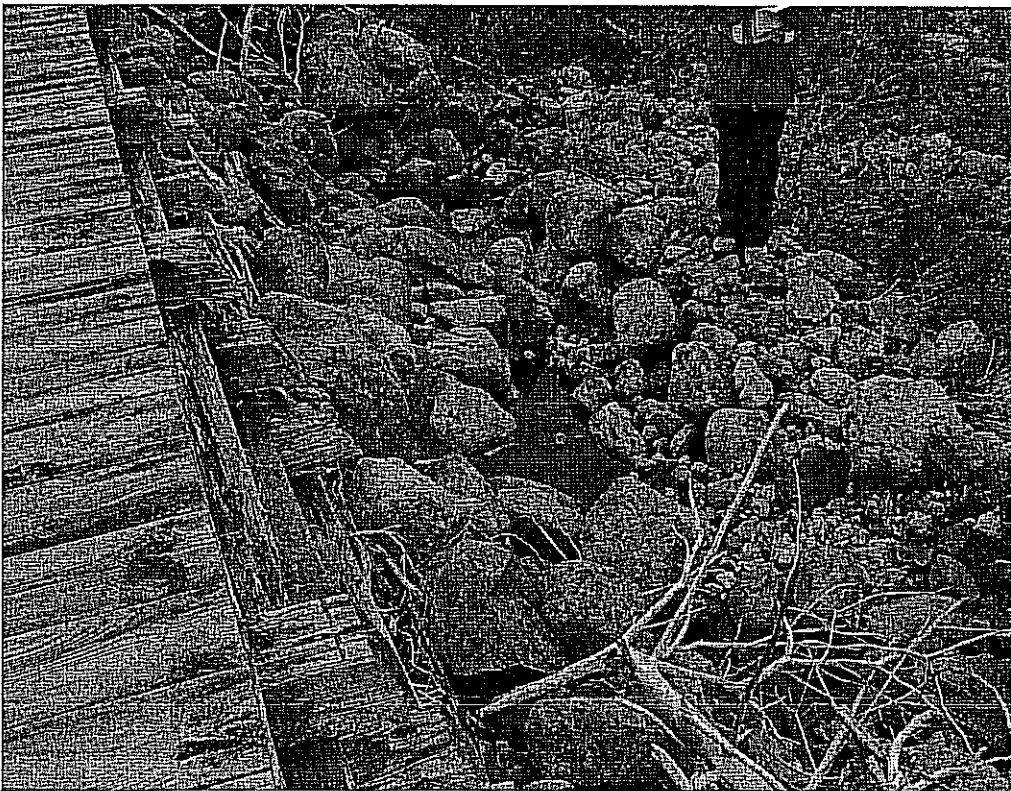
Access bridge should be considered for repairs or replacement,

Cluney's weir is in good condition.

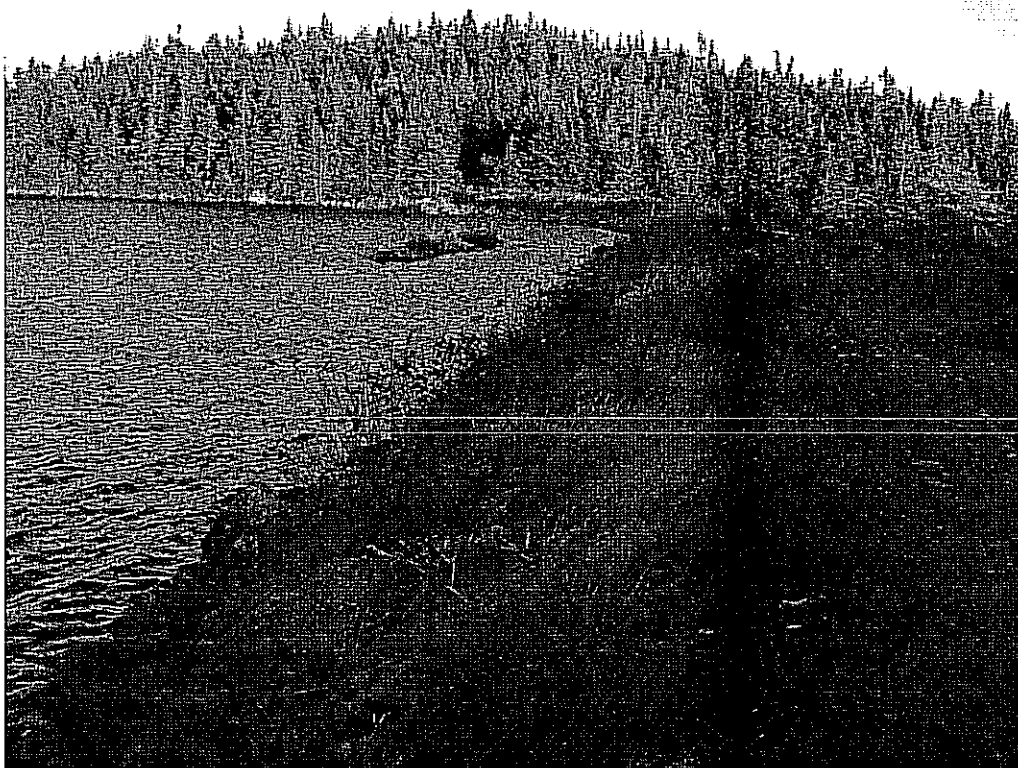
Rocky Pond Freeboard Dam No. 1

Dam in good condition overall.

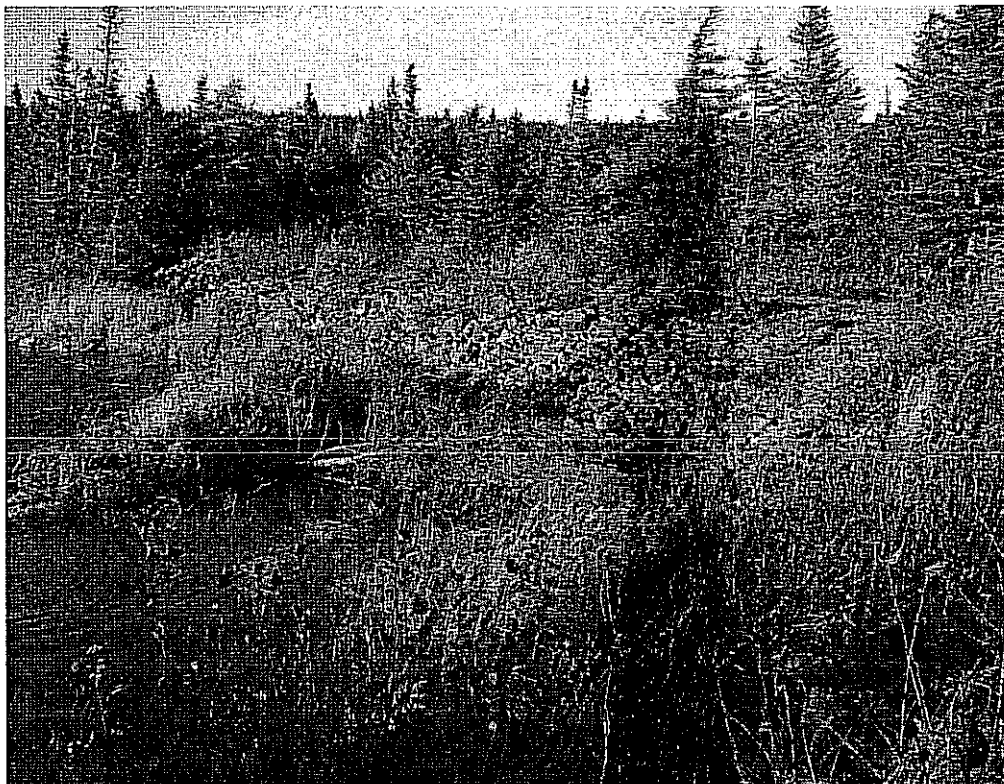
Rocky Pond Freeboard Dam No. 2

Vegetation previously cleared in 2004.

No signs of erosion caused by recent high storage levels.

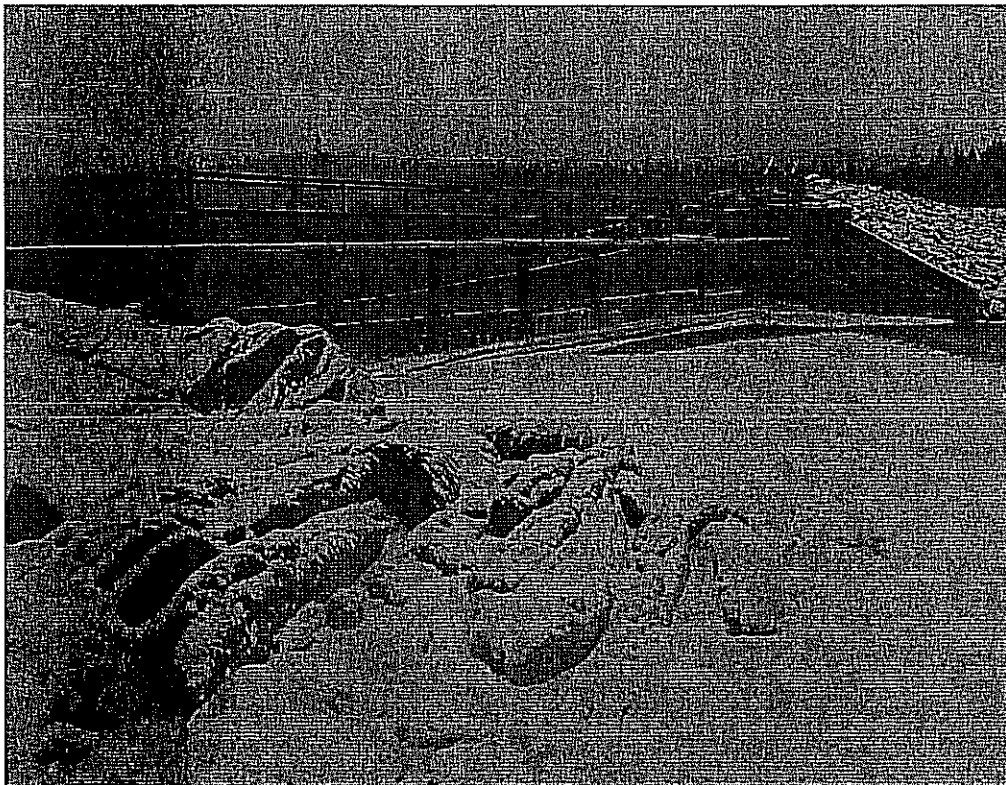
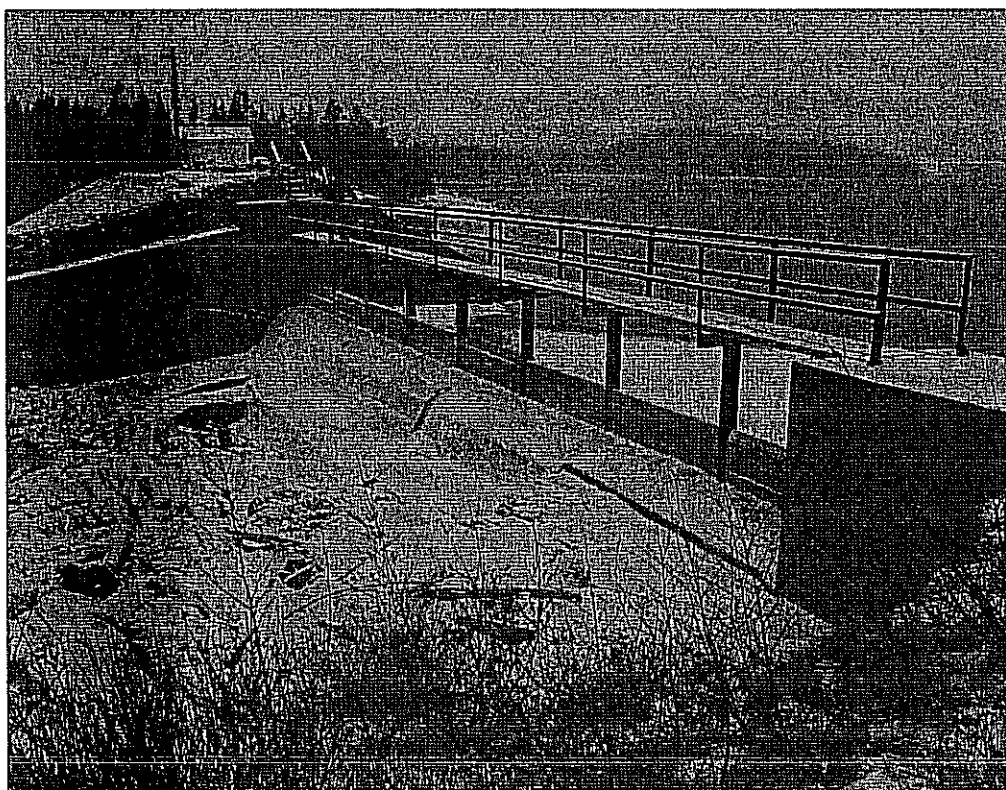
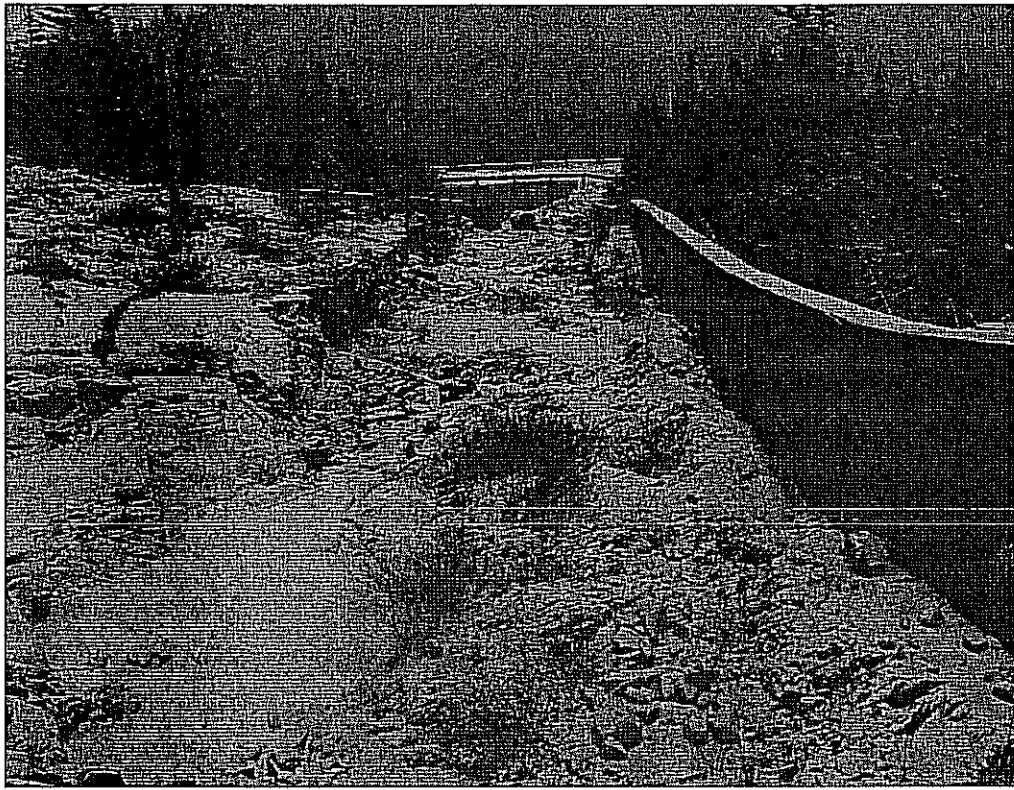
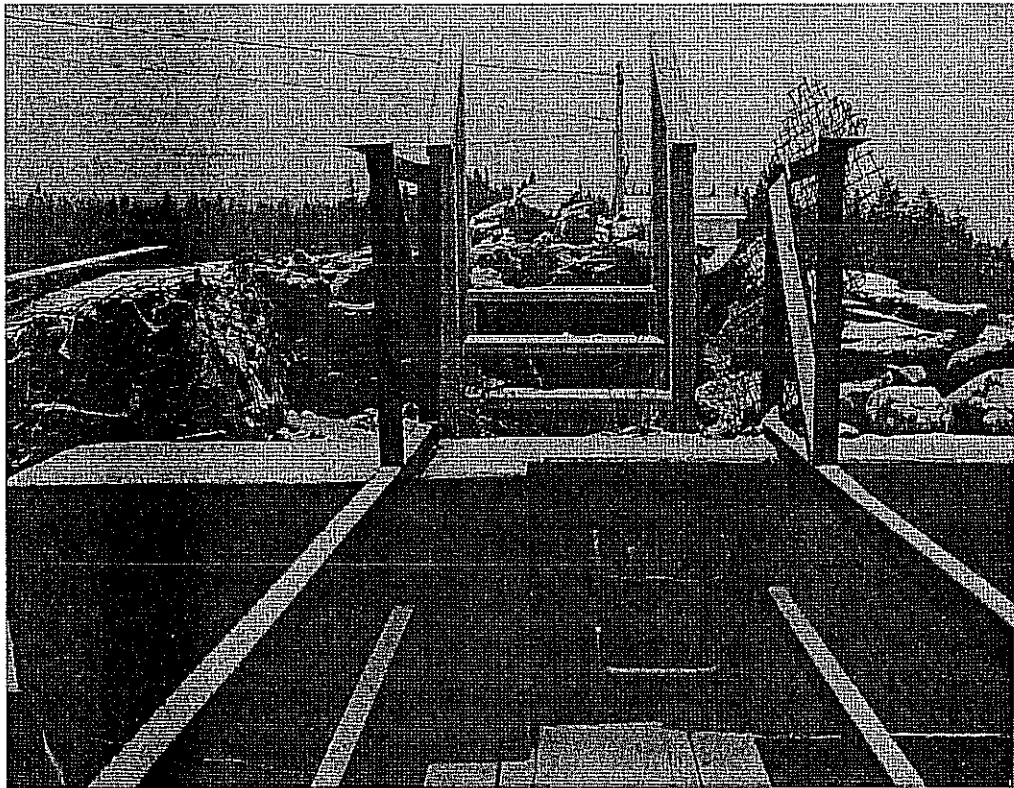
One stop log was displaced and found in spill channel. Stop log re-positioned during inspection.

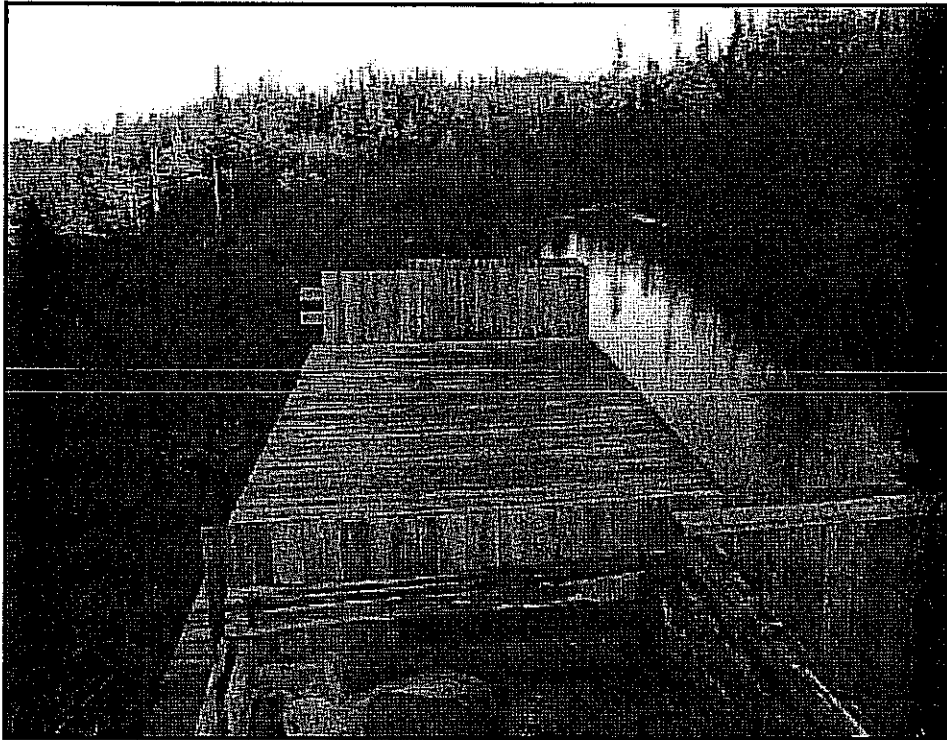
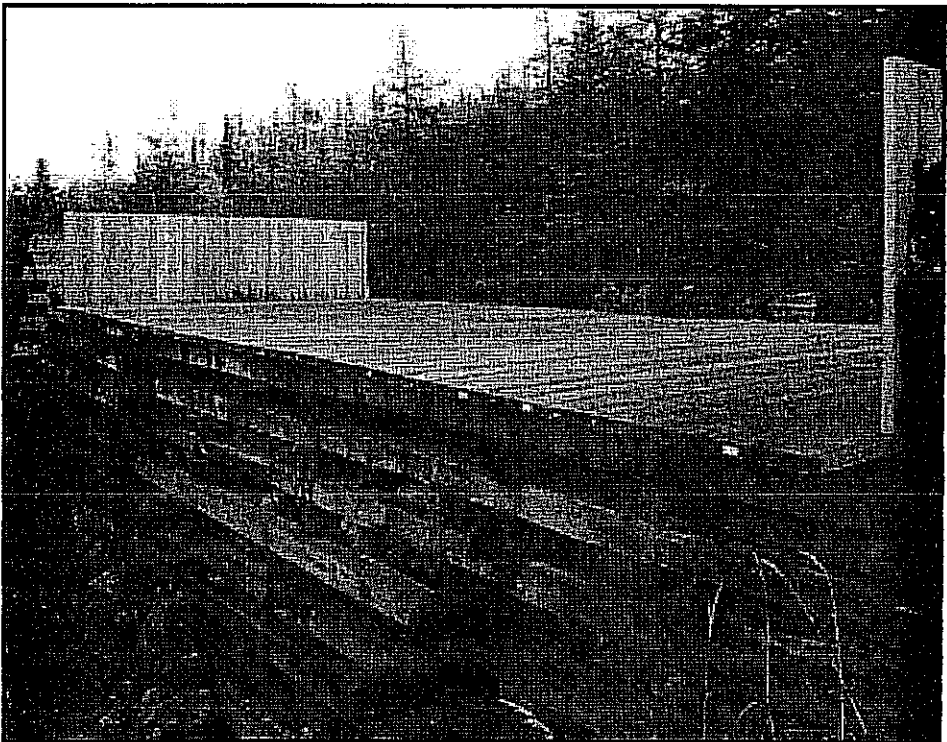
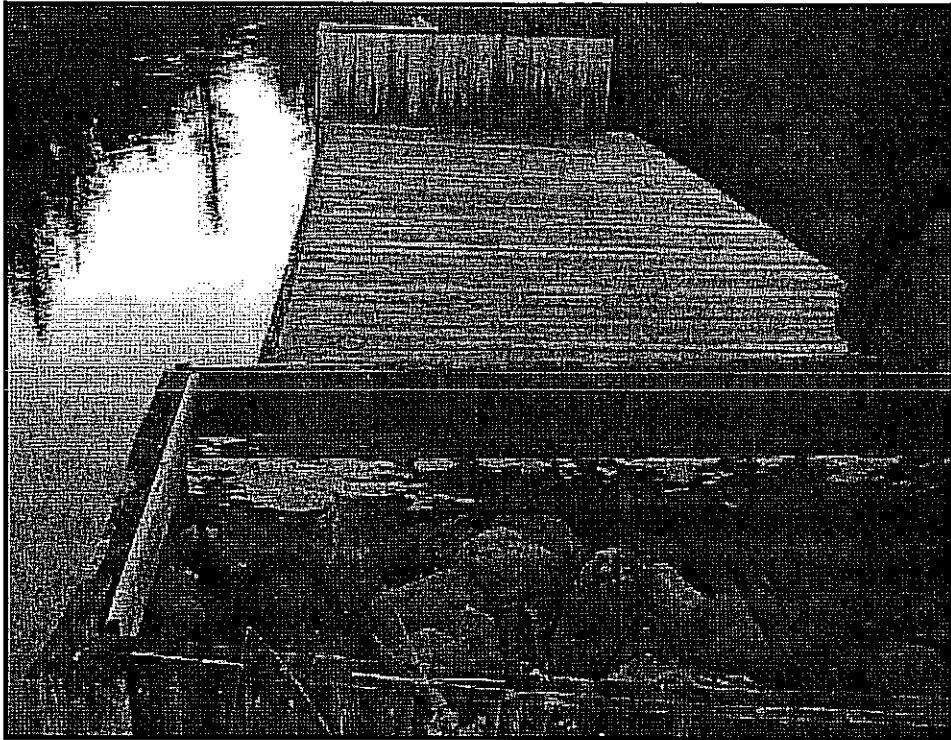
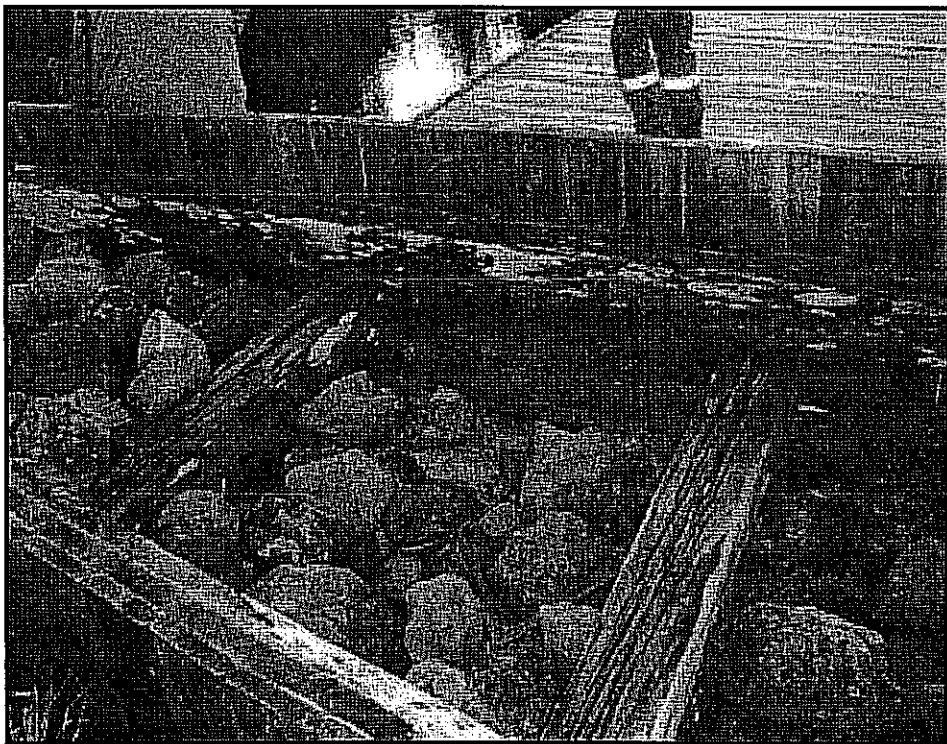
Deterioration/rot of structural timber members is evident, particularly at the abutments.

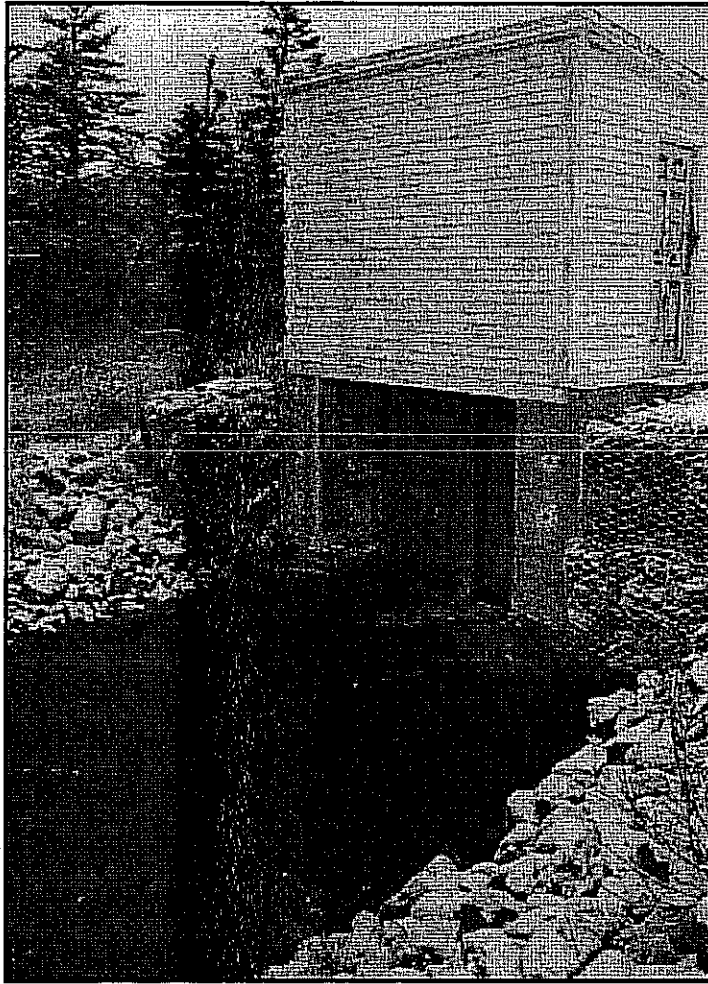
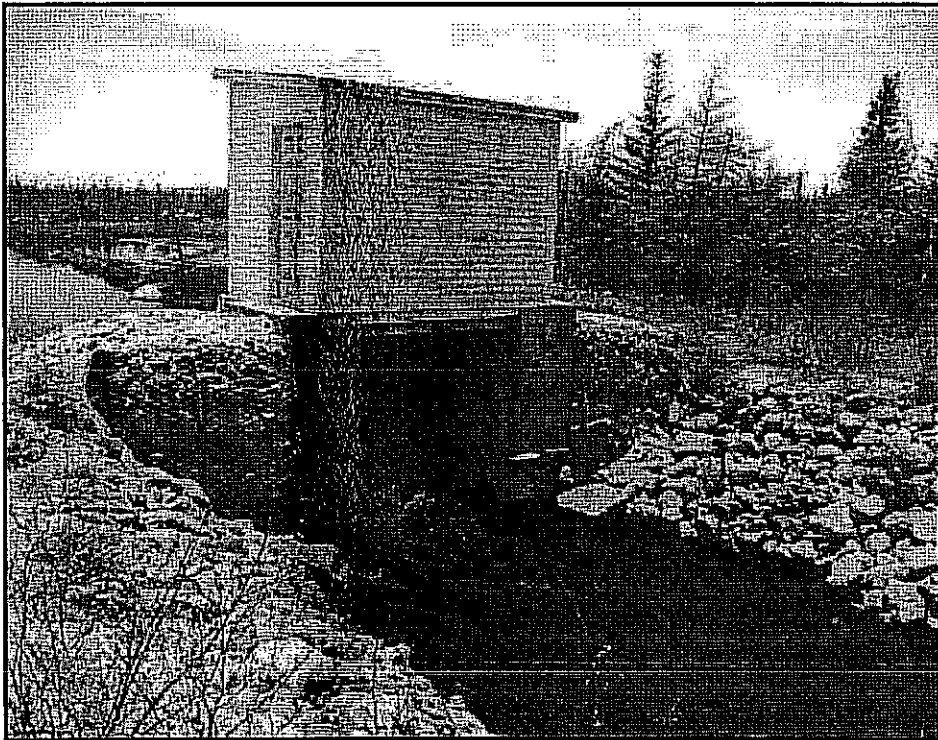
Gabion abutments are leaned and buckling — ~~should~~ be repaired or removed.

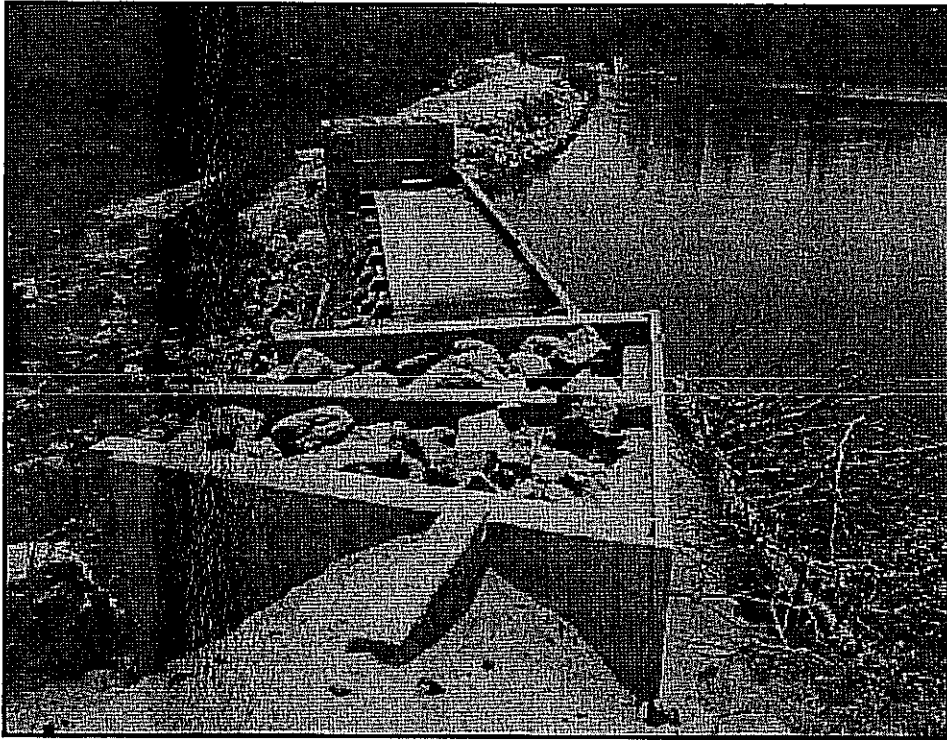
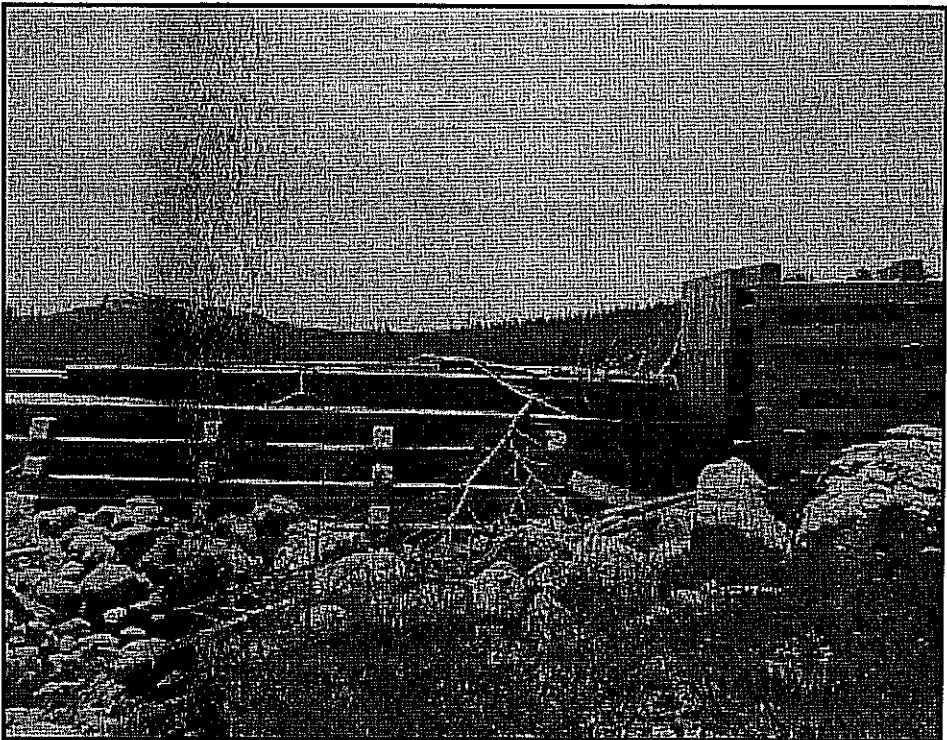
Some debris to be removed from d/s toe.

Leakage observed at toe near right-hand side abutment.

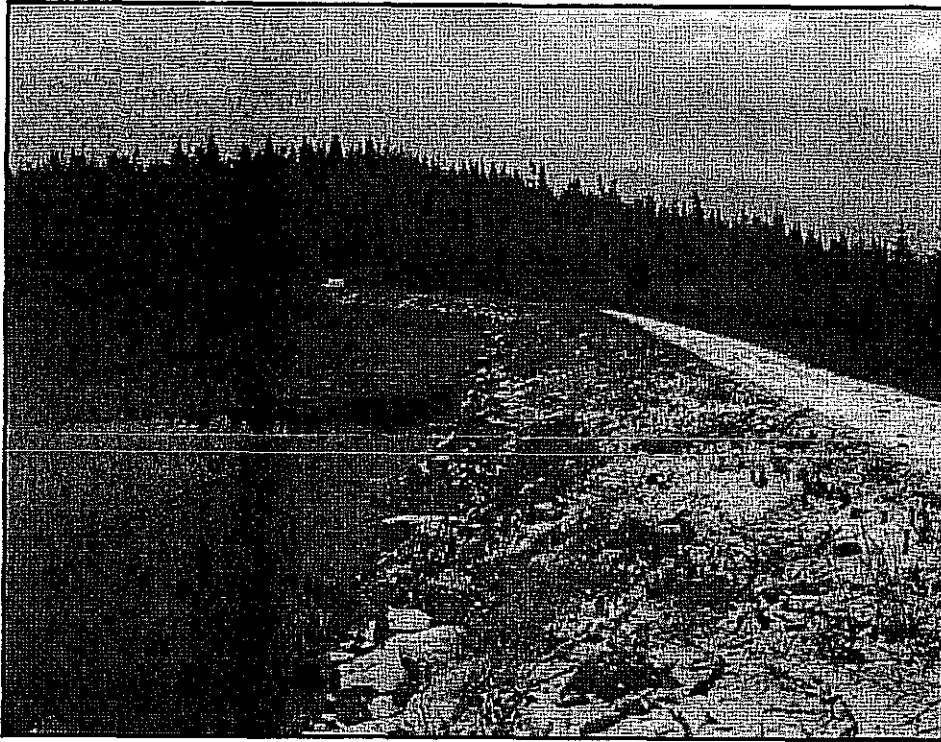
Rocky Pond Freeboard Dam No. 1

Dam in good condition overall.
