Q. Re: Rocky Pond Plant Refurbishment (p. 2 of 81, Schedule B) - Provide for the last five years:

2005 Dam Safety Inspection Report

**Tors Cove /
Rocky Pond
Developments**

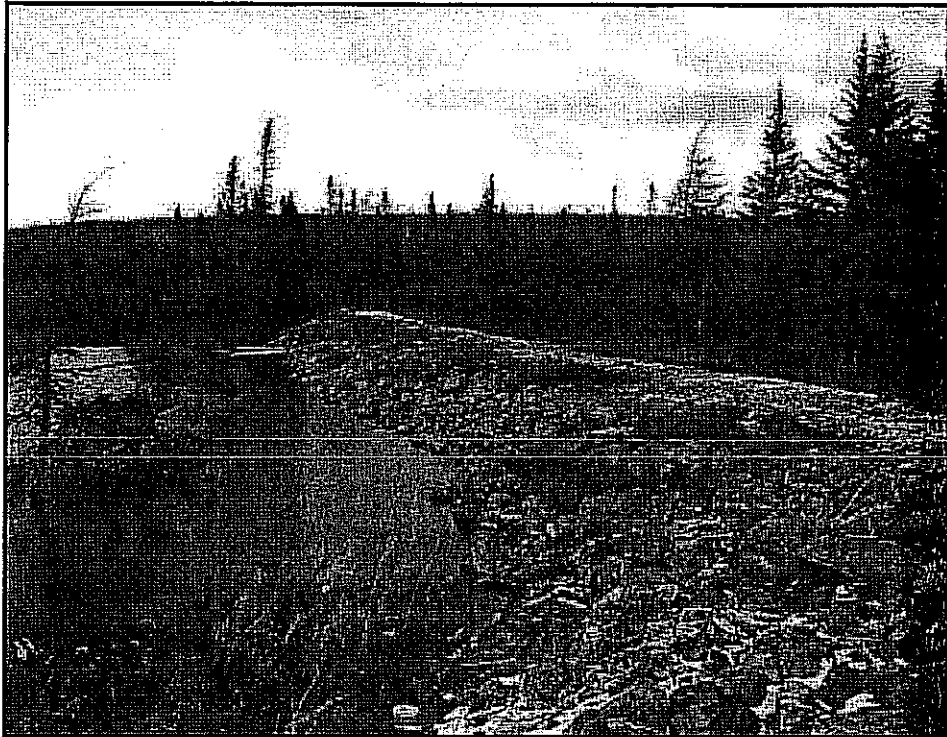
Rocky Pond Freeboard Dam No. 2

Previously reported vegetation was cleared in 2004.

No signs of erosion caused by recent high storage levels.

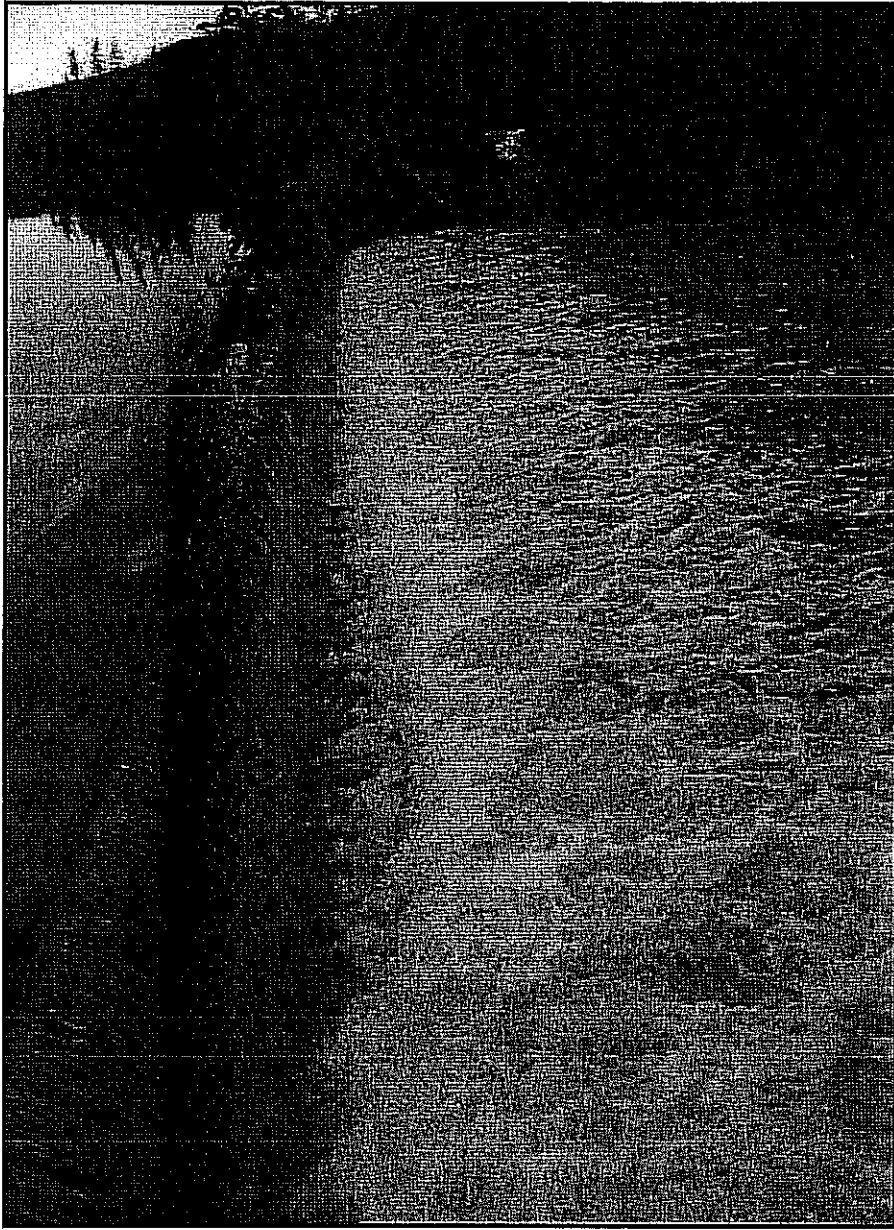
East concrete abutment was in recently repaired.

The plunge pool appears to be operating effectively with good dissipation of energy at the downstream toe.
