NEWFOUNDLAND AND LABRADOR HYDRO

Root Cause Investigation of System Disturbances

On January 4 and 5, 2014

March 2014

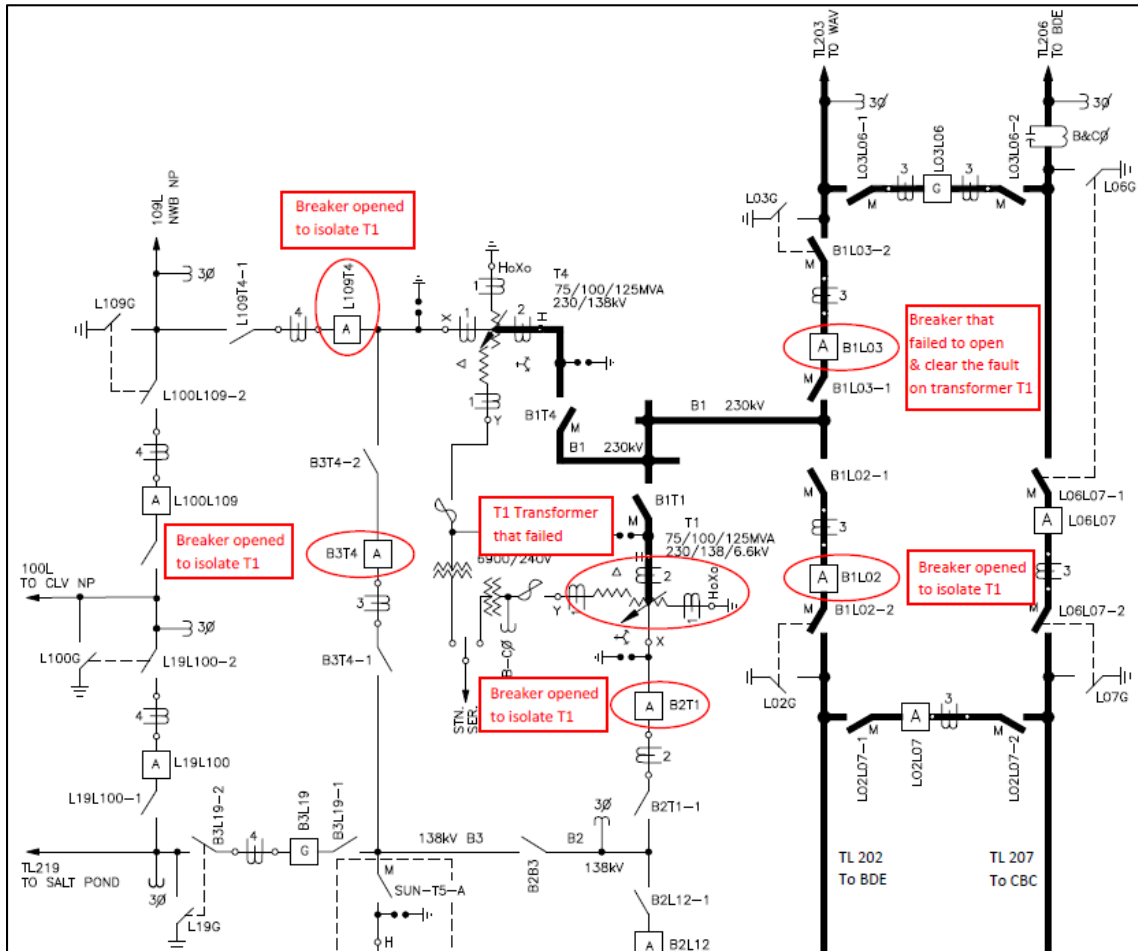
7
 8 Figure 3 – Sunnyside Terminal Station at 09:05:34

24 At 09:05:34 on January 4, 2014, a fault occurred on the Sunnyside T1 transformer. The T1
 25 protection operated correctly and initiated a trip to five breakers to clear the fault. Only four of
 26 the five circuit breakers tripped within 186 milliseconds to clear the fault. The breaker B1L03
 27 failed to open and the fault remained on Sunnyside T1 transformer. Since the fault was not

1 cleared quickly, it resulted in additional damage and the subsequent fire of the Sunnyside T1
 2 transformer. The fault lasted for two seconds until line protection on TL203 operated and
 3 cleared the fault. This resulted in a widespread (187,500 customers) power interruption across
 4 the system. Figure 3 below, is a portion of the single line diagram of the Sunnyside Terminal
 5 Station showing the equipment involved in the incident. The complete single line for Sunnyside
 6 Terminal Station is attached in Appendix 2 – Drawings.

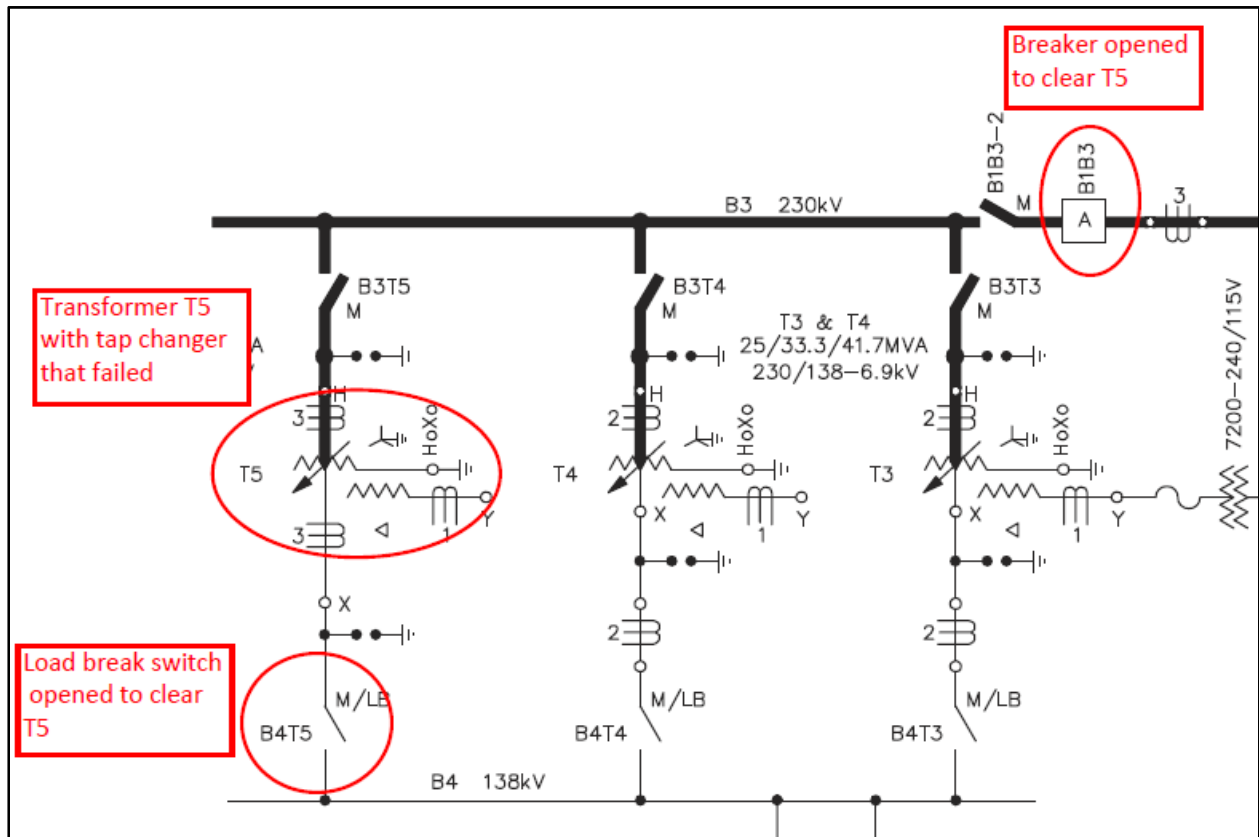
Figure 4 – Western Avalon Terminal Station at 12:22:39

11 At 12:22:39 on January 4, 2014, Western Avalon T5 tap changer failure resulted in a fault on the
 12 transformer. The T5 transformer protection operated correctly and initiated a trip of one
 13 breaker and one load break switch, both of which operated correctly and cleared the fault. This

1 incident resulted in an extended outage for some customers, as the T5 Transformer trip had to
 2 be investigated before restoration of the station. Figure 4 below is a portion of the single line
 3 for the Western Avalon Terminal Station showing the equipment involved in the incident. The
 4 complete single line for Western Avalon Terminal Station is attached in Appendix 2 – Drawings.

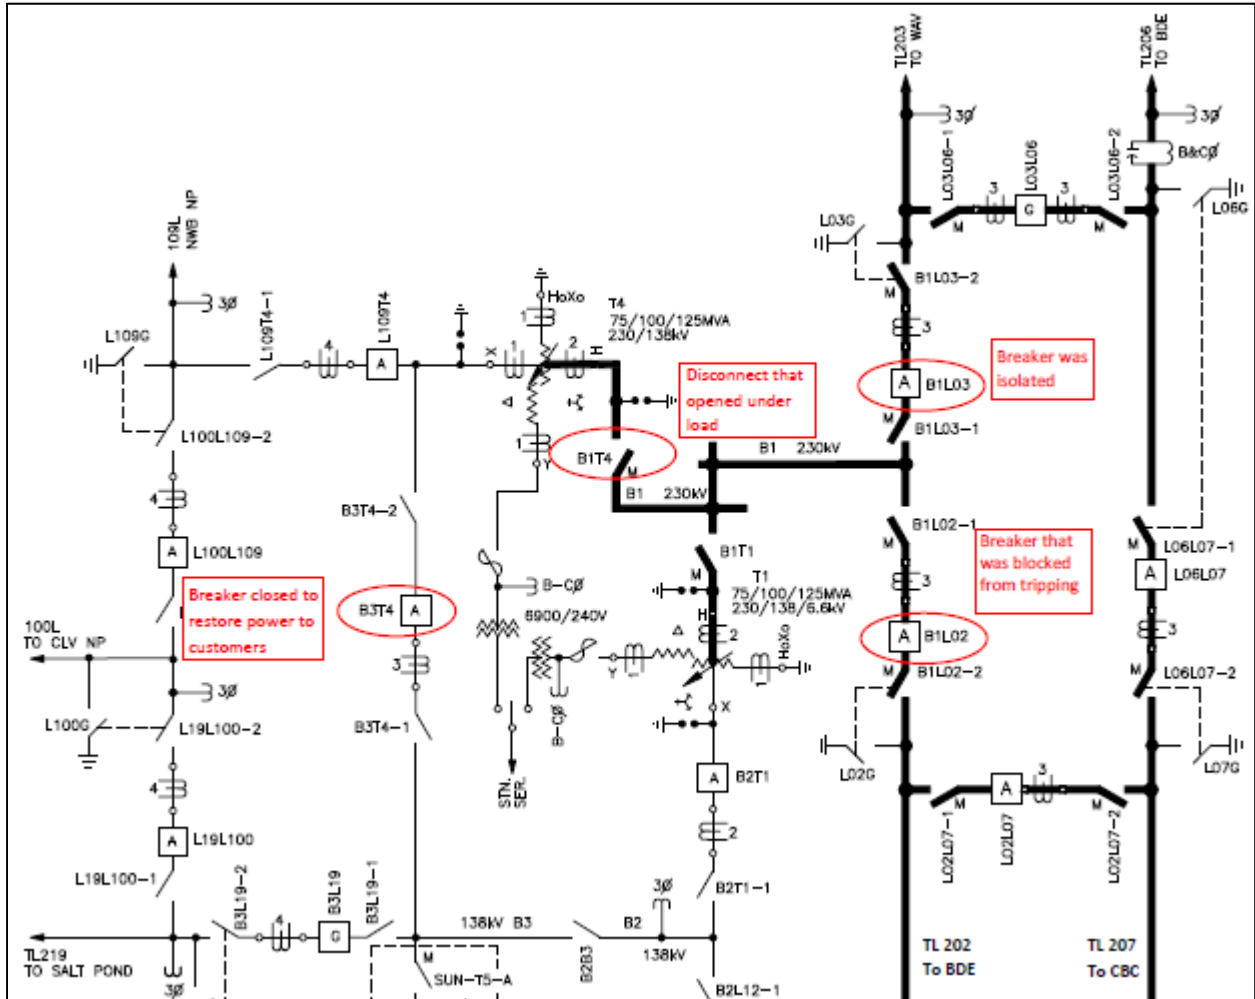
Figure 5 – Sunnyside Terminal Station

9 At 12:58:30 on January 4, 2014, an unsuccessful attempt was made to restore power to
 10 customers. Temporary protection modifications were made following that unsuccessful
 11 attempt to isolate the suspected area of damage due to the fire. At 15:33:26, a second attempt
 12 was made to restore power to customers supplied from the Sunnyside Terminal Station. These
 13 temporary modifications had an adverse effect on the protection and resulted in a power
 14 interruption (165,000 customers) across the system. The details of this event are complex and

1 involve inherent design issues that are further explained in the “Protection Systems Impacts on
 2 4 January 2014 Supply Disruptions - External Protection Review” by Mr. Henville. Figure 5 below
 3 is a portion of the single line of the Sunnyside Terminal Station showing the equipment involved
 4 in the incident. The complete single line drawing for Sunnyside Terminal Station is attached in
 5 Appendix 2 – Drawings.

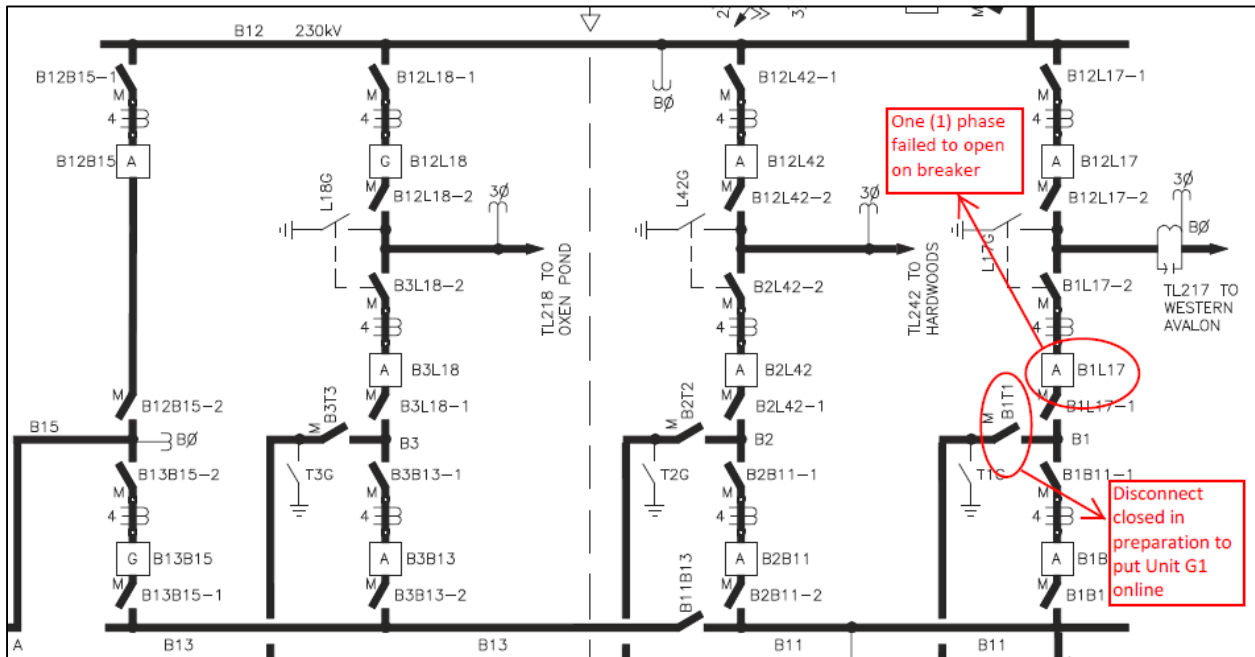
Figure 6 – Holyrood Terminal Station at 21:27:39

1 caused a significant system imbalance, as one phase of breaker B1L17 had failed to open
 2 despite breaker indications showing it as being open on all three phases. The protection for
 3 TL217 and Bus B1 operated correctly to clear the imbalance. However, as a result of the neutral
 4 overcurrent on the system that resulted from one phase of B1L17 failing to open and the heavy
 5 loading on the transmission system at the time, a widespread (110,000) customer interruption
 6 was initiated by this event. Figure 6 below is a portion of the single line for Holyrood Terminal
 7 Station showing the equipment involved in the incident. The complete single line for Sunnyside
 8 Terminal Station is attached in Appendix 2 – Drawings.

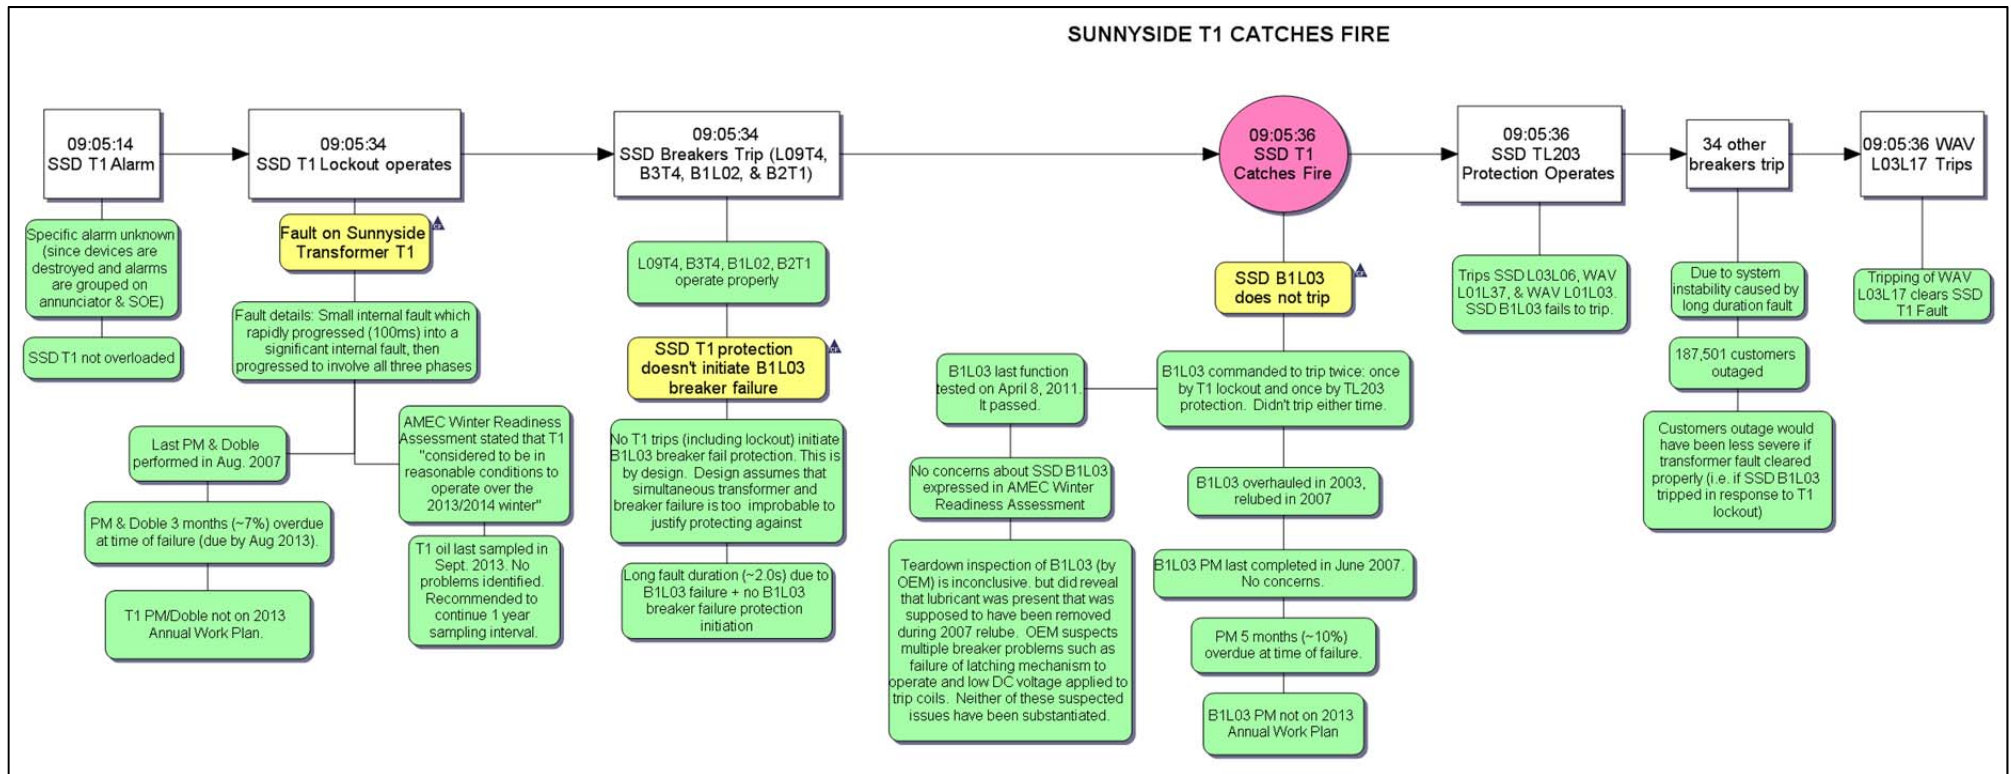
Figure 7 – Sunnyside Transformer T1 Fire SnapChart®

11 Sunnyside T1 transformer failed due to a bushing failure that initiated inside the transformer.
12 As a result of breaker B1L03 failing to open and no 230kV breaker failure protection associated
13 with T1 transformer fault, the fault was present for an extended period of time and
14 consequently, a fire developed. Figure 7 below is the SnapCharT® of the incident which shows
15 the sequence of events and associated information.

18 The presence of combustible gases in transformer oil is an indication of activity inside the
19 transformer and sudden changes can indicate a problem with the transformer. Early detection
20 of changes in these gases can prevent a catastrophic transformer failure.

22 Hydro currently performs annual independent laboratory analysis of transformer oil, and plans
23 on installing continuous online gas monitors on existing GSU transformers. In addition, all new
24 transformers being purchased have continuous online gas monitors. Sunnyside T1 had a gas
25 relay, which detects both gas accumulation and gas pressure, but does not have a continuous
26 online gas monitor. Continuous online gas monitors were not available at the time Sunnyside
27 T1 was installed in 1978.

Recommendation #	Recommendation
TA1	Conduct a formal risk/reward review on expanding the current program for the installation of online continuous gas monitor on GSU transformers to include other transformers installed on the Hydro system.

Recommendation #	Recommendation
TA2	When system conditions allow, conduct an in-depth analysis of the DC system for breaker B1L03 to determine if any high-impedance paths exist which may affect its operation.

Recommendation #	Recommendation
TA3	Consider conducting a formal risk/reward review of system design to determine whether 230kV transformers require their own 230kV breaker in all terminal stations, as this would reduce complexity and increase reliability.
TA4	Consider conducting a formal risk/reward review of the 230kV breaker failure protection philosophy for transformers at stations that currently do not have breaker fail protection.
TA5	Consider implementing transformer protection initiation of breaker fail protection at all stations that have breaker fail protection.

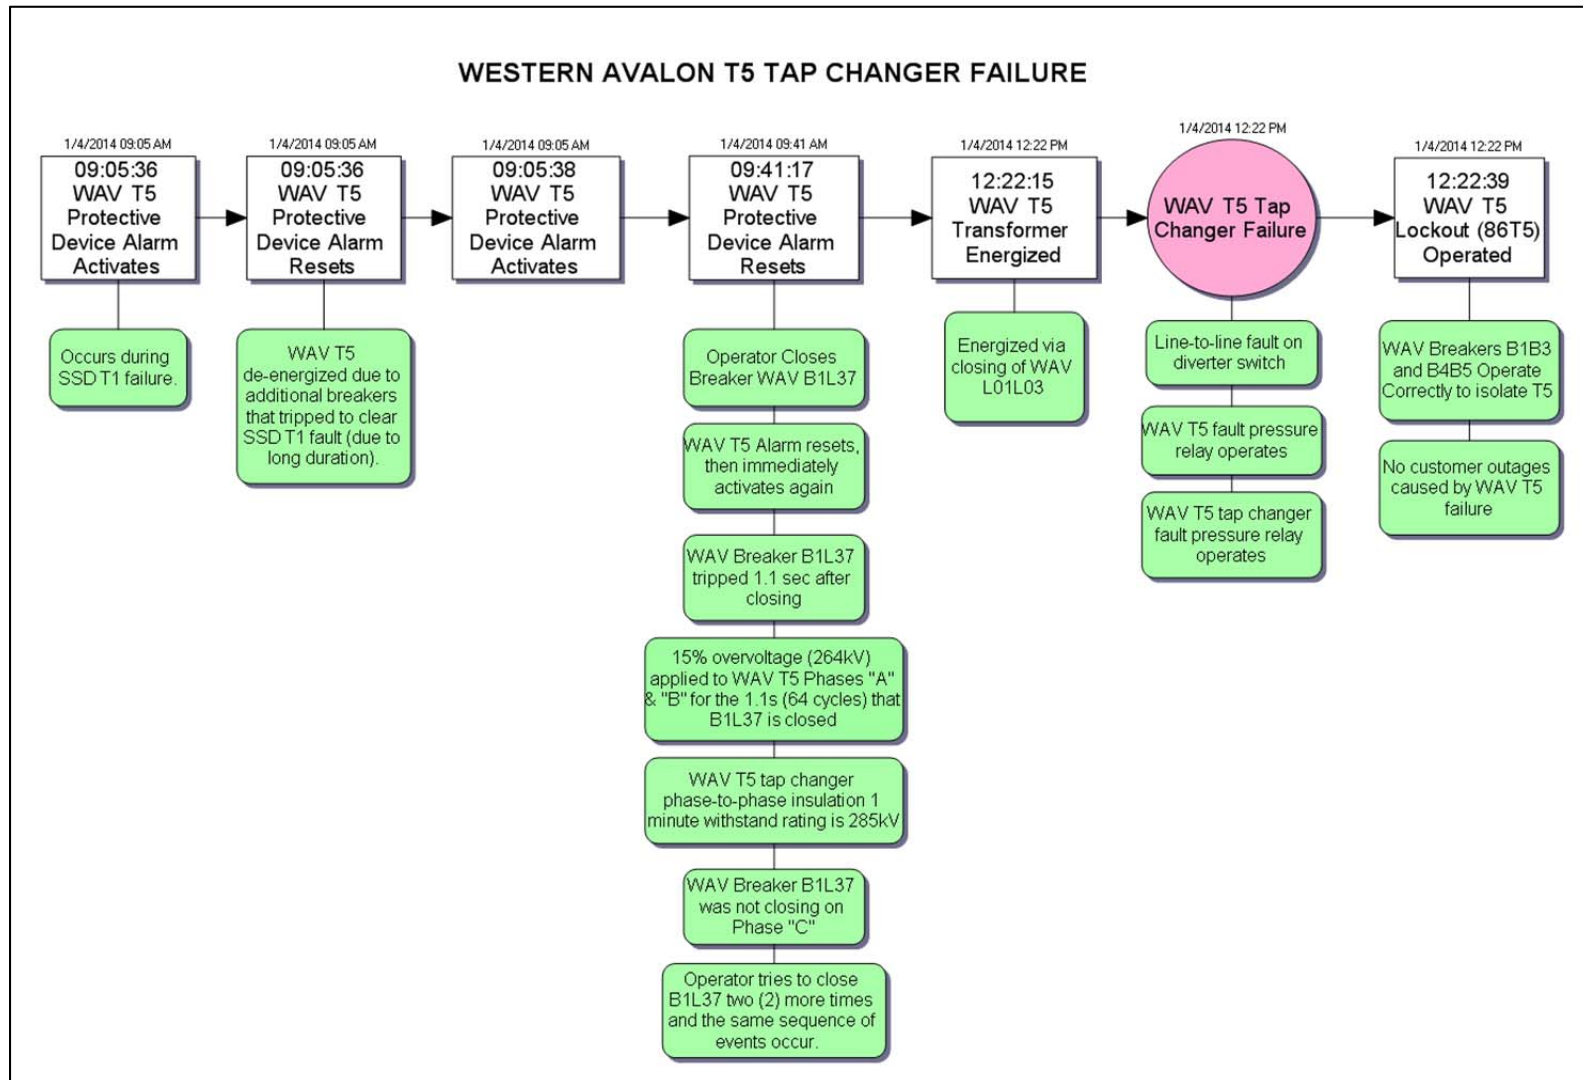
Figure 8 – Western Avalon T5 Tap Changer Failure SnapCharT®

2 A preliminary analysis of a phase-to-phase fault across the diverter switch of Western Avalon T5
 3 tap changer, suggests a breakdown of insulating materials and/or abnormally high system
 4 voltage. Further analysis is required to determine the cause of the fault. Internal inspection of
 5 the transformer suggests that it has sustained no damage other than to the tap changer, but
 6 further testing is required. Figure 8 below is the SnapCharT® of the incident which shows the
 7 sequence of events and associated information.

10 To date, the root cause for the diverter switch failure has not been determined. From the
 11 equipment inspection and subsequent report provided by Reinhausen’s field representative, it
 12 is their assessment that the failure of the diverter switch was due to a system overvoltage or
 13 break down of the insulating oil for the diverter switch. Due to the failure of the hard drive at
 14 the Western Avalon Terminal Station, just prior to the incident on January 4, 2014 digital fault
 15 traces are not available to determine if a system over-voltage was present. To determine if a
 16 system over-voltage or disturbance was the cause of the tap changer failure, further
 17 investigation is required.

Recommendation #	Recommendation
TA6	Conduct an analysis of the Island Interconnected System to determine if a transient overvoltage due to system harmonics is a cause of the Western Avalon T5 Failure.

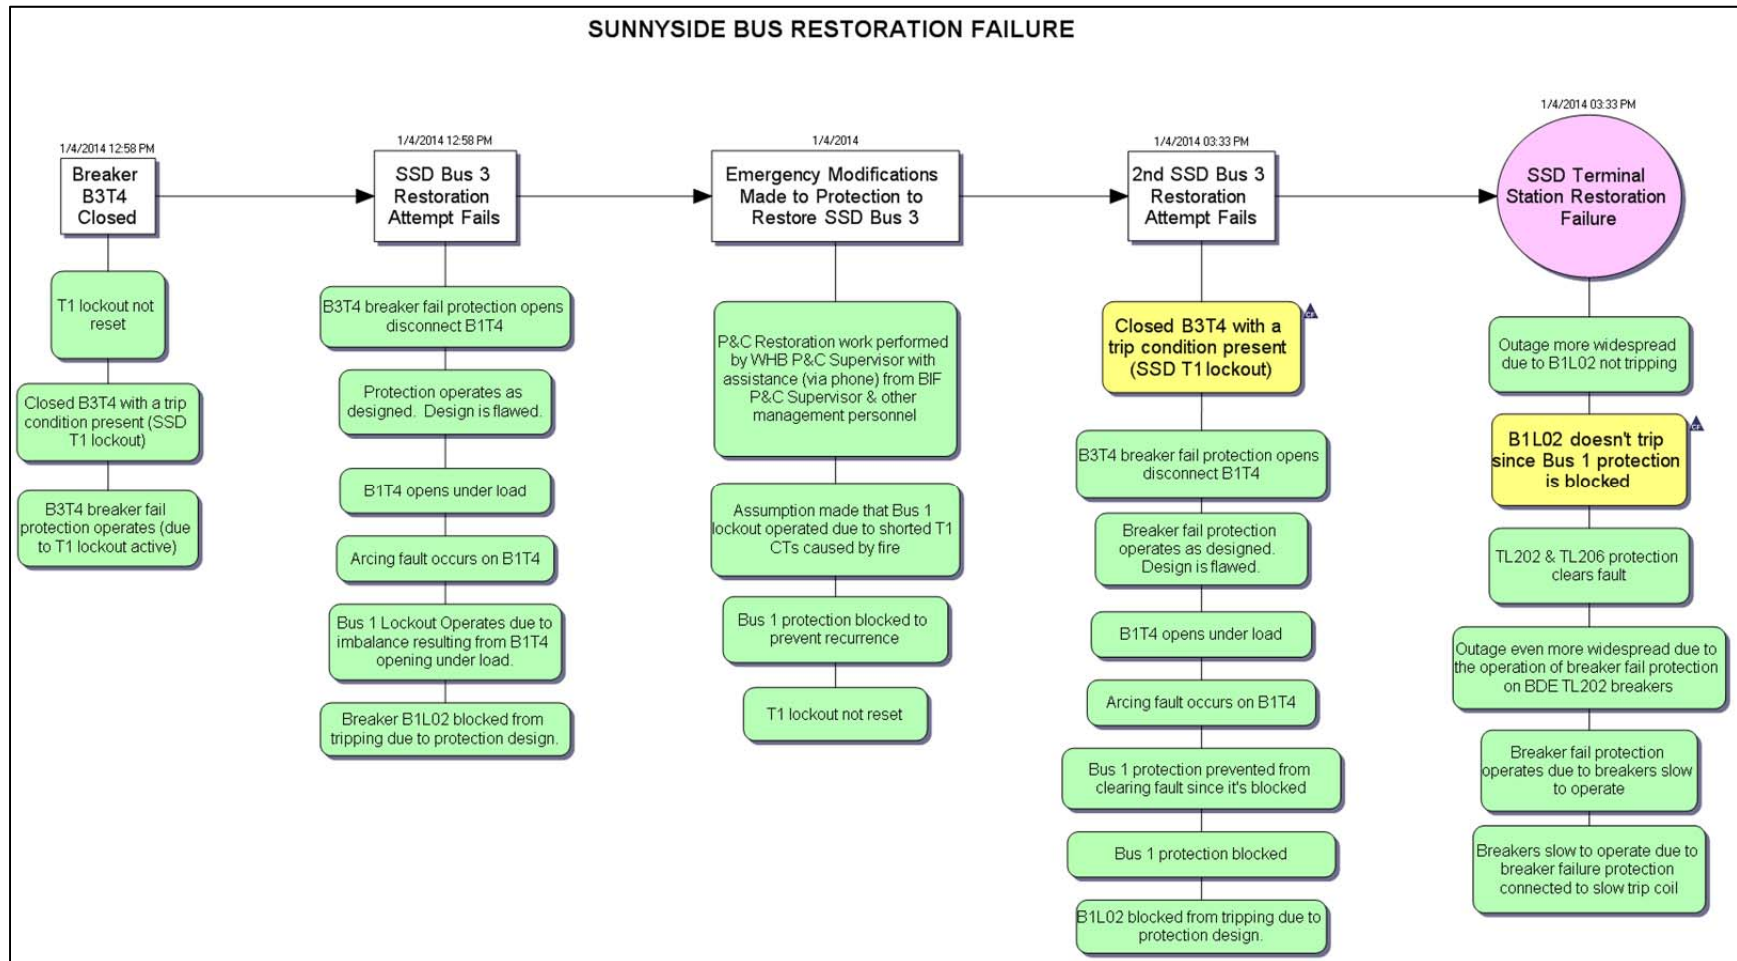
Figure 9 – Sunnyside Terminal Station Restoration Failure SnapCharT®

2 The Sunnyside Terminal Station restoration failure occurred as a result of unnecessary initiation
 3 of the breaker failure protection after the fault on T1 had been isolated. The restoration was
 4 further impeded by non-conventional application of the B3T4 breaker failure protection and
 5 modifications that occurred during the transformer fire event, which protection modification
 6 had an adverse effect on the Sunnyside Bus 1 protection. Figure 9 below is the SnapCharT® of
 7 the incident which shows the sequence of events and associated information.

10 By design, the initiation of B3T4 breaker failure protection was not removed after the isolation
 11 of the Sunnyside T1 transformer. When the crews isolated the T1 transformer via the 230kV
 12 B1T1 disconnect and 138kV B2T1-1 disconnect, the control circuitry should have automatically
 13 blocked the trip commands to any equipment associated with the tripping zone of transformer
 14 T1, such as breaker B3T4. However, this is not how the protection scheme is designed and as a
 15 result, when B3T4 was closed, its breaker failure protection was initiated and resulted in an
 16 extended outage to customers.

19 The design of the Sunnyside Terminal Station protection scheme is such that isolation of the
 20 T1 transformer would not block the initiation of B3T4 breaker failure.

Recommendation #	Recommendation
TA7	Review application of lockout protection on all transformers to ensure that the proper isolation of the transformer automatically blocks the initiation of 138kV breaker failure protection on the associated breakers.

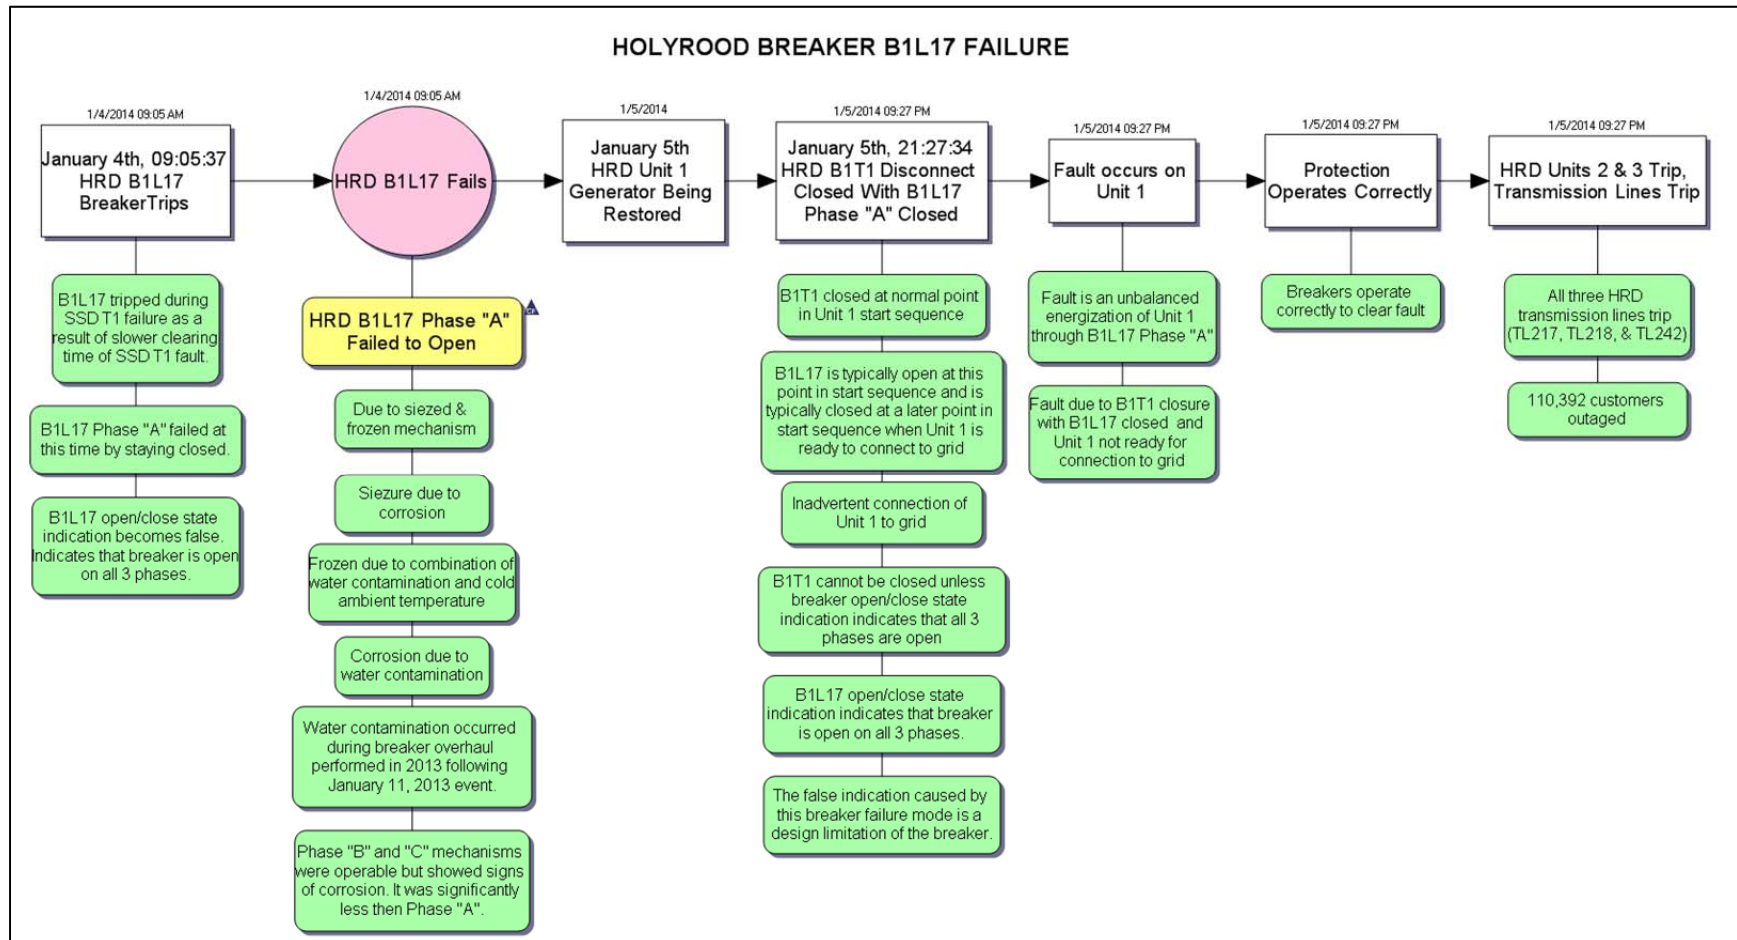
Figure 10 – Holyrood Breaker B1L17 Failure SnapChart®

11 At 21:27 on January 5, 2014 while attempting to connect Holyrood Generating Unit G1 to the
 12 grid, the Holyrood 230kV disconnect B1T1 was closed and a fault occurred on the system. It
 13 was subsequently determined that breaker B1L17 had previously failed during a trip operation
 14 and the failure allowed one of its phases to remain closed while the other two were open.
 15 There were no issues with Holyrood Generating Unit G1 that caused this incident. Figure 10
 16 below is the SnapCharT® of the incident which shows the sequence of events and associated
 17 information.

2 Based on an inspection conducted by Hydro maintenance personnel, supported by an expert
3 from the OEM ABB, it was determined that moisture in the main receiver tank for the phase “A”
4 on breaker B1L17 at Holyrood was the immediate cause of its failure to operate correctly on
5 January 5, 2014. Moisture in the main receiver tank lead to corrosion of the main control rod
6 drive on phase “A”. This combination of moisture and cold temperatures on January 4, 2014
7 resulted in the control rod on phase “A” seizing/freezing and failing to open.

20 The work method SWM-000318 entitled Interrupter Head (Air Blast Circuit Breaker) –
21 Replace, does not contain instructions on how to prevent moisture contamination of the
22 breaker air receiver tanks while the interrupters are removed.

- 1 **Root Cause #8: Scheduling Needs Improvement**
- 2 As a result of maintenance personnel being rescheduled to perform other high-priority
- 3 work, the reinstallation of the breaker B1L17 interrupters was deferred for four weeks.

Recommendation #	Recommendation
TA10	Revise work method SWM-000318 to include: <ul style="list-style-type: none"> <li data-bbox="630 373 1328 531">i) Correct procedure to seal the breaker air receiver tanks to prevent moisture ingress while the interrupters are removed; and <li data-bbox="630 552 1336 646">ii) Visual inspection of the breaker air receiver tanks prior to the reinstallation of the interrupters.

Recommendation #	Recommendation
TA11	Conduct a risk/reward review of the current practice for the application of the RTV coating with consideration given to the following alternatives which would reduce the amount of time the interrupters are removed from the main receiver tank: <ul style="list-style-type: none"> <li data-bbox="630 1430 1295 1524">i) Materials that can be applied without having to disassemble the breaker; <li data-bbox="630 1545 1279 1640">ii) Installing spare interrupters that have the RTV coating applied; and <li data-bbox="630 1661 1320 1755">iii) Applying RTV in a nearer controlled environment (Holyrood has some facilities).

Recommendation #	Recommendation
TA12	Conduct a review of the TRO Central Annual Work Plan to identify opportunities for improvement as it relates to the prioritization and timely execution of work. The review should include, but not be limited to, factors affecting the priority and execution of work, such as the availability of resources (staff, tools and equipment), to effectively execute the annual work plan.
