Re: An Application by Newfoundland and Labrador Hydro (Hydro) pursuant to Subsection 41 (3) of the Act for approval of a capital project to replace the alternator on the Hardwoods Gas Turbine

Hardwoods Gas Turbine Alternator Replacement 2013

Findings and Recommendations
 Stephenville Rotor Retaining Rings

**SERVICE
ENGINEER'S SITE
REPORT**

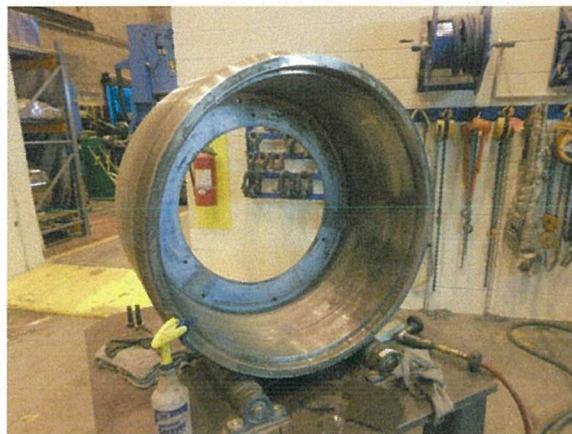
Figure 2: Retaining Ring

As part of the Stephenville alternator refurbishment work, the unit was dismantled and the alternator rotor assembly with attached retaining rings was sent to the Brush manufacturing facility in Pittsburg, Pennsylvania for inspection and rewind. During this inspection, it was discovered that the rotor retaining rings had stress corrosion cracks. (Refer to Appendix A - Stephenville Findings and Recommendations). Figures 2 and 3 show the Stephenville retaining rings and the cracks that were discovered.

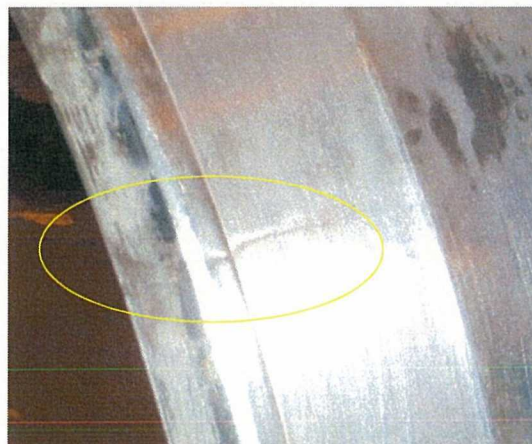
Figure 3: Retaining Ring Crack

Crack that has propagated through the entire nose of the ring

The Hardwoods and Stephenville Gas Turbine retaining rings are made of 18-5 MnCr stainless steel. This material was widely used in the power generation industry for retaining rings but its use was discontinued in the late 1980s when it was found to be susceptible to stress corrosion cracking. Stress corrosion cracking requires the material to be under stress and exposed to a corrosive element in order to be initiated. In the instance of 18-5 MnCr stainless steel the corrosive element is water or airborne moisture. It has been well

established in industry through reports by General Electric Power (GE) and other generator vendors, that 18-5 MnCr retaining rings in coastal climates, or locations with high humidity, are more susceptible to stress corrosion cracking than retaining rings in dry climates.

Brush has recommended that the Hardwoods retaining rings made of 18-5 MnCr steel be replaced by rings that are forged from an 18-18 MnCr alloy that has a high stress corrosion resistance based upon industry standards and findings. (Refer to Appendix A - Stephenville Findings and Recommendations).

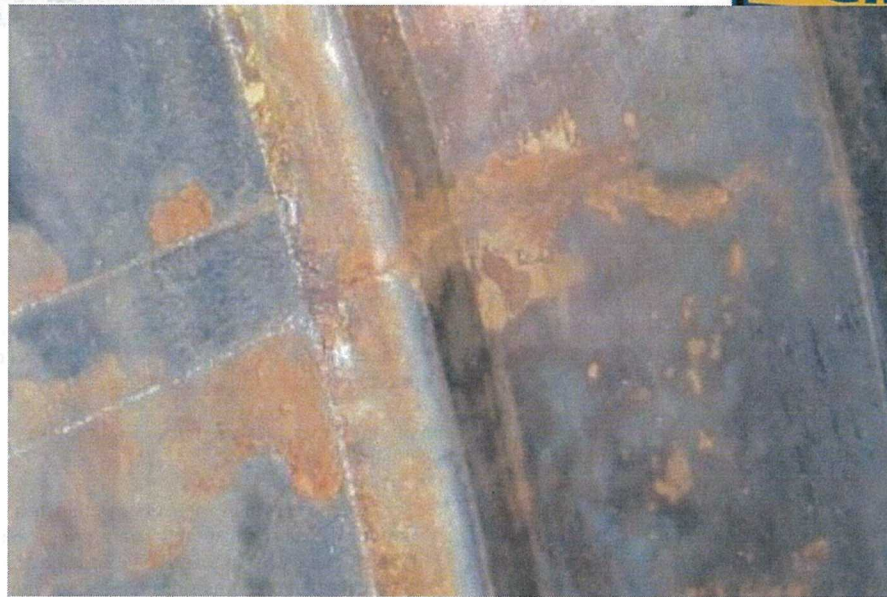
Upon inspection of the Stephenville rotor retaining rings it was observed that visible cracks were found in the inboard end of the retaining rings. See Figures 1 and 2.

Retaining rings are among the most heavily stressed components in the generator as they bear extremely high centrifugal and thermal forces during operation. The alloys that the retaining rings were originally comprised of are 18-5 MnCr stainless steel. This material has been found to be susceptible to stress corrosion cracking. There is supporting industry experience that retaining rings fabricated with 18-5 stainless steel are prone to failure. This problem is well documented. As a result, these types of retaining rings are being replaced with 18-18 MnCr alloy retaining rings as this has become industry standard.

Figure 1: Exciter End Retaining Ring with Visible Cracks

Given that the Hardwoods Gas Turbine is a sister unit of the same vintage, unless the retaining rings have been previously replaced, we strongly recommend that NL Hydro prioritize the replacement of the Hardwoods Gas Turbine retaining rings as expeditiously as possible.

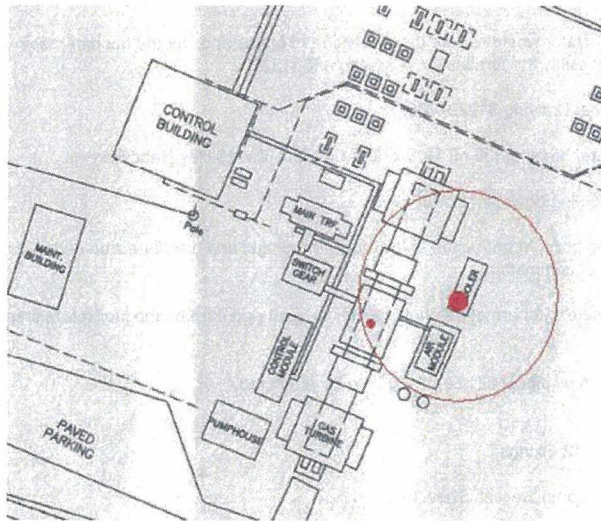
Crane will be sited at the oil cooler position after removal of the oil cooler, and will reach the centre of the generator with access to the yard for laydown area

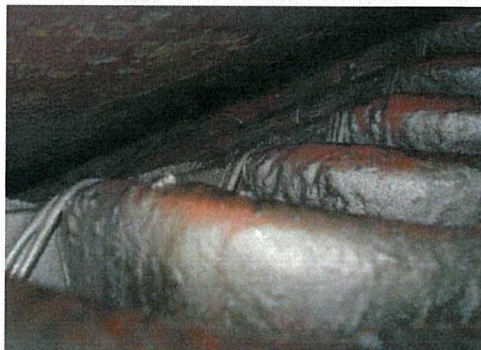
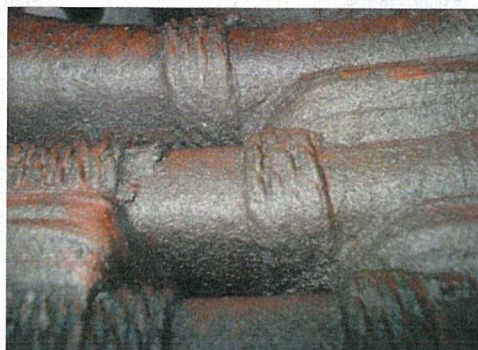
Contaminated Coils
