Re: An Application by Newfoundland and Labrador Hydro (Hydro) pursuant to Subsection 41(3) of the Act for the approval of the Turbine Rehabilitation of Bay d'Espoir Unit 4

A REPORT TO

Turbine Rehabilitation

Bay d'Espoir Unit 4

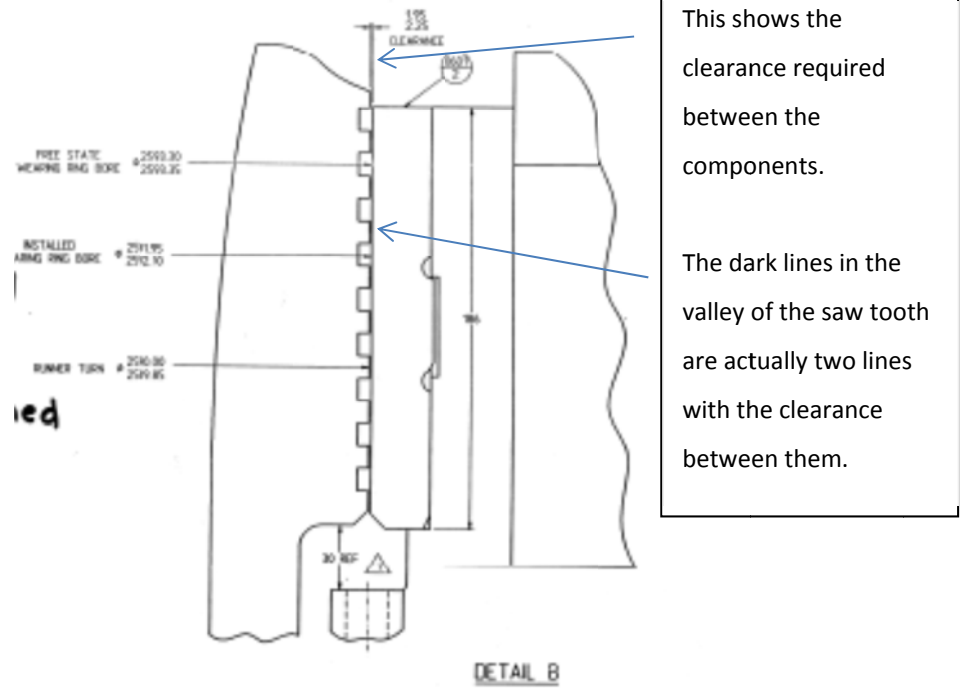
Figure 4: Close up detail of the lower seal area

17
18 Figure 4 shows a close up detail of the seal area of the turbine. Appendix A shows a large
19 cut away of the turbine generator assembly. In Appendix A, the area depicted below in
20 figure 4 is located by detail 47. Appendix B shows additional detail of the seal area.

1 There are various potential causes for seal clearance loss. A common reason is that the
2 concrete behind the seal is deteriorated and voids have developed, allowing the seal to
3 deform away from circular and ultimately become 'oval' thereby changing the clearance.
4 This appears to be the case when examining the Table 1 data. The US+DS diametric
5 clearances have actually increased, while the A1+A2 diametric clearances have decreased,
6 indicating the seal is 'ovalling'. Hydro has also performed hammer tests⁷ and the results
7 further suggest that there are voids that have developed now that the concrete is almost 50
8 years old. When this occurs, utilities will undertake to grout the voids as part of the work to
9 reestablish the seal clearance.

23 In order to reestablish the required seal clearances for safe, reliable operation, the scope of
24 work consists of the full dismantling of Unit 4. As the unit would be fully dismantled, Hydro
25 is proposing to complete the seal clearance reestablishment as part of the full scope of the
26 refurbishment that was planned for 2019, including a thorough inspection, and replacing or
27 refurbishing worn components found during the inspection. Completion of this work during

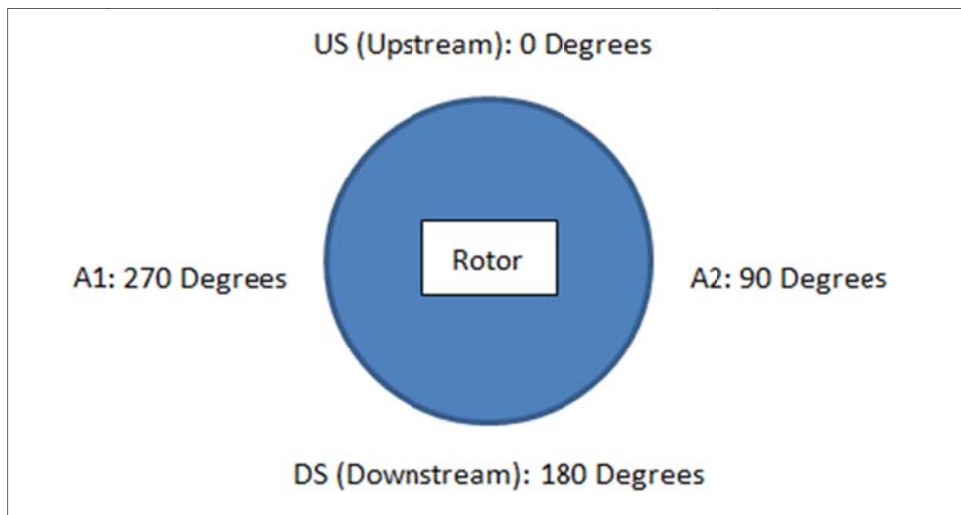
Figure 5: Position of the clearance readings as they relate to the data in Table 1

28 The lower primary seal clearance measurements taken in June 2016 for Unit 4 showed an
29 accelerated reduction in the amount of the clearance when compared to recent previous

1 publication: "Hydroelectric Turbine-Generator Units Guide for Erection Tolerances and Shaft
2 System Alignment" was reviewed and compared to the recent measurements. The
3 clearances were found to be not acceptable when compared to the CEATI guide, which
4 concurred with the external expertise consulted. For reference, see Table 1 for the current
5 readings as well as previous readings and CEATI recommended clearances.
