**Supply Issues and
Power Outages Review
Island Interconnected System**

**Executive Summary of
Interim Report**

**The Board of Commissioners of Public Utilities
Newfoundland and Labrador**

The Liberty Consulting Group

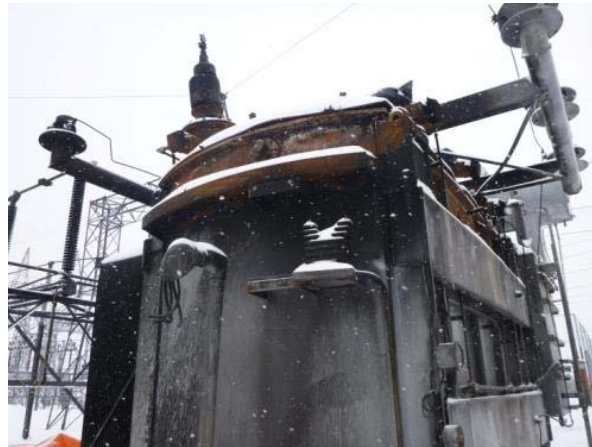
Illustration 3.1 Failed Sunnyside 125MVA T1 Transformer

At 9:05 a.m. on January 4th, Hydro experienced at its Sunnyside Terminal Station the first major event; *i.e.*, failure of the station's 125MVA T1 Transformer and a malfunction in an air-blast circuit breaker. A major power outage resulted from failure of one of five 230kV air-blast circuit breakers to open to interrupt the fault current produced by the T1 transformer fault, and because 230kV breaker failure protection had not been installed for a transformer fault.²⁹

The T1 transformer failure did not itself cause the major outage event. The Sunnyside terminal station has two 230/138kV 125MVA transformers (identified as T1 and T4). A fault in one of the transformers causes protective relays to sense the fault, and send "trip" signals to either the T1 or T4 "lockout relay." In order to clear (de-energize) a fault in either transformer, a fault detection

The long time required to clear the transformer fault resulted in the explosion and destruction of the T1 transformer. The oil expelled by the explosion ignited. The fire, the collateral damage caused, and ensuing system collapse most likely resulted from the two-second delay in clearing the transformer fault. The tripping of the transmission lines and long delay in clearing the transformer fault caused loss of supply, voltage depressions, and power frequency swings on the transmission system. A collapse of the transmission system and disconnection of the three Holyrood generating units (within three seconds of the transformer fault) ensued. The event caused power interruptions to about 187,500 customers on the Avalon Peninsula.

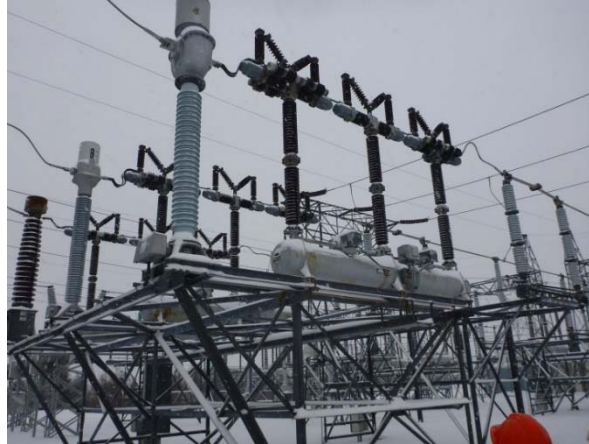
Illustration 3.2: Malfunctioning B1L03 Breaker

relay sends a trip signal to a lockout relay. This relay then sends trip signals to the two 230kV air-blast circuit breakers and to the three 138kV air-blast circuit breakers. These signals permit the rapid tripping (in less than 200 milliseconds) of all five circuit breakers, in order to isolate both transformers from the 230kV and the 138kV transmission systems. Correct operation of the equipment should have limited the consequences of transformer failure. Loads on each transformer at the time ran at less than 50 percent of capacity. Thus, the failure of one transformer should have permitted switching the 138kV load from that transformer to the other transformer within a short time.

The T1 transformer experienced an internal fault at 9:05 a.m. Breaker B1L03 malfunctioned. This breaker serves as one of the two 230kV air-blast circuit breakers connecting the transformers to the 230kV bus and to the four 230kV transmission lines. Breaker B1L03 “stuck,” and did not open. The line protection relays at the remote ends of the transmission lines exist primarily to protect the lines from faults. These relays therefore only provide time-delayed “back up” protection for a transformer/bus fault at Sunnyside. The last line to trip was the TL203 from the Western Avalon terminal station (where a transformer failed later in the day). The T1 transformer fault lasted a comparatively lengthy 2.0 seconds, because of the stuck breaker. The fault should have been cleared within the 200 millisecond standard.³⁰

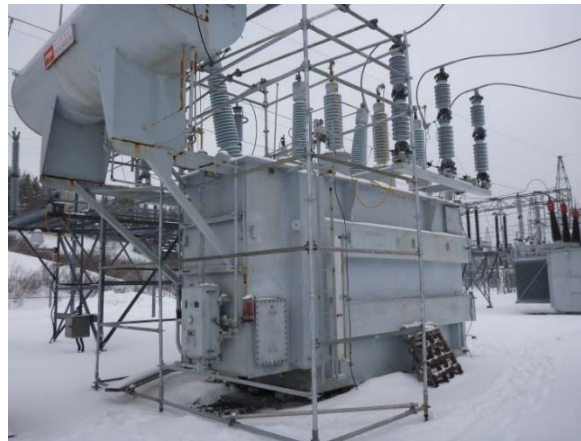
Illustration 3.3: Western Avalon Transformer T5

At 12:22 p.m. on January 4, 2014, Hydro's Western Avalon Terminal Station experienced an electrical fault in a transformer tap changer diverter switch and an air-blast circuit breaker malfunction. This event did not cause customer interruptions, but it did delay for several hours the restoration of service to customers already experiencing interruptions.⁴⁷

The Western Avalon terminal station has one 125MVA transformer (T5), two 41.7MVA 230/138kV transformers (T3 and T4) and two 25MVA 230/66kV transformers, connected on a straight bus. Hydro began attempting to restore the Western Avalon terminal station from the Come-by-Chance terminal station at about 9:30 a.m. on January 4th. Operators attempted to close Western Avalon air-blast circuit breaker B1L37 several times, in order to energize the bus and the transformers. The breaker, however, kept tripping shortly after each closing. The operators finally energized the terminal station by closing another breaker at 12:22 p.m. The 125MVA T5 transformer, however, faulted 12 seconds later. The 230kV bus tie breaker then tripped. This event cleared the T5 transformer fault, and also de-energized T3 and T4 (because they operate in parallel with T5, and connect to common 230kV and 138kV buses). Hydro later determined that the T5 transformer on-load tap changer faulted due to a flash over between the phases of the tap

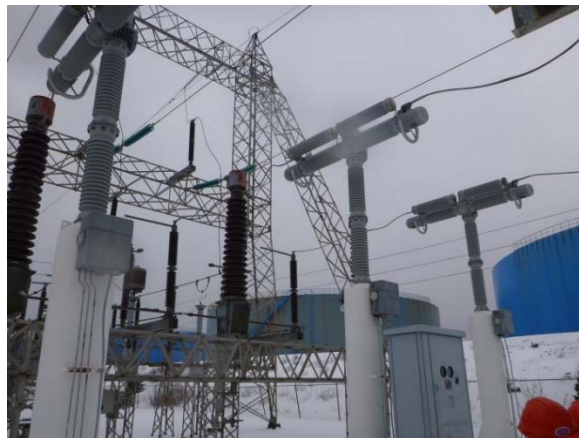
Illustration 3.4: Air-Blast Circuit Breaker B1L17

At 9:27 p.m. on January 5, 2014, a Holyrood Terminal Station air-blast circuit breaker failed to open. This third major customer interruption event affected 110,000 customers.

The arcing fault occurred because one phase of the 230kV air-blast circuit breaker B1L17 had been closed, even though the three position indicators (one for each phase) showed it as open on all three phases. The linkage to one of the indicators had also stuck. Because of the one stuck phase, single-phase current flowed back through the Unit 1 transformer. The disturbance caused the other two units, all transmission lines, and Holyrood station service to trip, and to disconnect from the system. The loss of the two other units at Holyrood generating station caused the interruption of about 110,000 customers.

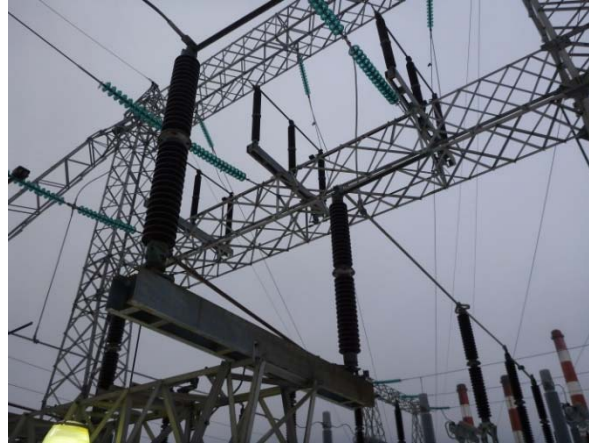
Illustration 3.5: Unit 1 Disconnect Switch

Hydro had restored Unit 2 and Unit 3 at Holyrood generating station. In preparing to bring Holyrood Generating Unit 1 on-line, operators had to close the Unit 1 switch between the line coming from the Unit 1 step up transformer and the presumably de-energized bus sections between the two breakers on the energized ring bus. The breaker open/close indicators on the control panel and on the breakers for the two air-blast circuit breakers showed both breakers to be in open status. When the operators closed the Unit 1 switch onto the supposedly de-energized bus section, an arcing fault occurred.⁶¹
