## **NEWFOUNDLAND AND LABRADOR HYDRO**

**Events of January 2013**

*January 11, 2013 Power System Outage Report*

December 2013

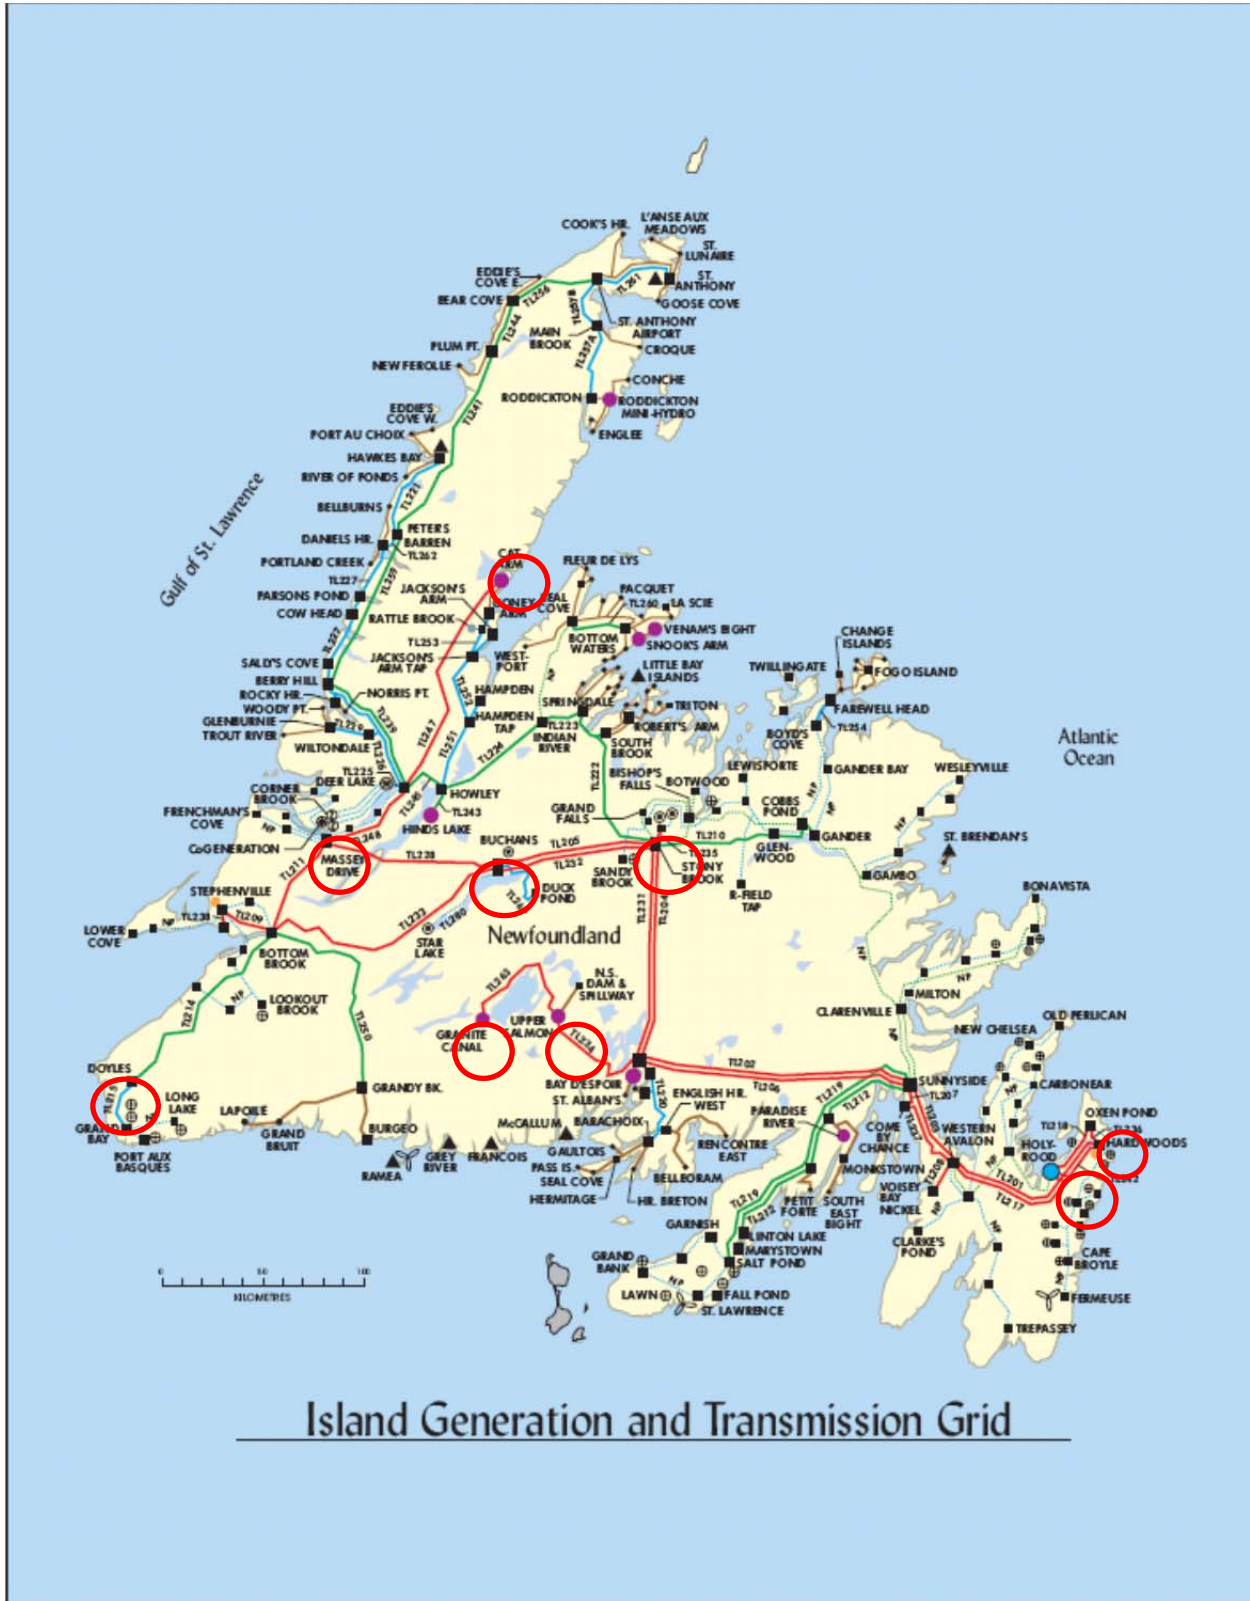
19 The system map in Figure 1 illustrates the extent of the power system problems experienced on  
20 January 11, 2013.

Figure 1: Locations Where Problems Were Encountered
