1 Q. **Refurbishment of Day Tank.**

2 With reference to the 2022 CFM report (Schedule 1, Attachment 3), CFM states that in
3 accordance with the API 653 calculations, a minimum of 10% of the existing floor area is
4 required to be replaced. Is Hydro proposing a complete floor replacement? Did Hydro consider,
5 and cost, a 10% replacement?

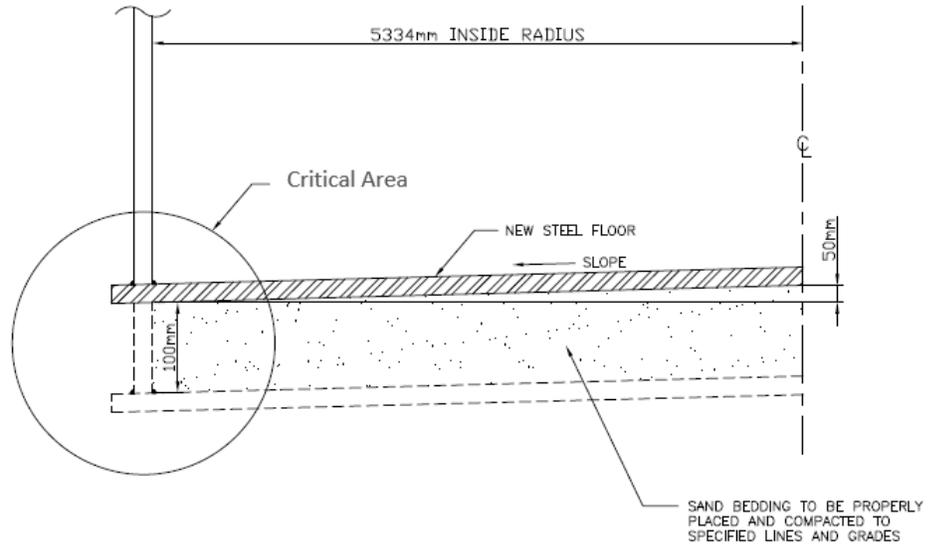
18 Because of this, the potential savings that would be associated with a partial versus a full
19 replacement is small. The corrosion rate of the tank floor critical area (see Figure 1) which was
20 repaired by patching in 2013, indicates that the remaining life of this area cannot exceed ten
21 years. As well, the API 653¹ does not permit installation of patches on top of patches in the
22 critical area; therefore, the previously-repaired sections of the critical area must be replaced.

Figure 1: Corrosion Rate of Tank Floor Critical Area

23 Hydro will inspect and assess the condition of the floor during the proposed project. If the floor
24 is found in considerably better condition than expected, installation of patch plates in some
25 areas may be cheaper than 100% floor replacement, and may realize some cost savings. Hydro
26 will avail of any opportunity to reduce costs by reducing the amount of floor replaced.
