1 Q. **Reference: Schedule 1, Page 14, lines 9-11. The Application states that "The existing fuel tanks**
2 **12C, 12E, and 12F will also be replaced with horizontal tanks in the size range of 60,000 -**
3 **80,000 litres."**

In-Service Inspection Form
(Atmospheric and Low Pressure Storage Tanks)

Tag Number: Rigolet: 12C , L-GAP05-080101.03	PO#/Work Order #: NL1502	Date of Inspection: November 11, 2020
Equipment Type: Diesel Fuel Storage Tank	Tank Status (Applicable Highlighted): In Operation	Inspection Type: (Applicable Highlighted): External Only
Fabricator: Burse Manufacturing	Shell Material: Carbon Steel	Year Built: 1998
Max. Operating Pressure: 7kPa	Max. Operating Vacuum: 300Pa	Inspection Specification: ULC-S601 / API 653
Nominal Thickness: Head and Shell 5mm	Corrosion Allowance: Unknown	Report #: EXT-12031-NL2020-035

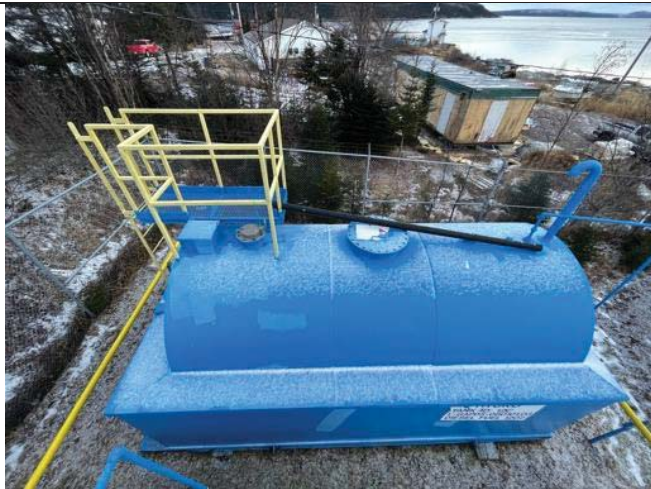
12C overview

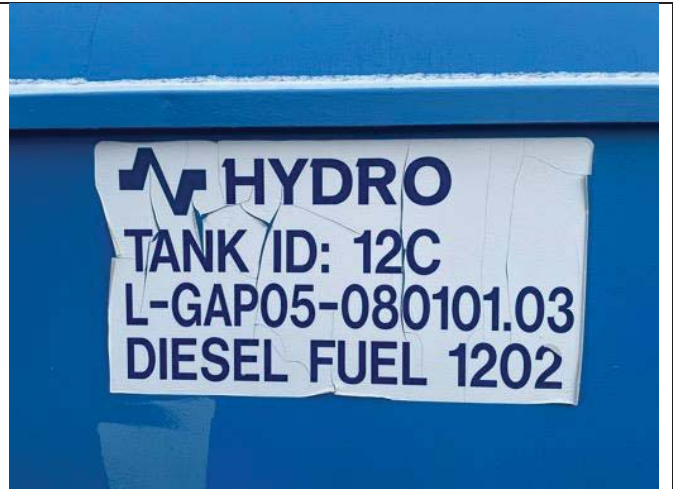
Nalcor tag

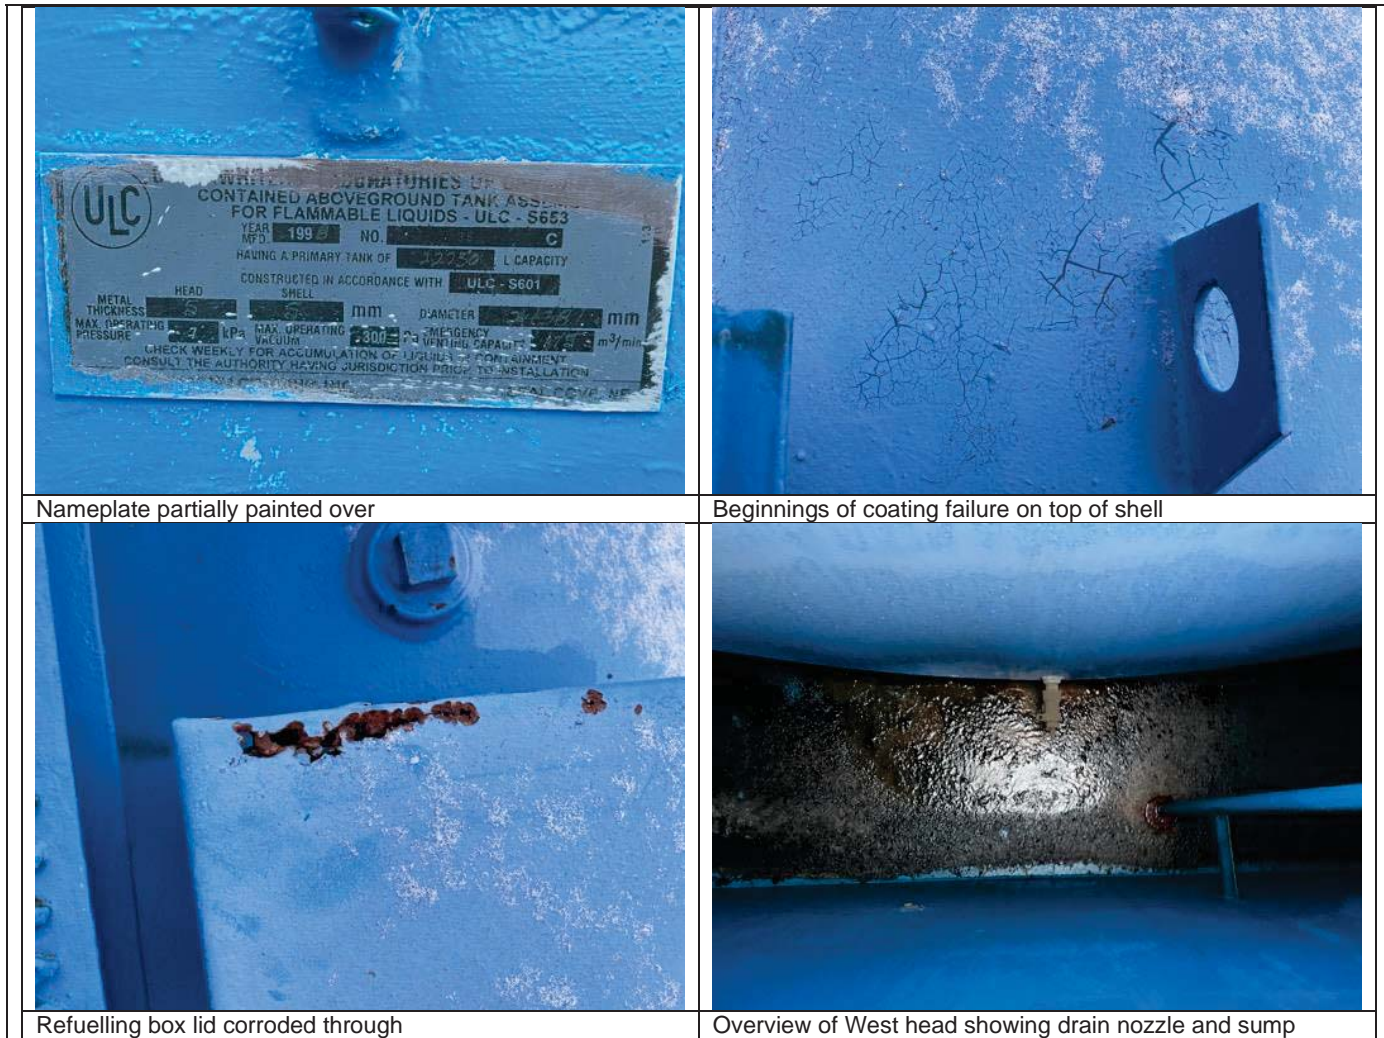
- Nameplate was securely attached and mostly legible. Paint partially obscured the edges.
- The lid to the refuelling box is corroded through along the West side.

Nameplate partially painted over

Beginnings of coating failure on top of shell

Refuelling box lid corroded through

Overview of West head showing drain nozzle and sump

- Repair or replace corroded refuelling box lid.
- Monitor coating on top of tank and repair as needed.
- Install proper ground connection.
- During the next internal inspection, get UT completed on the bottom of the shell. While doing that inspection use the confined space monitor to complete a visual inspection of the tank inside the basin. Perform external and internal inspections at the next required interval.

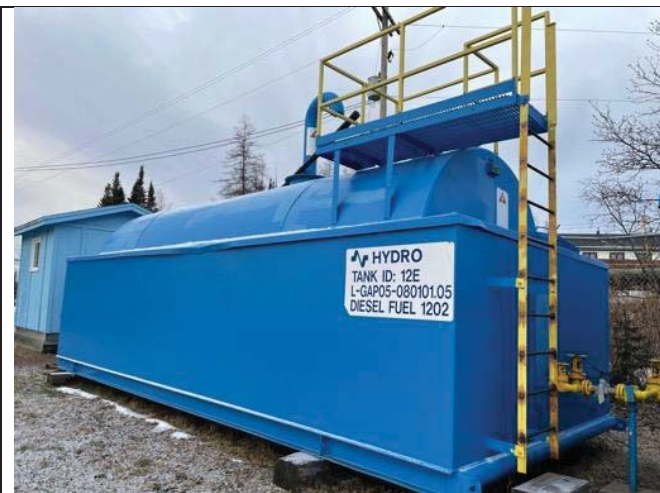
12E overview

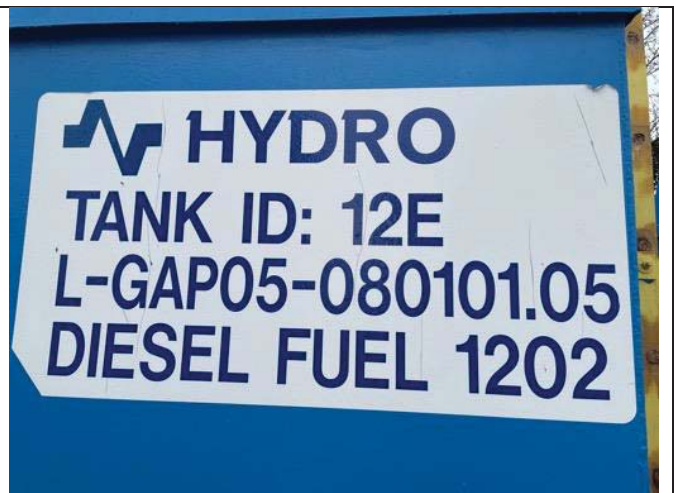
Nalcor tag

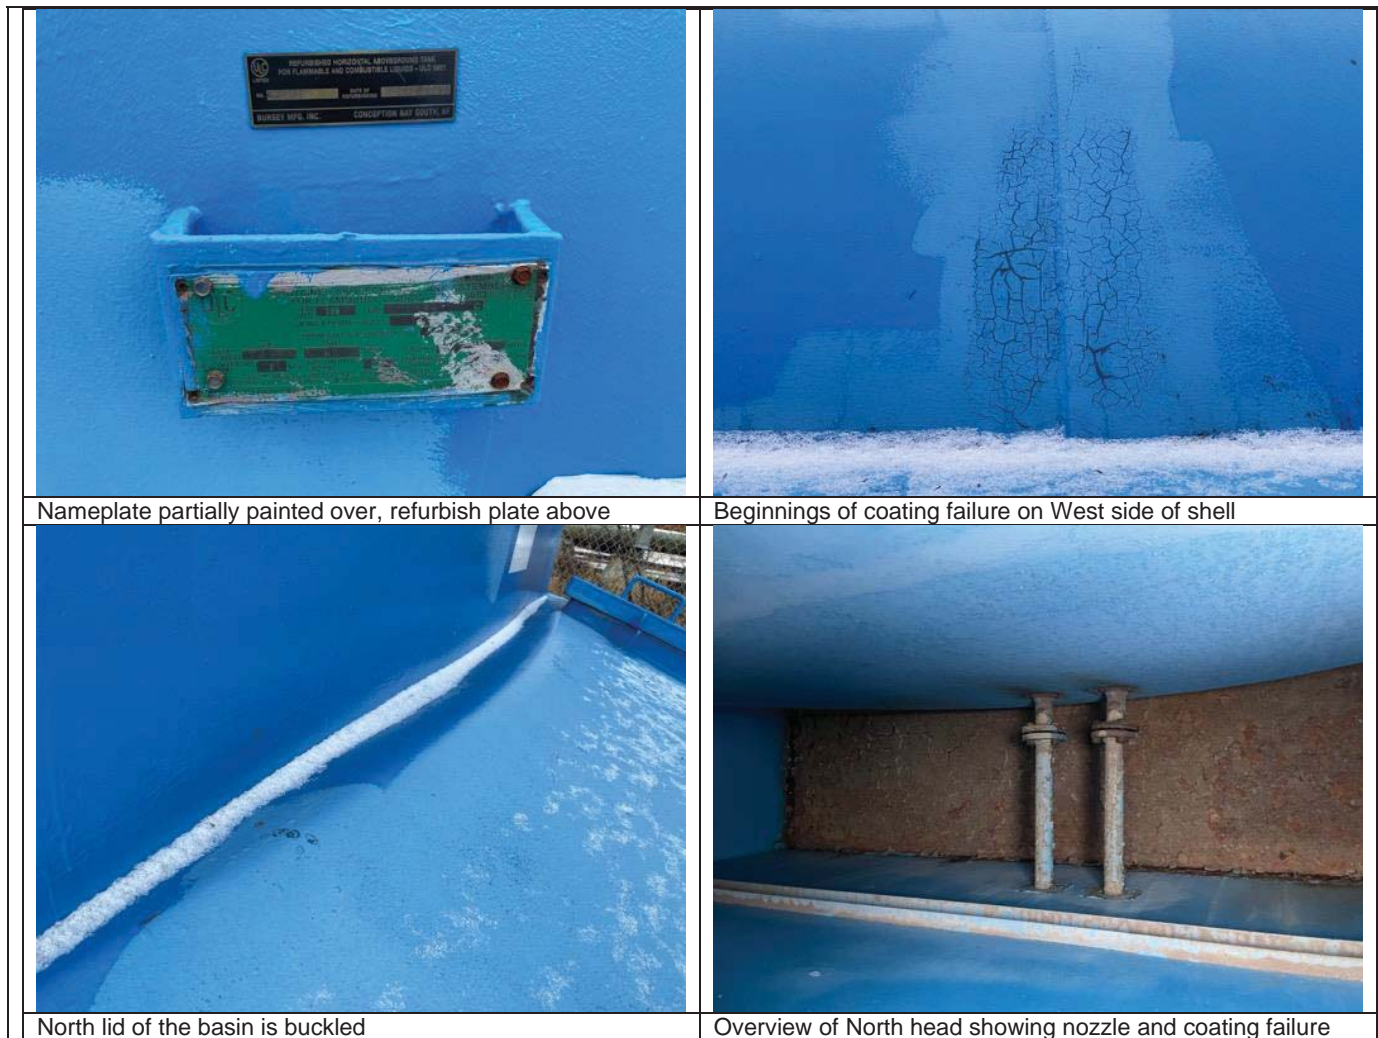
- Scattered coating failure noted on the basin, tank, ladder, and nozzles. Light surface corrosion was found on exposed metal. More extensive coating failure noted on inside surfaces of the basin, especially the floor and near the floor.

- No ground connection to the tank or basin was found.
- Nameplate was securely attached and mostly legible, with paint obscuring some parts. A refurbishment plate from 2007 was attached to the North head above the nameplate.

- The lid on the North end of the basin is buckled. It may have been damaged during original shipping. The damage has not affected the tank nor the functioning of the basin.

- Monitor coating on tank shell and repair as needed.
- Install proper ground connection.
- During the next internal inspection, get UT completed on the bottom of the shell. While doing that inspection use the confined space monitor to complete a visual inspection of the tank inside the basin. Perform external and internal inspections at the next required interval.

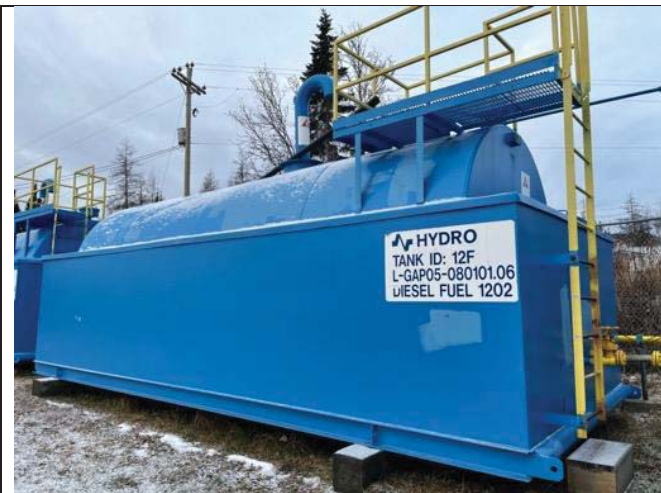
12F overview

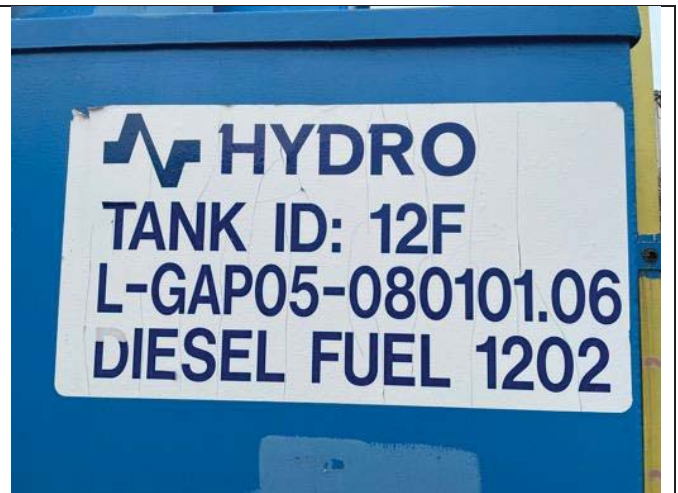
Nalcor tag

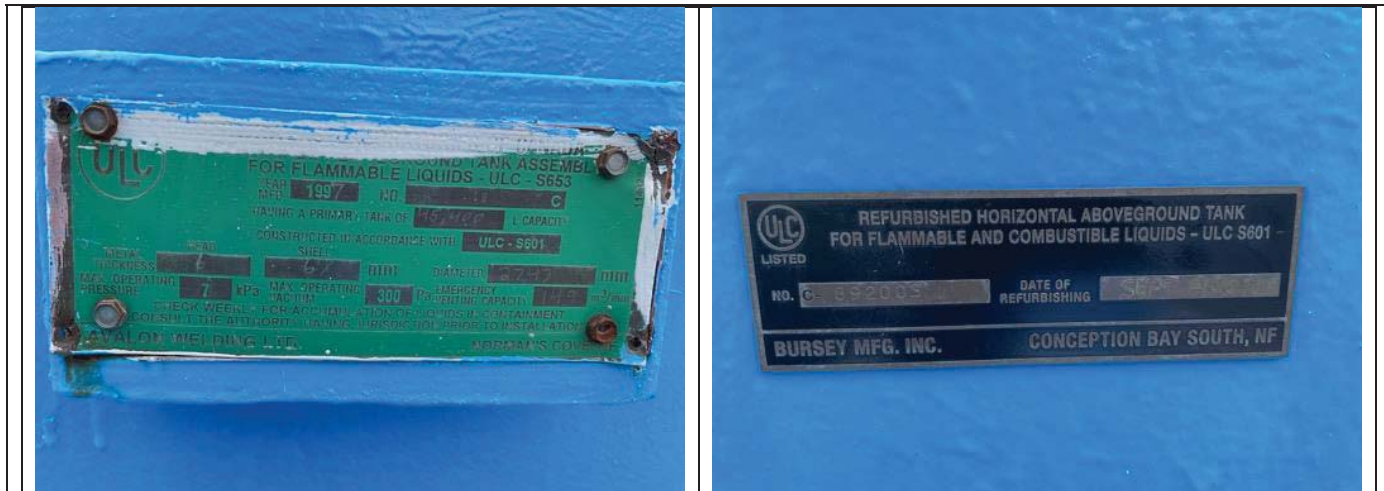
- No ground connection to the tank or basin was found.
- Nameplate was securely attached and mostly legible, with paint obscuring some parts. A refurbishment plate from 2007 was attached to the North head below the nameplate.

Nameplate partially painted over, refurbish plate above

Refurbishment plate

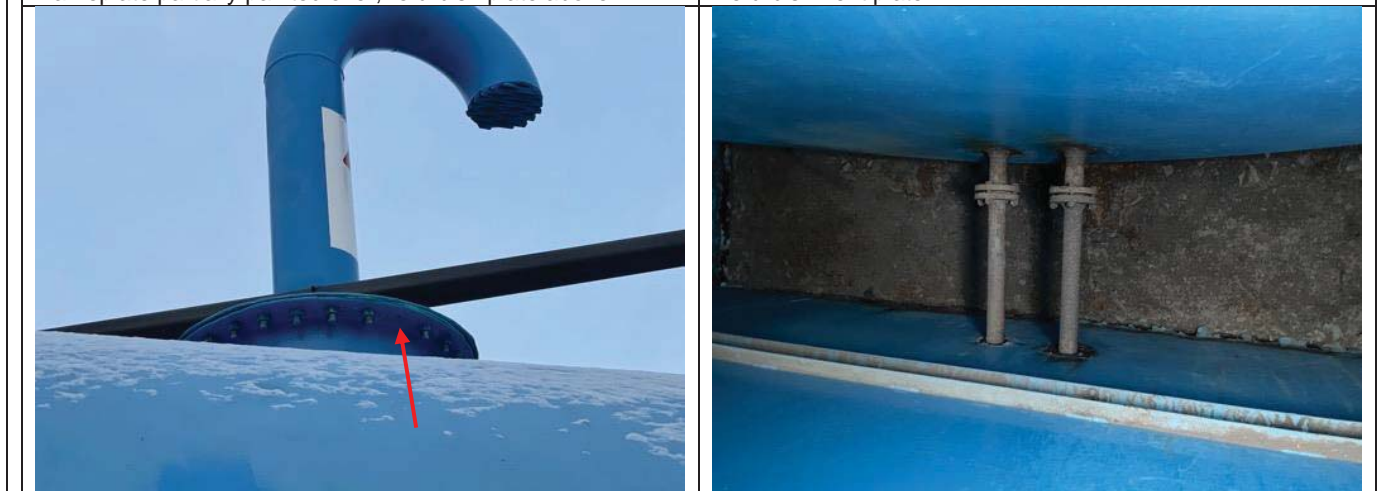
4. Is all bolting tight and extending fully through the nut?	<input type="checkbox"/>	<input checked="" type="checkbox"/>	<input type="checkbox"/>	Bolt missing from manway flange.

- The manway flange was missing 1 bolt.
- UT thickness readings taken on all sides and top and compared to the 2014 UT data. No issues were identified. Refer to report UT-12031-NL2020-013.

Bolt missing from manway/cover flanged connection

Overview of North head showing nozzle and coating failure

- Monitor coating on tank shell and repair as needed.
- Install proper ground connection.
- Replace missing bolt in manway flange.
- During the next internal inspection, get UT completed on the bottom of the shell. While doing that inspection use the confined space monitor to complete a visual inspection of the tank inside the basin. Perform external and internal inspections at the next required interval.
