1 Q. **Reference: Program 1 Overhaul Turbine and Valves Unit 3, page 12.**

HOLYROOD UNIT 3 INFORMATION

Holyrood Unit 3
March 2024

Holyrood Unit 3
April 2024

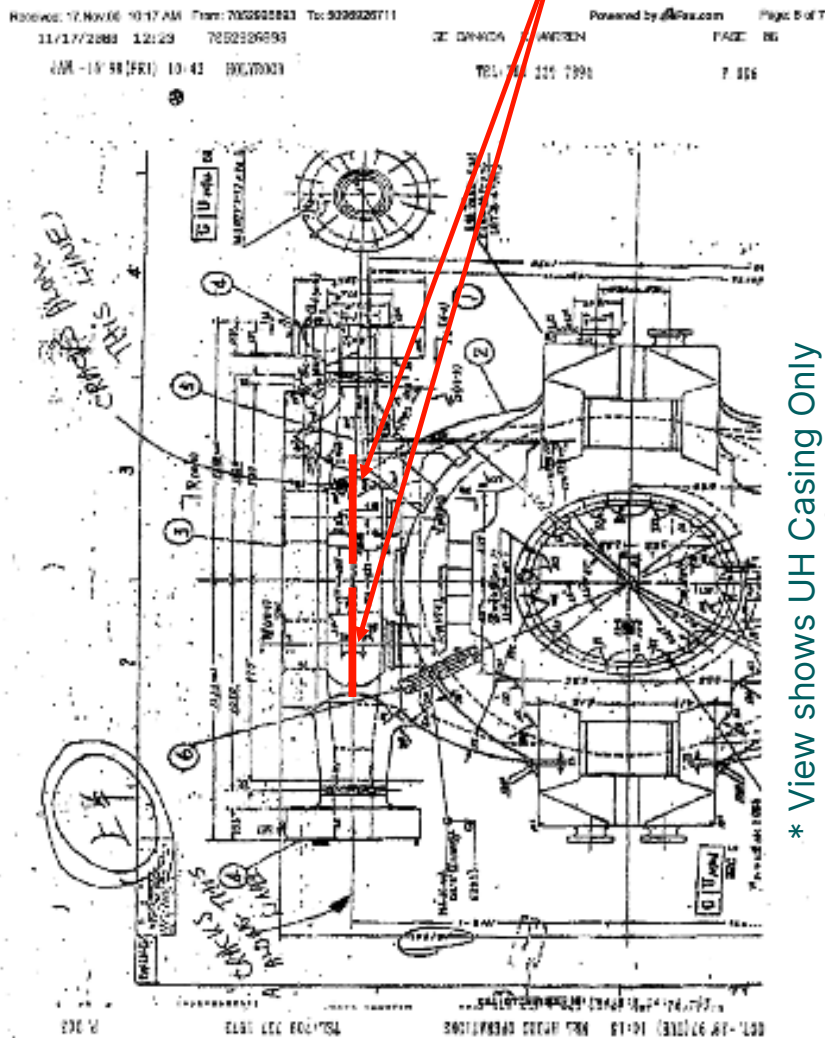
Assumed UH Valve Chest Configuration

- ~1998: Customer discovered cracks in the adjoining welds between the outer lower half HP/IP Casing and the Valve Chest
- ~1999: GE provides several repair options and life expectancy of each repair, recommending a reinforcement repair option with tempering solution
- ~2001: Customer performs reinforcement repair option via GE Schenectady
- Ultrasonic inspections have been completed in 2013, 2016, 2019, and 2021 with the crack growing to ~12mm in depth
- 2022: GE completed a fracture mechanics assessment on the unit to identify critical crack size, ultimately recommending a short remaining life and a valve chest replacement/repair
- 2024: Customer requested repair/replacement options going forward based on the continued operation of the unit

- Control Valves: 4 (2 Upper & 2 Lower)
- Valve Chest Material: Cr-Mo-V (Sim. to STG50T)
- Ass. Casing Depth at Indication: 100 mm
- Indication Approx. Locations

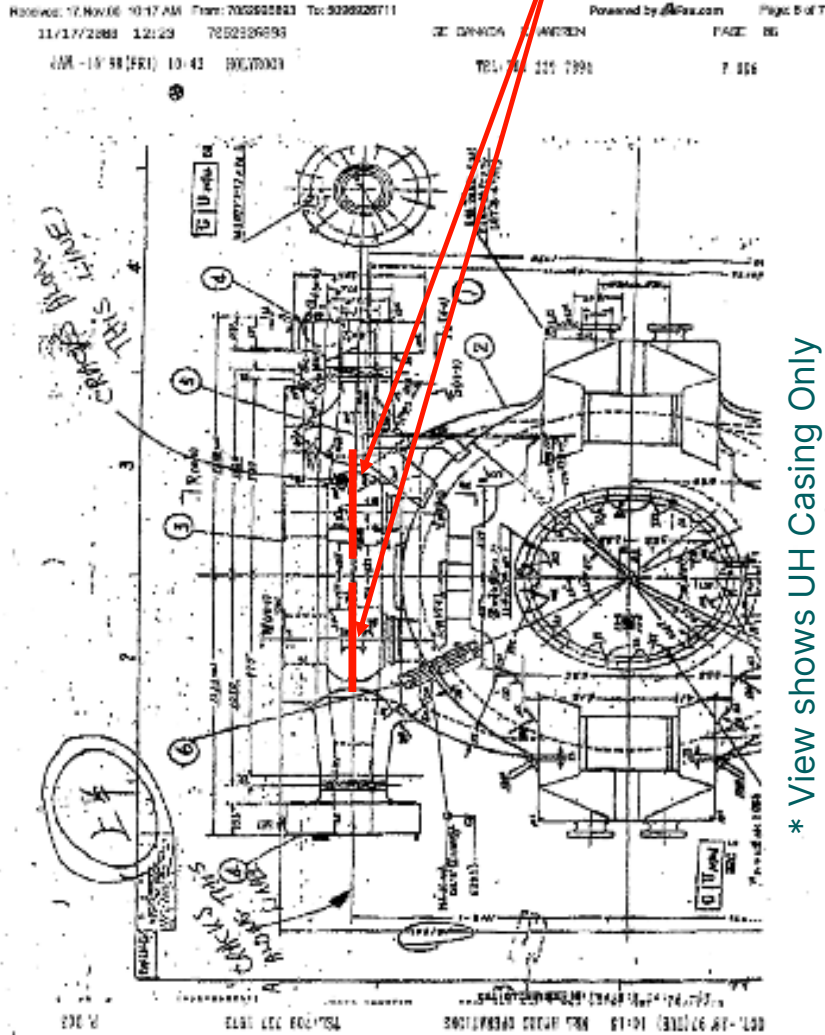
Assumed UH Valve Chest Configuration

- ~1998: Customer discovered cracks in the adjoining welds between the outer lower half HP/IP Casing and the Valve Chest
- ~1999: GE provides several repair options and life expectancy of each repair, recommending a reinforcement repair option with tempering solution
- ~2001: Customer performs reinforcement repair option via GE Schenectady
- Ultrasonic inspections have been completed in 2013, 2016, 2019, and 2021 with the crack growing to ~12mm in depth
- 2022: GE completed a fracture mechanics assessment on the unit to identify critical crack size, ultimately recommending a short remaining life and a valve chest replacement/repair
- 2024: Customer requested repair/replacement options going forward based on the continued operation of the unit

- Control Valves: 4 (2 Upper & 2 Lower)
- Valve Chest Material: Cr-Mo-V (Sim. to STG50T)
- Ass. Casing Depth at Indication: 100 mm
- Indication Approx. Locations
