**Subject/Project:** CAT ARM RUNNER INSTALLATION ASSESSMENT

**Title:** TURBINE AND GENERATOR U1, U2, AND SPARE RUNNER INSPECTION REPORT

**Ref. number:** 27293400MEP00-PA00DC-05

**CLIENT:** NEWFOUNDLAND HYDRO

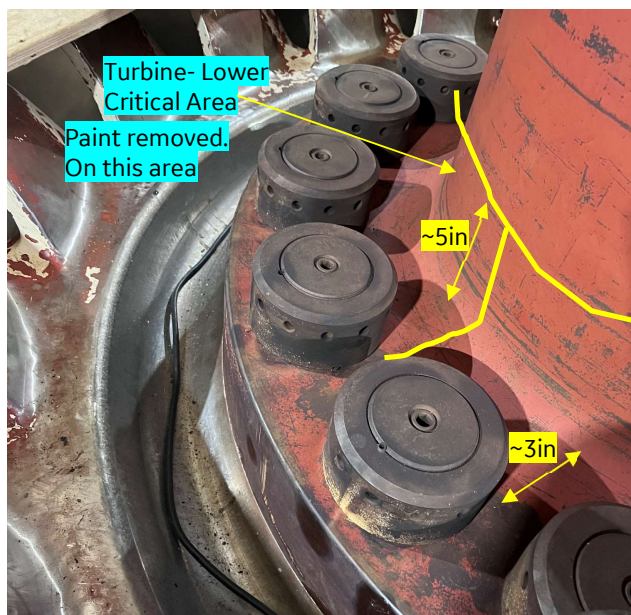
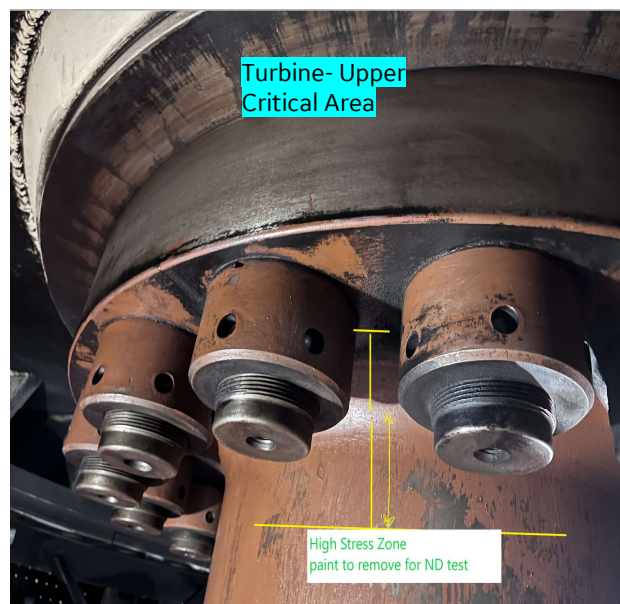
To allow access for the shaft inspection, the bearing support extension was dismantled and removed. It was required to remove the paint from the shaft's high-stress zone in order to conduct the visual and magnetic particle (MT) tests. The high-stress zones at both the top and bottom, which were cleaned and tested, are located at the interface between the flange and the journal. The image below shows the cleaned area prepared for testing.

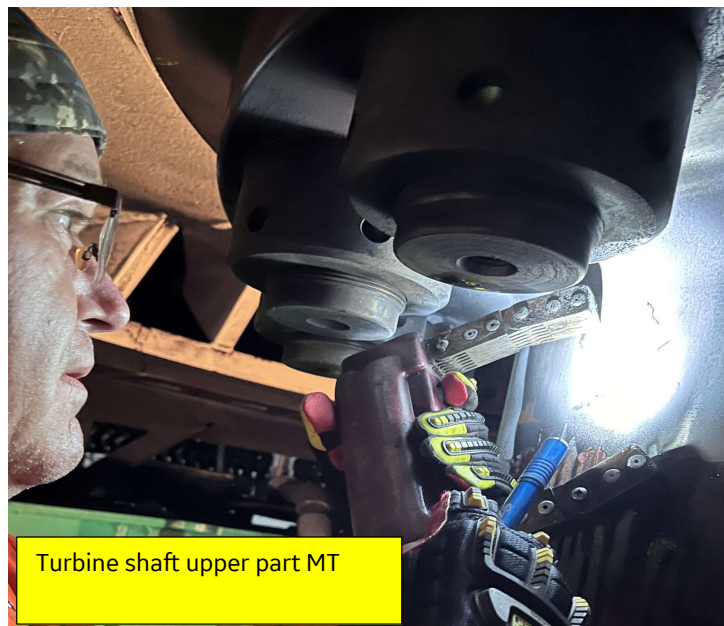
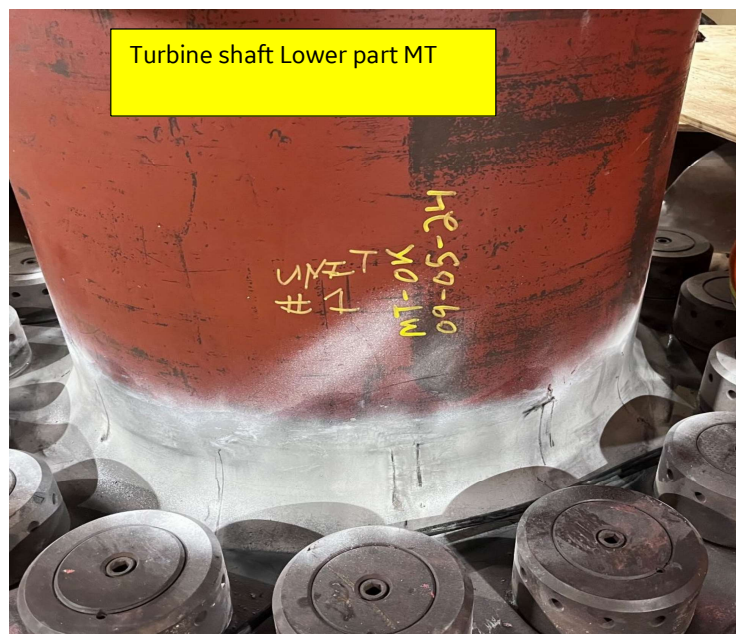
After cleaning the turbine shaft and removing the paint, both the top and bottom critical zones were visually inspected, with no indications of defects observed. Following the visual inspection (VT), magnetic particle testing (MT) was performed on both the top and bottom areas of the shaft. No indications were found during the MT inspection. The MT test procedure and results are shown in the following pictures.

- c) **Turbine Shaft:** Turbine shaft partial inspection did not reveal rejectable defects. The shaft should be fit for service. After dismantling the runner and before positioning the new runner beneath the turbine shaft, the bottom surface of the turbine shaft flange must be inspected, cleaned, and its elevation/levelness measured. Any discrepancies identified during this process should be addressed and corrected before the assembly of the new runner.

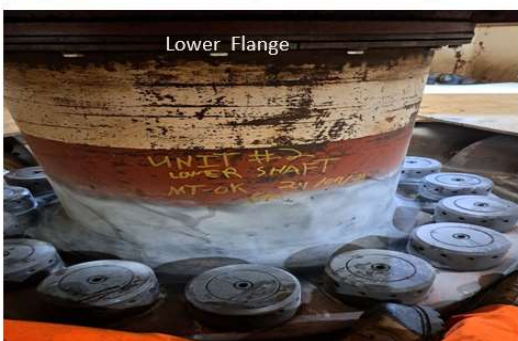
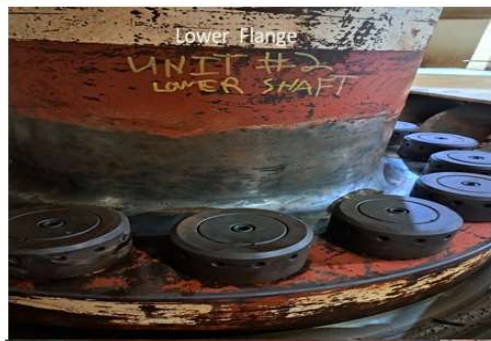
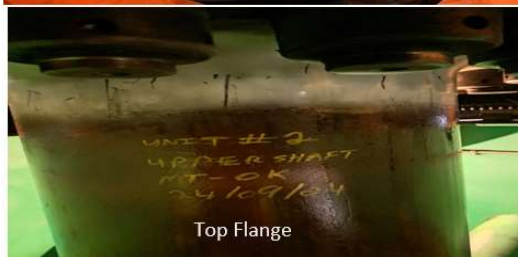
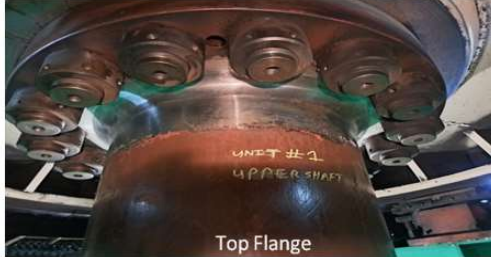
Turbine Shaft MT Result- U2

At the time of examination, no relevant or rejectable indications were found on upper and lower flanges area inspected.

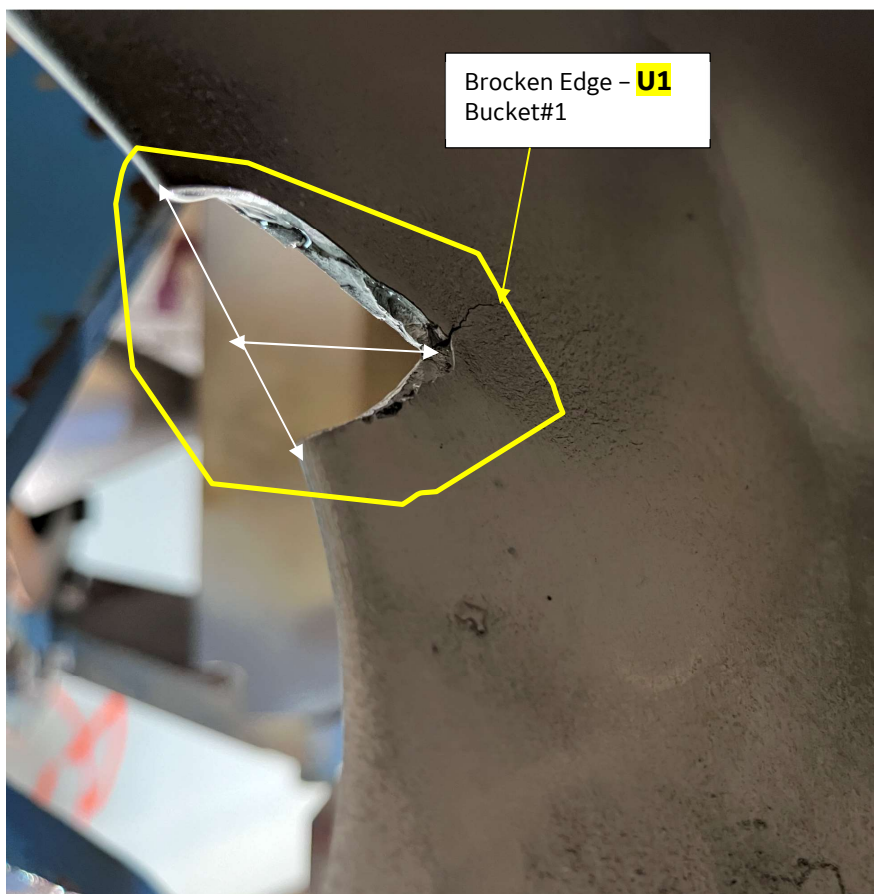
During the visual inspection of Bucket #1, in addition to the deep cavity on the bucket outlet edge, it was observed that approximately 50mm by 50mm of material was missing from the edge, with a crack propagating about 15mm along the length of the bucket. Aside from the major mechanical cavitation defects, visible near the outer edges of all buckets, no other issues were identified in the tested buckets. Buckets #1, #6, #8, and #12 underwent magnetic particle testing (MT). The following are pictures of the damaged spots on the buckets identified during the visual inspection (VT).

- a) **Runner Replacement:** It is recommended to replace the Unit 1 runner with the spare runner during the upcoming outage. To prevent further damage and minimize operational risks, this replacement should occur within the next 12 months. Runner replacement process is described in document 27293400MEP00-PA00 DC-01

- b) **Replaced U1 Runner:** After removal from U1, the runner should be sent to a workshop for repair and refurbishment. The dismantled runner from Unit 1 should undergo full testing, including Magnetic Particle Testing (MT) and Ultrasonic Testing (UT), to evaluate the necessary refurbishment. A complete dimensional assessment is required, including flange surface levelness, bucket levelness, upper and lower bucket bowl heights, and bucket thickness measurements in various areas.

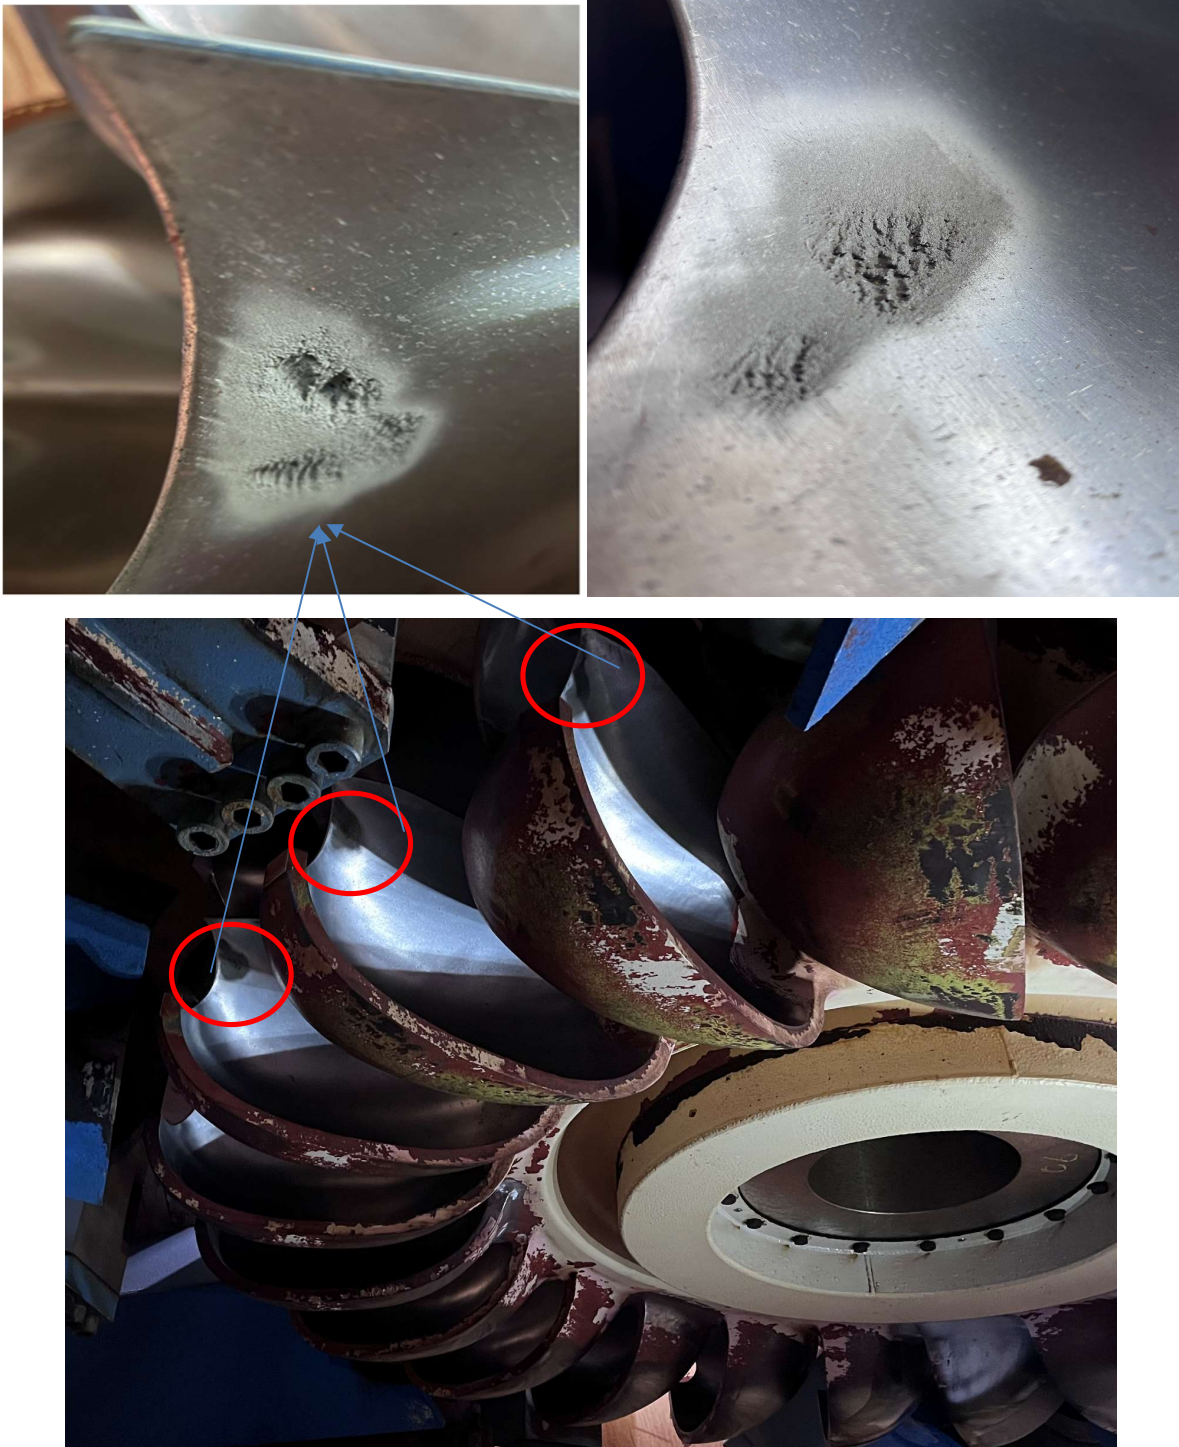
## Buckets Cavitation

The depth of cavitation in the buckets outer part measured 1 to 3mm. in this area the bucket thickness is around 5mm. Repair should be performed in the short.

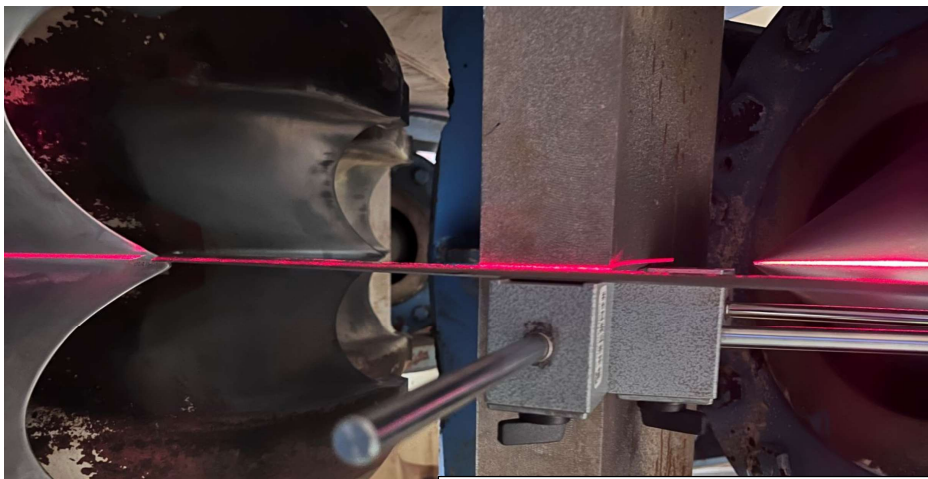
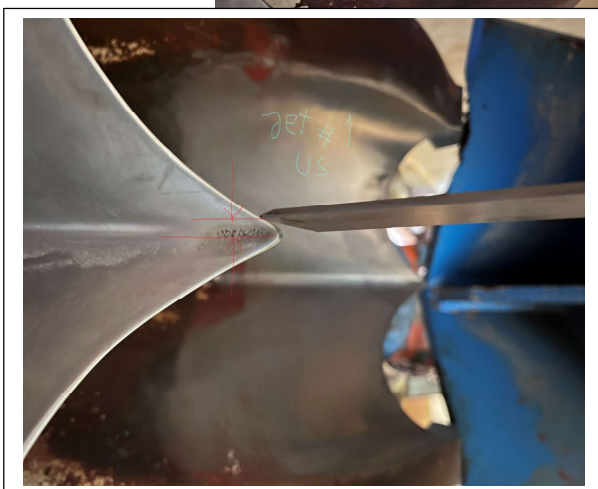
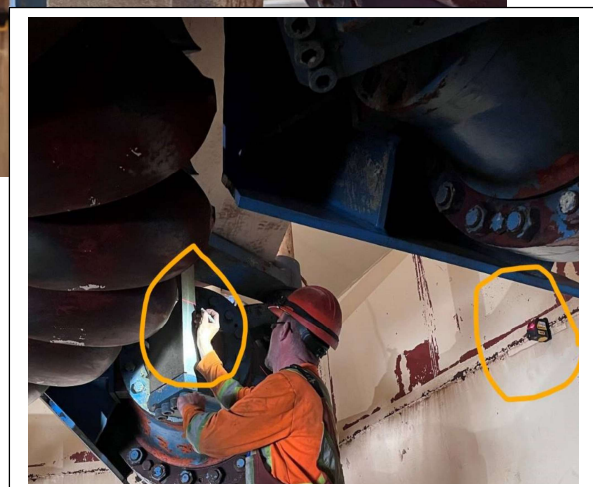
The runner elevation measurements relative to the injector tips were taken. A discrepancy of a few millimeters was found between the bucket tips and injector tips, exceeding the acceptable tolerance levels. The average deviation for the six injectors was 3.5mm, while the tolerance limit is 1.7mm. Several factors contributed to this deviation, such as:

1. **Tool Accuracy:** The measuring tool used was a self-leveling laser, which may lack the precision required for accurate measurements.
2. **Injector Elevation:** The deviation may stem from the misalignment of the injectors relative to one another.
3. **Runner Manufacturing:** Variations in the manufacturing process may have led to discrepancies in the tips of the runner buckets.
4. **Initial Machine Settings:** Since all readings indicated that the bucket tips were below the injectors, this could be attributed to the initial settings of the machine.
5. **Excessive Deflection:** The upper bracket may experience excessive deflection due to the weight of the rotating parts.

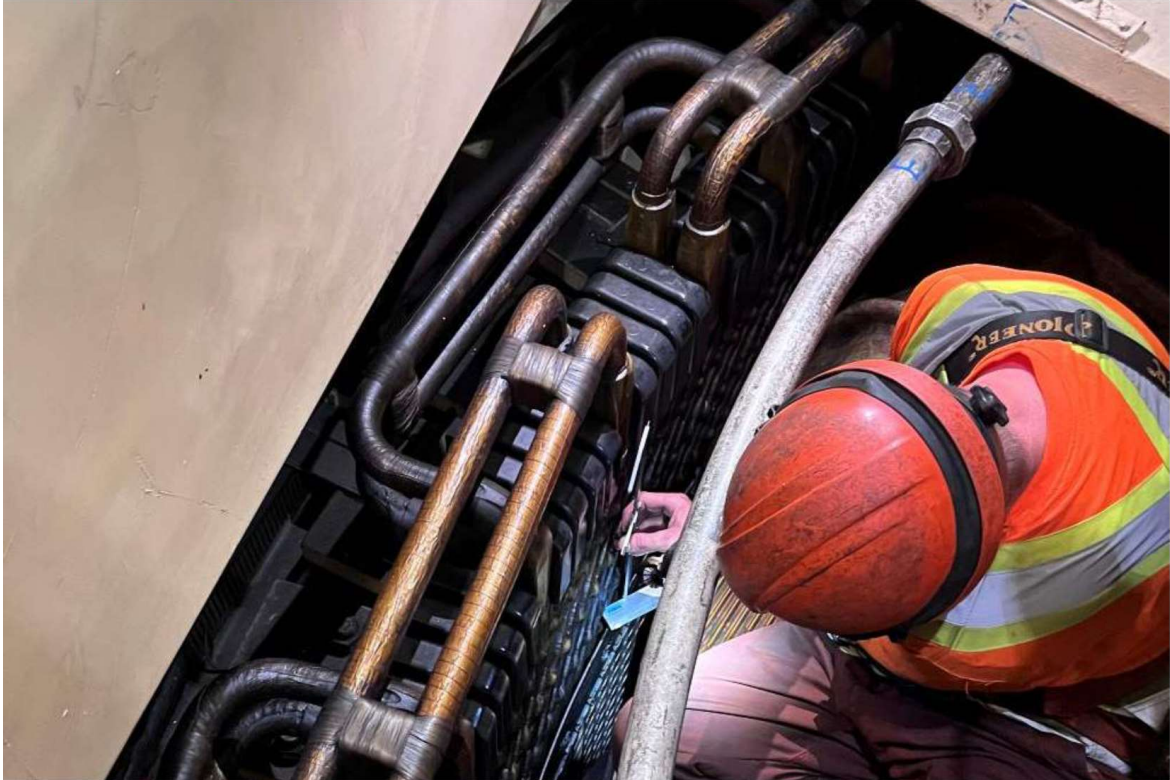
### Top Reading.

Based on readings from 4 poles on both the upstream and downstream sides, at the top and bottom (as shown in the following pictures and check sheet), the poles appear to be positioned too high. To align them with the stator core center, each pole will need to be readjusted and lowered to match the center of the stator core.

Several root causes are associated with the deviation in pole height readings from the stator core center, including the following:

- 1. Initial Misalignment of Poles:** The poles were not properly adjusted during the initial setup, contributing to the current deviation.
- 2. Surface Waviness in Measuring Areas:** Surface irregularities on both the pole and core were observed, with an expected impact of 5 to 10% of the air gap. This factor cannot be corrected and should remain "as is."
- 3. Deviation in Stator Core Elevation:** There is a discrepancy between the calculated and actual stator core elevation. If this is the case, the modification should focus on adjusting the rotor pole position, as no changes can be made to the stator core elevation.

To address these issues, all air shields on both the top and bottom must be removed to allow full access to the measurement areas.

Based on the limited magnetic center measurements obtained from rotor pole readings across four poles, pole adjustment is recommended for machine life extension and stable operation. During the measurement of rotor pole heights relative to the stator core, it was determined that the U1 poles are more than an 0.75" off from the center of the stator core. Given that the air gap value is 0.85 inches (approximately 22 mm), and according to CEATI standards, the maximum allowable deviation is 0.21 inches (approximately 5.4 mm).

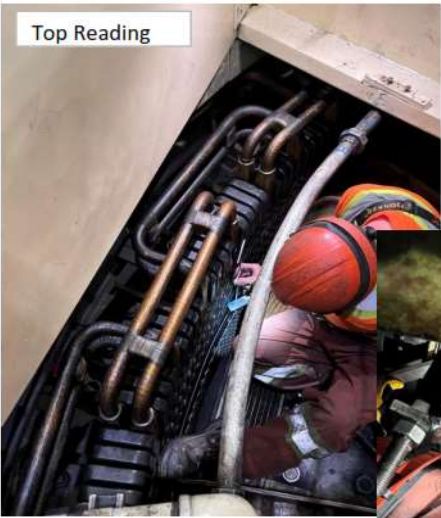
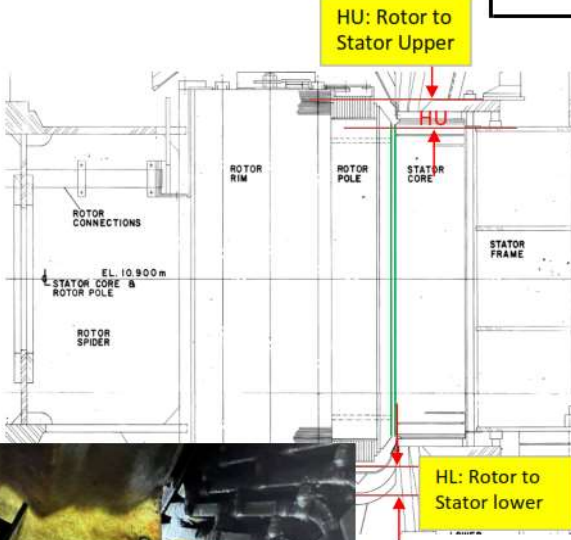
## Rotor pole height measuring check sheet.

value in inch	Top(HU)	Bott(HL)	T-B
Pole # 10	5.805	4.026	1.779
Pole # 11	5.65	3.96	1.69
Pole # 18	5.56	4.307	1.253
Pole # 19	5.558	4.225	1.333

CEATI accepted tolerance: 25% airgap ~0.25in  
AVG Measured deviation: 1.51in

Based on initial measuring on 3poles height to stator core it seems the poles should move down around 3/4 inch

Regarding to this observation, it is required to remove all the air shields on top and bottom of rotor and provide proper tooling and take the measurement on all of the poles and readjust in proper elevation.

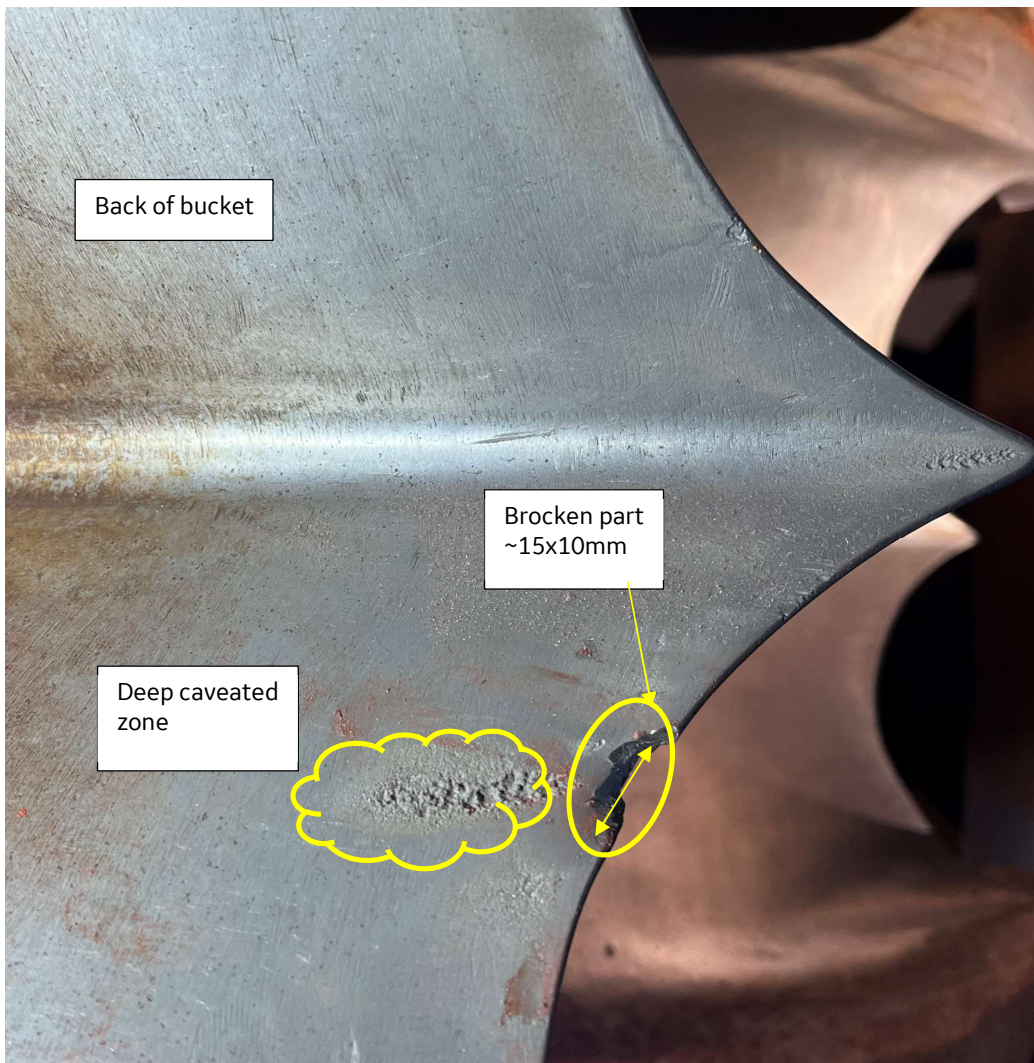
#### Bucket #2 Picture

During the visual inspection of Bucket #2, in addition to the cavity on the bucket outlet edge, it was observed that approximately 15mm by 10mm of material was missing from the bucket's edge, but it did not cause any crack in that bucket. Like unit #1, aside from the major mechanical cavitation defects, visible near the outer edges of all buckets, no other issues were identified in the tested buckets. Buckets #2, #5, #8, and #11, #14, #19, and back of bucket #21 underwent magnetic particle testing (MT). The following are pictures of the damaged spots on the buckets identified during the visual inspection (VT).

The condition of the runner in Unit 2 is generally much better than that in Unit 1; however, for life extension runner should be replaced by 2026.

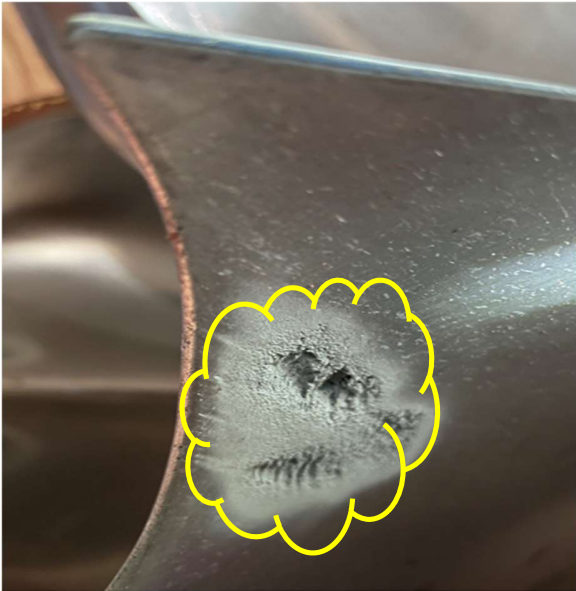
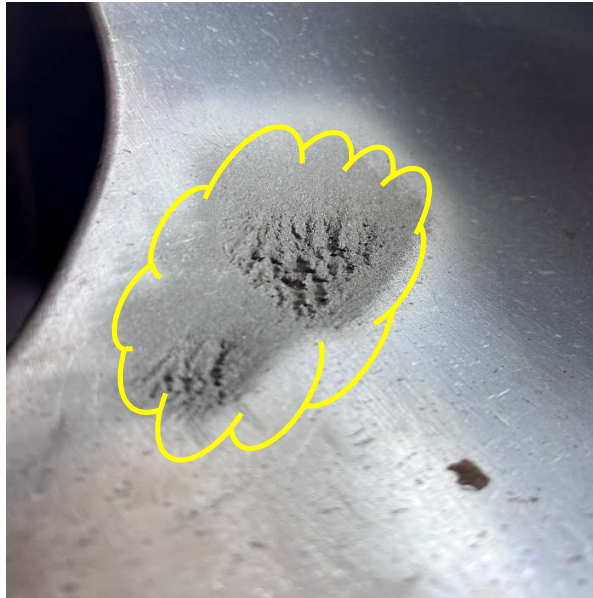
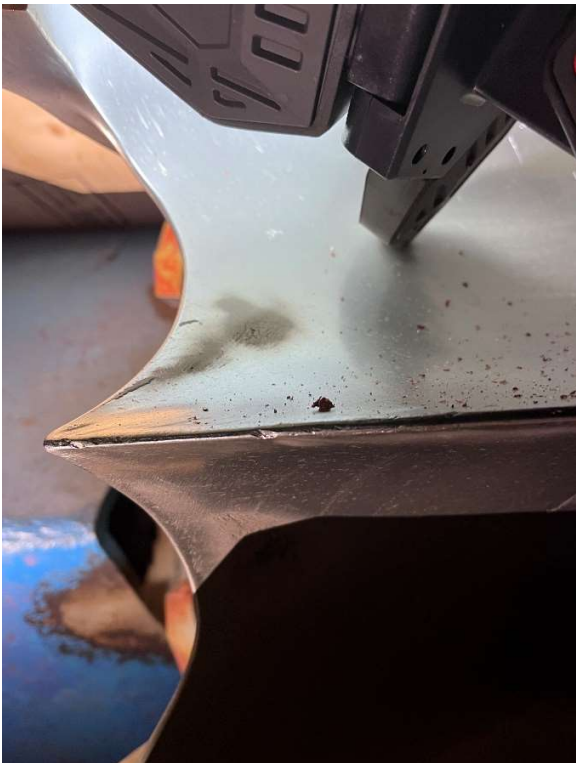
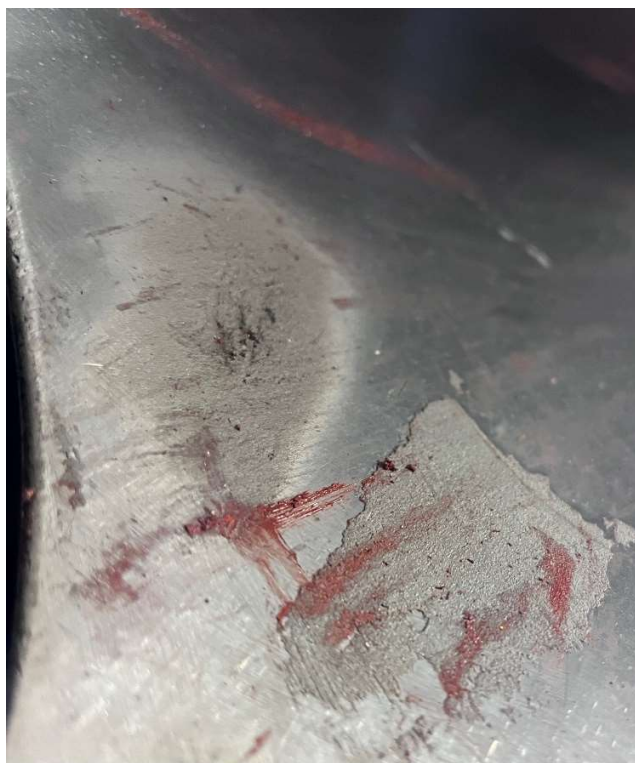
## Buckets Cavity

The depth of cavitation in the buckets outer part measured 1 to 3mm. in this area the bucket thickness is around 5mm. Repair should be performed in the short-term

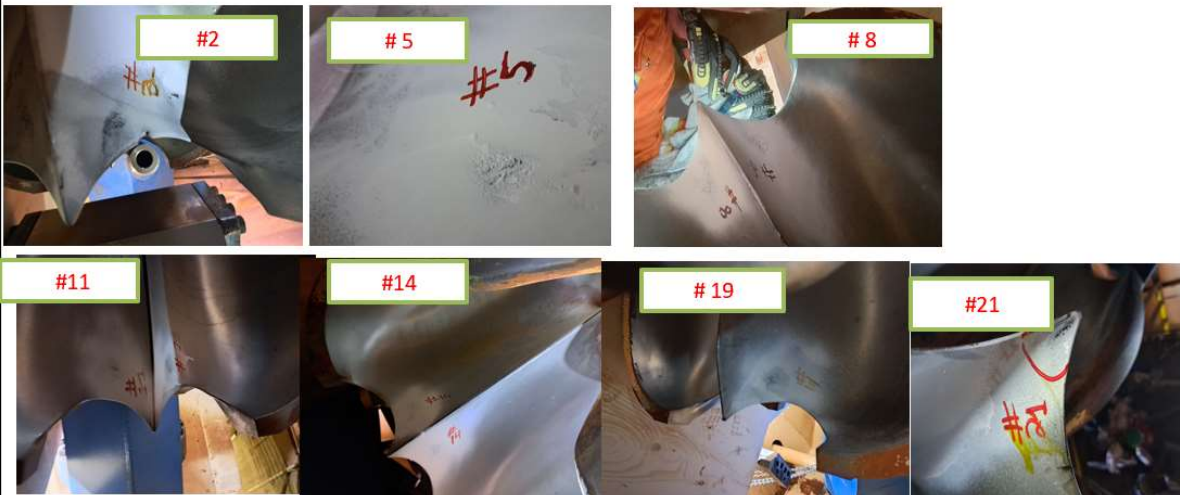
Bucket # 2 has mechanical damage (broken edge), no linear indications were found  
At the time of examination, 6 bucket crotch areas were inspected. No linear indications were found.  
Cavitation damage exists on all buckets inspected. MT was also performed on these areas with no linear indications found.  
See attached pictures.

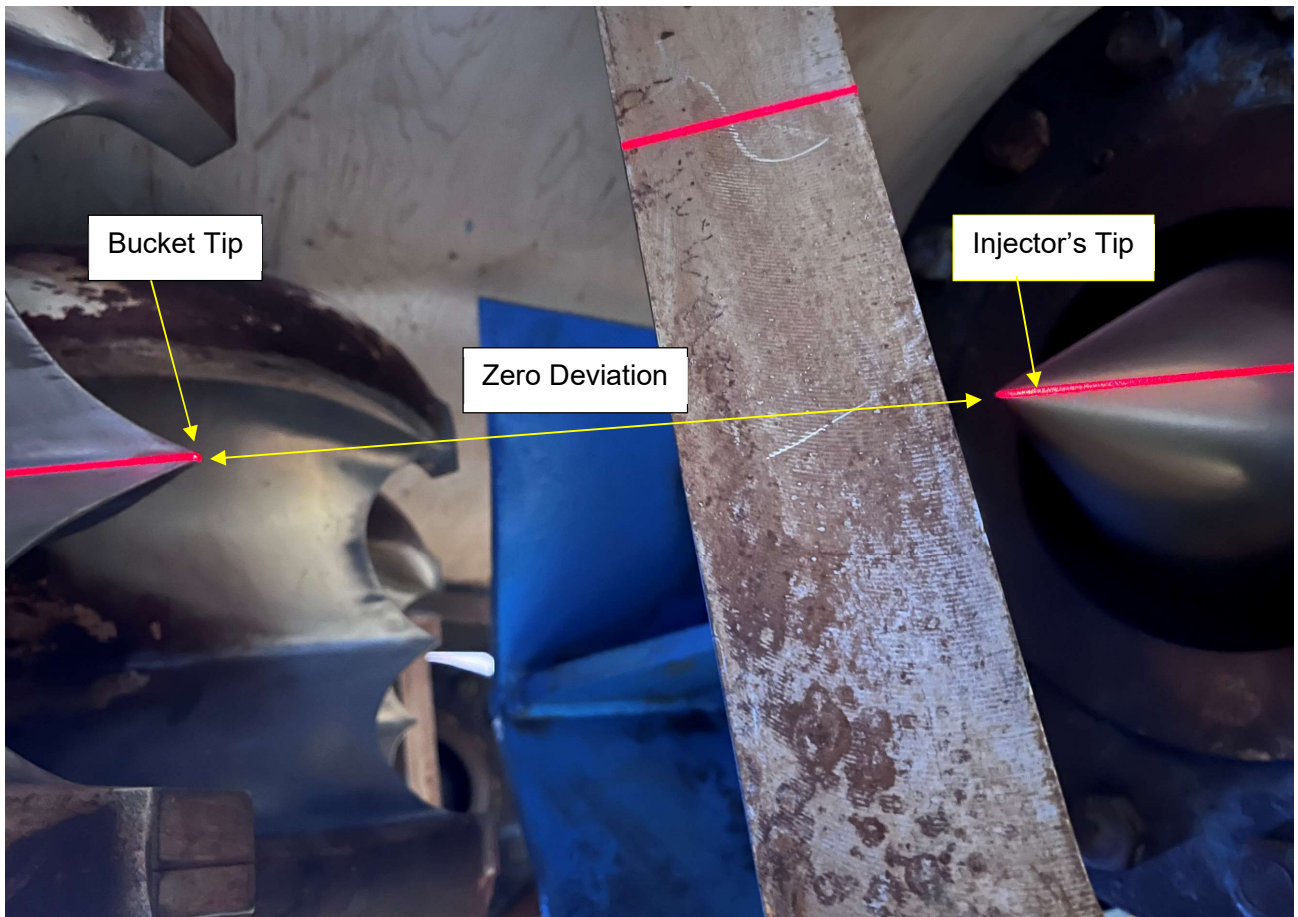
Runner Elevation measurement by self-leveling laser beam

The runner elevation measurements relative to the injector tips were taken. Runner to jet alignment is within IEC 60193.

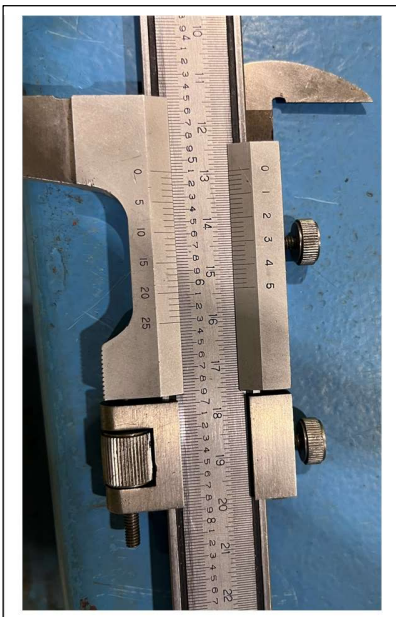
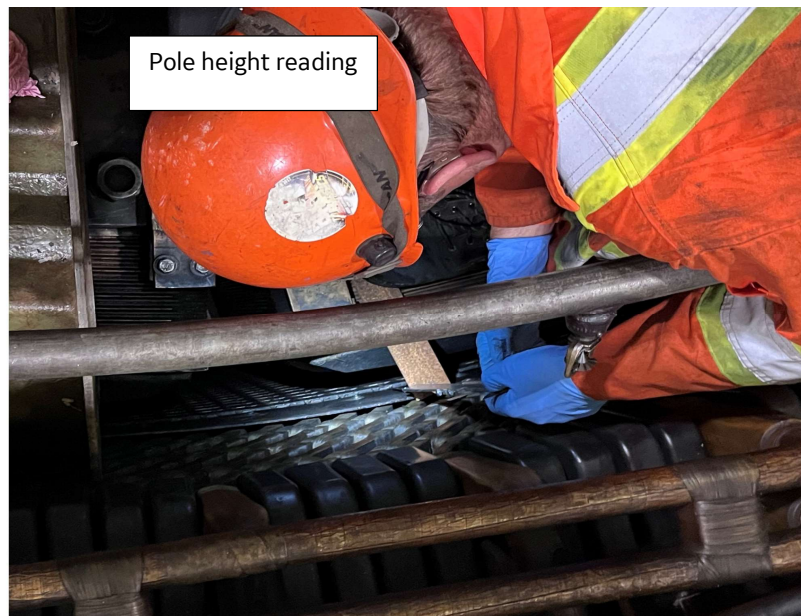
By 4 poles elevation reading, magnetic axis alignment exceeded the CEATI tolerance. . However, based on the readings from these four poles in Unit 1, the poles are generally better positioned relative to Unit 1. As shown in the attached check sheet, two of the poles are within the acceptable tolerance range according to CEATI standards, while the other two require repositioning. For a more accurate analysis and precise measurements, the removal of all shrouds on both the top and bottom is essential. The root causes of the misalignment are consistent with those observed in Unit #1, including:

- 1. Surface Waviness in Measuring Areas:** Surface irregularities on both the pole and core were observed, with an expected impact of 5 to 10% of the air gap. This factor cannot be corrected and should remain "as is."
- 2. Deviation in Stator Core Elevation:** There is a discrepancy between the calculated and actual stator core elevation. If this is the case, the modification should focus on adjusting the rotor pole position, as no changes can be made to the stator core elevation.

In next outage of the machine, it is recommended to check all poles height and readjusted with magnetic center.

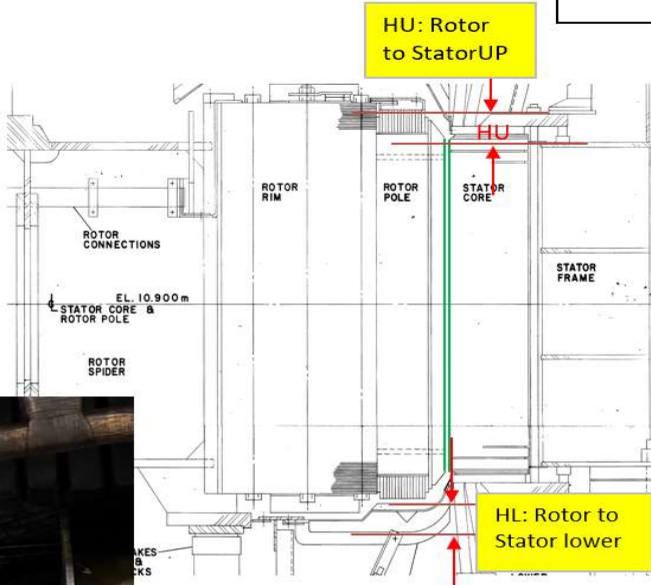
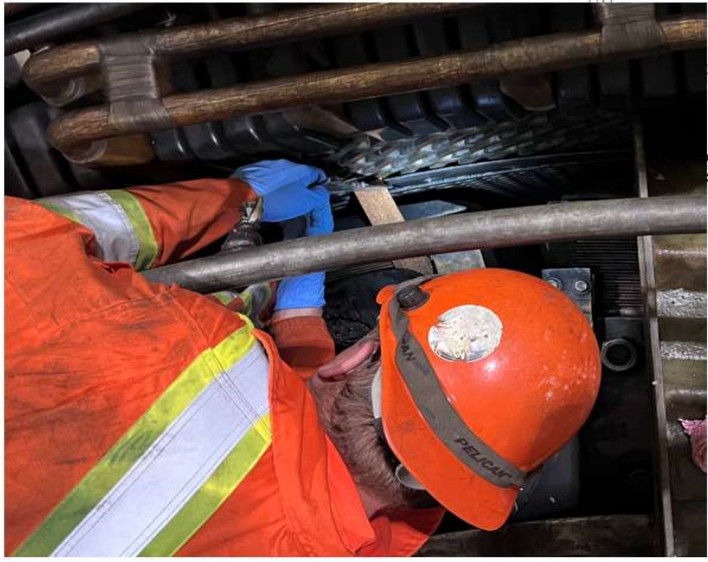
value in inch		Top(HU)	Bott(HL)	T-B	
# Pole	UPS	16	127.5	123	4.5
		17	129	124	5
DWS		5	132.25	121.75	10.5
		6	133	118.5	14.5

CEATI accepted tolerance: 25% airgap ~5.5mm  
AVG Measured deviation: 9mm

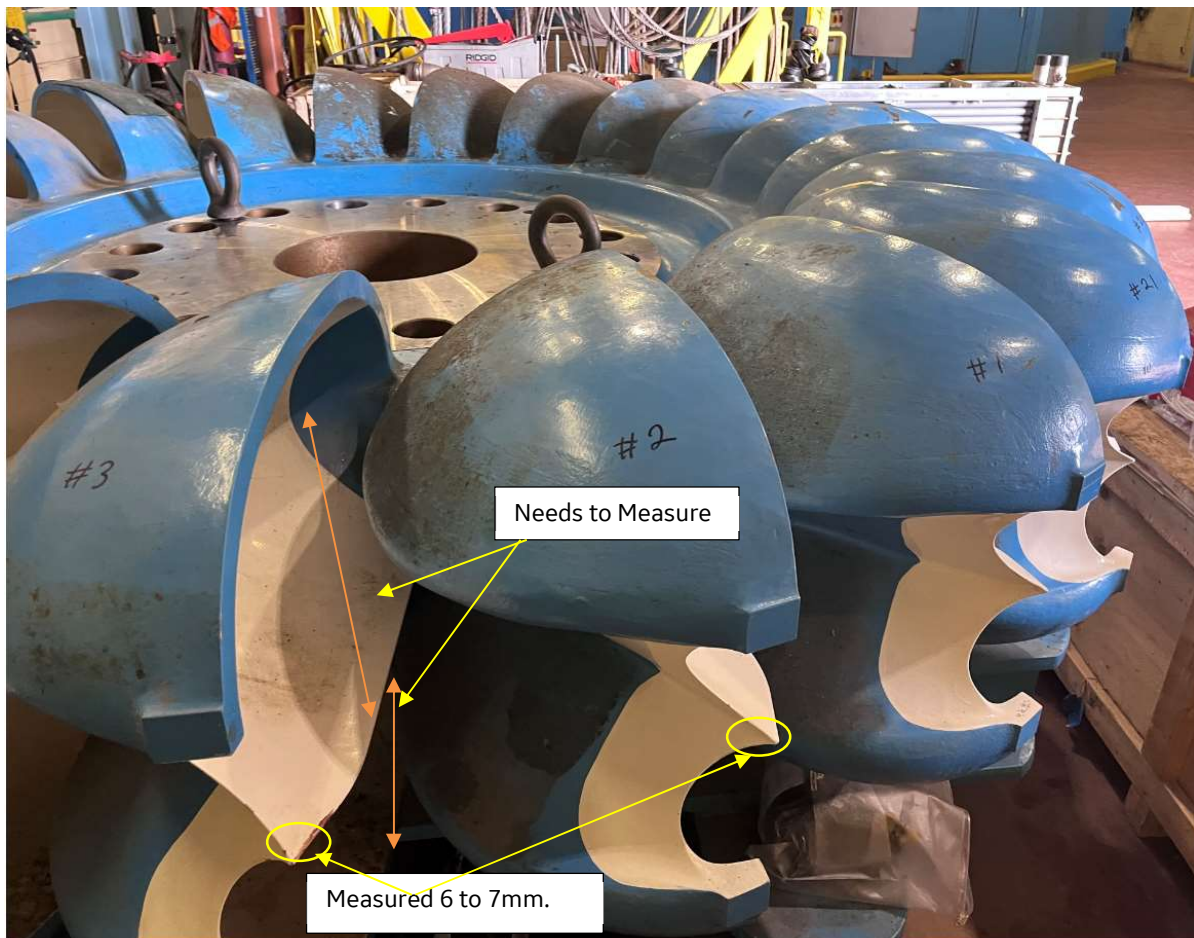
**Buckets measurement**

The spare runner on the generator floor underwent a visual inspection. No VT indications were observed on the painted buckets. The elevation of the bucket tips relative to each other was measured using a self-leveling laser beam and a straight edge. Below are a few images documenting these measurements. Due to tooling constraints and limited resources, the tip measurements were conducted twice. On both occasions, significant deviations in the tip elevations were observed.

- Visual inspection for linear indication or impact damage. GE does not expect NLH to remove existing paint.
- Visual inspection for protrusion on the coupling surface.
- Maintain OEM recommended periodical inspection as per OMM.
- The runner inspection should include VT 100% + PT or MT on the bucket critical areas. Refer to OMM page 5 of 33.

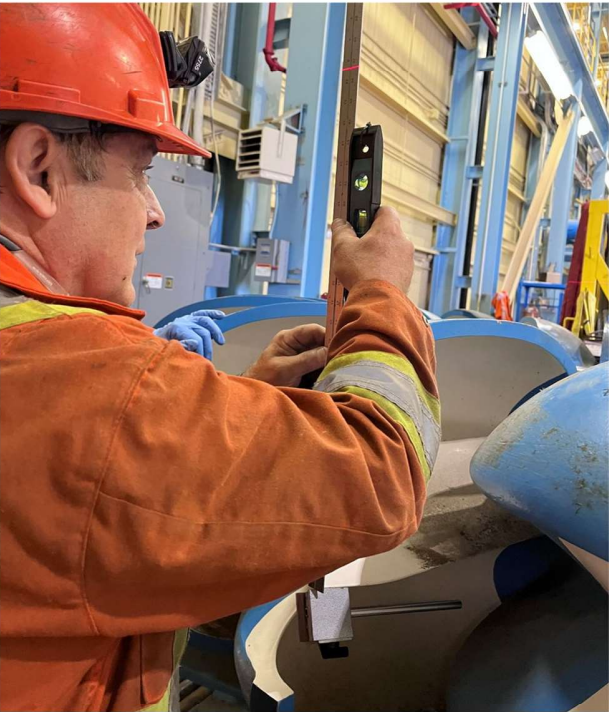
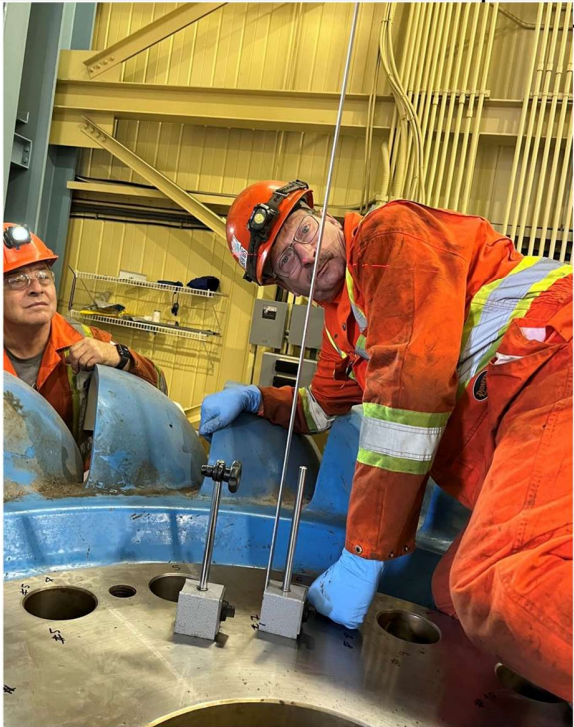
Measurements taken in September 2024 on the runner tip elevation relative to the runner flange indicated a deviation of approximately 7 mm between the tip elevations. Based on the condition of the runner on the generator floor and the available measurement methods, there is a doubt on September 2024 measurement precision.
