Re: Application for Capital Expenditures for the Life Extension of Bay d'Espoir Unit 7 – Redacted

Please find enclosed Newfoundland and Labrador Hydro's ("Hydro") application for the capital expenditures required for the life extension of Unit 7 of the Bay d'Espoir Hydroelectric Generating Facility ("Bay d'Espoir Unit 7").

Engineering Report
Mechanical Engineering
Bay D'Espoir Unit 7 Condition Assessment Condition
Report

Bay d'Espoir – Newfoundland and Labrador Hydro		
Unit 7 Refurbishment Report Project Report	TFS7000	
	PDM Doc ID:	Doc. Revision:
	2-10066279	-

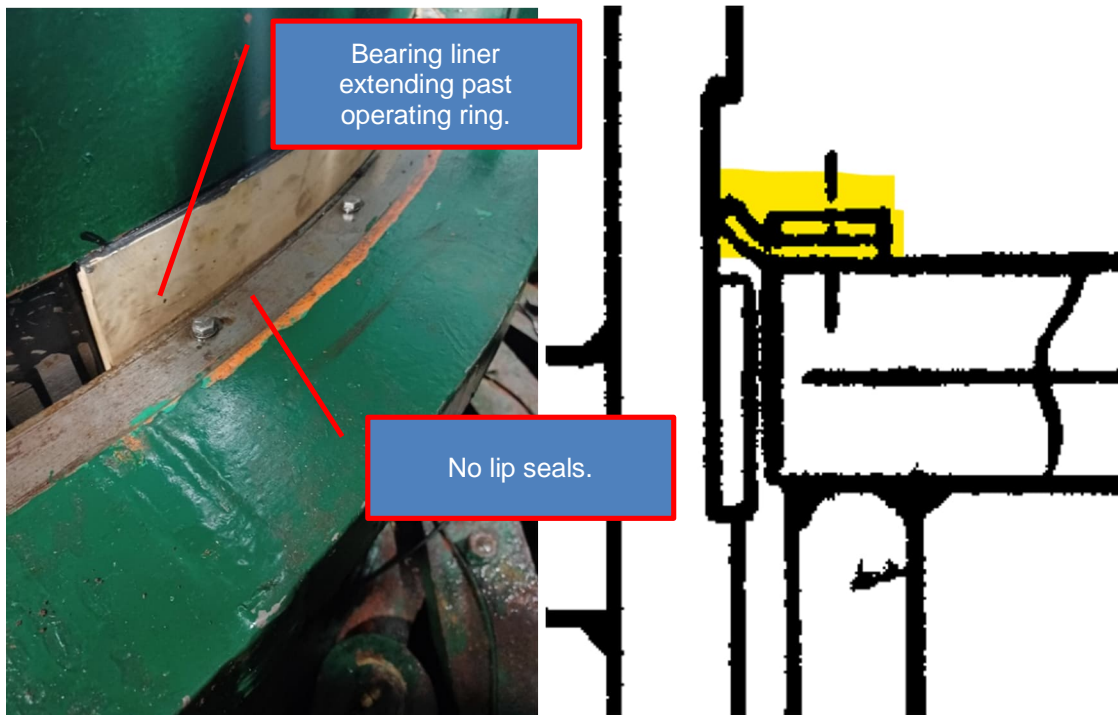
The OEM drawings indicate the bolts that are on top of the operating, as shown in Figure 3-10, are supposed to have a lip seal to contain the grease. There are no lip seals currently installed.

Figure 3-10: Operating Ring and Lip Seal

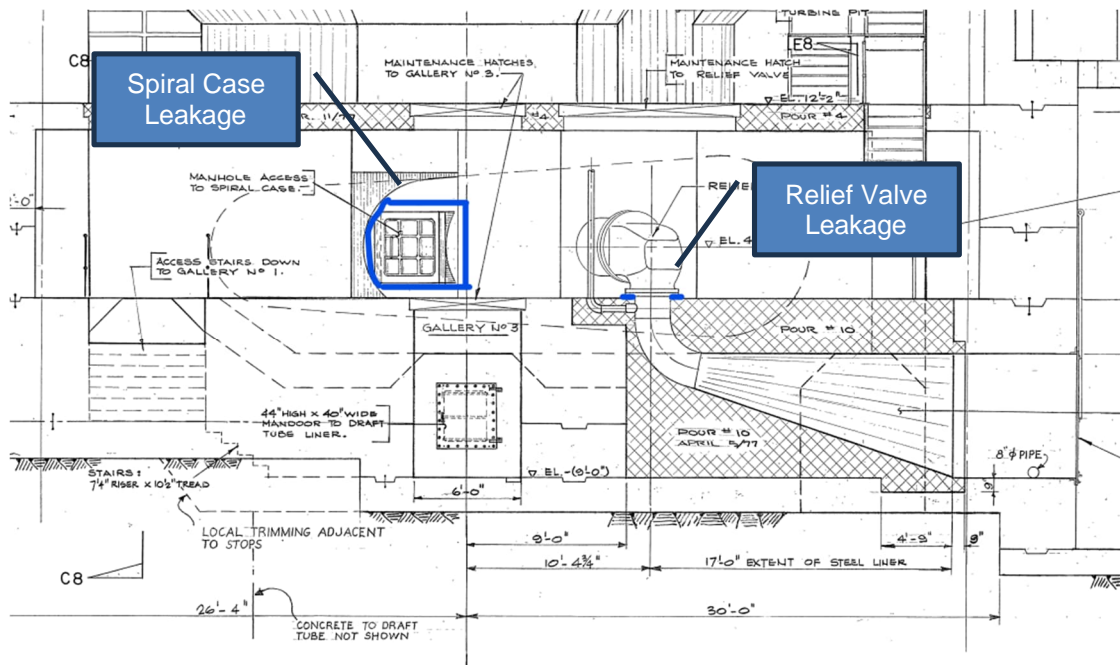
Figure 3-16: Powerhouse Layout Highlighting Concerning Leakage Areas in Blue

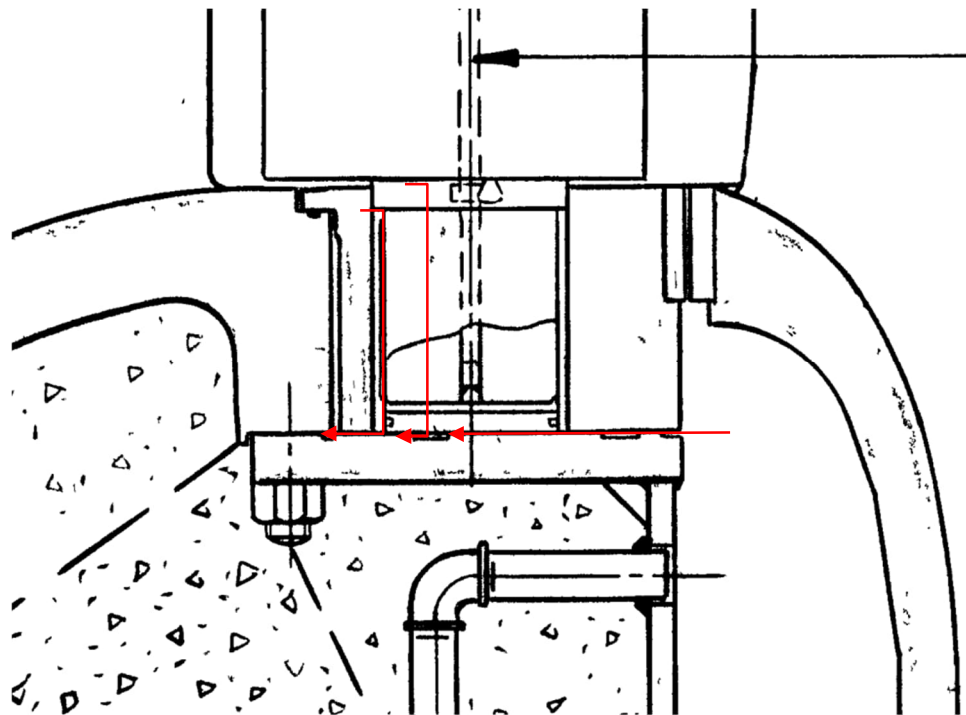
- It should be noted that part of penstock exposed at spiral case inlet shows signs of rust. NL Hydro reported leakage around this area of the penstock decreased after silicon was installed in 2022.
- Water could be leaking past the wicket gate stem bushing.
 - ♦ Water could be leaking between the bottom ring and discharge ring.

Figure 3-28: Leakage Paths to Stay Ring and Discharge Ring Flange

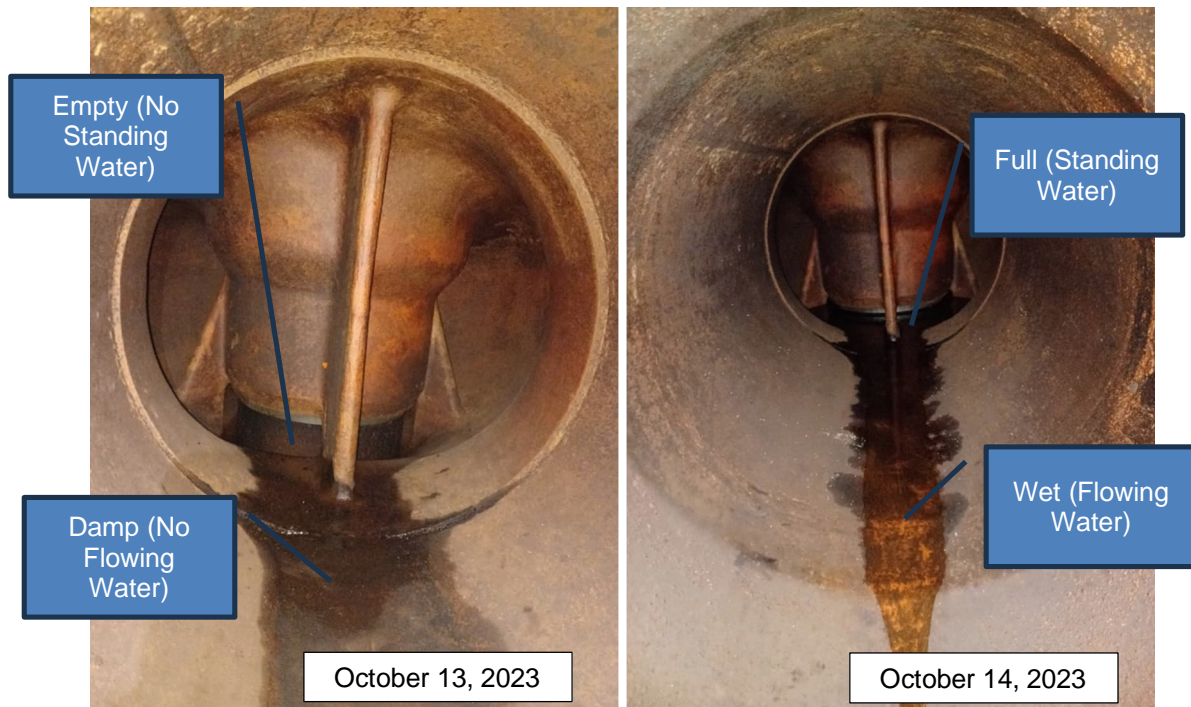
Figure 3-36: Leakage in Relief Valve as Seen from the Spiral Case

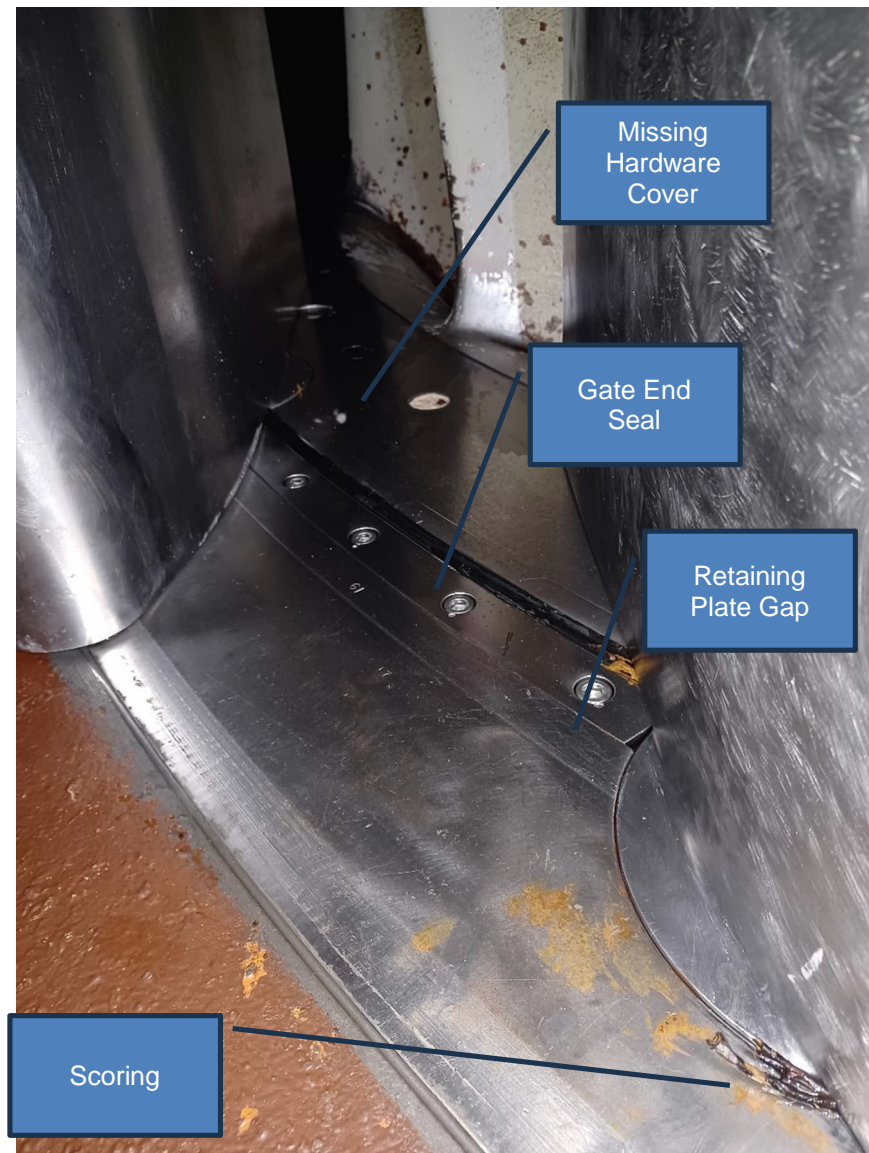
During the 2023 site visits, the bottom ring was not able to be assessed at site other than the facing plates and gate end seals. The gate end seals were partially damaged in some areas, but this is typically for the type of rubber seal used. The facing plates appeared to be in fair condition with some scratches and scoring. Some of the covers to the hold down hardware appeared to be missing or damaged. The gate end seal retaining plates appear to have a gap between the gate trunnion and the retaining plate. It's not certain if this is a design issue or is an intentional feature.

Figure 3-38: Bottom Ring Facing Plates and Gate End Seal

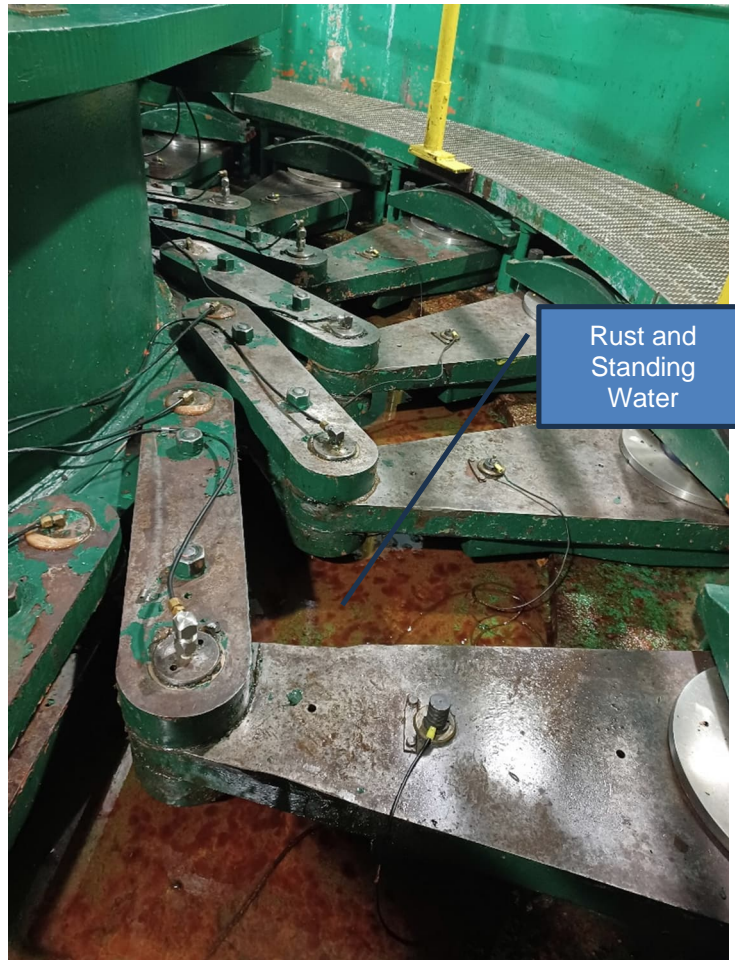
During the 2023 site visits, there was limited access to assess the head cover. The facing plates and gate end seals were visible from the spiral case and the top of the head cover was visible from the turbine pit. The condition of the facing plates and gate end seal are similar to that of the bottom ring. From the turbine pit, the top of the head cover had some standing water and some rusting.

Figure 3-39: Head Cover from Turbine Pit

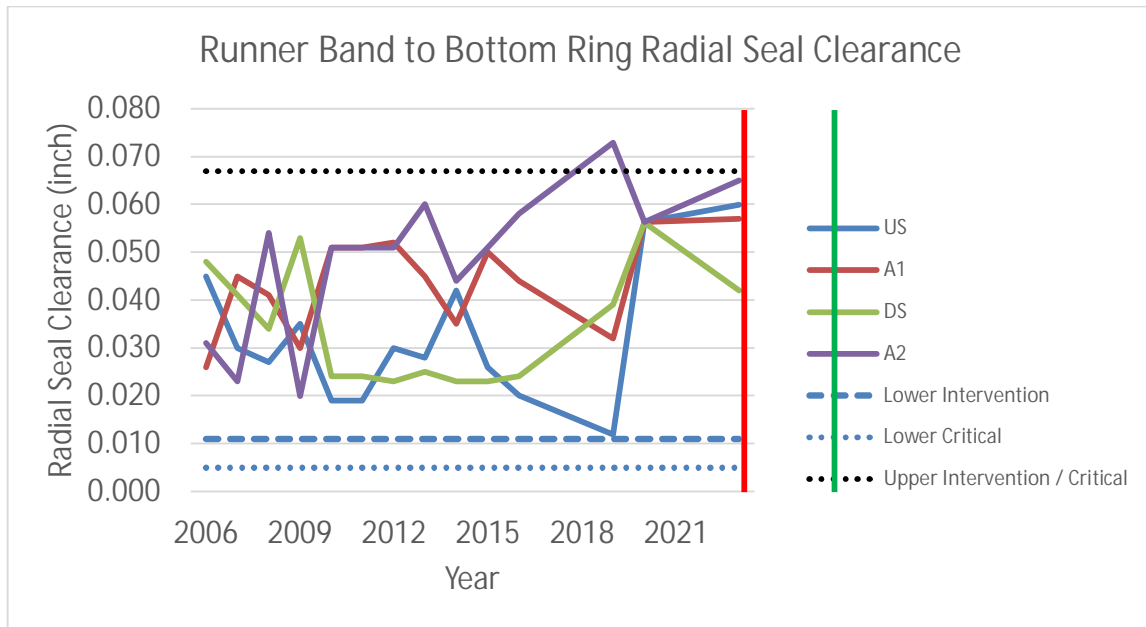
Figure 3-40: Runner Band Radial Seal Clearance

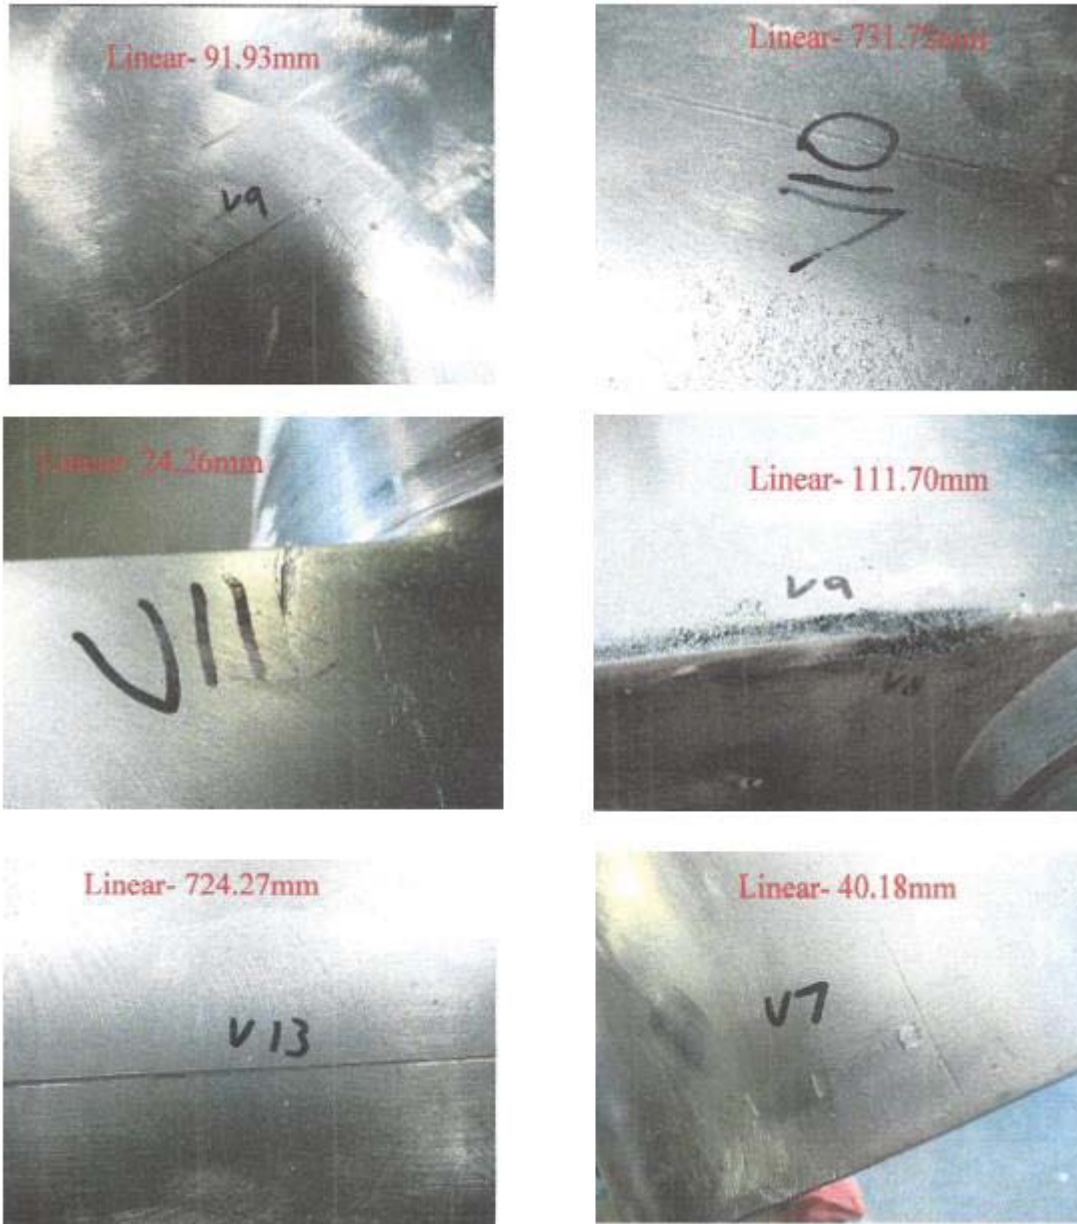
Figure 5-4: Typical Gate Body Damage

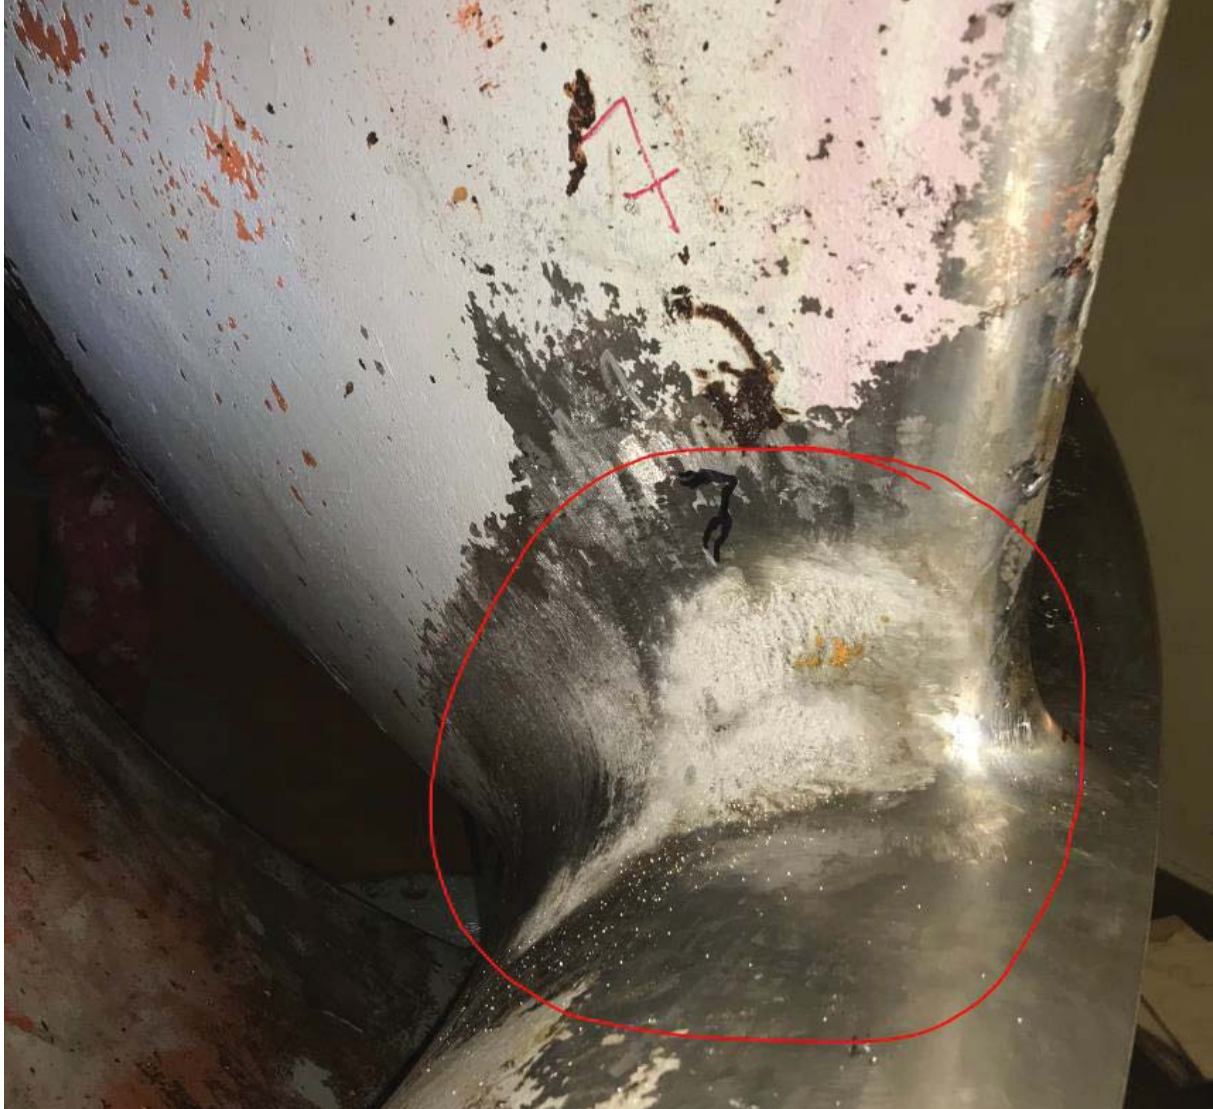
Figure 5-17: Runner Bucket Cavitation, VT-2

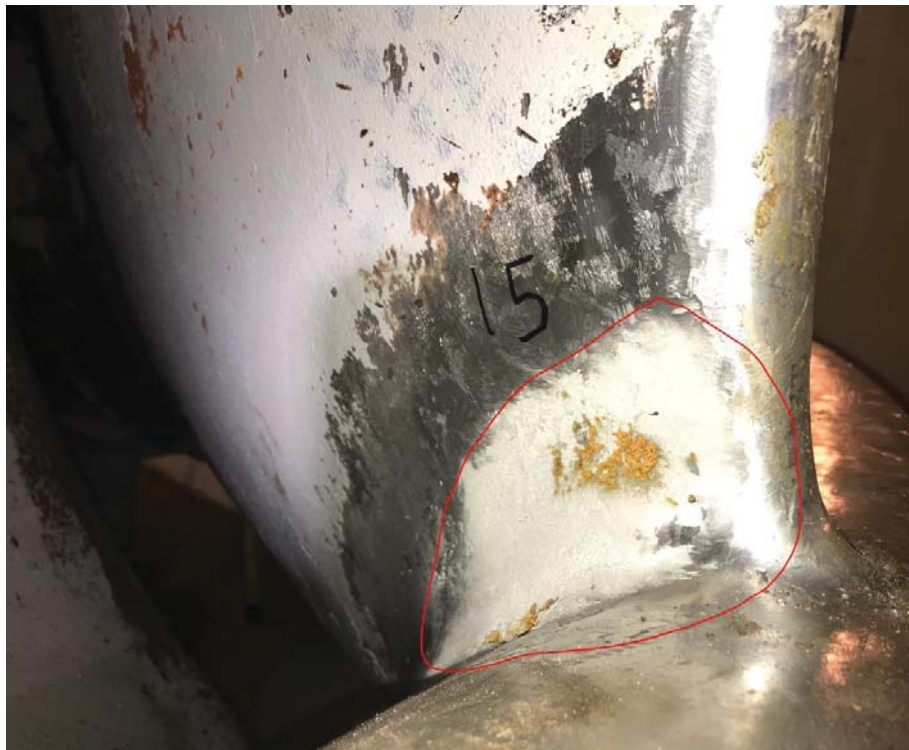
Figure 5-19: Runner Cavitation Damage, VT-2

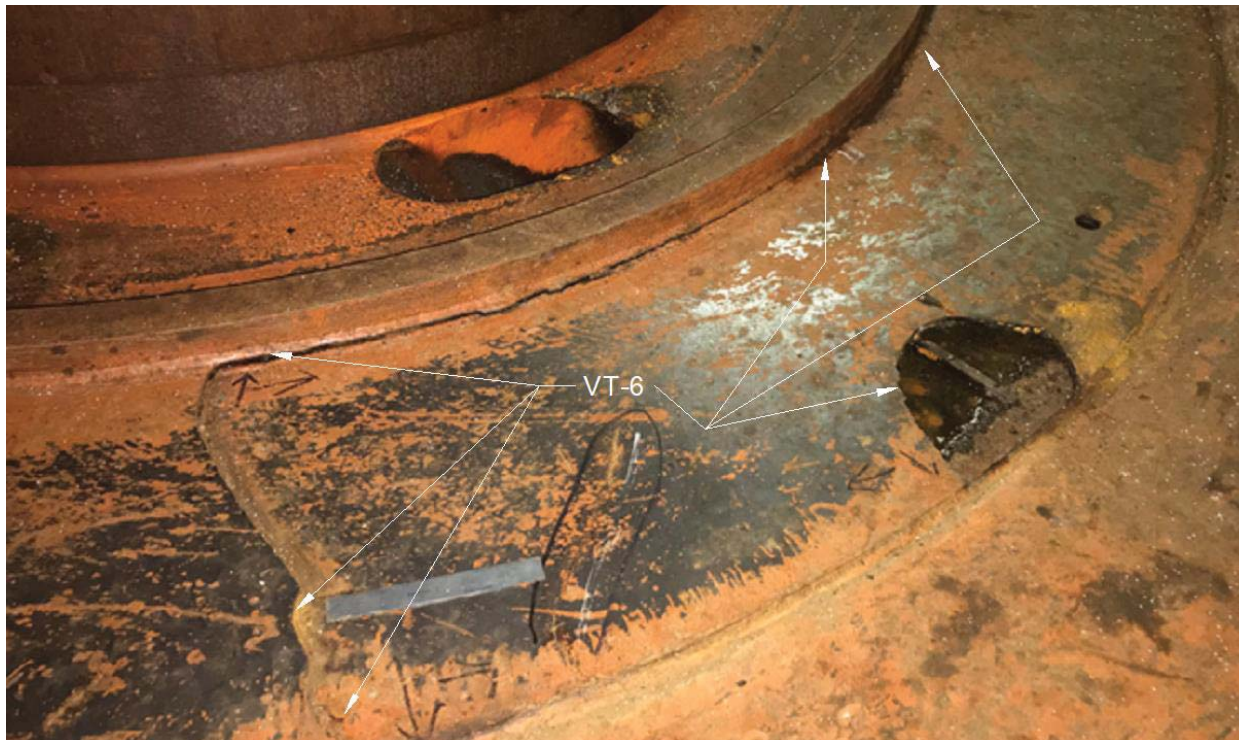
Figure 5-26: Runner Crown Balance Plate Damage, VT-6

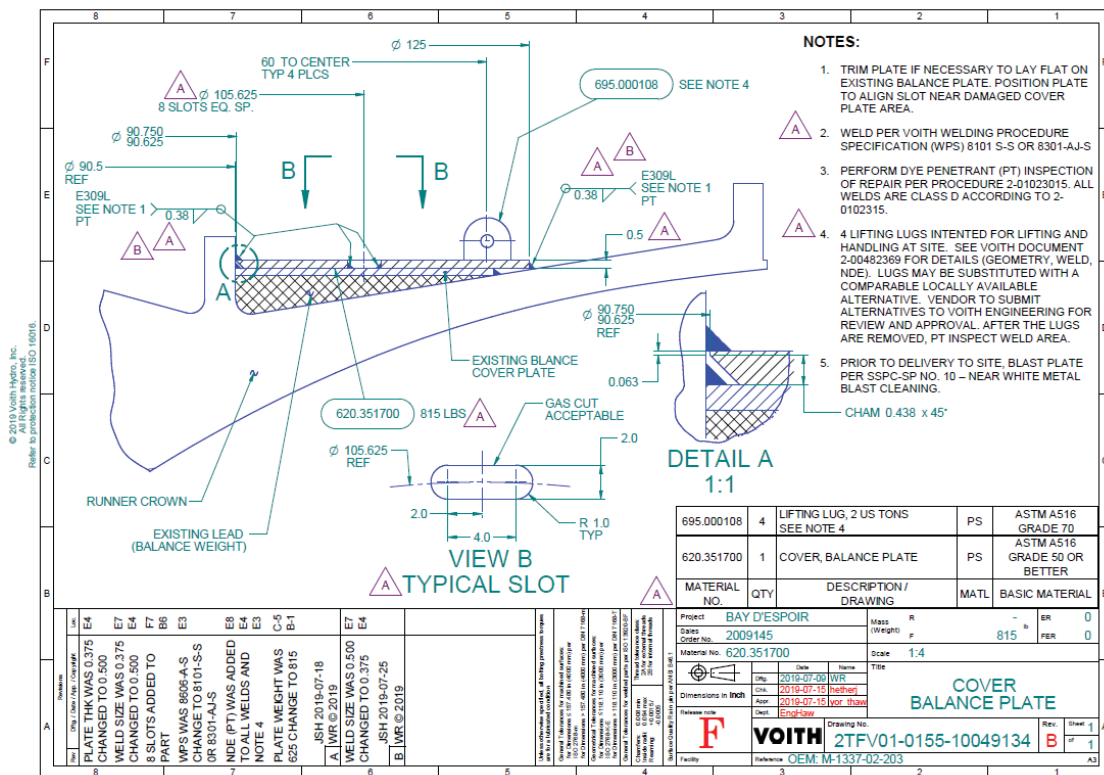
Figure 5-41: Runner Balance Cover Plate Repair

do not require a heating source like the OEM nut. During the assembly of the unit in 2019 only two sets of Super Nuts were used. One set was used at the connection joint of the Rotor and Generator Shaft and the second set was used at the connection joint between the Turbine and Generator Shafts. The third set, which is intended for the connection joint between the Runner and Turbine Shaft, was not used during the assembly because the Runner and Turbine Shaft were not disassembled during the 2019 outage; therefore this set was saved and stored until required, which can during the next major outage.

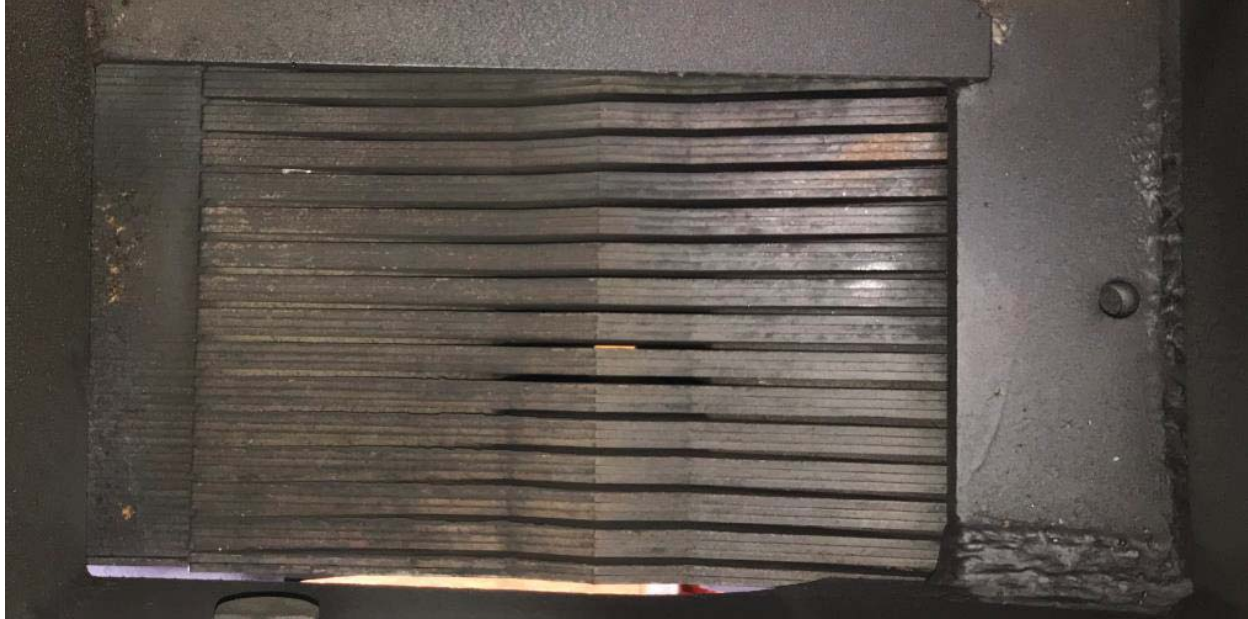
Figure 5-95: Rotor Rim, Back View through the Spider- Light Surface Rust

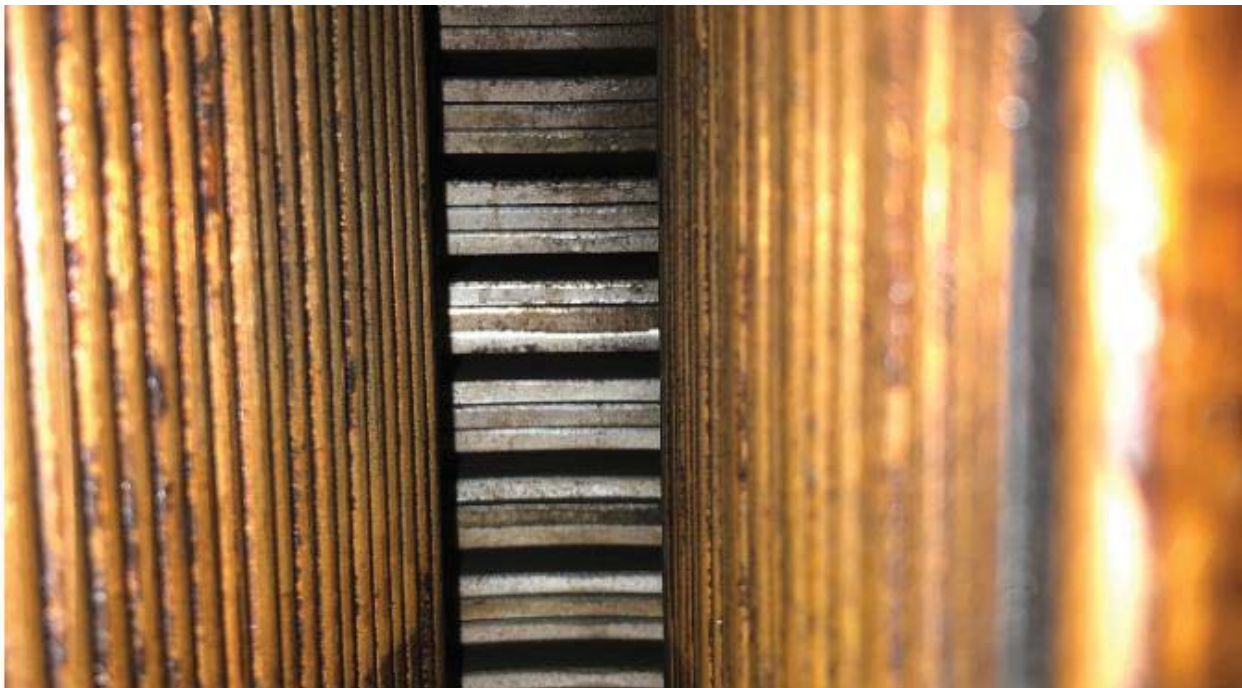
Figure 5-96: Rotor Rim, Outer condition of Rim Laminations (June 2019, Inspection)

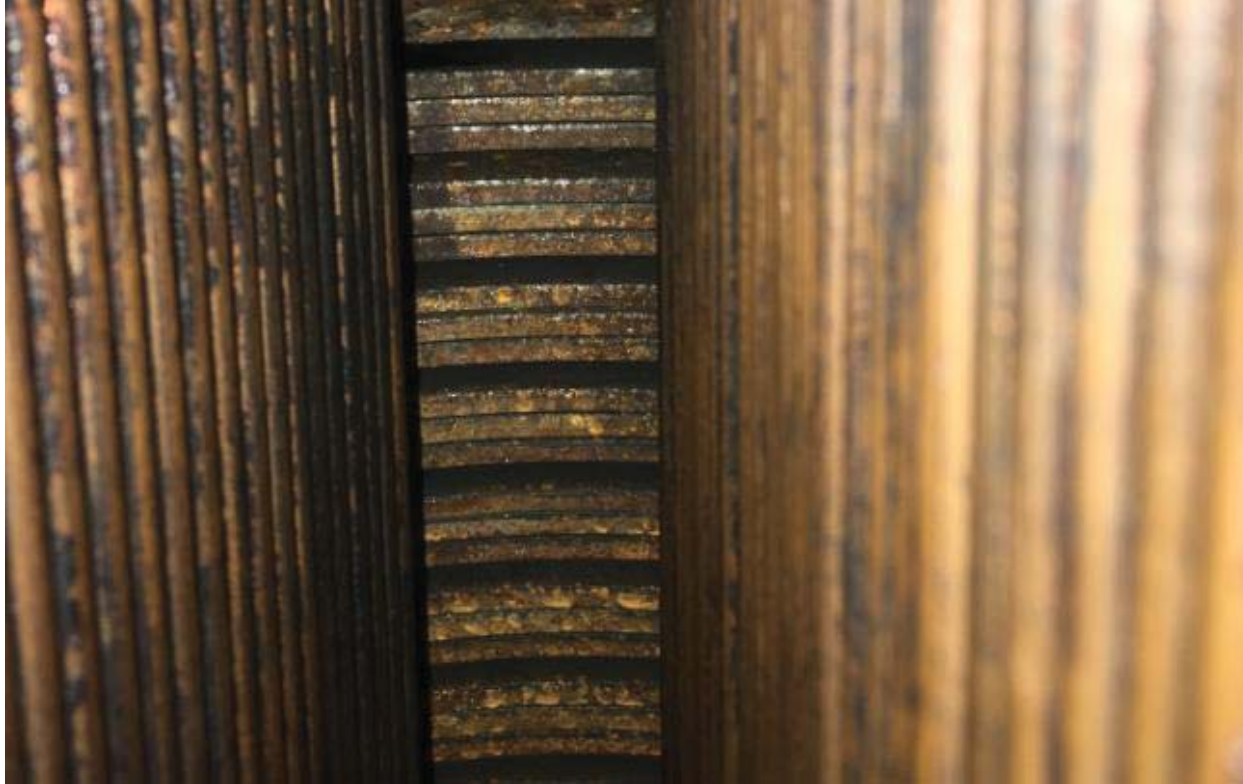
Figure 5-97: Rotor Rim, Outer condition of Rim Laminations (August 2019, Preassembly Oxidation)

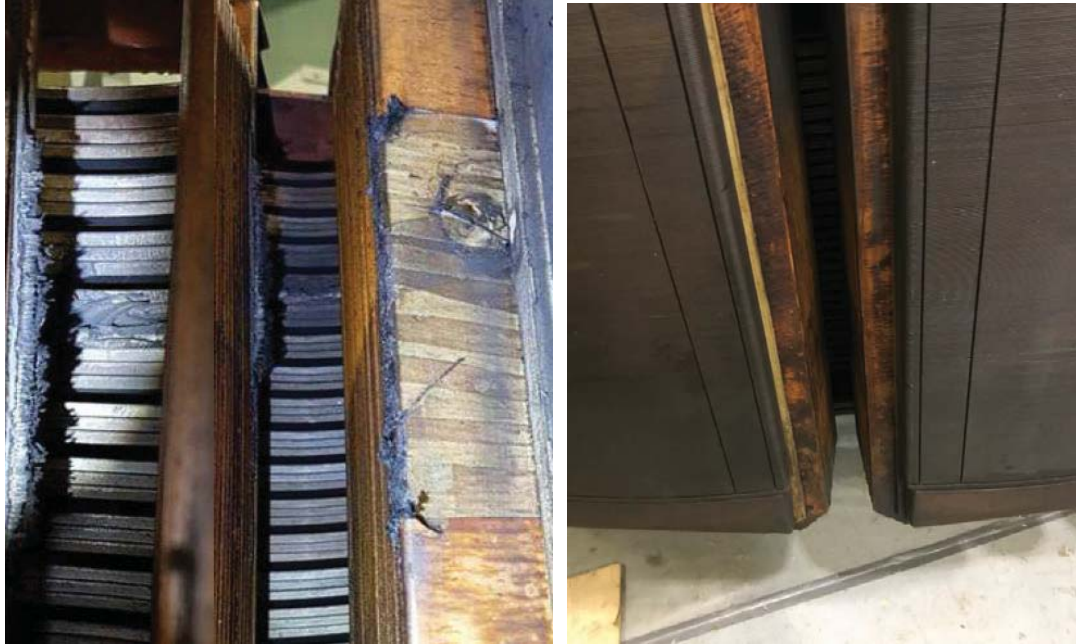
Figure 5-101: Rotor Pole, (Left) Damaged Tape, (Right) Film of Dirt and Grease

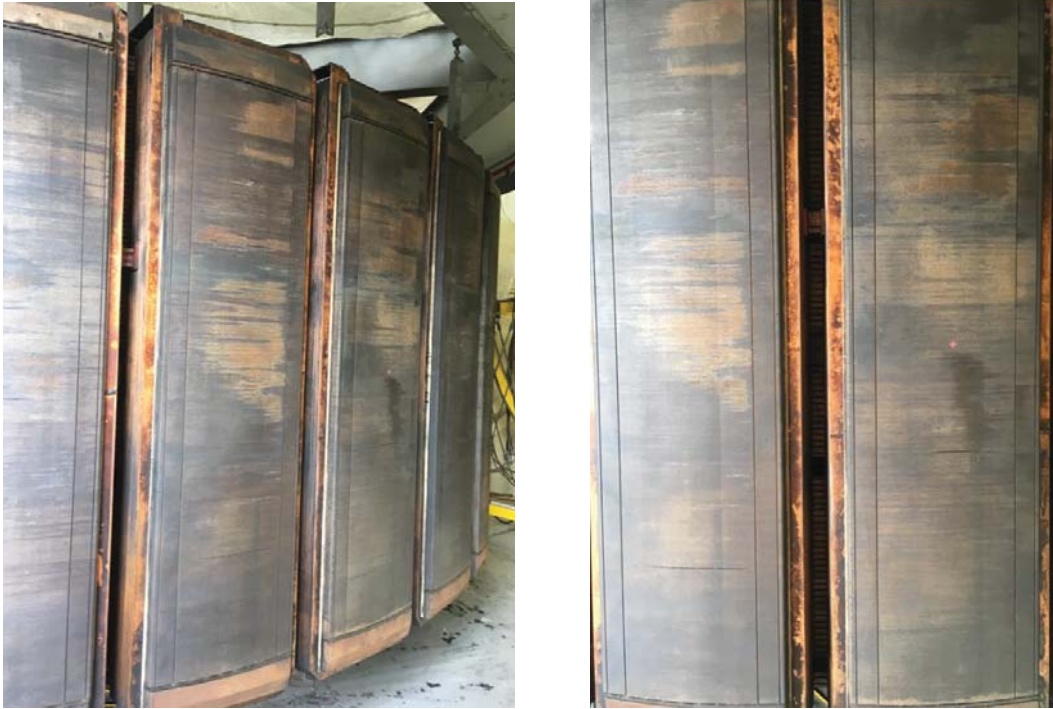
Figure 5-112: Rotor Pole: Rust and Oxidation

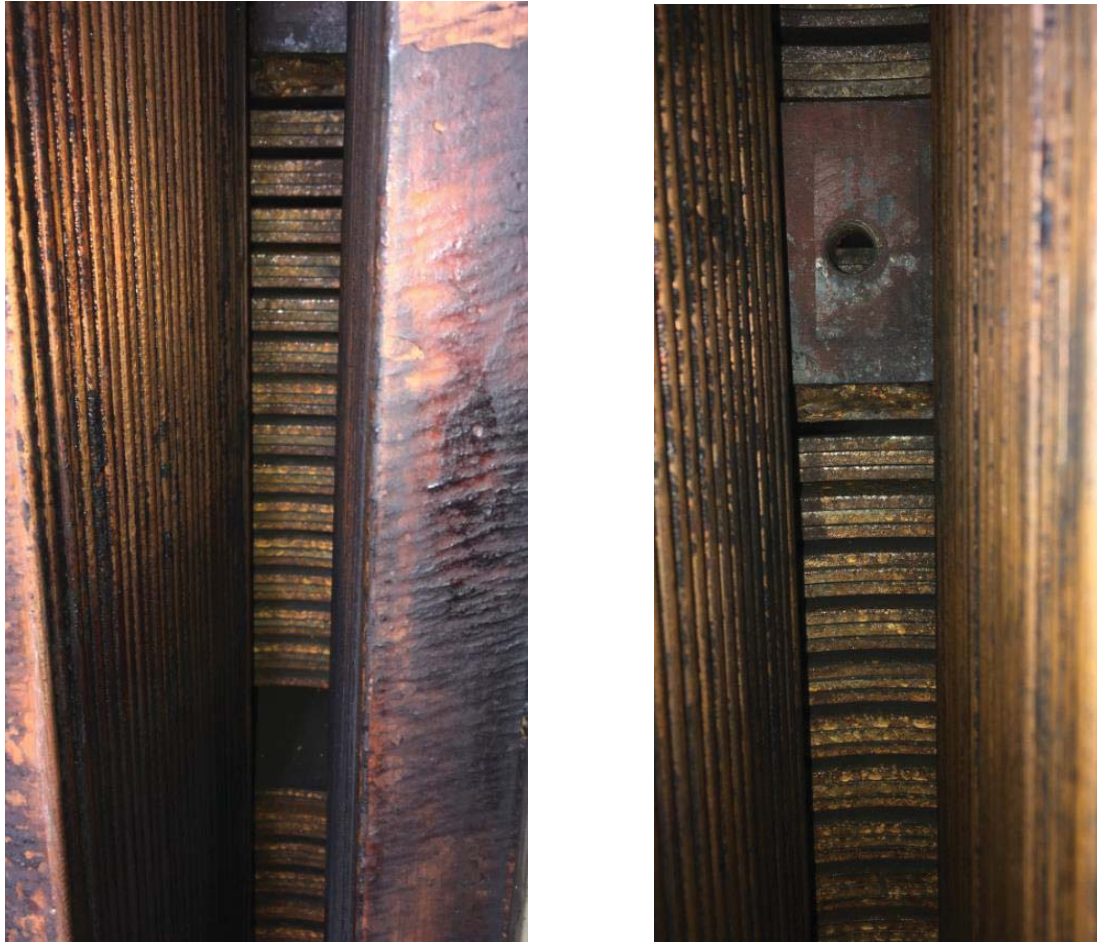
Figure 5-114: Rotor Poles: Rim Rust and Oxidation

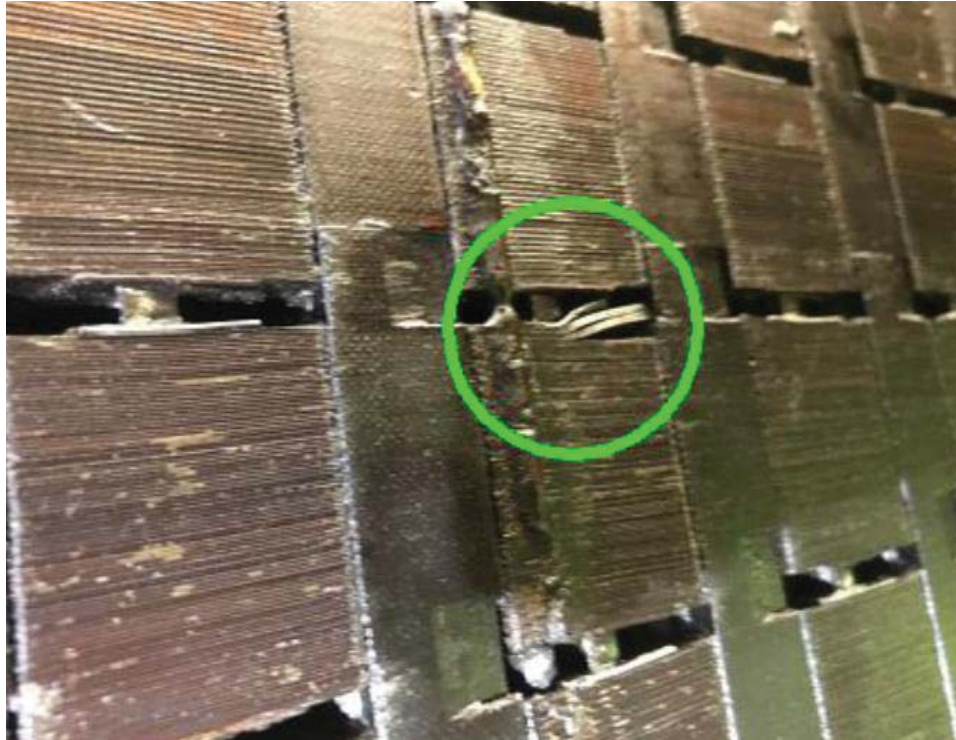
Figure 5-137: Stator Core, Bent Lamination Damage, the Cause was Unclear.

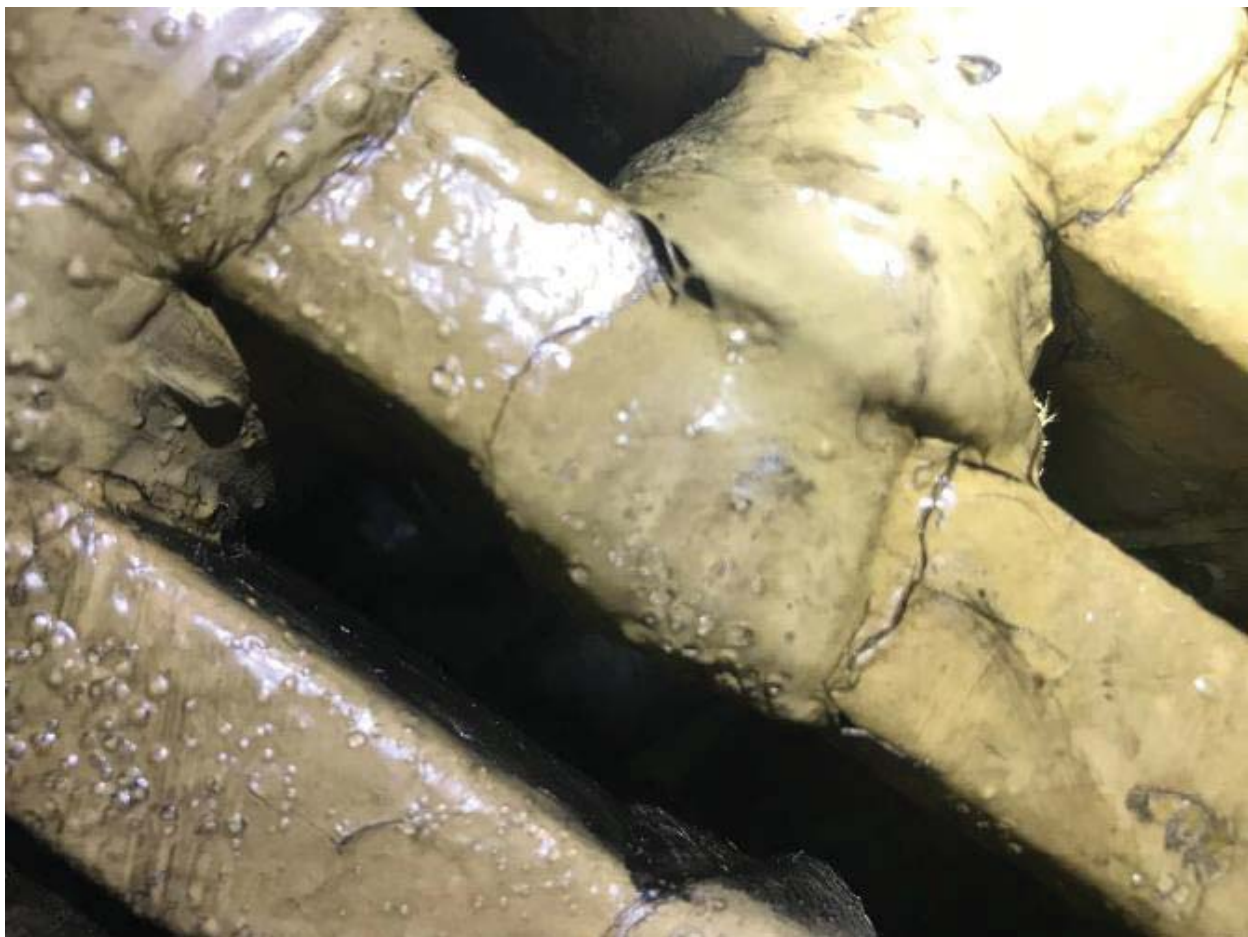
Figure 5-139: Stator Windings: Typical Insulation Cracking Found

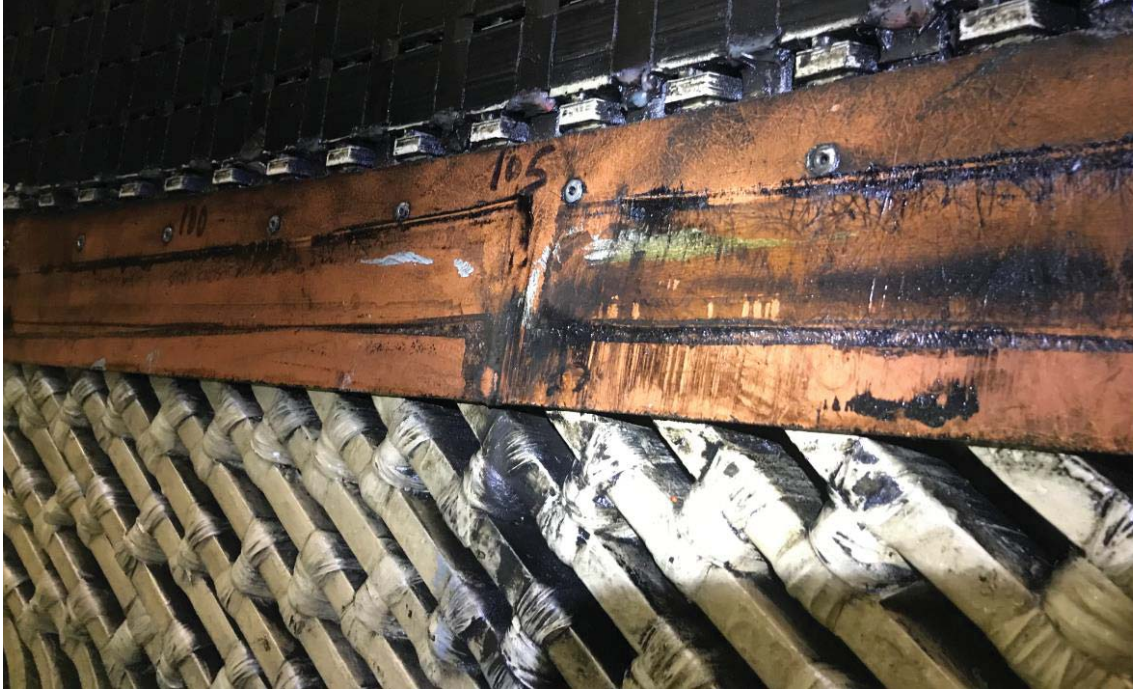
Figure 5-141: Stator Windings: Typical Grease and Oil on Bottom End of Windings

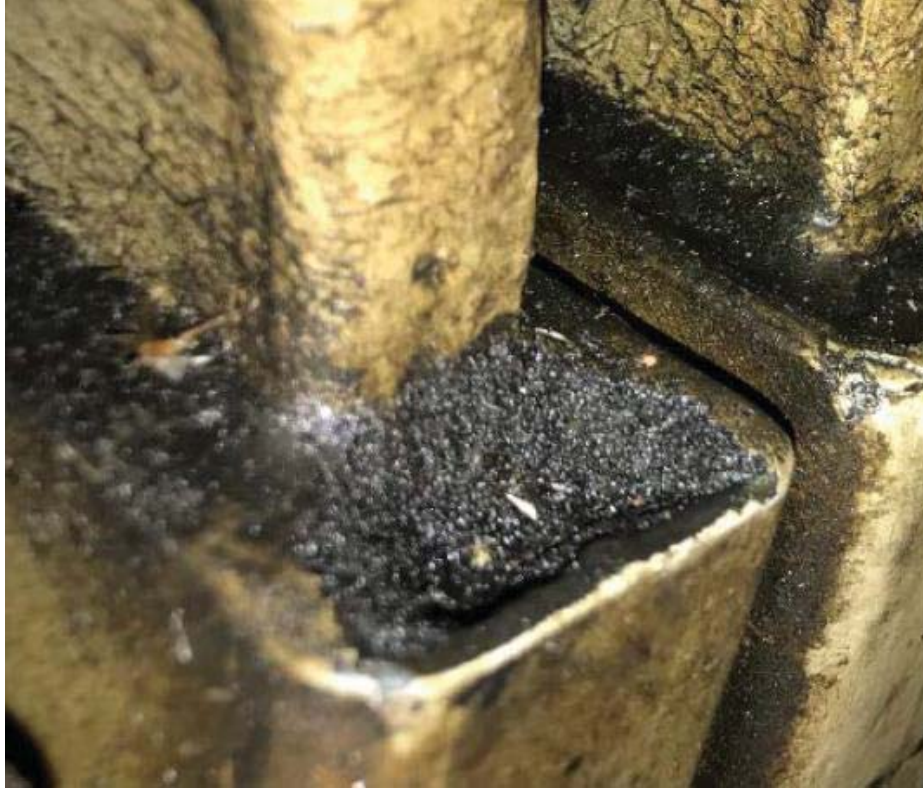
Figure 5-145: Stator Windings: Damaged End-Cap

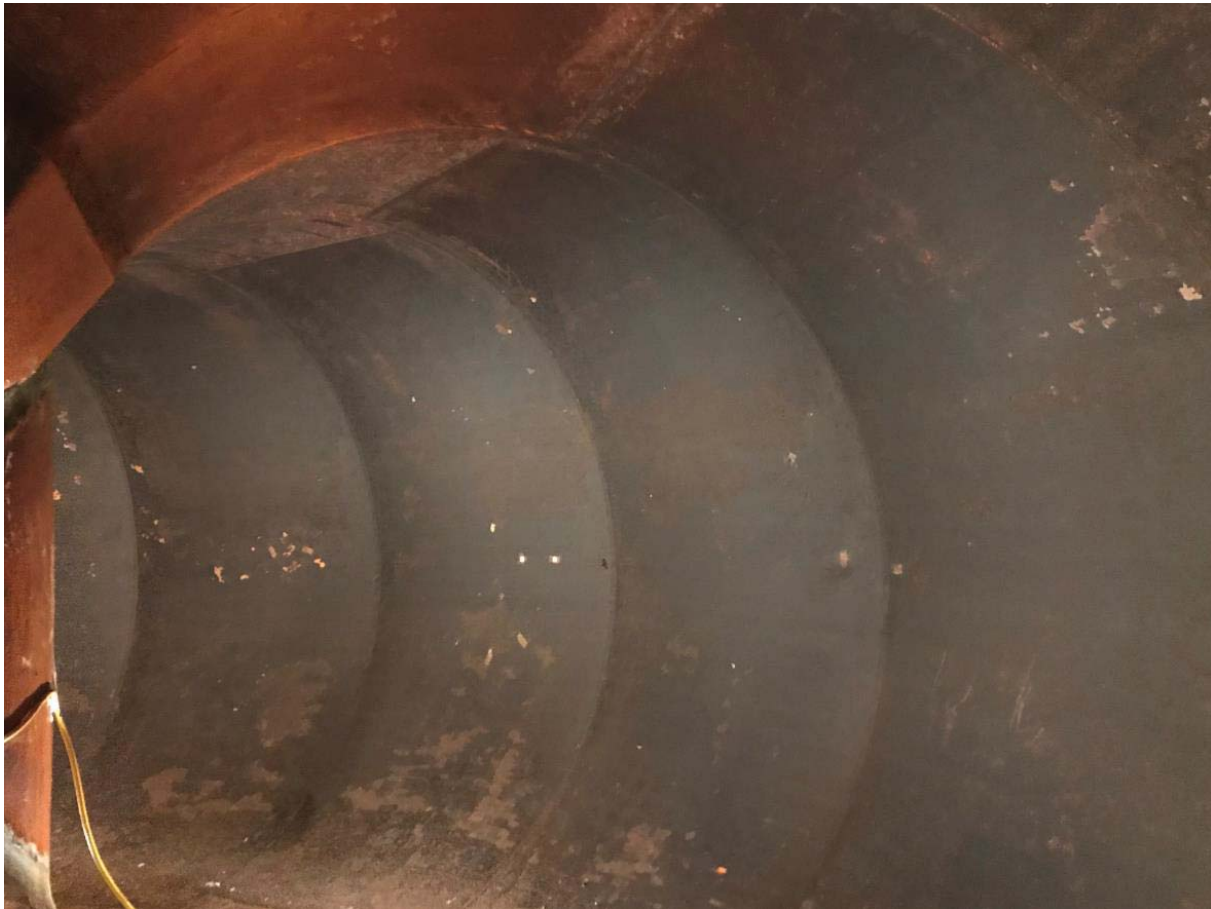
Voith performed a visual inspection of the Spiral Case to look for any obvious signs of damage or failure. The Spiral Case was in good condition considering the age and amount of time the unit was under operation. The orange paint (possibly OEM) was in fair to poor condition with limited signs of base metal deterioration. As shown in the figures below, the paint was missing from the middle section of the Spiral Case; however a fair amount of paint was still present on the top and bottom sections. No signs of obvious damage or cracks were present at the time of the inspection. The base metal on the middle section of the Spiral Case was slightly worn and some pitting or deterioration was present.

Figure 5-165: Spiral Case, Upstream

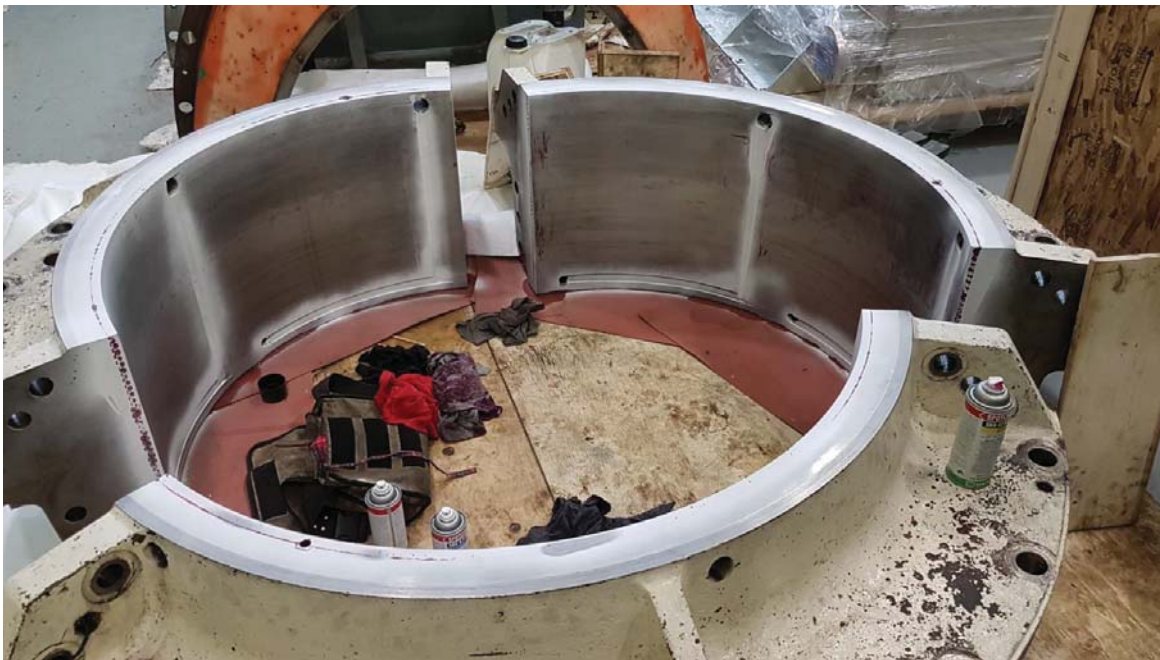
Voith performed a visual inspection of the Turbine Guide Bearing to look for any obvious signs of damage or failure. The Turbine Guide Bearing was in good condition considering the age and amount of time the unit has been under operation. The paint covering the outside of the TGB was in fair condition with limited signs of wear or deterioration. The split face surfaces had no signs of damage or fretting. The Babbitt surfaces of the TGB third sections had visible signs of wear, but no alarming damage was reported from the visual inspection.

Figure 5-170: Turbine Guide Bearing, Visual Inspection
