Re: Application for Capital Expenditures for the Life Extension of Bay d'Espoir Unit 7 – Redacted

Please find enclosed Newfoundland and Labrador Hydro's ("Hydro") application for the capital expenditures required for the life extension of Unit 7 of the Bay d'Espoir Hydroelectric Generating Facility ("Bay d'Espoir Unit 7").

Engineering Report
Mechanical Engineering
Bay D'Espoir Unit 7 Condition Assessment Condition
Report

Bay d'Espoir – Newfoundland and Labrador Hydro		
Unit 7 Refurbishment Report Project Report	TFS7000	
	PDM Doc ID:	Doc. Revision:
	2-10066279	-

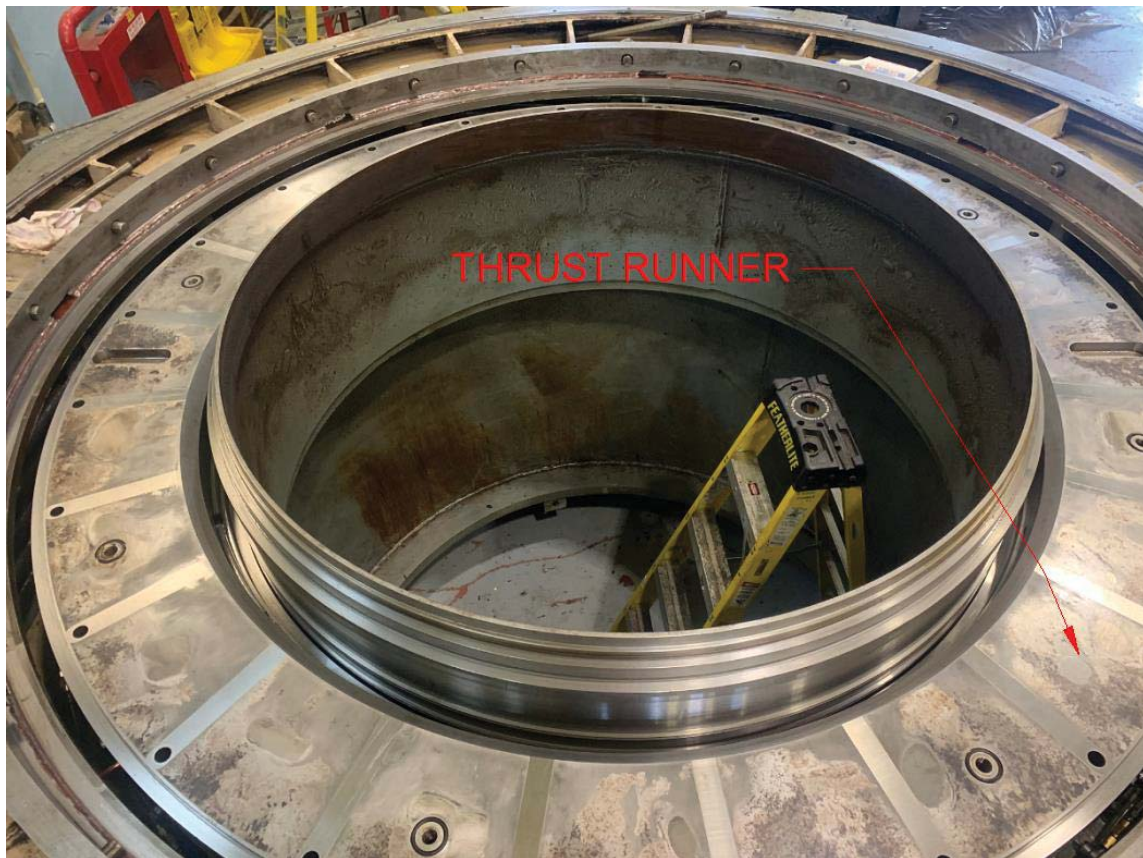
Overall the fretting was not deemed an immediate threat to the operation of the machine. On the opposite side of the Thrust Runner is the bearing journal of the thrust bearing assembly. This surface rotates on a thin film of oil. The Thrust Pad, which is located just below the Thrust Runner during operation is the sacrificial wear component made of softer material. The thin film of oil is located between the Pad and Runner and in theory, as long as the hydrodynamic condition exists the life of the bearing journal (Thrust Runner) is virtually limitless. In the case of the Unit 7 Thrust Runner the bearing journal was in good condition and no visual indications of damage or failure. All of the threaded holes and oil holes were also in good condition. The inner diameter and outer diameter surface did not show any indications or concerns.

Figure 5-186: Thrust Runner, after reassembly into Unit.

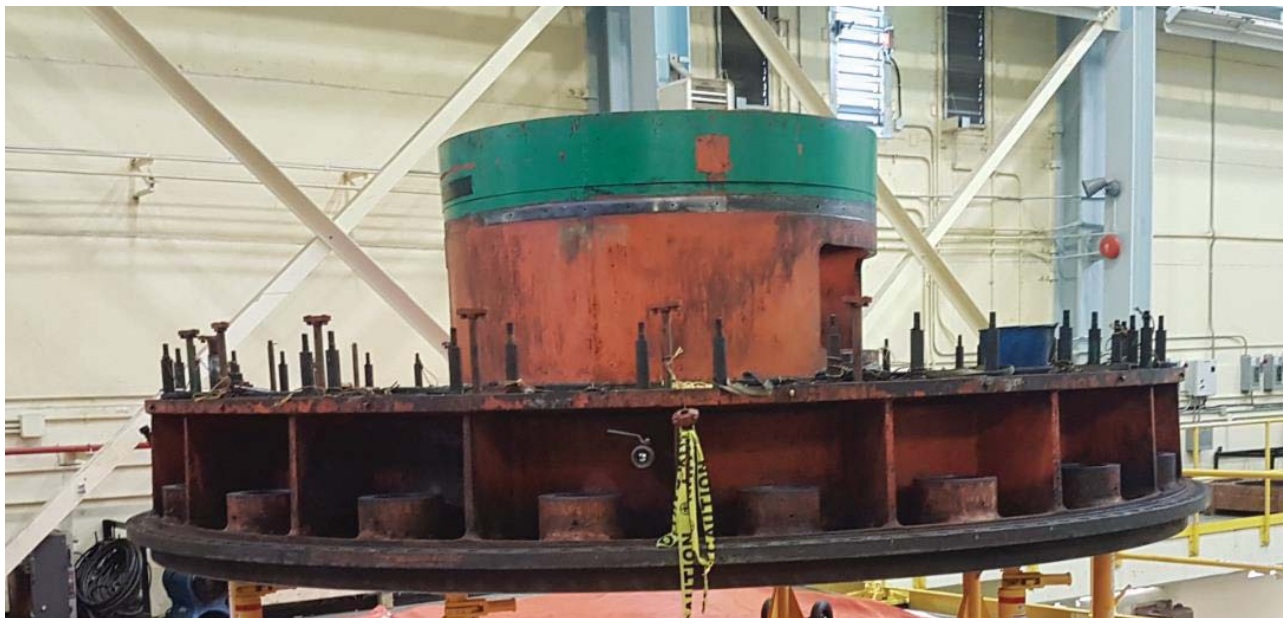
The condition of the paint was poor, especially on the flanges, top and bottom surface, and area in contact or near moving parts of the Gate Mechanism. Moderate rust, corrosion, and pitting was present on the top (dry side) and the bottom side (wet side) of the Head Cover.

Figure 5-197: Head Cover, Paint Condition and Overall Appearance

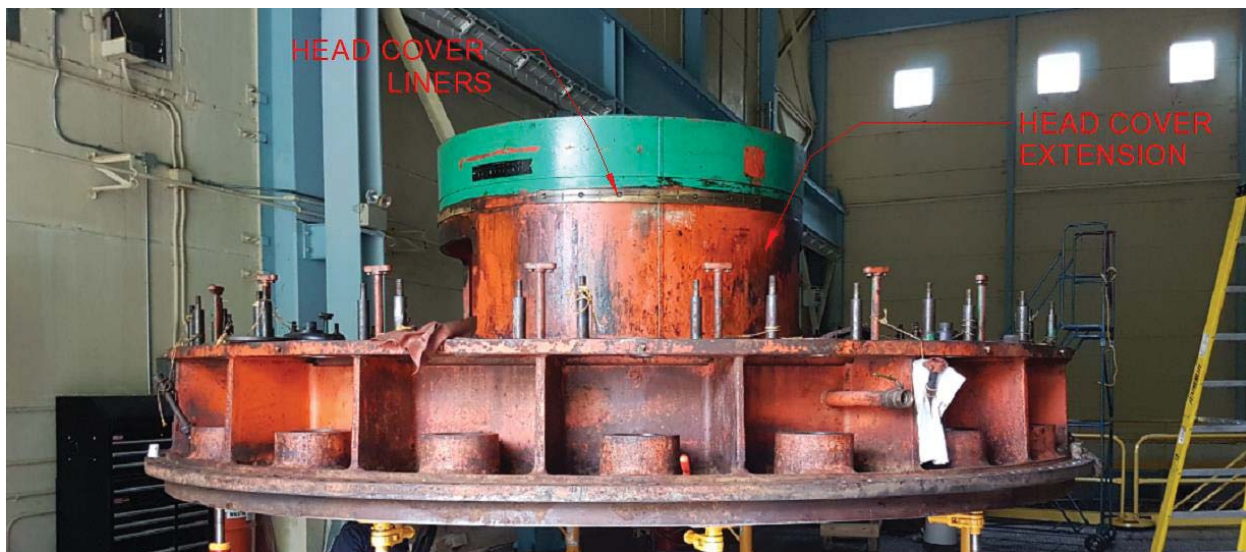
The Head Cover Extension, which is the cylindrical part extending upward that houses the Turbine Guide Bearing, was also in fair condition. This part not only provides support for the TGB, but also acts as the framework on which the Operating Ring rotates. Specifically, the Operating Ring rotates on the greased copper alloy liners on the Head Cover Extension. Once the Operating Ring was removed, the liners were visible and revealed to be in a poor condition. The condition of the liners was so severe that they were not repairable and would require immediate invention from NLH to remedy the problem. This topic is discussed in more detail in the Operating Ring Section 5.12.

Figure 5-201: Head Cover, Extension and Liners

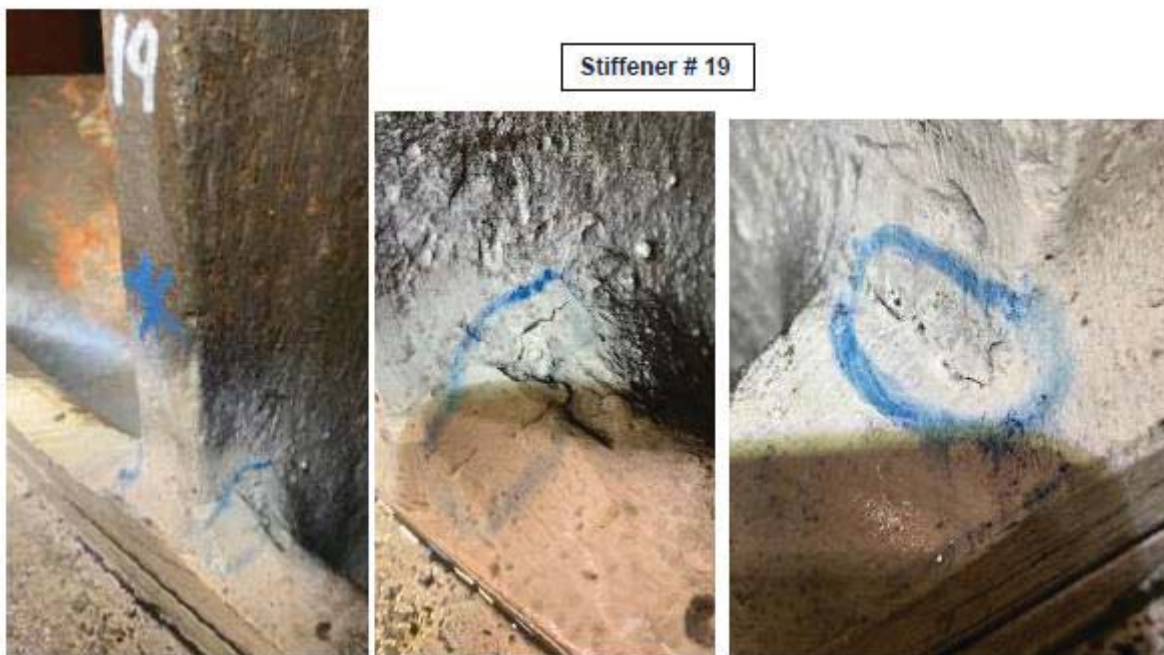
Figure 5-232: Head Cover, Small Stiffener Cracks

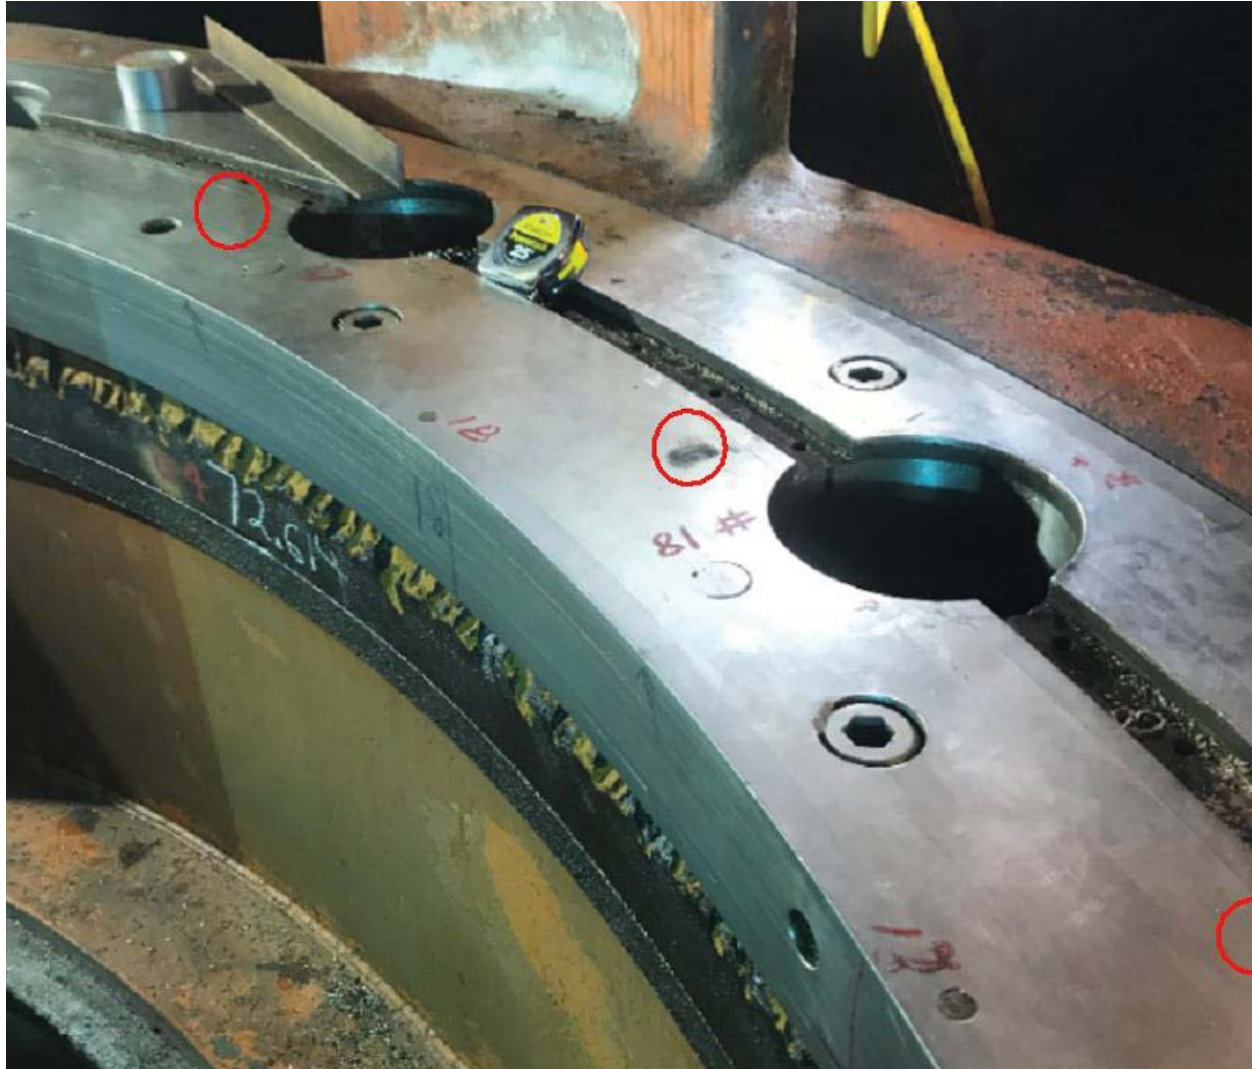
Figure 5-238: Bottom Ring, Water Passage Surface Cavitation

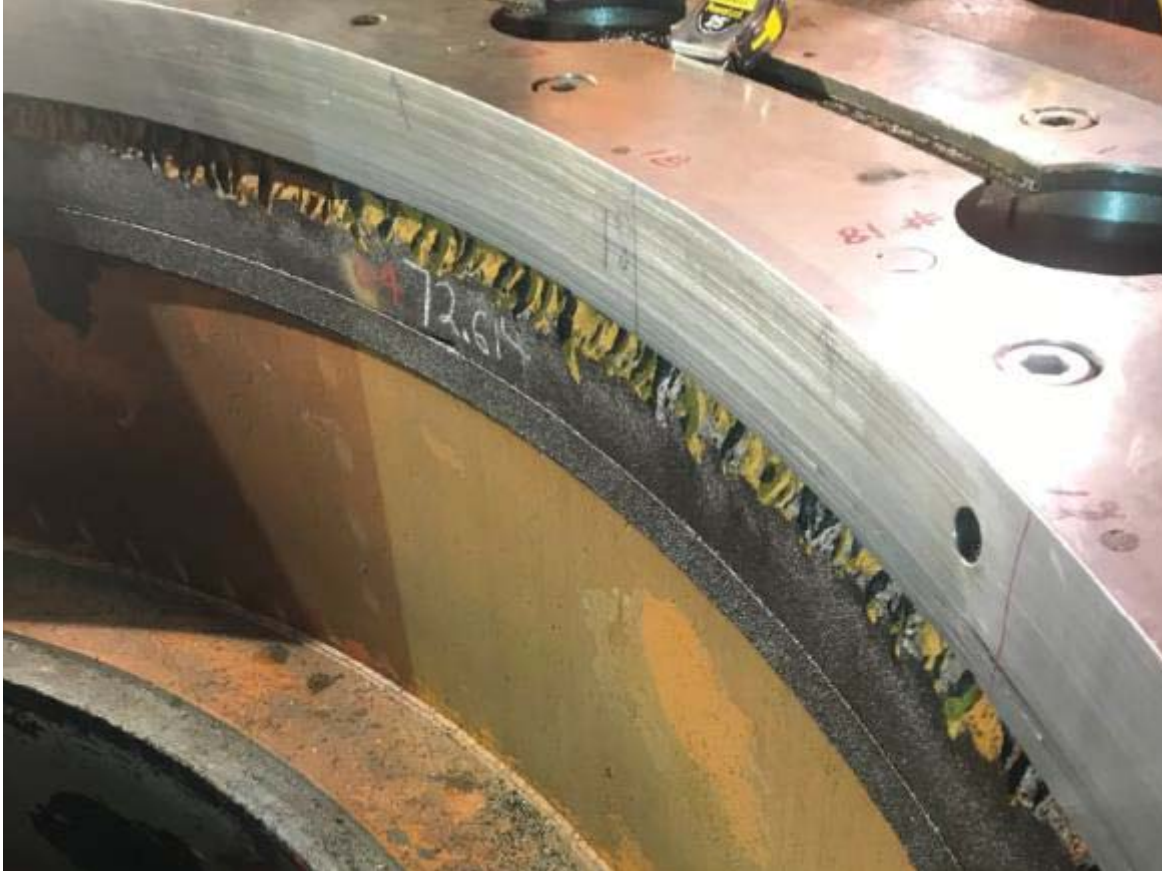
Figure 5-244: Bottom Ring, Wearing Ring Damage

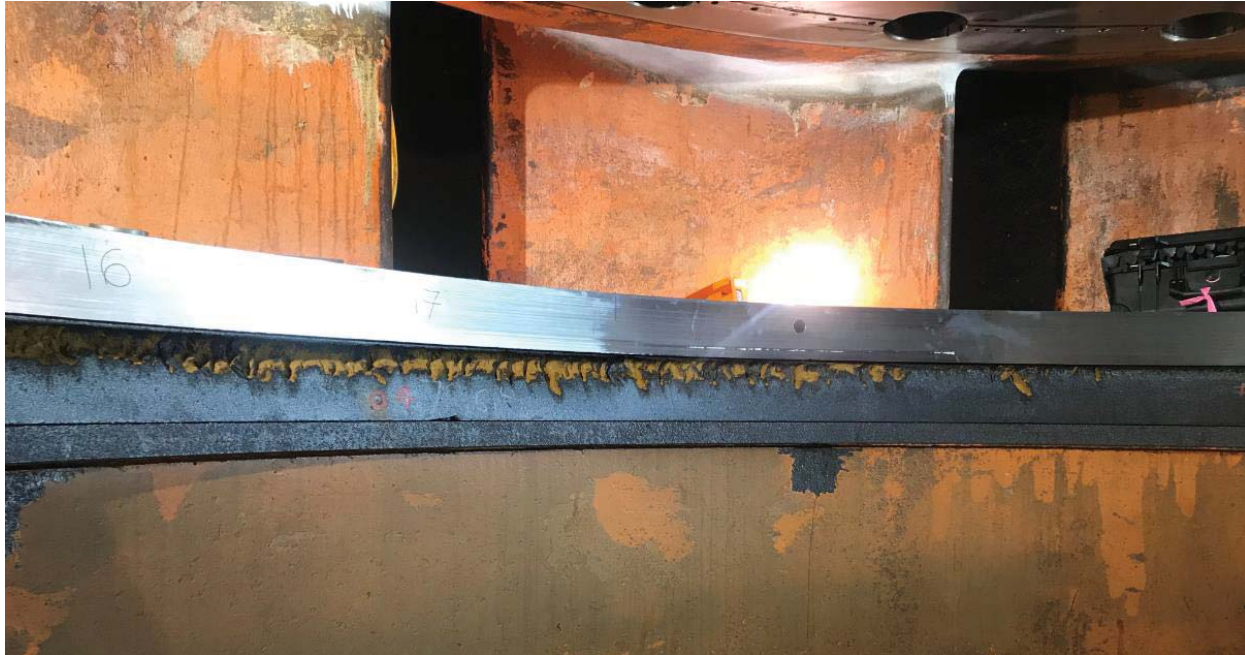
Figure 5-245: Bottom Ring, Cavitation Damage

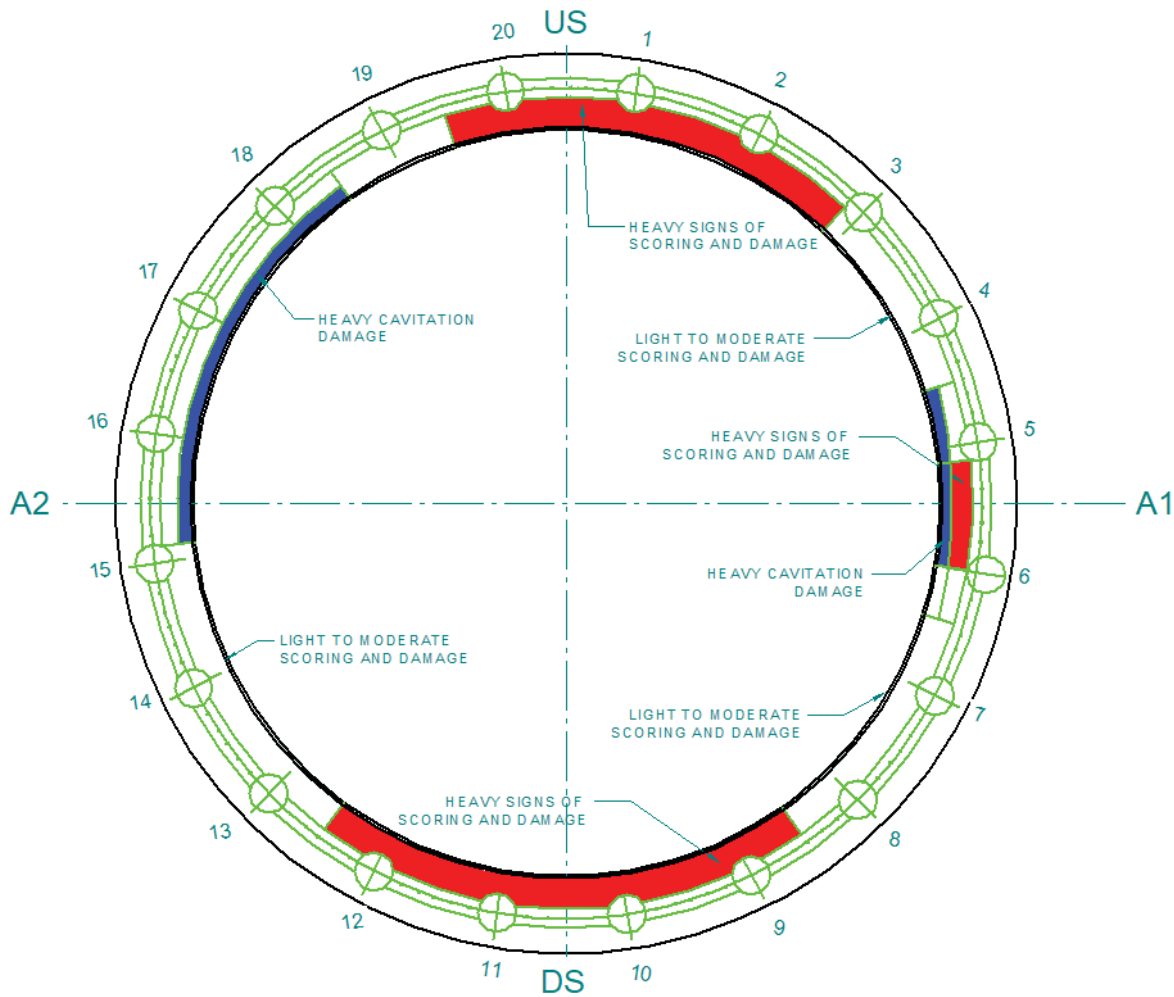
Figure 5-248: Bottom Ring, Overview of Cavitation and Scoring Damage

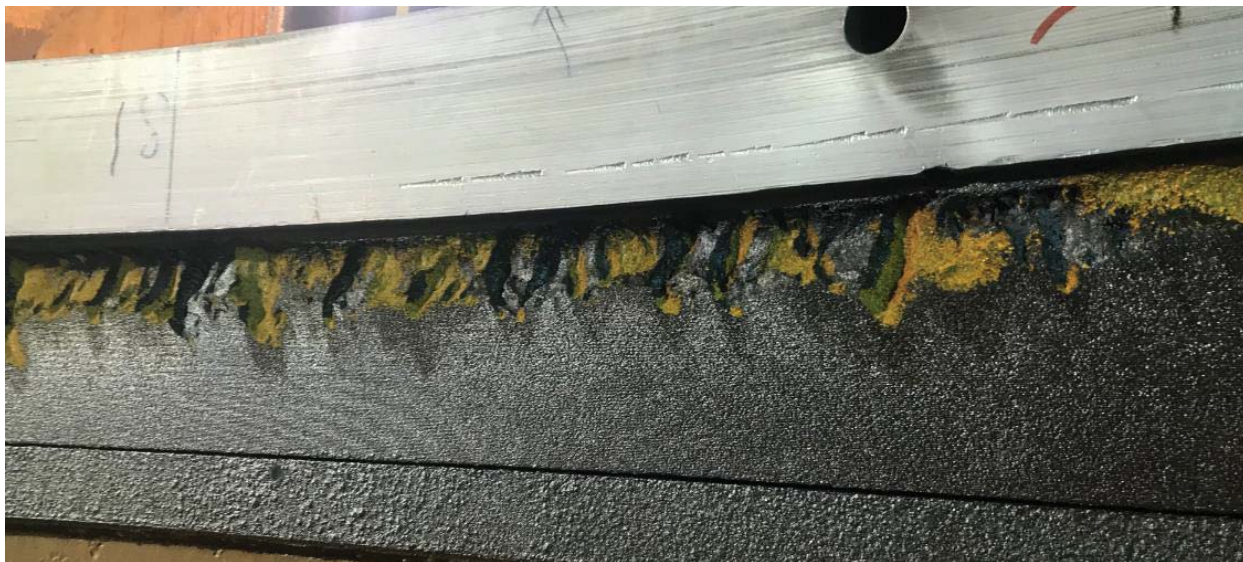
Figure 5-274: Bottom Ring Cavitation Damage

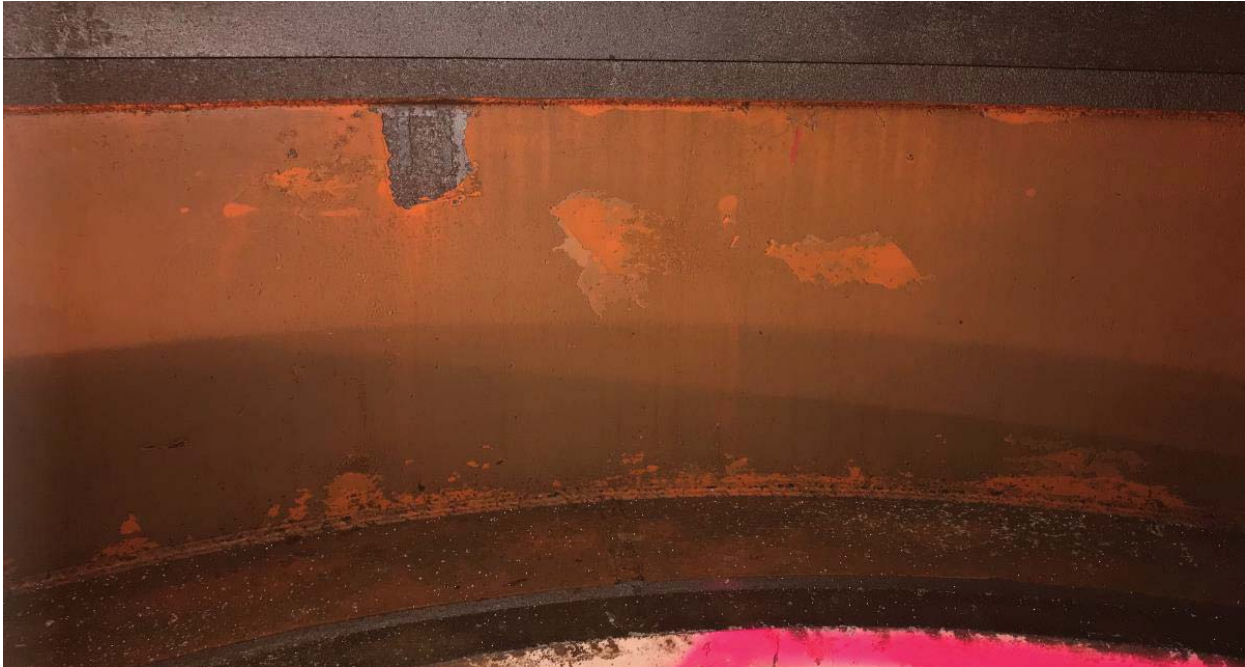
Figure 5-288: Discharge Ring, Paint Condition
