**Re: Allowance for Unforeseen Items Account – TL219 and TL203 Storm Damage Repairs –
Final Report**

TL219 and TL203 Storm Damage Recovery

Final Report

March 10, 2022

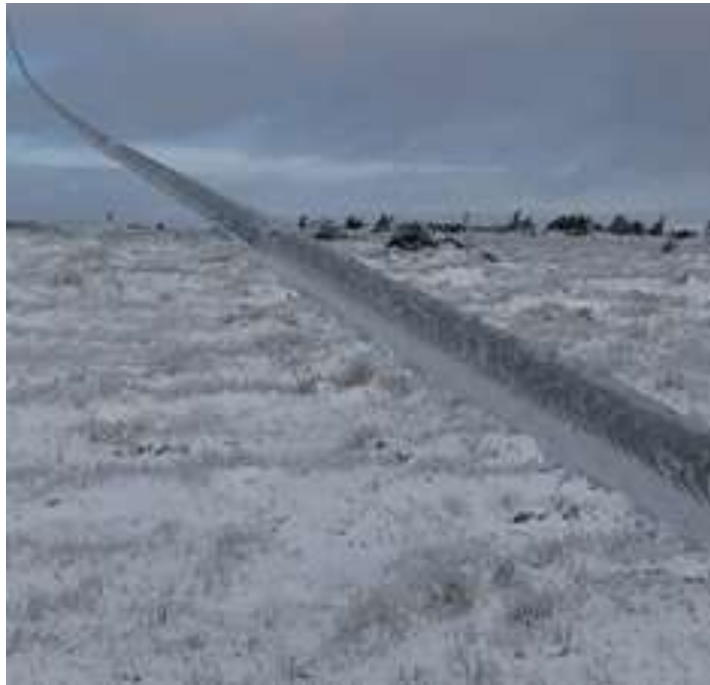
1 On the morning of February 5, 2022, Hydro’s TL203 and TL219 tripped while heavy freezing rain was
2 observed in the region. Freezing rain persisted for several hours, resulting in accumulation of variable
3 amounts of ice on transmission lines and structures (Figure 2) and causing damage to TL219 and TL203
4 conductor and structures. Due to transmission redundancy serving the region, there was no immediate
5 customer impact as a result of the trip; however, to ensure reliable service to customers and ensure
6 damaged structures did not pose a risk to public safety, Hydro had to execute required repairs
7 immediately to mitigate the risk of further damage and restore the system.

Figure 2: Ice Accumulation on TL219 Conductor

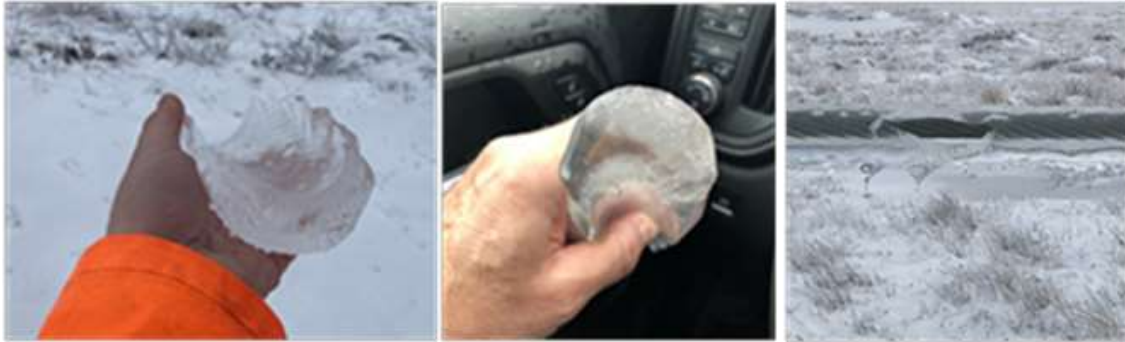
4 The extended weather event resulted in significant, variable ice accumulation on the transmission lines
 5 in the area. Figure 4 shows examples of ice accumulation in the area of the failures.

Figure 4: Ice Accumulation on TL219 and TL203

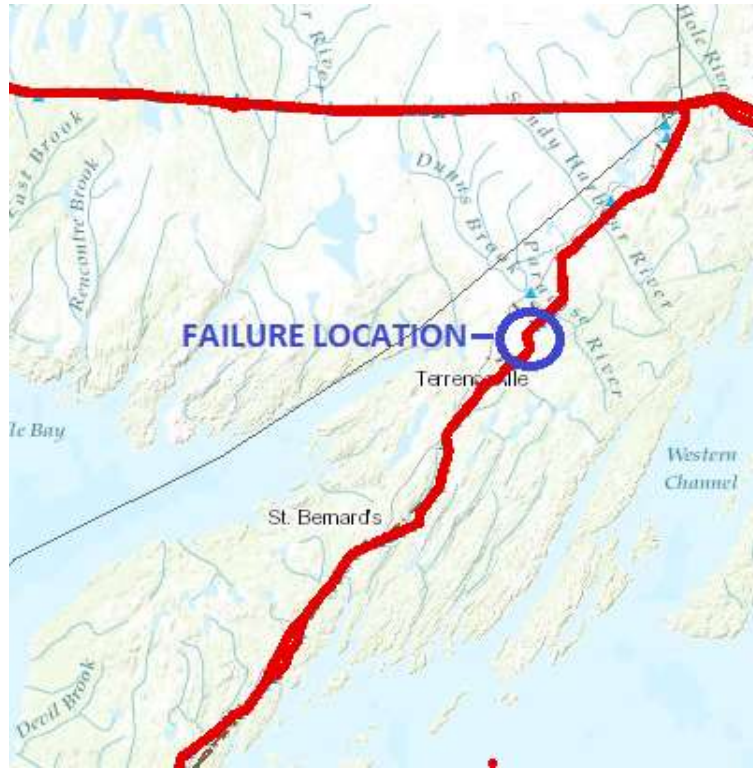
Figure 5: TL219 Failure Location

2 The damages experienced on TL219 included the structural failure of four consecutive Tangent H-frame
 3 structures (Structures 392–395) in the Terrenceville area as shown in Figure 5. The damage included
 4 broken conductor, poles, crossarms, and cross braces as shown in Figure 6.

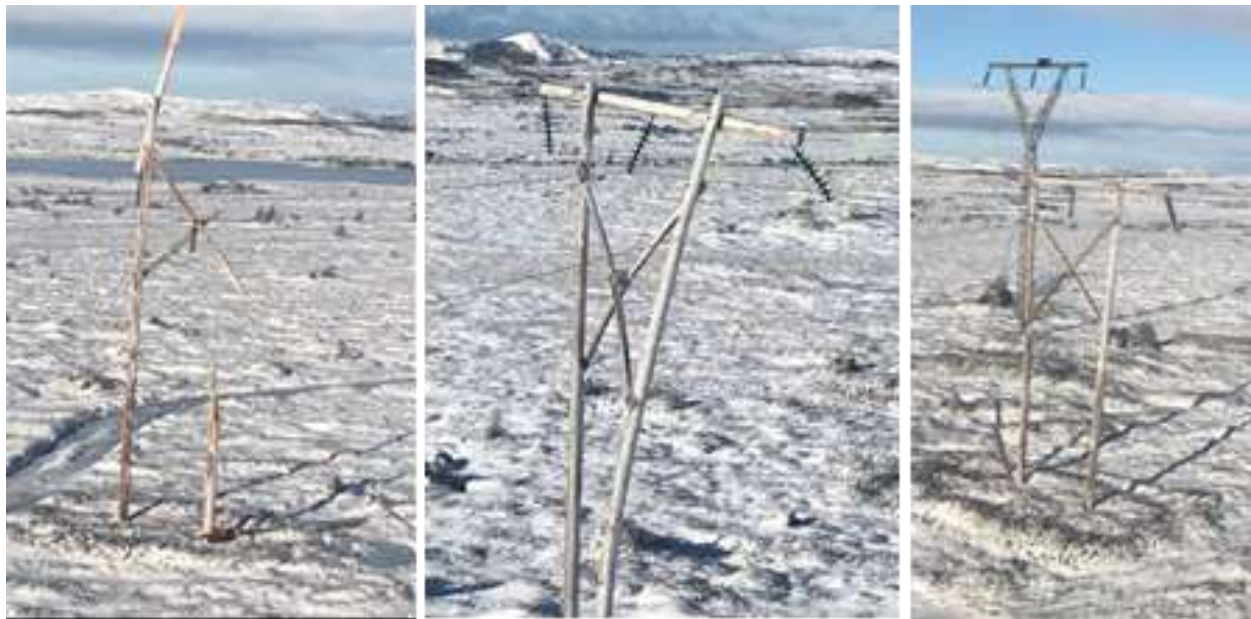
5 Based on observations at site, it appears that ice accumulation on the conductor began to shed off as
 6 the temperatures began to increase (refer to Figure 7), resulting in a longitudinal load that caused the
 7 conductor and structure to pull in one direction. Due to the vintage of this line, it was not designed for
 8 such longitudinal loading and resulted in mechanical bending of the crossarms and structures as shown
 9 in Figure 6. The loading experienced had the potential to result in a significant cascade type of failure,
 10 similar to a domino effect. As seen in Figure 8, the failure on TL219 was located on a short section of line
 11 between two dead end structures,¹ which likely prevented the cascade failure of additional structures.

Figure 6: TL219 Structure Failures and Mechanical Bending

3 The scope of work for TL219 included the full replacement of four Tagent H-frame structures. This
4 includes the following work tasks:

- 5 • Remove and dispose existing damaged structures;
- 6 • Splice broken conductor;
- 7 • Install new poles;
- 8 • Install new crossarms and cross bracing; and
- 9 • Install insulators.

10 The existing tangent structures were designed using a single dimensional wood crossarm configuration
11 supported by class 4 poles. As Hydro no longer uses class 4 poles for transmission infrastructure, the
12 existing structures were replaced with class 2 poles, increasing reliability of the structures as per current
13 standards. In addition, a double dimensional wood crossarm was utilized instead of a single crossarm to
14 increase the structures ability to resist future unbalanced loading. Figure 11 illustrates the design
15 difference between the existing structure and the new structure. The more robust material components
16 utilized during the repair effort provide a significant increase in structure capacity. Refer to Figure 12–
17 Figure 14 for photos showing repair work.

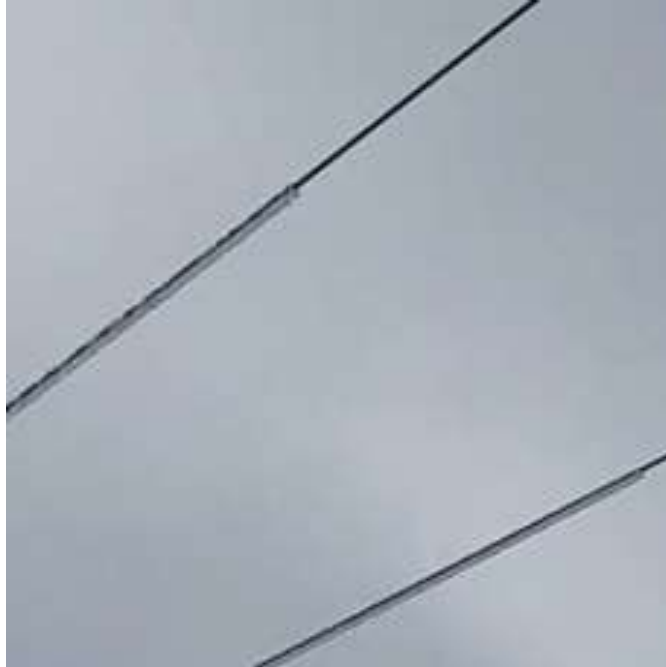
Figure 7: Ice Shedding from Conductor

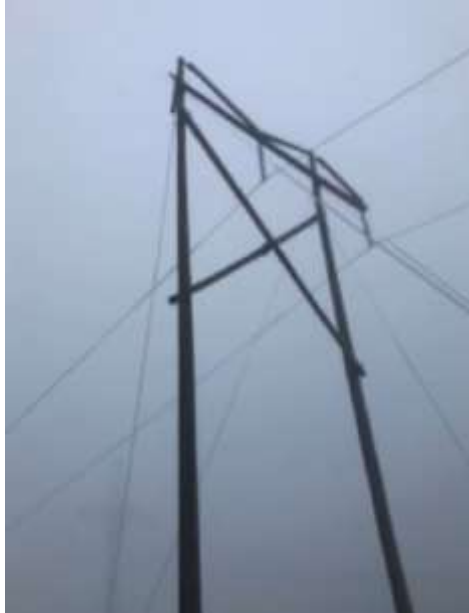
- 2 The damage experienced on TL203 included the structural failure of a crossarm on Structure 77 as
3 shown in Figure 9 near the isthmus on the Avalon Peninsula (Figure 10).

Figure 9: Broken Crossarm on TL203 – Structure 77

2 The scope of work for TL203 included the replacement of a single wood pole crossarm on Structure 77
3 as shown in Figure 9. This was replaced as per the original design.
