Bay d'Espoir Penstock 1 Life Extension Project Update

December 17, 2025

A report to the Board of Commissioners of Public Utilities

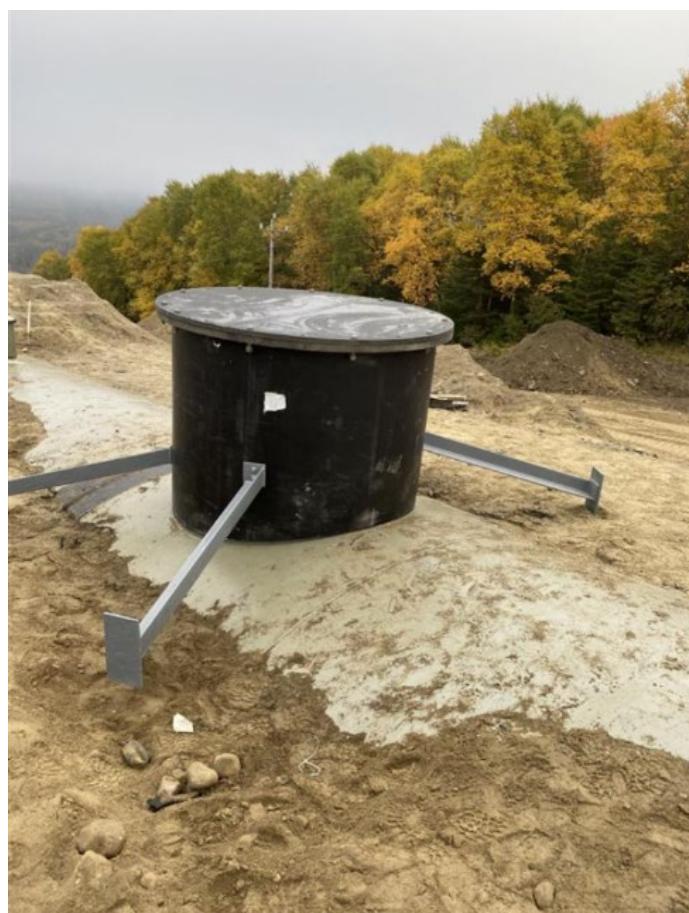
Figure 1: New Access Cover Installation

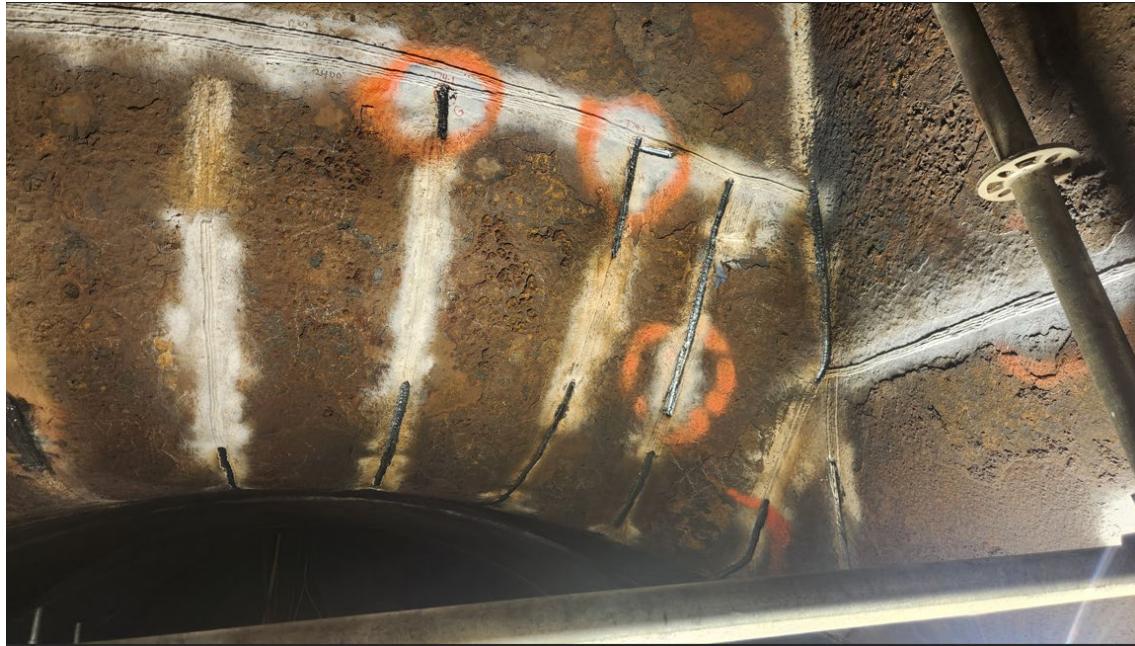
21 The additional repairs identified in the surge tank transition area of the penstock have also been completed.

Figure 2: Weld Repairs at Surge Tank Transition

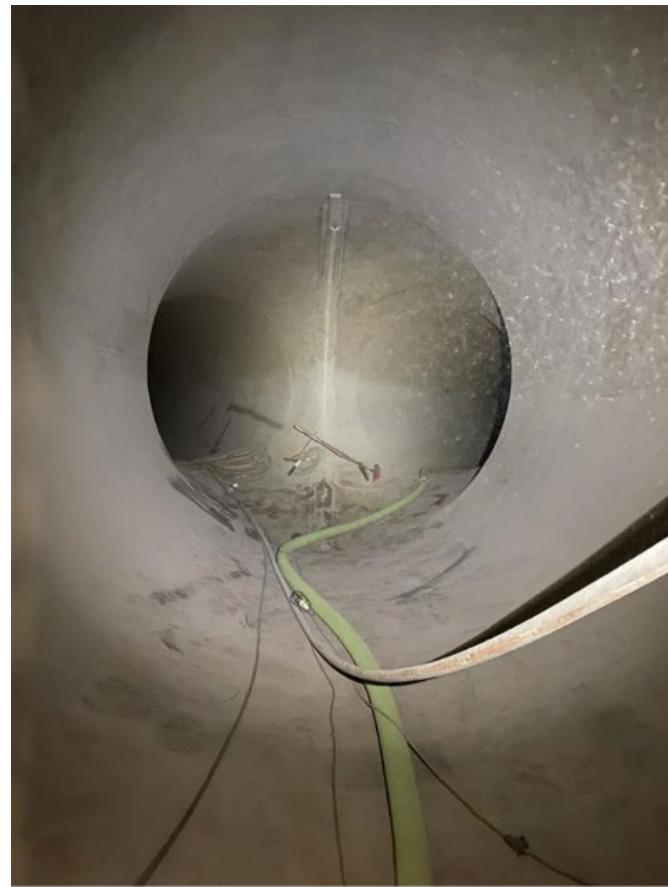
Figure 3: Sandblasting and Cleanup at the Bifurcation

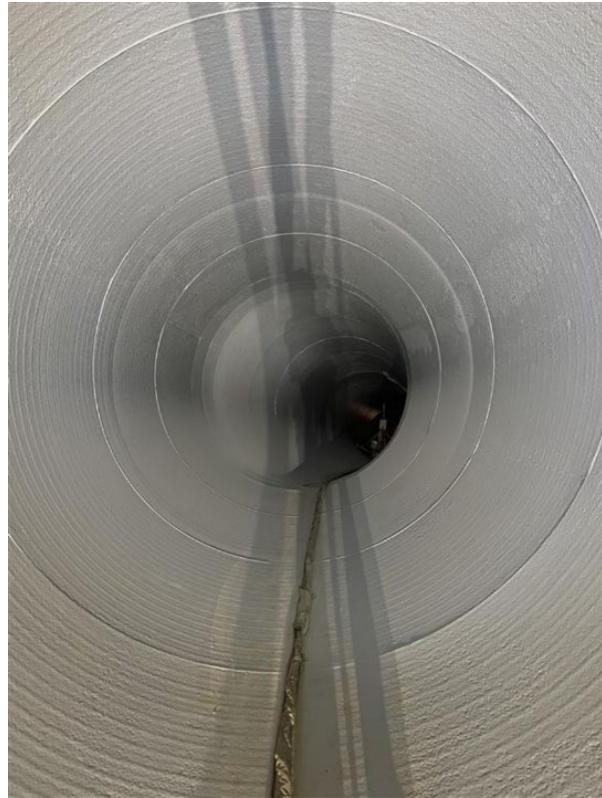
- 1 Work scope associated with the internal coatings of the refurbishment section continued during this period.
- 2 Coatings were applied in the refurbishment area between Bend 9, station 9+44, and Bend 10, station 11+00
- 3 and between Bend 8, Station 7+99 and the Surge Tank, Station 6+85. Sandblasting started in the
- 4 replacement section from Can 6 to 14 on the circumferential joints and internal bracing locations.
- 5 Additionally, the sandblasting and coatings in the area near the powerhouse at bend 10, station 11+00 to
- 6 station 11+57, was completed. Approximately 63% of the sandblasting and 47% of the coatings work have
- 7 been completed up to the end of the reporting period.
- 8 Figure 1 to Figure 7 show progress within the current reporting period.

Figure 4: Typical Coating Application

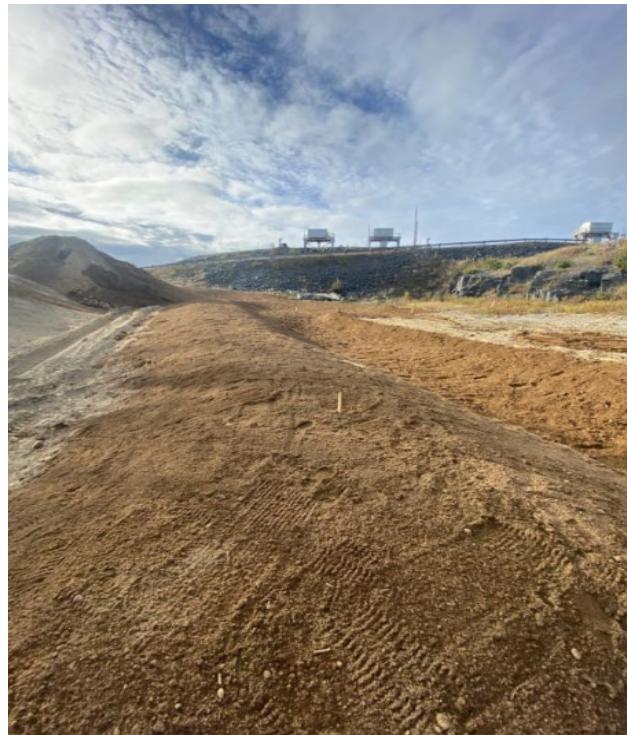
Figure 5: Topsoil Placed Can 2 to Can 4 Area

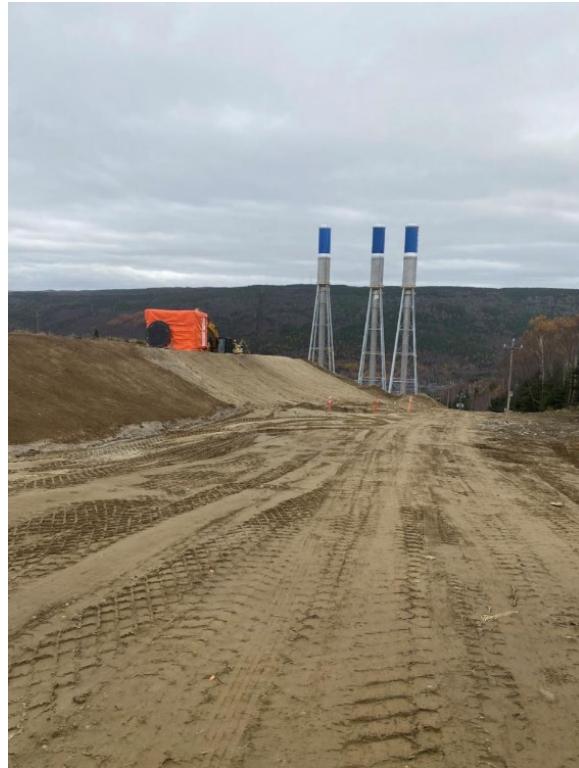
Figure 6: Sloping Complete Can 22 to Can 25 Area

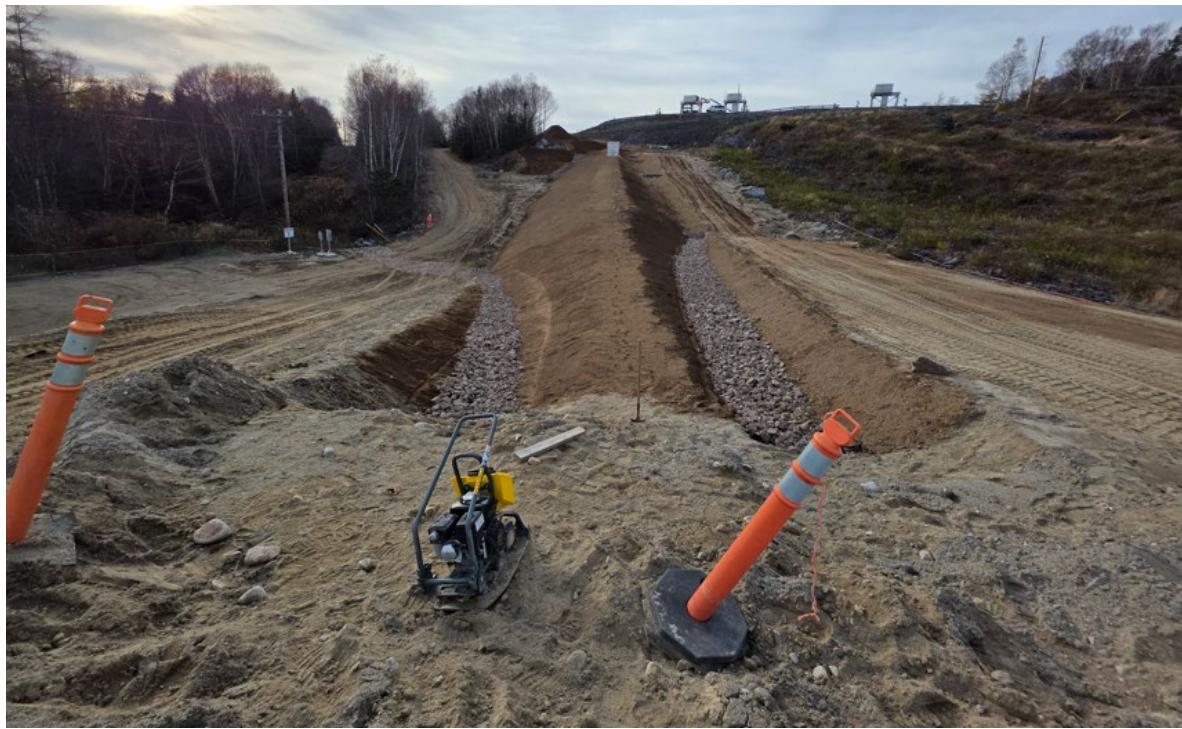
15 On-site construction continued during the reporting period with general backfilling and placement of
16 topsoil, removal of interior bracing, and internal coating activities. Placement and sloping of common fill
17 up to Can 27 was completed. Hauling and stockpiling of common material from the quarry at Upper
18 Salmon was completed during this reporting period, and hauling and placement of topsoil has started.

Figure 7: General Penstock Backfill and Final Grading
