Re: Holyrood Thermal Generating Station Unit 1 – Root Cause Investigation Report

Holyrood Thermal Generating Station Root Cause Investigation

Unit 1 – Cold Reheat Piping Support Failure

December 2021

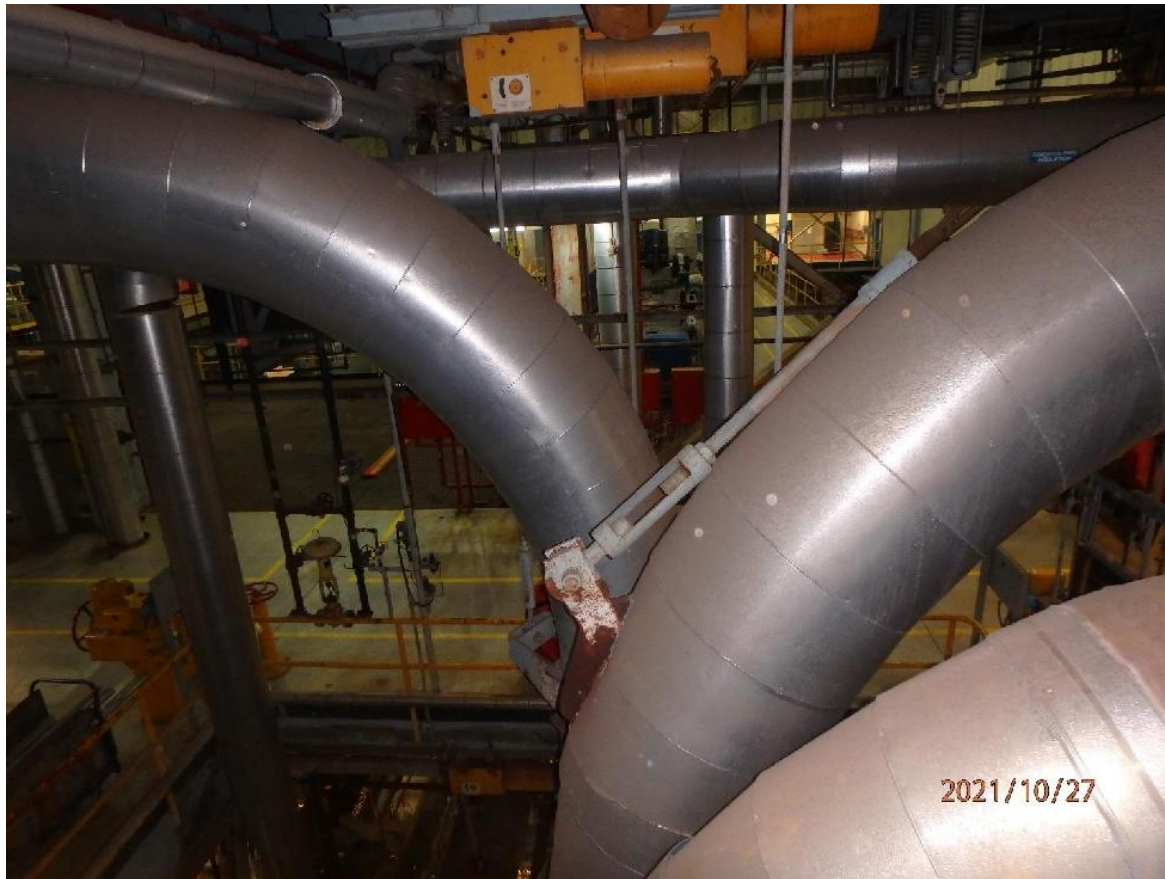
CRH Hanger CR14 failure (4th floor).
