**Re: Transmission System and Terminal Station Asset Management Execution Report**

# Transmission System and Terminal Station Asset Management Execution Report

**May 11, 2020**

A report to the Board of Commissioners of Public Utilities

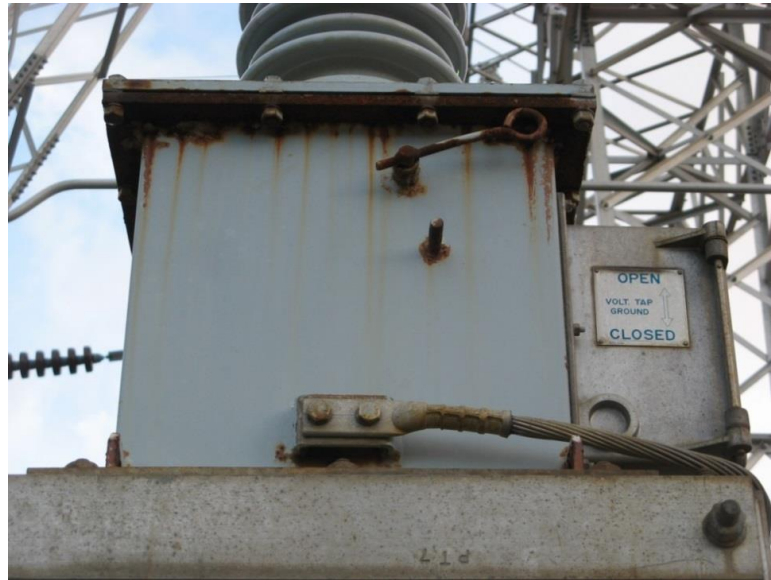
**Figure 2: Rusting PT**

5 Physical deterioration involves conditions such as oil leaks, rusting, or small chips and cracks in the  
6 insulation. Figure 2 shows an example of rusting on a PT tanks.

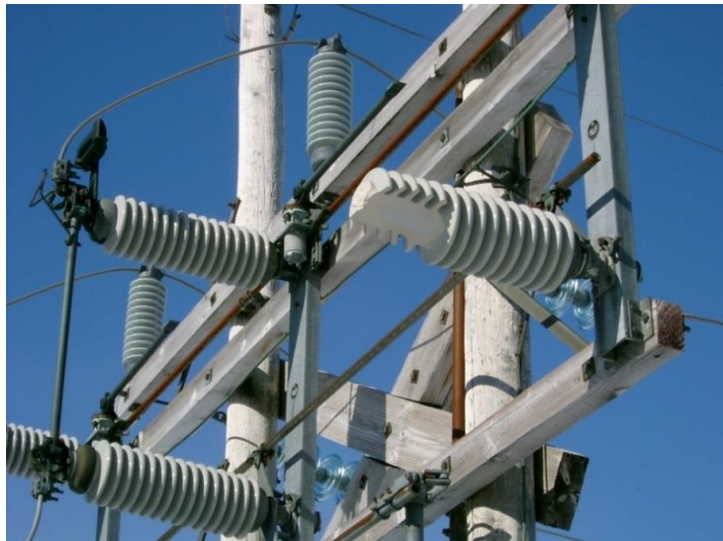
**Figure 4: Broken Insulator on 69 kV Disconnect Switch**

10 Figure 4 shows an example of a badly damaged disconnect switch.

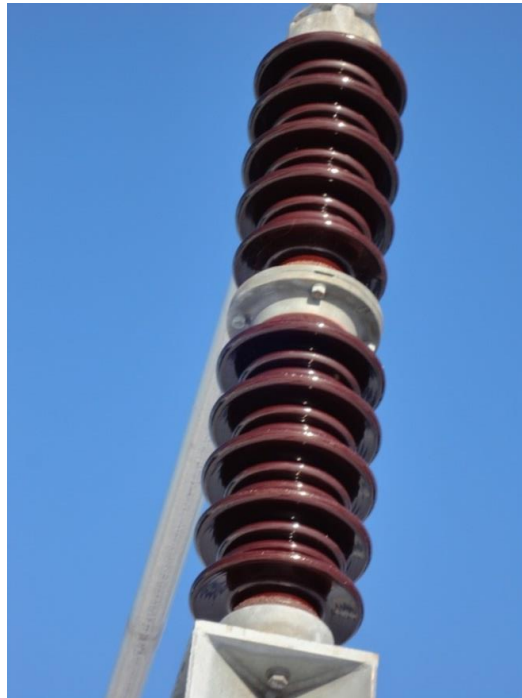
**Figure 6: Multi-Cone Type Insulator Prone to Failure due to Cement Growth**

1 For insulators using porcelain, cement is used in mating the porcelain and metal hardware. Some older  
2 insulators have been damaged by a phenomenon known as cement growth. This is a common problem  
3 in the utility industry. In such situations, water is absorbed into the concrete, during freeze/thaw cycles,  
4 causing swelling of the cement placing stress upon the porcelain. Over time, the increasing pressure  
5 caused by cement growth will crack or break the porcelain resulting in insulator failure. In such  
6 situations, porcelain may fall presenting a safety hazard to crews or damaging equipment below. Also  
7 faults resulting in outages to customers often occur, when insulator failure leads to flash-over. Some  
8 time ago, insulator manufacturers identified and researched cement growth problems and have  
9 improved their cement quality to eliminate this problem.

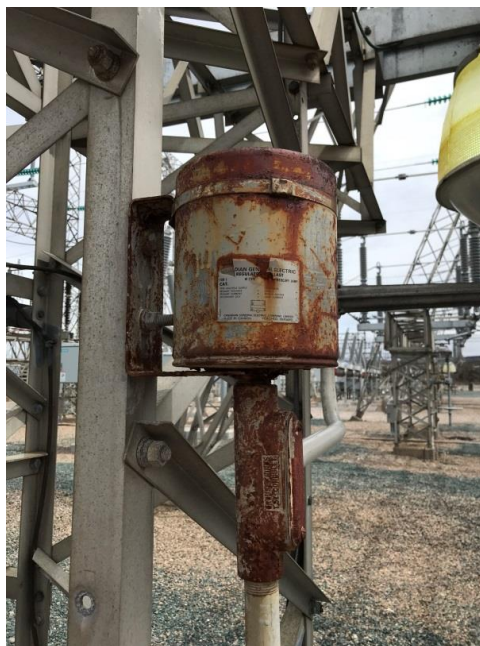
Figure 13: Corroded Ballast Requiring Replacement

13  
14 Under this program, Hydro will replace deteriorated lighting systems as they become unable to provide  
15 adequate illumination of the terminal station and have become obsolete or beyond repair. Hydro will  
16 replace legacy lighting systems with modern, efficient lighting technologies whenever possible.

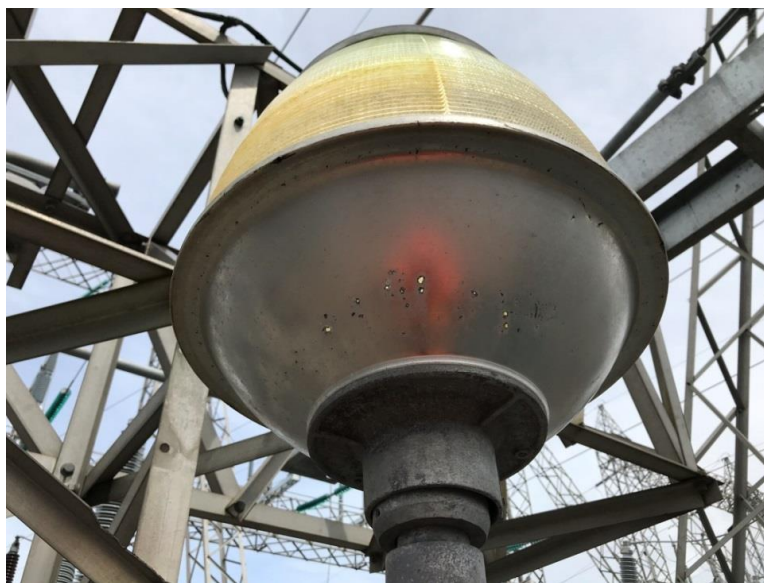
Figure 14: Light Fixture Showing Perforations due to Corrosion, Enabling Moisture Ingress

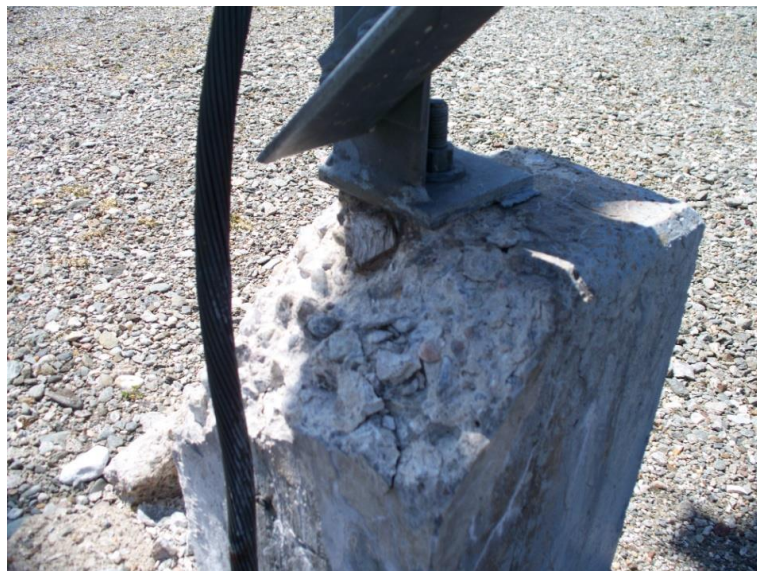
**Figure 15: Structure B1T1 Bottom Brook Terminal Station**

7 The service life of galvanized steel structures varies depending on the operating environment, but can  
8 exceed 100 years, outliving the foundations on which they are built. A number of the foundations in  
9 Hydro terminal stations have deteriorated significantly due to repeated exposure to damaging  
10 freeze/thaw cycles, weathering, and age, leading to concerns over their integrity. Examples of degraded  
11 structure foundations are shown in Figure 15 and Figure 16.

1 To ensure foundations perform as per the original design intent, severely deteriorated concrete  
2 foundations must be refurbished or replaced. Failure to complete repairs could result in a catastrophic  
3 failure, causing outages or personal injury. Hydro has carried out engineering inspections of all 230 kV  
4 stations and identified foundations requiring repairs. Additionally, Hydro performs visual inspections of  
5 foundations every 120 days during regular terminal station inspections. Foundations identified for repair  
6 are addressed under this program.

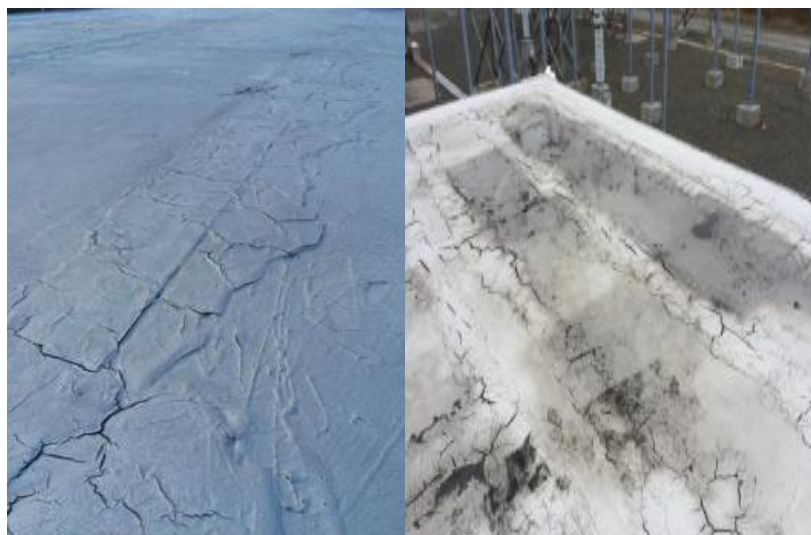
Figure 17: Terminal Station Control Buildings (Come by Chance and Sunnyside) Showing Cracking and Deterioration of the Roof Membrane System

24 In 2016, Hydro submitted its “Upgrade Office Facilities and Control Buildings Condition Assessment and  
25 Refurbishment Program Asset Management Strategy Plan” in its 2017 CBA, which outlined Hydro’s  
26 approach to address aging and failing building infrastructure. Beginning with the 2019 CBA, Hydro will  
27 undertake the refurbishment of control buildings under the Project.

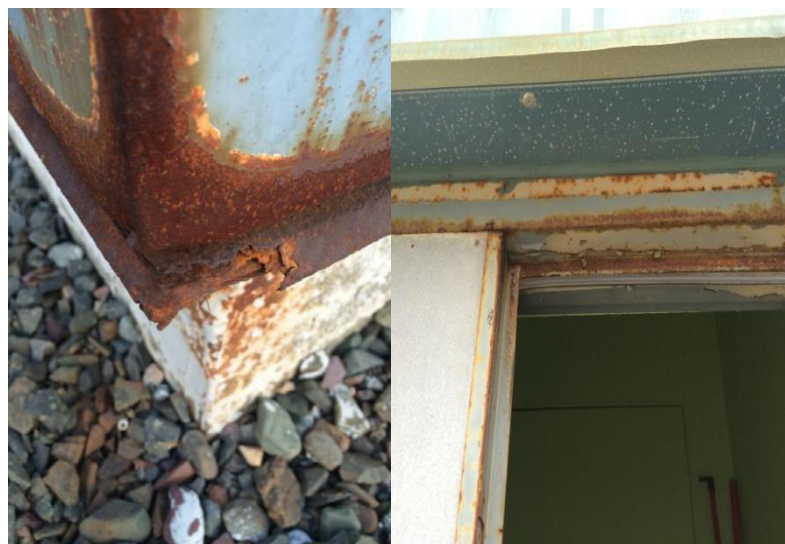
Figure 18: Building Exterior Cladding and Exterior Doorways Displaying Severe Rusting and Deterioration
