Re: 2019–2020 Winter Readiness Planning Report – Further Update – Bay d’Espoir Terminal Station General Electric Dead Tank Circuit Breaker Failure Report

Bay d'Espoir Terminal Station General Electric Dead Tank Circuit Breaker Failure Report

February 14, 2020

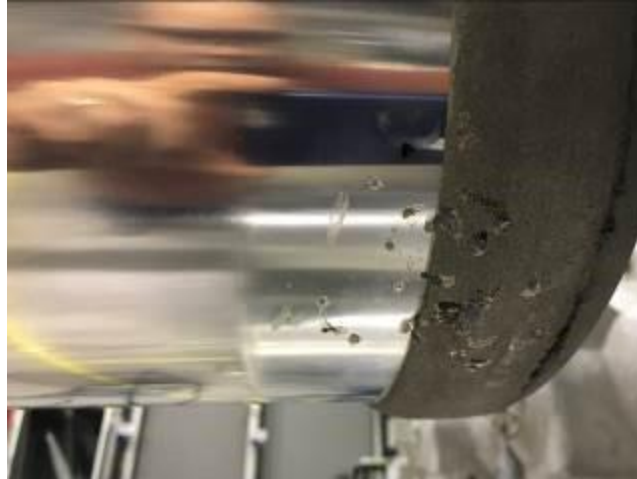
22 GE performed the failure investigation of circuit breaker B2B3 on January 4, 2019. When the interrupter
23 was removed from the tank arc damage was found on the pin side support casting and exhaust
24 enclosure, see Figure 1.

Figure 1: Arc Damage on Interrupter

1 The evidence found during the investigation strongly suggests that the root cause of the flashover was a
2 dimensional non-conformance of the exhaust enclosure. This prevented the end casting on the pin side
3 from seating properly, which allowed for relative movement between the exhaust enclosure and the
4 casting during transportation to site. This relative movement resulted in damage to the mating parts and
5 produced the metal particles found; this, likely caused the flashover upon initial energization.

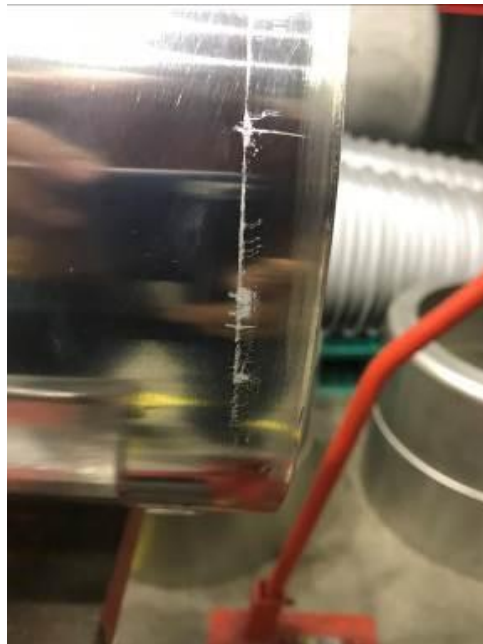
1 Arc damage and metal splatter was also found on the bottom of the tank on the pin side directly under
2 the damage to the interrupter. The end casting for the exhaust enclosure was not properly seated as a
3 bolt was not fully engaged. When this casting was removed metallic particles were found inside the
4 exhaust enclosure and the enclosure itself had some scratches due to the relative motion between the
5 parts. See Figures 2 and 3.

Figure 2: Scratches on Exhaust Enclosure

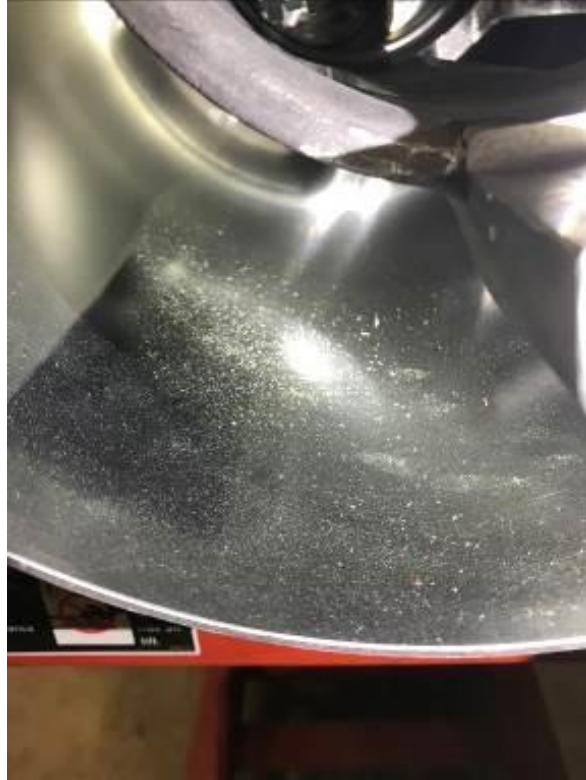
Figure 3: Metal Particles inside Exhaust Enclosure

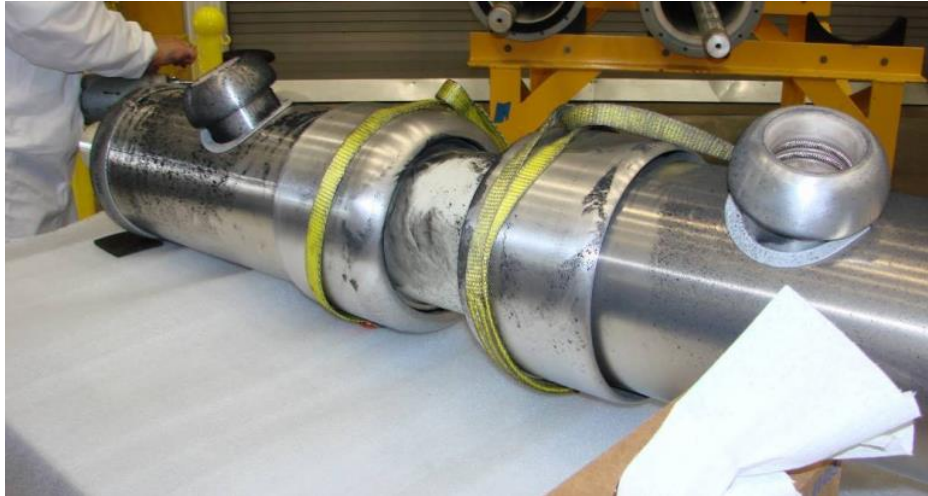
7 GE performed the failure investigation of circuit breaker B3T5 on June 4, 2019, with Hydro
8 representatives present. When the bushings were removed black material was found on the conductors
9 and internal surface of the porcelain, predominantly on the bushing opposite the spring drive. The
10 interrupter was removed from the tank and revealed black material coating most internal surfaces of
11 the tank as well as the interrupter itself, see Figure 4.

Figure 4: Black Material on Interrupter

9 It is possible that over the course of several hundred operations the arcing pin became loose and started
10 depositing metal and grease in the nozzle throat. In this case, the voltage withstand capability would
11 degrade and could eventually cause a flashover across the open gap.

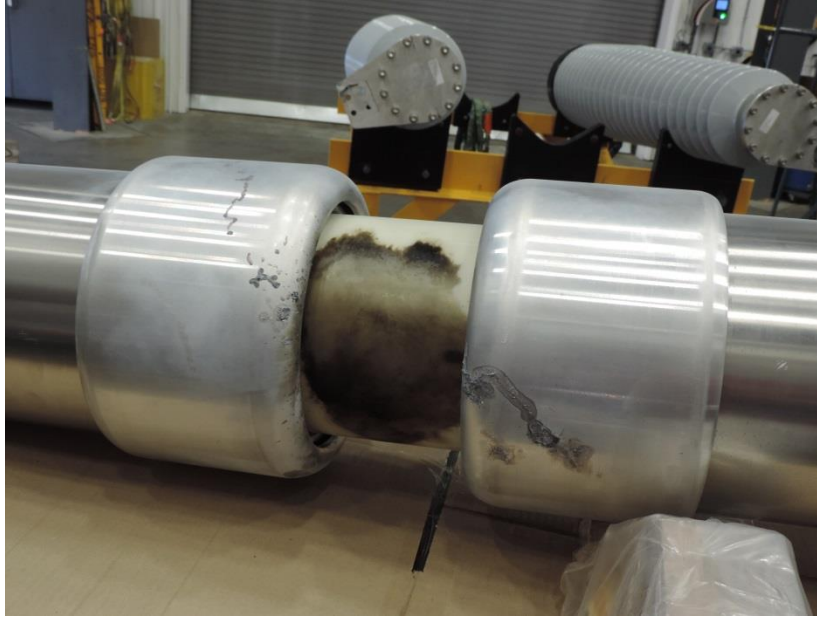
13 GE performed the failure investigation teardown of the BDE B3T6 circuit breaker on September 24,
14 2019. The faulted C Phase was completed first. There were burn marks noted from the pin side of the
15 interrupter to the tank as well as a blackened gap insulator. The failure theory proposed was a phase-to-
16 ground fault on the pin side due to foreign particles and it developed into a flash over across the open
17 contact, see Figure 5.

Figure 5: Flash To Ground and Across Insulator Gap

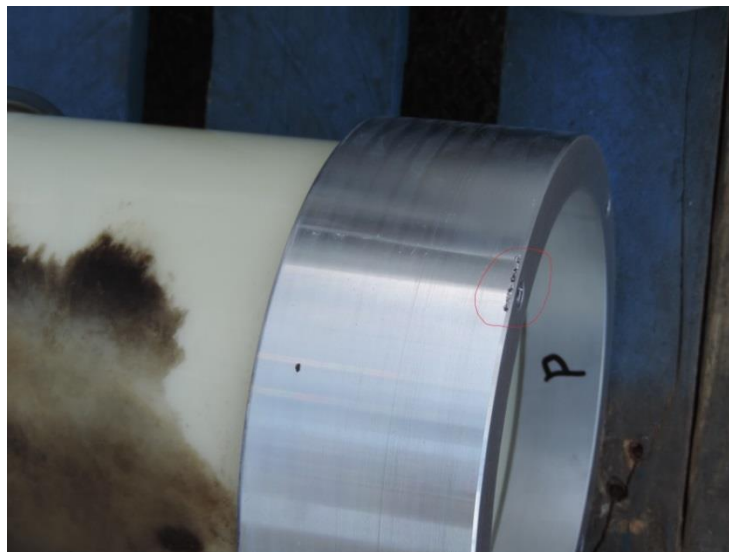
- 1 From GE's review they have indicated that the initial fault was related to foreign particles inside the
- 2 circuit breaker tank. Further investigation has identified an area where metal scraping was shown where
- 3 the gap shield was installed, see Figure 6.

Figure 6: Gap Insulator Flange where Gap Shield was Installed

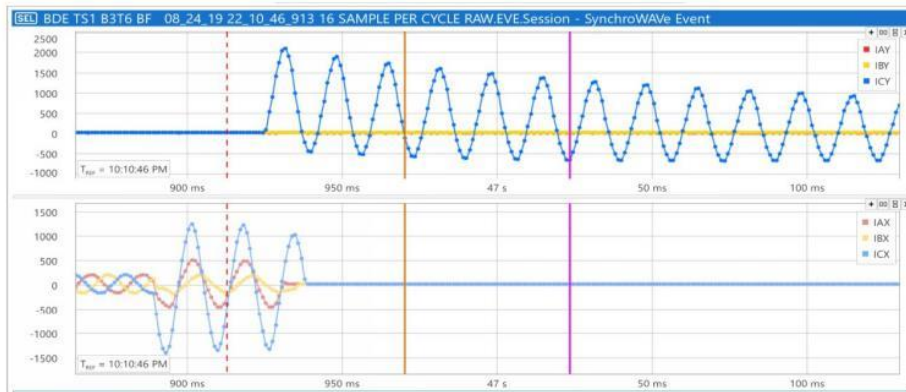
Review of the fault traces obtained from protection relays on Transformer T6, the breaker and Generators 5 and 6 show development of two faults during operation of the disconnect switch. Figure 2-1 illustrates the current waveforms seen by relays on high voltage side of the transformers T5 and T6. Waveforms labeled “X” are on G5/T5 branch and those labeled “Y” are related to the G6/T6 branch. As per the fault traces, the initial fault (a flashover to the ground) only affects generator G5, which contributes to the fault current. After almost two cycles, the second fault (contact to contact flashover of breaker B3T6) affects the G6 and current starts flowing in B3T6. After 3 cycles from the first fault, the bus protection operates, isolating bus B3 and G5 from rest of the system (breakers B3T5, B2B3 and B3B4 are opened). However, G6 keeps contributing to fault current. Based on the waveforms, both faults are at 230 kV level on phase C.

Figure 2-1: Waveforms Obtained from Breaker Failure Relay (Located on High Side Bushings of T5 and T6)

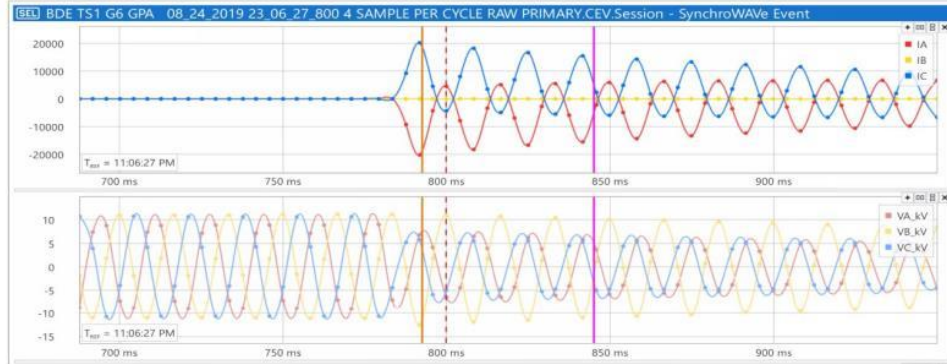
Figure 2-2 shows the waveforms seen from Generator 6 relay. The current waveforms are seen from 13.8 kV side (delta side) of the delta-wye transformer. The voltage and current waveforms show that G6 starts contributing to the fault current two cycles after the initial fault.

Figure 2-2: Waveforms Obtained from Generator G6 Relay

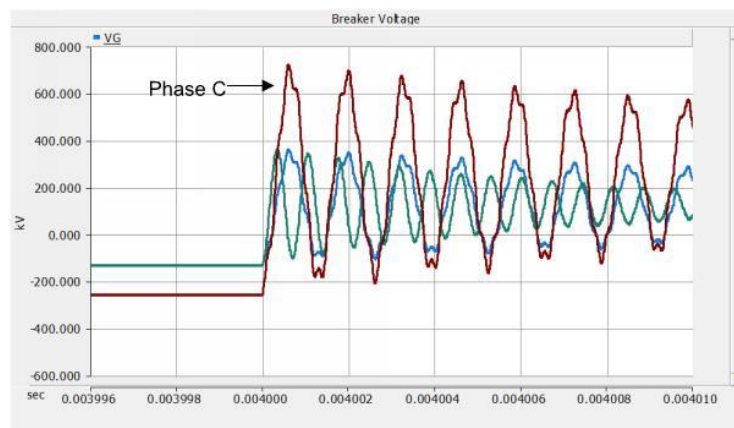
The simulation results show a transient voltage of up to almost 800 kV at the breaker terminals. This is an approximate value which depends on various parameters used in the simulation model. With more accurate data, a more realistic estimation can be obtained. The transient voltage at the breaker terminal and the current through the disconnect switch are shown in Figure 2-9 and Figure 2-10. The frequency of this transient voltage is in the order of 0.7 MHz.

Figure 2-9: Transient Voltage at the Bus Side of the Breaker

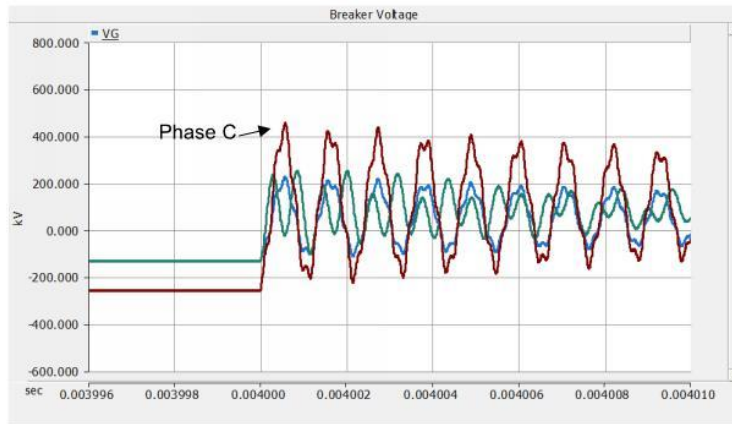
Figure 2-12: Transient Voltage at the Bus Side of the Breaker After Replacing CVTs With PTs

Replacing bus CVTs with inductive (wound type) PTs has been considered one of the mitigation methods to minimize the transients due to capacitive effect. According to the values provided in IEEE Std 37.011 and as shown in Table 2-1 and Table 2-2, inductive PTs have considerably lower capacitance values compared to CVTs. In order to investigate the effect of inductive PTs, the capacitance values of CVTs in the PSCAD model were replaced by those of inductive type PTs. The results of PSCAD simulations show a reduction in voltage and current transient magnitudes on the bus side of the disconnect switch, thus showing the impact of the lower capacitance values.

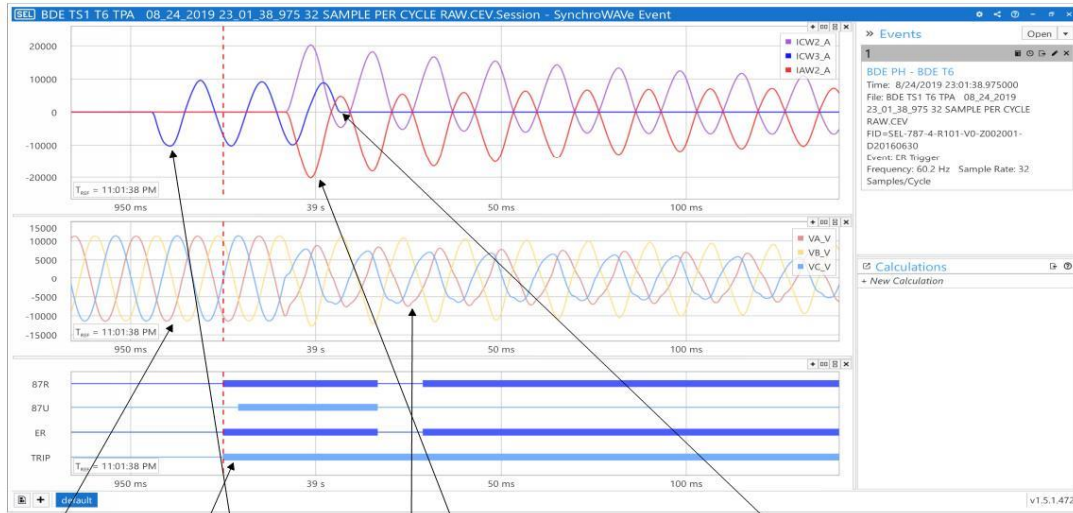
TRIP VIEWED FROM TRANSFORMER T6 PROTECTION RELAY

No effect to generator voltage until current starts to flow on low side.

Initial contribution to fault seen from Phase C bushing on bus side of Breaker B3T6.

Fault contribution through high side Phase C bushing on Breaker B3T6 ceases when other breakers on Bus B3 open. This is the result of the bus differential protection operation; the breaker failure relay trips approx. a0.2 seconds later.

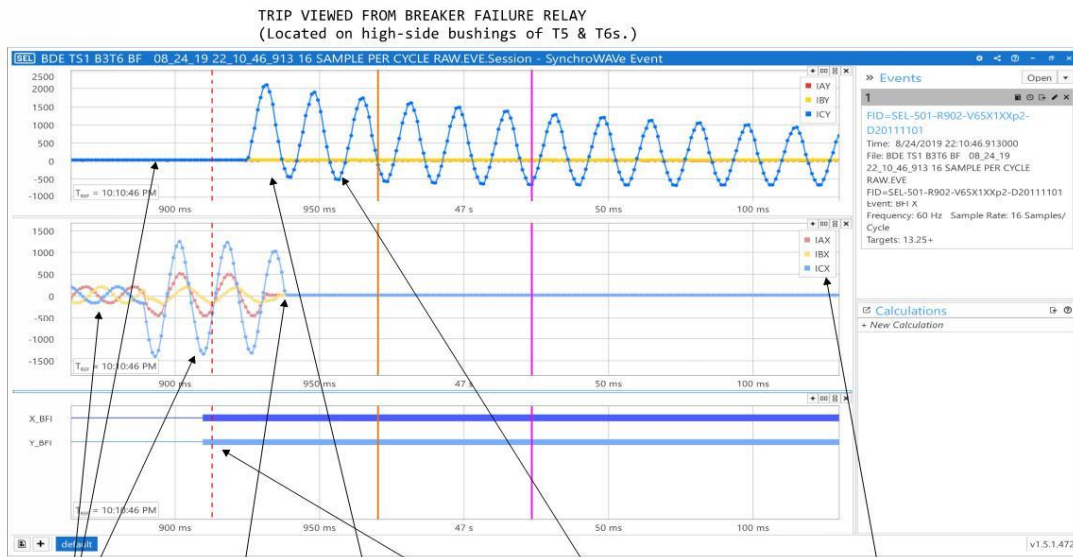
Generator G5 in normal operation prior to fault. Generator G6 is supposed to be offline already with breaker open. Fault initially only affects Generator G5.

Current starts to flow to low side of Breaker B3T6 about two cycles after fault initially starts.

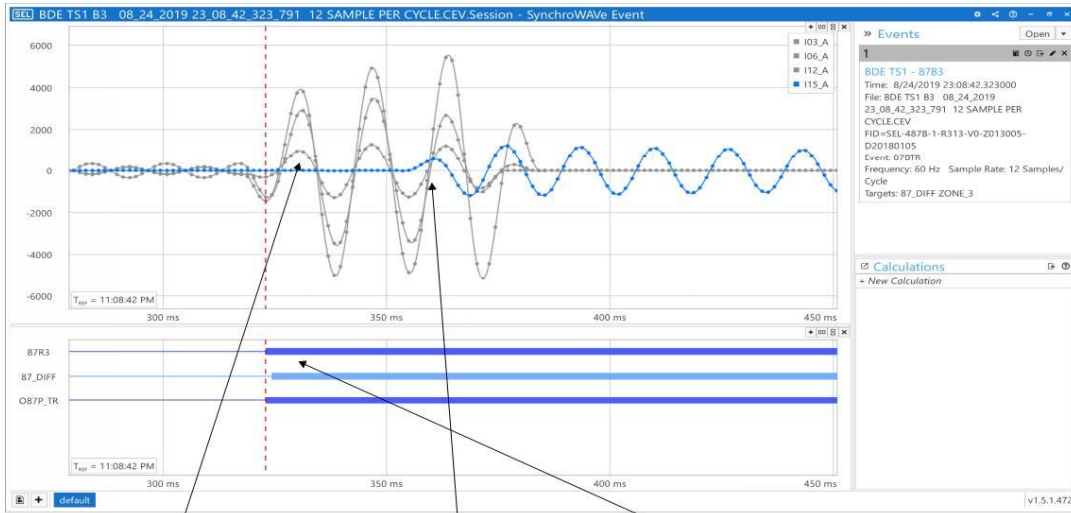
TRIP VIEWED FROM BUS DIFFERENTIAL RELAY
 (CT's located in 230 kV bushings.)

Current initially starts to flow in Phase C of Breakers B3T5, B2B3, and B3B4. No current for two cycles in Breaker B3T6 (supposed to be open).

Blue trace shows current in Phase C generator-side bushing of Breaker B3T6 two cycles after fault starts. Note that this is measured on load-side bushings of Breaker B3T6, showing that the issue is in the breaker.

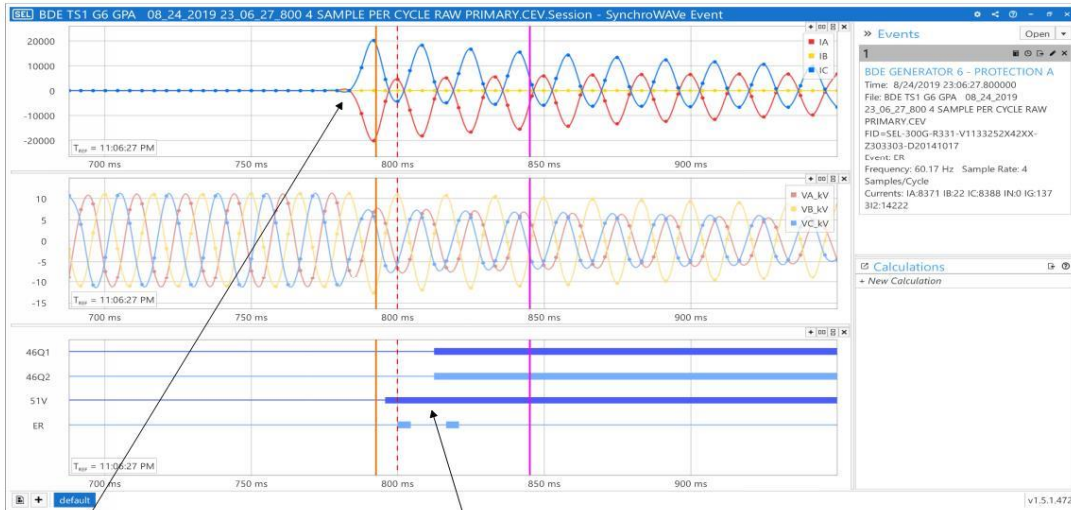
TRIP VIEWED FROM GENERATOR G6 RELAY

Current only starts two cycles after the 230 kV-level fault begins.

46 and 51V protections provide sensitive, time-delayed protection for unbalance and overcurrent, respectively. This appears to indicate that Breaker B3T6 was open and that the fault initially only affected the 230 kV side. If Phase C of B3T6 had jammed, I would have expected the 46 element (negative sequence/unbalance) to already be picked up at this point.
