#### Re: 2023 Supplemental Capital Expenditure Application – Memorial Substation Power Transformer Replacement

### Memorial Substation Power Transformer Replacement

Appendix C: van Kooy Transformer Consulting Services Inc. Condition Assessment

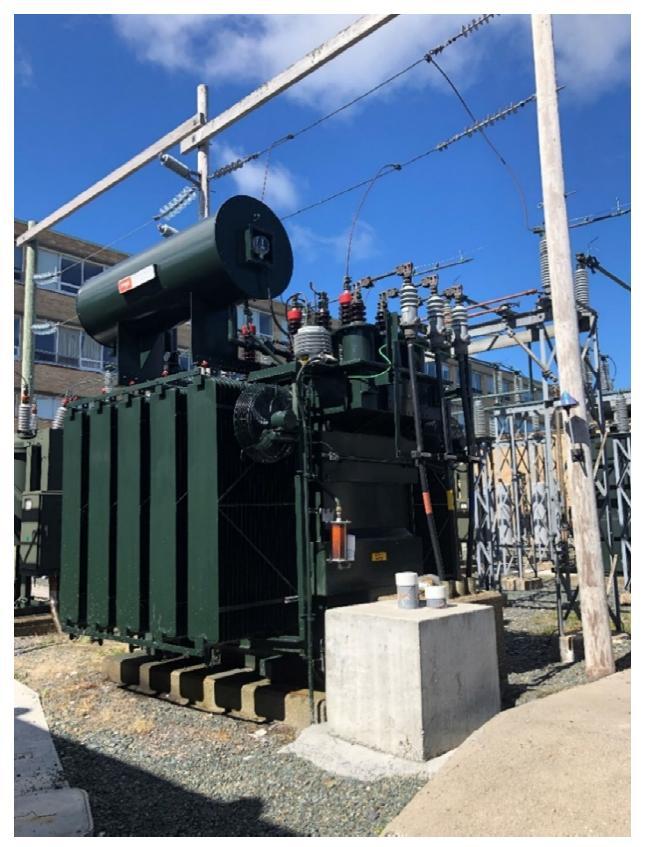
Figure 2: MUN-T2 Power Transformer

In August 2022, Newfoundland Power was notified by the University that MUN-T2 was producing a high noise level during operation and was experiencing a higher than normal internal temperature. The unit was removed from service to permit an internal inspection. An independent assessment of the inspection results determined that the abnormal noise and temperature levels were likely caused by deterioration of the core lamination to lamination insulation. This is a rare condition that exposes MUN-T2 to a high probability of failure. Newfoundland Power has not previously experienced this failure mode. There is no standard industry practice to monitor core deterioration.

Figure 2 shows MUN-T2.

Based on the identified costs and benefits, replacing MUN-T2 with a new unit is the recommended alternative.

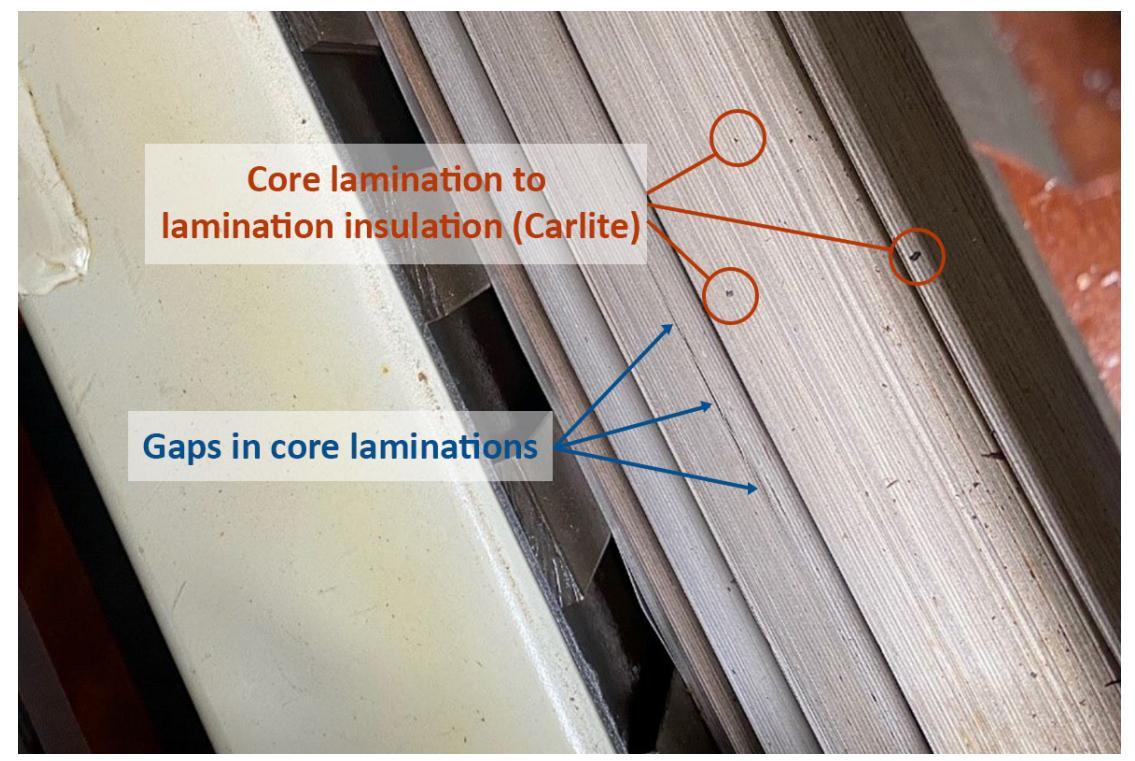
Figure 3: Debris and Gaps Observed in Core Lamination of MUN-T2

Following the oil analysis, an internal inspection of MUN-T2 was completed to further assess the cause of the abnormal noise and temperature levels. The inspection identified particles in the oil and slight gaps in the core, as shown in Figures 3 and 4.

The particles were determined to be non-metallic, indicating the high noise level and temperature were likely caused by deterioration of the core lamination to lamination insulation. An independent assessment was performed by van Kooy Transformer Consulting Services Inc. (the "Consultant" or "van Kooy").<sup>7</sup> The Consultant confirmed the operational issues being experienced by MUN-T2 are due to deterioration of the core lamination to lamination insulation.

van Kooy confirmed there is currently no standard industry practice used for monitoring core deterioration. A deteriorating core is a rare condition that cannot be monitored while the transformer is still in service. van Kooy has only observed one other instance of this failure mode in its 35-year experience. While there is no industry data to predict with precision the timing of the eventual failure of MUN-T2, industry experience suggests the insulation material between transformer core laminations will continue to break down without the ability to monitor the rate of deterioration.

A further decrease of insulation material will likely lead to additional core vibration. Increased vibrations can cause shifting in the transformer windings, resulting in an internal fault. The severity of this type of fault ranges from a fault between windings tripping the transformer protection to a severe failure that damages other components.

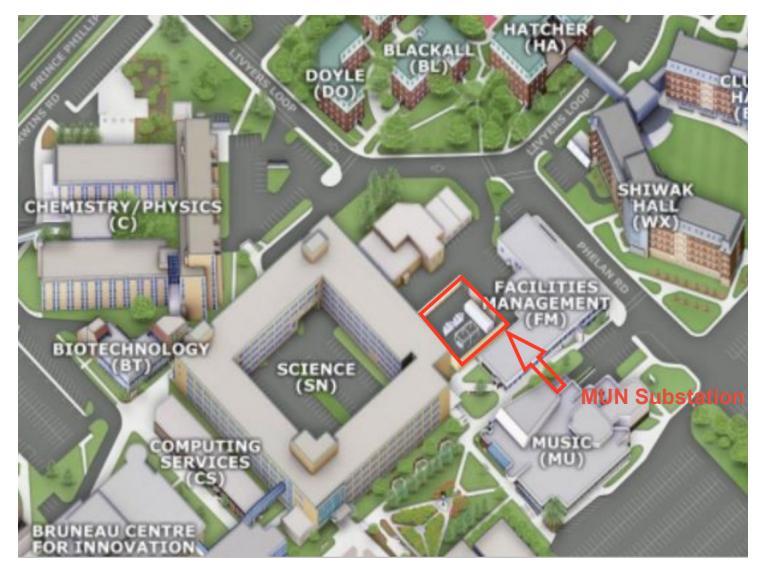
Figure 5: The University Campus Faculty Buildings

MUN Substation is relatively unique in that it is located in close proximity to the University's Science Building and Facilities Management Building, as shown in Figure 5.

This area is frequented by students and staff of the University. A failure of MUN-T2 could result in damage to substation equipment, customer infrastructure and public property.

Based on its condition and location, and uncertainties associated with the identified failure mode, Newfoundland Power has determined that MUN-T2 cannot be returned to service without exposing the University to additional risks of damage and an unacceptable safety risk.

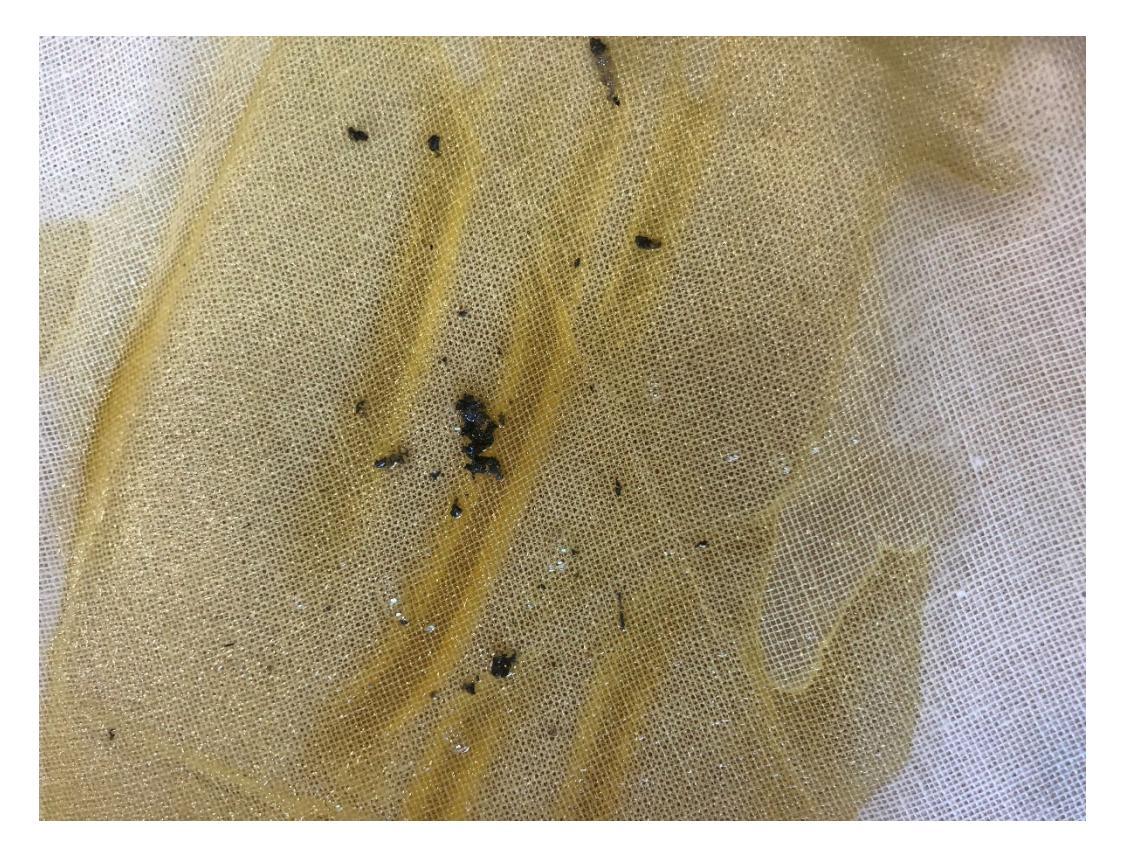
Oil samples taken at the time show various sized particles which is unusual. Some of these particles were filtered out, see picture below.

This led to a de-energization and investigation. Part of this investigation including draining part of the oil and performing an internal inspect from a manhole access on the top of the transformer cover.

During this inspection, more particles were noted on the top of the laminated steel core along with slight gaps in the core sections and indications of core heating.
