1 **Q. Reference: “2022/2023 General Rate Application,” Newfoundland Power, May 27,**  
2 **2021, Volume 2, Section 3.**

3  
4 **Please provide any reports and the data and data analysis prepared on the future of**  
5 **Newfoundland Power’s existing gas turbine facilities.**

## Purchase Mobile Generation

**Appendix A:  
Mobile Gas Turbine  
Condition Assessment**

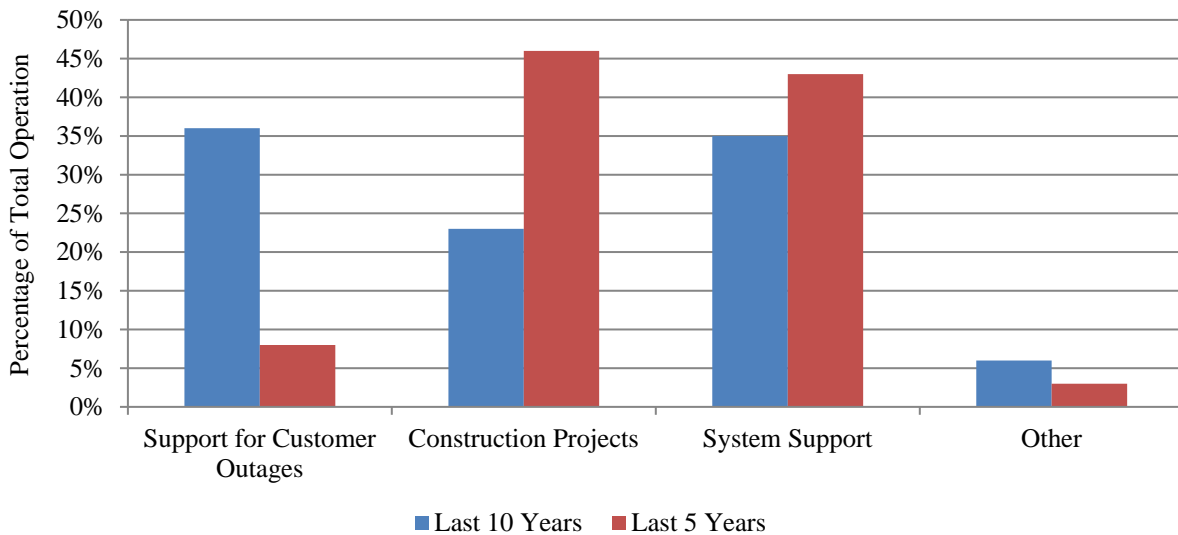
**Figure 1: Historical Operation of MGT by Function**

A review of the past 10 years of operation indicates that the average annual generation for the MGT is 488 MWh at an average load of 3.51 MW. The past 5 years of operation had an average annual generation of 639 MWh at an average load of 3.96 MW. A summary of the historic operation of the MGT over the 10 and 5-year periods is shown in Figure 1.

The use of the MGT for system support has increased in the last 5 years. This can be attributed to it being located on the Avalon Peninsula during this period, and the more frequent requests by Hydro for generation support related to the Avalon Peninsula reserve requirements. The use of the MGT to support customer outages has been less in the last 5 years than it was during the past 10 years. This is related to the timing of storms that caused damage to the Company’s transmission and distribution systems.<sup>6</sup>

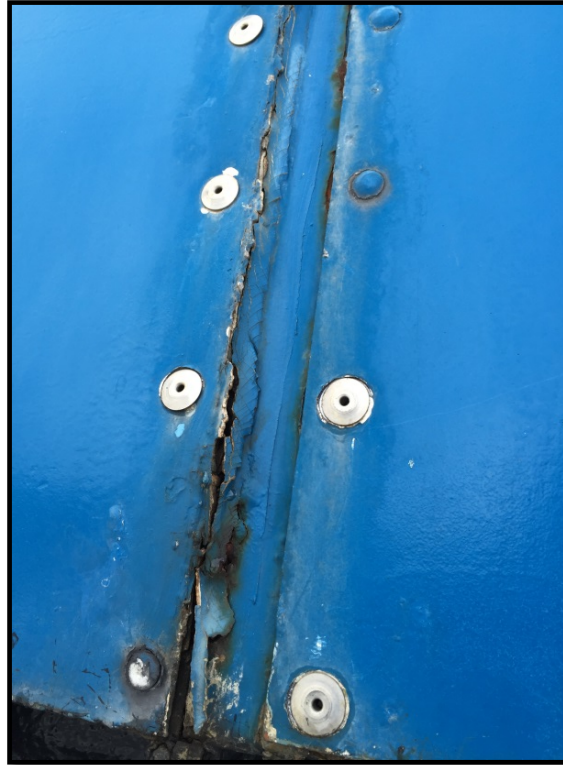
**Picture 13: Enclosure – Old Repair**

The enclosures on the trailers that house the equipment are in very poor condition. There is some damage to the enclosure envelope, allowing water to leak into the enclosures, which could jeopardize the equipment inside. Where possible, leaks are repaired, but often reoccur once the unit is moved. The doors and sills are in particularly poor condition.

Given the current condition of the rolling components, the MGT should be retired from mobile service over the next 3 years.

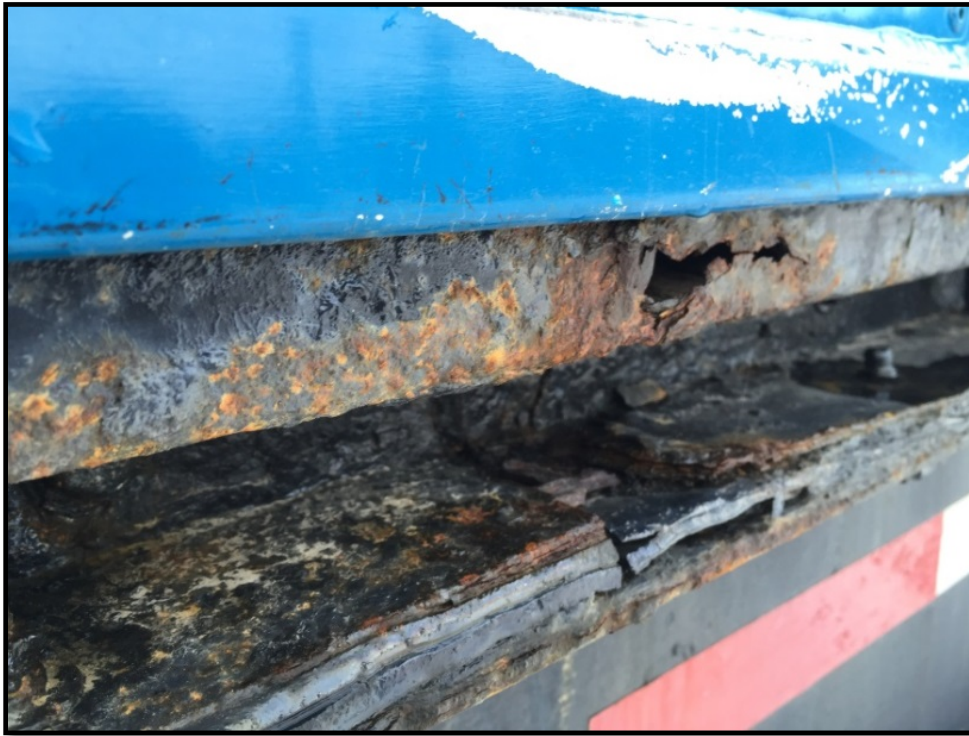
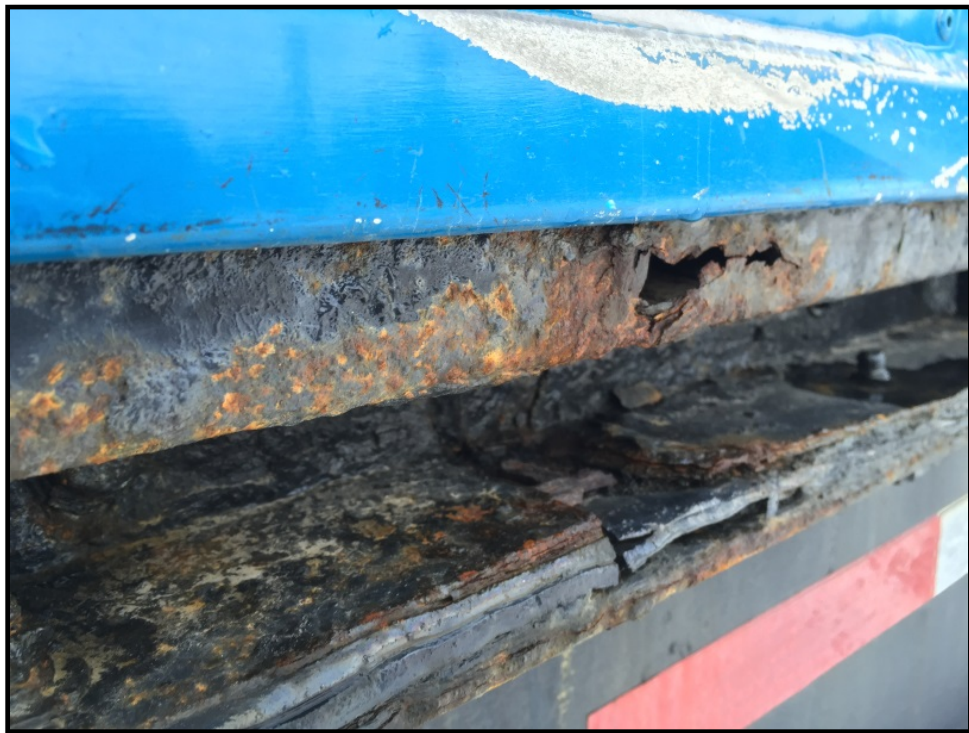
**Picture 17: Chassis**

The gas turbine components are mounted on 2 trailers originally manufactured by Bartlett Trailer Corporation. The undercarriage structures have experienced heavy corrosion. The undercarriage was assessed by Hatch in 2010. As a result of the assessment, the cross members were replaced and undercoating repaired. Also in 2010, the trailer suspension, wheels and brakes of both trailers were inspected and repairs were made where necessary.

The repairs done are considered a short-term measure to keep the unit operational. Recent inspections indicated that the chassis still appears to be in reasonable condition, but the undercoating is starting to deteriorate again and, as a result, the underlying steel components are exposed to the elements and corrosion is prevalent throughout.<sup>4</sup>

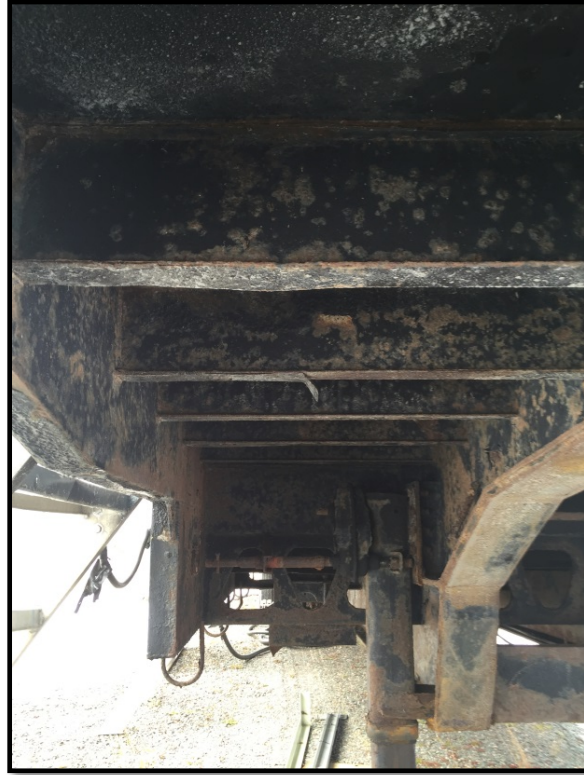
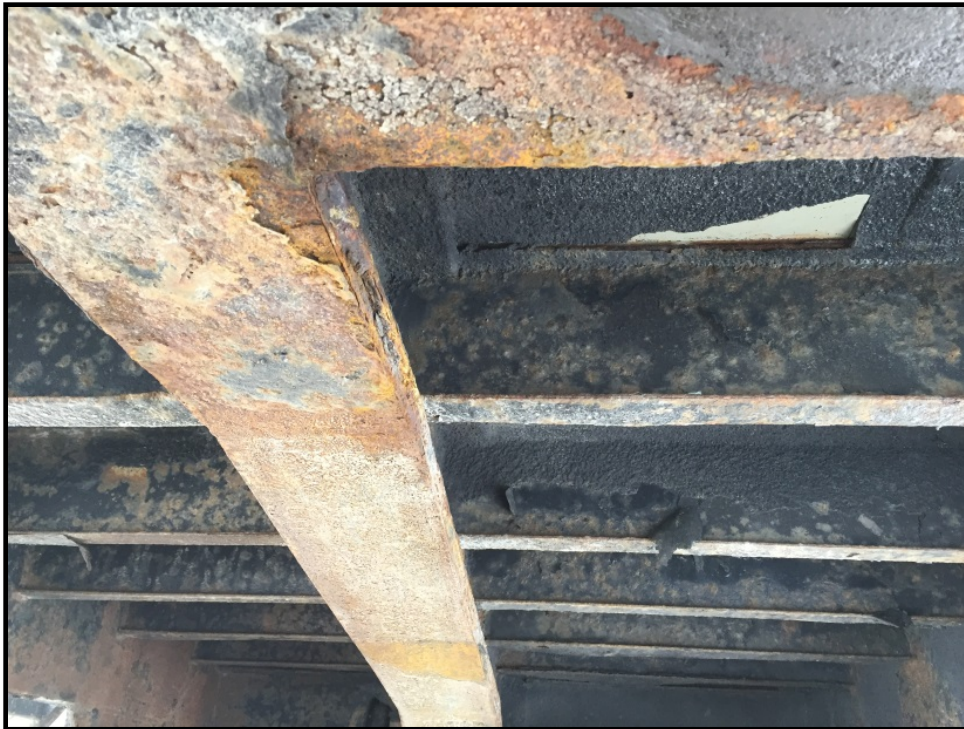
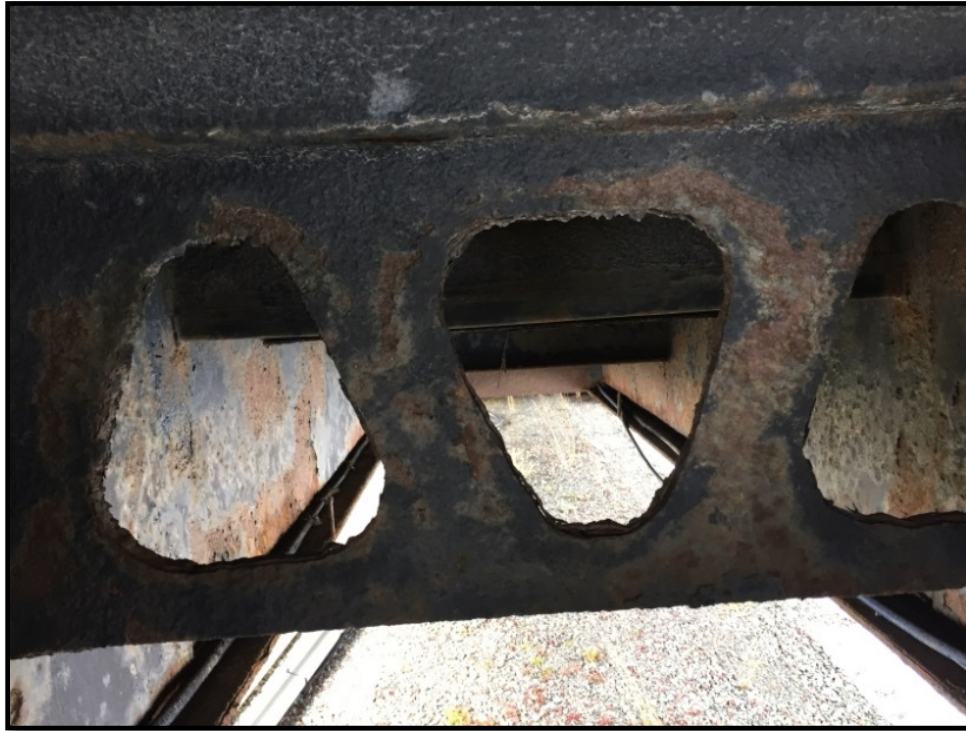
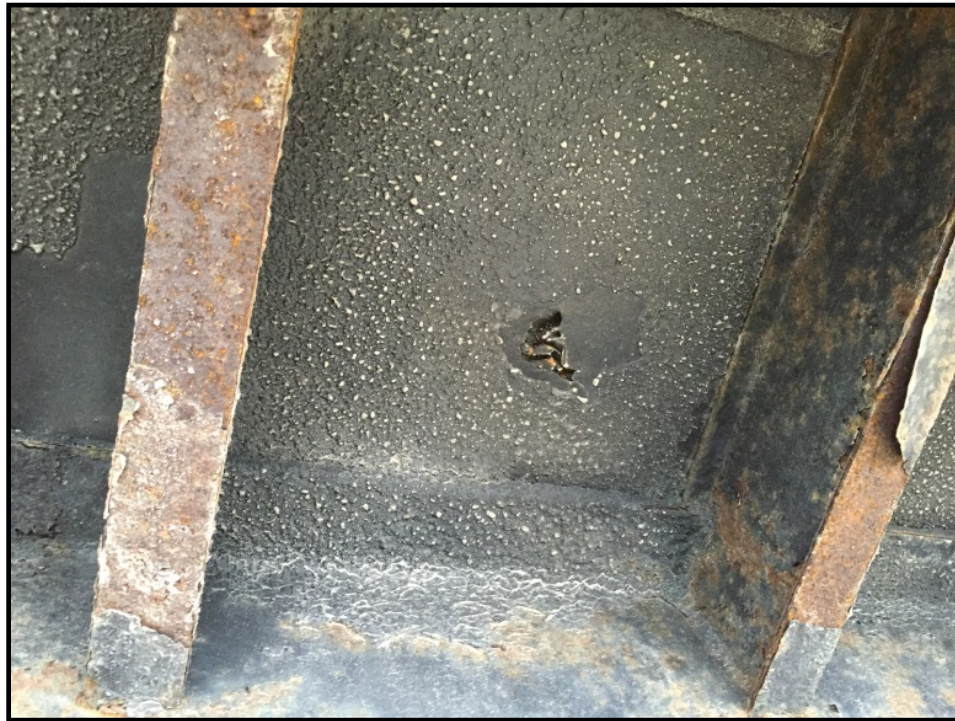
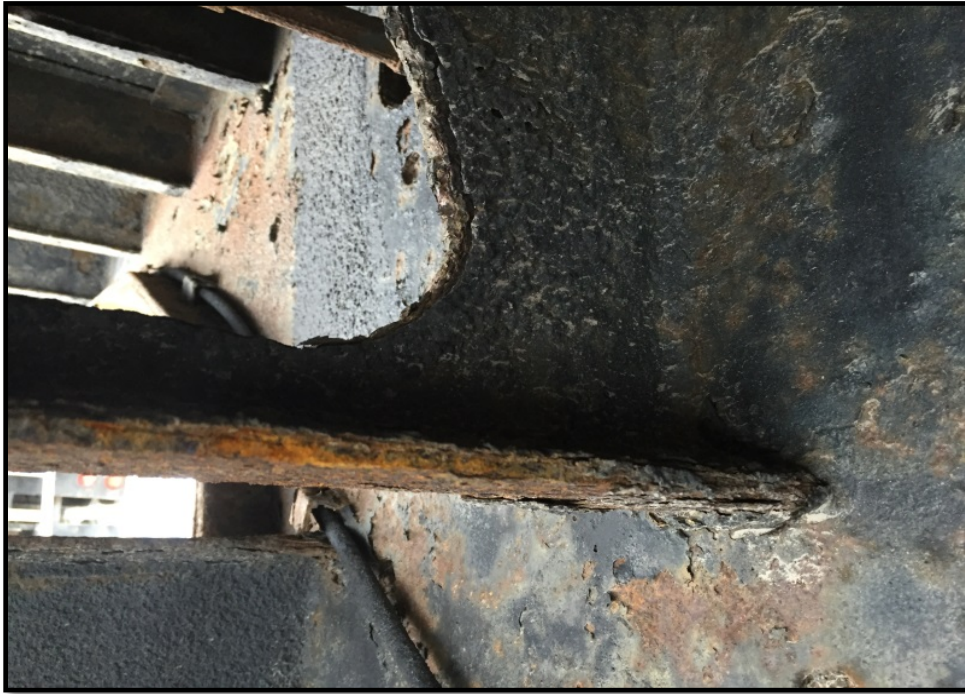
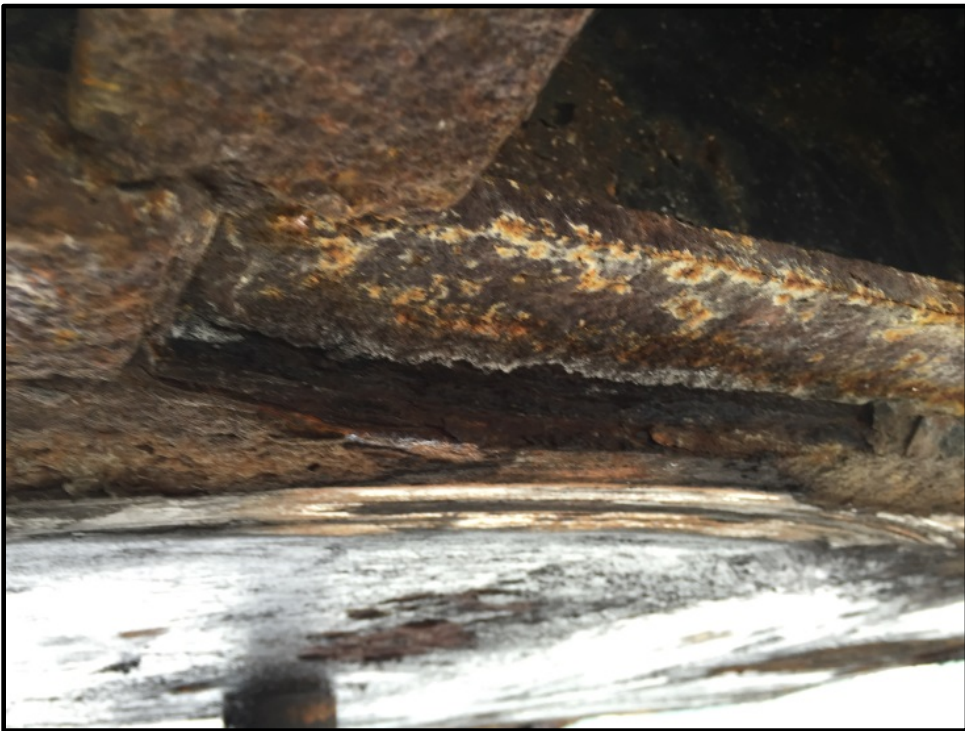
**Picture 20: Undercarriage**

The trailers that house the gas turbine components are deteriorating. The undercarriage is susceptible to heavy corrosion with major repairs done in 2010. In late 2016, extensive chassis and axle repairs to the two trailers were again necessary to make the MGT roadworthy. The undercarriage continues to deteriorate. The enclosures are also in very poor condition with water leaks into the trailers occurring.<sup>8</sup>

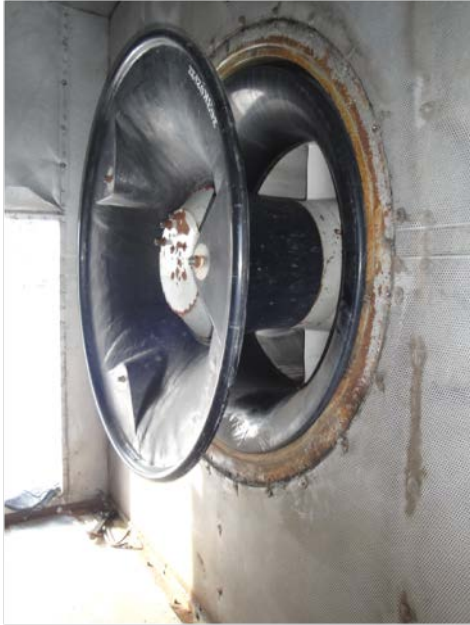
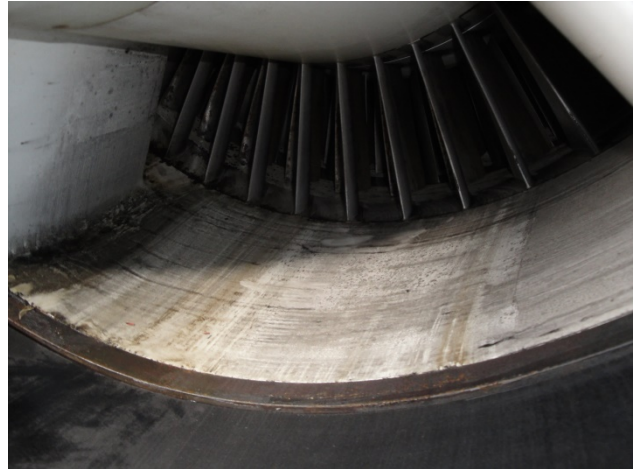
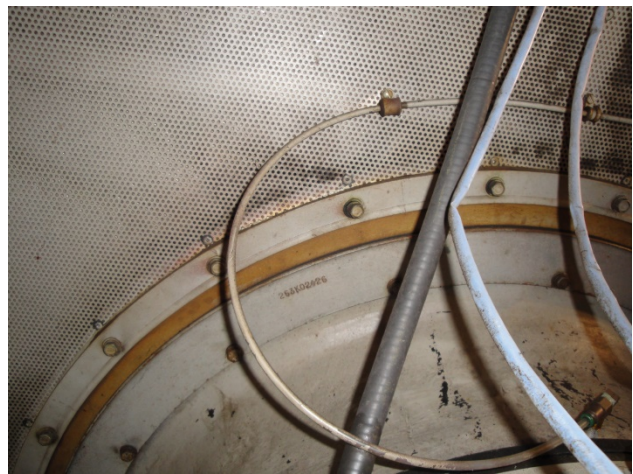
Upon arrival the generator skid appeared not to be plumb. The trailer was sloping rear to front with a noticeable wave in the support of the port side of the skid.

- Intake screen was removed to inspect Bellmouth and Compressor forward.
  - Silencer cabinet corroded with perforations.
  - Stage 1 and 2 blading and stators were slightly corroded with no evidence of impact damage.
  - Verified Stage 1 and Stage 2 blades were free to move.
  - Bellmouth touching rear intake wall at bottom.
  - Witness marking on engine side of engine / intake seal indicating engine had moved downward relative rear intake wall.

1. Generator skid supports to be leveled with a quality sight level any time the generator is relocated and verify level seasonally.
2. Once generator skid has been verified level. Check alignment of all components of the generator in particular engine to PT. Ensure alignment is within manufacturer's specification.
3. Ensure there is no contact or binding such as observed at the bell mouth to intake silencer rear wall.

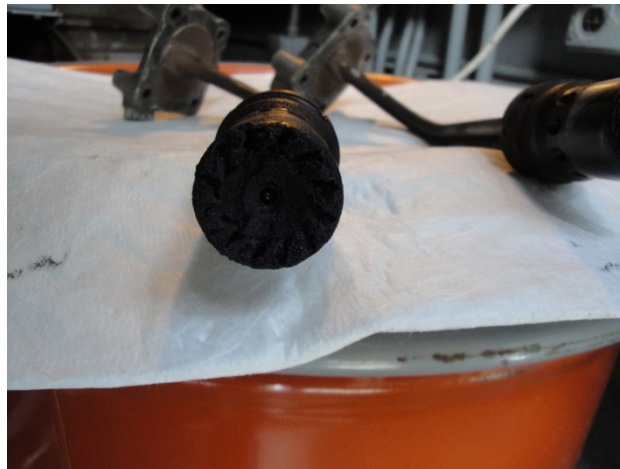
- Fuel Nozzles were numbered and removed to allow bore scope inspection of combustors and turbine nozzles.
  - Nozzle swirler tips were sooted. John Budgell opted to change out with spare set.

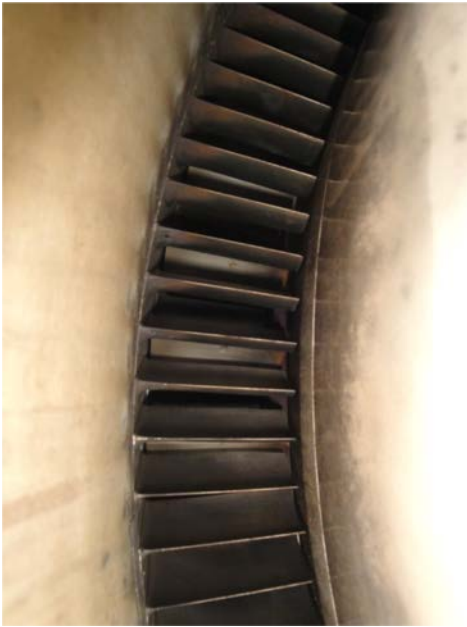
- Removed Combustor #5 to better inspect compressor OGV and stage 10 compressor blading.
  - Found slight impact damage approximately mid blade on the trailing edge of 2 consecutive stage 10 compressor blades.

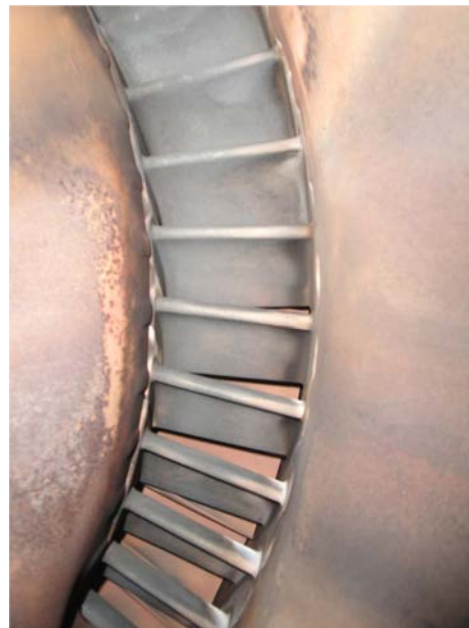
- Combustor liner, turbine nozzles and blading appear in serviceable condition.

- Completed Bore scope inspection of remaining combustors.
  - All combustor liners, turbine nozzles appear in serviceable condition.

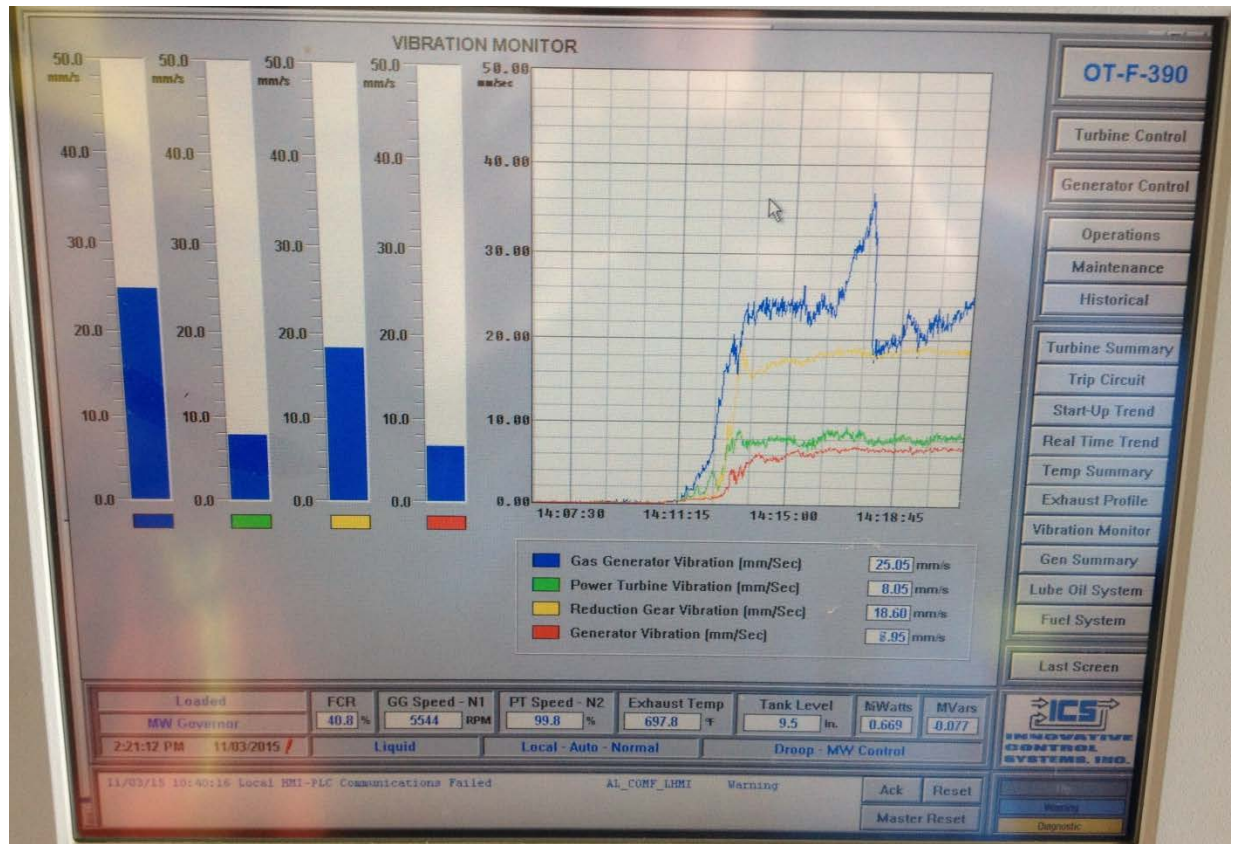
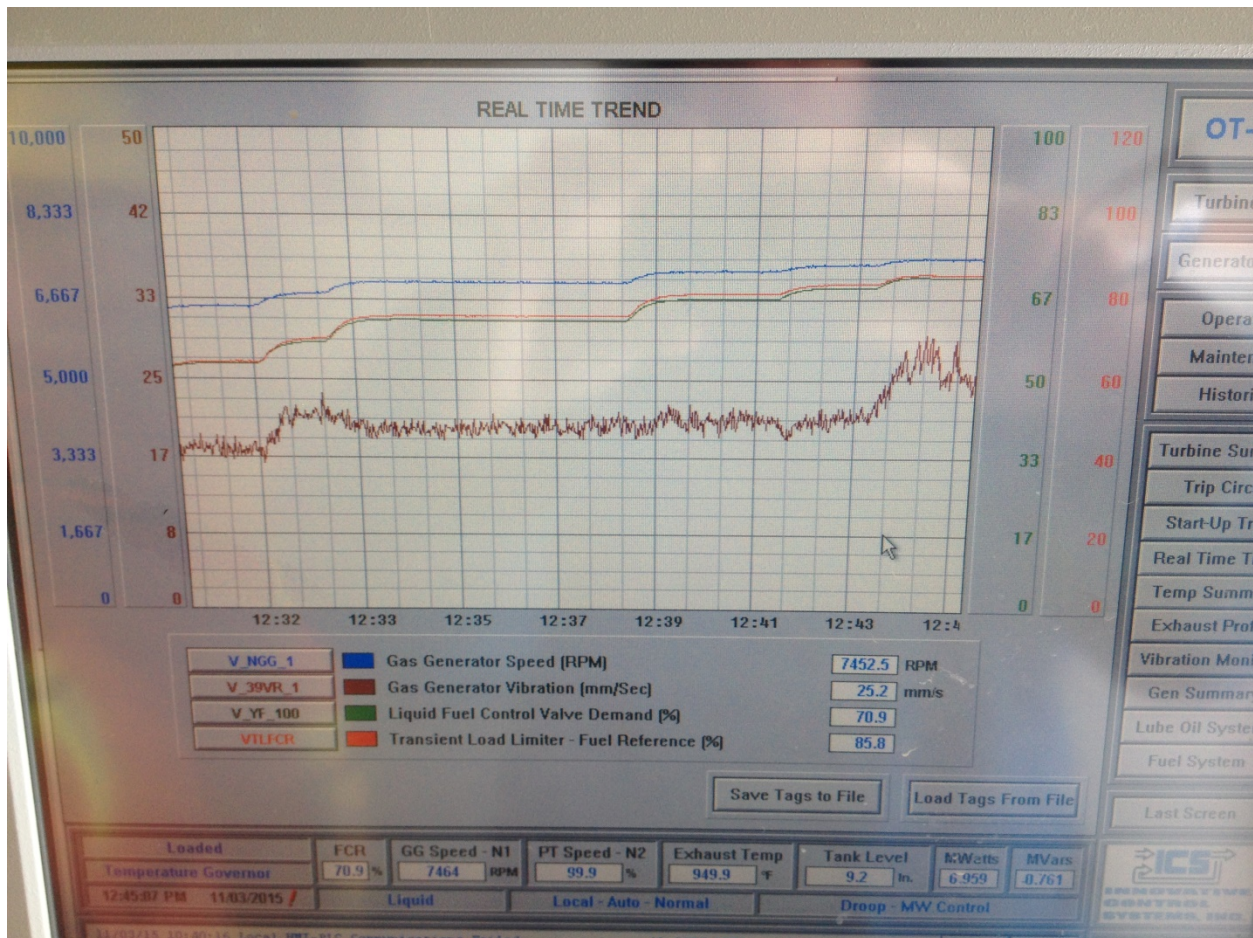
- Replaced Inlet screen, oil lines and magnetic plug, #5 combustor and fuel nozzles. Secured, lock wired and checked all disturbed hardware. Vacuumed debris from intake.
- Used a 4' bubble level to survey the installation of the generator trailer. Found the forward supports slightly off level from side to side. Lowered port forward support more than 1/8" and then lowered both the port and starboard forward supports 1/4".
- Cold rolled unit on starter to verify oil pressure, listen for rubs and bearing noise.
- Started unit and checked again for oil and fuel leaks. Physically felt unit to verify smooth operation at all 3 bearing sumps.
- When loading the engine overall vibration levels increased to 30 mm/s Pk-Pk or alarm levels at approximately 0.8 MW rising to 36.5 mm/s Pk-Pk 0.9 MW or 5400 RPM Gas generator speed.

- In an effort to raise over all vibration levels to near shut down level for analysis we increased the load on the generator. Above 0.9 MW vibration fell to approximately 17 mm/s Pk-Pk.
- Increased load to EGT limit of the engine.
  - Used Pruftechnik portable analyser to verify vibration monitoring equipment and take FFT spectrum at all 3 engine bearing supports.
  - On the mount next to the engine vibration probe the Pruftechnik analyser indicated.  
Gas Generator 7440 RPM  
1X Peak @ 19.8 mm/s Pk-Pk  
Overall @ 22.7 mm/s Pk-Pk

We were unable to duplicate the shutdown conditions on loading at this time. However the vibration spectrum information gathered previously by John Budgell indicating a large 2X component of the overall vibration reading leads to S&S Turbines Services LTD. to recommend the following.

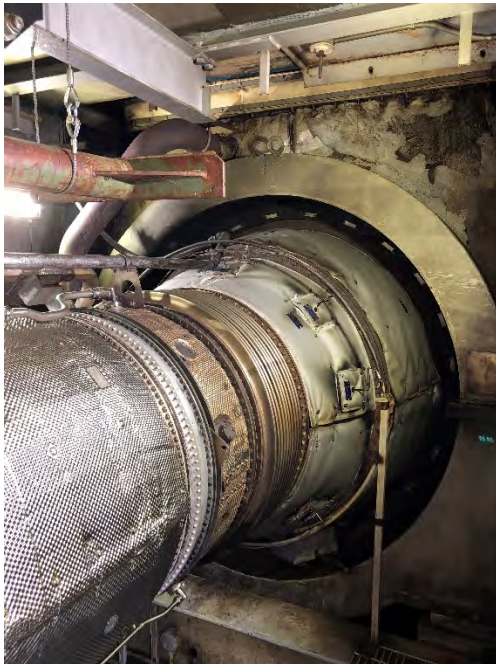
### A.1.3 Greenhill Power Turbine

The Curtis-Wright power turbine (PT) has had known casing cracking problems identified by the OEM in 1984 as a critical service issue. To limit the crack propagation the unit had been de-rated from 25 MW to 20 MW, to limit the exhaust gas temperatures as per recommendations from the OEM. In 1995, Newfoundland Power installed a surplus original OEM casing and replaced the internal bolting/fastening components with new. The cracking is monitored on an annual basis.

Inspections in 2014 by Alba Power discovered a portion of the PT shrouding protruding into the gas path. Continued cracking of the casing and shrouds were noted and replacement of the casing was recommended. Fern Engineering previously had a modification available to address these cracking issues, however this modification has not been installed at Greenhill.

Picture and outline of PT.

In general, the PT should be considered for replacement for any continued operation.

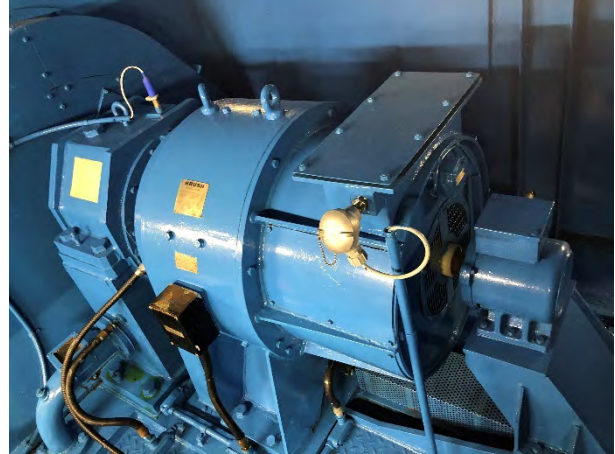
### A.1.5 Greenhill Generator

The Brush 31.8 MVA, type BDAX 70-76 generator is in relatively good shape with the exception of a potential rotor retaining ring cracking issue. The unit's AVR is old and outdated. An upgrade is required for on-going operation.

Brush Generator and exciter

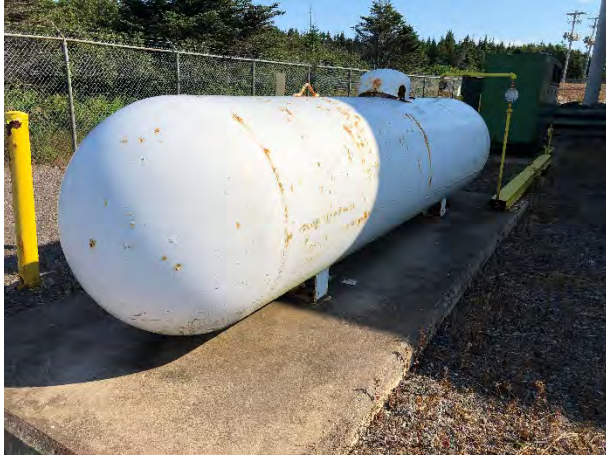
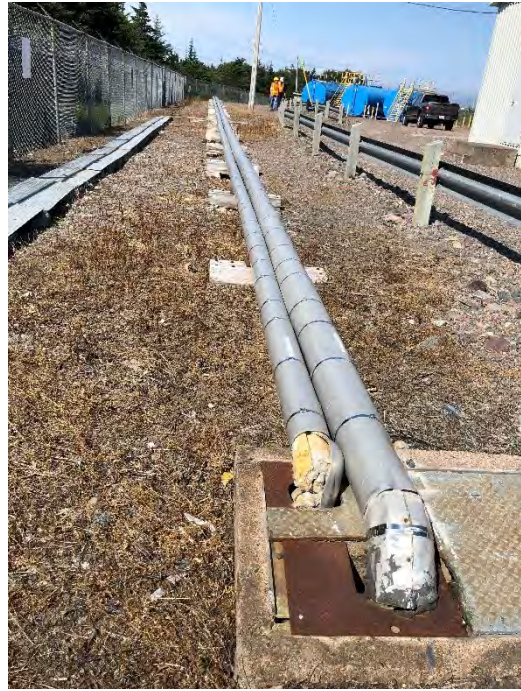
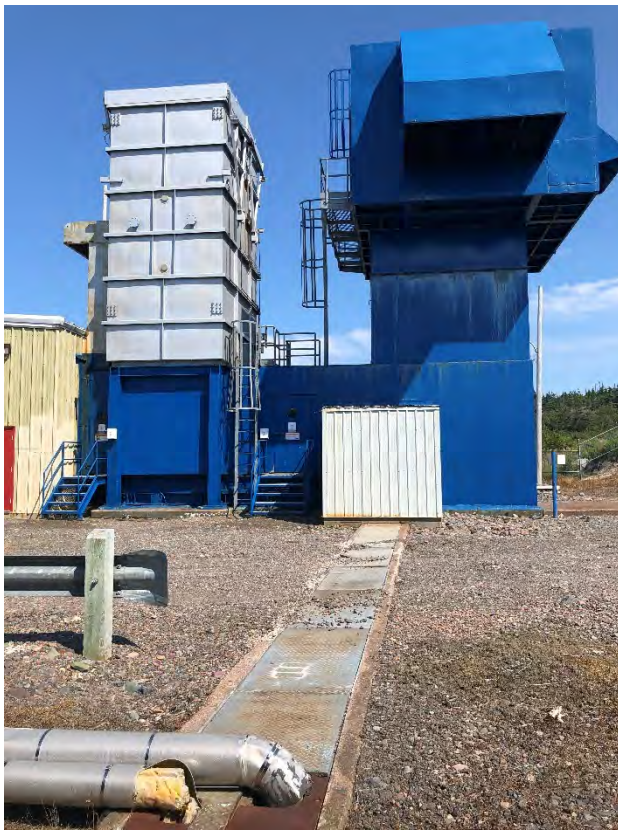
### A.1.6 Greenhill Fuel System

The storage tanks are showing signs of rust deterioration. There is noticeable rusting on the top of the two older tanks.

There are 2 older storage tanks, installed in 2002 with each having a capacity of 90,000 litres. These tanks need to be inspected and coating replaced, for continued operation.

The following pictures show the bulk fuel storage tanks and propane tanks.
