**Re: Approval of Capital Expenditures Supplemental to Newfoundland Power Inc.'s  
(the "Company") 2017 Capital Budget Application – Rose Blanche Hydroelectric  
Plant**

6. Schedule C to this Application is a report titled *Rose Blanche Hydro Plant Turbine No.1 Refurbishment*, which details the results of the assessment of the damage to Turbine No. 1 and provides estimates of the expenditures necessary to return the turbine to service.

8. Schedule D to this Application is a report titled *Rose Blanche Hydro Plant Rockfall Remediation*, which provides a detailed assessment of the results of the rockfall and provides estimates of the expenditures necessary to return the Plant site to a safe condition.

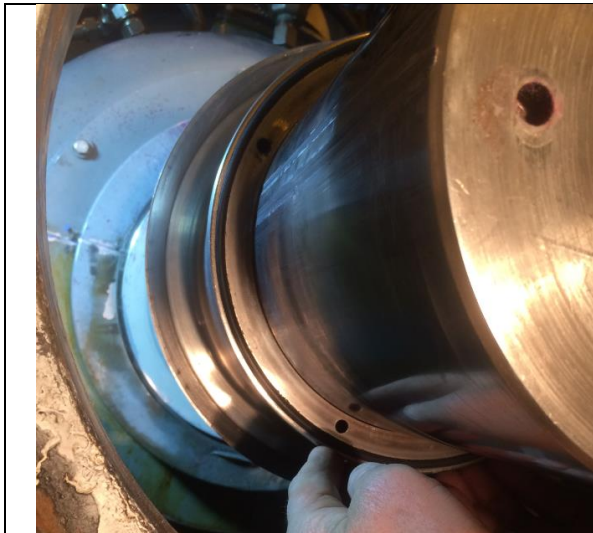
For validation purpose, the shaft bushing was installed in position. The wear area on the bushing matches the worn area on the shaft shoulder.

During the installation of the seal bushing

Seal bushing in position

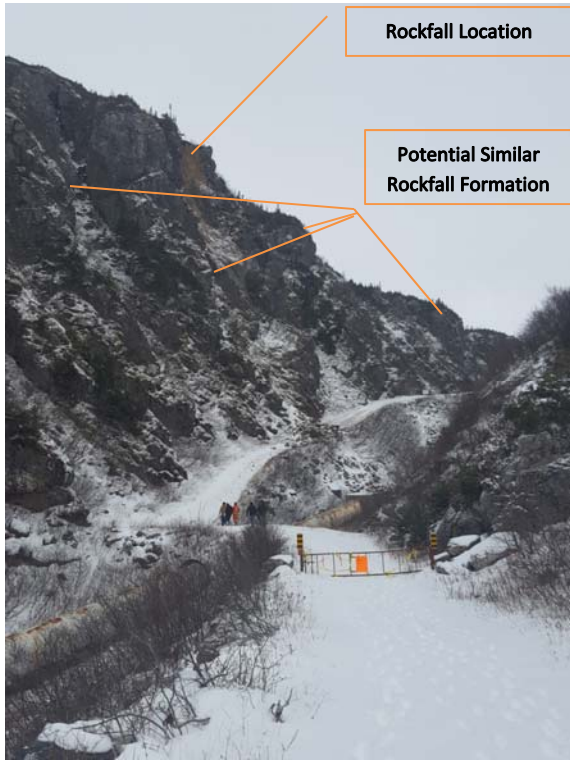
The landslide occurred below the Main Dam, on the right side (looking downstream) of the valley, and closed the access road to the dam (Photo #1-5, Appendix B). The land slide is technically described as a rockfall, which was likely very rapid. A rock block, approximate insitu dimensions of 6-8 metres wide, by 8-10 metres high and 3-5 metres deep, failed on a joint surface that dipped at about 70 degrees. The volume is estimated at between 500 and 1,000 tonne, with a talus rubble pile of stones varying in size from under one tonne to over five tonne, at a visual average of about one tonne (Photo #5, Appendix B).

**Photo 1** – View of the Rockfall Zone looking North.

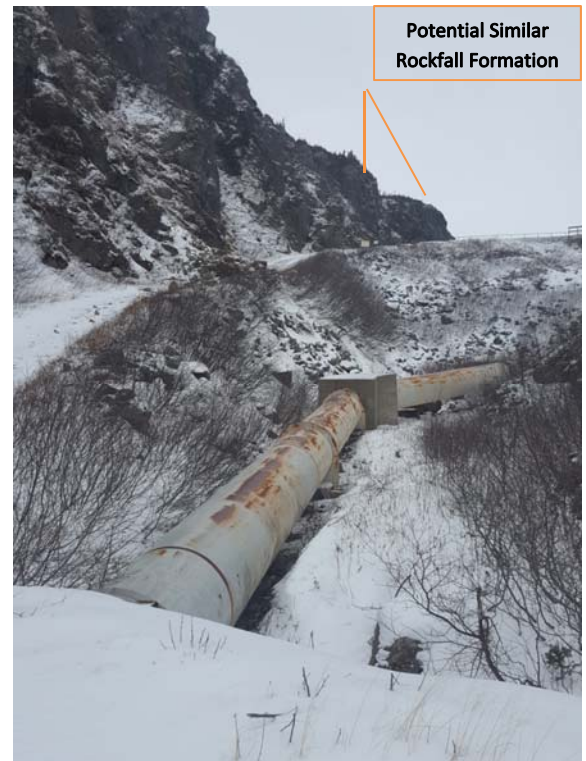
**Photo 2** – Rockfall area from the culvert crossing.

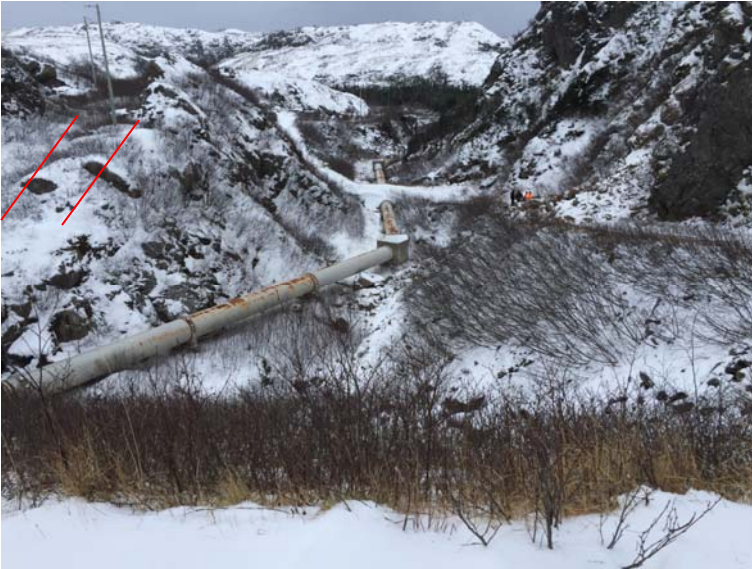
**Photo 3** – Rockfall area looking south from the top of dam.

Relocating the access road to the left abutment will likely require retaining structures to support the road and prevent the constructed fill from encroaching on the penstock. An abandoned construction access road at the left side is identified in Photo #3, Appendix B. The old access road could be reinstated but access is limited and will likely require controlled blasting or retained fill solutions to complete. Access will be challenging and construction difficult. Newfoundland Power will need to engage specialist engineers and contractors for design and construction to improve opportunities for success.

Red lines show potential area of alternate access road. Work will require relocation of the power poles, as well as drilling and blasting. It is likely a retaining wall will be required to support the new road.

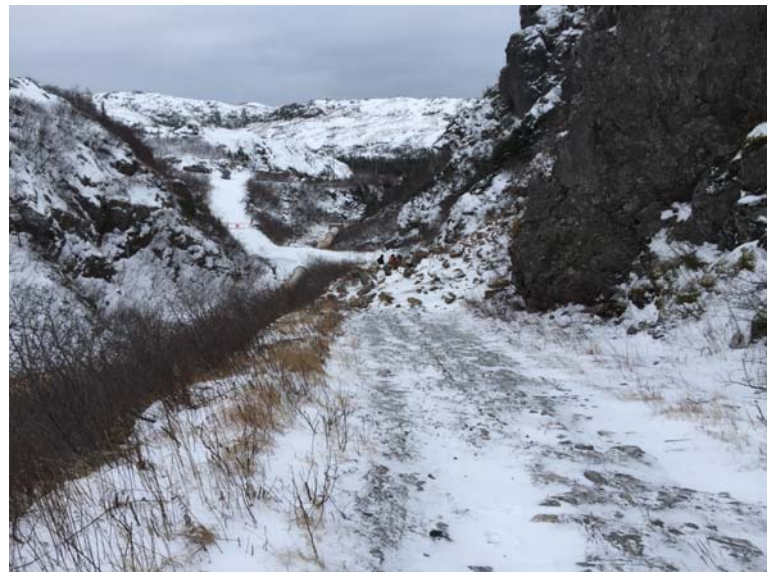
**Photo 4** – Access road blocked by debris field.

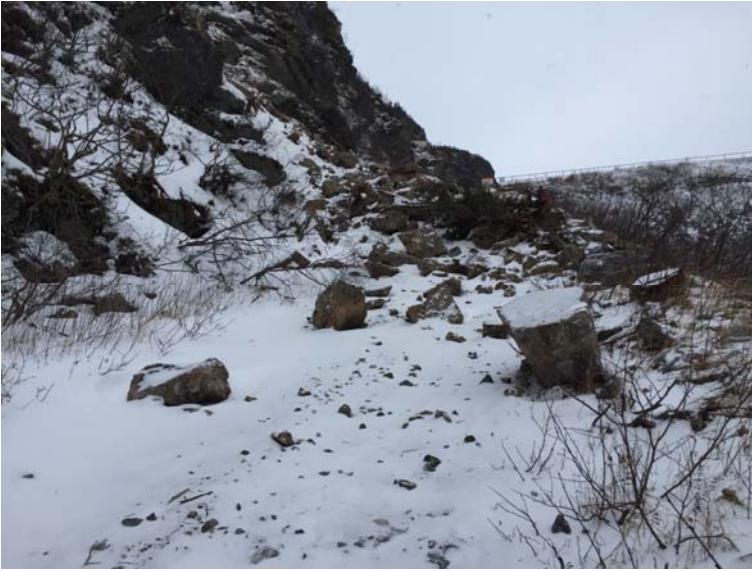
**Photo 5** – Debris field on access road looking towards dam.

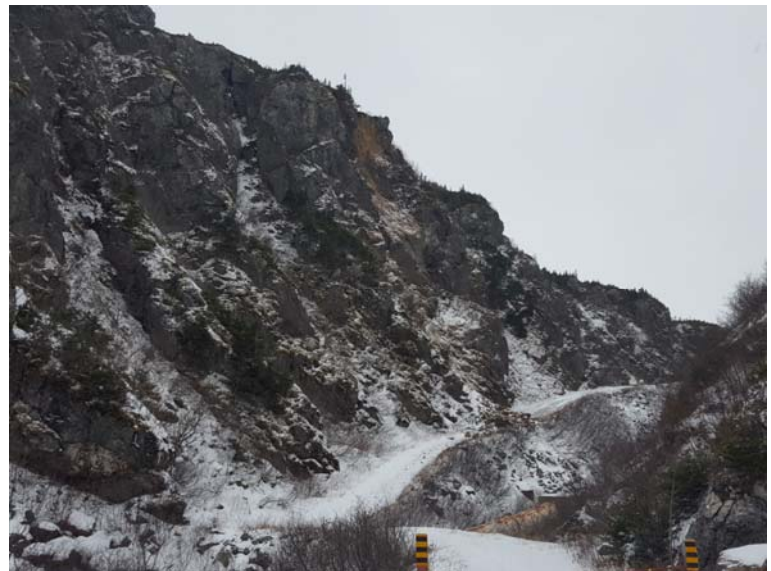
**Photo 6** – Scarp on rock slope of fall area.

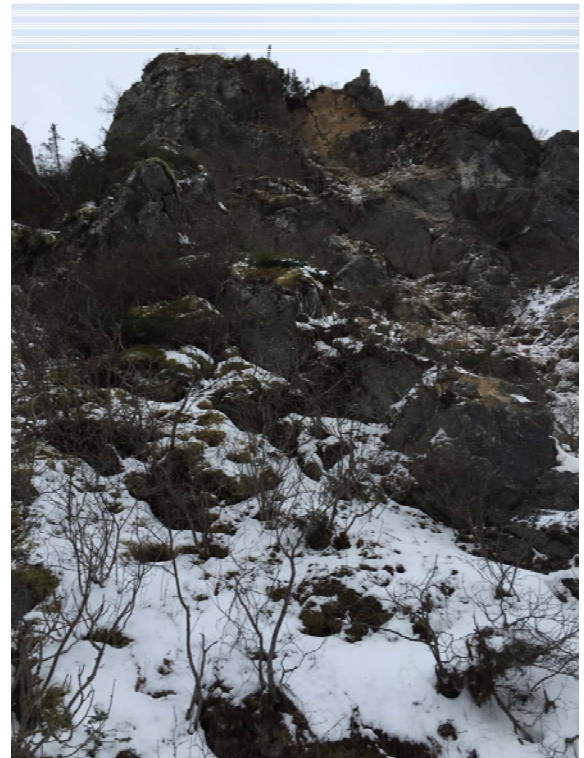
**Photo 8** – Rock slope geology.

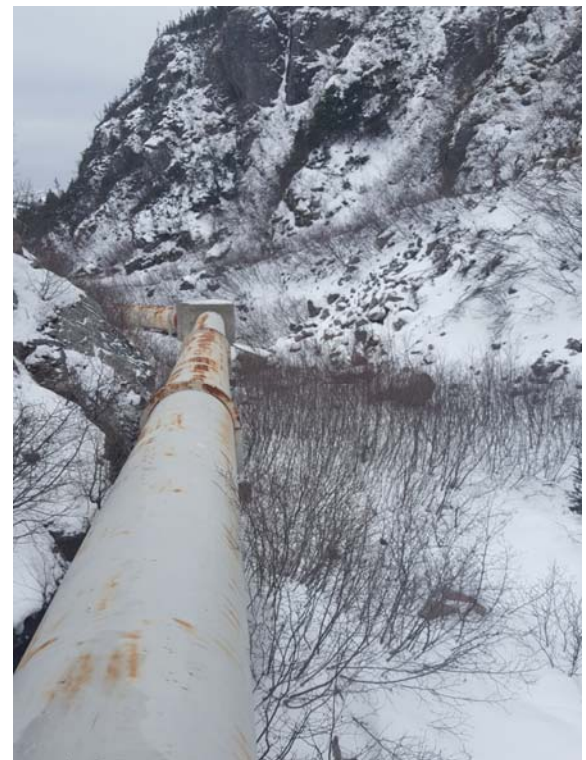
**Photo 10** – Debris Field below the access road.

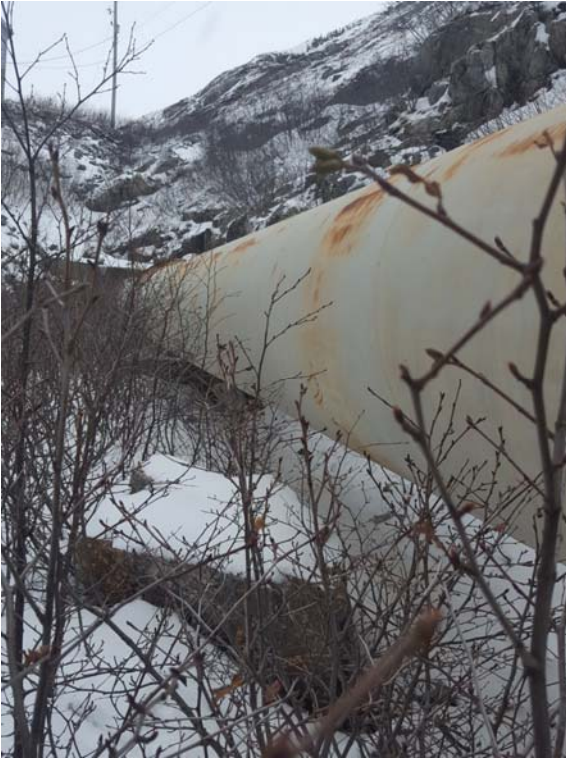
**Photo 13** – Impact Area 1, approximate 2 tonne rock at base of penstock.
