Distribution Rebuild Update

June 2012

Byron Chubbs, P.Eng.

4.4 *Rebuild Distribution Lines Update*

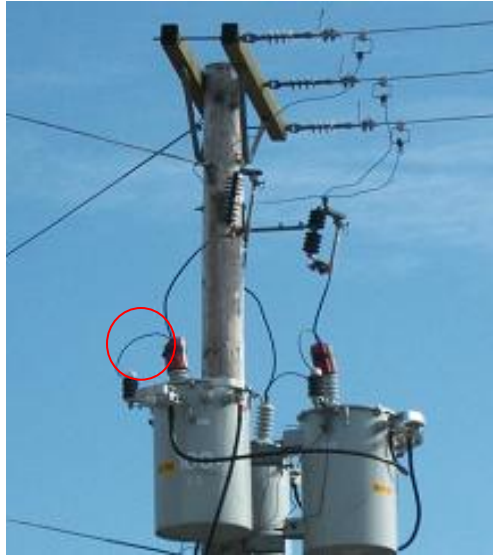
Figure 5: Lightning Arrestors In Service

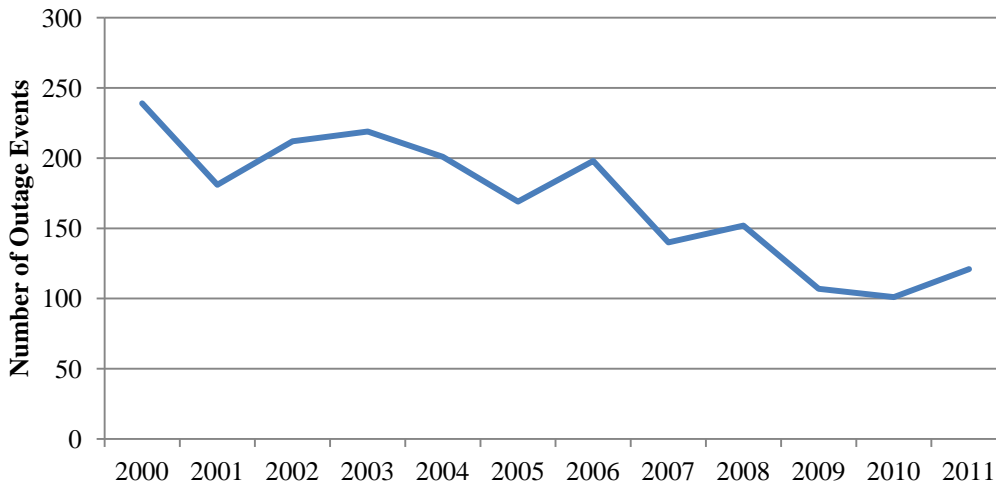
**Graph 1
 Outages Caused by Insulator Failure**

As shown in Graph 1 below, since 2000 the number of outages resulting from insulator failures has reduced to nearly half as a result of removing CP8080 and 2-Piece insulators from service as part of the *Rebuild Distribution Lines* project.¹⁵ This has resulted in a positive impact on reliability.

¹⁵ In 2000 there were 239 outages resulting from insulator failures while in 2011 the number of outages related to insulator failure had reduced to 121, or 50.6% ($121/239 = 0.506$)

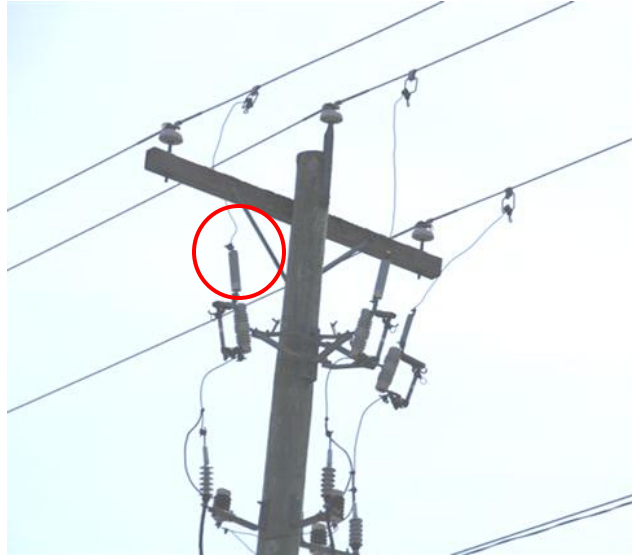
Pole top distribution transformers are generally a very reliable component of the distribution system. However, they do eventually fail.¹⁶ On rare occasions, transformer failures can lead to a buildup of pressure inside the tank, resulting in tank ruptures, oil spillage, or other *eventful* conditions. The probability of an eventful failure increases in locations with higher available fault current.

Figure 8: Current Limiting Fuses In Service

To reduce the probability of eventual transformer failures, the Company uses Current Limiting Fuses (“CLFs”) to limit the available current when a fault occurs.¹⁷ The Company installs CLFs in the following locations:

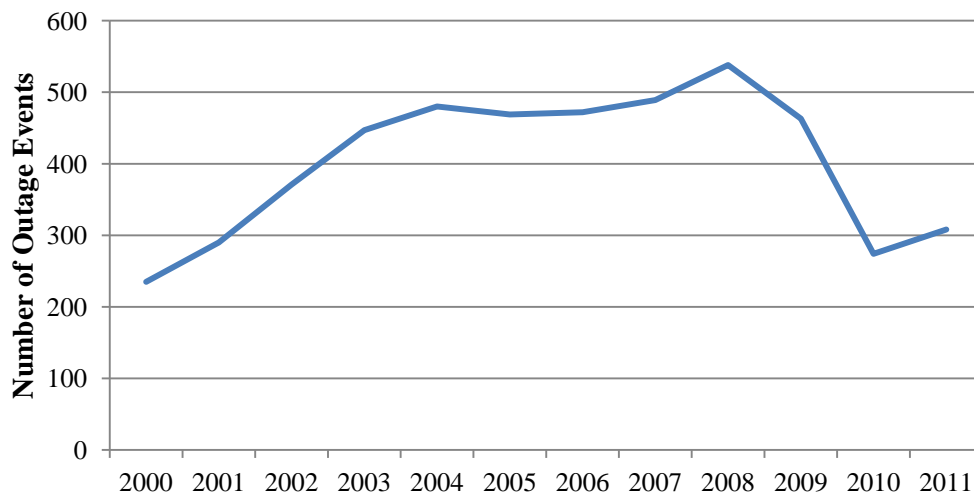
Graph 2
Outages Caused by Cutout Failure

Porcelain cutout failures continued to increase after 2003, and since that time, the Company has expanded the replacement program to all porcelain cutouts on the main trunk of distribution feeders, as well as lateral taps and large customers.

As shown in Graph 2 above, the number of outages resulting from cutout failures steadily increased up until 2008, but declined in recent years as a result of removing porcelain

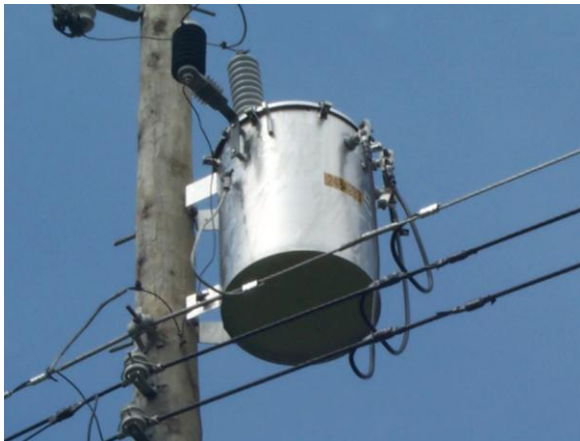
The Company began purchasing pole mounted transformers manufactured with 316L stainless steel in 2001. This was done as a result of numerous failures due to rusting transformer tanks, largely due to higher levels of salt contamination in Newfoundland. After several years of using the new stainless steel tank design, the issue of broken hanging brackets began to surface on 25 kVA and 50 kVA transformers.²⁶

Following discussions with the manufacturer it was determined that the hanging brackets were not sufficient for the mechanical forces exerted by higher wind conditions in the Newfoundland environment. To address this issue, the Company changed its specification for stainless steel transformers in 2007, requiring a hanging bracket made of a thicker gauge stainless steel.

Figure 13: Stainless Steel Pole Mounted Transformer
