Q. Re: Rocky Pond Plant Refurbishment (p. 2 of 81, Schedule B) - Provide for the last five years:

2005 Dam Safety Inspection Report

**Tors Cove /
Rocky Pond
Developments**

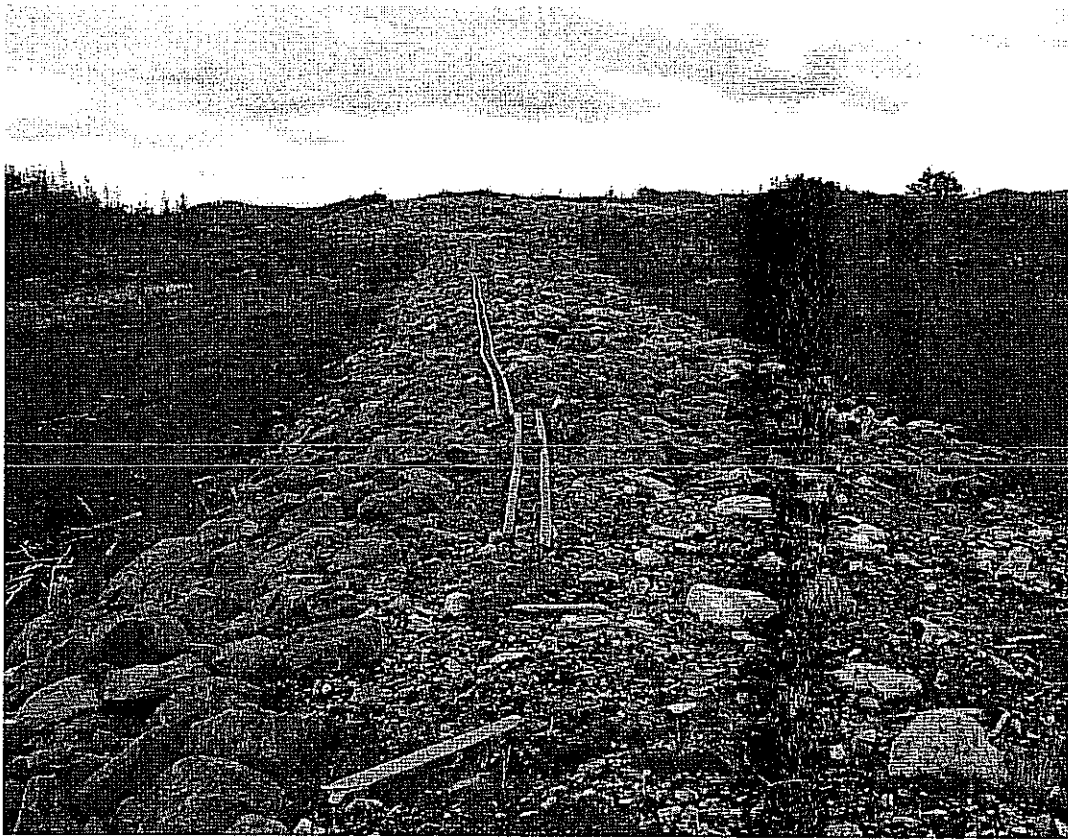
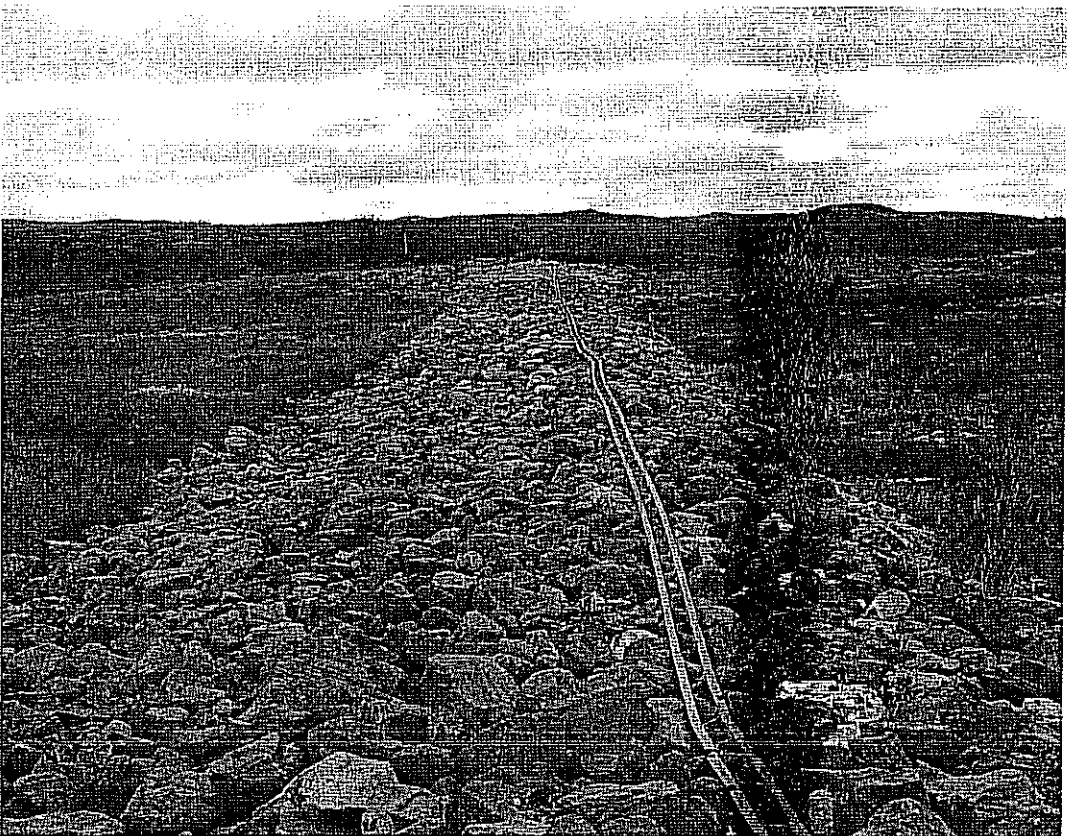
The structure rarely impounds water.

The dam acts as an emergency spillway.

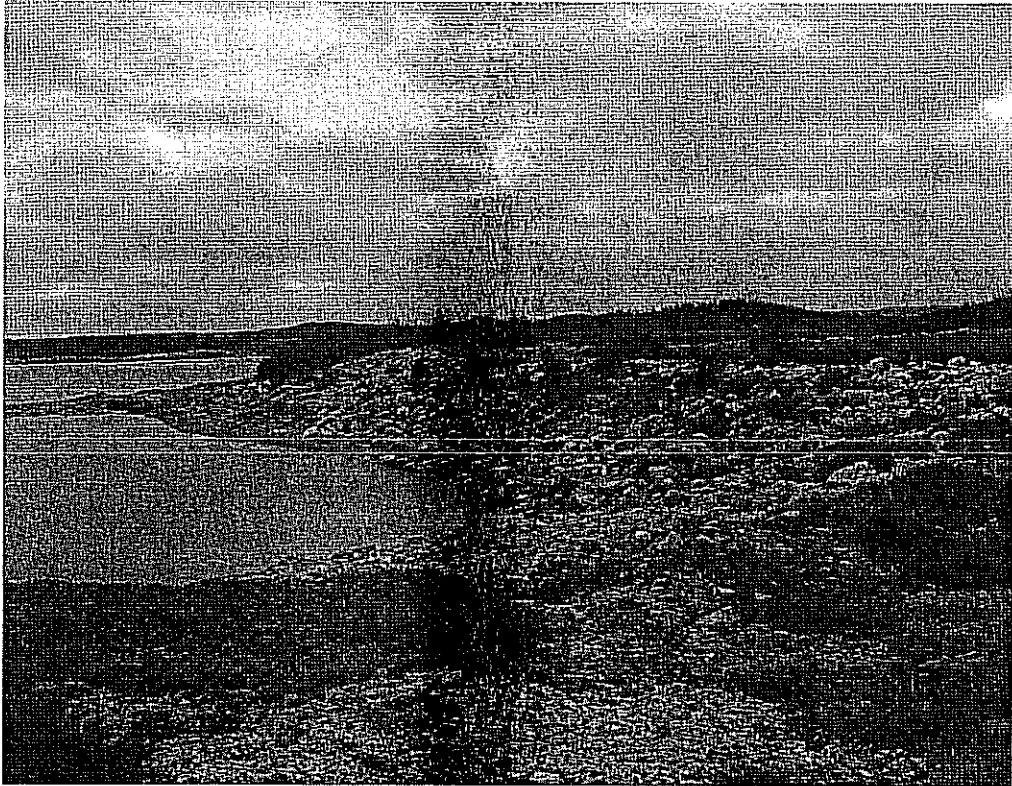
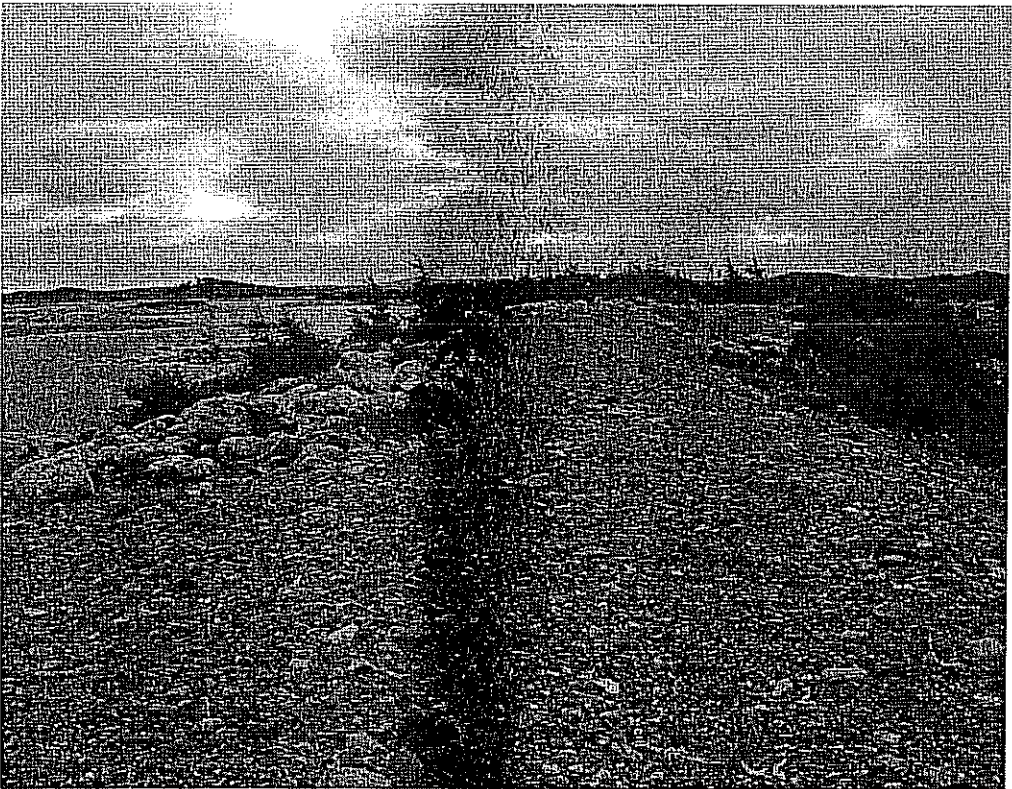
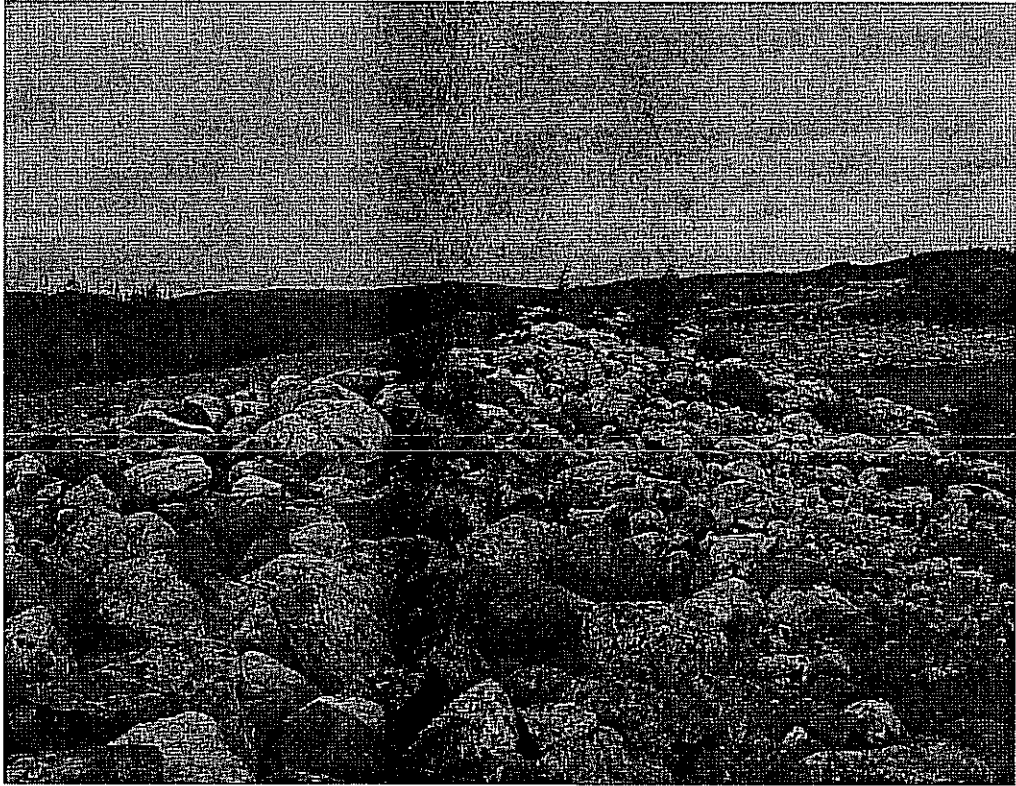
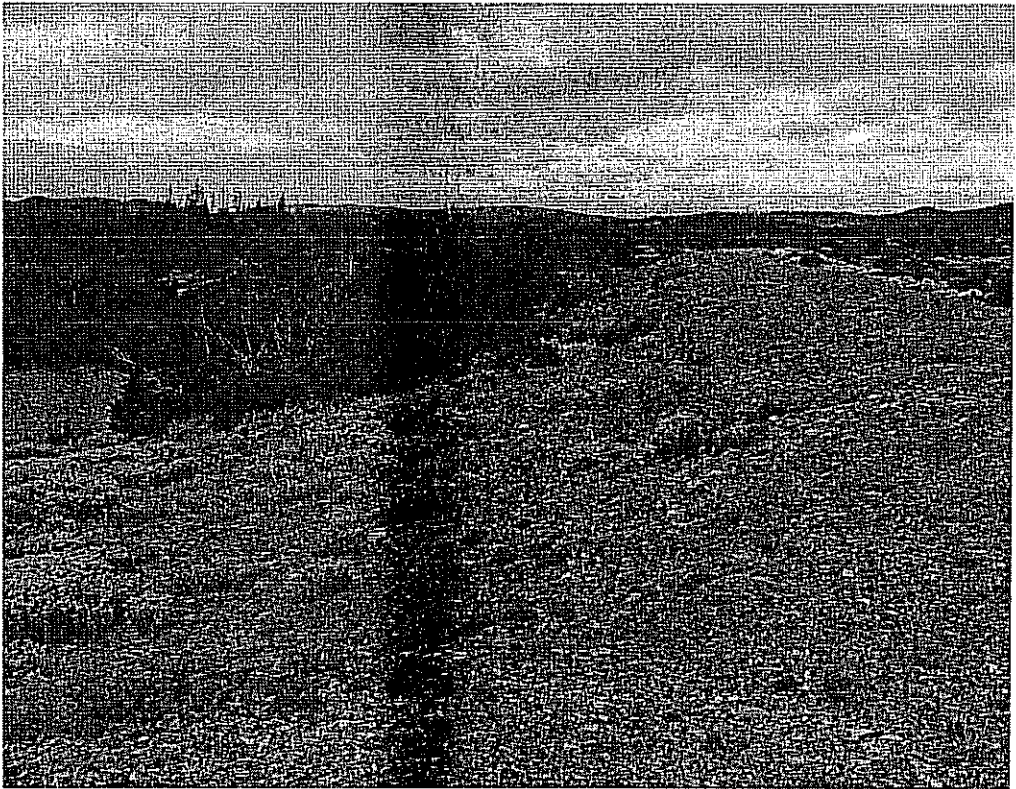
Crest is in good condition.

Some minor seepage observed (previously reported). No apparent loss of material or other concerns.

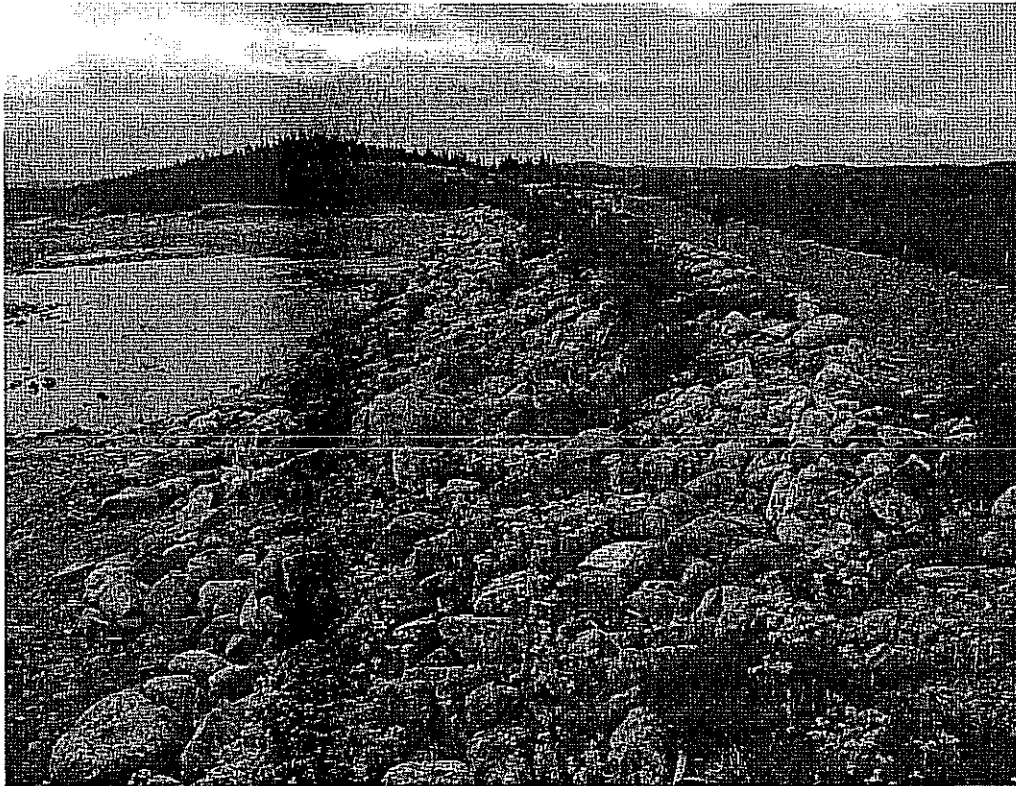
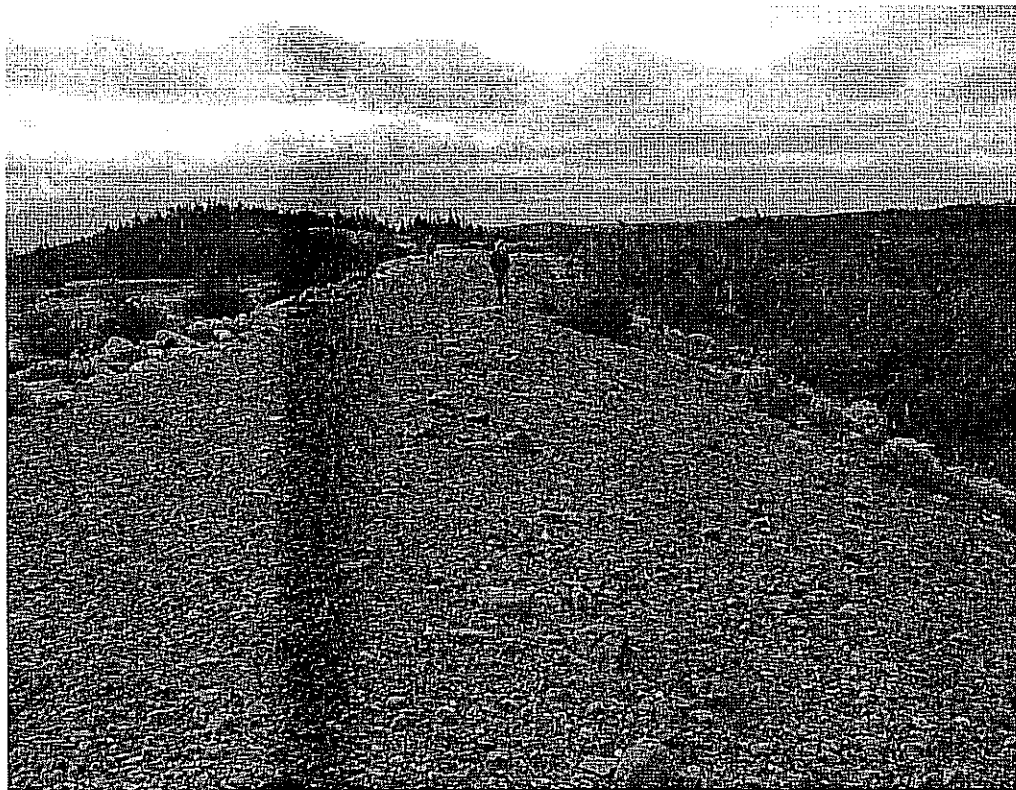
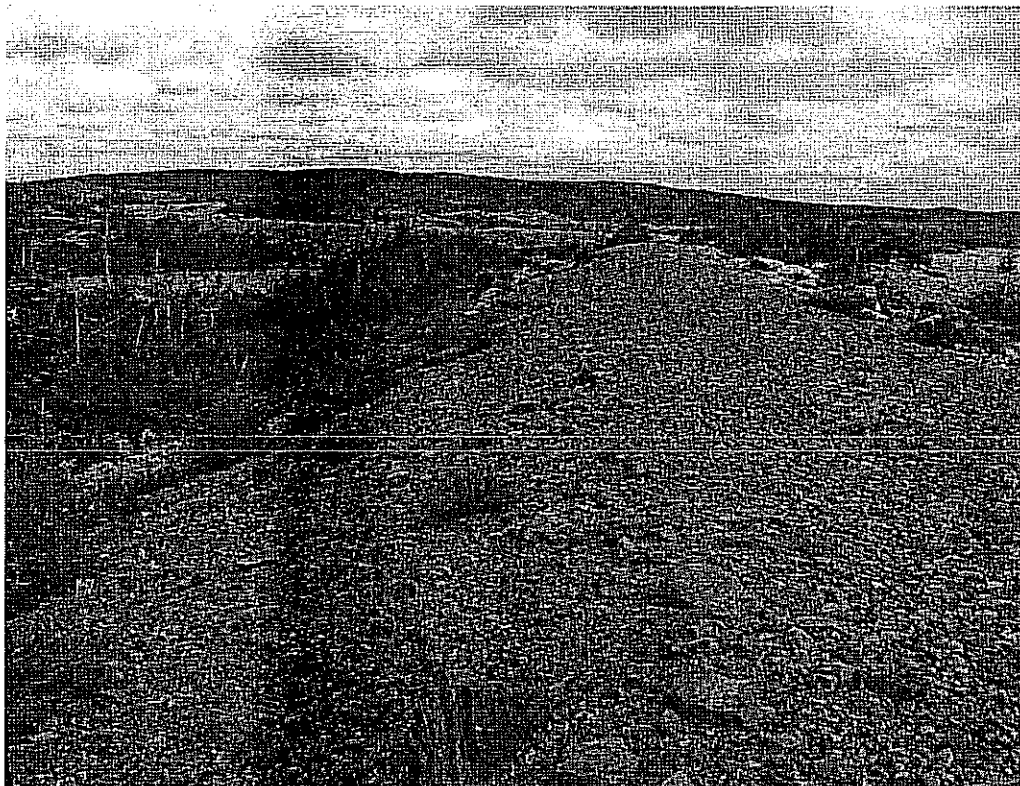
Structure :	Franks Pond Dam #4	Date/Time :	2007-10-02
Inspected by :	GH,JW,BT, BH	Water Level :	
Weather :	Sunny 14°C	Releases :

Downstream face in good condition – stable.

Abutments in good condition. Some vegetation present.

Crest in good condition.

No seepage observed.

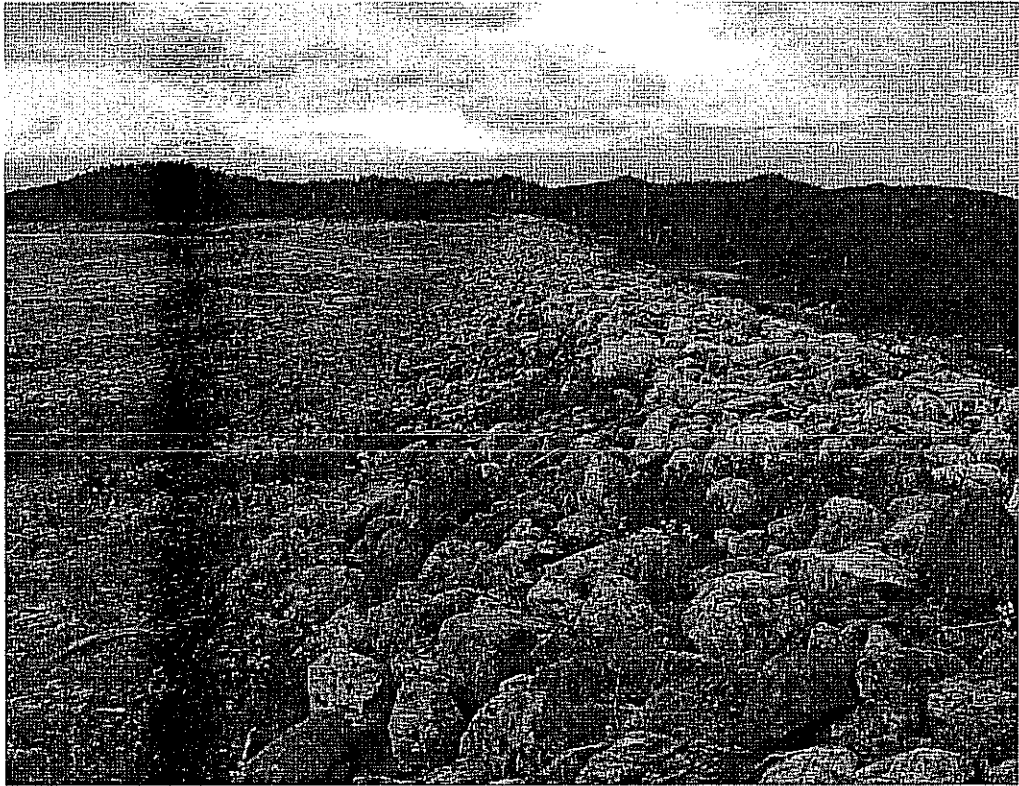
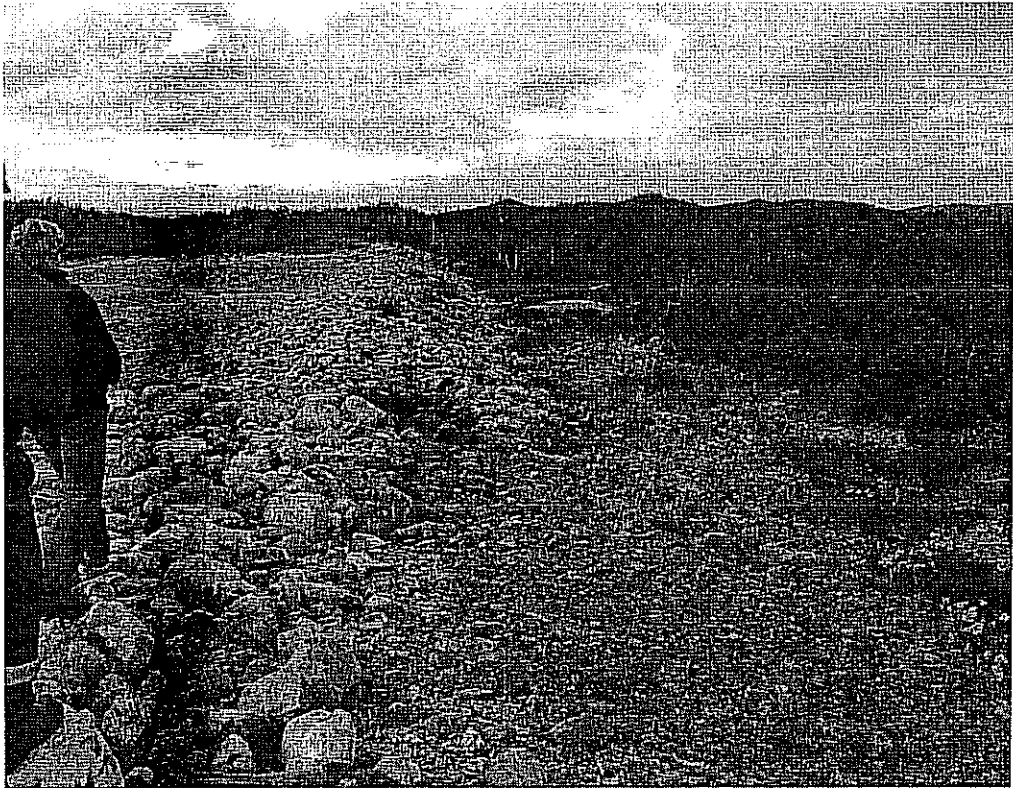
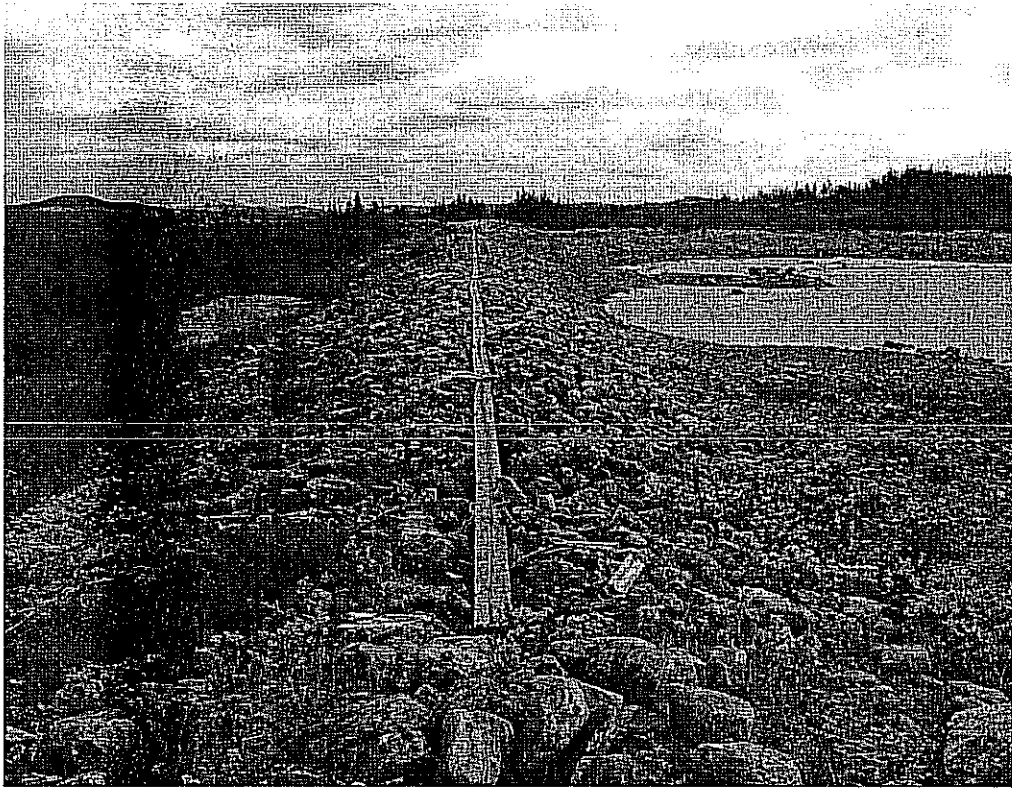
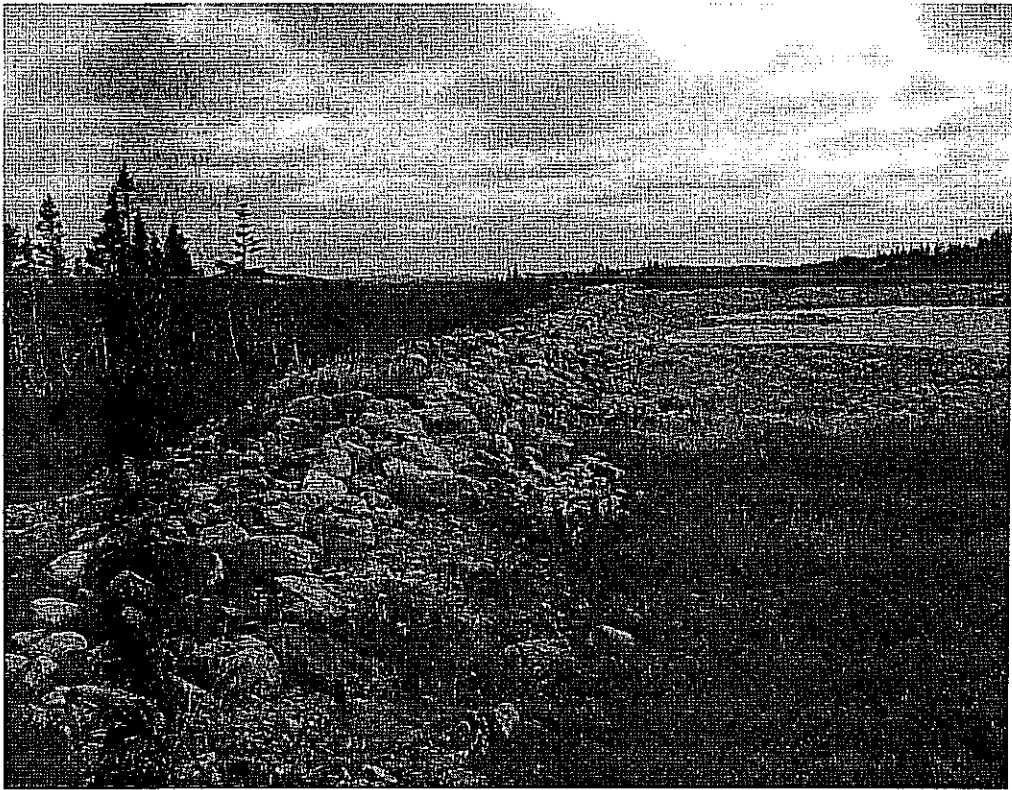
Structure :	Franks Pond Dam #5	Date/Time :	2007-10-02
Inspected by :	GH,JW,BT, BH	Water Level :	
Weather :	Sunny 14°C	Releases :

Upstream face in good condition. Good riprap slope.

Crest in good condition.

Small amount of leakage through steel cut-off wall. Ponding d/s toe near mid dam.

This structure is the primary spillway for Frank's Pond reservoir.

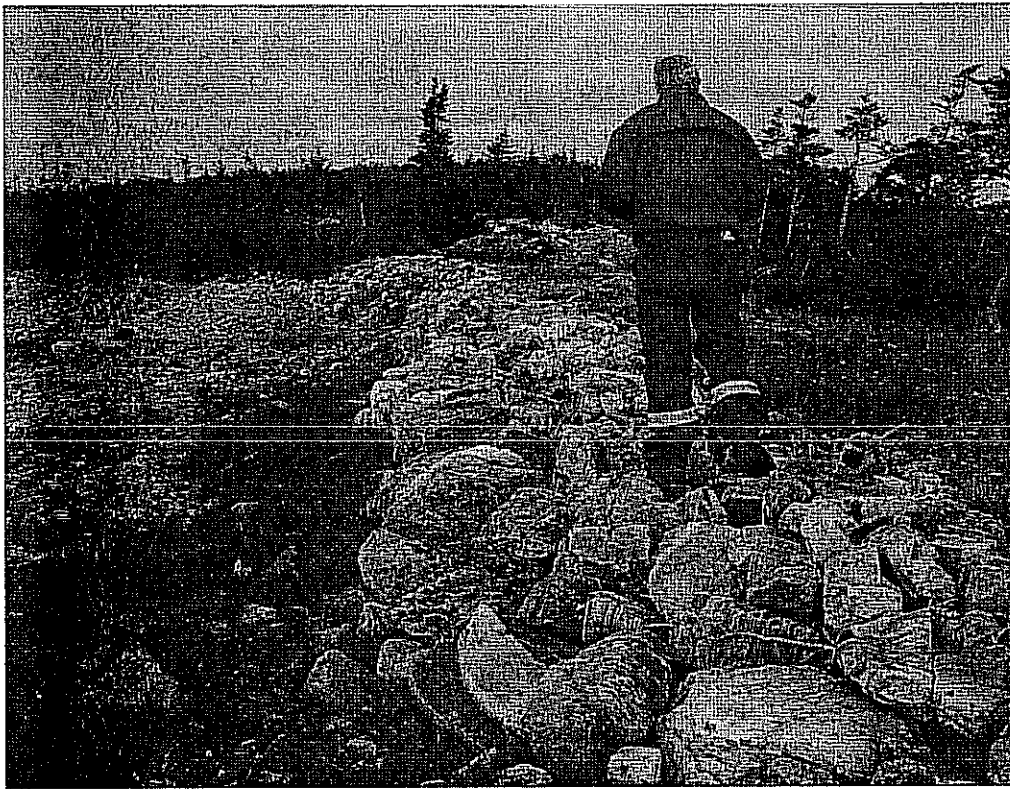
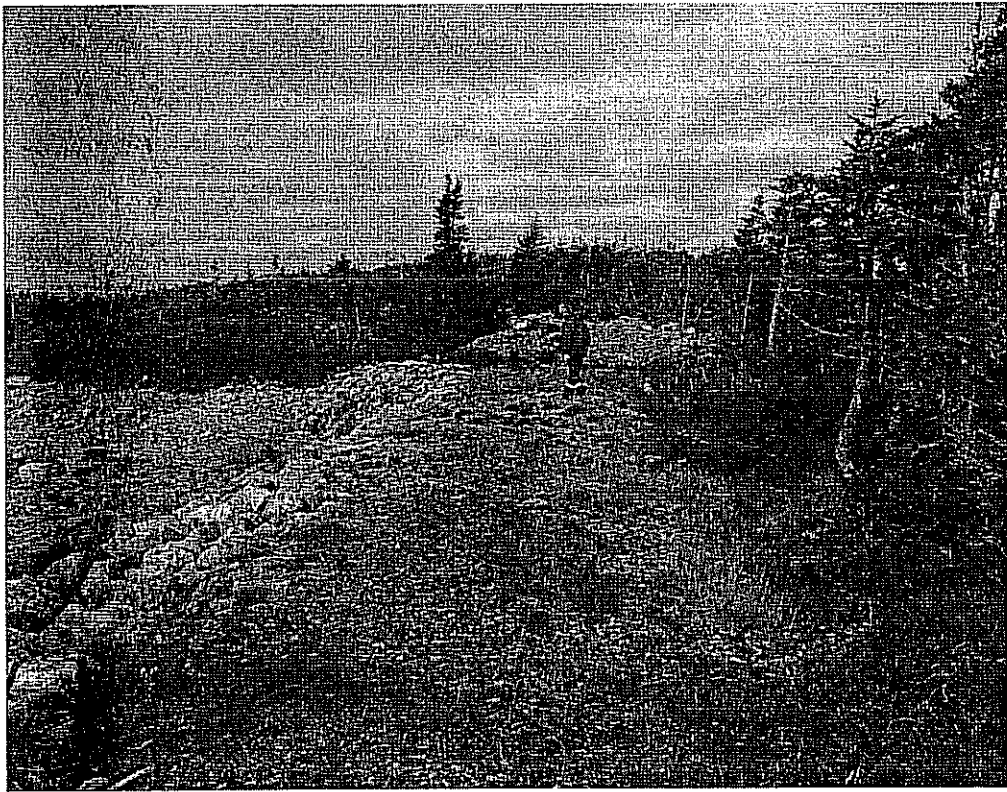
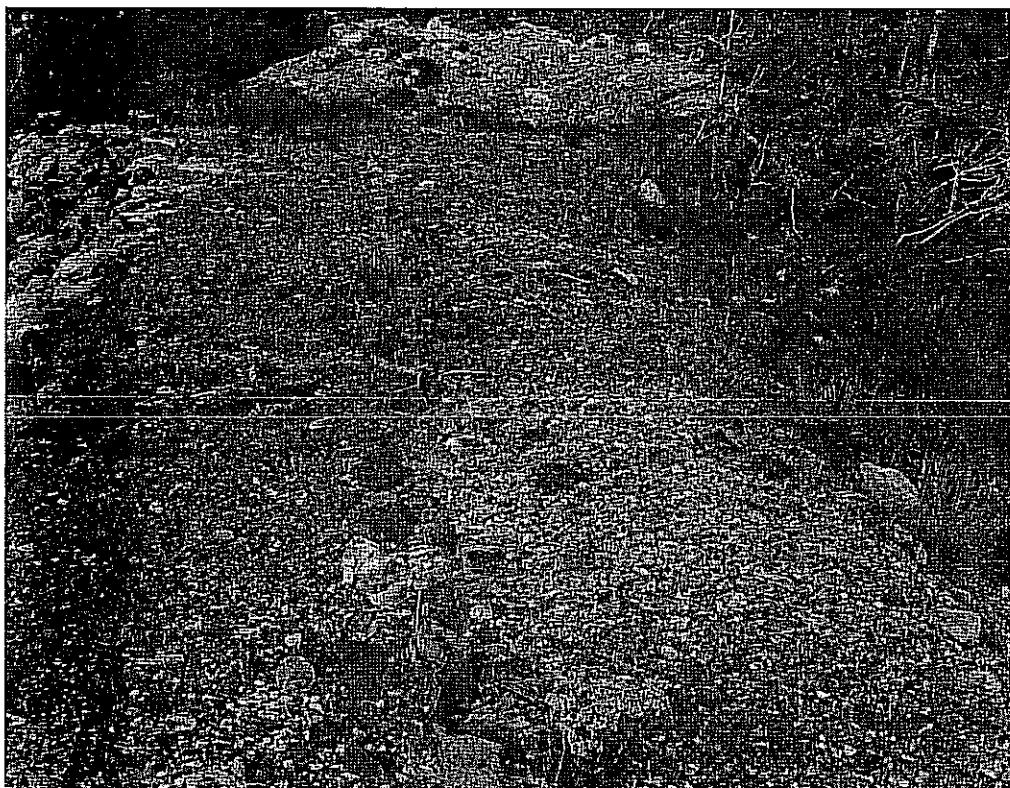
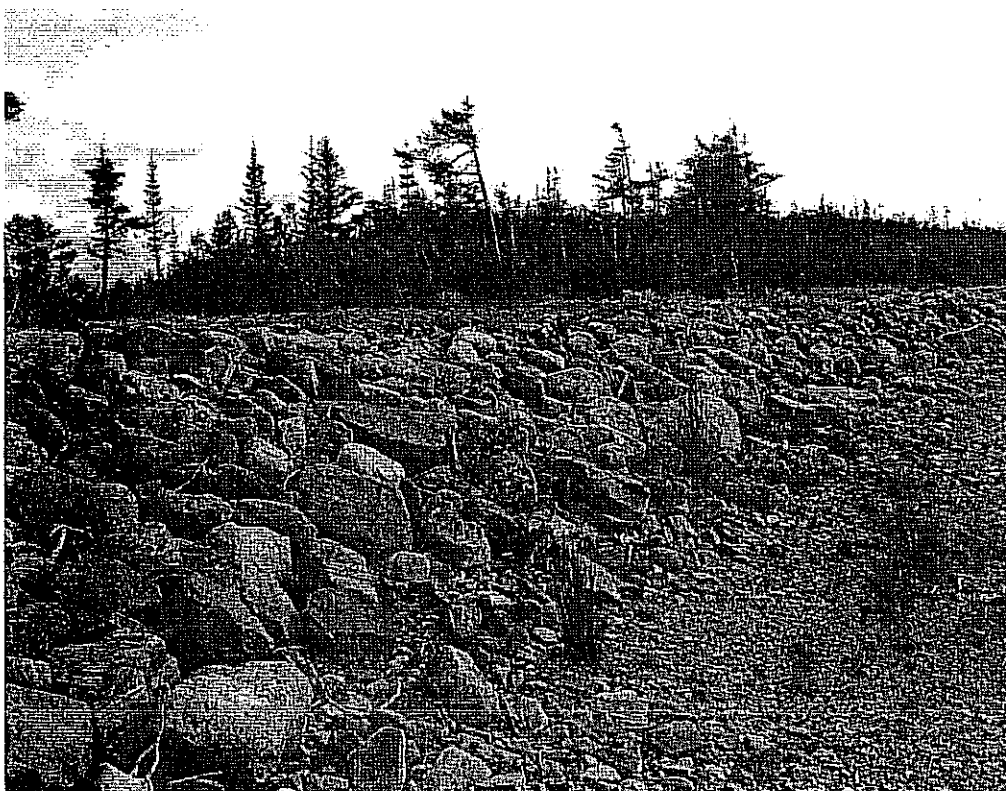
Structure : Franks Pond Dam #6 Date/Time : 2007-10-02
Inspected by : GH,JW,BT, BH Water Level : _____
Weather : Sunny 14°C Releases : _____

Riprap in good condition. Generally small in size.

Slope in good condition - stable.

Abutments in good condition.

Minor seepage observed at d/s toe near mid dam.

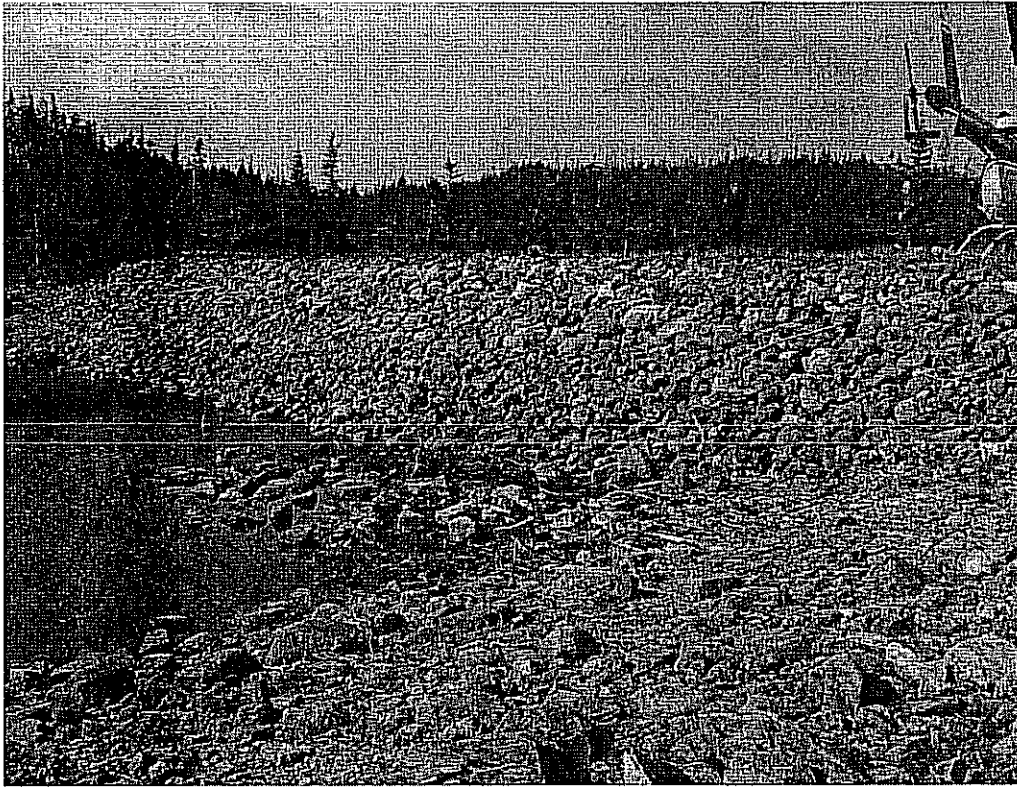
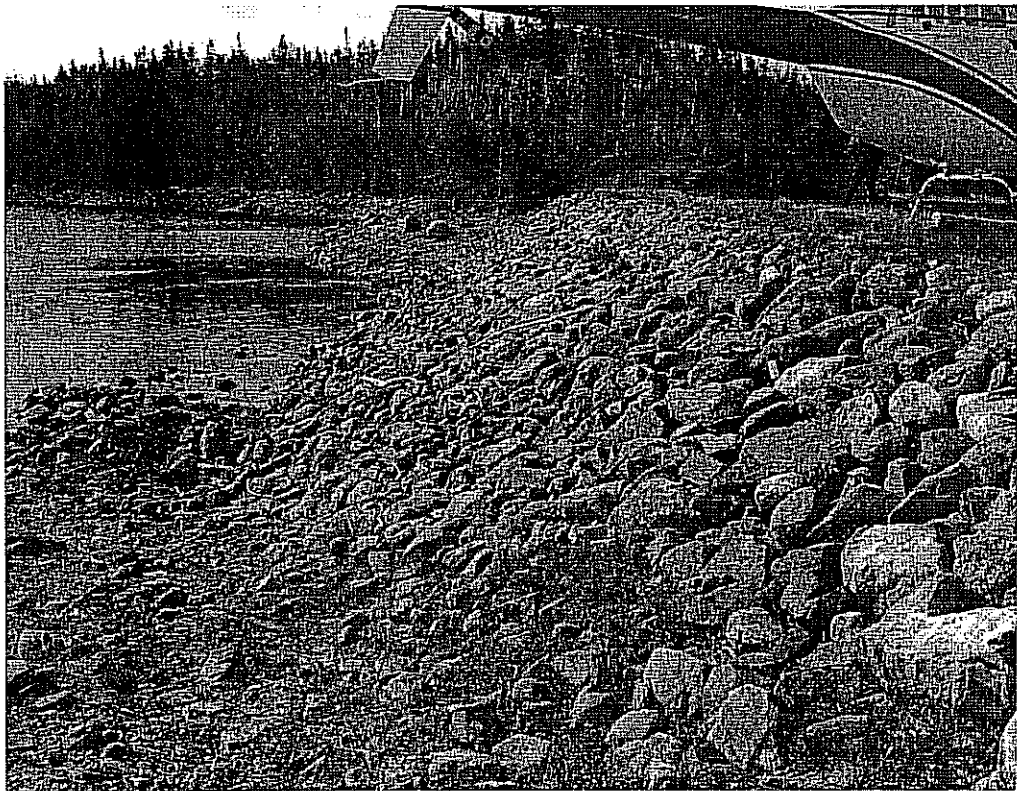
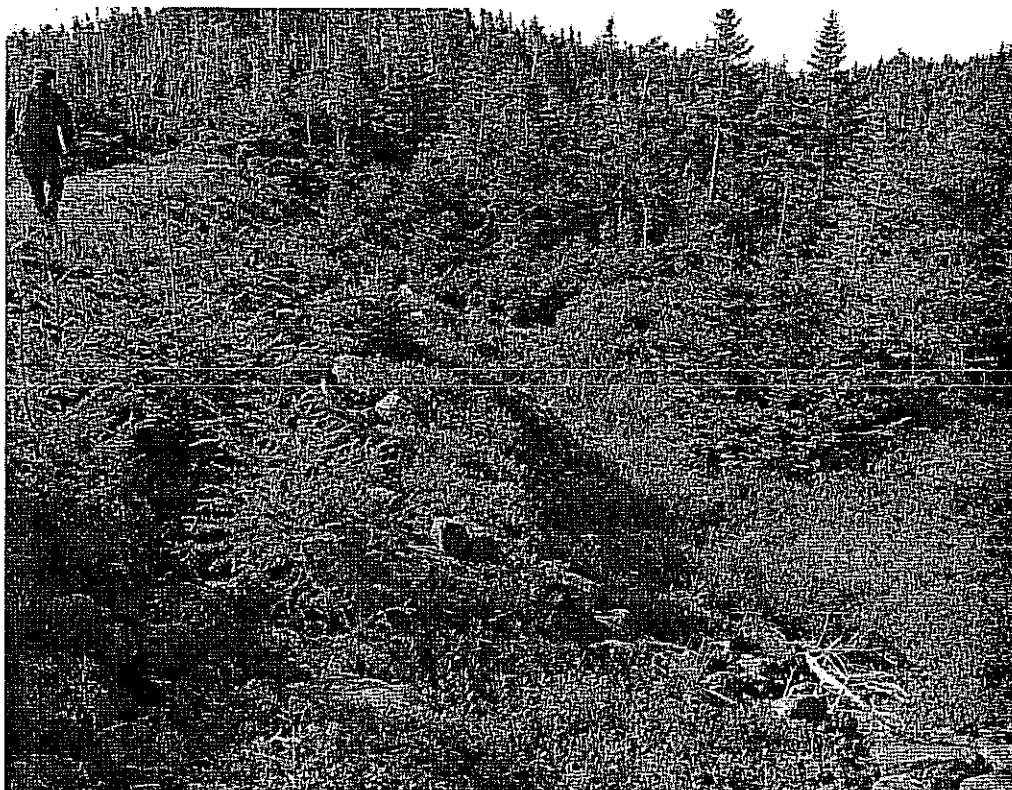
Structure : <u>Franks Pond Dam #7</u>	Date/Time : <u>2007-10-02</u>
Inspected by : <u>GH,JW,BT, BH</u>	Water Level : _____
Weather : <u>Sunny 14°C</u>	Releases : _____

Upstream face in good condition. Riprap is well graded and stable, however, generally small in size..

Slope is steep. Minor erosion observed.

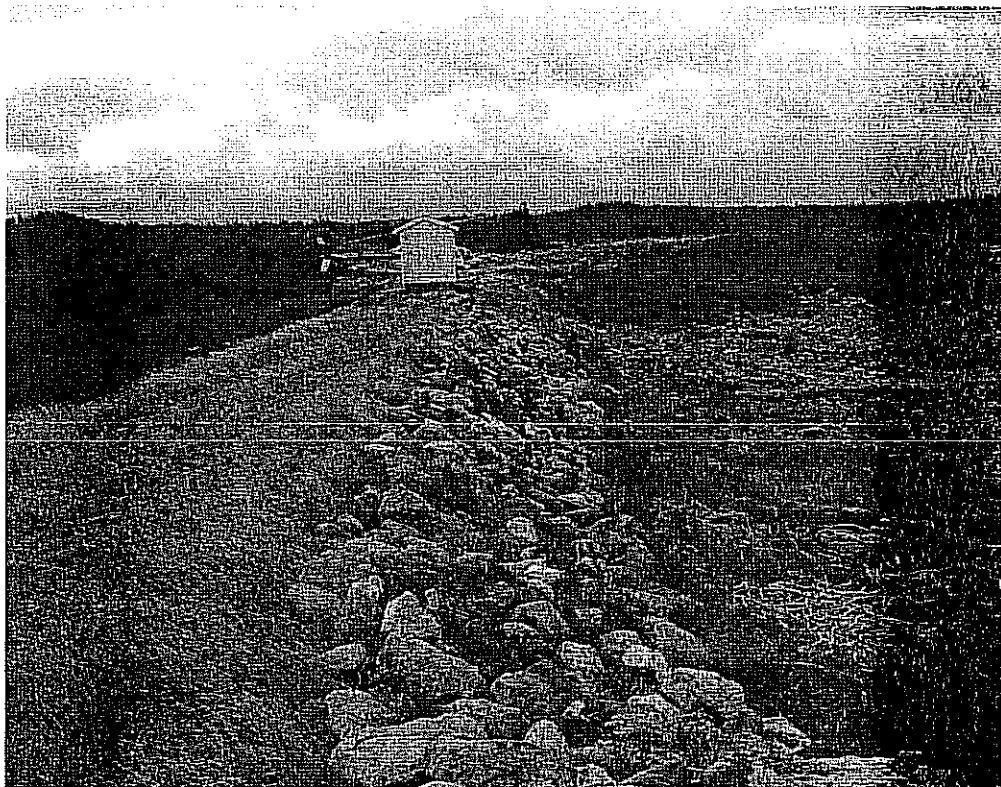
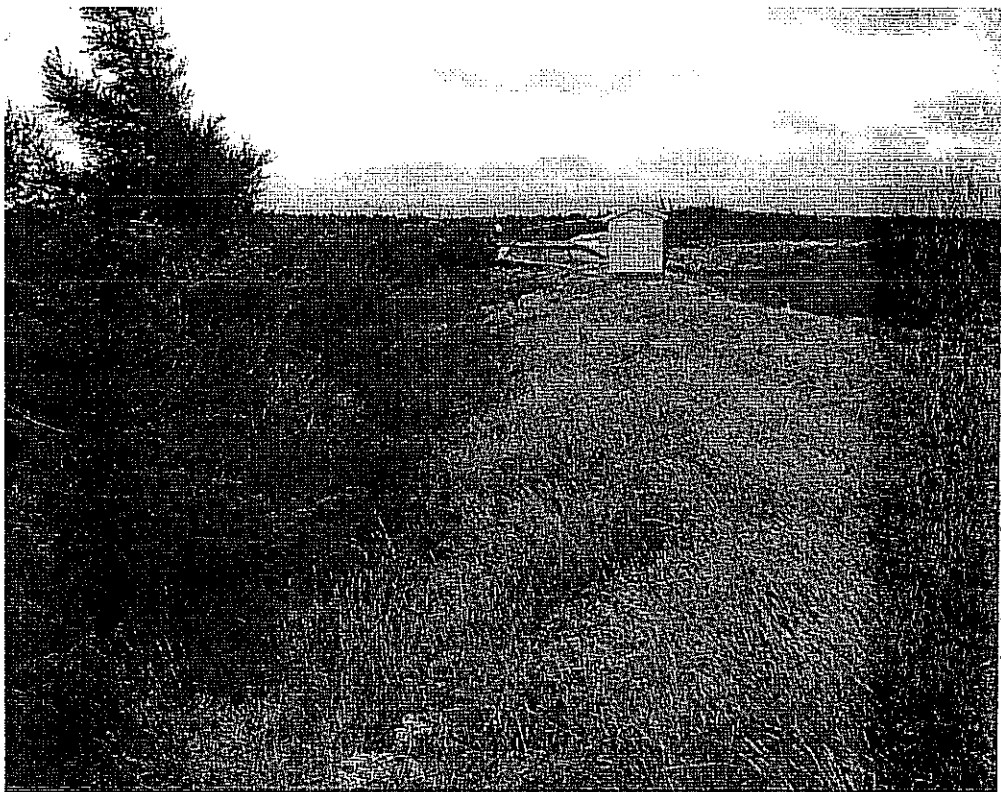
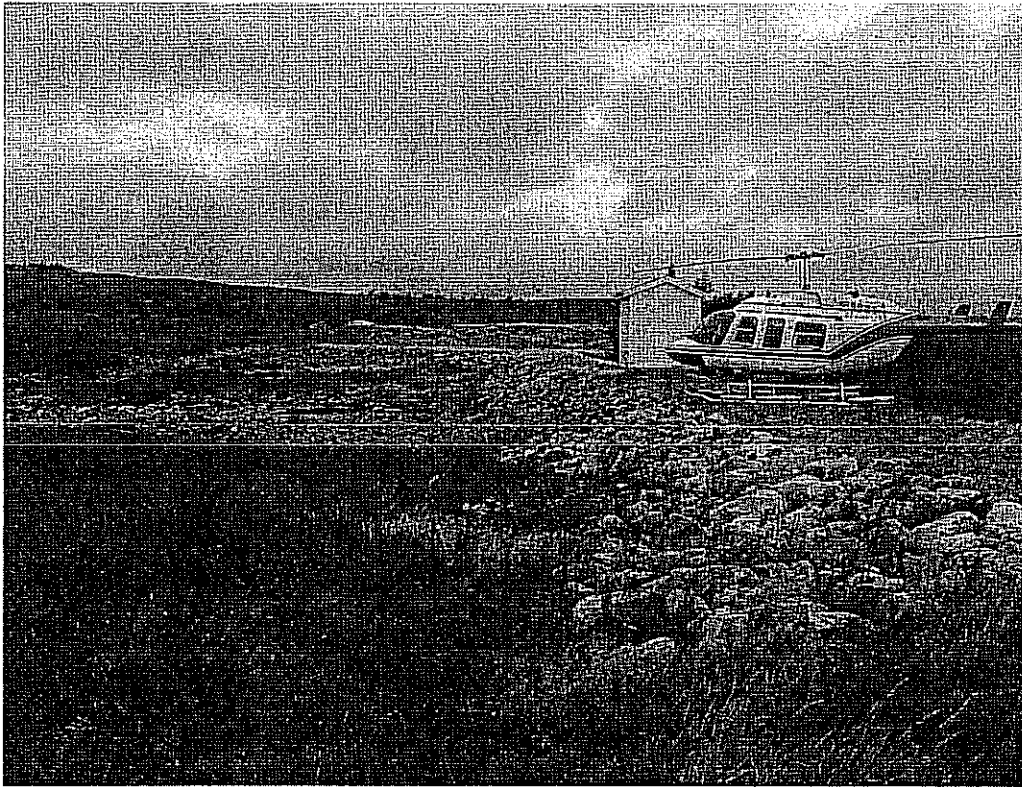
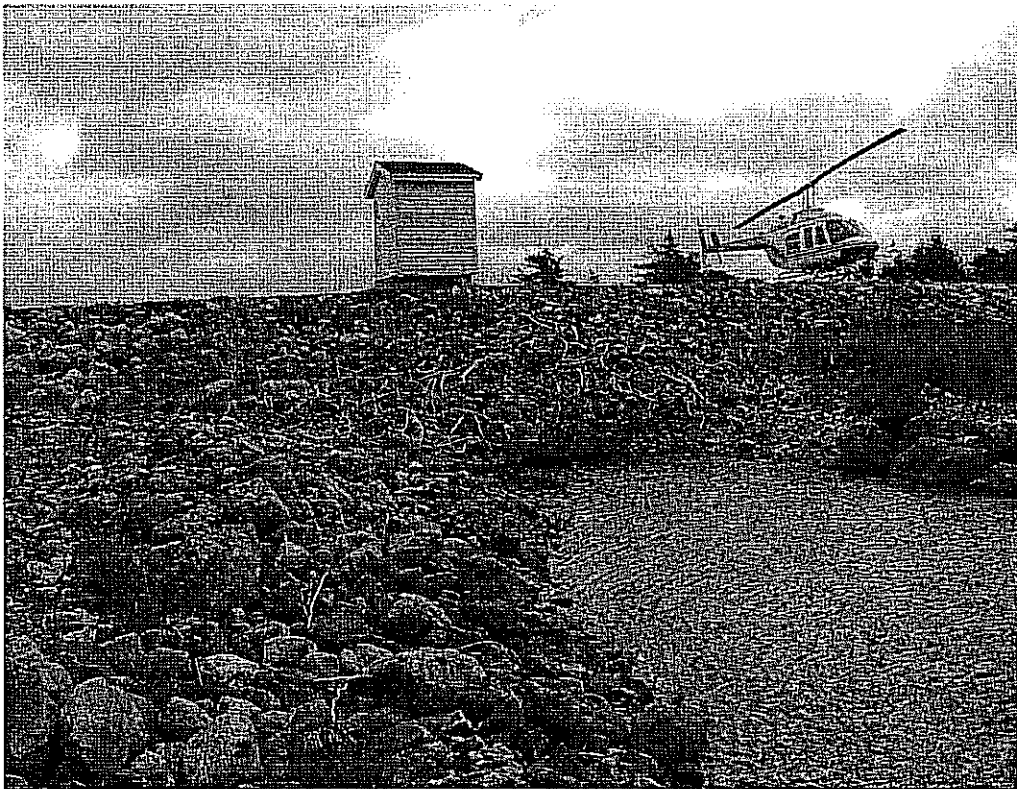
Structure : Franks Pond Storage Dam Date/Time : 2007-10-02
Inspected by : GH,JW,BT, BH Water Level : _____
Weather : Sunny 14°C Releases : _____

Overall good condition.

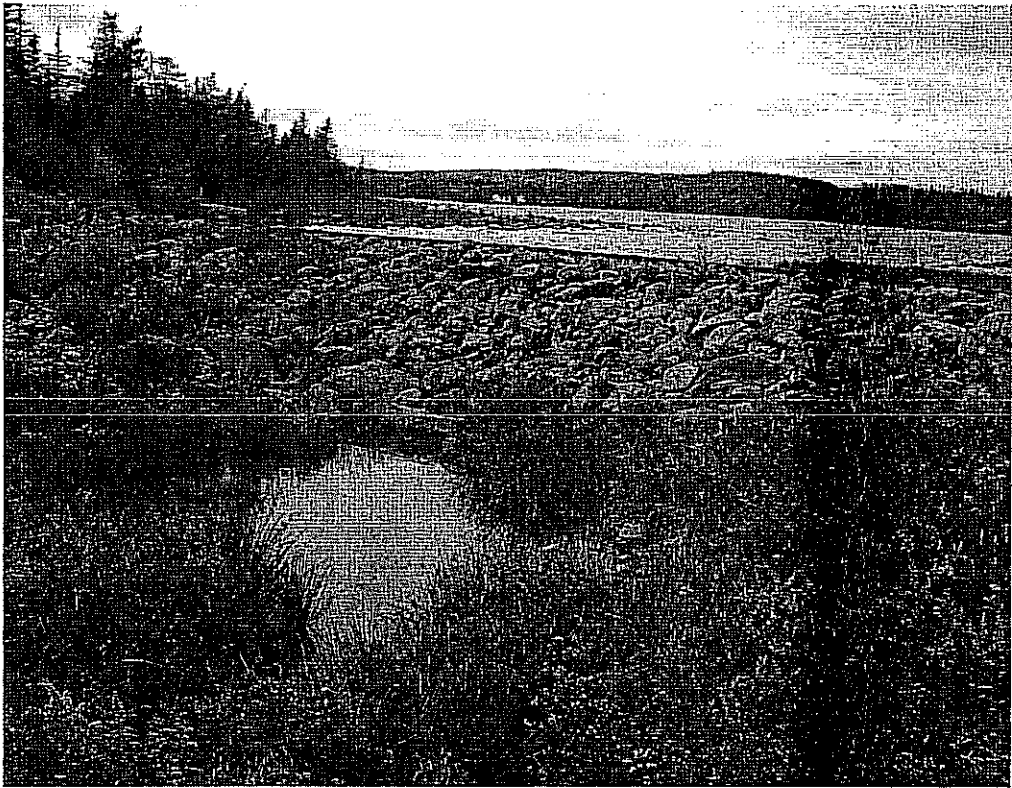
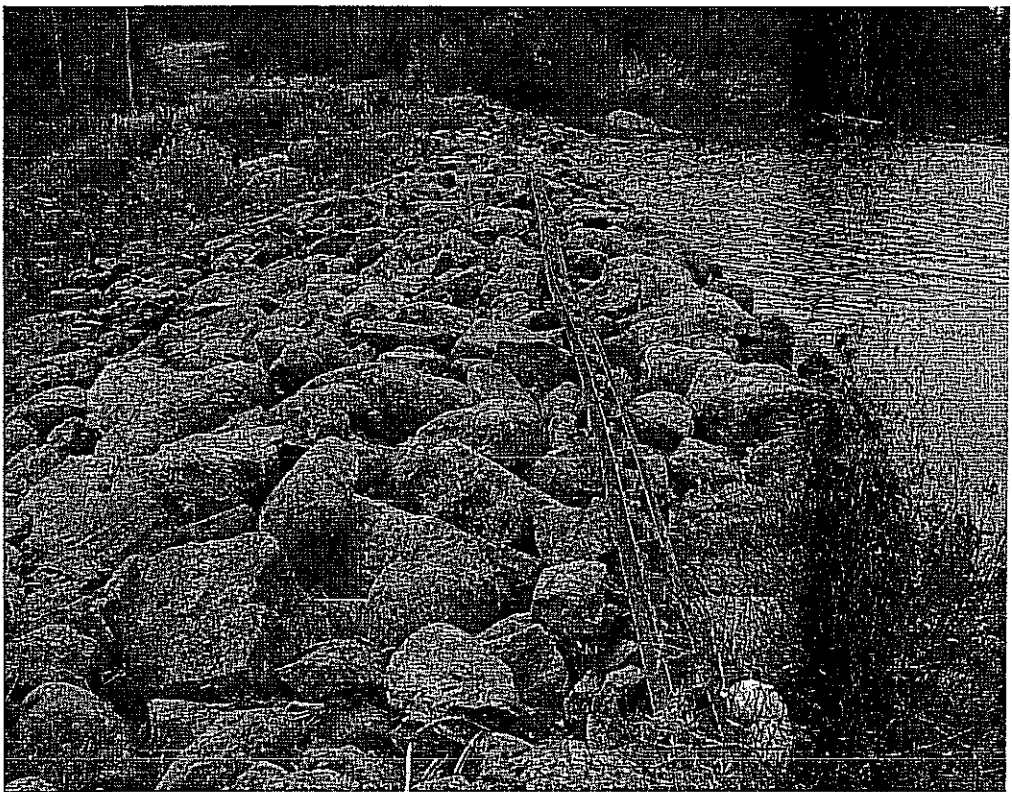
Structure :	Rocky Pond Freeboard Dam #1	Date/Time :	2007-11-05
Inspected by :	JW,JC,BH	Water Level :	
Weather :	Overcast, 5°C	Releases :

Riprap protection is fair – sparse in some locations. No problems observed.

Downstream face in good condition. No evidence of movement.

Crest was in good condition – no problems caused by vehicular traffic.

Dam in good condition overall.

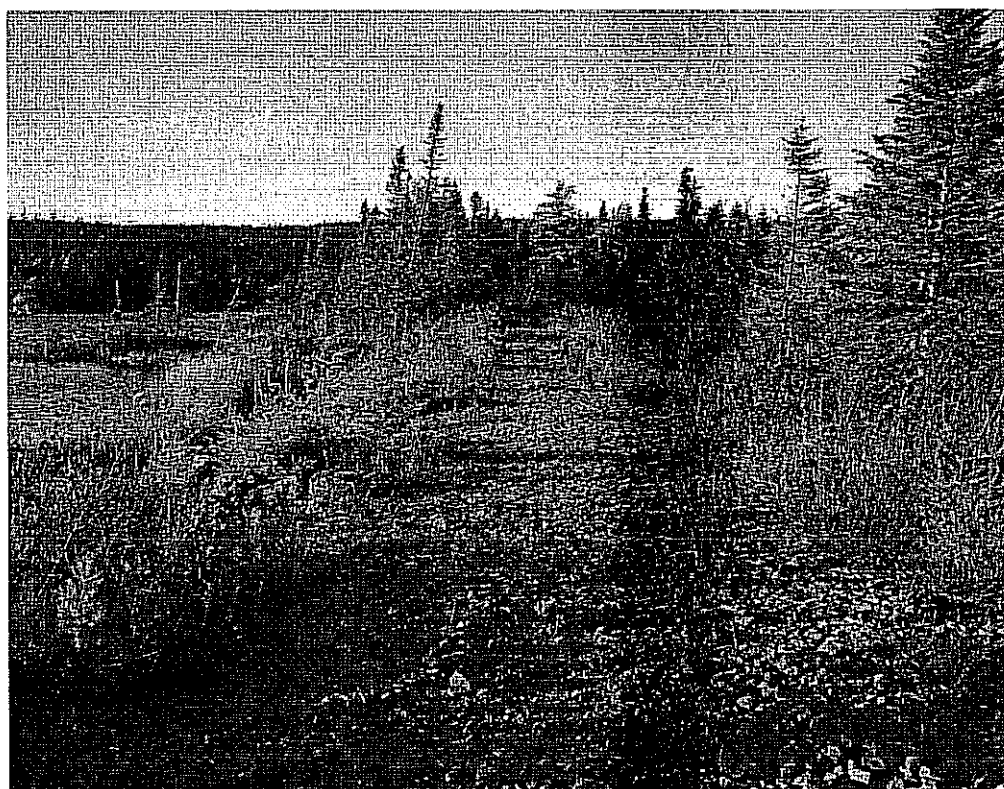
Rocky Pond Freeboard Dam No. 2

Rock fill protection is in fair condition.

The abutments are in good condition. No unusual conditions.

Crest was in good condition. No deterioration of crest due to vehicular traffic.

Area of ponded water at d/s toe of dam #2 (same level as reservoir). No flow observed.
