Q. Re: Rocky Pond Plant Refurbishment (p. 2 of 81, Schedule B) - Provide for the last five years:

2005 Dam Safety Inspection Report

**Tors Cove /
Rocky Pond
Developments**

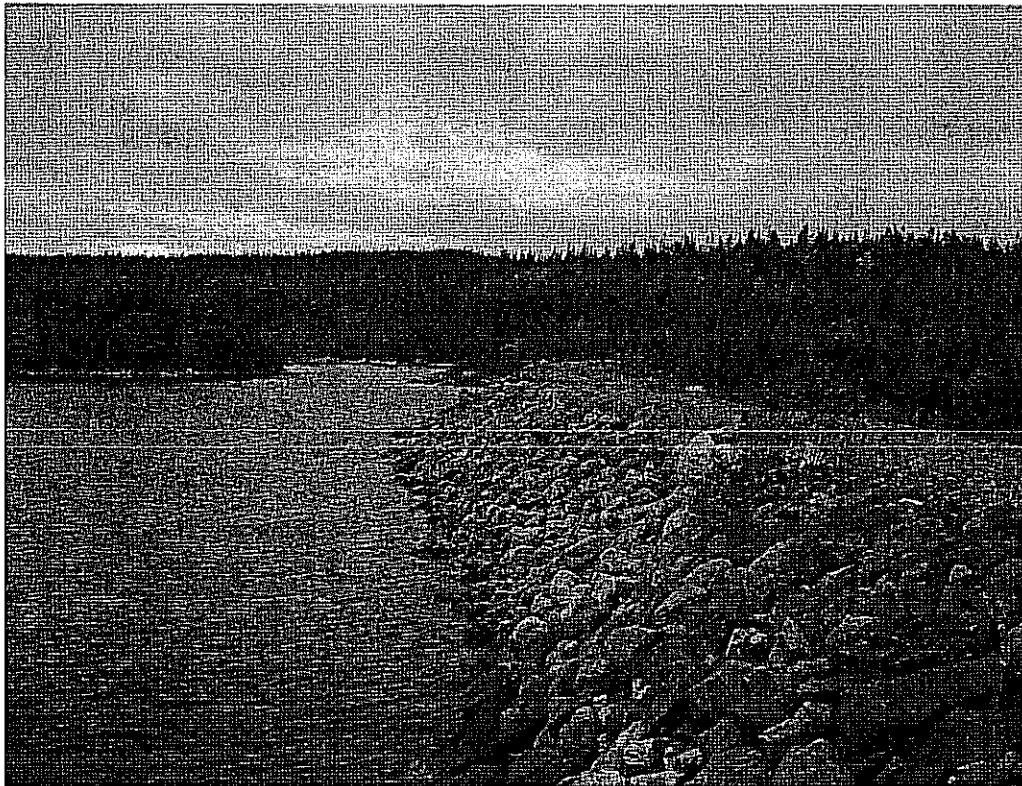
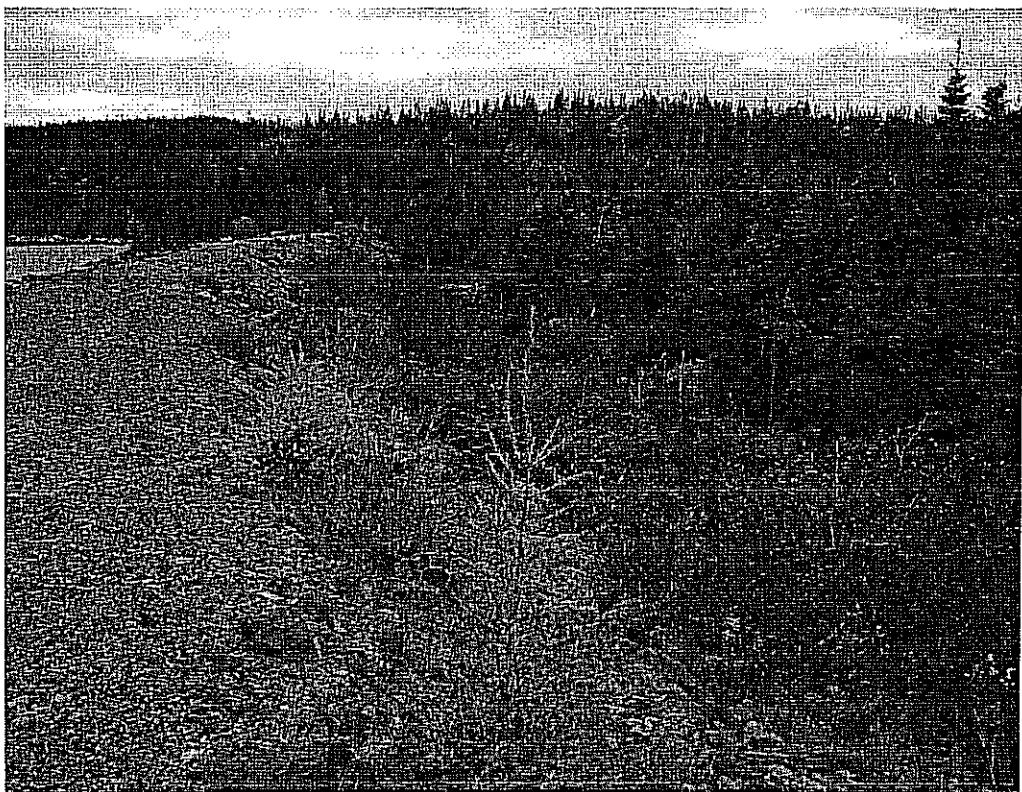
Riprap is generally undersize with some voids observed in the riprap.

Downstream face was in good condition. Slopes are steep but appear to be stable.

South abutment is OK. North concrete abutment in good condition.

Small amount of standing water observed at d/s toe near mid-section of dam (deepest section). Otherwise, very little seepage observed.

Reservoir spills infrequently.

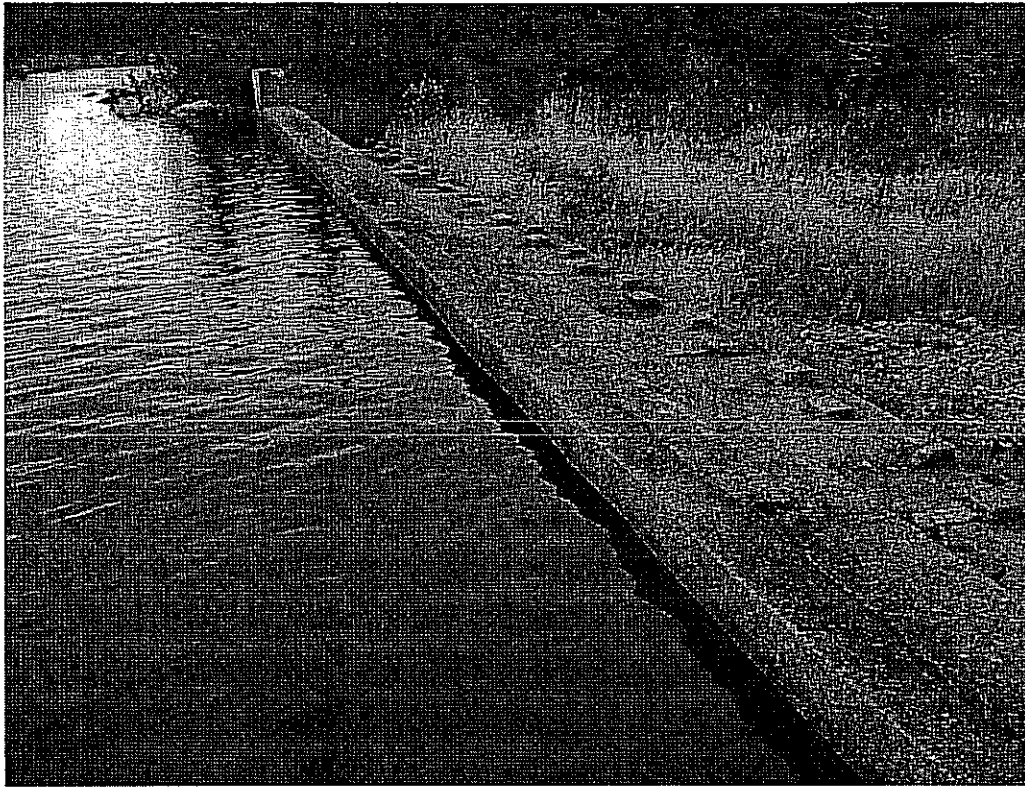
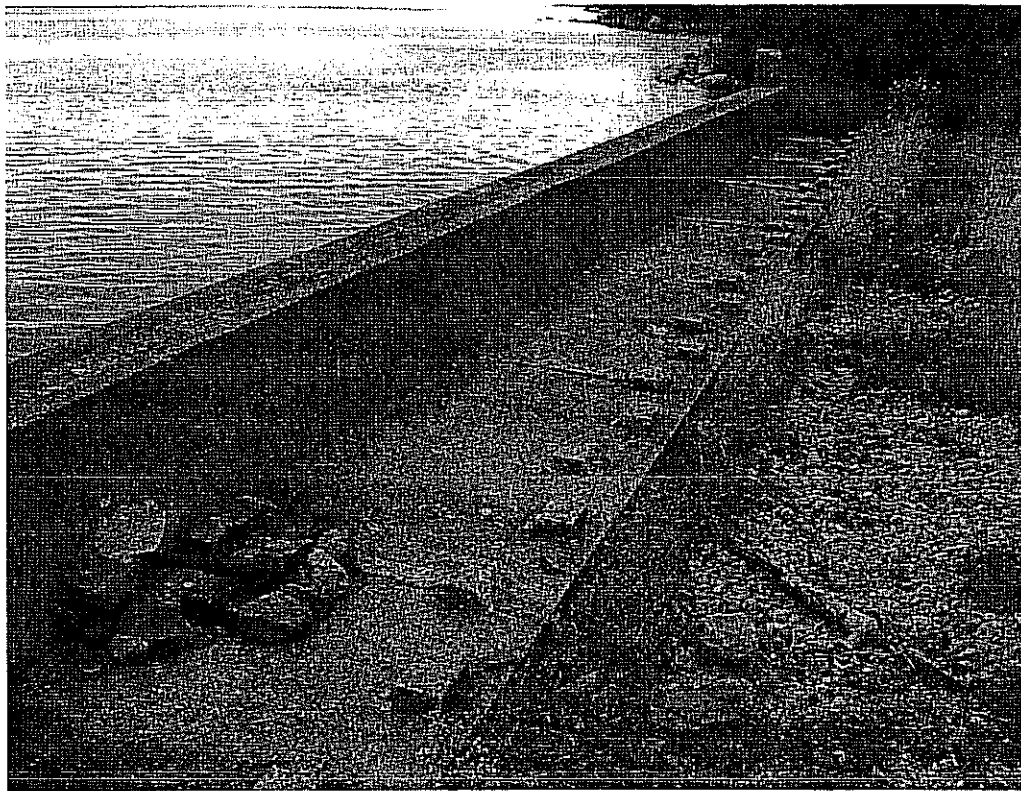
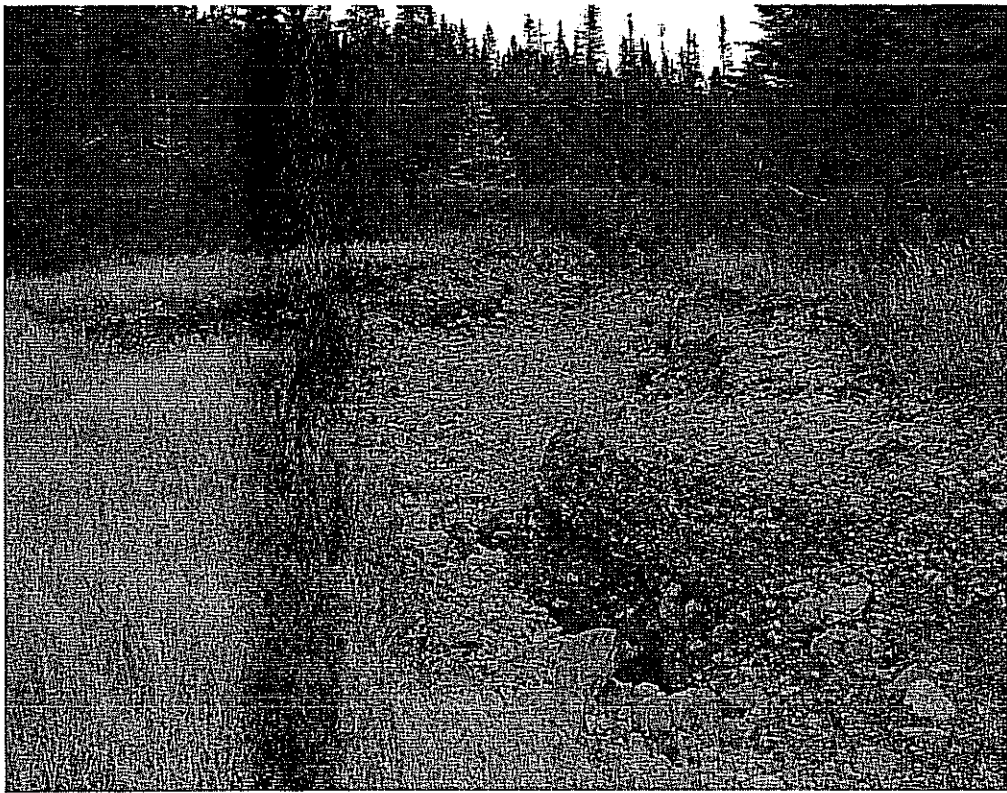
Structure :	<u>Rocky Pond Forebay Spillway</u>	Date/Time :	<u>2007-11-05</u>
Inspected by :	<u>JW,JC,BH</u>	Water Level :	<u></u>
Weather :	<u>Overcast, 5°C</u>	Releases :	<u></u>

Concrete crest is in good condition. Normal signs of concrete aging observed.

Gouging observed – ice dam formed and broke during 2006

Minor gouging observed at toe of spillway.

East concrete abutment repaired during 2003.

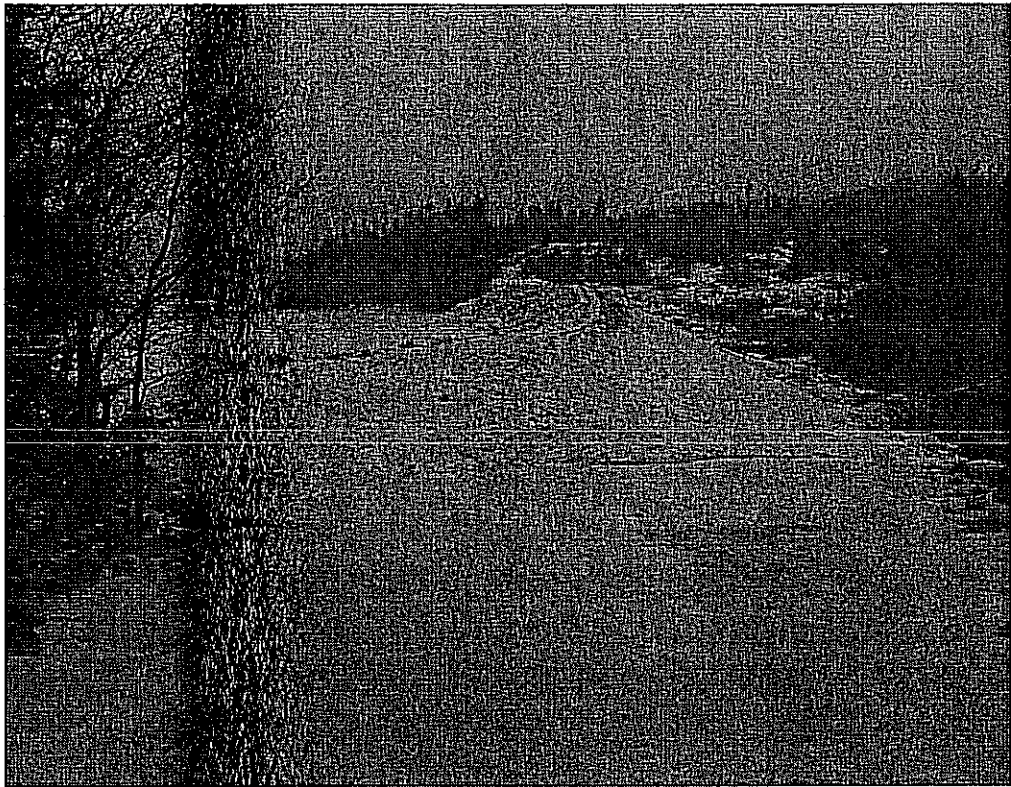
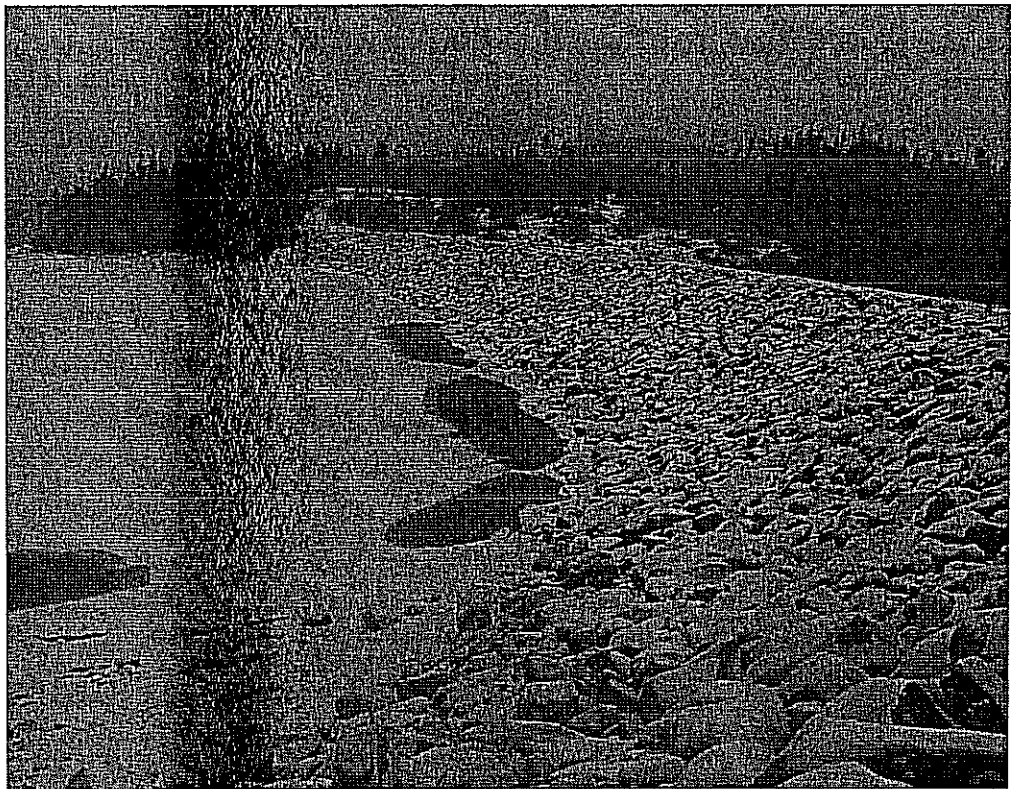
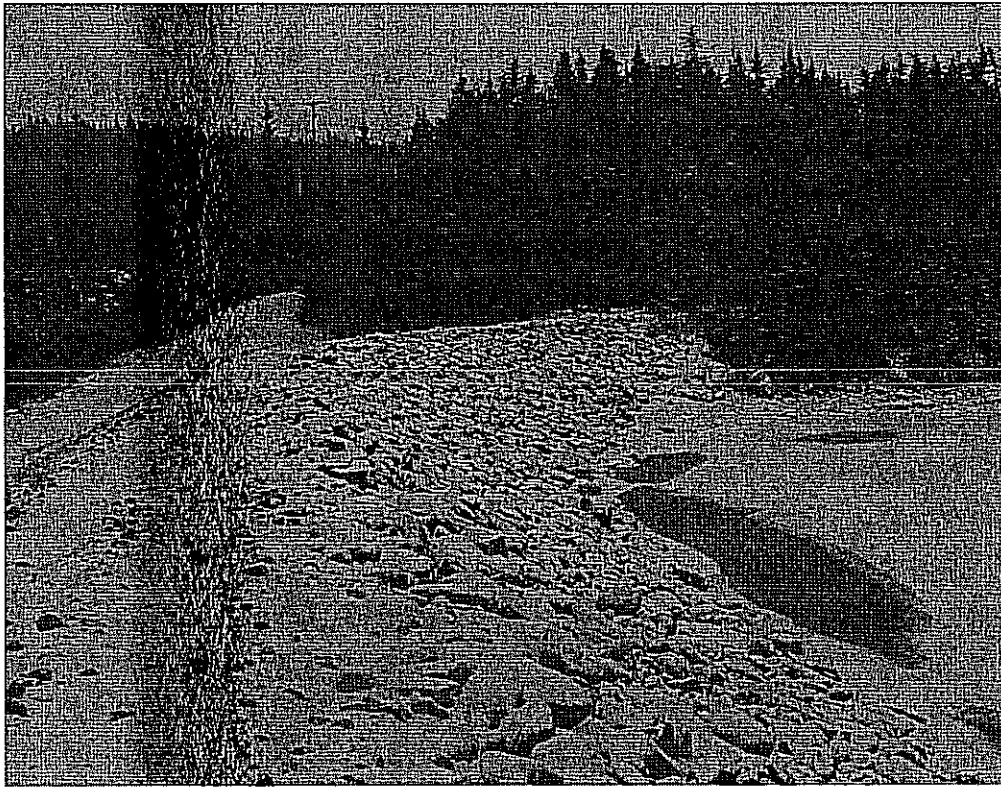
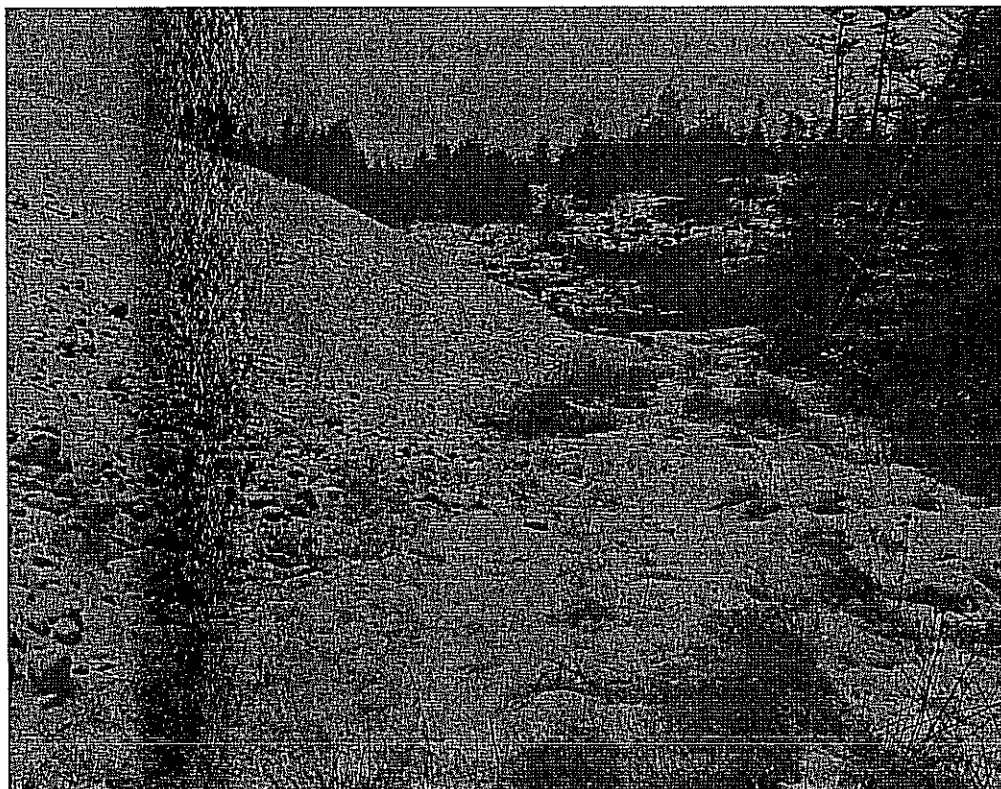
Structure :	Tors Cove West Dam	Date/Time :	2007-12-12
Inspected by :	BT,BH	Water Level :	2.7' below FSL
Weather :	Overcast, Light snow -2°C	Releases :

Abutments in good condition. No unusual conditions noted.

Rutting due to ATV traffic observed. Integrity of the dam not affected.

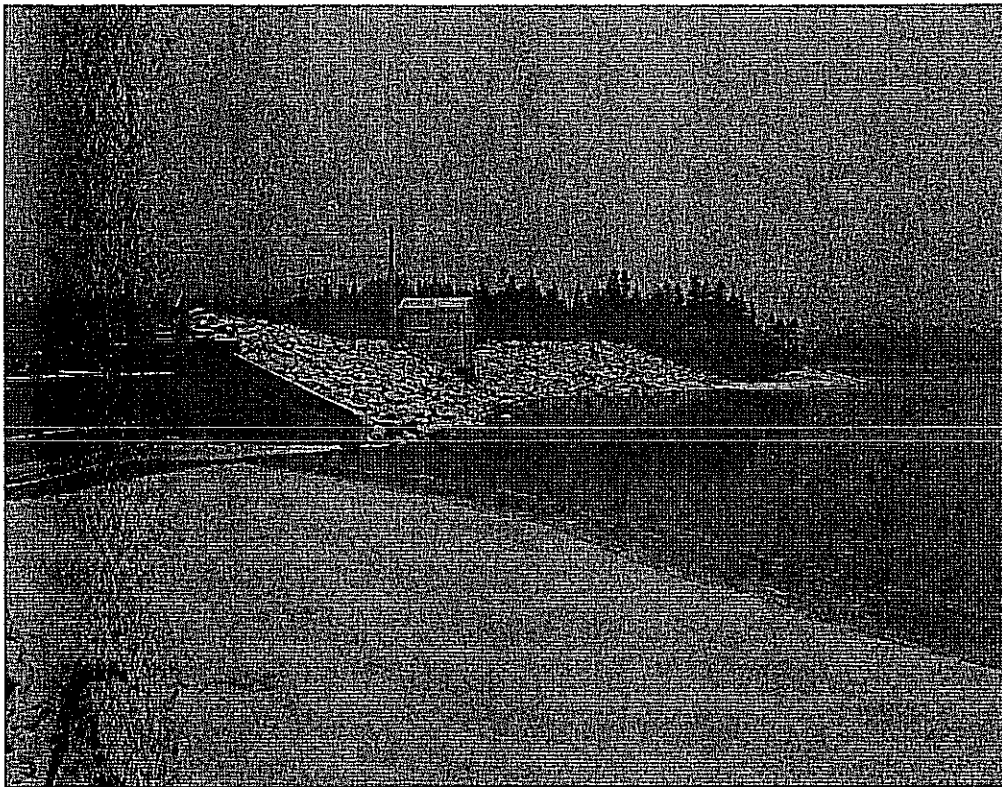
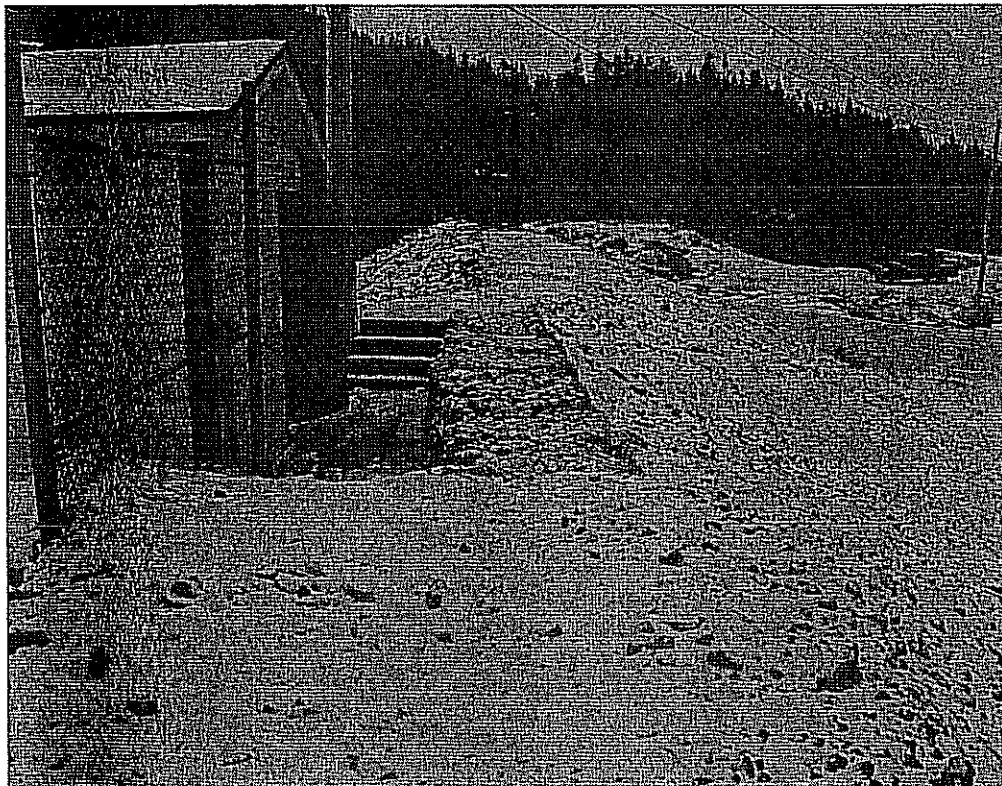
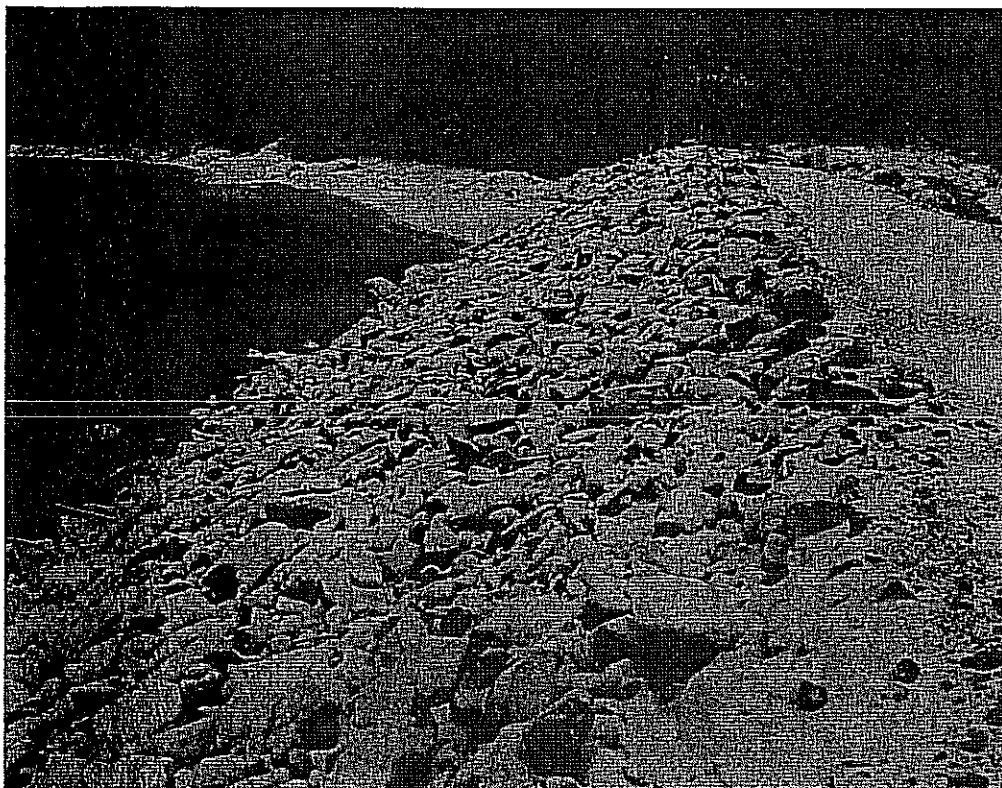
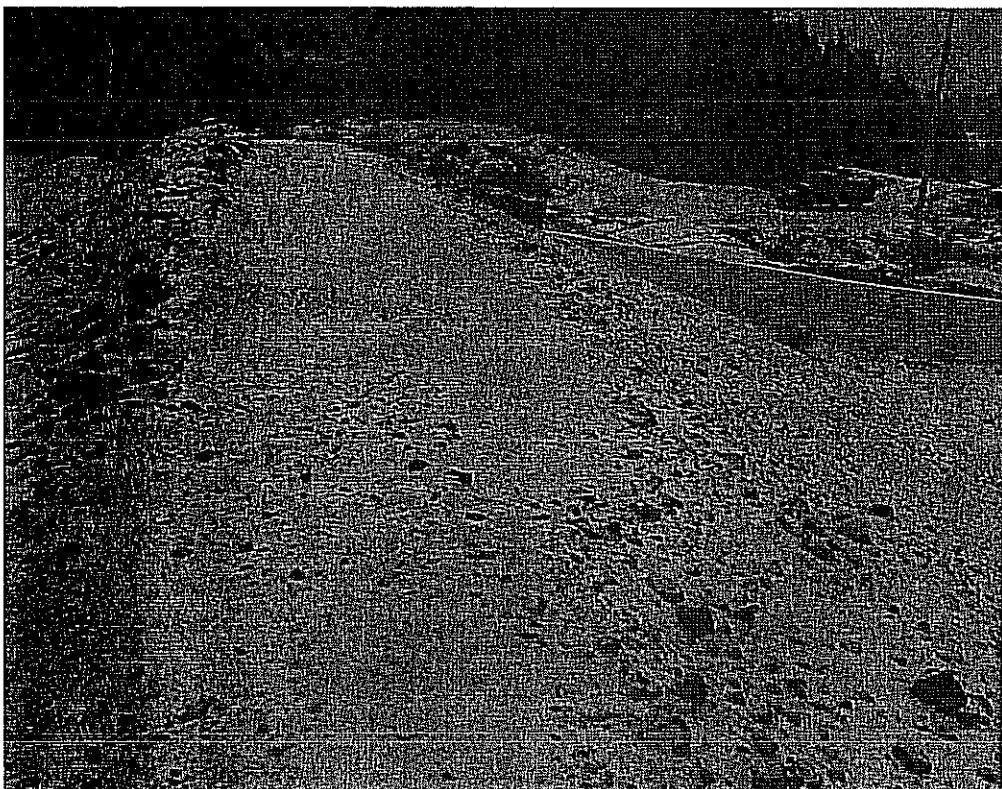
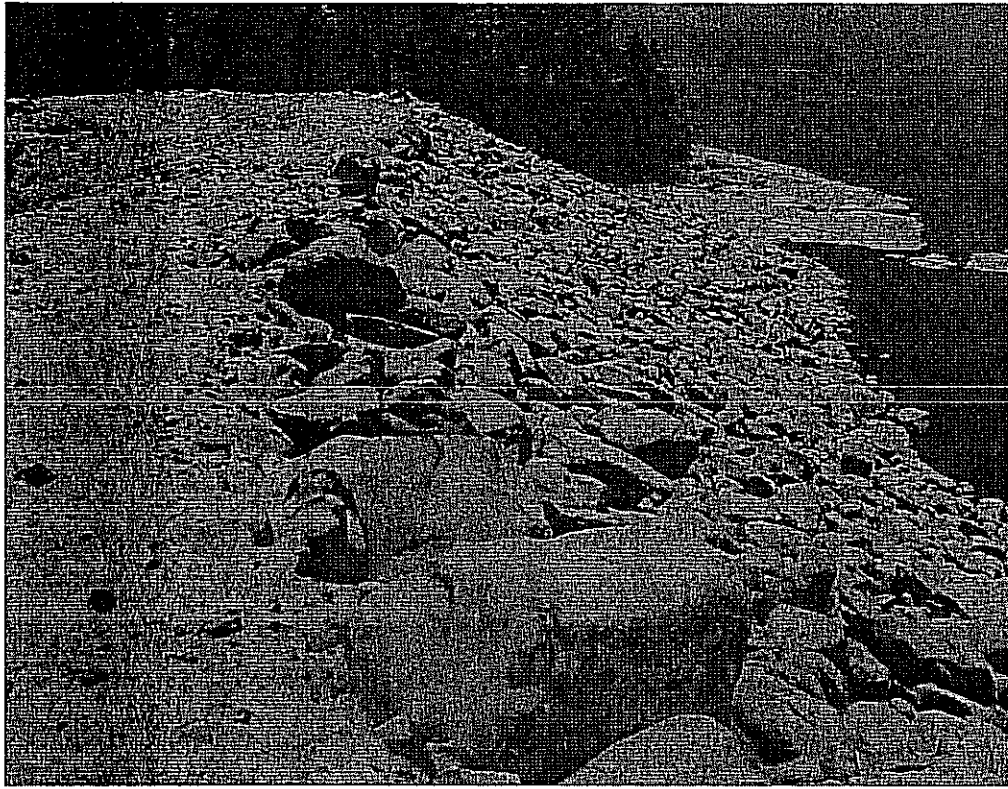
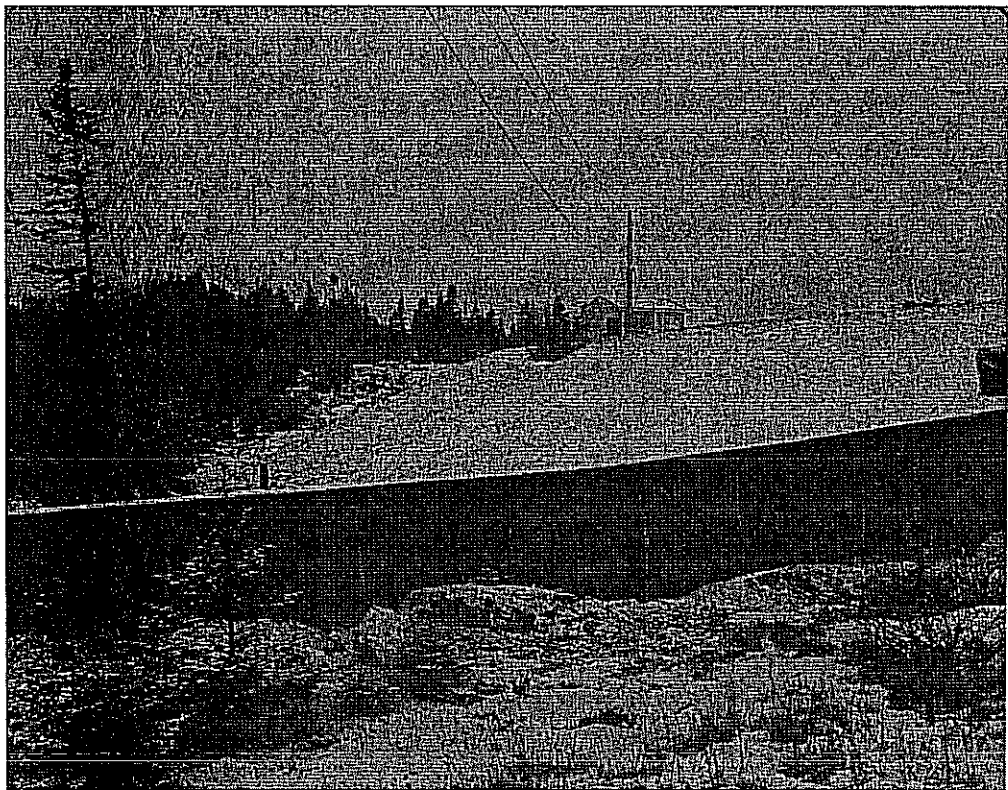
Structure :	<u>Tors Cove East Dam</u>	Date/Time :	<u>2007-12-12</u>
Inspected by :	<u>BT,BH</u>	Water Level :	<u>2.7' below FSL</u>
Weather :	<u>Overcast, Light snow - 2°C</u>	Releases :	<u></u>

Good. Maintenance staff indicated that gate and lift are in good operating condition.

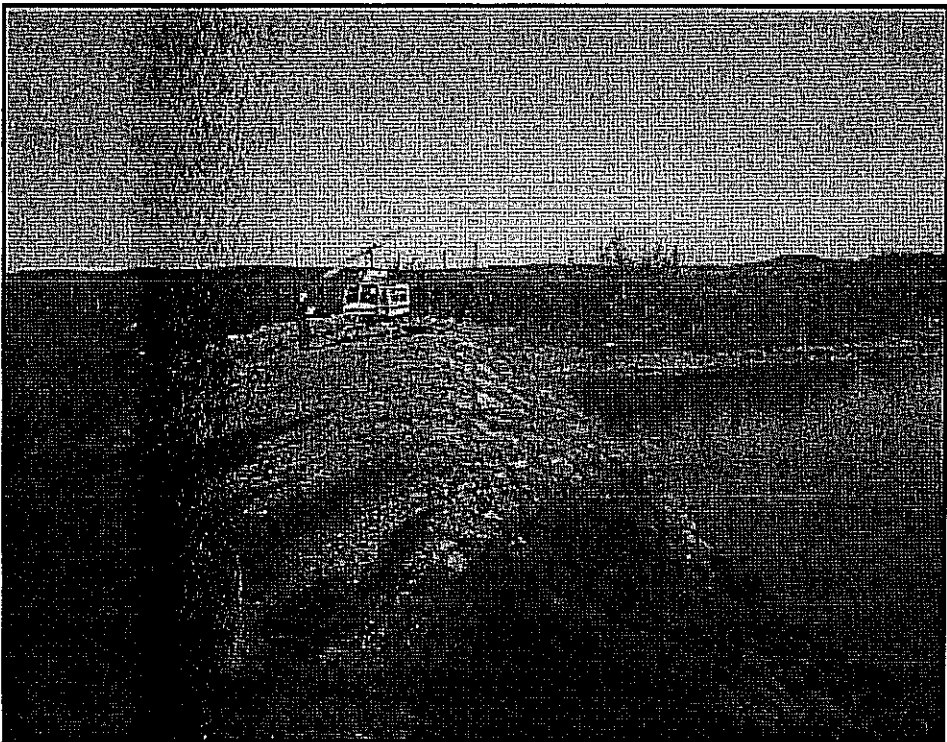
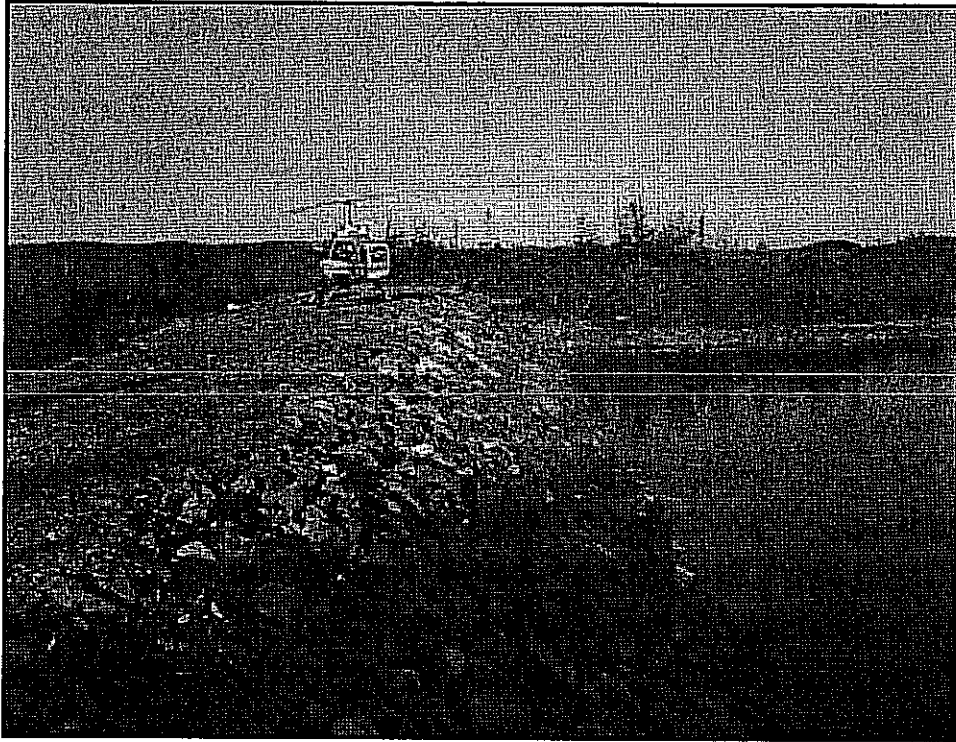
Structure :	Franks Pond Storage Dam	Date/Time :	2005-11-30
Inspected by :	GH, TC, BH	Water Level :	3' below FSL
Weather :		Releases :

Upstream face in good condition. Riprap has been upgraded since last inspection.

Slope was steep, but no movement noted.

Crest was OK. Vehicular and ATV traffic does not appear to be causing deterioration.

Overall good condition.

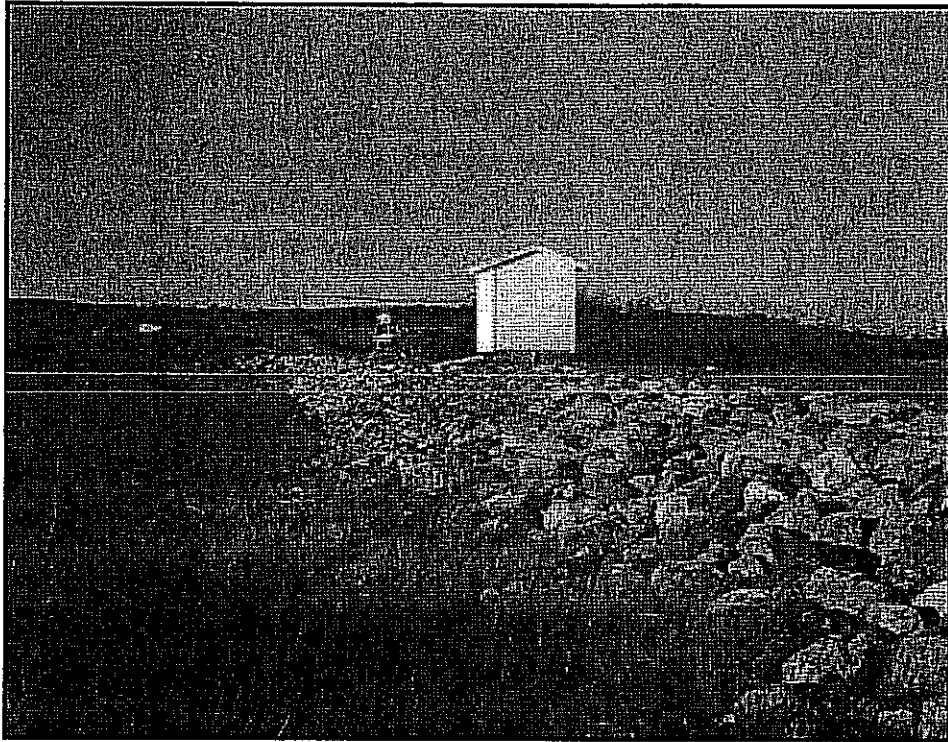
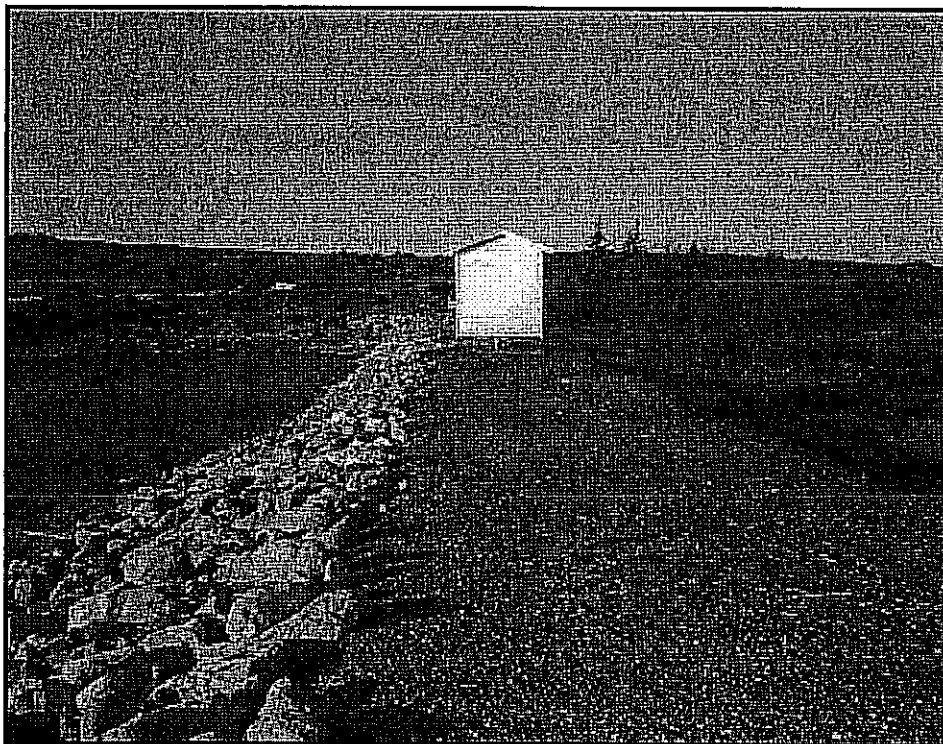
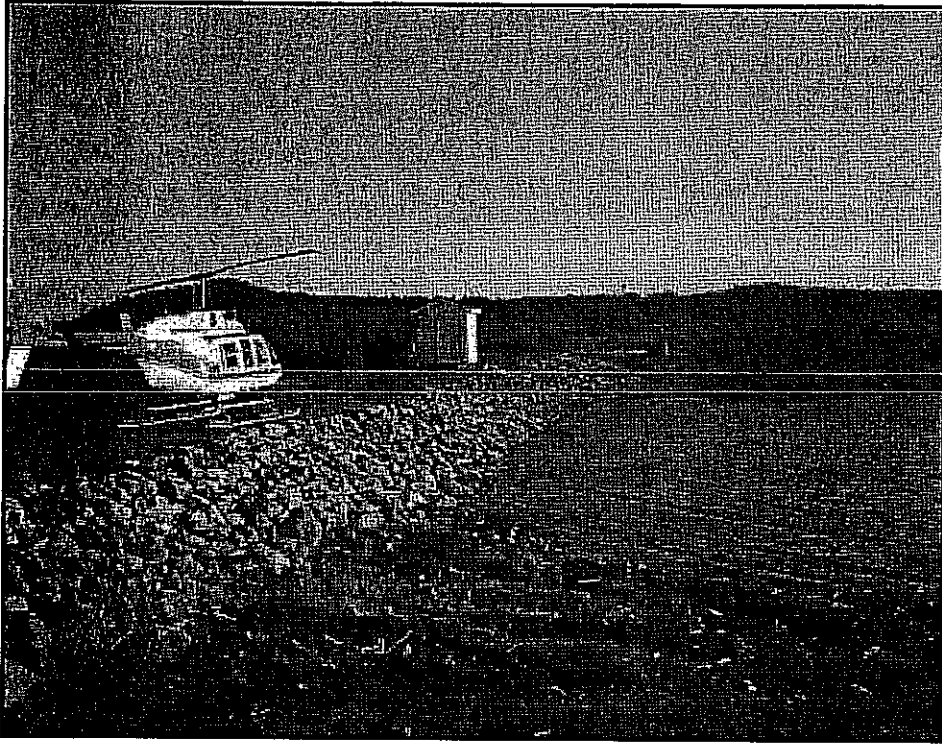
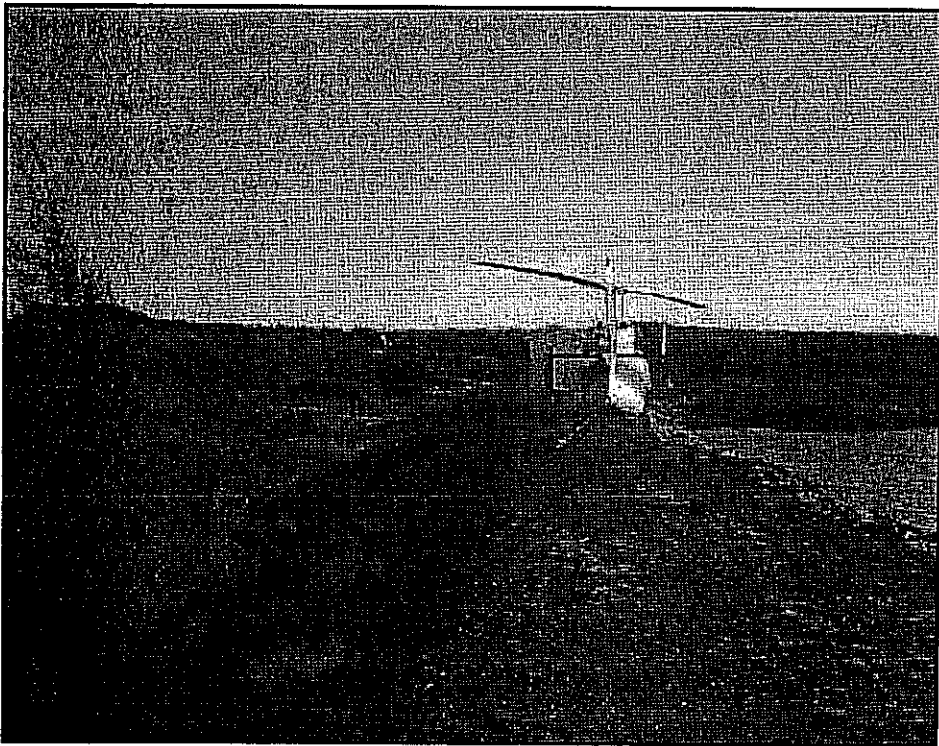
Structure : <u>Franks Pond Canal Embankment</u>	Date/Time : <u>2005-11-30</u>
Inspected by : <u>GH, TC, BH</u>	Water Level : <u>near FSL</u>
Weather : _____	Releases : _____

Significant vegetation throughout – otherwise good condition.

Significant vegetation throughout – no unusual conditions.

Difficult to detect in some locations due to vegetation. No problematic areas observed.

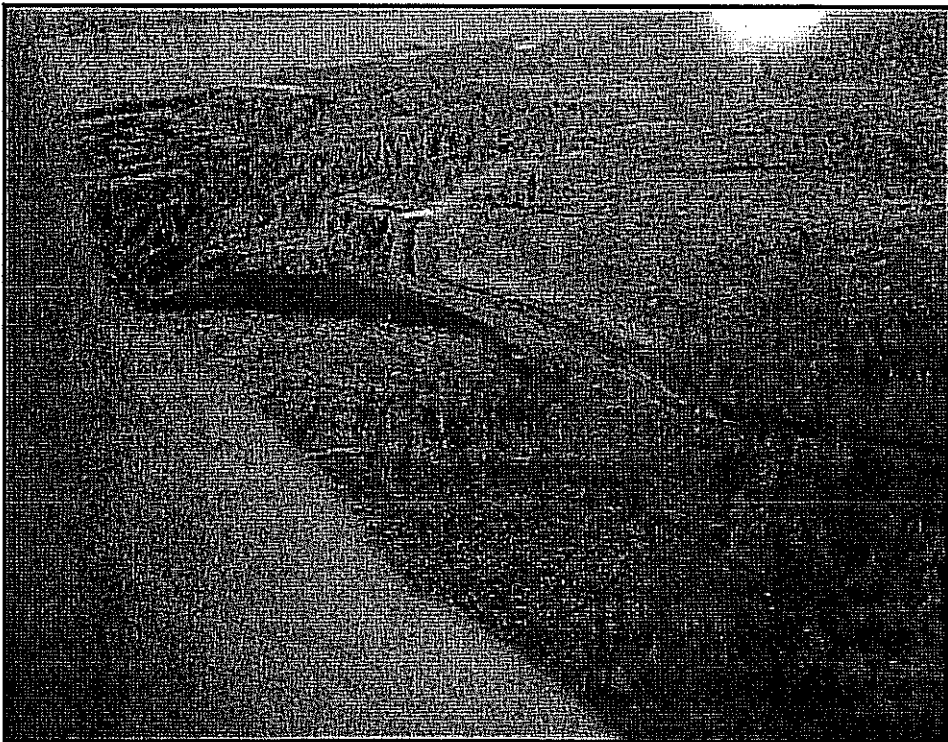
Structure : Franks Pond Canal Spillway Date/Time : 2005-11-30
Inspected by : GH, TC, BH Water Level : near FSL
Weather : _____ Releases : _____

Timber facing and apron in fair condition.

Deterioration/rot of structural timber members is evident, particularly at the abutments.

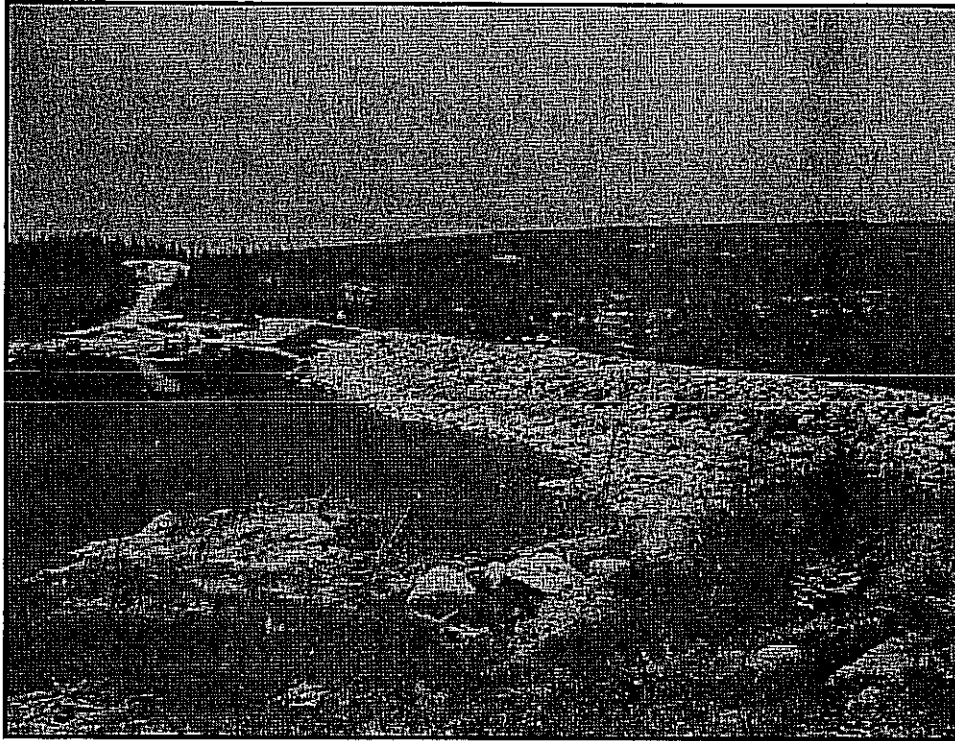
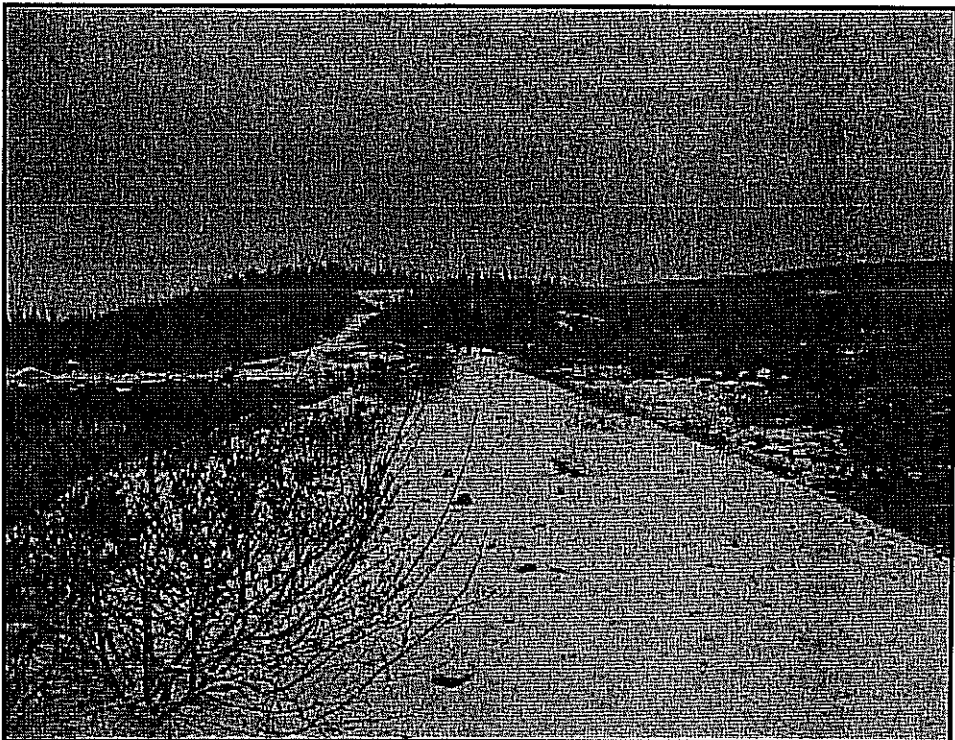
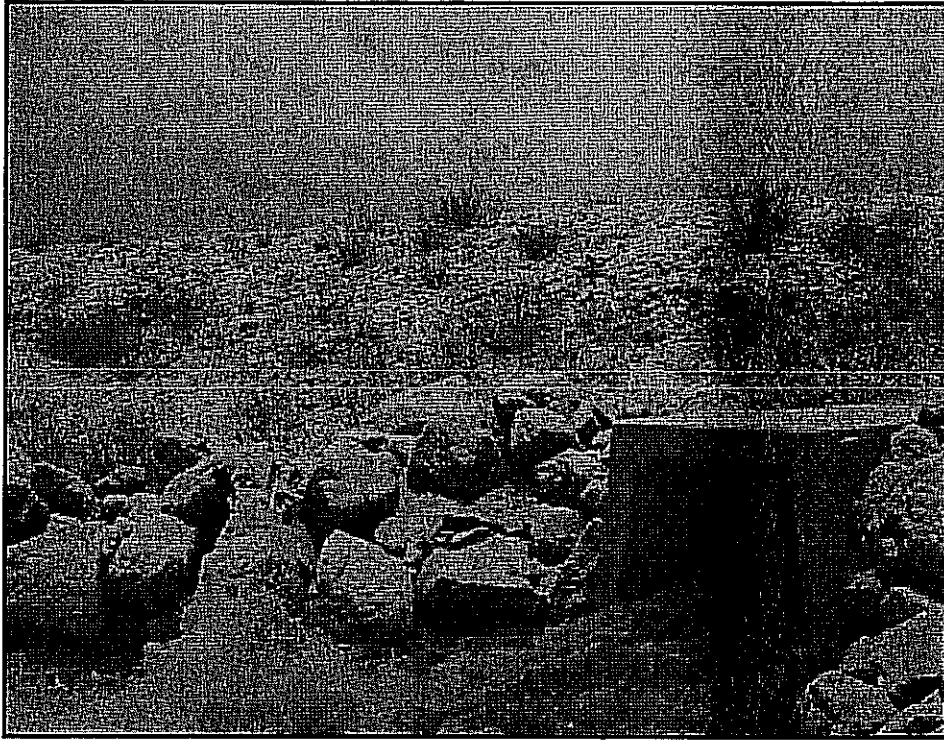
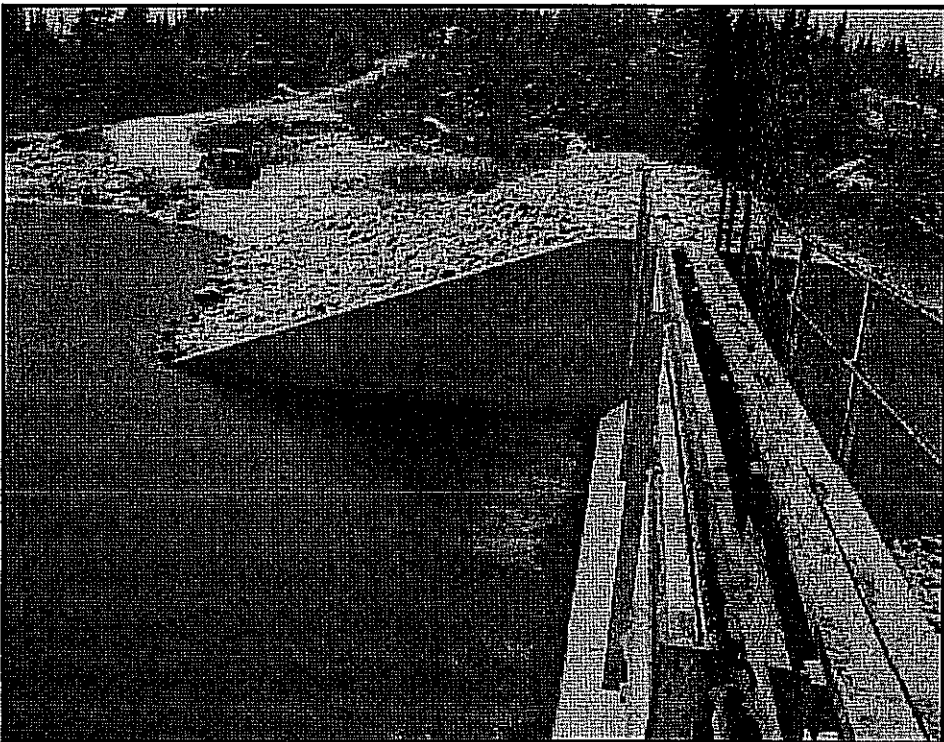
Structure : Cape Pond Spillway Date/Time : 2001-12-20
Inspected by : TC, RH, RV Water Level : 588.0
Weather : Overcast, 2°C Releases : N/A

Concrete was in good condition.

Some surface rust on piers and handrails.

Displacement of rockfill observed at d/s toe.

Concrete is in good condition with some isolated cracks.

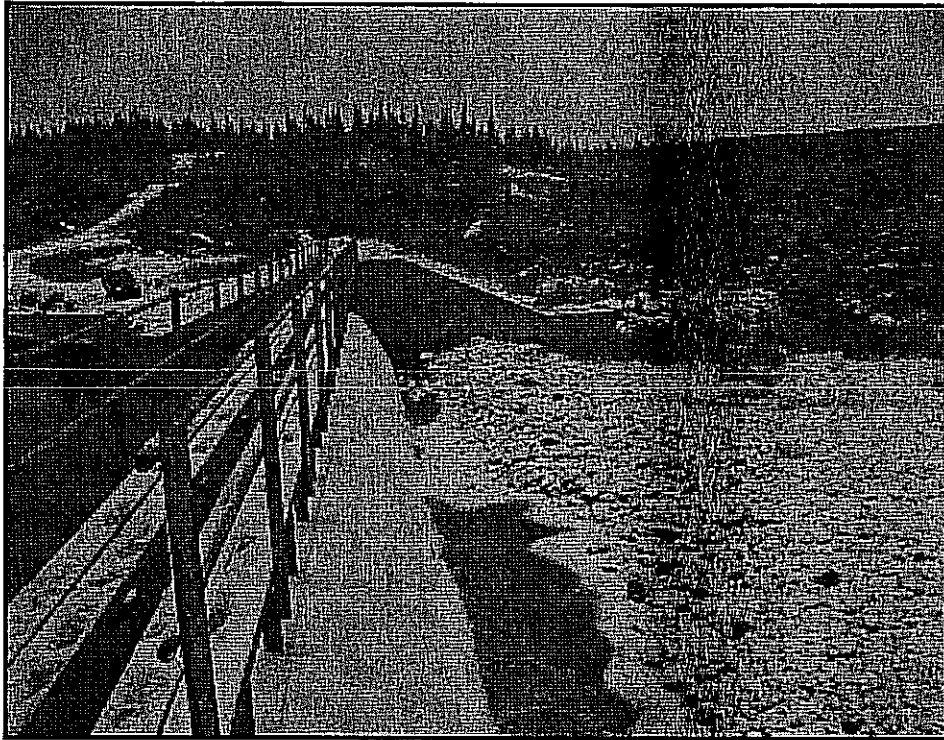
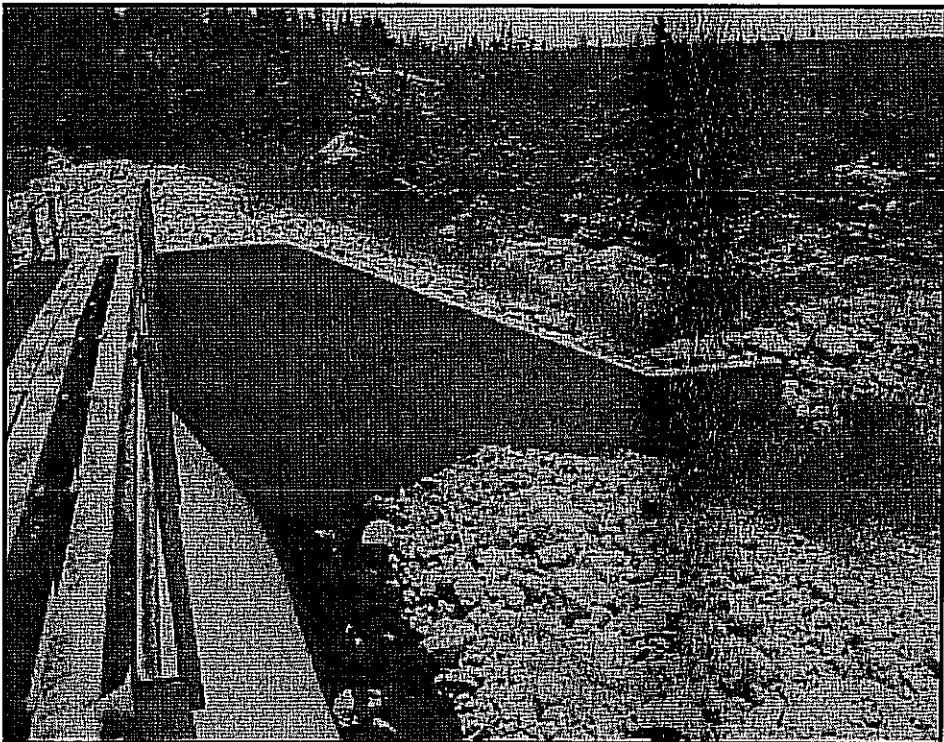
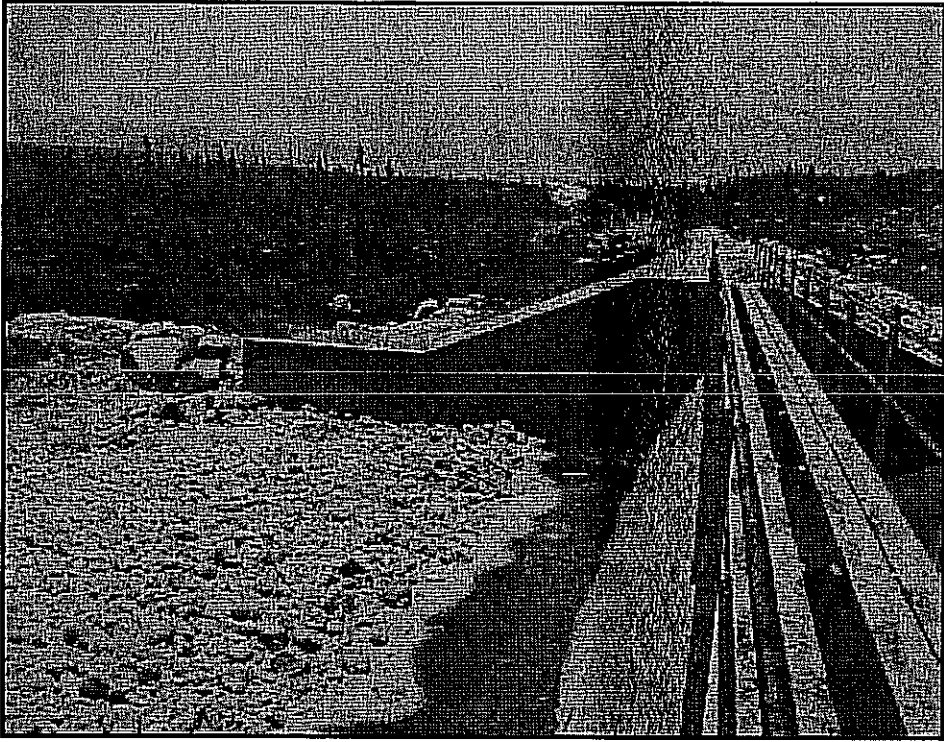
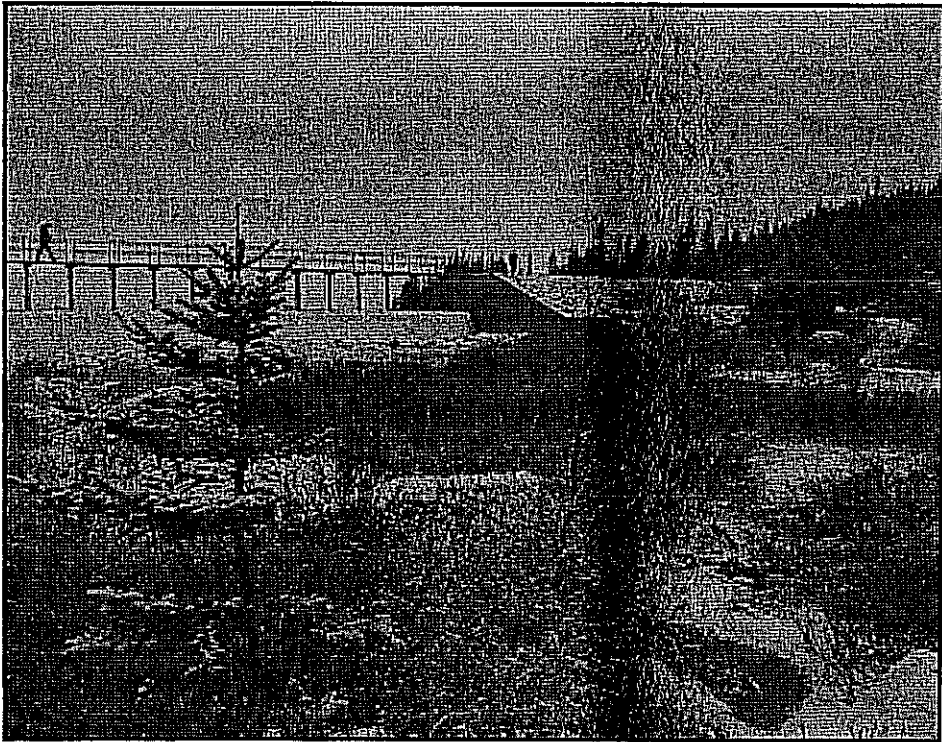
Structure : Cluneys Canal Diversion Dam/Spillway Date/Time : 2005-12-20
Inspected by : TC, RH, RV Water Level : 3' below spill
Weather : Overcast, 2°C Releases : N/A

No problems noted. Rockfill in good condition.

The abutments were in good condition. Cutting and clearing of vegetation is required.

Galvanized steel cut-off wall appears to be in good condition.
