Q. Re: Rocky Pond Plant Refurbishment (p. 2 of 81, Schedule B) - Provide for the last five years:

2005 Dam Safety Inspection Report

**Tors Cove /
Rocky Pond
Developments**

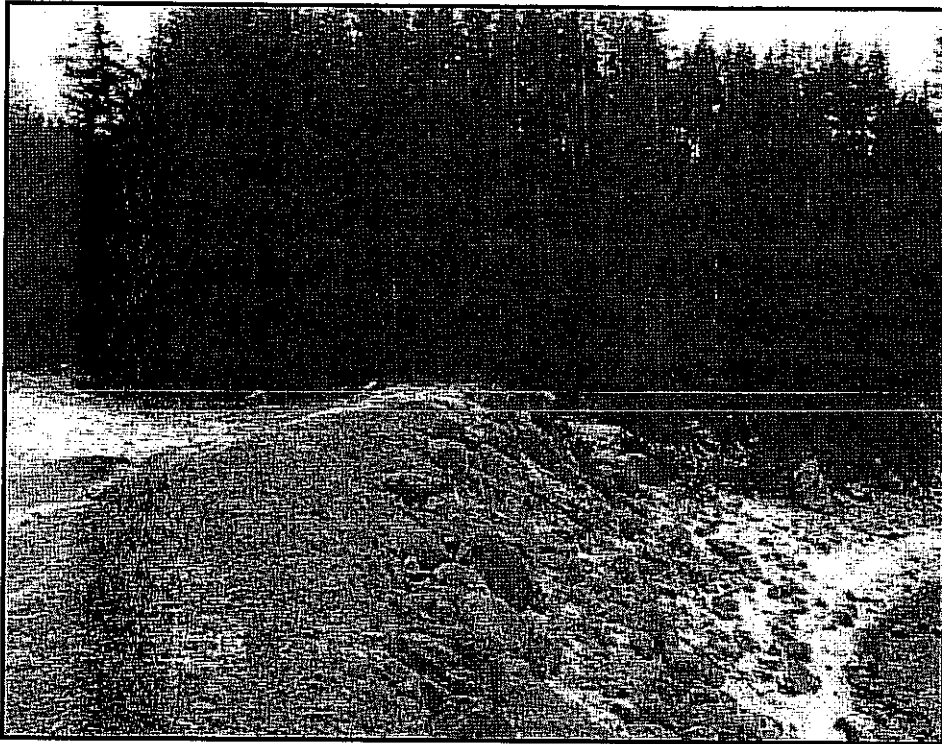
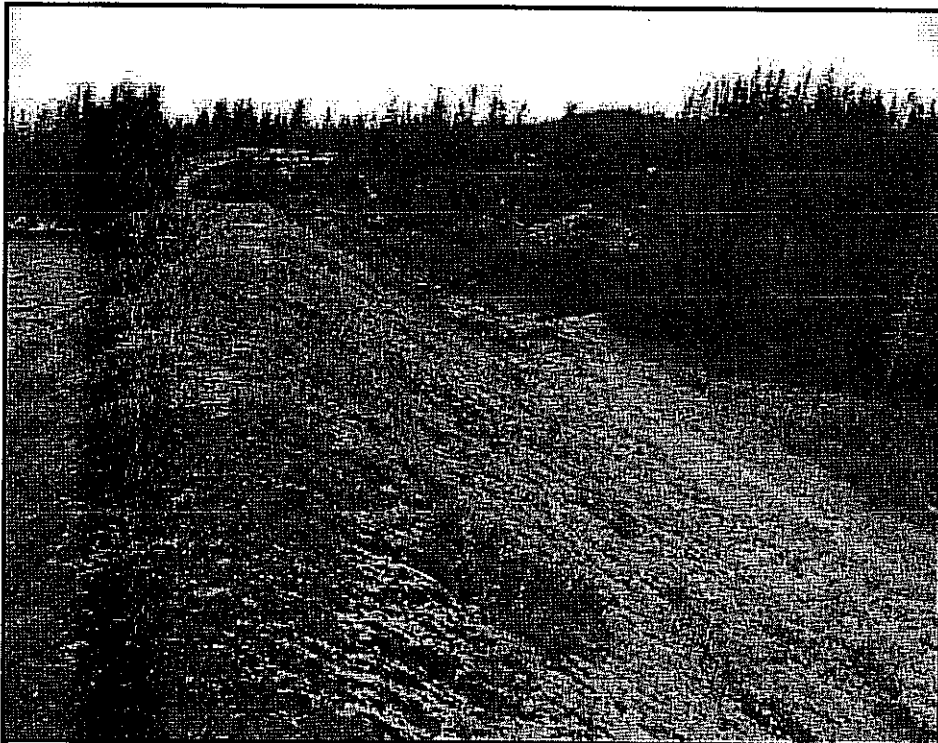
Abutments in good condition. No unusual conditions noted.

The crest appeared to be in good condition. There were no signs of overtopping.

ATV traffic is not causing deterioration.

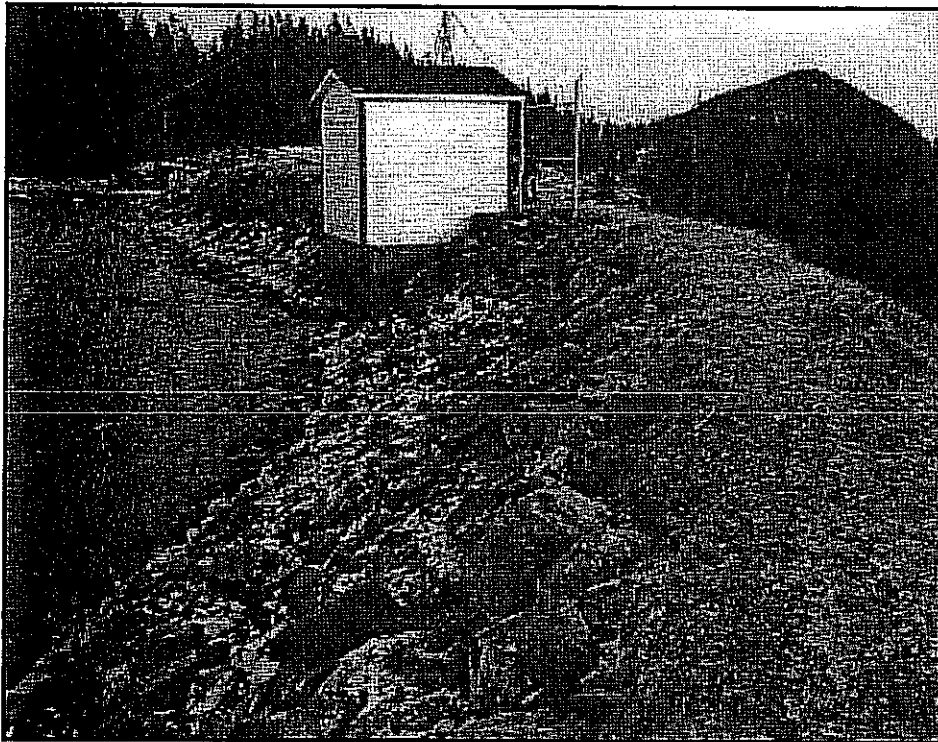
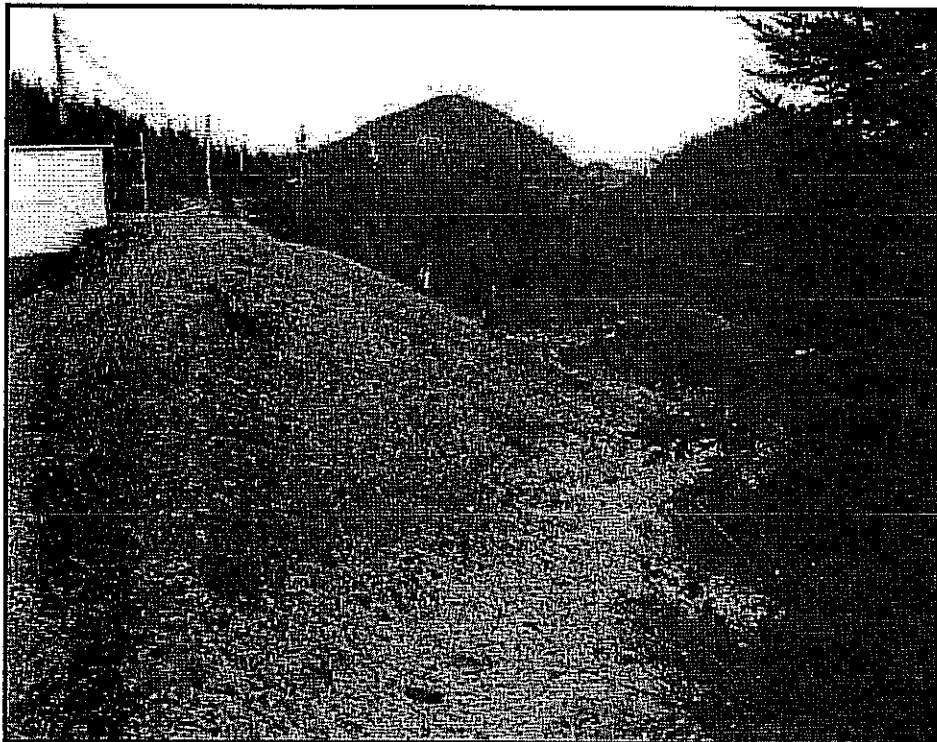
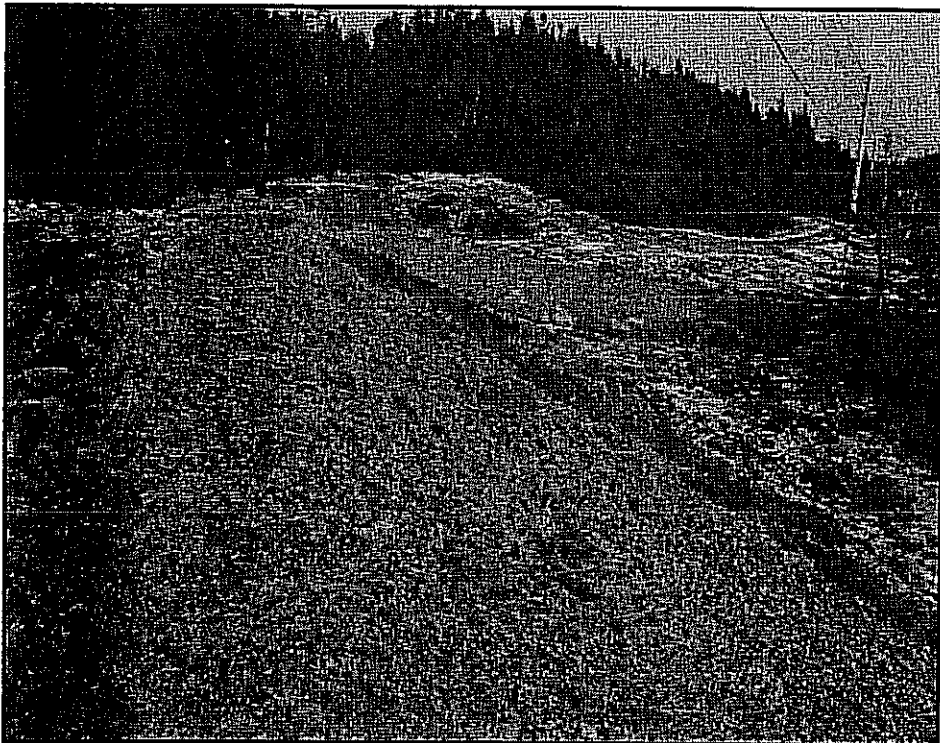
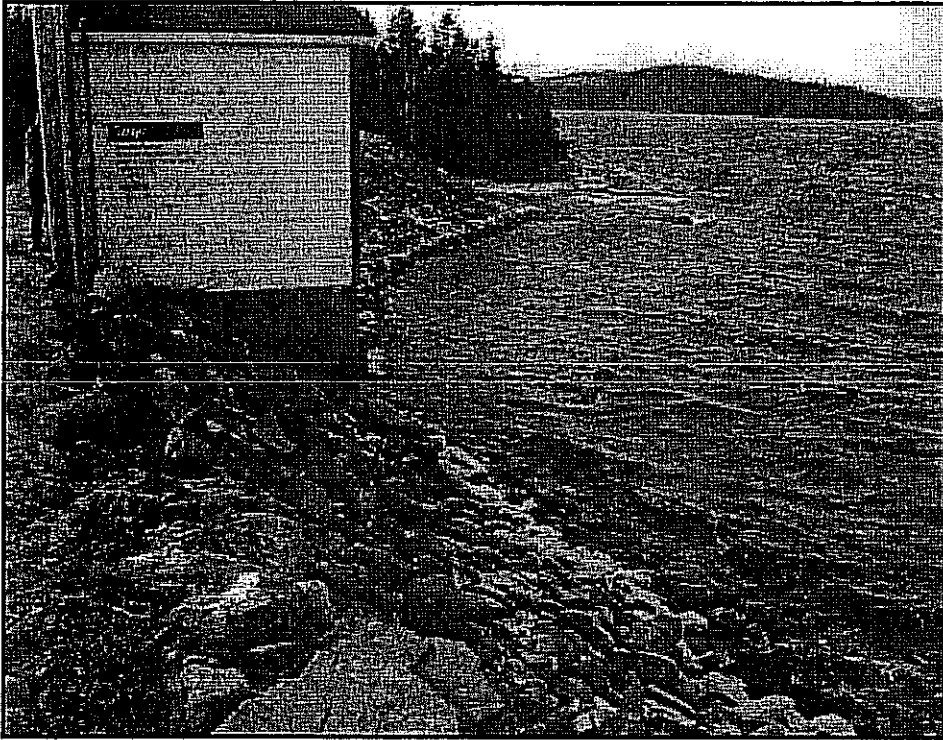
Some isolated areas of erosion damage (likely due to wave action).

The downstream face appeared to be in good condition.

Abutments were in good condition. No unusual conditions.

None observed

Intake structure not inspected at this time.

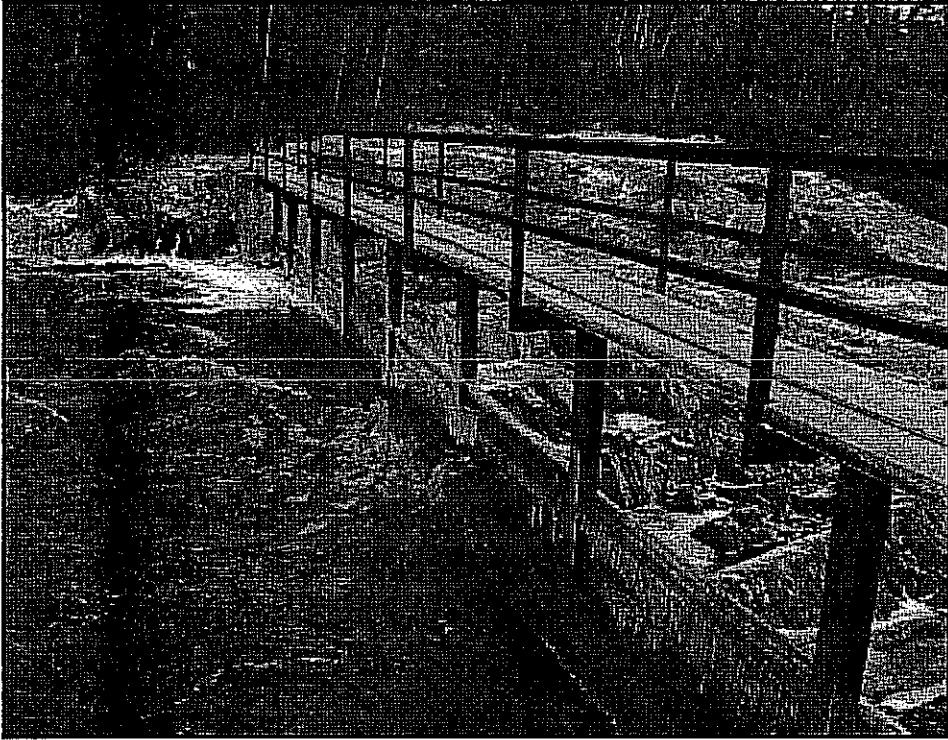
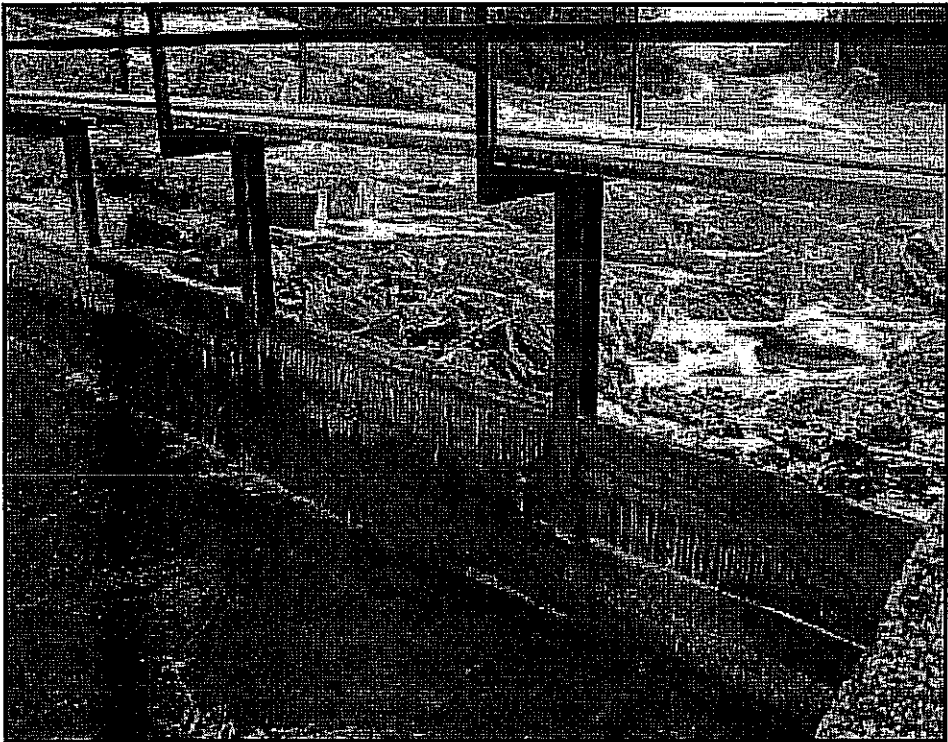
The walkway was in fair condition overall.

No problems were observed.

Abutments were in good condition.
