1 Q. **Reference: Program 1 Overhaul Turbine and Valves Unit 3, page 12.**

HOLYROOD UNIT 3 INFORMATION

Holyrood Unit 3
March 2024

Holyrood Unit 3
April 2024

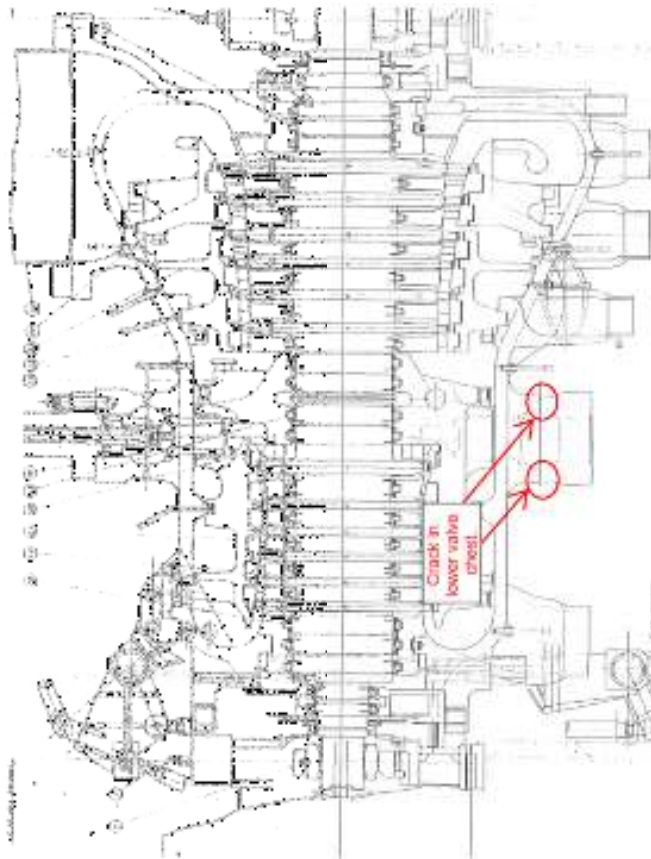
Cross Section & Steam Temperatures

Inlet Steam: 1000 F

Reheat Steam: 1000 F

Inlet Pressure: 1800 PSI

Mass Flow: 135 kg/s

Rated Speed: 3600 RPM

COD: 1979

OH: > 250,000
