Re: Application for Capital Expenditures for the Life Extension of Bay d'Espoir Unit 7 – Redacted

Please find enclosed Newfoundland and Labrador Hydro's ("Hydro") application for the capital expenditures required for the life extension of Unit 7 of the Bay d'Espoir Hydroelectric Generating Facility ("Bay d'Espoir Unit 7").

Engineering Report
Mechanical Engineering
Bay D'Espoir Unit 7 Condition Assessment Condition
Report

Bay d'Espoir – Newfoundland and Labrador Hydro		
Unit 7 Refurbishment Report Project Report	TFS7000	
	PDM Doc ID:	Doc. Revision:
	2-10066279	-

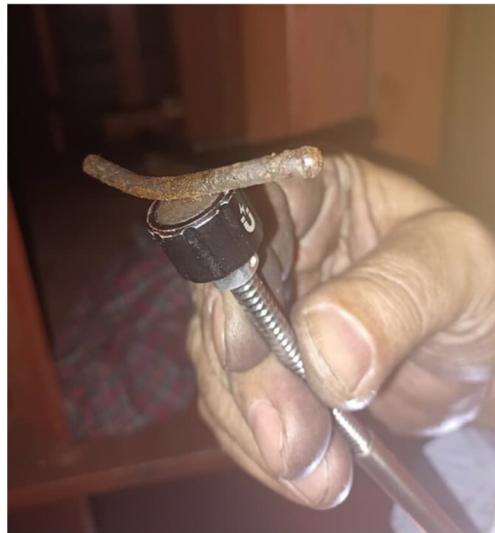
Figure 3-1: Example of Typical Magnetic Debris (Piece of Welding Rod) Found on the Shelves of the Stator Frame

Significant amount of steel chips and debris at the bottom and intermediate frame shelves were observed. Figure 3-1 shows an example of such debris. These were confirmed as being magnetic materials by picking them up with a magnet. It included fillings, chips, pieces of welding materials and small nuts and bolts. This debris could be brought from the back of the core into the bar slot by the flow of cooling air.

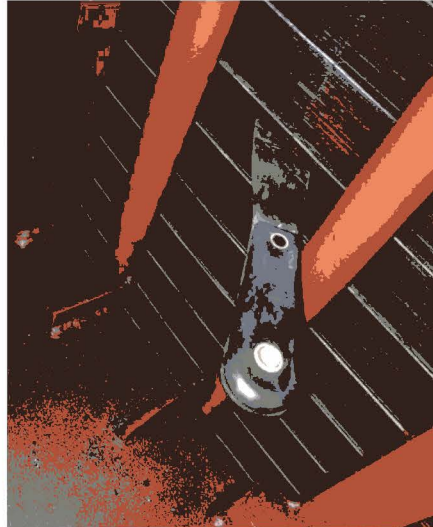
Figure 3-2: Blade Inserted Between Core Laminations

Hatch performed stator core knife test at the back of the core where cooler # 6 was removed. A 0.010" thick blade was inserted with very small resistance between adjacent core

laminations for almost an inch. A core considered properly clamped would allow an insertion of no more than $\frac{1}{4}$ inch.

The result of the knife test indicates there is looseness on the core clamping. Documentation indicates movement of nuts on at least two core clamping studs, which corroborate the knife test result.

The core back was also rusted in its entirety. The brown color can be seen in Figure 3-2. Normally, even with age, the back of the laminations does not rust, unless due to a chemical reaction that happens when ozone is created as part of the partial discharge process or when the stator core is exposed to high humidity for prolonged periods out of service.

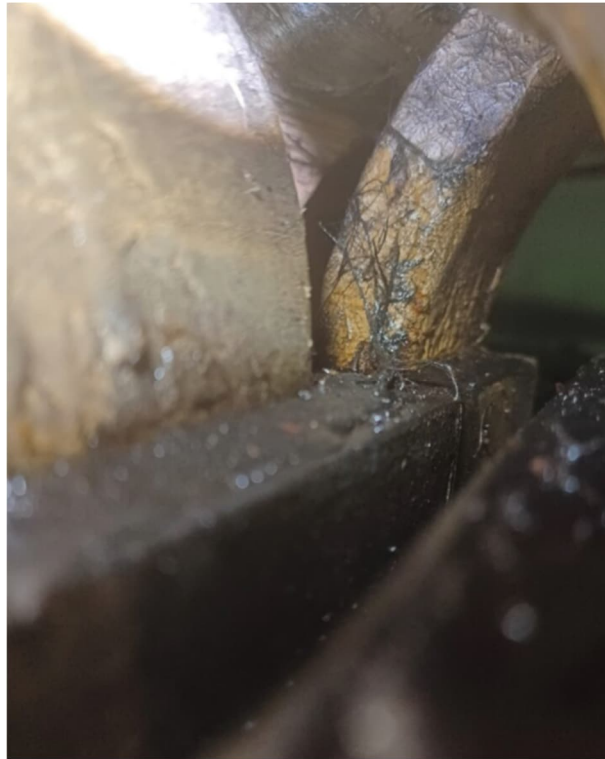
Figure 3-3: Fiberglass Sticking from Edge of Slot

Slot wedges seem to be intact when checked from the access point of top of the rotor between the adjacent poles. Stator winding lashing, tying and supports are intact, but a number of instances were verified where glass fibers are seen sticking out. Figure 3-3 shows an example. This is normally a result of poor workmanship at the time of installation. This can create conditions for tracking, bridging of insulating paths, and increased partial discharge over time. However, no visible evidence of such phenomena was seen at the locations inspected.

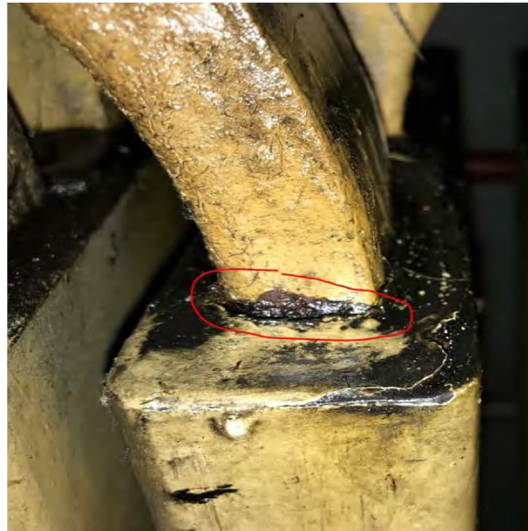
Figure 3-4: Example of Cracks at the Edges of End-Winding Caps

Inspection of the winding on the bottom of the unit revealed some bars with cracks in the insulation right at the bar entrance into the cap compound (Figure 3-4). Such cracks are far from the active part of the bar, but they increase the likelihood that conductive dirt (like carbon dust mixed with oil) can be collected in the crack. This creates possible conductive paths closer to grounded elements, leading to increased partial discharge and possibly even a flashover.

These cracks may become particularly troublesome in the presence of the metallic debris described in Section 3.4.1.1. Even in our limited inspection, we managed to collect a significant amount of magnetic metallic filings deposited on top of the bottom end-windings caps (Figure 3-5).

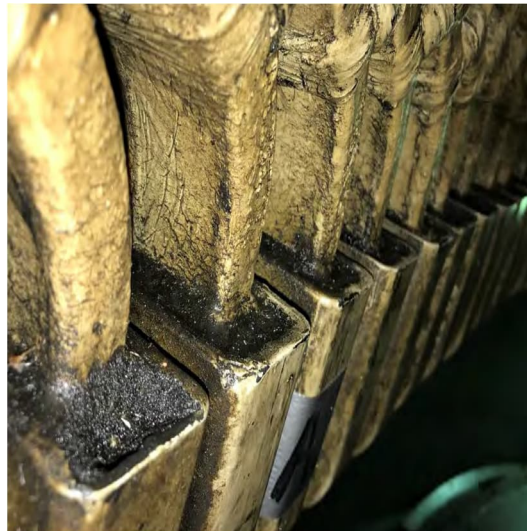
Figure 3-6: Bubbling of the Paint of Top Bars from Slots 196 and 197. Slot of Top Bar Closest to Observer is 196 (Source: NL Hydro Engineering Report, Part of the 2019 Outage Report)

End-winding caps at the bottom of the unit in slots from 194 to 200 have significant stress of the ground wall insulation. It seems that a proper overlap of epoxy resin and mica powder mixture with factory finished ground wall insulation was not achieved during installation. In addition, the significant bubbling of the paint on the back bars in slots 196 and 197 is a sign of possible cold joints inside the caps. The combination of those two workmanship issues during installation can create conditions for overheating. The apparent pitting of the insulation compound that fills the end cap of the top bar of slot 196 is a typical result of overheating at a defective brazing where the resin as organic material can gradually burn out. The fact that the damage seems to be symmetrical in relation to the top bar of slot 196 is also an indication of defective brazing of the end-winding arms. Figure 3-6 shows the paint bubbling and the cavity in the end cap of the top bar of slot 196.

Furthermore, the bars in this region are subjected to high voltage stress, including low and high voltage bars in proximity. The heavy collection of conductive soot of carbon dust and oil over creates a tracking path that can bridge insulation between phases and amplify the stress they experience. A phase-to-phase failure is a possible outcome if the area is not thoroughly cleaned, and the affected insulation repaired.

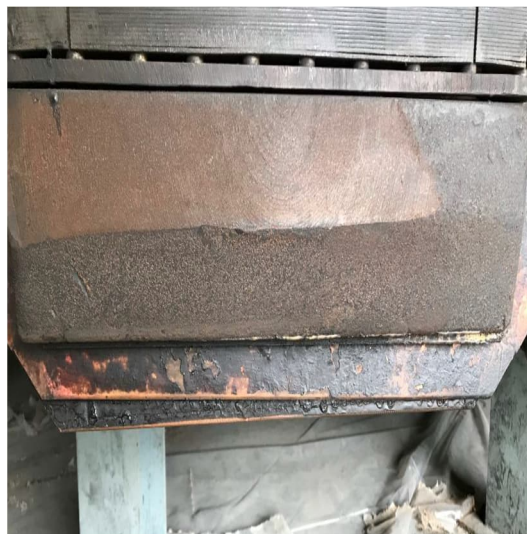
Figure 3-7: Dislodged Field Coil on Pole #20 (Source: 2019 Outage Report)

The insulation between each turn of each coil is still mostly intact, but all the rest that is exposed to air and not compressed between the turns is degraded and in advanced stage of deterioration. In Figure 3-7 it is possible to see the edges and fraying of the interturn insulation.

Minor signs of movement from the field coils in these two poles are also visible (Figure 3-7), although the extent of movement is minimal. It was not possible to verify dislodging to the

Reinsulating the field winding is the only repair possible, and there are no partial repairs to be considered. This repair must include all components of the field windings insulation, except for the field leads – these have been reinsulated during the 2019 outage. Therefore, the repair must include reinsulating pole coils, the pole bodies, and the U-shape connectors. A detailed inspection of the bolts, nuts and washers need to take place. Seen as it is a common practice for NL Hydro to regularly remove two poles to clean the core superficially, verification of the state of the keys is also required, and it is likely they will need to be replaced as well.

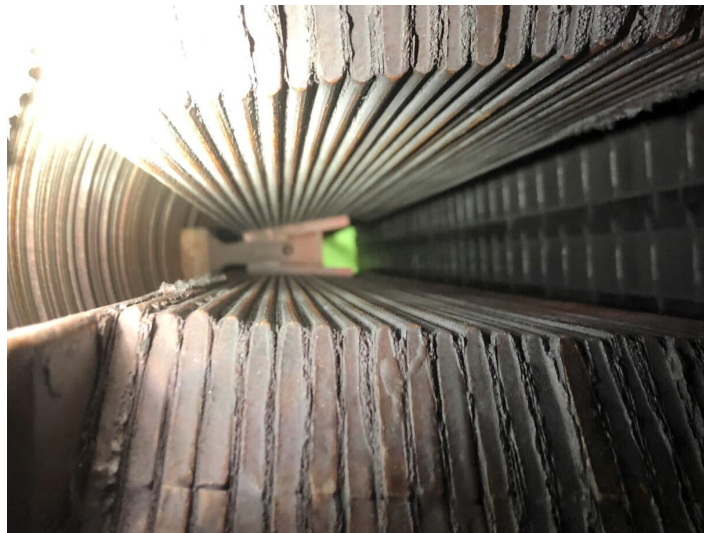
Figure 3-8: Typical state of pole coil Insulation seen from the top. In red are marked minor movement of a few coils.

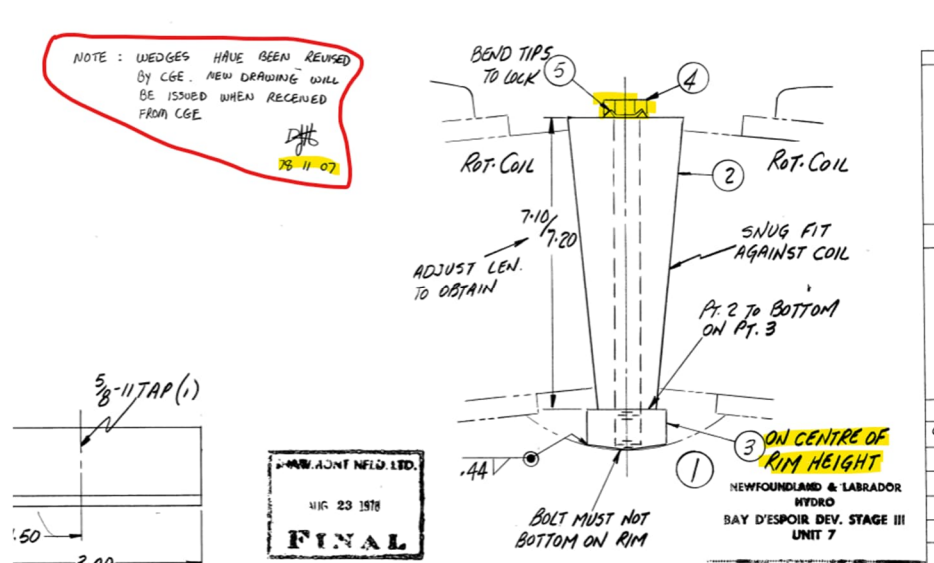
The V blocks that restrain the field coil of the adjacent poles are intact but installed at a different height and in a different method than indicated in the OEM drawing. However, the drawing contains a note of a date more recent than the issue date stating that the coil V blocks (called “wedge” in the note) has been reviewed. No further information is available. An excerpt is show in Figure 3-9.

Figure 3-9: Excerpt from Coil Bracket Drawing (M-1337-03-213G) showing installation details not verified during the 2019 outage. Note mentions a further drawing to be issued.

As the hub and rim are in a sound state, a large life extension can be obtained by reinsulating the field winding to class F insulation. The poles bodies also need repair, but their repair on its own will not achieve any extension of useful life. It is also necessary to confirm the proper installation method of the coil brackets / V blocks.

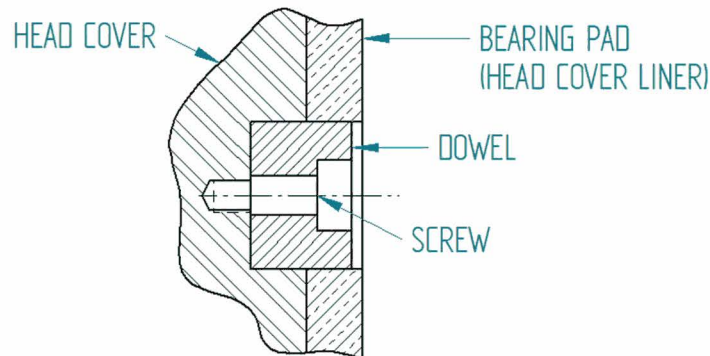
Figure 3-11: Example Dowel Concept Sketch to Secure Operating Ring Bearing Pads (NTS)

Supply new greaseless bearing pads (head cover liners). Preference towards metallic base material with self-contained lubricant that is machinable. It is recommended to secure the bearing pads to the head cover with a dowel to hold the pads in place. Refer to Figure 3-11 for a conceptual sketch.

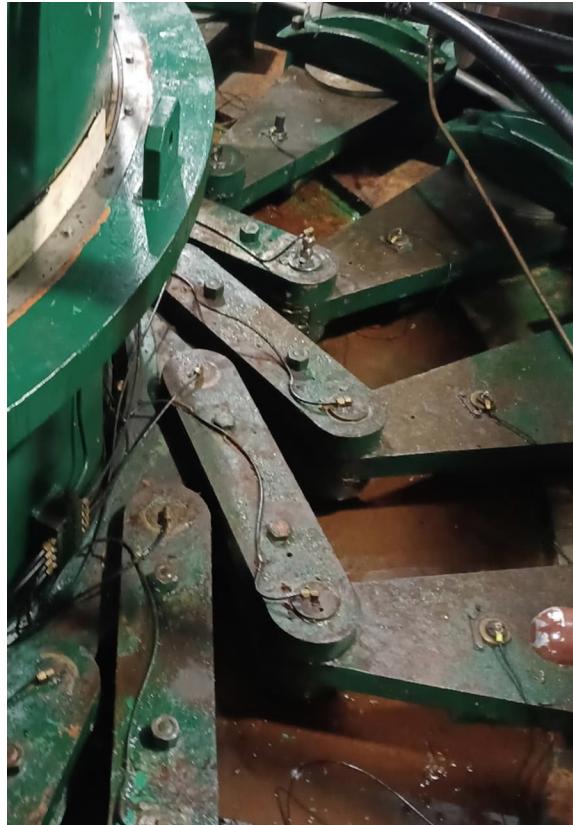
Figure 3-13: Gate Arms and Links (October 2023)

During the 2019 outage, the wicket gate arms and linkages were removed from the turbine pit and disassembled. The components were cleaned and Voith performed a visual assessment of the components. There was no NDE or dimensional inspection of the gate arms, linkages, or pins during the 2019 outage. Voith did not find any indications of concern and did not provide any formal recommendations during the outage.

During the next major outage, adjust the wicket gate alignment, seal clearances, operating links / levers, and gate servomotor to re-establish the OEM design gate squeeze. This process is standard during the reassembly process.

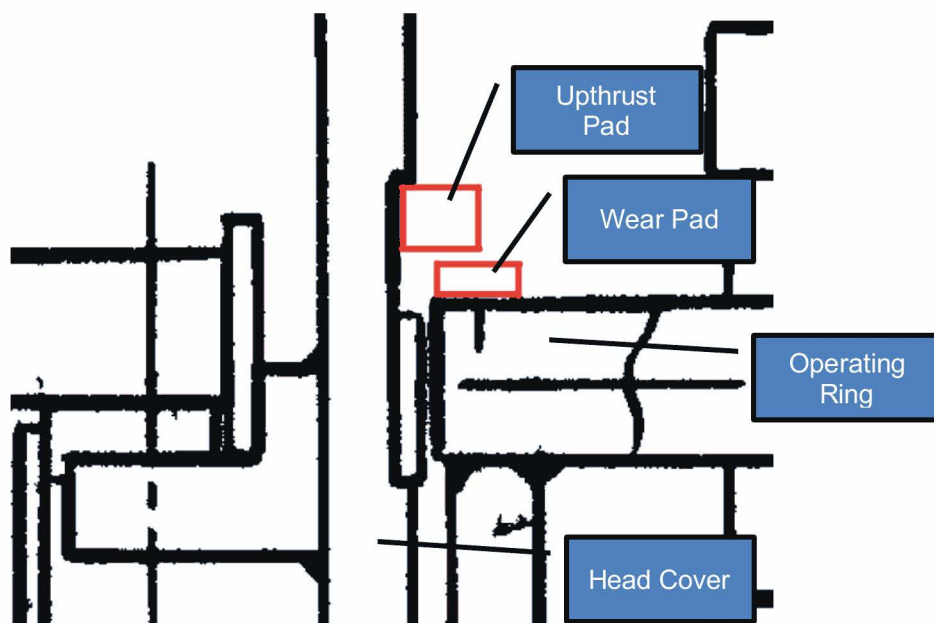
Figure 3-14: Example Upthrust Pad Concept Sketch (NTS)

Installation of upthrust clips is recommended where the OEM lip seal was. The lip seal is not necessary if converting to greaseless / self-lubricated bearing pads. Refer to Figure 3-14 for a conceptual sketch.

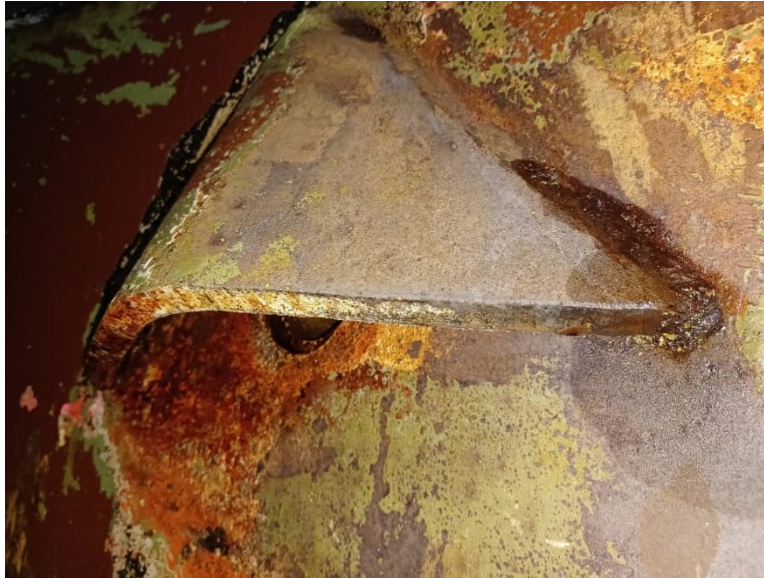
During the 2023 site visits, Hatch was not able to inspect or assess the discharge ring. Hatch was able to verify the draft tube was absent of major Voids as this was checked by Mike Taylor of NL Hydro with the witness of Andrew Breighner of Hatch. There was minor deterioration of the welds connecting air admission vent covers to the draft tube, but nothing of structural concern. See Figure 3-15. There were also areas where the paint was eroded and areas of rust.

Figure 3-15: Aeration Pipe Injection Pipe to Draft Tube with Scoop / Cover

The long-term recommendation by Voith in 2019 was for the discharge ring and draft tube to be blasted, NDE, void checked, and painted. Hatch agrees with Voith's recommendations.

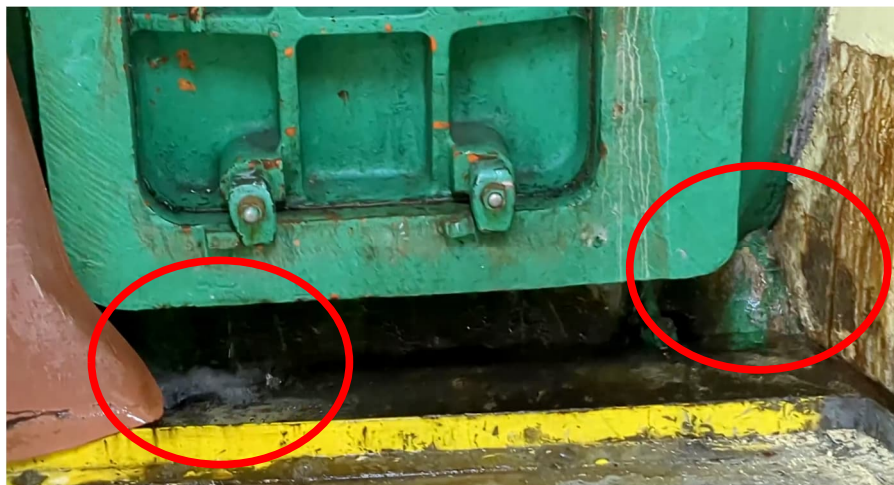
There is significant flow of water leaking around the spiral case access door between the concrete and the spiral case. NL Hydro reported that this leakage has existed in some form for at least 30 years (Customer Meeting November 6, 2023). A photo of the leakage is shown in Figure 3-17.

Figure 3-17: Scroll Case Leakage

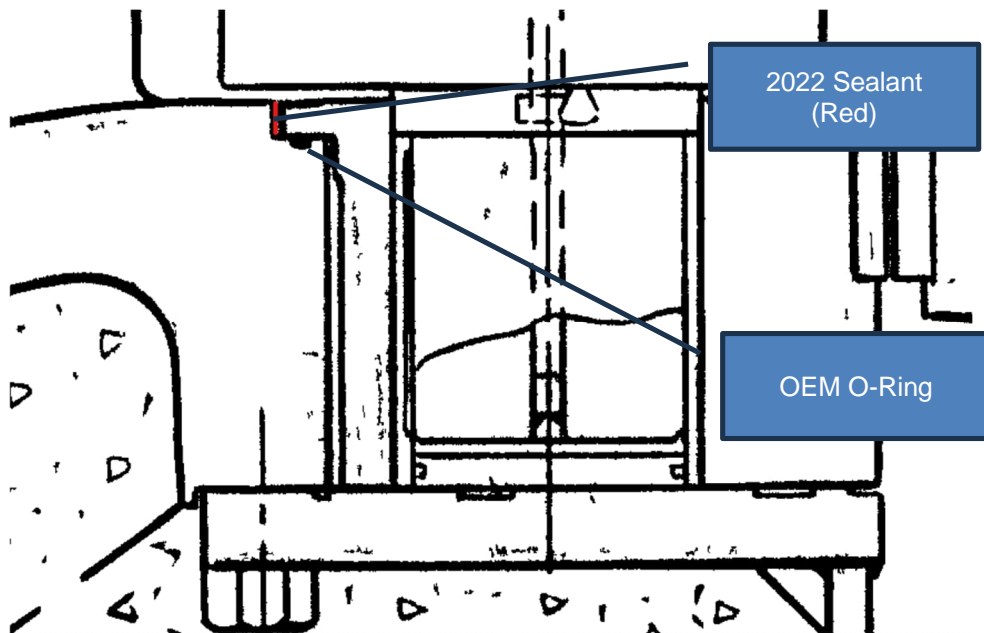
In the fall of 2022, an O-ring and silicone based Permetex product was placed between the bottom ring and stay ring. Refer to Figure 3-18 and Figure 3-19. This was inspected in October 2023 and appeared to be intact, but the effectiveness of the seal was not measured. The bottom ring was not removed in 2019 and therefore the O-ring seal under the bottom ring flange was not able to be inspected or replaced. The silicon was an attempt to re-establish this seal between the two components.

Figure 3-18: Location of Silicon Highlighted in Red (Turbine Cross Section)

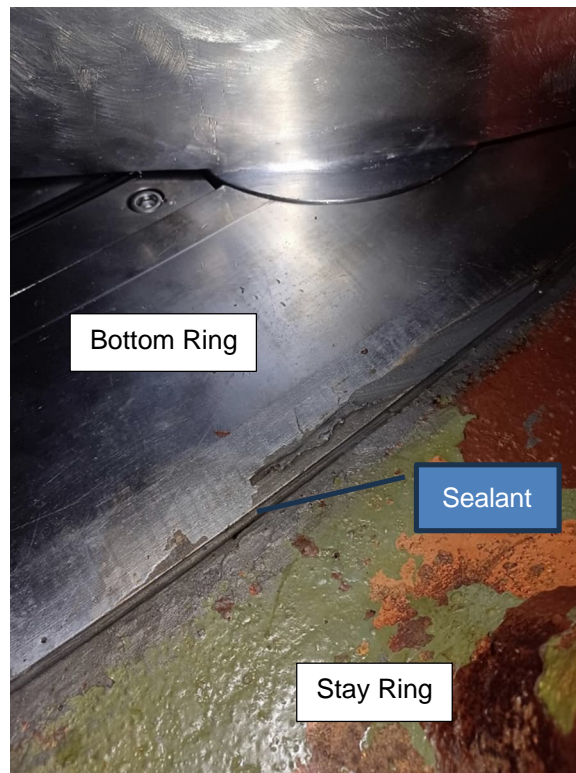
Figure 3-19: Silicon Sealant between Bottom Ring and Stay Ring (October 2023)

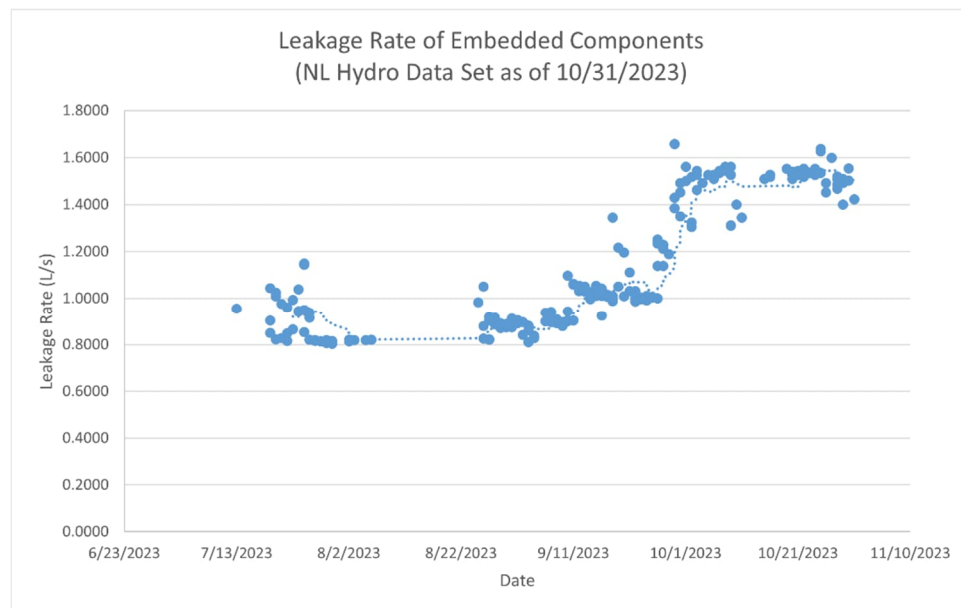
NL Hydro provided Hatch flow information regarding the leakage around the spiral case in October 2023. Data was collected over 200 times from July through October of 2023 with three samples being taken each time. The leakage was measured by recording the time it took to fill a bucket of a known volume that flowed to the sump pit from the drainage canals. As part of the data collection, the date, time, weather, headwater elevation, tailwater elevation, unit output (MW), and unit status (ECON / Power Generation or Synchronous Condense Operation) was recorded. Figure 3-20 summarizes the flow rate data over time.

Figure 3-20: Leakage Rate of Spiral Case Over Time (NL Hydro Collected Data)

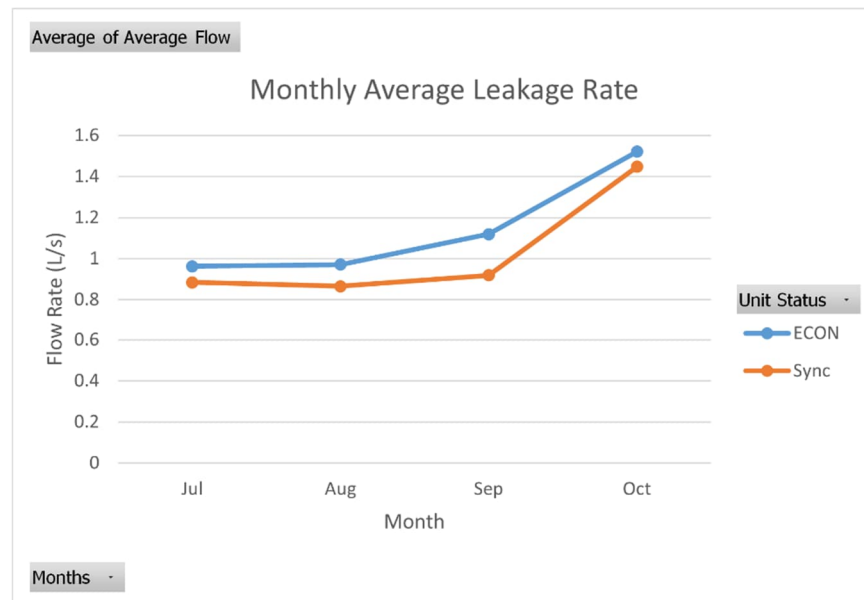
The data shows that the average leakage during synchronous condense operation is lower than the average leakage during ECON operation. However, the percentage difference is not consistent month to month. See Figure 3-21.

Figure 3-21: Average Leakage Rate of Spiral Case per Month (NL Hydro Collected Data)

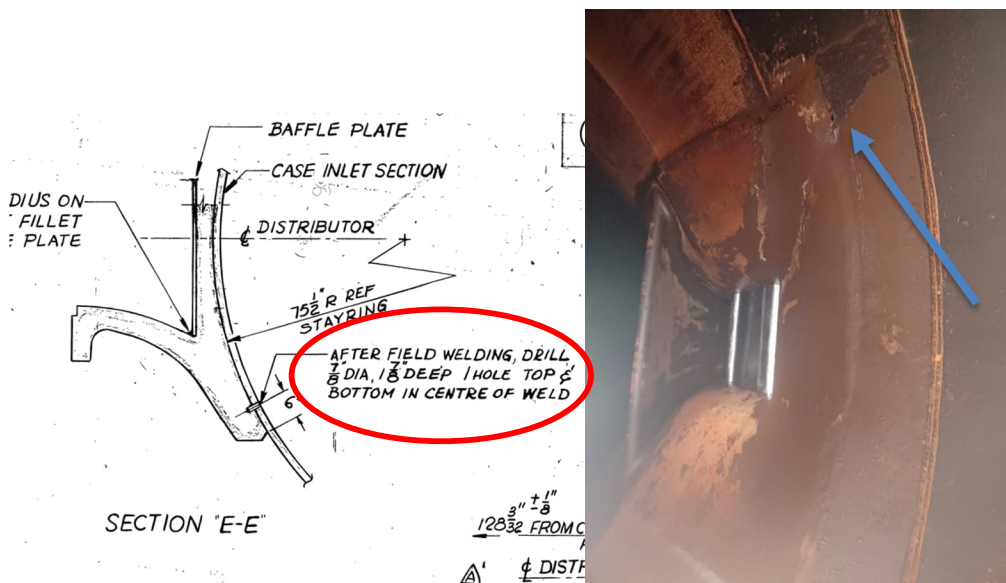
Another possible source of the water is from drilled holes in the weld seam of the spiral case inlet. From the original build, two 7/8-inch diameter holes were drilled 1 7/8 inch deep in the center of the weld. This could have opened a path between the walls of the spiral case and the stay ring casting.

Further investigation is needed as to the use of these holes. If deemed unnecessary, these holes could be filled and capped as to prevent any leakage.

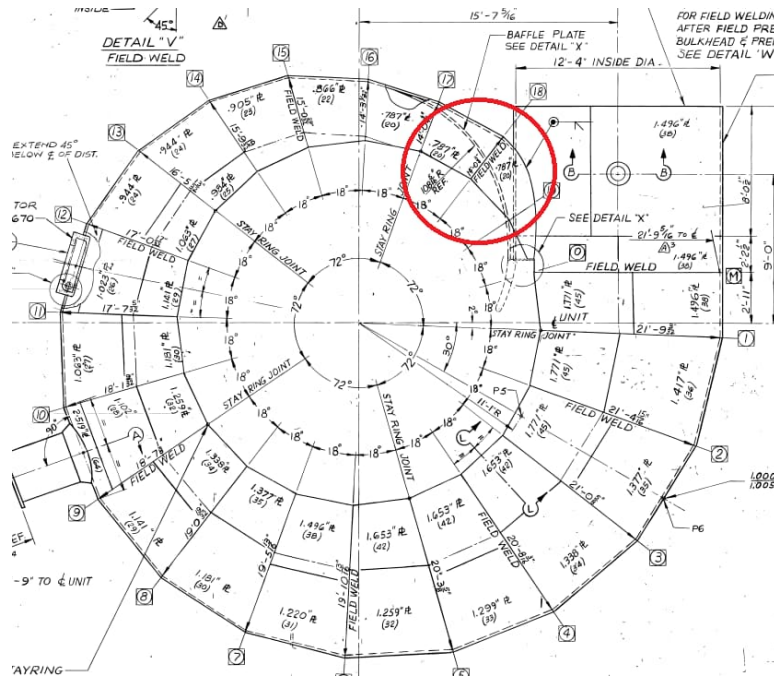
On October 13th the bottom of the scroll case was slightly damp as the water hadn't fully drained and evaporated from dewatering. On October 14th, the spiral case was dry except for one stream of water still coming from behind the baffle plate at the end of the spiral and a stream of water coming from the pressure relief valve. The leakage behind the baffle could have been water dripping from debris built up behind it, but it was not possible for Hatch to fully inspect with the equipment available during the October 2023 site visit.

Figure 3-23: Spiral Case Location of Observed Possible Water Leakage

Any recommended changes or repairs would require a better understanding of the location and extent of any discovered leakage path. Worst case scenario would be to remove the baffle plate, weld repair parts of the spiral case, then reinstall or replace the baffle plate.

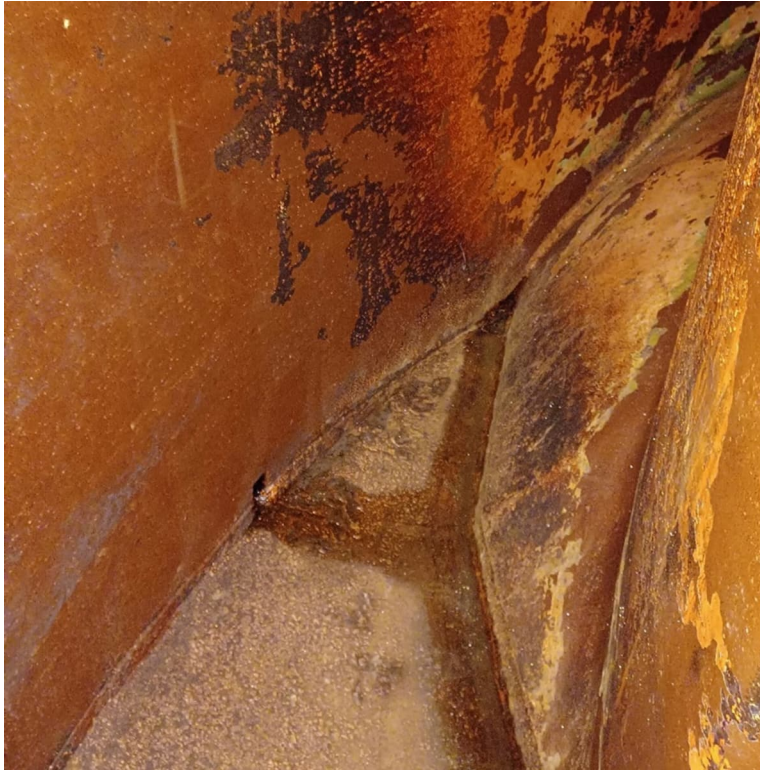
Figure 3-24: Spiral Case Location of Observed Water (October 14, 2023)

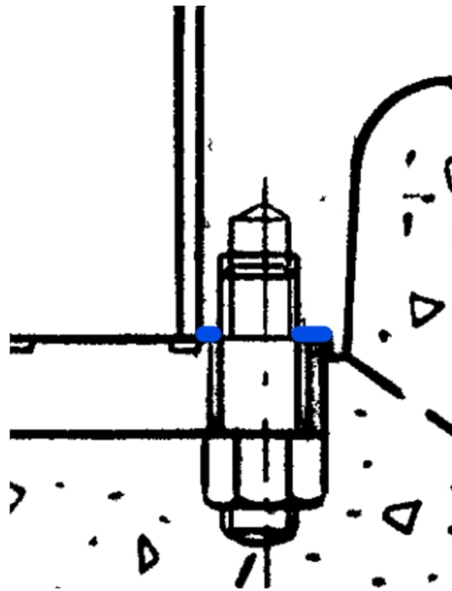
Figure 3-29: Stay Ring to Discharge Ring Bolted Connection

There is no means to inspect this connection without removing the discharge ring. To prevent leakage from any of these sources, a fillet weld should be added between the stay ring and discharge ring to seal the connection. A chamfer on the bottom ring would be required to ensure proper clearance.

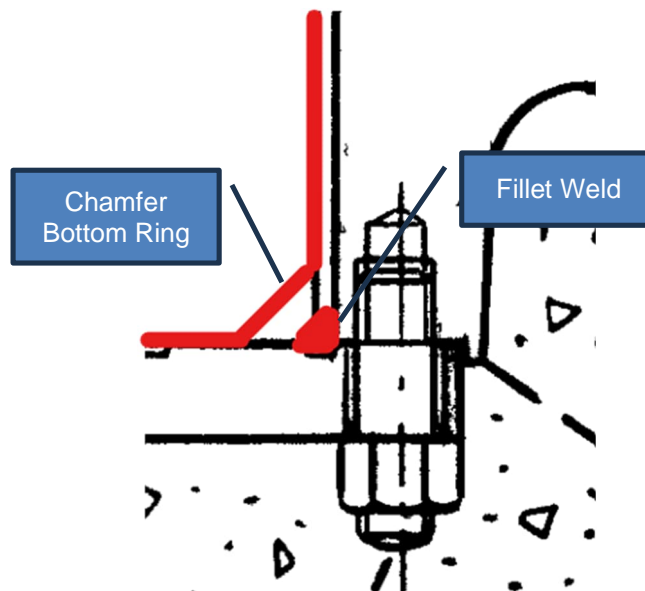
Figure 3-30: Stay Ring to Discharge Ring Recommended Modifications

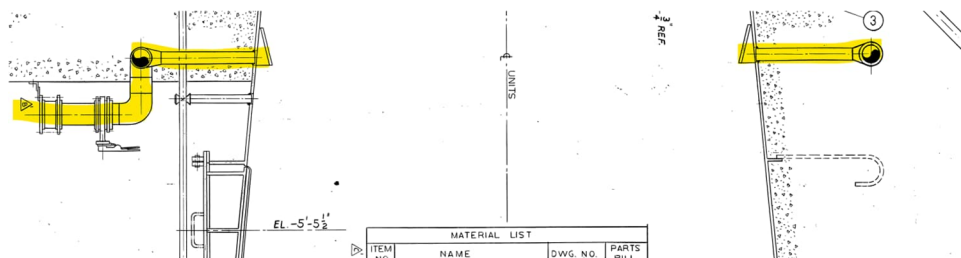
There is reported correlation between the aeration pipe check valve opening and pulsing of the leakage around the spiral case access door. There is no documentation or data collected and required further investigation to determine the causality between the two.

Figure 3-31: Draft Tube Aeration Piping

During the next major outage, it is recommended to inspect the piping with a borescope and pressure test the piping.

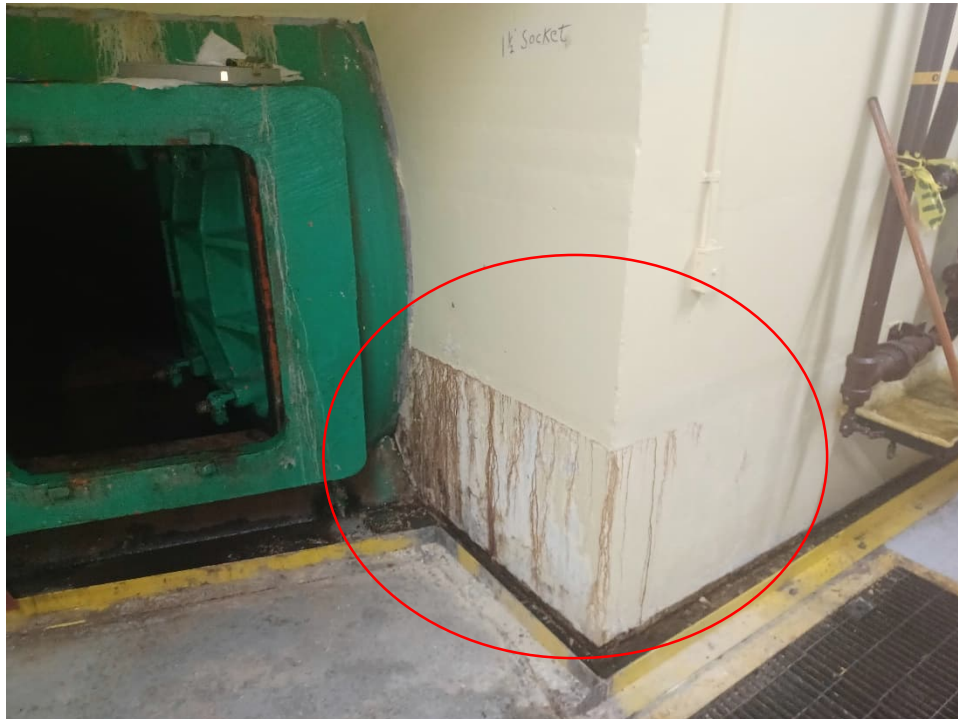
From the tailrace, there are possible seepage paths through the concrete that would align with the elevation of the spiral case access door. The area around the spiral case was poured in two stages. This would allow for cracks or gaps between the concrete pours. Evidence of water seeping through the two pours can be seen around the spiral case in the powerhouse. Refer to Figure 3-36.

Figure 3-34: Water Seepage Between Concrete Pours

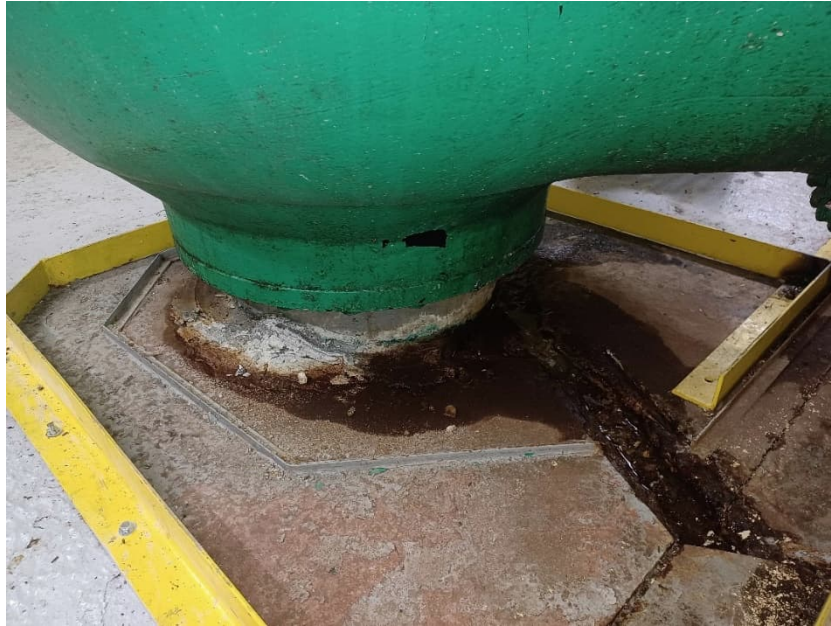
There was observed leakage around the spiral case pressure relief valve outlet pipe connecting to the concrete as shown in Figure 3-35. There was also observed leakage in October 2023 inside the relief valve. A photo of the relief valve leakage is shown in Figure 3-36

Figure 3-35: Relief Valve Discharge Pipe Leakage (Unit Dewatered)

During the next outage, it is recommended to examine the outlet pipe and diffuser of the relief valve for any signs of corrosion, cavitation, or other damage. The water velocities through the pipe could be very high and turbulent. Partial replacement or repair of the connecting flange and piping just downstream of the valve may be required depending on the results of an inspection. This would be considered the worst-case scenario.

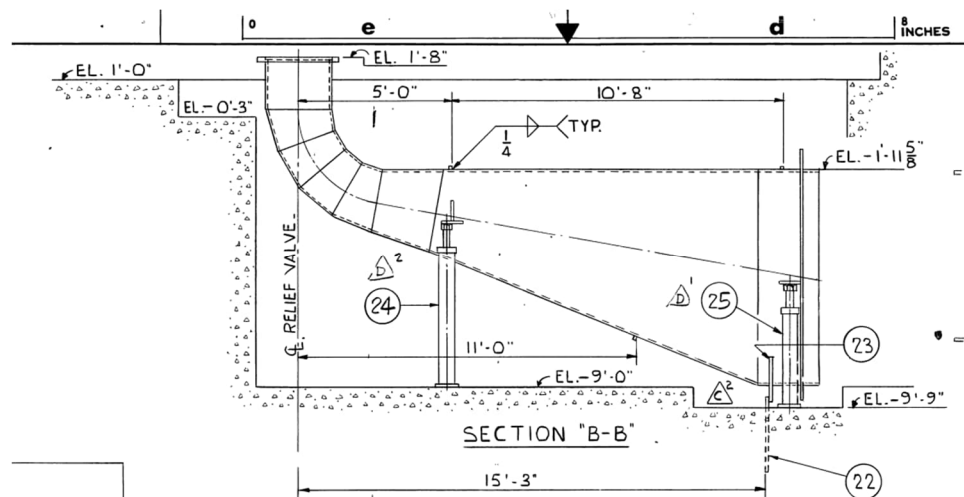
Figure 3-37: Relief Valve Outlet Pipe and Diffuser

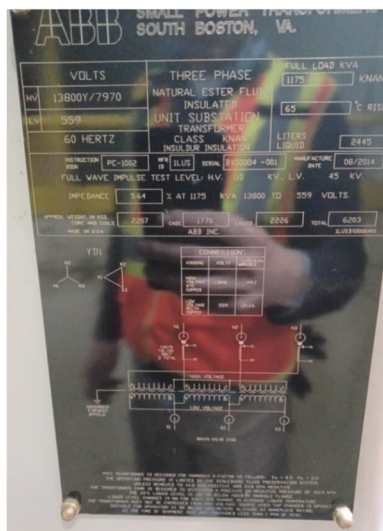
The excitation transformer was replaced in 2014 and is in very good state. It is an oil filled transformer coupled directly to the isophase bus. No issues were identified and upon visual inspection it seems to be in very good condition.

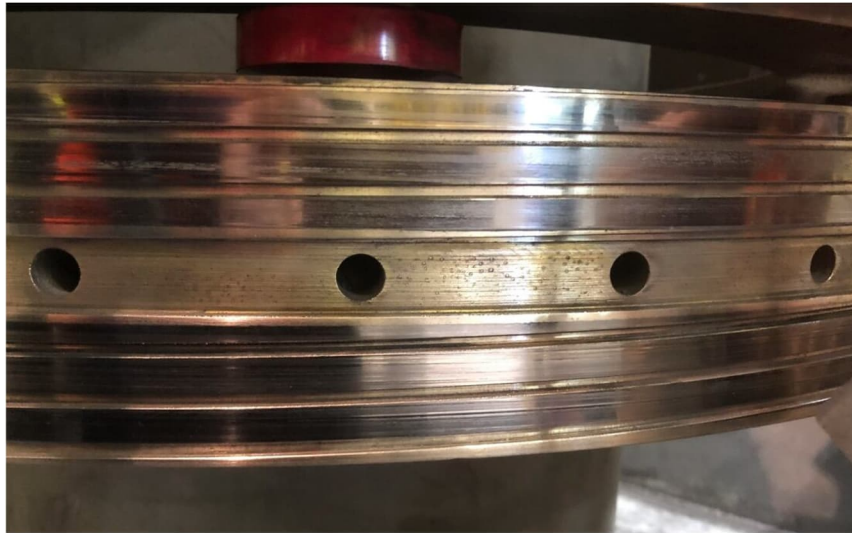
The slips rings are in good condition with standard patina due to use built on them and very light pitting on the bottom ring. This is common for the positive polarity ring. The contact surface of the brushes that were removed from brush holders were smooth and without tracks.

Figure 3-44: Typical condition of the Slip Rings (no concerns to note)

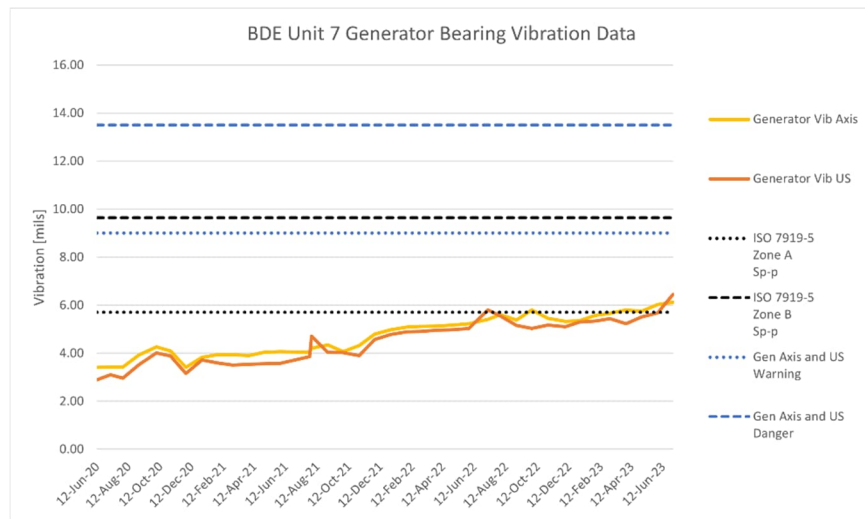
Figure 3-45: Generator Peak to Peak Vibration Trends Over Time

NL Hydro provided asset data logs from June 2020 through July 2023. Hatch noticed a trend in the data that the generator bearing vibrations have been increasing over time. Hatch took sample data for one day each month from June 2020 through July 2023 and plotted the generator and turbine vibrations against NL Hydro alarm points and ISO 7919-5 operating zone limits. See Figure 3-45 and Figure 3-46. The alarm points are set by NL Hydro to be 50% of bearing clearance for warning and 75% bearing clearance for danger. ISO 7919-5 Zone A and B limits are considered acceptable for extended operation in normal operating conditions.

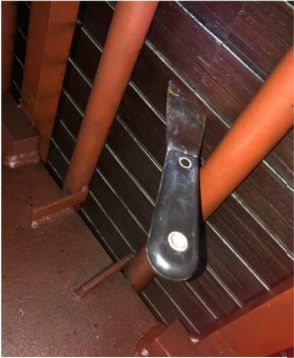
Photo 3: Turn tape peeling off

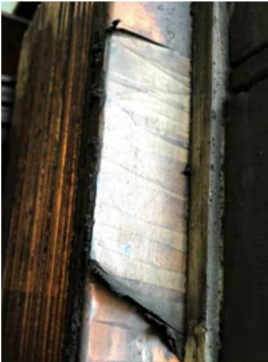
Photo 4: Misaligned field coil turn

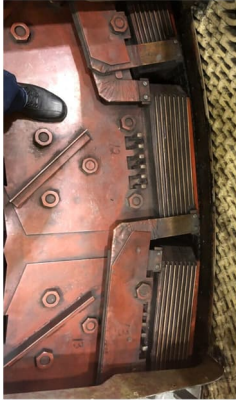
Photo 6: Debry found on the stator frame shelves

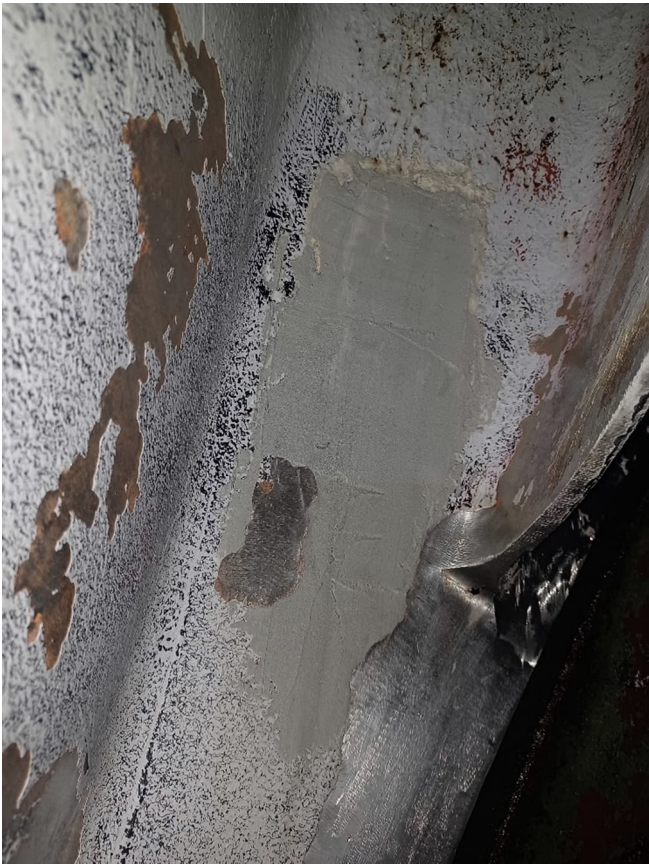
Photo 5: Cavitation Repairs on
Runner Band using Belzona

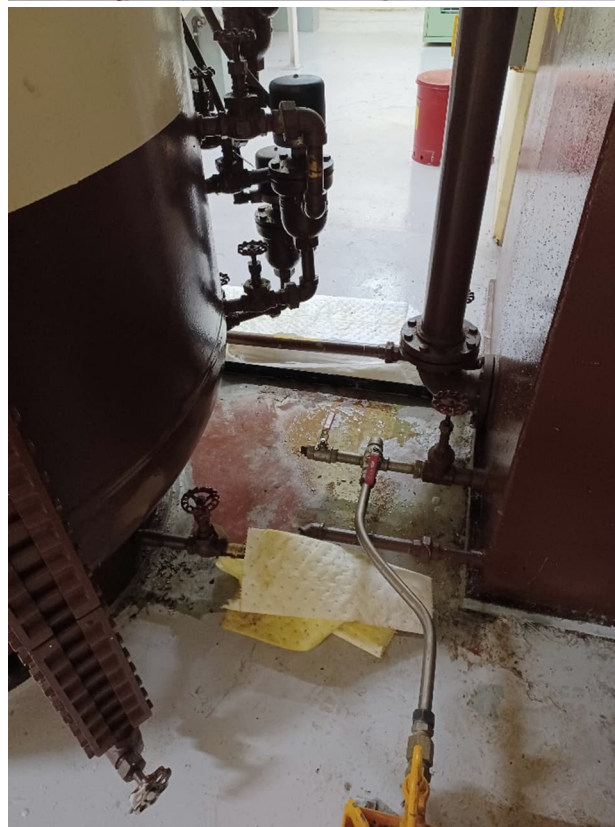
Photo 5: Leakage around
Accumulator Tank and HPU

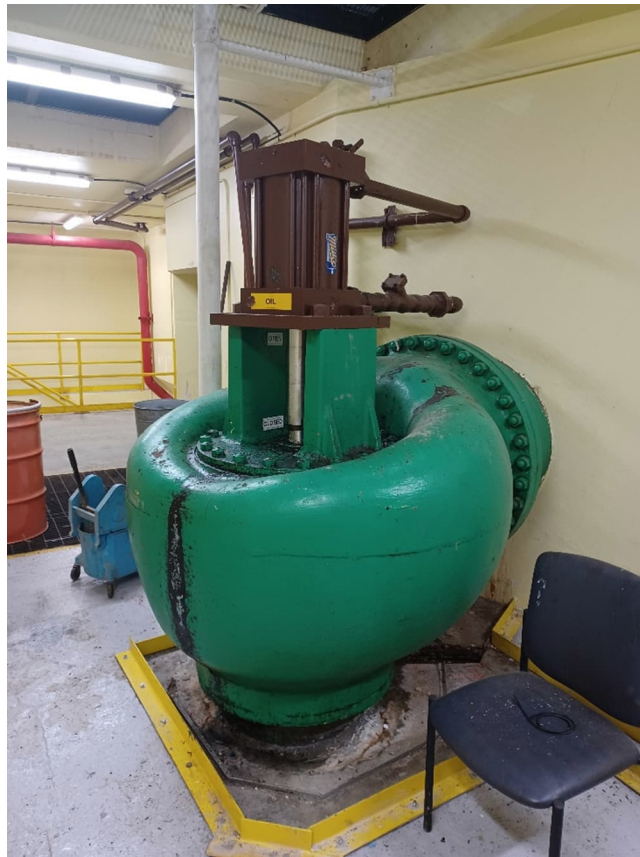
Photo 1: Valve

Relief Valve Checklist	
Site Name	Bay d'Espoir
Date of Inspection	Oct 14, 2023
Weather	Rainy, Mild
Description of Item	Main Relief Valve
Station/Unit	Bay d'Espoir, U7
Commissioning Date	1977
Diameter	
Type	<input type="checkbox"/> Butterfly <input type="checkbox"/> Spherical <input type="checkbox"/> Gate <input checked="" type="checkbox"/> Plunger
Date of Last Inspection	No known inspection.
Internal Inspection Now	<input type="checkbox"/> Yes <input checked="" type="checkbox"/> No
Estimated Number of Cycles Per Year	
Overall Condition of Relief Valve	<input type="checkbox"/> 1 <input type="checkbox"/> 2 <input type="checkbox"/> 3 <input checked="" type="checkbox"/> 4 <input type="checkbox"/> 5 <input type="checkbox"/> 6 <input type="checkbox"/> 7
Specific Notes for Condition of:	Leakage found inside of valve during Scroll Case inspection. Leakage during site visit on outlet piping and concrete.

• Leakage	<input type="checkbox"/> 1 <input type="checkbox"/> 2 <input type="checkbox"/> 3 <input type="checkbox"/> 4 <input checked="" type="checkbox"/> 5 <input type="checkbox"/> 6 <input type="checkbox"/> 7
General Comments	<p>Was not able to view the disassembled valve. Condition assessment based solely on reported data and visual assessment from inside scroll case and gallery in powerhouse.</p> <p>October 13, 2023 inspection is scroll case did not show any leakage or water inside the valve.</p> <p>October 14, 2023 inspection in the scroll case showed leakage and water inside the valve.</p>

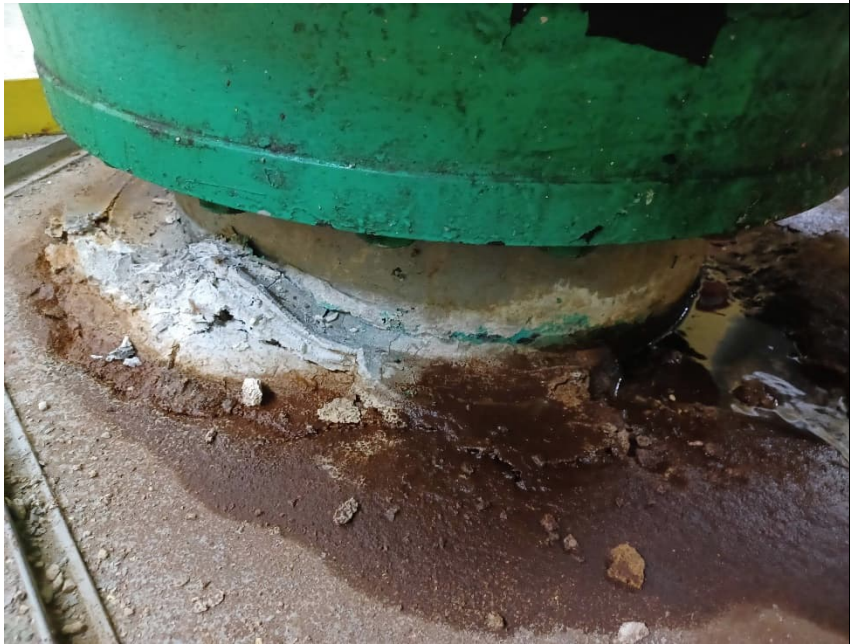
Photo 3: Outlet Piping to Concrete (Leakage shown on right when unit was dewatered)

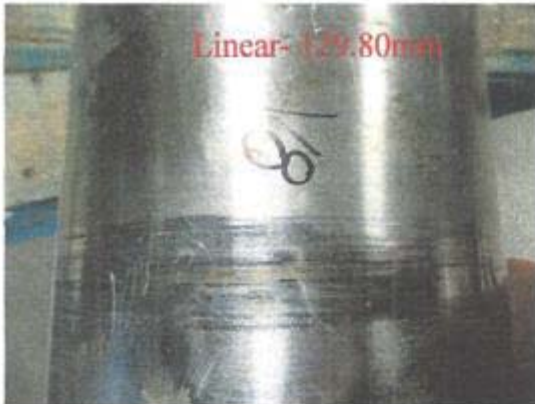
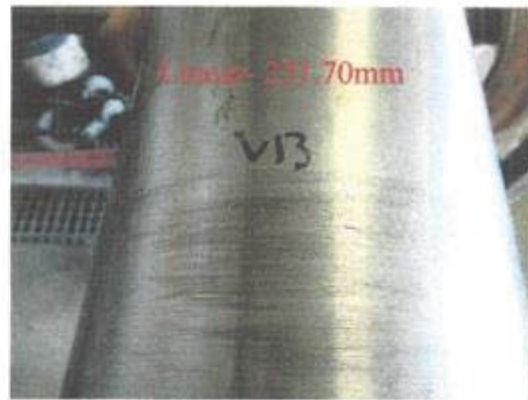
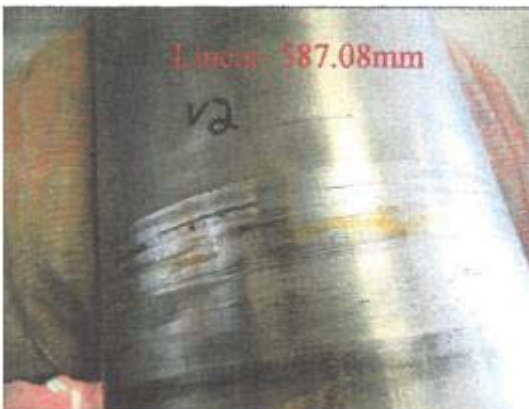
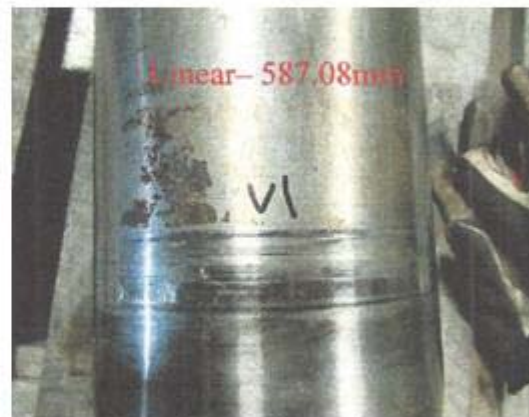
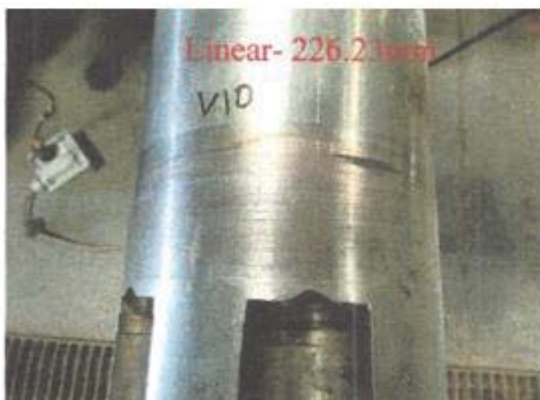
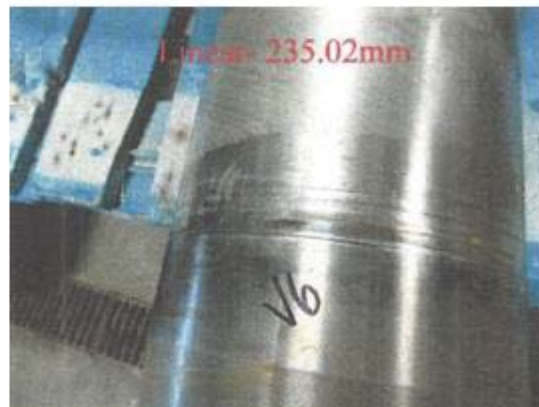
Figure 5-2: Visual Inspection - Typical Trunnion Indications

Light to moderate scratches, dents, and small surface cracks were also observed on the main body of the gates, all of which can be due to debris, rocks, and other hard material being forced through the turbine. Some of the gates had small surface cracks and imperfections, but it was difficult to determine when the cracks occurred; some of them could have been present during the commissioning of the machine. Of all the gates, Gate 18 showed the most significant signs of wear and damage (numerous scratches and moderate surfaces cracks were among the indications found). All of the Visual Inspection Reports and Voith Dispositions are located in the Wicket Gate Section of the Appendix. Below in Figures 5-2 through 5-4 are images of typical visual indications found.

VH used the provided dimensional and NDE inspection information to analyze and determine the best course of action to recommend for the Wicket Gate rehabilitation. Section 5.4.5.1 includes a summary of the recommendations VH provided prior to machining being approved. Refer to Figures 5-1 to 5-7 for a visual representation of the indications. The complete list of documentation and dispositions from VH are located in the Appendix.

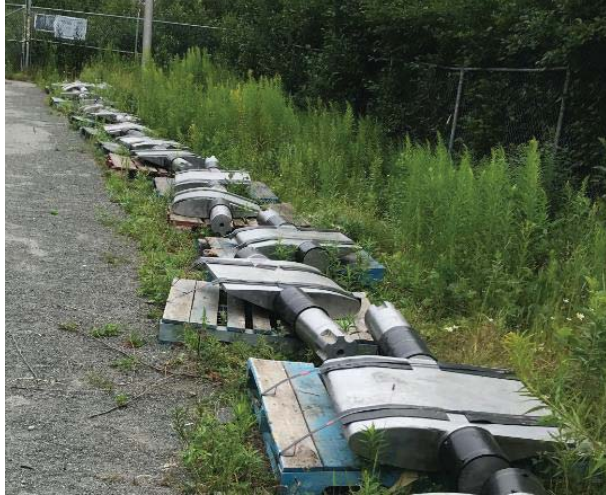
Figure 5-8: Finished Wicket Gates outside BDES Powerhouse 2

On July 25, 2019, the Wicket Gate machining was accepted by the VH and NLH and the gates were released for shipment back to Bay d'Espoir Generating Station. The gates were prepared according to the document 2TFV04-0101-10042478 and shipped back to site, arriving on July 27, where the gates were stored outside the powerhouse until reassembly.
