Re: Application for Capital Expenditures for the Life Extension of Bay d'Espoir Unit 7 – Redacted

Please find enclosed Newfoundland and Labrador Hydro's ("Hydro") application for the capital expenditures required for the life extension of Unit 7 of the Bay d'Espoir Hydroelectric Generating Facility ("Bay d'Espoir Unit 7").

Engineering Report
Mechanical Engineering
Bay D'Espoir Unit 7 Condition Assessment Condition
Report

Bay d'Espoir – Newfoundland and Labrador Hydro		
Unit 7 Refurbishment Report Project Report	TFS7000	
	PDM Doc ID:	Doc. Revision:
	2-10066279	-

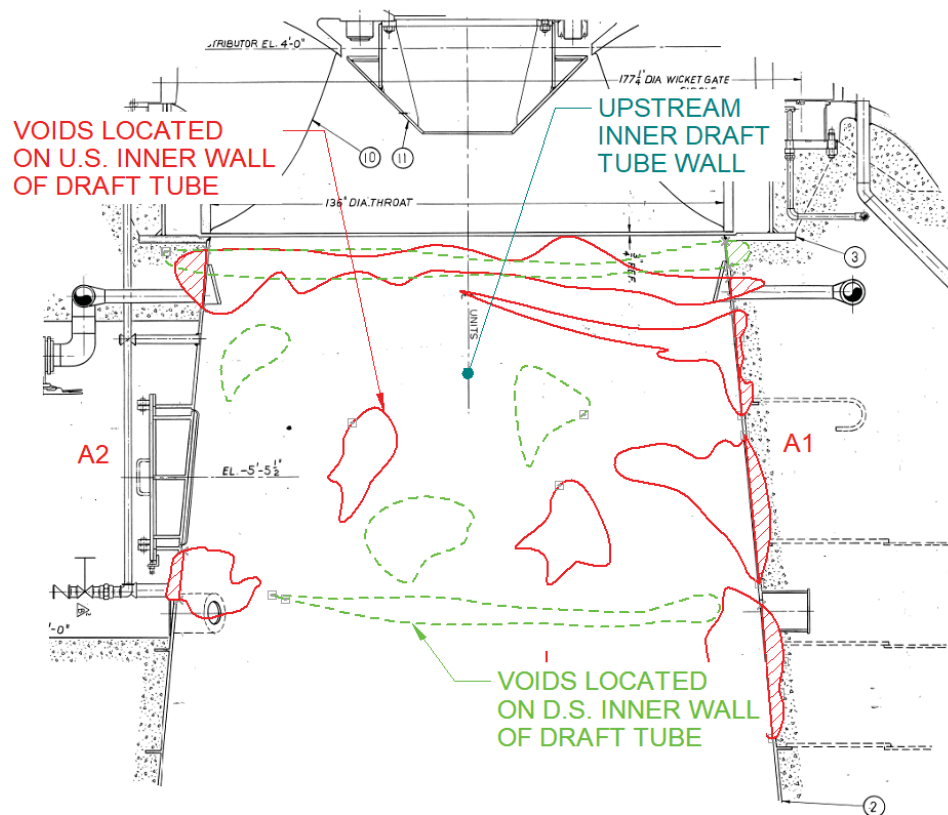
Figure 5-10: Draft Tube Void Mapping Overview

Once the unit was disassembled, the VH Field Services team began their concrete void inspection of the Draft Tube. The Draft Tube was inspected by tapping a hammer against the side wall of the Draft Tube and listening for different tones. The different tones would distinguish between void, a hollow location where grouting would be required, and a location where the original concrete was still intact and no voids were present. When voids were found, the inspectors marked the location with pink marking paint; this indication would help the inspector establish a map of the voids and help determine where the holes should be drilled to create a tapped port for pumping grout.

Once a thorough inspection of the Draft Tube Liner was completed, VH's lead abatement contractor removed the paint in areas where the pumping was planned to occur. VH drilled 25 holes in the Draft Tube, generally, the center of the void, after which these holes were tapped to accept fittings for the attachment of the grout pump. The Discharge Ring was also inspected, but no signs of concrete voids were present. A total of ten gallons of the Prime Rex 1100 grout was pumped into the voids behind the Draft Tube and Discharge Ring. The fittings and pumps were removed after the grout was cured. A small non-malleable iron plug was used to fill the hole. The plug was welded into position and the surface was ground flush. On surfaces where VH removed the paint to perform grouting tasks, touch-up paint was applied to all exposed surfaces. According to the Refurbishment Report for the previous Unit 3 and 2 outages, the quantity of grout used for Unit 7 was three gallons less (VHY-9, 2017). This reveals that the voids found in the Unit 7 inspection are similar to those of the Unit 3 and are comparable NLH's plan. Due to the individual design of every turbine and powerhouse, it is difficult to quantify the amount of the voids found at BDES. In general, the voids found on the Unit 7 machine were somewhat small, but on average with the amount VH typically finds on Francis turbines of similar size and age. Figures 5-10 through 5-13 show the areas of the Draft Tube that had voids.

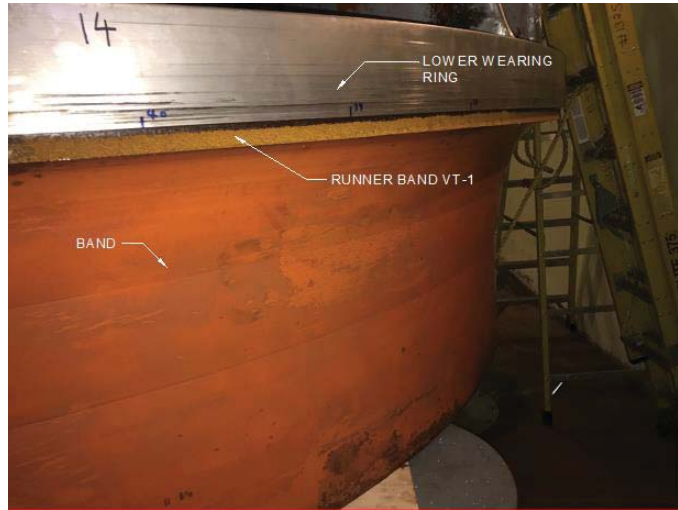
The Unit 7 Runner Band was found to be in average condition for the machine's age and usage. The lead base orange paint was still mainly intact with limited signs of deterioration on the outer and inner diameters. The Runner Band had minor debris impact scratches and scrapes. The only notable indication, Runner Band indication, noted VT-1 in Figures 5-15 and 5-16 from the inspection was underneath the Wearing Ring where minor cavitation and corrosion was present. Refer to the following inspection images.

Figure 5-15: Runner Band Cavitation Damage

- **Recommendation Summary:** The location and severity of the cavitation damage determined the recommendation for repair methods. The smaller signs of damage could easily be addressed by lightly grinding and blending the surface flush with adjacent non-damaged surfaces. For moderate damage and pitting (deterioration), an epoxy was recommended to fill the impaired areas. Once the epoxy cures, an anti-cavitation paint can be applied over the epoxy. For heavy cavitation damage and deep pitting, mainly on the runner buckets, a filler metal was suggested to fill the deterioration, after which the welds would be ground flush. Using the filler metal method was not recommended for all of the cavitation damage due to the risk of heat distorting the shape of critically machined surfaces. While the thrust relief holes showed moderate cavitation damage VH believed there was no significant gain in repairing the damage, especially with the new five year plan for the unit.

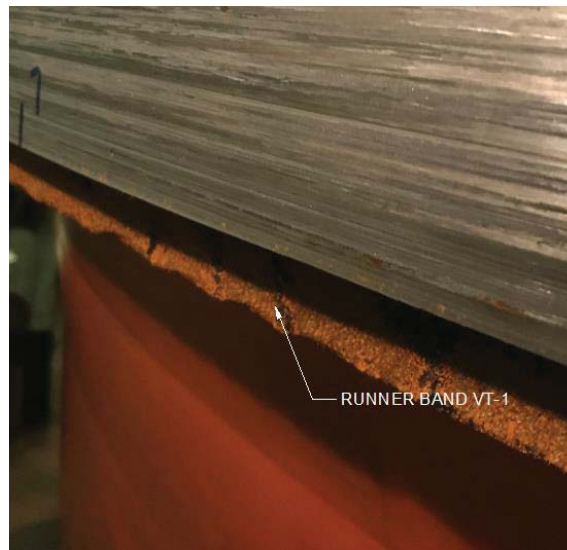
Figure 5-16: Runner Band Cavitation Damage

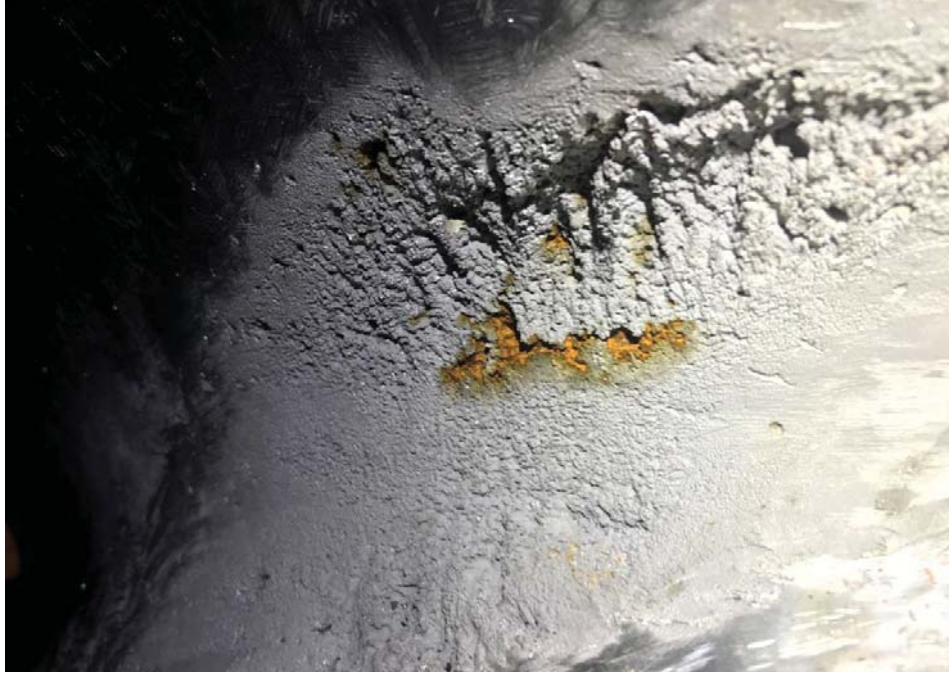
The fifteen Runner Buckets were in fair condition overall; however, they all show locations of moderate to heavy cavitation damage. The cavitation damage follows a pattern across the entire lot of buckets, presenting in the same general location on each individual bucket. The indication locations were typically found at: entrance edge where the bucket is attached to the band on the lower pressure side (VT-2), middle of the lower pressure side close to discharge edge (VT-3), and the top of the discharge edge where the bucket meets the crown (VT-4). Refer to the following inspection images.

Figure 5-18: Runner Bucket Cavitation, VT-2

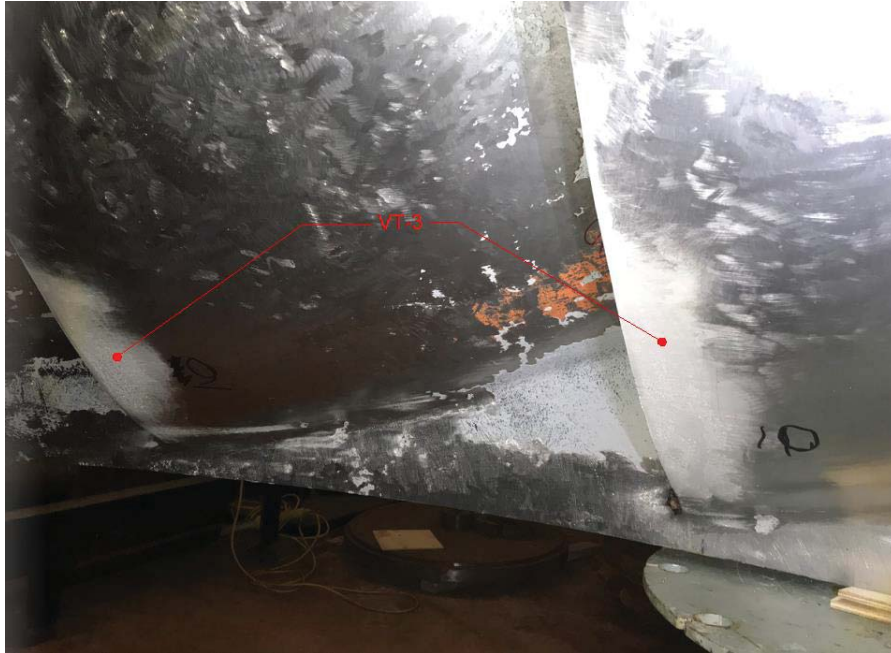
Figure 5-20: Runner Cavitation Damage, VT-3

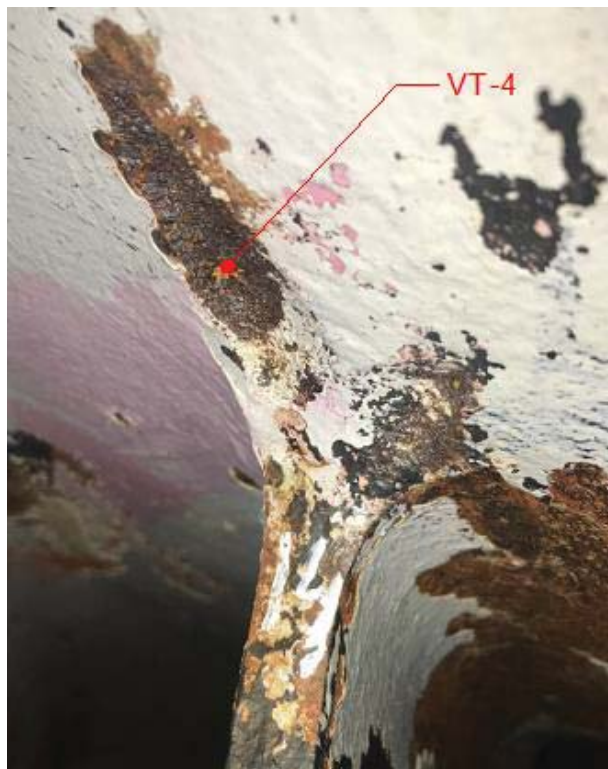
Figure 5-21: Runner Bucket Cavitation Damage, Discharge Edge near Crown, VT-4

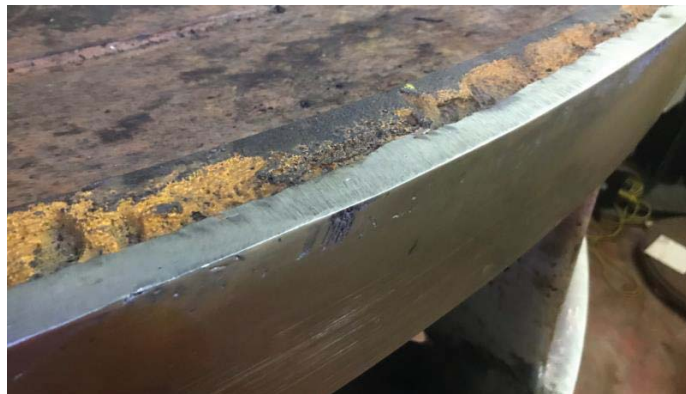
The Runner Crown was found to be in average condition; however, moderate corrosion and cavitation damage were found near the outer diameter of the Crown close to the Upper Wearing Ring mating surface (VT-5). One serious indication was found to the Balance Cover Plate located on the top of the Crown. Large cracks were present in the cover plate with large pieces missing (VT-6). Also, moderate to heavy cavitation damage was found around the pressure relief holes on top of the Crown (VT-7). Refer to the following inspection images.

Figure 5-22: Runner Crown Cavitation Damage, VT-5

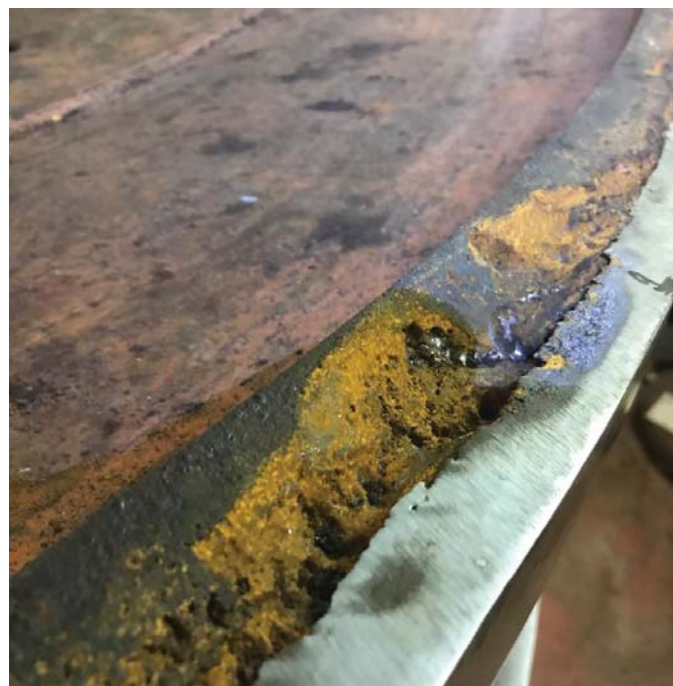
Figure 5-23: Runner Crown Cavitation Damage, VT-5

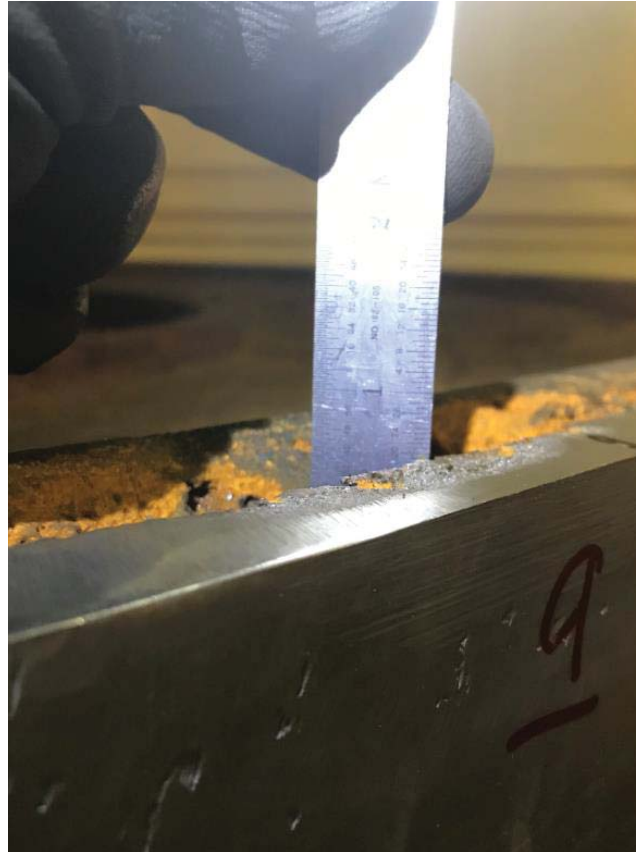
Figure 5-24: Runner Crown Cavitation Damage, VT-5

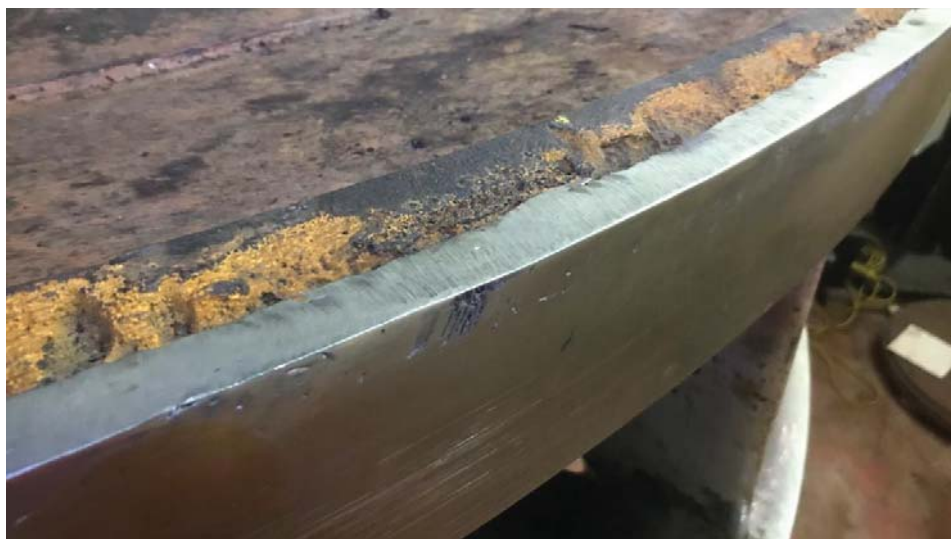
Figure 5-25: Runner Crown Cavitation Damage, VT-5

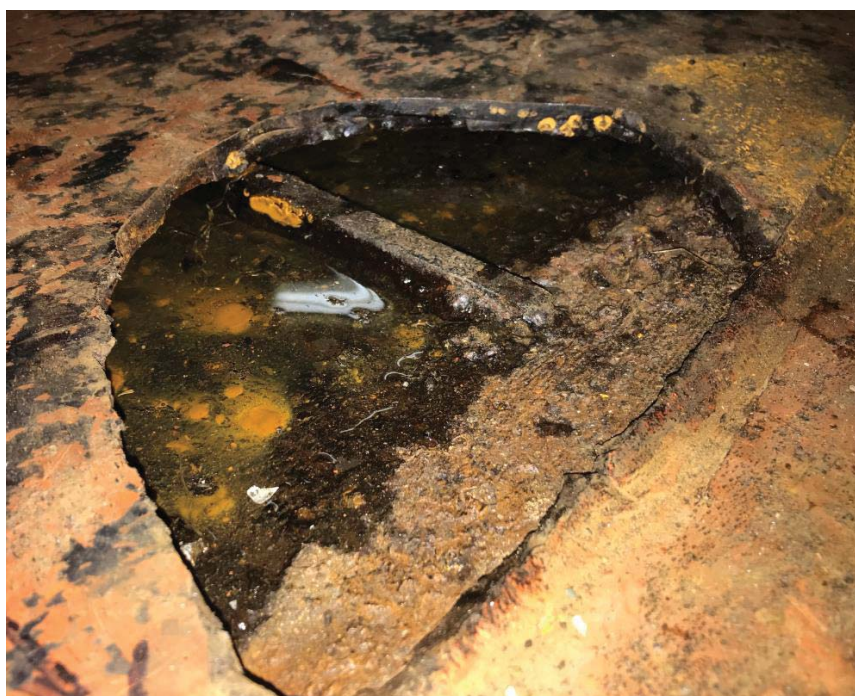
Figure 5-27: Balance Plate Missing Piece, VT-6

- Voith recommended the Runner Balance Cover Plate be repaired prior to reassembly.
 - **Reason:** Not repairing the Runner Balance Cover Plate poses a risk to the Unit due to the extent of damage and the numerous cracks. The main concern was that the remainder of the Cover Plate would become dislodged from the rest of the Runner at some point and cause significant damage to the Runner and Head Cover, ultimately forcing NLH into an unplanned outage. Also, repairing the Cover Plate once the machine was assembled is impossible due to the location. Repair in place would require disassembling the entire machine. Repairing the Runner Balance Cover Plate during the 2019 outage would help improve the Runner's life expectancy and the likelihood that it could remain in service for five years after the 2019 commissioning, at which time a plan could be developed to perform a major rehabilitation on the Unit 7 machine.

- **Recommendation Summary:** Voith evaluated the repair options with the impacts to the outage schedule and NLH's five year plan in mind, and determined a solution to remedy the damaged Cover Plate. Voith recommended a steel plate be placed and welded directly over top of the existing Cover Plate. This annular shaped plate was of homogeneous in size and volume, which means no balance issues of the rotating Runner would be expected to develop. All of the lead paint in the proximity of the welds required removal to weld the plate to the Runner. Once the lead paint was removed, the new plate was lowered into position and centered over the existing plate. After centering, the circumferential welding on the ID and OD of the plate began. To aid in fusing the existing Cover Plate to the new one, Voith included equally spaced slots near the centerline of the plate. These slots would create a joint to weld the two plates together and limit the potential for the existing plate to vibrate under the new one. After welding the new Cover Plate the welds were to be inspected for quality (NDE-(PT)) and the surface was painted for protection.

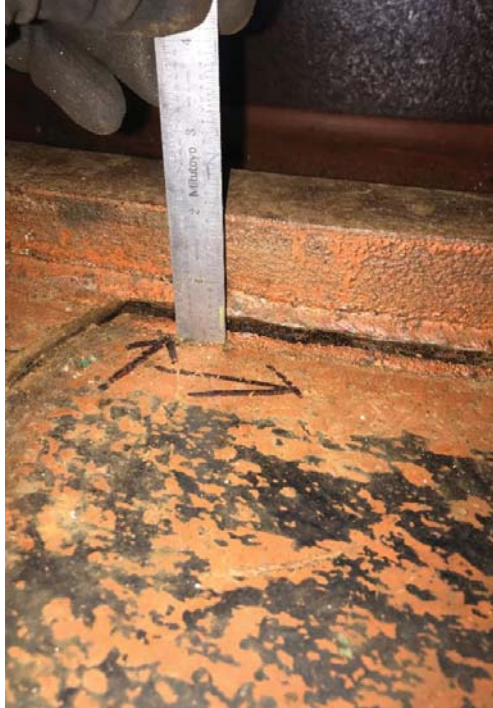
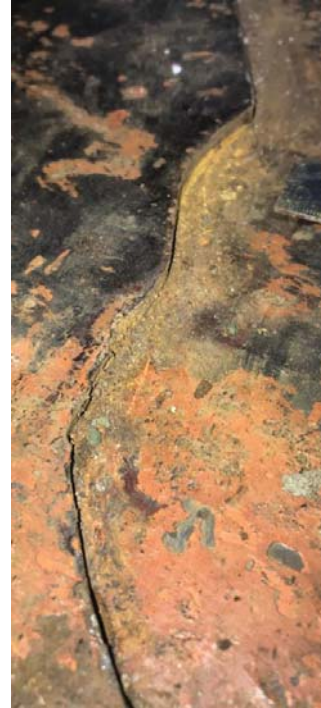
Figure 5-28: Balance Plate Cracks, VT-6

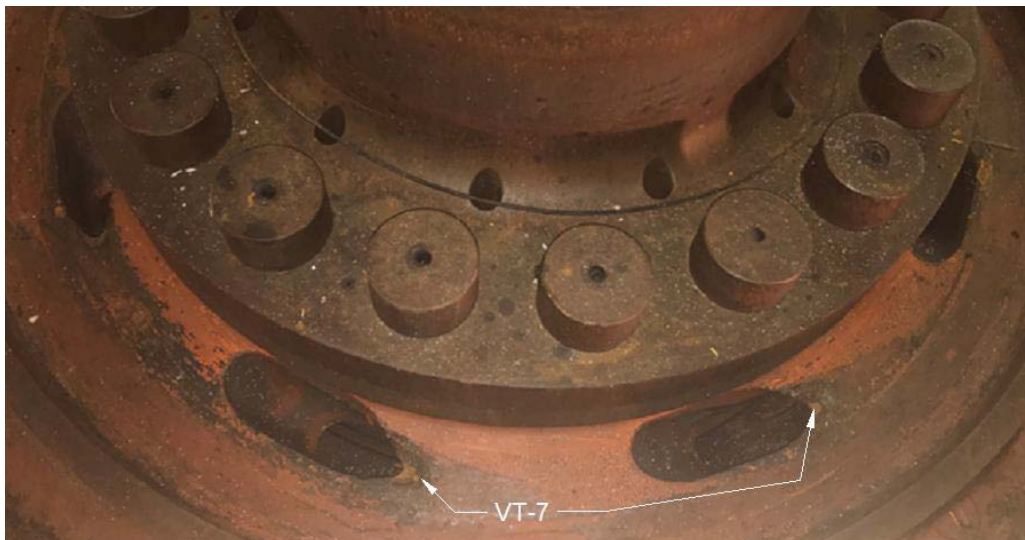
Figure 5-29: Runner Crown Pressure Relief Holes Cavitation Damage, VT-7

- The cavitation damage in Figures 5-29 and 5-30 on the thrust relief holes was not repaired. While all cavitation should be repaired, there is a low risk of this posing a threat prior to the next major outage which is expected in five years.

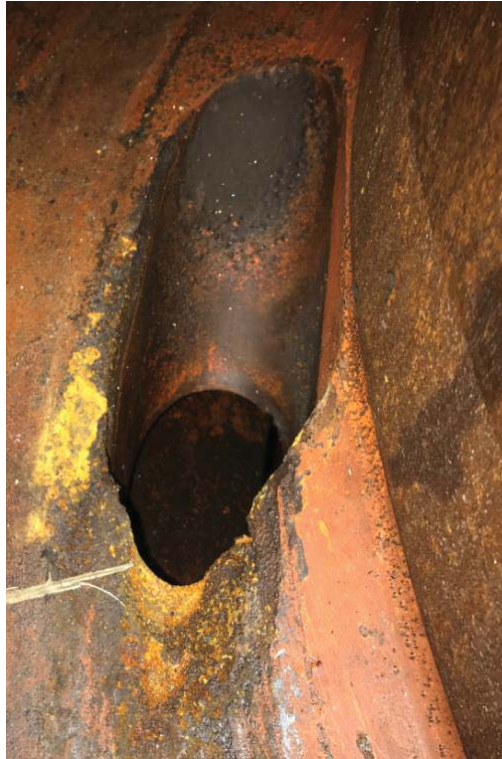
Figure 5-30: Runner Crown Pressure Relief Holes Cavitation Damage, VT-7

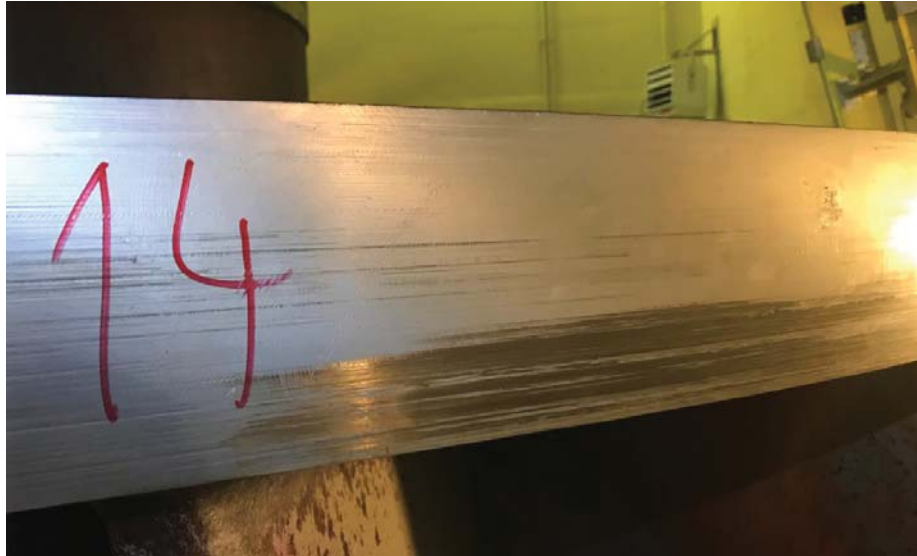
The inspection performed on the Upper Wearing Ring of the Runner showed light scratches, galling, dents, and some minor cavitation damage. The cause of scratches and physical damage on the outer diameter of the ring was difficult to determine with absolute certainty. Although the likely source is either from debris forcing its way between the rotating and stationary Wearing Rings, or the Runner came in contact with the Stationary Wearing Ring. This indication could be from several different sources, but the RSC issues described in Section 3.1 or shaft alignment (vertically) could easily explain the damage. Refer to the following inspection images.

Figure 5-31: Runner Upper Wearing Ring, Contact Damage

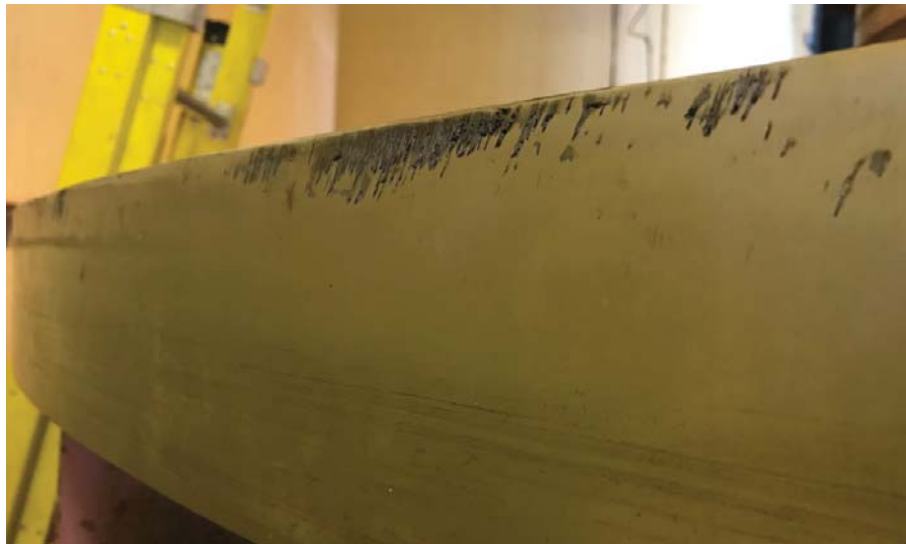
Figure 5-32: Runner Upper Wearing Ring, Cavitation Damage

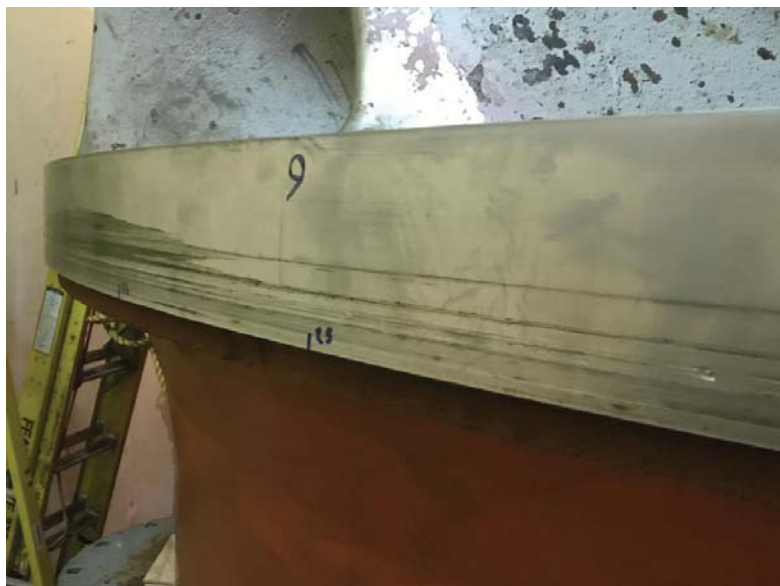
The inspection performed on the Lower Wearing Ring of the Runner showed light scratches, galling, dents, and some minor cavitation damage. The cause of scratches and physical damage on the outer diameter of the ring was difficult to determine with absolute certainty. The likely the source damage is either from debris forcing its way between the Rotating and Stationary Wearing Rings, or the Runner came in contact with the Stationary Wearing Ring. This indication could be from several different sources, but the RSC issues describe in Section

3.1 or shaft alignment (vertically) could easily explain the damage shown below; in fact, the as found conditions of the Bottom Ring Wearing Ring supported this causation. Refer to the following inspection images.

Figure 5-33: Runner Lower Wearing Ring, Contact Damage

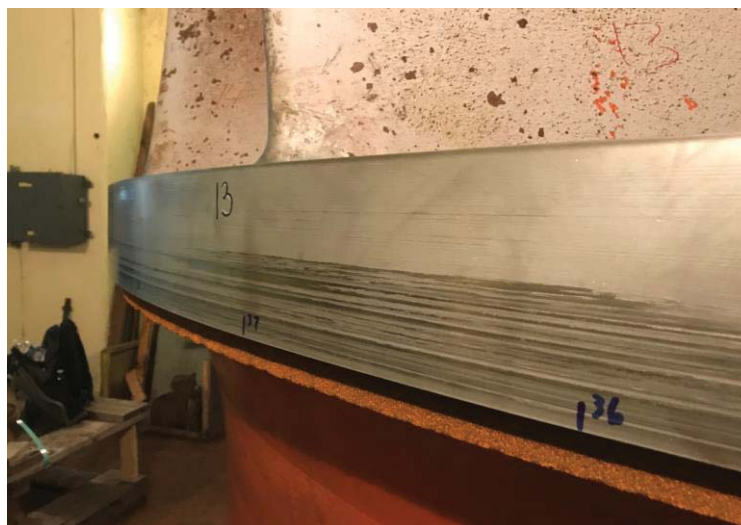
Figure 5-34: Runner Lower Wearing Ring, Contact Damage

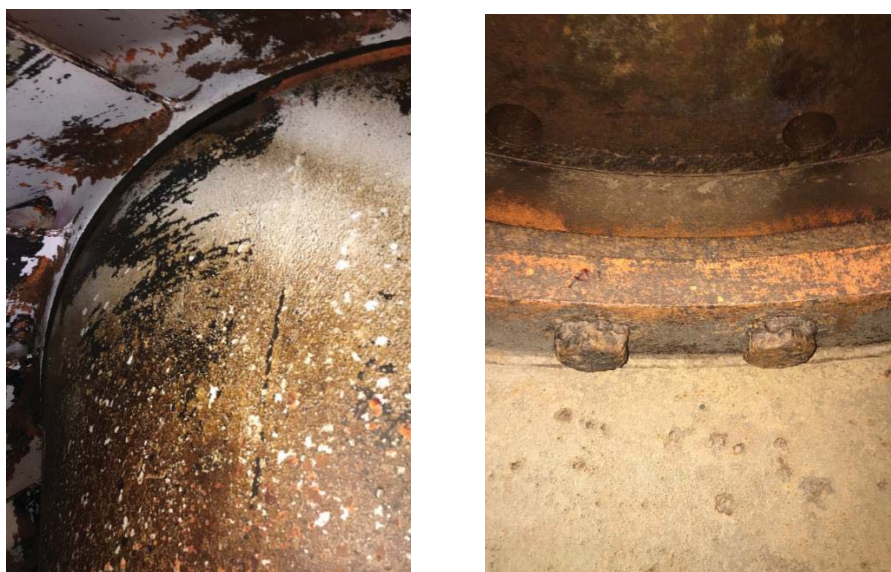
The Runner Deflector Cone and hardware was inspected for any visible signs of damage or deterioration. VH engineering found limited signs of damage, corrosion, or signs of cavitation deterioration. The surfaces had minor imperfections with some of the original paint still intact. The hardware appeared to be in good working order with no signs of damage or deterioration to the locking welds. Inspection images are shown in the following figure.

Figure 5-35: Runner Deflector Cone and Hardware

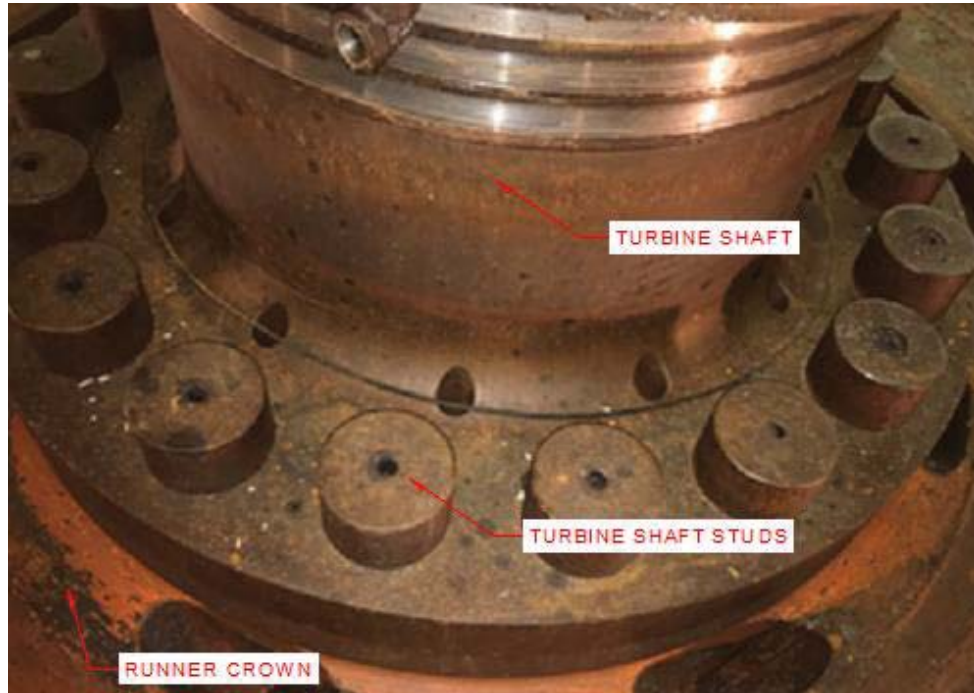
Figure 5-48: Turbine Shaft, Flange Hardware

The only noteworthy indication of the Turbine Shaft was on the Generator coupling flange where discoloration and scoring were present, which was more than likely from the removal of the coupling hardware. Due to the shaft still being connected to the Runner, the spigot joints and mating surfaces of the shaft and Runner were not inspected. Also, due to the location and height of the shaft, the mating surface of the Turbine and Generator Shafts were not inspected; however, NLH millwrights and Hatch Engineering informed VH that they did not see any visual indications of damage or deterioration on the mating flanges during the disassembly process. The nuts on the flange studs between the Runner Deflector Cone and Turbine Shaft, shown in Figure 5-49, were not easily accessible but appeared to be in good working order.

- **Recommendation Summary:** Smooth and blend light scratches, clean the entire shaft of dirt and debris, and clean and restore critical surfaces and spigot joints by hand.

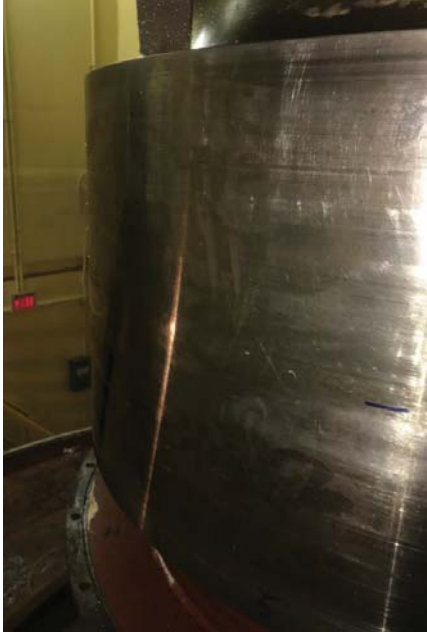
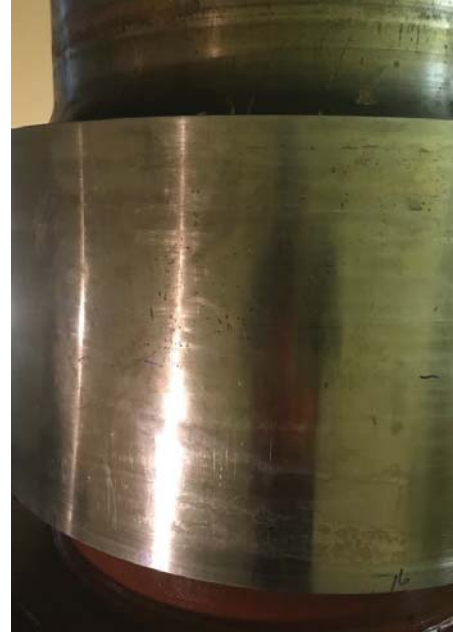
Voith engineering performed a visual inspection of the Unit 7 Turbine Shaft and coupling bolts and created a report that defined the as-found condition. The inspection report document (Bay d'Espoir Inspection Recommendations Rev-, (VHY-10, 2019)) is included in the Appendix. In summary, while light scratches and small dents were present on the shaft and journal surfaces, no indications found required immediate attention.

Figure 5-50: Turbine Shaft Bearing Journal, Light scratches

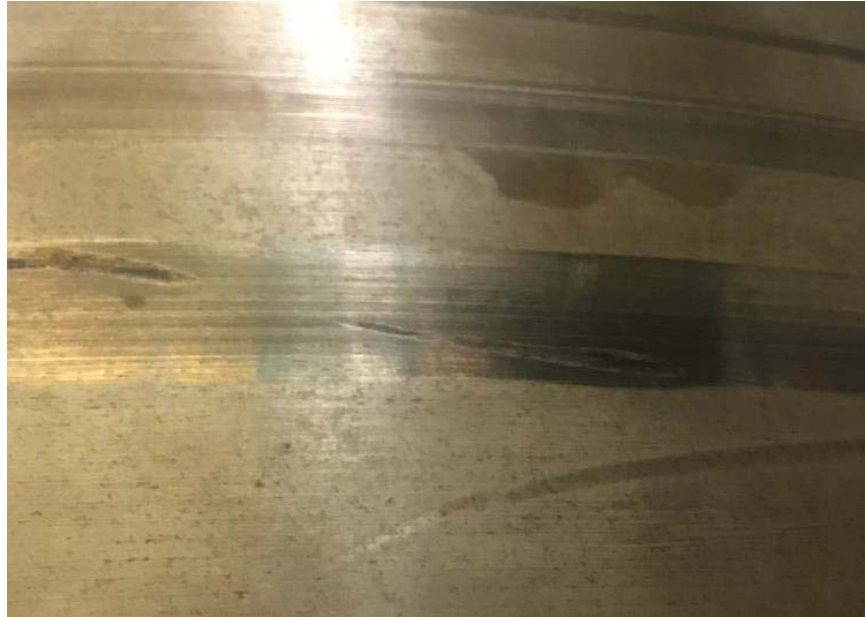
Voith engineering performed a visual inspection of the Unit 7 Generator Shaft and created a report describing its as-found condition and features. The inspection report document (Bay d'Espoir Inspection Recommendations Rev-, (VHY-10, 2019)) is located in the Appendix. While light scratches and small dents were present on the shaft, no indications requiring immediate attention were found. The only noteworthy indication of the Generator Shaft was on the Rotor coupling flange where discoloration and scoring were present, more than likely from the removal of the coupling hardware. Due to the shaft being placed on the floor the mating flange between the Generator Shaft and Turbine Shaft was not inspected; however, NLH millwrights and Hatch Engineering informed VH that they did not see any visual indications of damage or deterioration on the mating flanges during the disassembly process.

Figure 5-54: Generator Shaft, Light Scratches

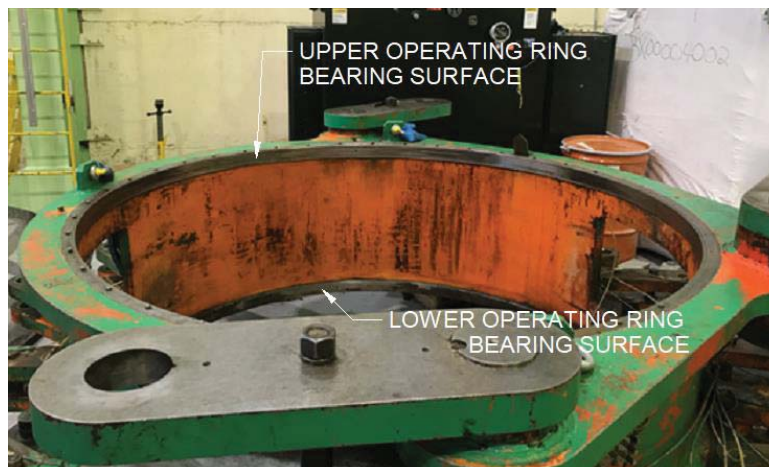
Figure 5-62: Operating Ring Bearing Surfaces

Voith engineering performed a visual inspection of the Unit 7 Operating Ring and Head Cover Extensions and created a report defining the as-found condition and associated features. The inspection report document (Bay d'Espoir Inspection Recommendations Rev-, (VHY-10, 2019)) is located in the Appendix. In summary, the visual inspection revealed significant deterioration to the bearing surfaces of the ring. This damage was reflected on the Head Cover Liners, the pads the Operating Ring rides on during operation (Figures 5-65 and 5-66).

- Due to the condition of the Operating Ring bearing surfaces and the amount of wear on the Head Cover Liners, Voith recommended that the bearings surfaces be dressed and sanded; all of the high and rough locations should be sanded flush and blended into the surrounding material. The heavily pitted area should be filled with an epoxy and sanded flushed. The purpose for doing these activities is to improve the bearing surface roughness to as close to the OEM design as possible. The epoxy is a temporary repair for the pitted areas. This specific repair was an attempt to protect the new Head Cover Liners from being damaged by the rough surface. This improved surface finish would help extend the life of new OEM Head Cover Liners, which were required to be replaced due to the deterioration beyond repair of the liners. Ideally, the Operating Ring would have been sent to a machine shop and the bearing surfaces machined to the desired finished. This would have returned the shape of the ring to a circle, eliminate the elliptical shape, and ultimately improve the mechanical function and service life of the parts. The option of machining the ring was not feasible due to the time constraints of the 2019 NLH maintenance outage and the fact that the condition of the Operating Ring was unknown prior to the outage.

- After VH presented their findings and discussed options with NLH, the decision was to follow VH's recommendation and repair the bearing surface of the Operating Ring and procure new OEM Head Cover Liners. Due to the time constraints of the 2019 outage, the OEM Head Cover Liner material, ASTM B171 Alloy 365, was unavailable and the lead time to obtain the raw material and manufacture the part was not parallel with maintaining the assembly schedule of the unit. To possibly remedy this issue, NLH contacted Thordon Bearing Inc. to investigate if a polymer material would be suitable alternative. After Thordon conducted their research of the application of the bearings, it was determined that the alternative SXL material was a viable candidate for replacing the OEM material.

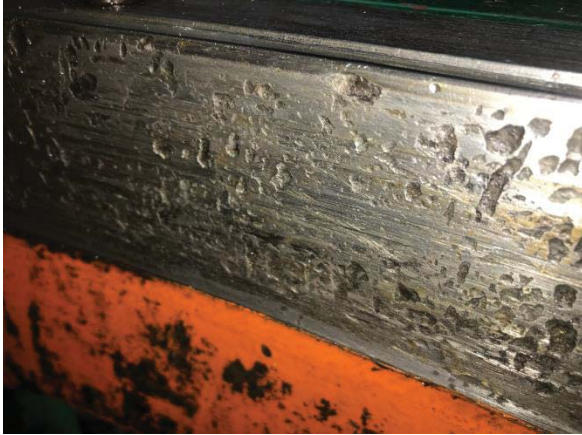
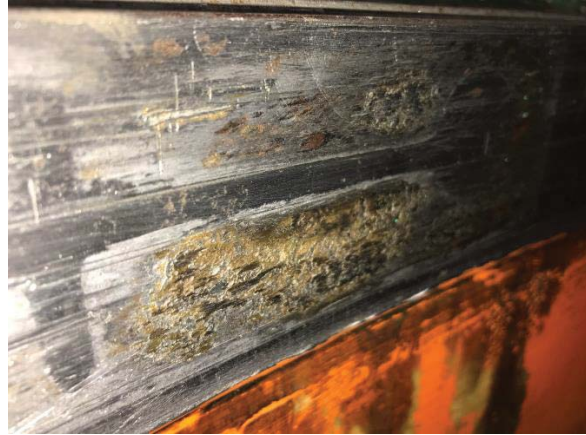
Figure 5-63: Operating Ring, Upper Bearing Surface Damage

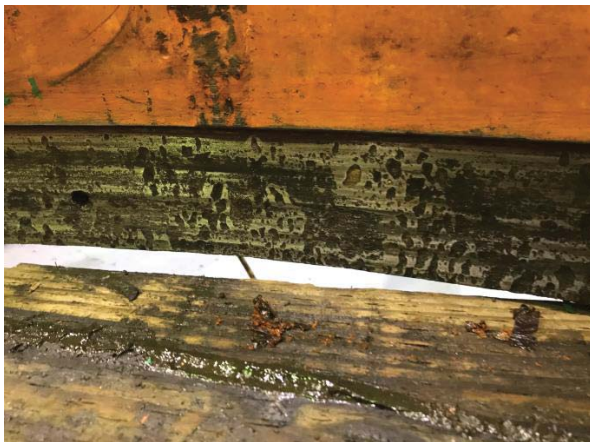
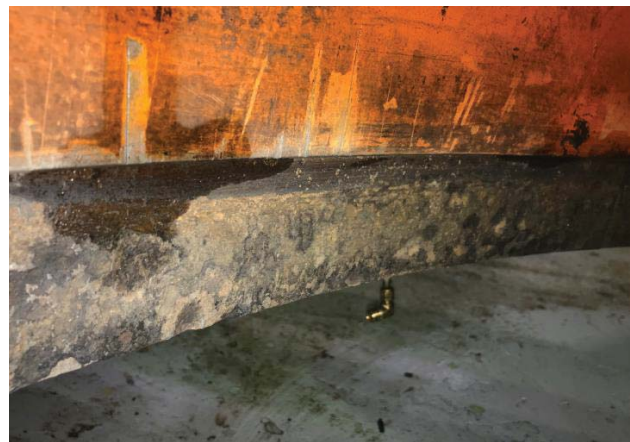
Figure 5-64: Operating Ring, Lower Bearing Surface Damage

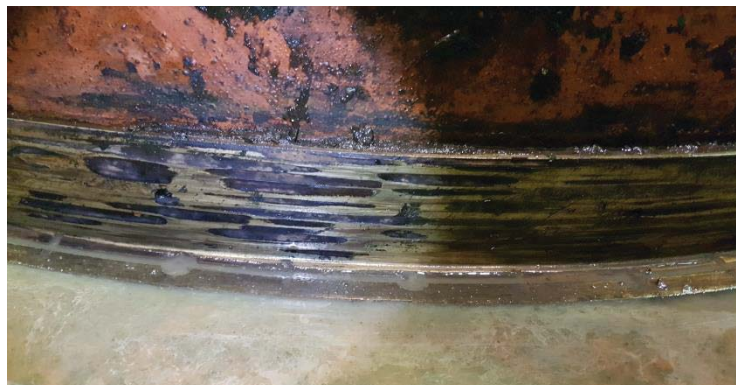
Figure 5-65: Lower Head Cover Liner

Prior to purchasing the Thordon bushings NLH discussed the material choice with VH and jointly evaluated the advantages and risks. While the polymer Thordon offer has many advantages, it would not be VH's first recommendation, but in the timeframe and limited resources available to NLH at the time of the outage, VH agreed that the Thordon material was the best option. At this time NLH worked directly with Thordon in the design and procurement of the liners, although VH offered input and recommendations as needed.

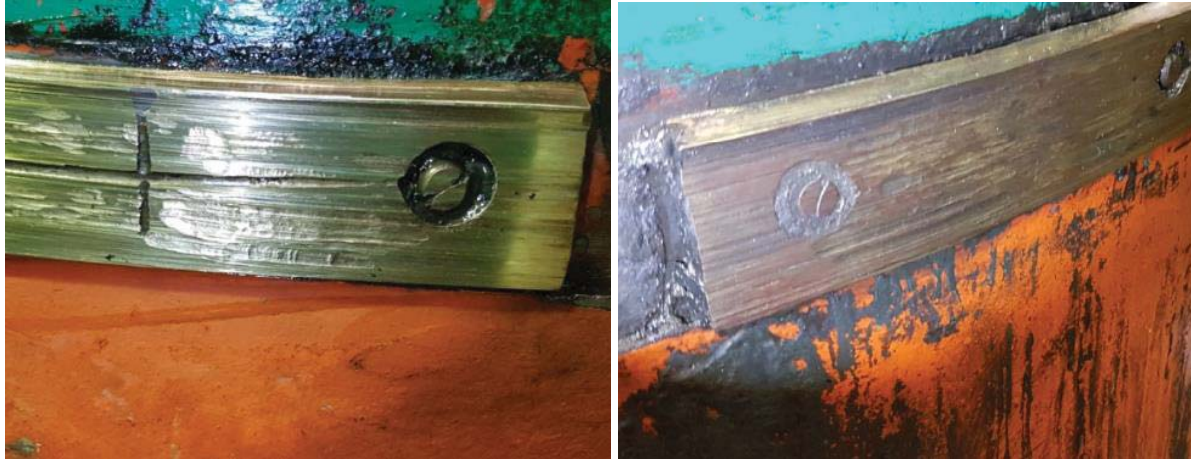
Figure 5-66: Upper Head Cover Liner

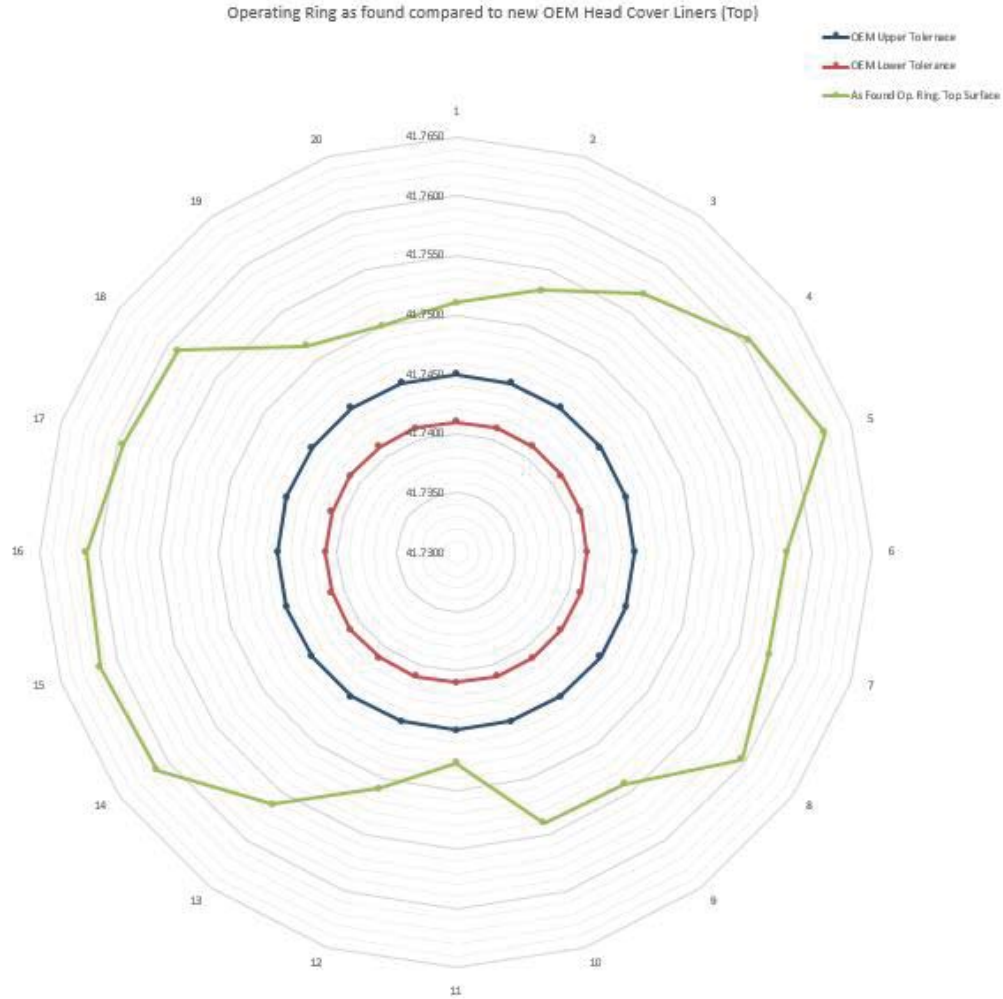
Figure 5-69: Operating Ring, Upper Bearing Surface (Green)

The Operating Ring measurements in Figures 5-67 and 5-68 show the inside radii of the bearing surfaces compared to the OEM design (upper/lower tolerance). The measurements reveal that the Operating Ring, which is intended to be a circle, has slightly ovalized. This oval shape is clearly shown in Figures 5-69 and 5-70. Figure 5-71 shows the Operating Ring measurements compared to new OEM Head Cover Liner dimensions. Analysis of this data determined that the overall shape and critical dimensions of the Operating Ring were still within an acceptable range, although precautions would need to be taken to account for the deteriorated bearing surfaces of the ring.

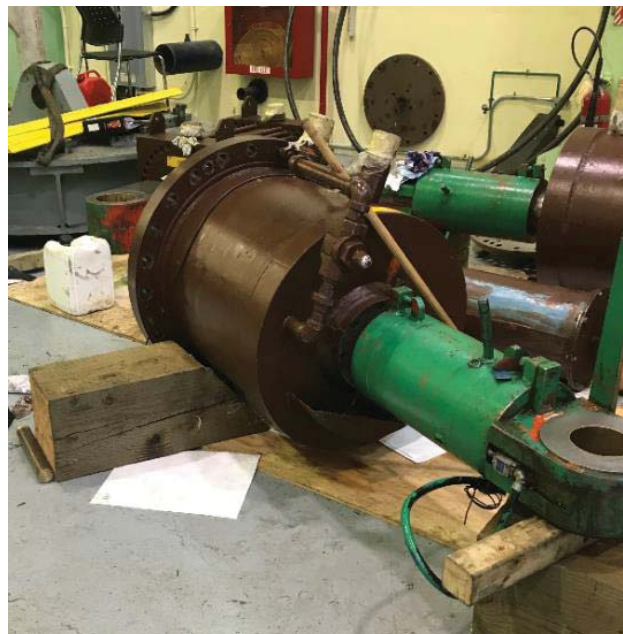
Figure 5-73: Bay d'Espoir Unit 7 Servomotors

In order to evaluate the condition of the Servomotors and determine a rehabilitation plan, Voith conducted a high level visual inspection of both pieces. Externally both of the Servomotors were in good condition. As shown in Figure 5-73, the Servomotors had at least three different colors of paint applied to them since commissioning. Overall, the paint and exterior features of each of the Servomotors were in good condition and no signs of leaks or damage were present. Some light scoring and damage were found once the Servomotors were disassembled. The indications were located on the piston head and main cylinder of the Servomotor. Shown in Figure 5-75, two types of the damage were found: light scorings on the piston head outer diameter and gouging to moderate scratches on the piston rings. Similar damage was found on the internal diameter of the Servomotor cylinders. Illustrated in Figure 5-76, abnormal wear, scratches, and gouges were present.

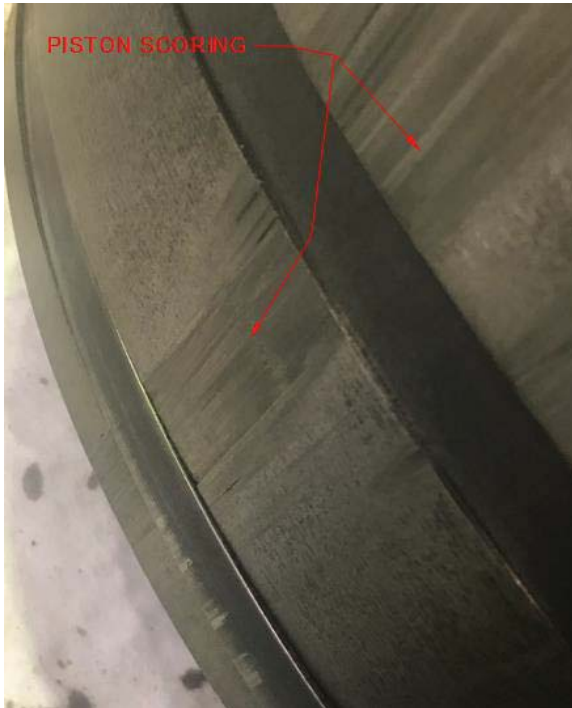
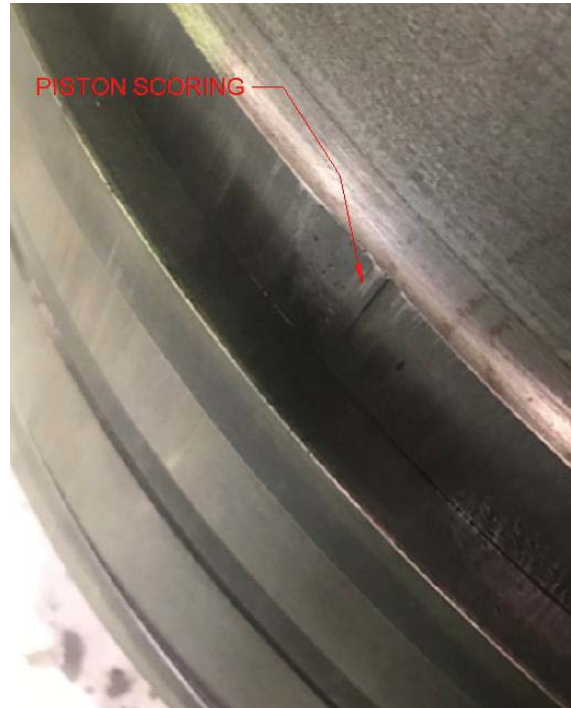
In both instances the indications found could be categorized as light damage with minimal impact to function, posing a low risk to the operation of the machine. However, these surfaces are intended to be sealing surfaces, which allows the Servomotors to maintain a constant design pressure. If these cylindrical surfaces are not smooth or concentric to each other, it can lead to oil seepage and affect the pressure. This constant change (leak) in pressure causes the secondary or jockey pumps to be activated to maintain squeeze pressure on the Wicket Gates. This squeeze occurs anytime the Wicket Gates are closed and are required to prevent the head water from entering the Runner. In general, the gates are closed for maintenance, when power generation is not required, or when the unit is operating as Synchronous Condenser, which is approximately 20 percent of the time. The Servomotors did not have any other notable signs of damage or alarming wear at the time of the inspection.

Figure 5-75: Servomotor, Piston Scoring

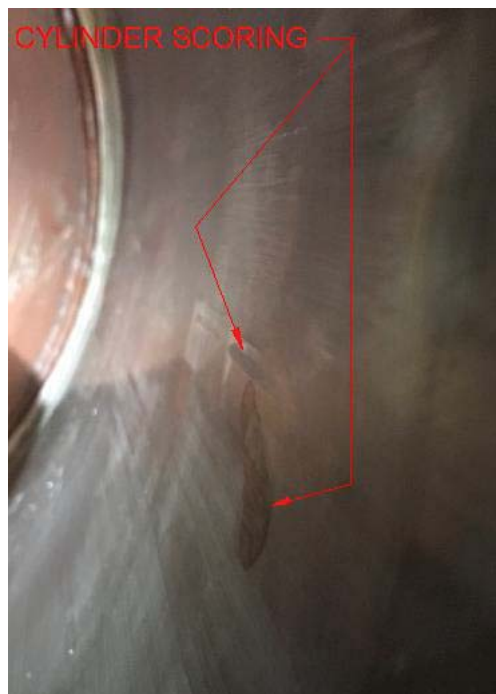
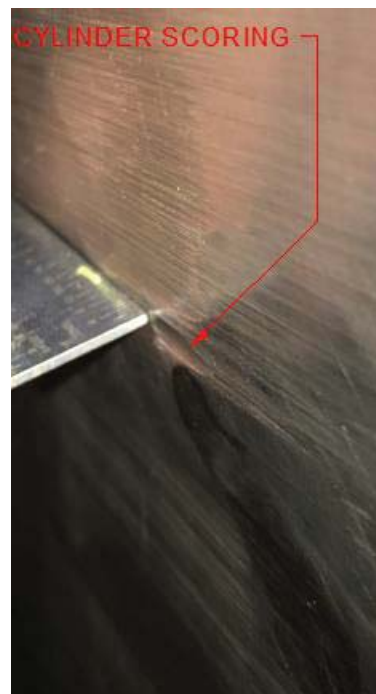
Figure 5-76: Servomotor, Cylinder Scoring

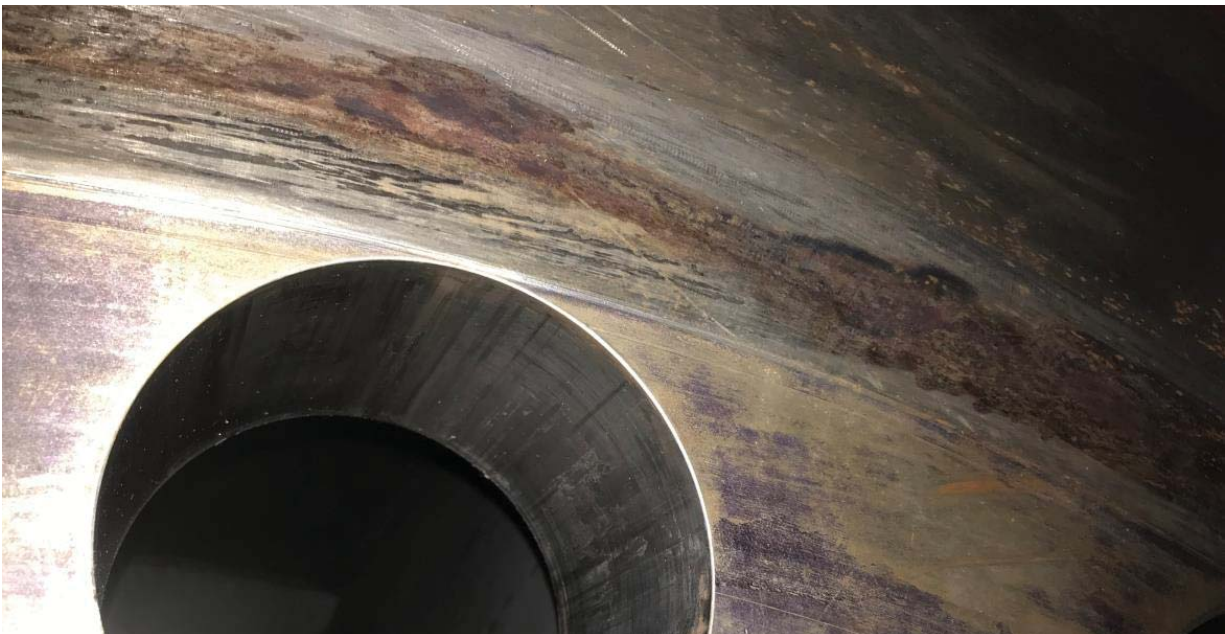
Figure 5-87: Rotor Hub, Light Fretting and Oxidation on Coupling Flange
