Re: Application for Capital Expenditures for the Life Extension of Bay d'Espoir Unit 7 – Redacted

Please find enclosed Newfoundland and Labrador Hydro's ("Hydro") application for the capital expenditures required for the life extension of Unit 7 of the Bay d'Espoir Hydroelectric Generating Facility ("Bay d'Espoir Unit 7").

Engineering Report
Mechanical Engineering
Bay D'Espoir Unit 7 Condition Assessment Condition
Report

Bay d'Espoir – Newfoundland and Labrador Hydro		
Unit 7 Refurbishment Report Project Report	TFS7000	
	PDM Doc ID:	Doc. Revision:
	2-10066279	-

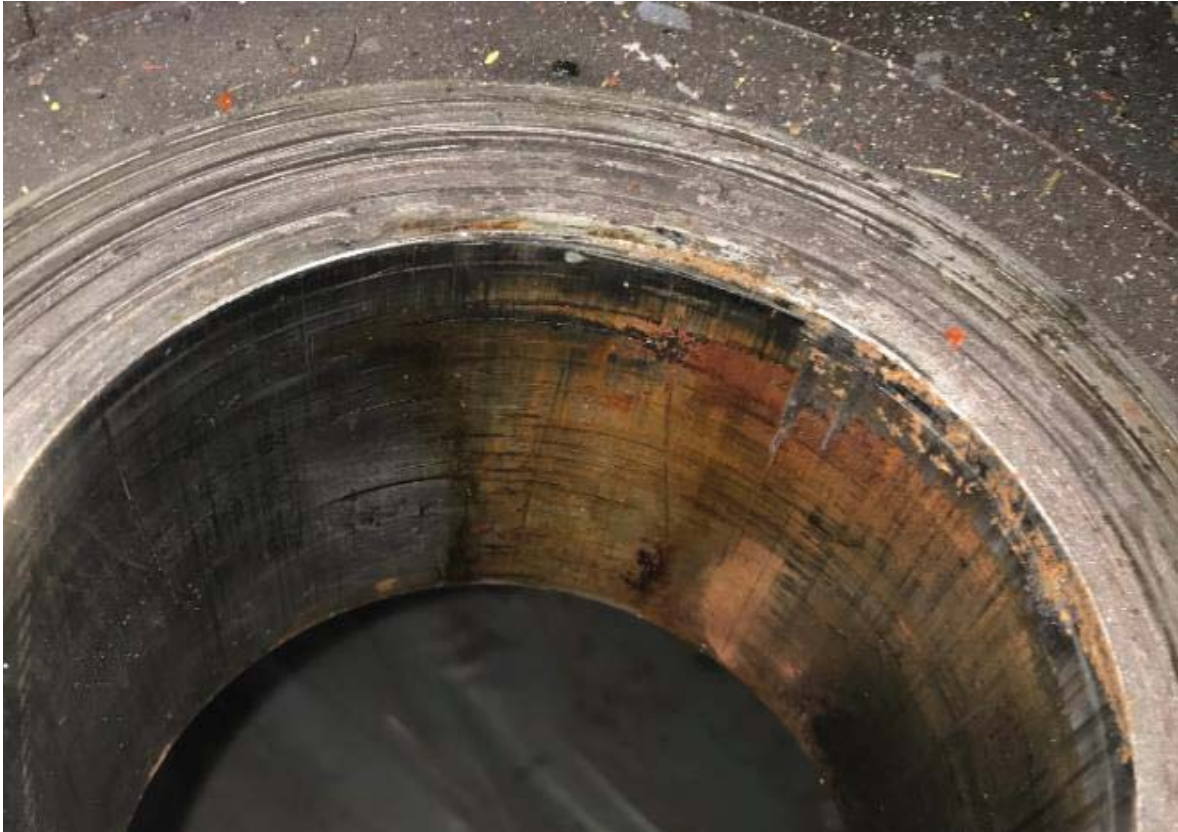
Figure 5-88: Rotor Hub, Coupling Hole Fretting

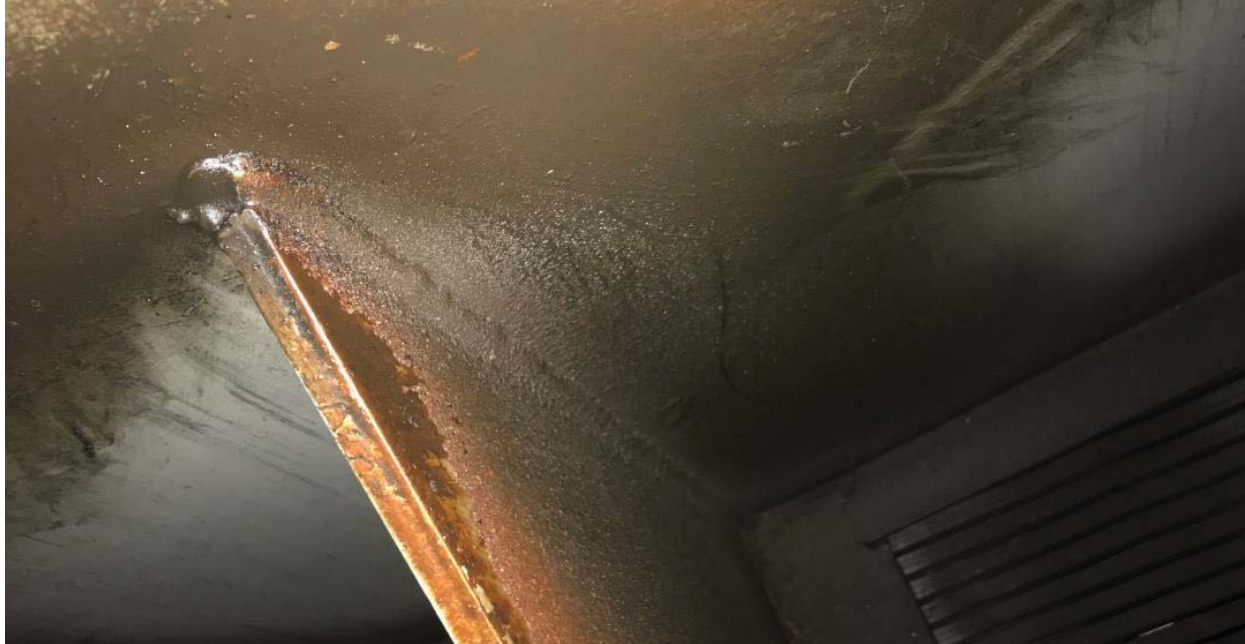
Figure 5-90: Rotor Hub, Oil Film, Grease, and Dirt

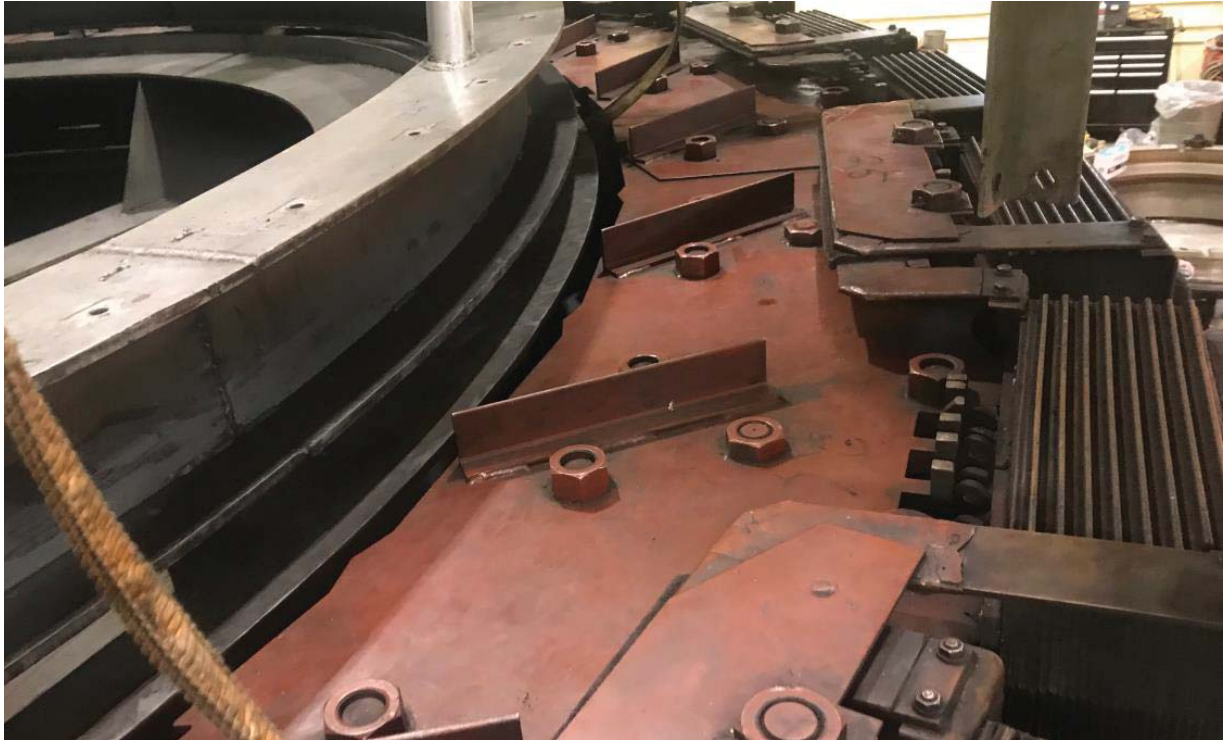
Figure 5-91: Rotor Rim, Top View 1

At the time of the inspection Voith engineering found the Rotor Rim to be in fair condition. Light surface rust was present on the individual Laminations during the inspection; however, more oxidation developed during the outage, consequently causing the laminations of the Rotor Rim to have a moderate coat of surface rust present when NLH started to perform electrical tests on the Rotor prior to assembly. The top and bottom surface of the Rotor Rim did not show any signs or indications of failure or fatigue. The red coating (paint) was still in good condition with light grease and dirt present.

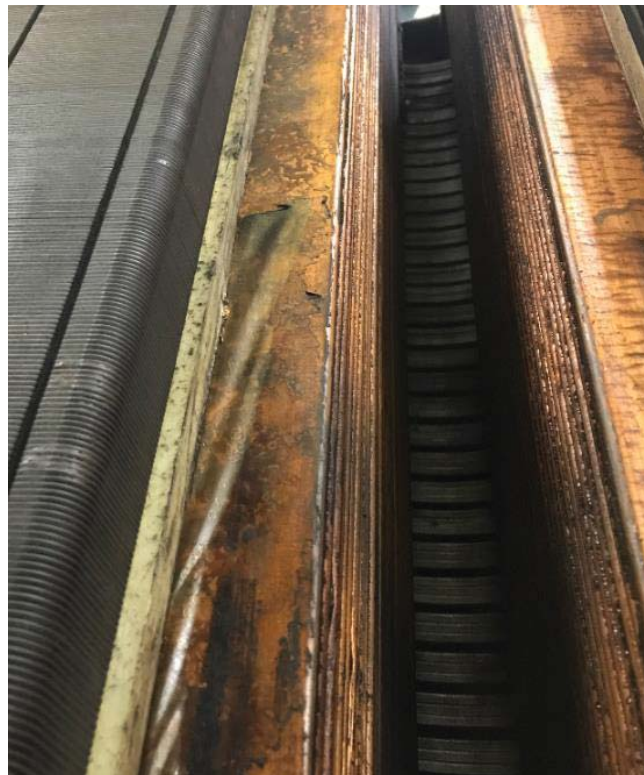
at the top and bottom of the Rim, where plates seemed to have various states of degradation, mostly broken at the top and generally intact at the bottom. The tape on the outer pole winding was either damaged or absent on several of the Poles. This tape is typically used to keep the winding in place against the centrifugal forces of the Rotor.

Figure 5-104: Rotor Pole: Insulation Peeling or Absent

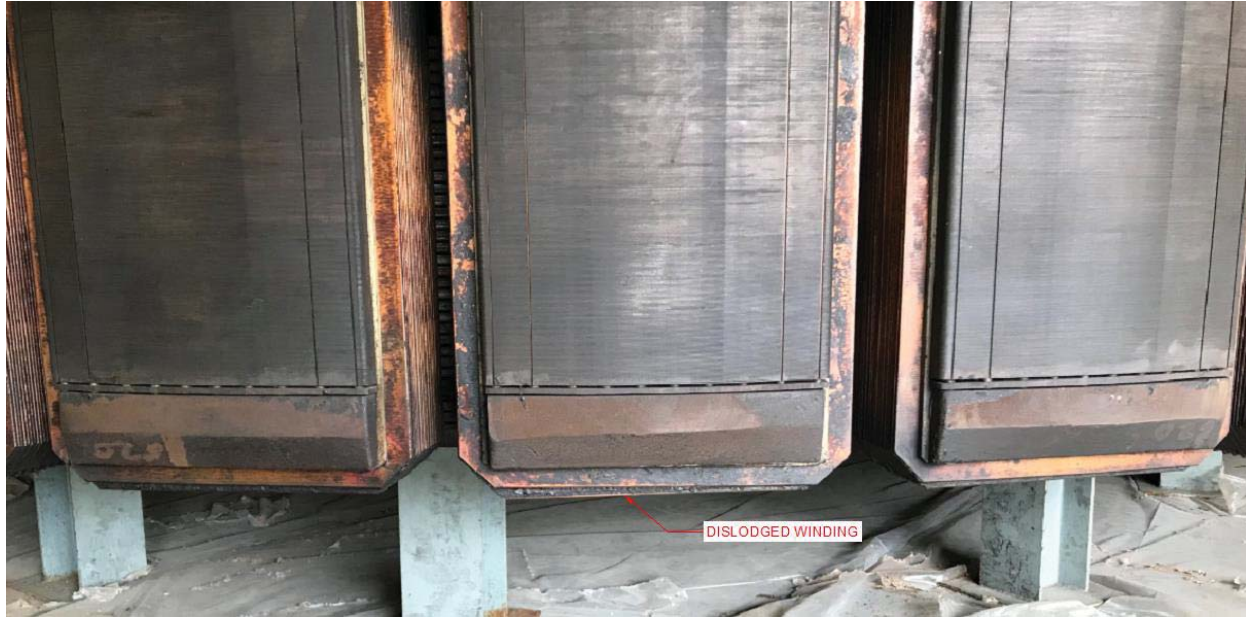
On Pole number 20 it was obvious that one of the windings had become dislodged at one point. While there was a misalignment of one winding compared to the rest on Pole 20 it did not appear to be damaged or defective and it was unknown when this occurred. This could have occurred during the original manufacturing of the pole and thus it has been misaligned for 42 years. All of the clamping and connection hardware appeared to be in good working order. There were signs of melting Rim Laminations, which could be signs of a short in the Poles, in certain areas of the outer diameter of the Rim Plates. The impacted area was between the Poles

Figure 5-105: Rotor Pole: Dislodged Winding

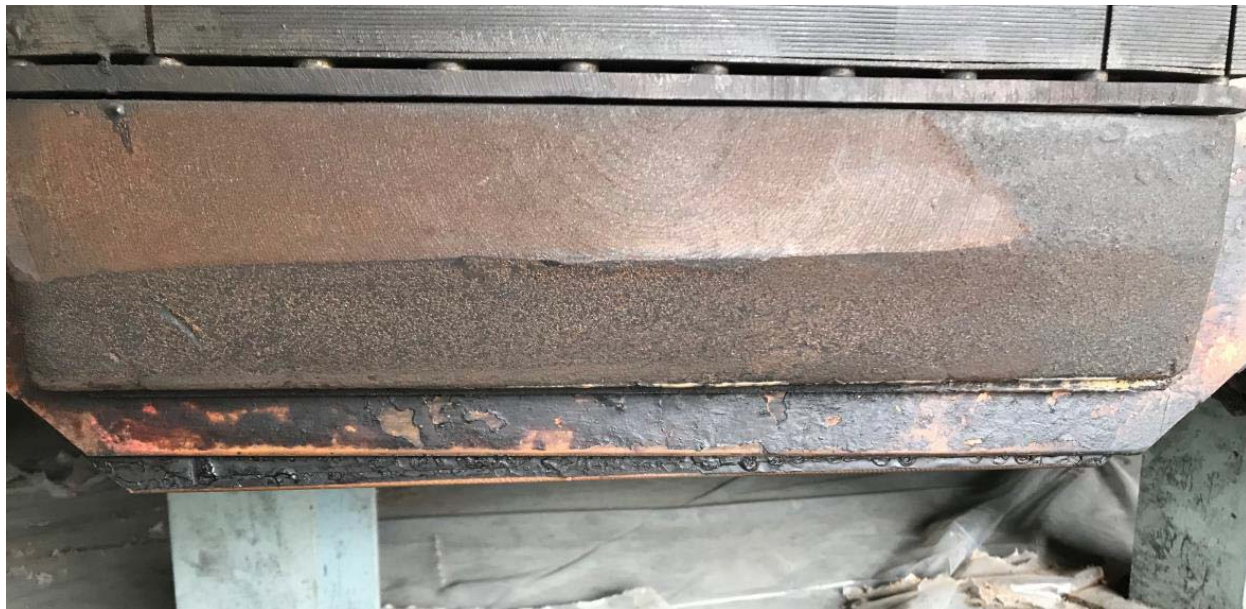
Figure 5-106: Rotor Pole: Dislodged Winding

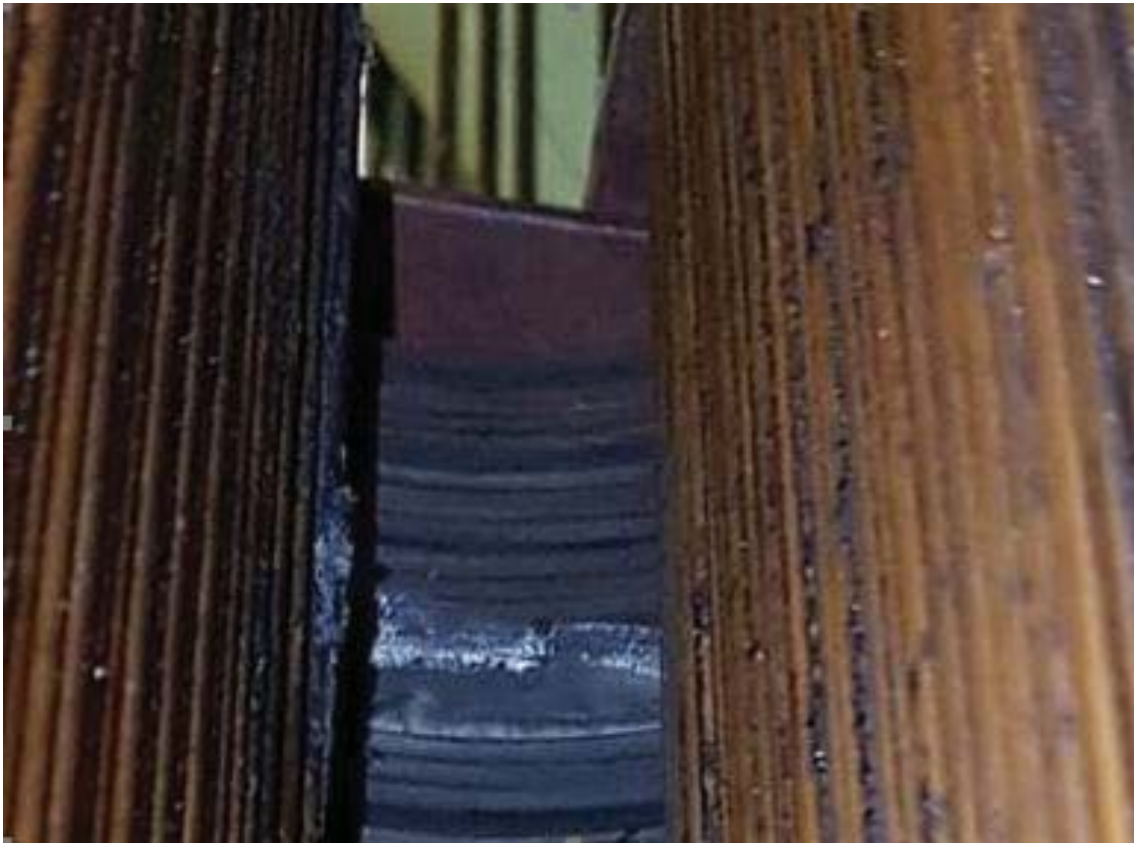
Figure 5-108: Rotor Pole: Melting Rim Laminations

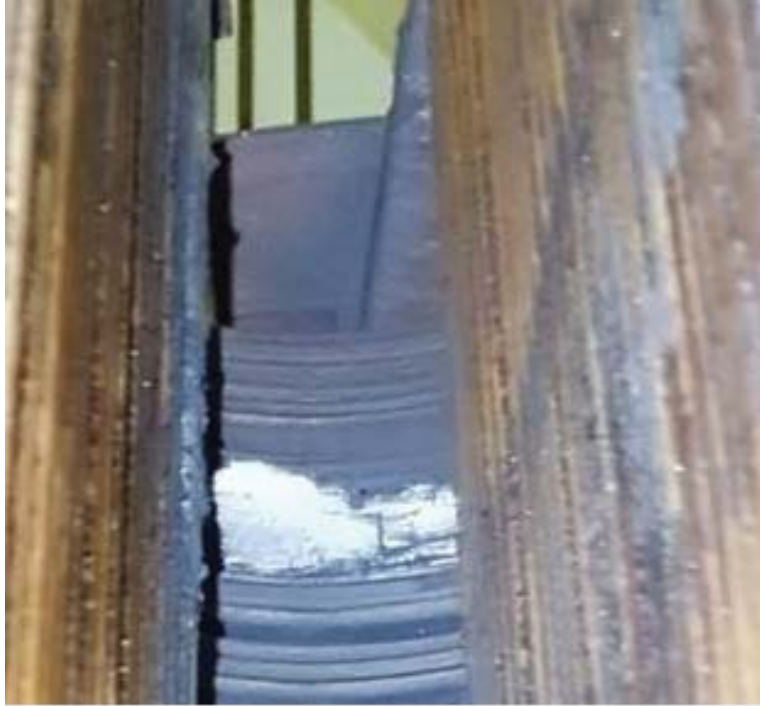
Figure 5-109: Rotor Pole: Melting Rim Laminations

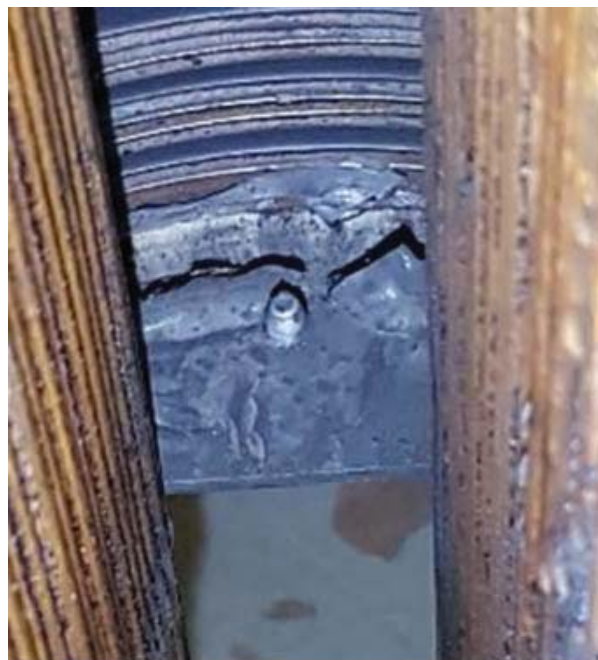
Figure 5-110: Rotor Pole: Melting Rim Laminations

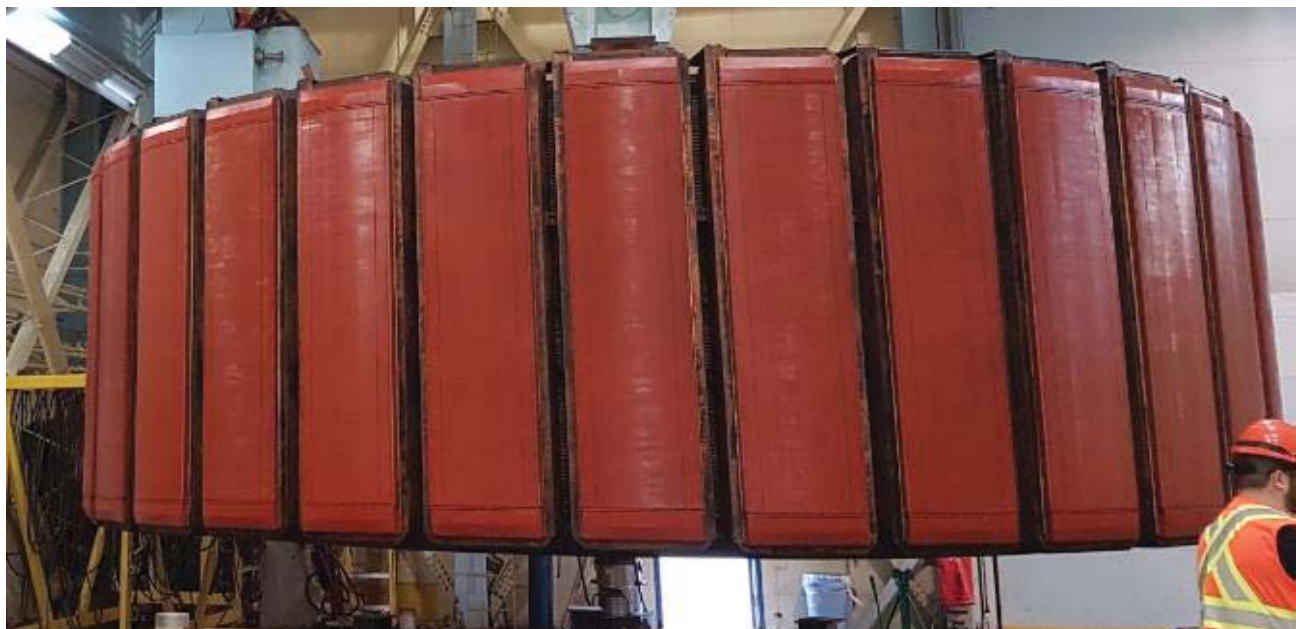
Figure 5-113: Unit 7 Rotor after Cleaning and Painting

- After further discussion, NLH followed Voith's recommendation and clean, paint, and test the Rotor prior to commissioning. All of the completed reports and data from electrical testing of the Rotor are provided in the Appendix.

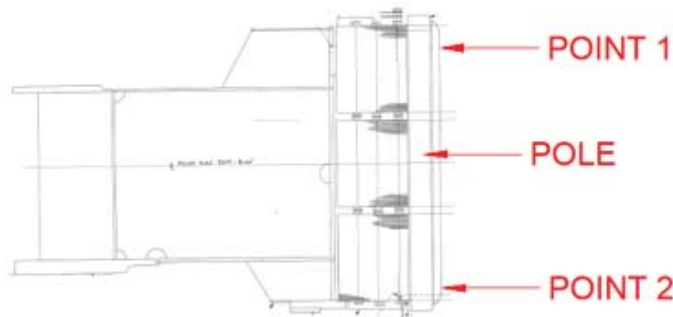
The verticality of the 32 Poles, which is also a CEATI requirement, was also checked during the 2019 maintenance outage. Figure 5-120 shows the results of the Pole verticality check. During the inspection two measurements were taken: one on the upper front face of the Pole and the other on the bottom face. Both measured points were taken roughly 150 mm from their respective ends. Poles 1 through 24 measured very good verticality; however the verticality started to increase clockwise from Pole 25 to Pole 30 and then improved for the remaining two poles.

While the verticality was increased from Pole 25 to 30, only three of the Poles measured out of the CEATI Part 2 tolerance range. This tolerance range, which is for a new machine, is a function of the OEM Air Gap. For BDES Unit 7, the verticality tolerance from CEATI Part 2 is 0.0525 inch. The three Poles found outside of this tolerance zone were in a range of 0.055 to 0.059, which is very close to the upper limit. While this could seem alarming, due to the delicate nature and function of the Poles, it was difficult to determine why and when these Poles verticality started to change; in fact, it is possible that the Poles were installed this way during the original commissioning in 1977.

Figure 5-120: Rotor Pole Verticality

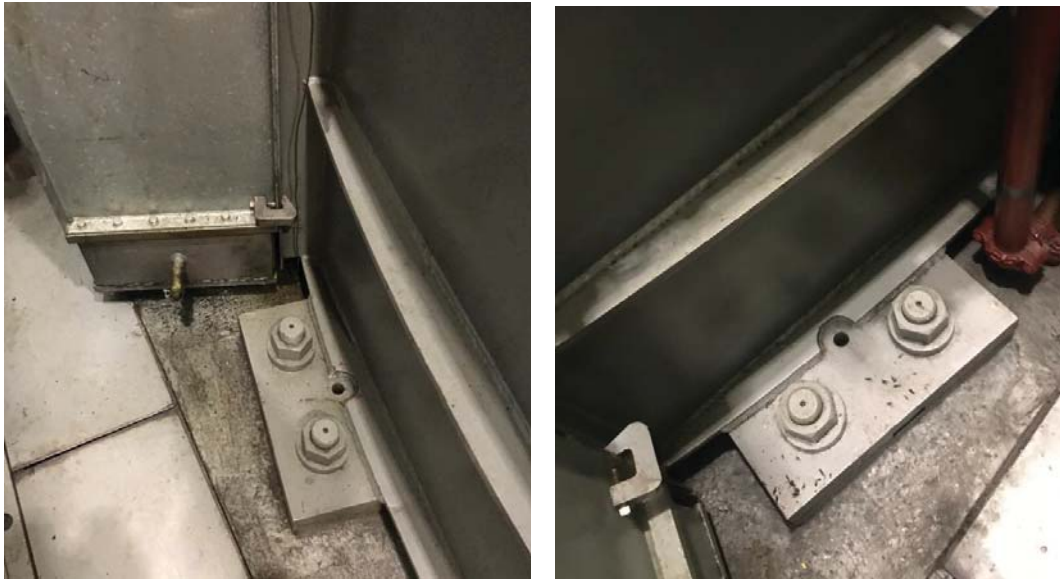
From what VH could visually inspect, the Sole Plate Keys were in place with no signs of movement. The concrete around the Sole Plates did not show any signs of cracking or damage; in fact all of the concrete in the area of the Stator appeared to be in good condition. The only notable finding was light grease and oil found

on the coolers, concrete foundation, and shelf plates of the Frame. The sources of the oil film was unclear, but was consistent throughout the inspection of the entire generator.

Figure 5-125: Stator: Stator Frame Sole Plates

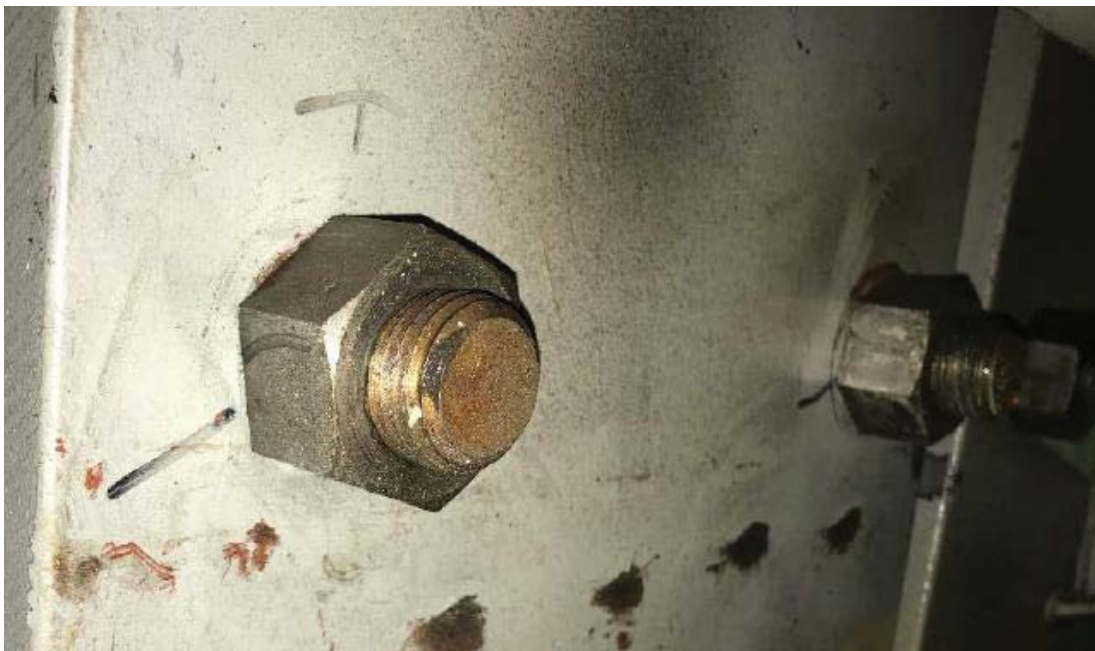
Figure 5-132: Stator Core, Pressure Plate Nut Movement

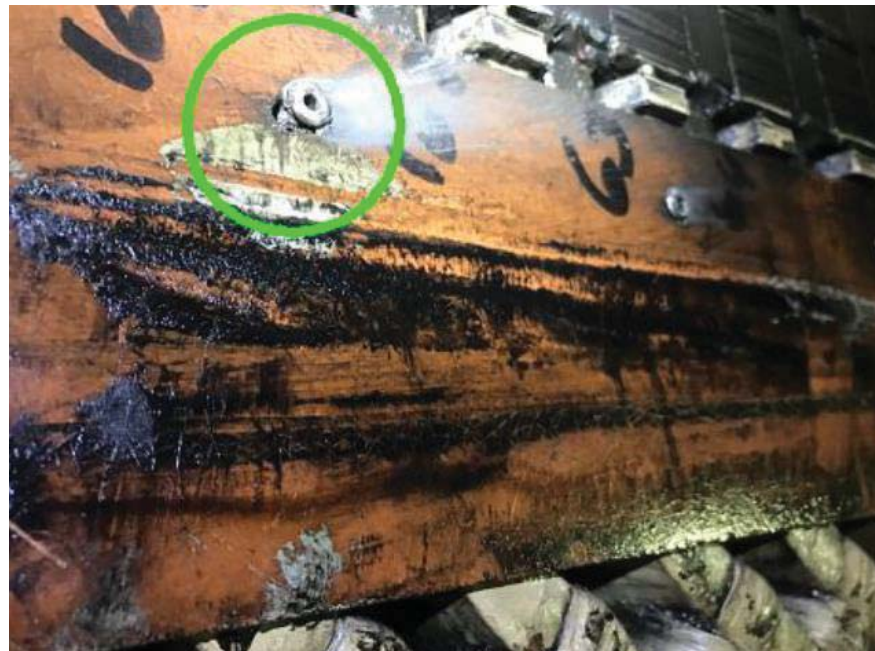
Figure 5-134: Stator Core, Loose Rivet beginning to pull through Air Guide

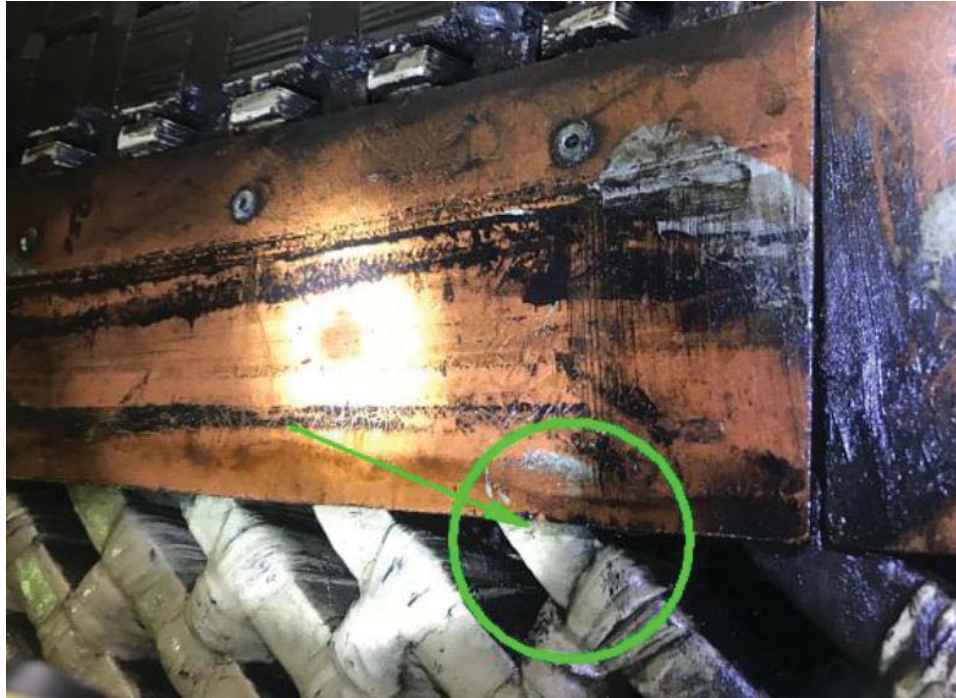
Figure 5-135: Stator Core, Air Guide Rubbing on Winding, due to Loose Hardware

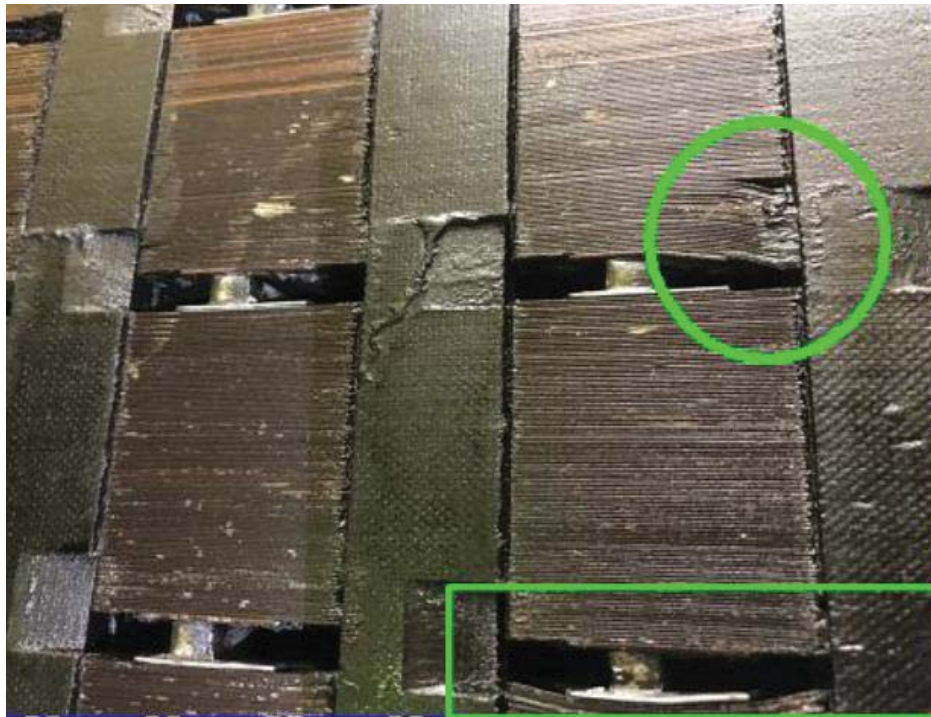
Figure 5-136: Stator Core, Bent Lamination Damage; the Cause was Unclear.

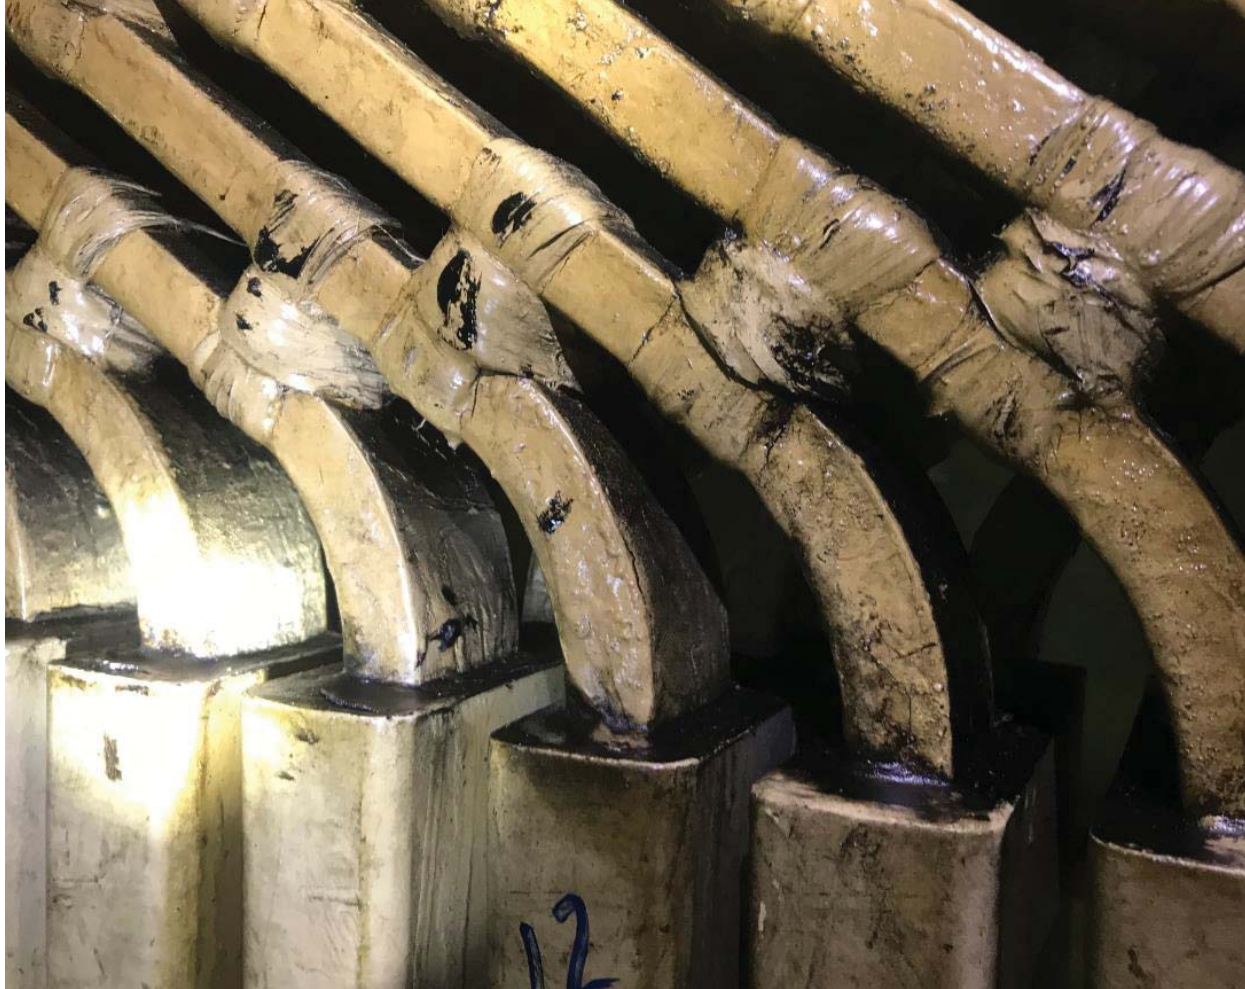
Similar to the Stator Core, the Windings were dirty with significant oil and carbon dust from the exciter and brake pads on the surface of the Wedges and Punchings. The insulation tape around the Windings was cracked and dry. The ties between the Windings appeared to be fraying and brittle. The oil that covered the Core and Windings appeared to have run down the Core and collected in top of the bottom end caps. This was somewhat concerning because the insulation coating was in poor condition, and in some instances the insulation was missing from the end cap. In some locations the paint coating the Windings had severe bubbling and cracking present.

Figure 5-140: Stator Windings: Typical Condition of Bottom End of Windings

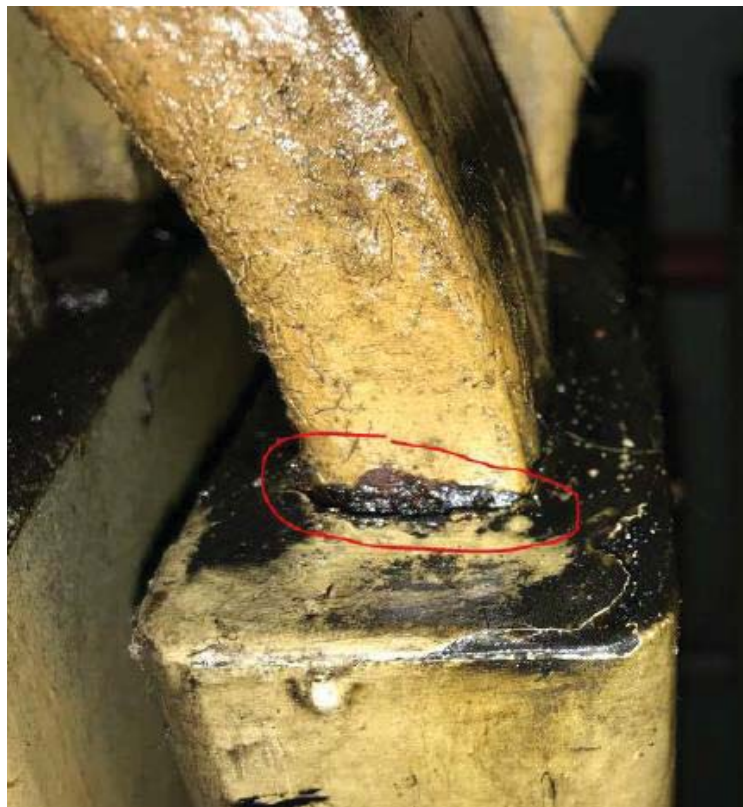
Figure 5-144: Stator Windings: End-Cap Insulation Cracked

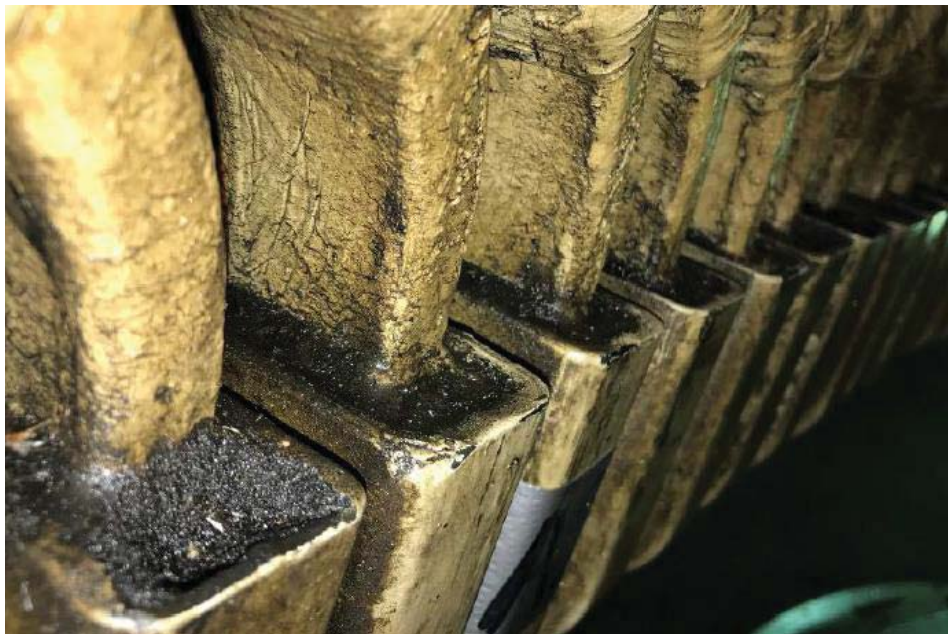
Figure 5-146: Stator Windings: Damaged End-Cap

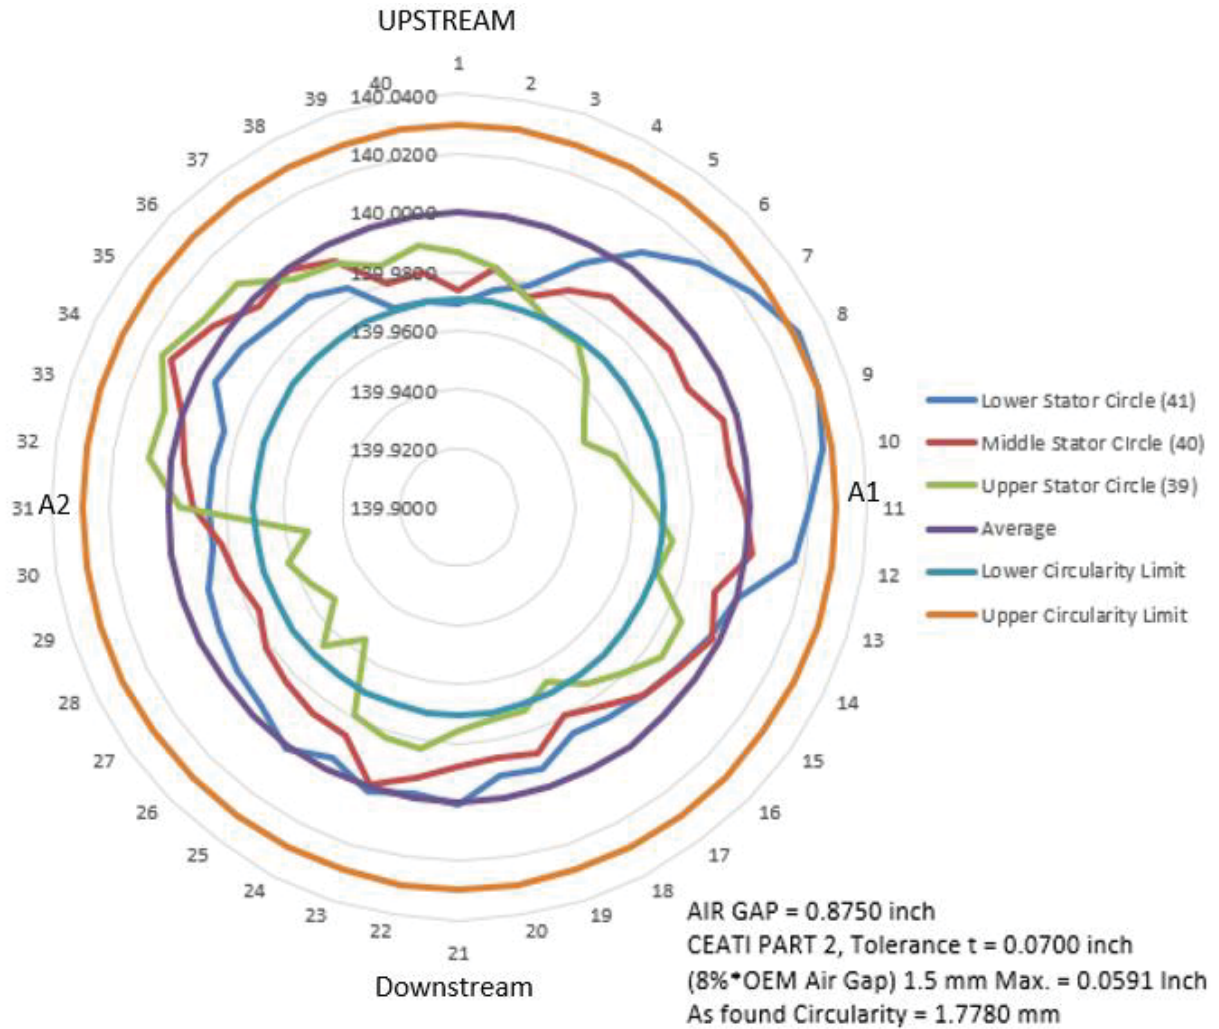
Figure 5-153: Stator Core, Inner Diameter Circularity

The circularity of the Stator Core of top, middle, and bottom is shown in Figure 5-153. The plot shows the three data point circles created during the inspection with the average shown in purple. The circularity tolerance is based upon the new machine standards set by CEATI (Part 2). The tolerance set by CEATI is a function of a percentage of the Air Gap. In this case, the circularity tolerance was 8 percent of the OEM Air Gap value of 0.875 inch, which was 0.070 inch. However, this calculated number was higher than the 0.059 inch (1.5 mm) limit established by CEATI, which was used during the analysis. As shown in the circularity graph, almost all

of the data points are within the tolerance zone set by CEATI with the outliers falling just outside of the allowable range.

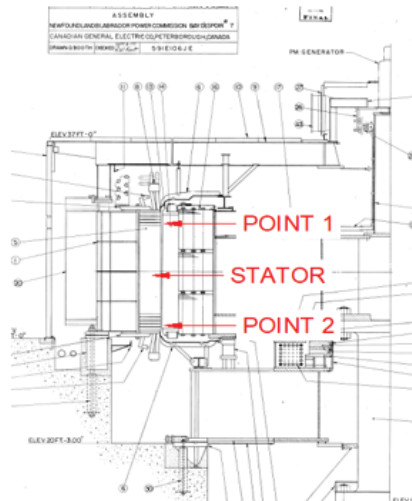
Figure 5-156: Stator Core, Verticality Results – Reference Figure 5-155 for Location

The verticality of the Stator Core was also recorded and analyzed and, similar to the circularity, the tolerance zone was a function of the Air Gap based upon CEATI standards. The points used for the verticality inspection were taken on the inner diameter of the top and bottom of the Core. The results of the verticality inspection showed that 85 percent of the Core was found to be within the tolerance zone of 0.053 inch. The 15 percent of the Core out of tolerance was in the location or direction where the elliptical (oval) shape had taken form over all of the embedded components.

Polar Angle Position	Verticality
266	0.025
257	0.016
247	0.019
238	0.016
228	0.047
218	0.030
209	0.042
210	0.035
201	0.029
201	0.033
171	0.010
162	0.022
156	0.022
147	0.020
139	0.016
130	0.019
119	0.008
110	0.009
102	0.015
Upstream	0.019

CEATI PART 2 Tolerance, $t = 6\% \times \text{OEM Air Gap or } 1.5 \text{ mm max.}$
OEM Air Gap = 0.875 inch
CEATI Tolerance applied to OEM Air Gap = 0.0525

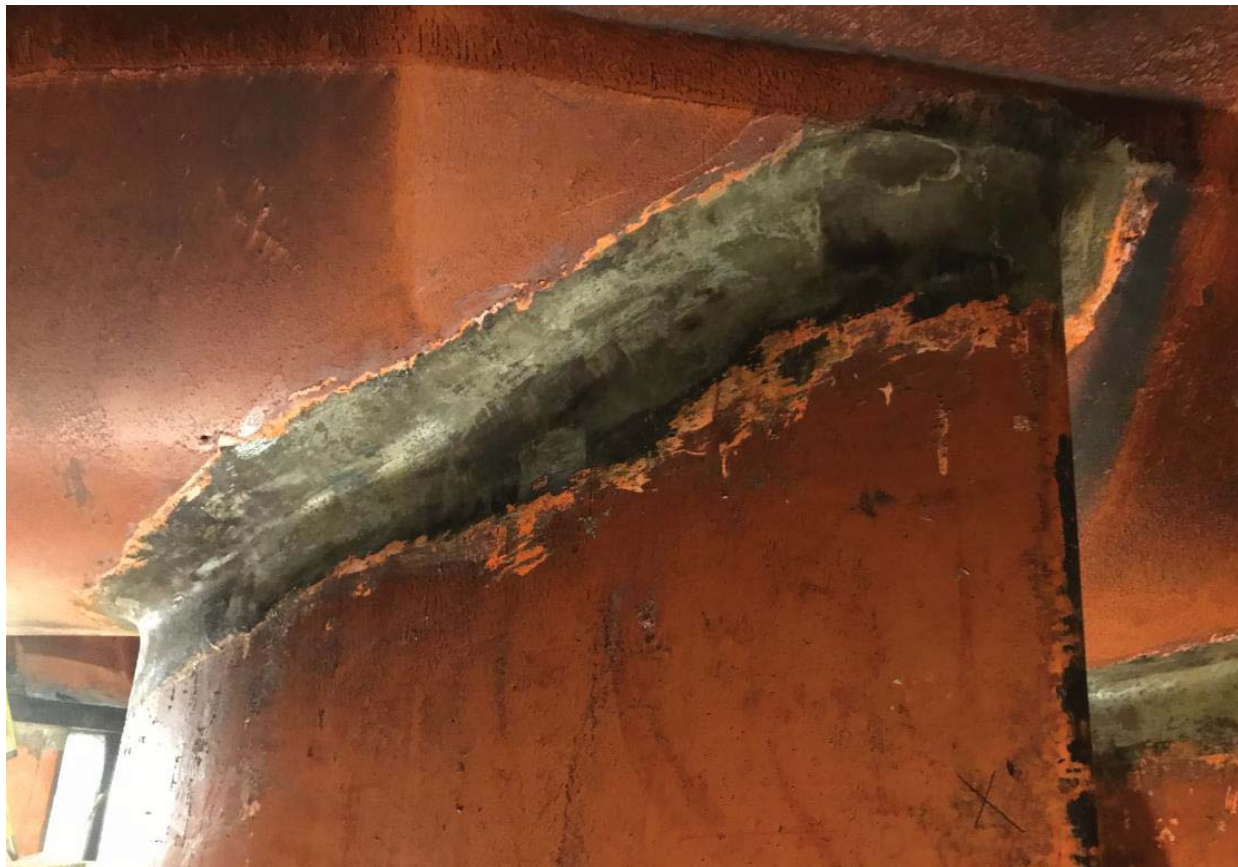
Figure 5-159: Stay Ring, Vane NDE

A non-destructive examination was planned for the Stay Vane fillet welds for the 2019 maintenance outage. The NDE contractor, Acuren, performed the examination using the method of Magnetic Particle Test (MT). The contractor used a VH-provided document (2-10044792) to guide their inspection. Within this document the contractor was instructed to inspect all of the large fillet welds that connect the upper and lower rings of the Stay Ring assembly. Prior to doing so the lead paint was removed from the areas that were examined. Once the paint was removed, Acuren MT inspected all of the joints and reported that no relevant indications were found during the inspection.

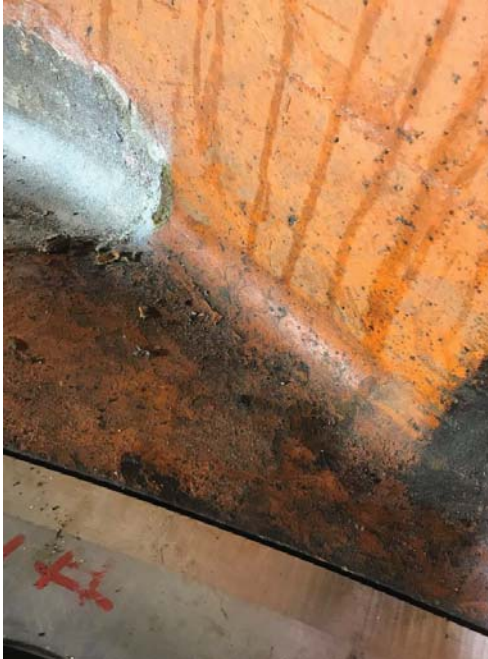
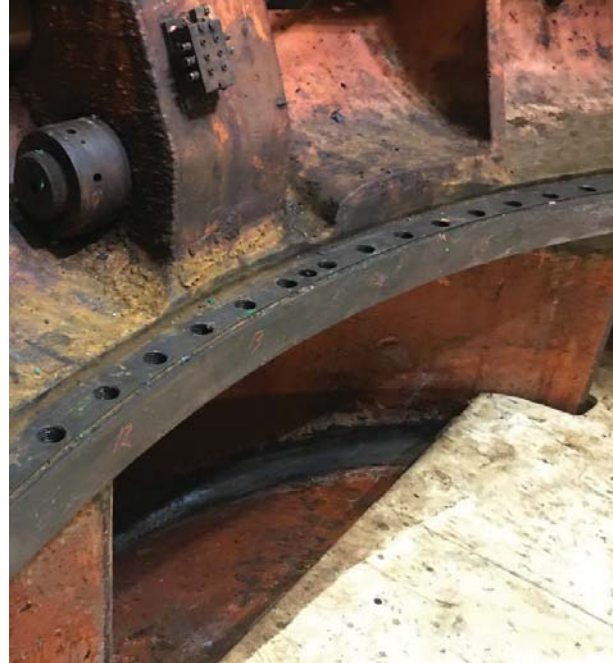
Figure 5-162: Turbine Pit Platform Interference

Due to the temporary platform constructed during the 2019 maintenance outage, a small section close to the discharge edge of the Stay Vanes was not inspected. The platform was critical to other outage tasks and removing it to inspect the small area would not be conducive with maintaining the outage schedule. Since no indications were found on the Stay Vanes inspection, which was close to 97 percent, it was decided not to remove the platform for the remaining three percent. A comprehensive NDE report, with results and notes is located in the Appendix.

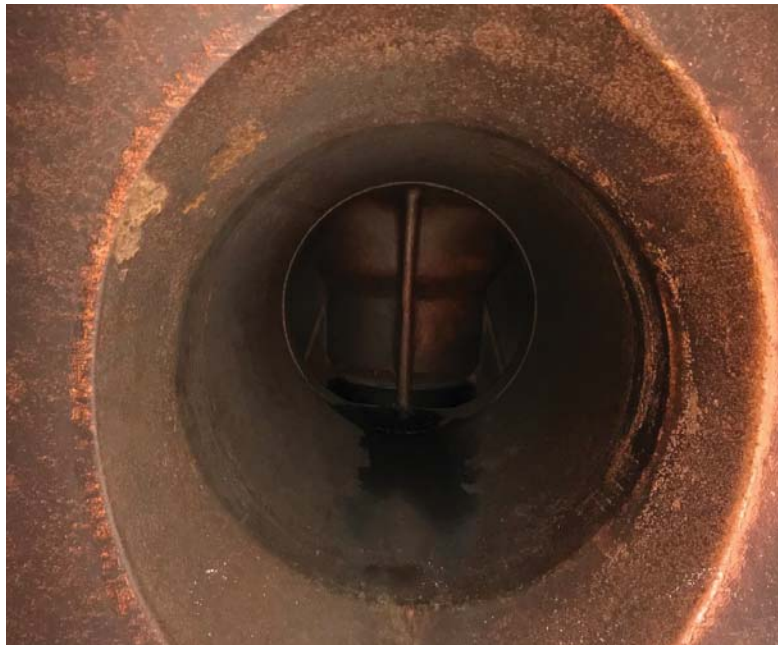
Figure 5-167: Spiral Case, Pressure Relief Valve

Voith performed a visual inspection of the Spiral Case to look for any obvious signs of damage or failure. The Spiral Case was in good condition considering the age and amount of time the unit was under operation. The orange paint (possibly OEM) was in fair to poor condition with limited signs of base metal deterioration. As shown in the figures below, the paint was missing from the middle section of the Spiral Case; however a fair amount of paint was still present on the top and bottom sections. No signs of obvious damage or cracks were present at the time of the inspection. The base metal on the middle section of the Spiral Case was slightly worn and some pitting or deterioration was present.

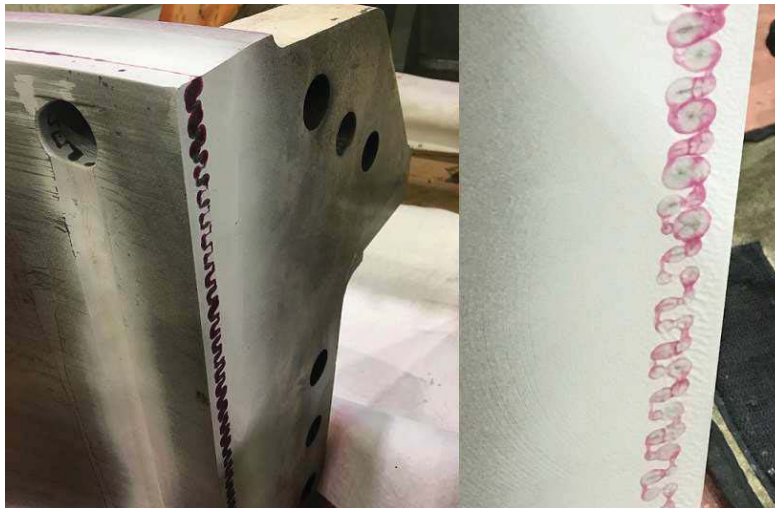
Figure 5-172: Turbine Guide Bearing, PT Section 1-3

1. **Section 1-3:** Unacceptable linear indications were found on the entire length of both mating sides. Across the top linear, indications were noted, the first starting at the edge stamped 1 for a length of 19" and the second starting at edge stamped 3 for a length of 22".

- **Recommendation:** Voith provided a recommendation to NLH to use the spare Turbine Guide Bearing and to consider rehabilitating the bearing removed during the 2019 maintenance outage.

During reassembly of the Unit 7 machine NLH proceeded with the VH recommendation and installed the Spare Turbine Guide Bearing. The spare TGB was installed upon unit alignment and no issues or concerns were present prior to or during commissioning. The Turbine Guide Bearing taken out of service was sent to Canadian Babbitt Bearing for refurbishment.

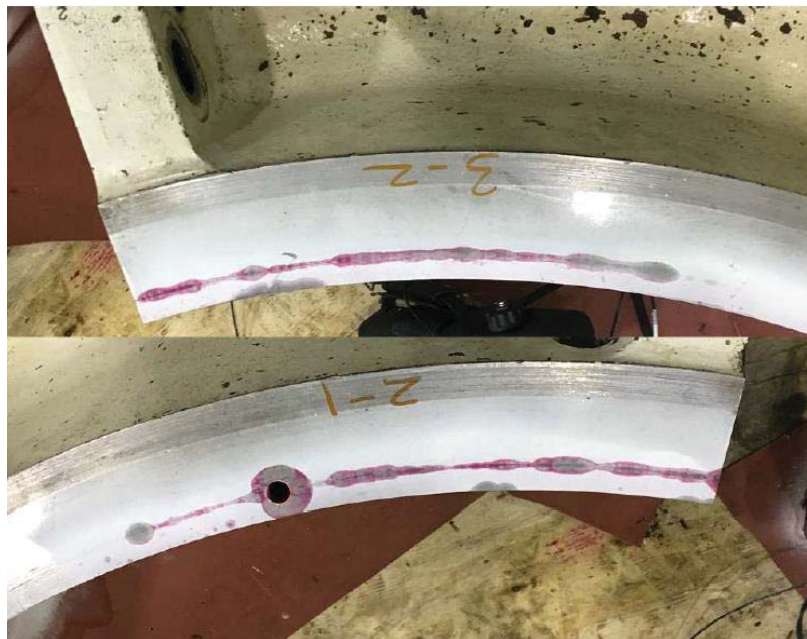
Figure 5-173: Turbine Guide Bearing, PT Section 1-2 and 2-3

2. **Section 2-3:** Unacceptable linear indications were found for the entire length of both mating sides. Across the top, linear indications were noted, the first starting at edge stamped 2 for a length of 13.5" and the second starting at edge stamped 3 for a length of 18.25".
3. **Section 1-2:** Unacceptable linear indications were found for the entire length of both mating sides. Across the top, linear indications were noted, the first starting at edge stamped 1 for a length of 13.5" and the second starting at edge stamped 2 for a length of 13".

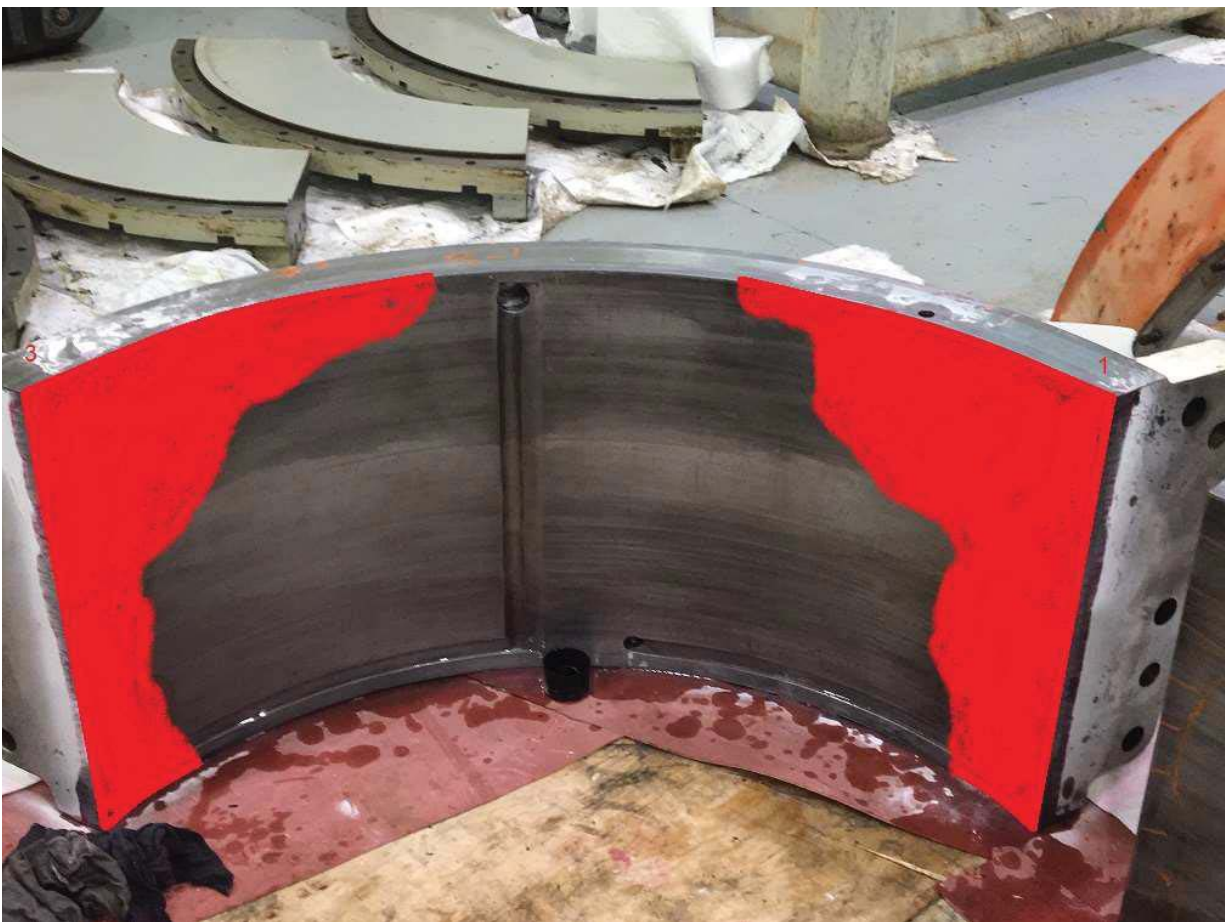
Figure 5-174: Turbine Guide Bearing, Section 1-3

- The Ultrasonic Examination revealed significant delamination of the Babbitt material on all three sections of the Turbine Guide Bearing. Shown below and highlighted in red, the UT inspection located these areas of delamination. All of the UT indications are unacceptable per Voith's Babbitt Bearing Test Requirements 2664-000300 procedure.

Once Voith reviewed the reports provided by Acuren, Voith determined the condition of the Turbine Guide Bearing was unacceptable. This determination is a result of NDE indications and delamination of the Babbitt material listed in Section 5.19.4.2. Per Voith Standards, this bearing should be placed out of service and repaired.
