Re: Application for Capital Expenditures for the Life Extension of Bay d'Espoir Unit 7 – Redacted

Please find enclosed Newfoundland and Labrador Hydro's ("Hydro") application for the capital expenditures required for the life extension of Unit 7 of the Bay d'Espoir Hydroelectric Generating Facility ("Bay d'Espoir Unit 7").

Engineering Report
Mechanical Engineering
Bay D'Espoir Unit 7 Condition Assessment Condition
Report

Bay d'Espoir – Newfoundland and Labrador Hydro		
Unit 7 Refurbishment Report Project Report	TFS7000	
	PDM Doc ID:	Doc. Revision:
	2-10066279	-

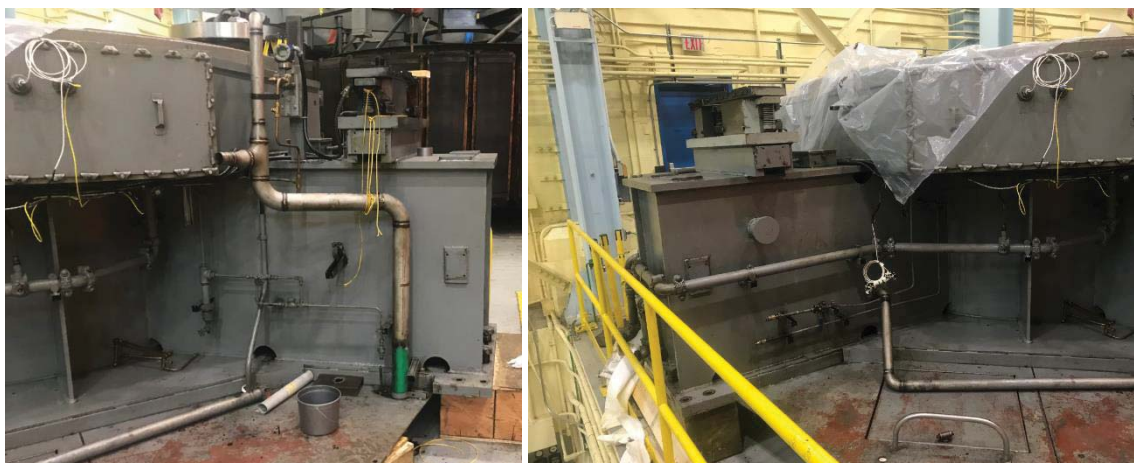
Figure 5-180: Main Bracket

The Main Bracket was visually inspected by Voith engineering for any obvious signs of damage, cracking, and any indications that the bracket may require repair prior to placing the unit back into to service. Overall the Main Bracket was found to be in good condition. No signs of major leaks or damage were present at the time of the inspection. The braking mechanism, piping, and electrical system were visually in good working order. The paint on the Main Bracket was in good condition with limited signs of wear and deterioration. During the 2019 maintenance outage, NLH covered the exposed internal components of the combined bearing to ensure the dust and debris did not enter the area.

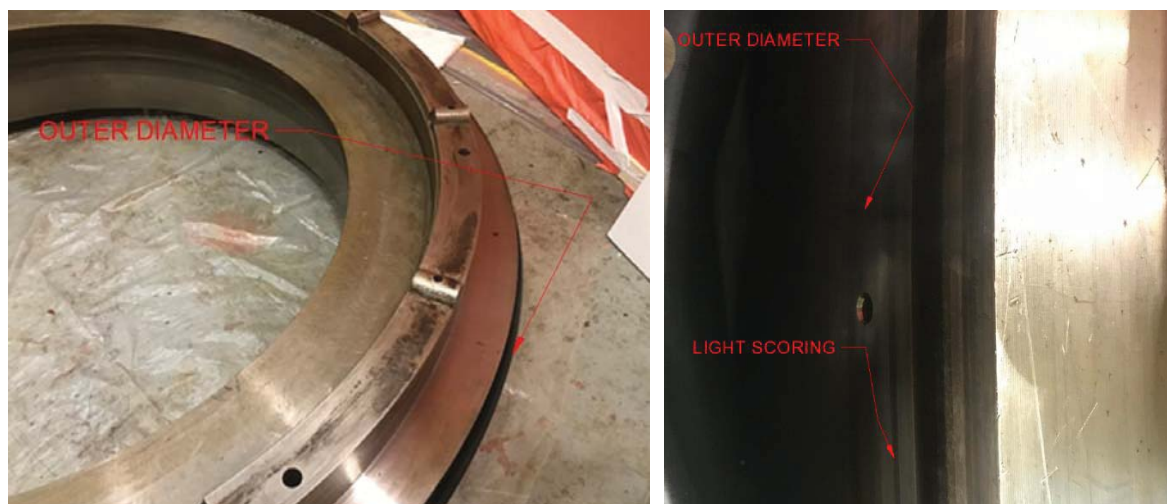
Figure 5-183: Thrust Collar, OD Light Scoring

Thrust Collar: The Thrust Collar was found to be in good visual conditional with limited signs of wear. The mating surface on the Thrust Collar that contacts the Thrust Runner had light signs of fretting and corrosion. No signs or indications of damage or failure were present during the time of inspection. The round keys, which mate with the Generator Rotor, were also found to be in good condition with some light fretting located on a few of the keys. The lower outer diameter of the Thrust Collar is the journal surface. The Guide Pads surround this surface, and with the use of oil a hydrodynamic environment is created. As shown below the outer diameter of the Thrust Collar had some wear and very light scoring, possibly from coming into contact with the Guide Bearing Pads or debris in the oil.

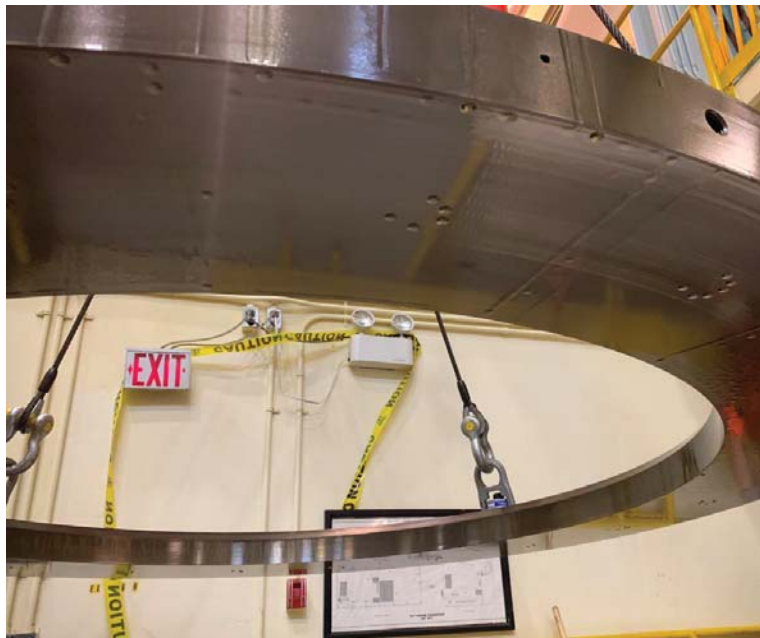
Figure 5-188: Thrust Runner Journal Surface

Overall the fretting was not deemed an immediate threat to the operation of the machine. On the opposite side of the Thrust Runner is the bearing journal of the thrust bearing assembly. This surface rotates on a thin film of oil. The Thrust Pad, which is located just below the Thrust Runner during operation is the sacrificial wear component made of softer material. The thin film of oil is located between the Pad and Runner and in theory, as long as the hydrodynamic condition exists the life of the bearing journal (Thrust Runner) is virtually limitless. In the case of the Unit 7 Thrust Runner the bearing journal was in good condition and no visual indications of damage or failure. All of the threaded holes and oil holes were also in good condition. The inner diameter and outer diameter surface did not show any indications or concerns.

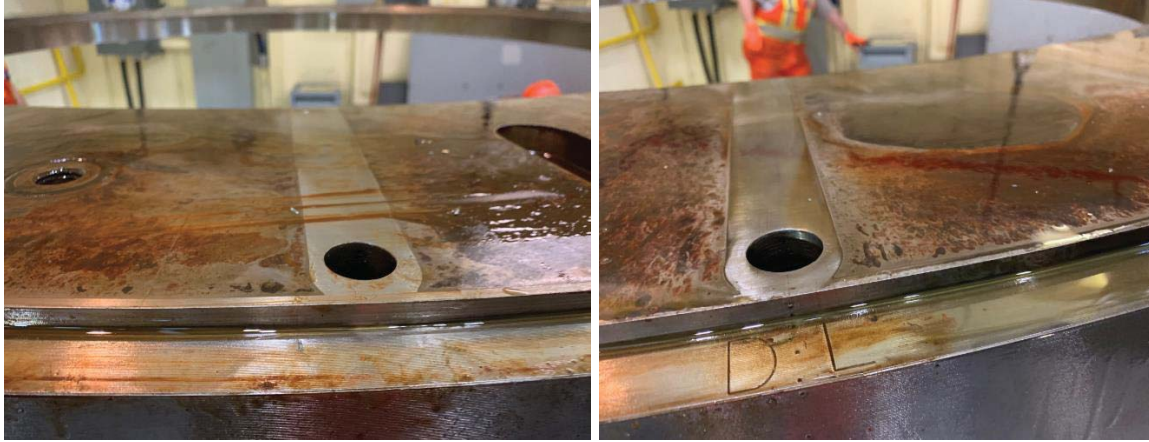
Figure 5-189: Thrust Runner, Fretting

Thrust Runner: The Thrust Runner was found to be in good visual condition with limited signs of wear. The mating surface on the Thrust Runner that contacts the Thrust Collar had light signs of fretting and corrosion. The fretting that was found between the Collar and Runner is not uncommon to find and in the case of Unit 7 was very light in nature. The fretting can be a result of high load vibrations, micro-debris between the contact

surfaces, and/or repeated relative surface motion. It is difficult to determine the exact root cause of the fretting without performing a detailed inspections and analysis of the design and operation of the unit.

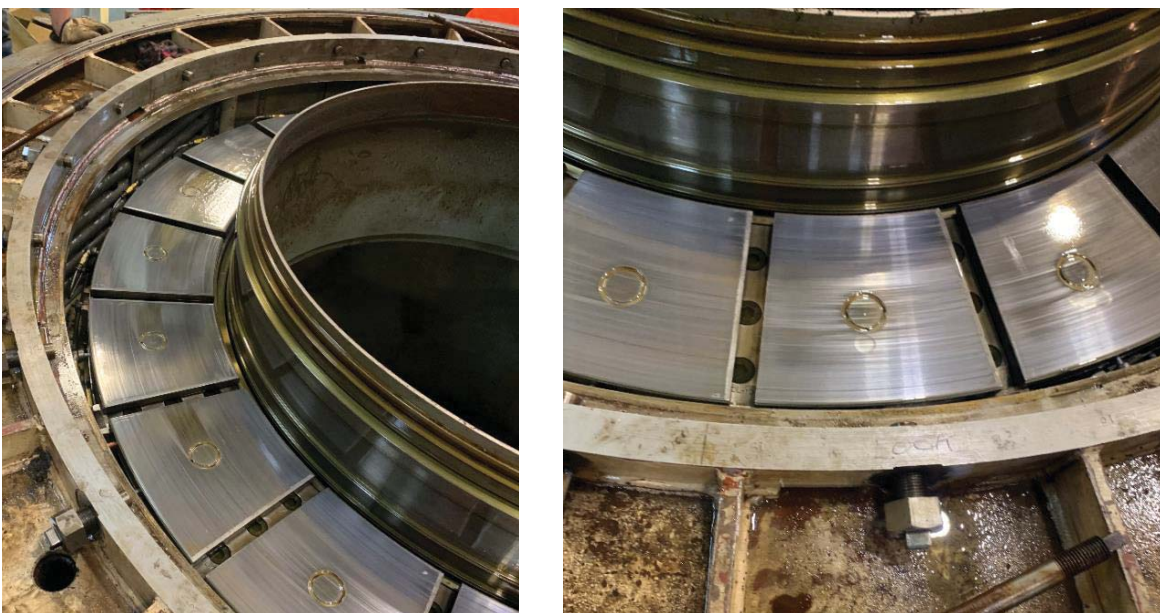
Figure 5-192: Thrust Pads

- **Voith Recommendation:**
 - Voith recommended disassembly of the Thrust and Guide Pads from the unit and a complete NDE inspection should occur to verify the condition of the Babbitt surface of the pads. The individual springs that make up the spring beds under the Thrust Pads should be inspected while the Thrust Pads are removed from the Main Bracket. This inspection would help to determine if new springs were required; however, new springs should only be introduced into the unit only if all of the springs are replaced.

- **Outcome:**
 - The Guide Pads were removed from the unit and visually inspected and cleaned; however, NDE was not performed on the Guide Pads. The Thrust Pads remained installed in the Main Bracket where a visual inspection was performed. Due to delicate nature of the Thrust Pads and the risk of damaging the pads during the inspection, NLH decided not to perform the NDE inspection on the pads. The decision was reinforced by the long lead time to manufacture and replace any pads that might become damaged; therefore, the risk did not outweigh the reward for a detailed inspection of each pad. Moreover, a full lot of replacement springs for the spring beds was not available at the time of the outage, deeming the inspection of each spring bed futile. NLH compromised and removed two of the Thrust Pads briefly to visually inspect the condition of the springs to ensure none of the spring were broken. The springs were in good condition and no signs of damage were present. With this information and the overall good visual condition of all of the pads, NLH reassembled the bearing components into the Main Bracket.

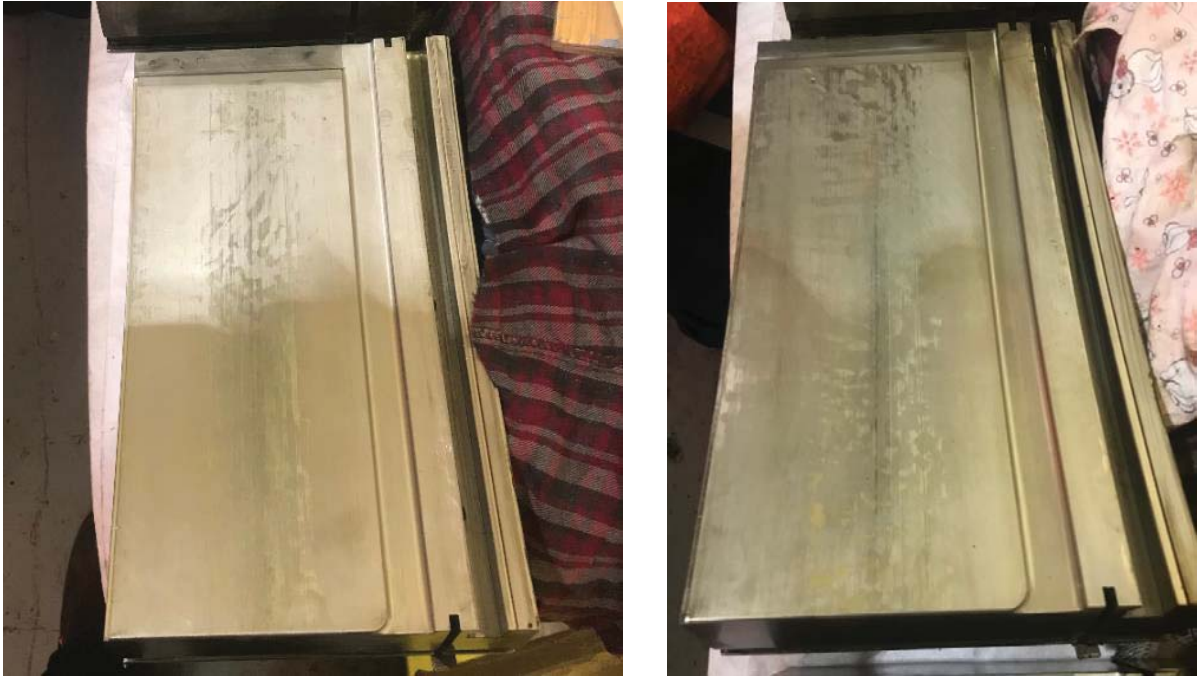
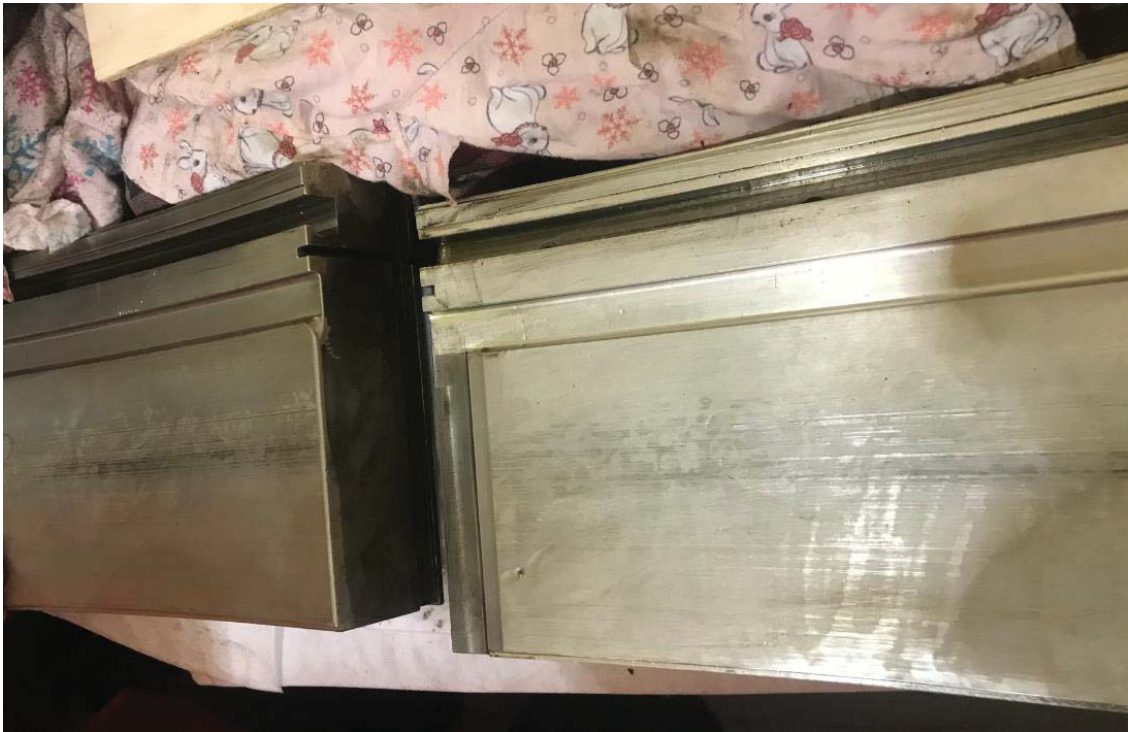
Figure 5-193: Guide Pads

Figure 5-194: Guide Pads

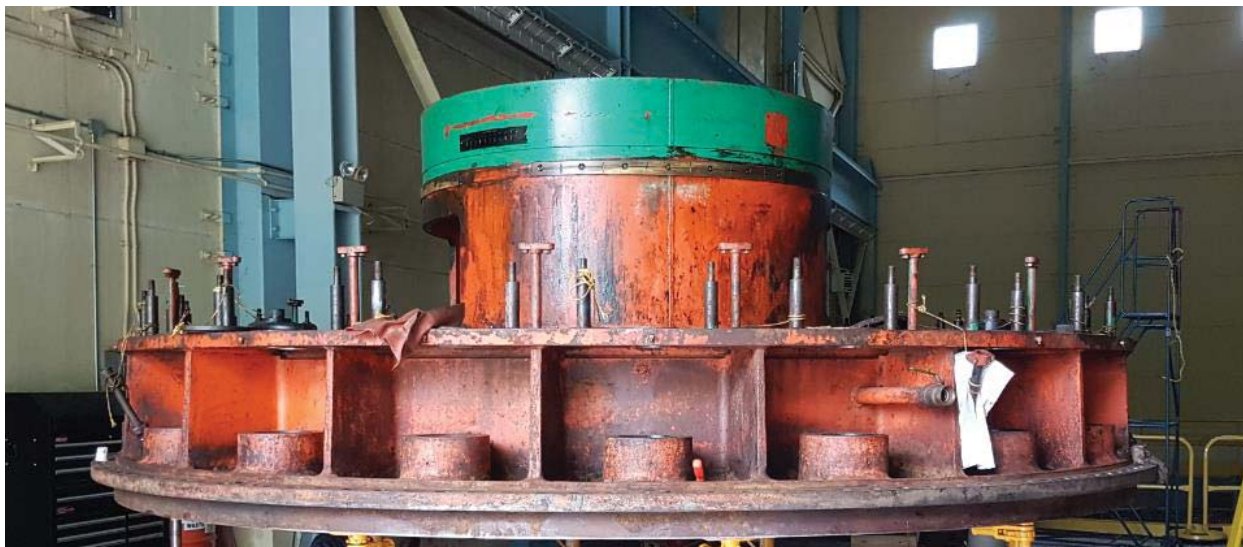
Figure 5-196: Head Cover, Post Disassembly

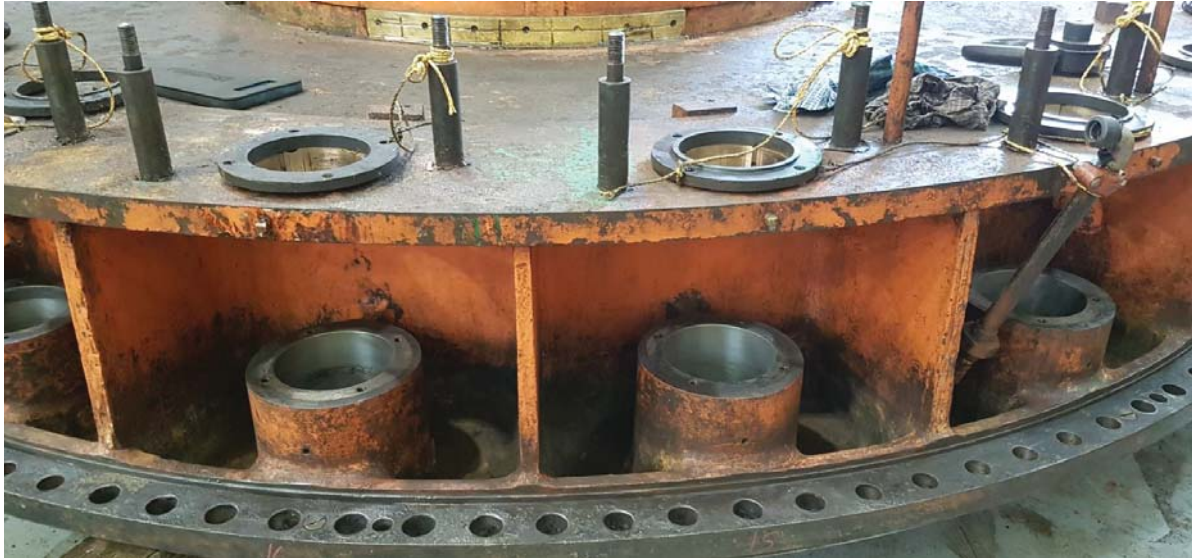
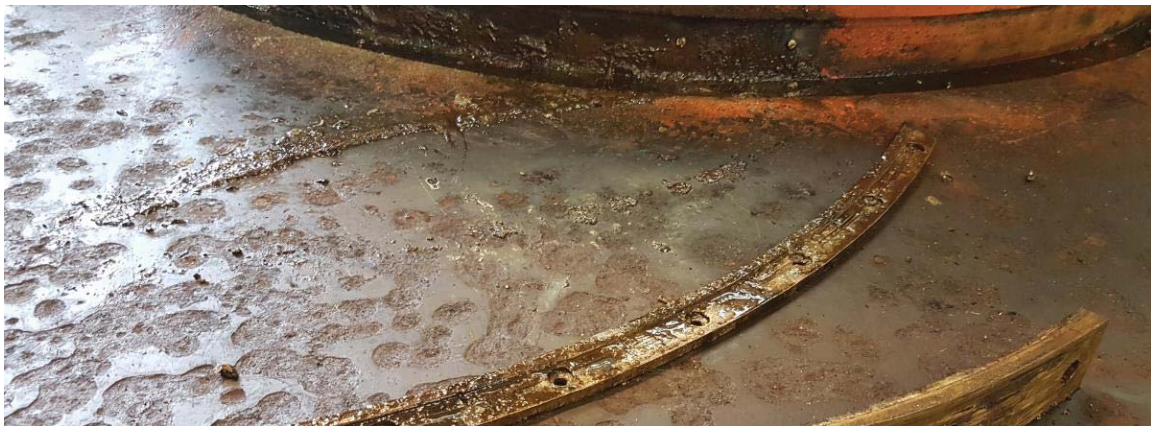
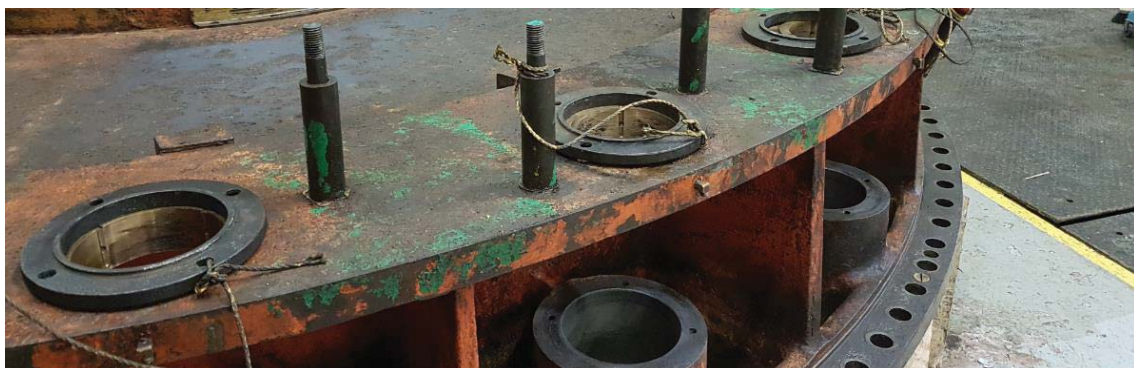
The condition of the paint was poor, especially on the flanges, top and bottom surface, and area in contact or near moving parts of the Gate Mechanism. Moderate rust, corrosion, and pitting was present on the top (dry side) and the bottom side (wet side) of the Head Cover.

Figure 5-198: Head Cover, Paint Condition and Overall Appearance

Figure 5-199: Head Cover, Paint Condition and Pitting of Upper Surface

Figure 5-200: Head Cover, Paint Condition of Bolting Flange

- NLH cleaned and painted the Head Cover. See figure below.

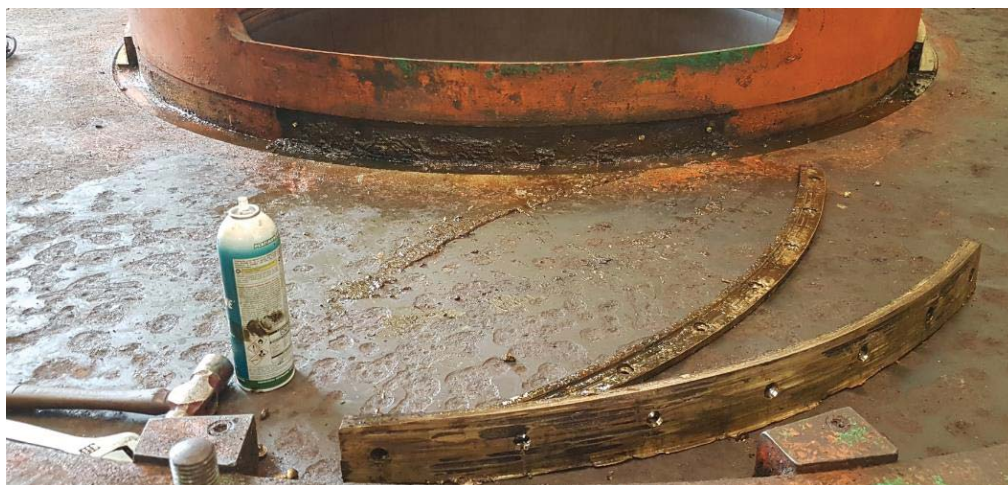
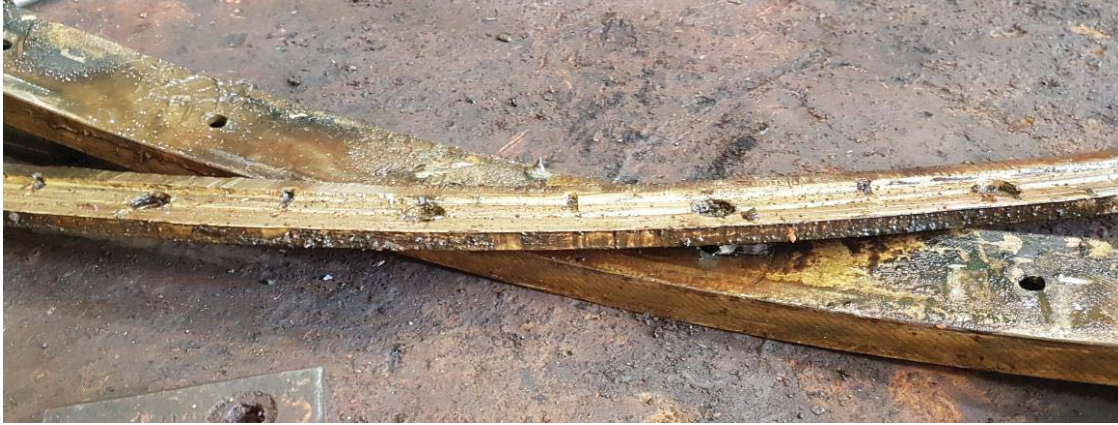
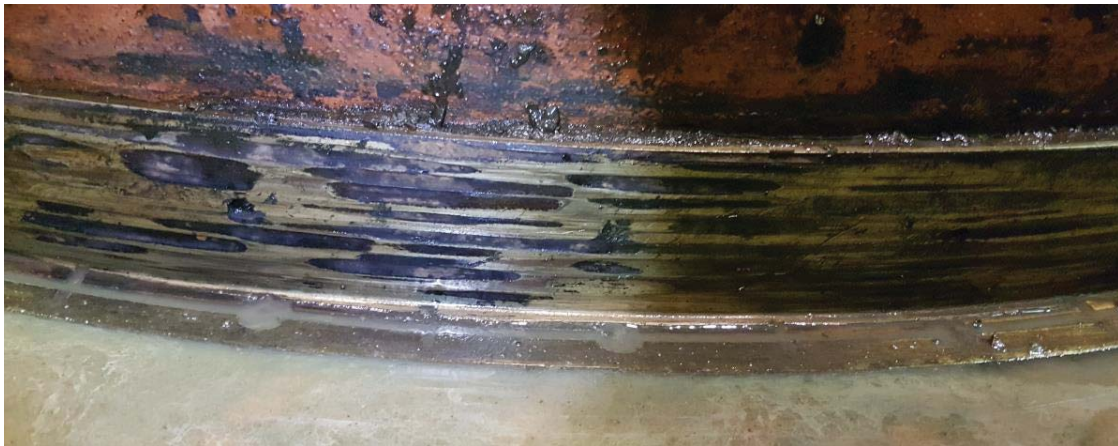
The Head Cover Extension, which is the cylindrical part extending upward that houses the Turbine Guide Bearing, was also in fair condition. This part not only provides support for the TGB, but also acts as the framework on which the Operating Ring rotates. Specifically, the Operating Ring rotates on the greased copper alloy liners on the Head Cover Extension. Once the Operating Ring was removed, the liners were visible and revealed to be in a poor condition. The condition of the liners was so severe that they were not repairable and would require immediate invention from NLH to remedy the problem. This topic is discussed in more detail in the Operating Ring Section 5.12.

Figure 5-202: Head Cover, Extension and Liners

Figure 5-203: Head Cover, Extension and Liners

Figure 5-204: Head Cover, Extension and Liner

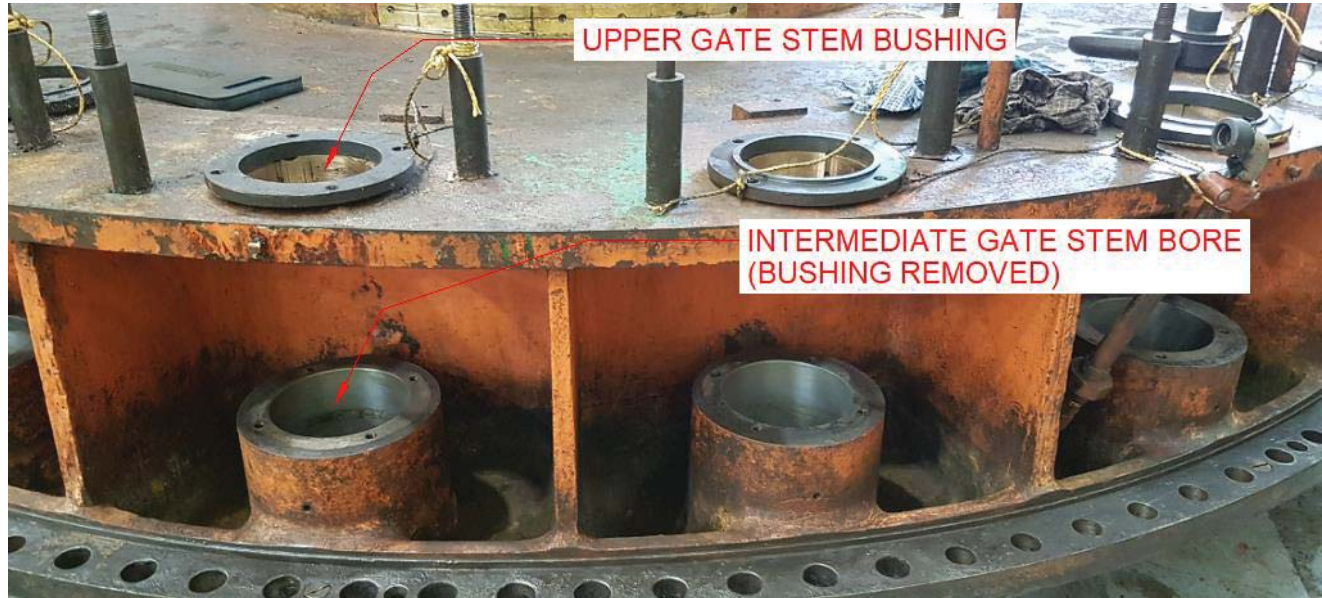
As part of the predefined work, NLH removed the Intermediate Gate Stem Bushing (IGSB) from the Head Cover in preparation of the installation of the greaseless Thordon bushing. Once the IGSB were removed the internal diameter of the bores was visible and showed to be in good condition. While the GSB concentricity was unknown at this time the surface finish and condition of the bores was suitable to accept the new Greaseless Bushing. However, the same was not the case for the Upper Gate Stem Bushings, which were not planned to be replaced due to impact this would have on other components. For the time being the Upper Gate Arm Bushing will remain greased until a major unit outage (six or more months) is planned.

Figure 5-205: Head Cover, Gate Stem Bores

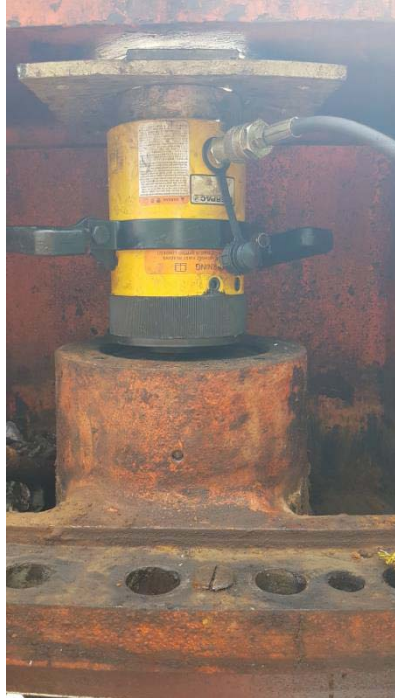
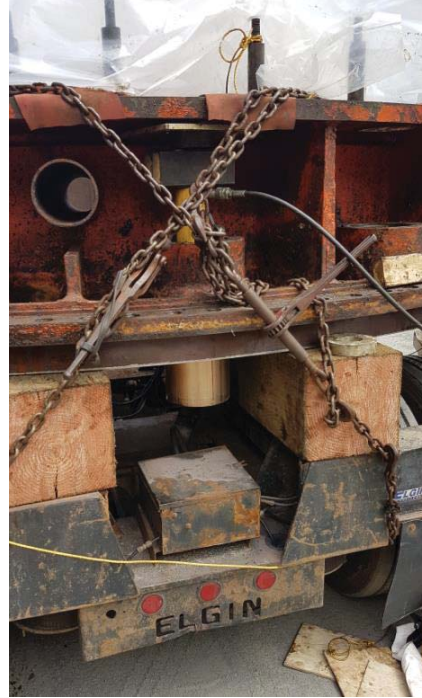
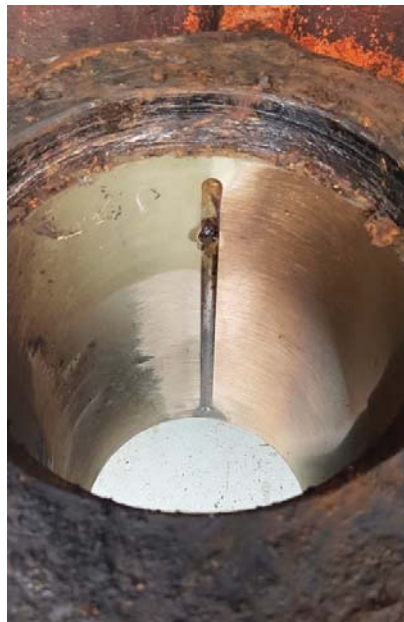
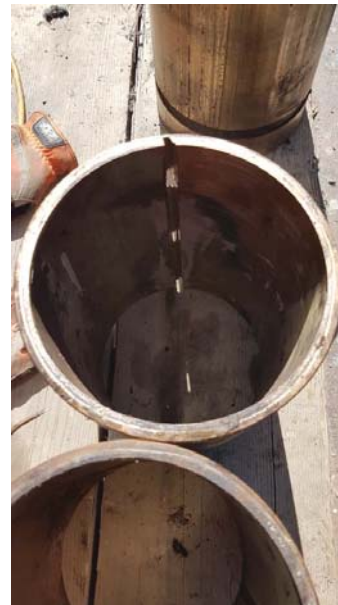
The condition of the Upper Gate Arm Bushings was poor; in fact, some of the bushings were scored and damaged enough to cause the bushing to take on an elliptical shape, rather than a circular one. This same wear pattern was found on the Intermediate Gate Stem Bushing and the Lower Gate Stem Bushing, which resides in the Bottom Ring. This pattern of wear and damage indicated that a misalignment or lack of concentricity between the Gate Stem Bores was present. The concentricity and alignment of all the Gate Stem Bores is discussed in Section 5.23.

Figure 5-206: Head Cover, Intermediate Gate Stem Bushing Removal

Figure 5-207: Head Cover, Intermediate Gate Stem Bushings

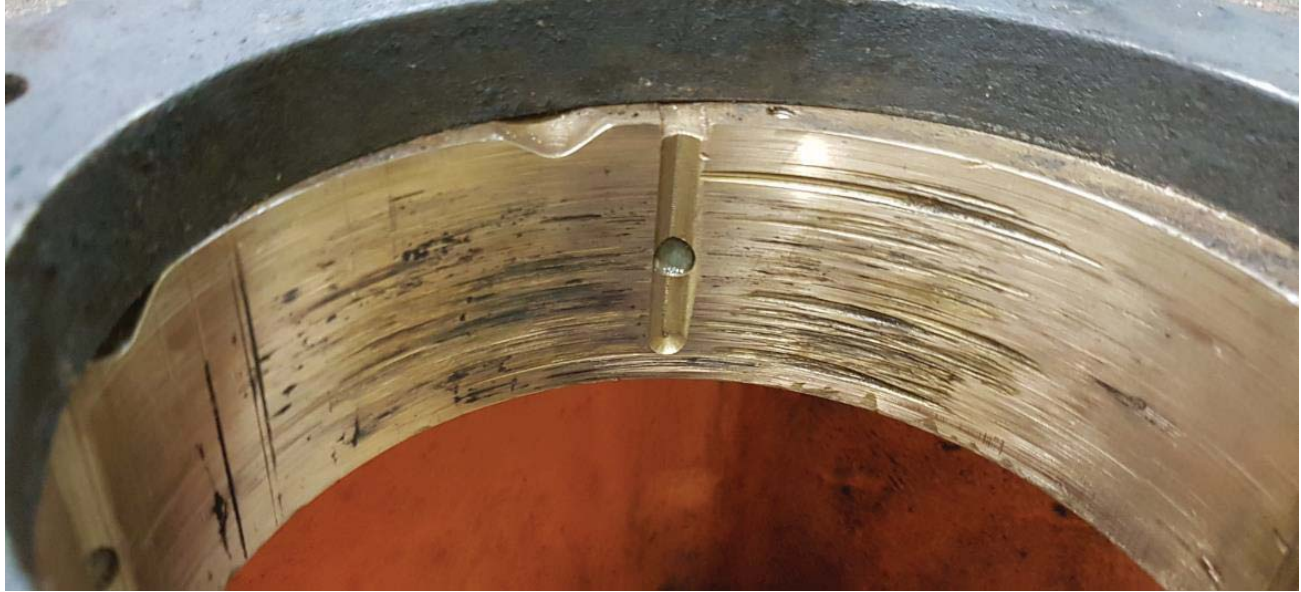
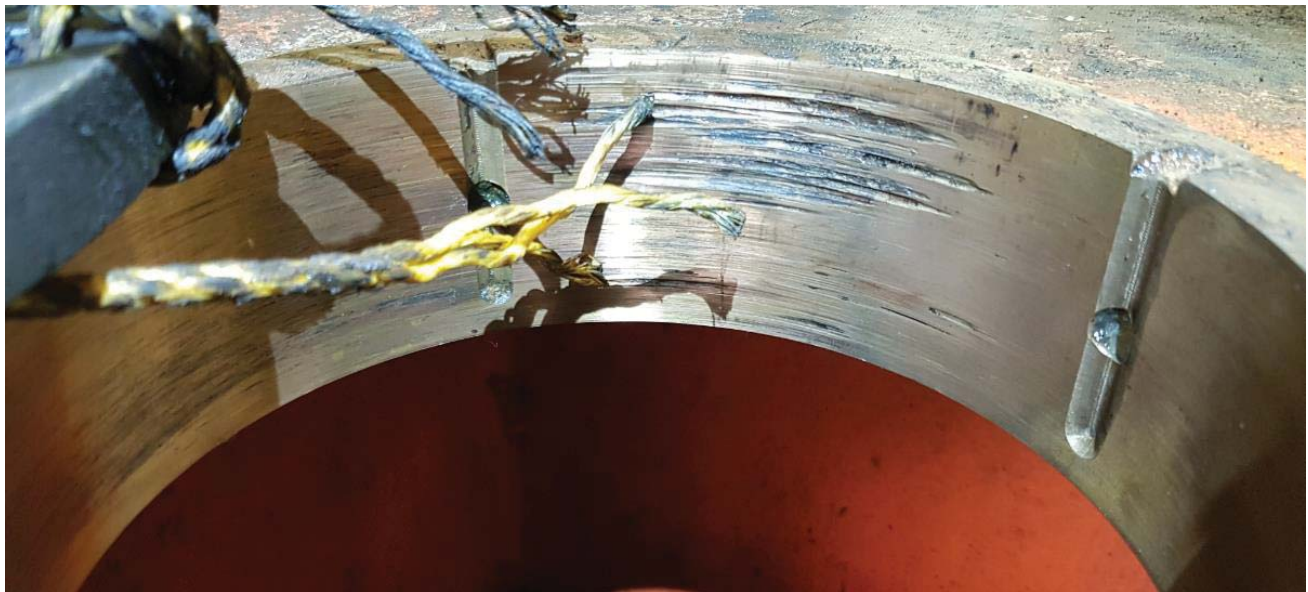
Figure 5-208: Head Cover, Upper Gate Stem Bushing

Figure 5-209: Head Cover, Upper Gate Stem Bushing

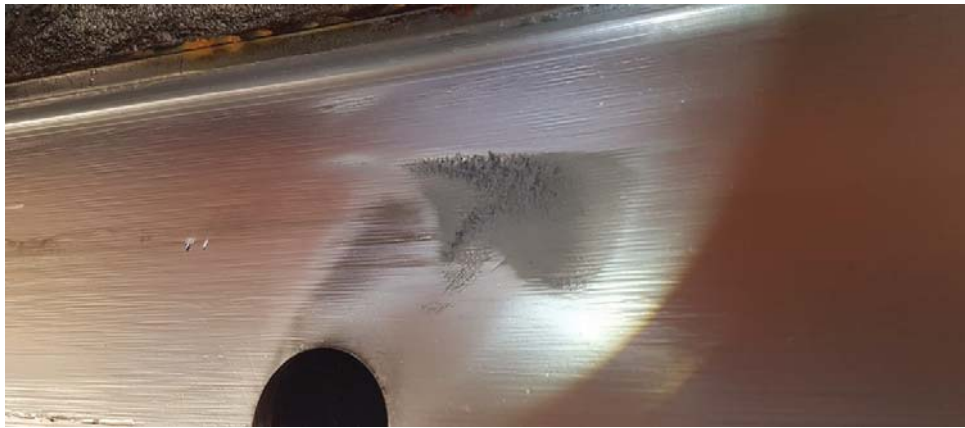
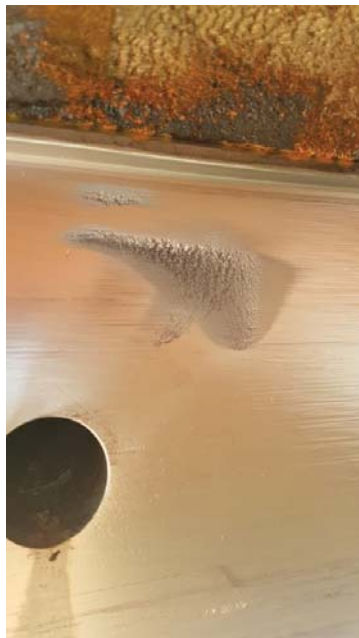
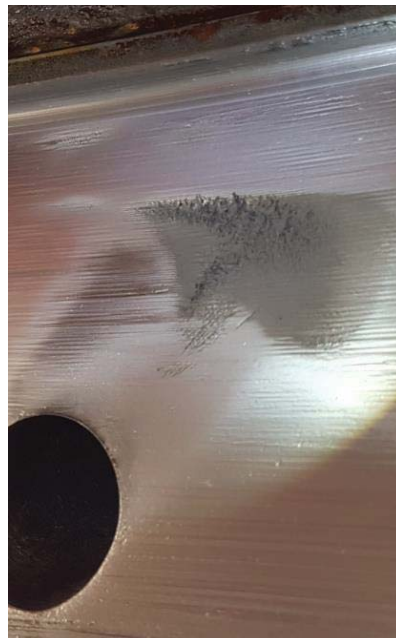
The Runner rotates between the Wearing Ring of the Head Cover on the bottom side or wet side of the Head Cover. As shown in the following pictures, light to moderate cavitation damage was present on the Wearing Ring, specifically around the cooling holes. These holes are used when the machine operates in Synchronous Condenser mode. It is unknown when this cavitation occurred, but cavitation evidently develops during normal operation when the water flow past the hole is interrupted, creating a turbulent zone. This turbulent zone creates a difference in pressure, causing the cavitation to develop, ultimately deteriorating the metal of the wearing ring.

Figure 5-210: Head Cover, Wearing Ring Cavitation

Figure 5-211: Head Cover, Wearing Ring Cavitation

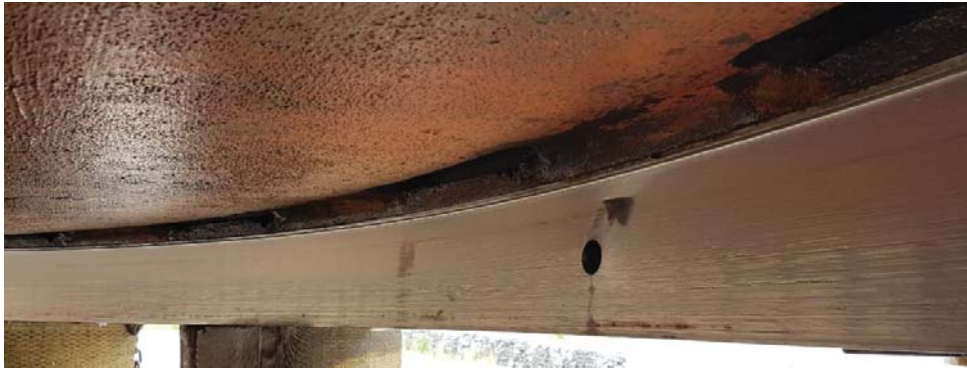
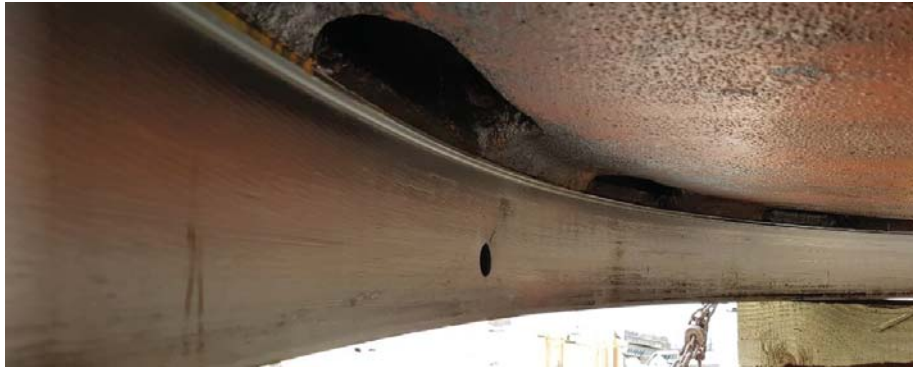
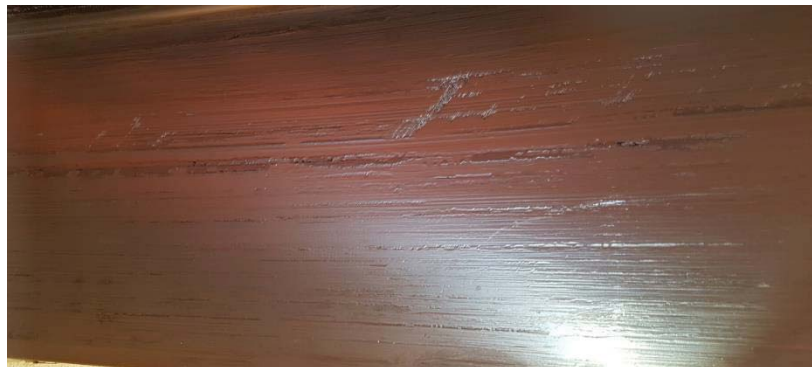
The Head Cover Wearing Ring also had scratches and scoring present during the inspection. The scratches can be sign of debris getting between the seal rings and causing damage or the Runner could possibly be contacting the ring. This is quite plausible due to the reduction of the radial seal clearance of the Runner the unit had been experiencing. Along with the cavitation found on the wearing ring there was also moderate to heavy signs of cavitation around all of the thrust relief holes on the Head Cover.

Figure 5-212: Head Cover, Wearing Ring Scratches and Scoring

Figure 5-213: Head Cover, Wearing Ring Scratches and Scoring

Figure 5-214: Head Cover, Wearing Ring Scratches and Scoring

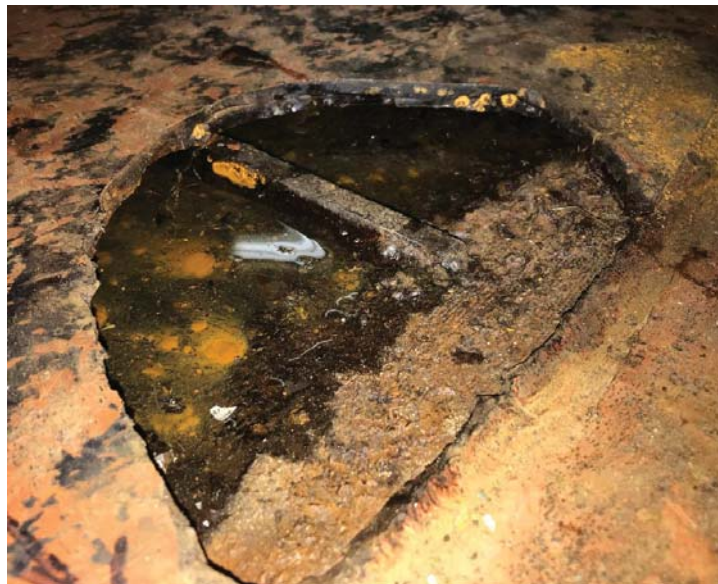
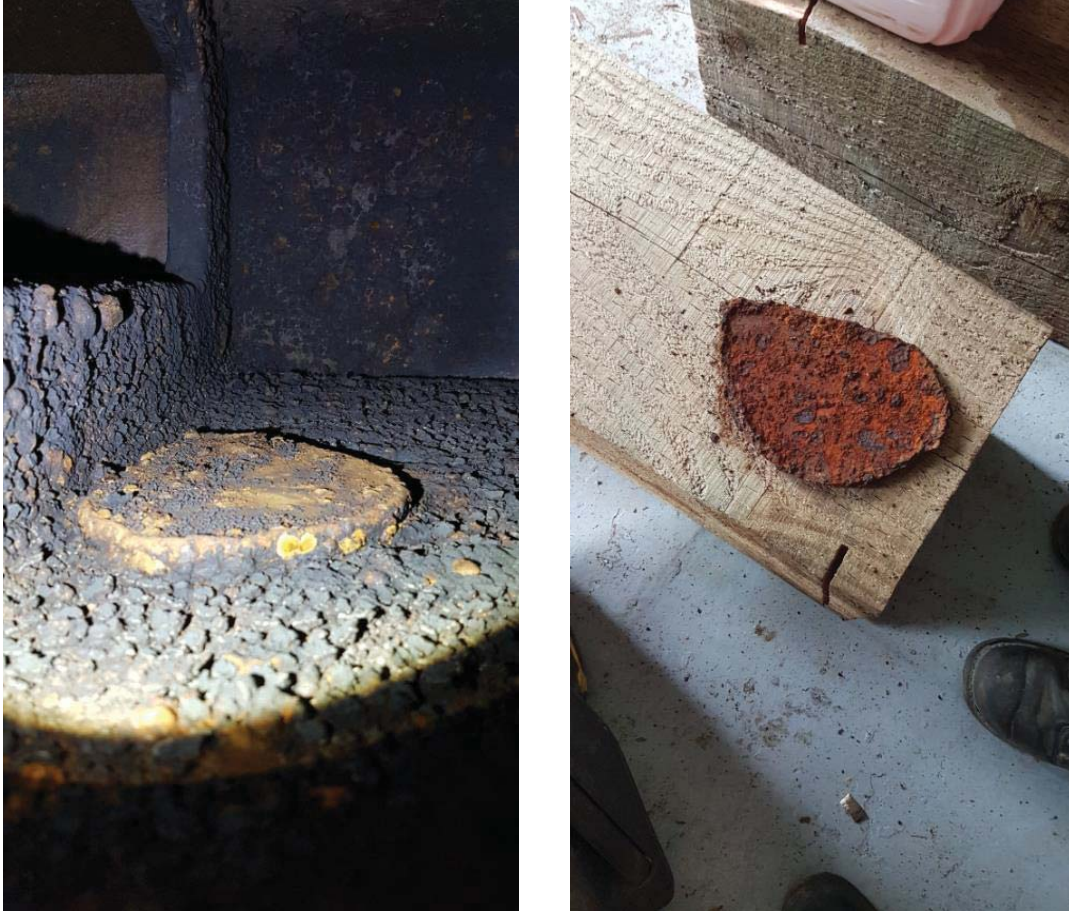
As mentioned in Section 5.9, a small piece of steel from the Runner Crown Balance Cover Plate broke free of the cover plate. The dislodged steel plate was able to move between the bottom side of the Head Cover and the Runner Crown and moved with the rotating motion of the Runner. This is very troublesome because the steel piece, now traveling a high velocity, had the opportunity to cause significant damage to Head Cover and Runner. The steel piece was found inside one of the internal Head Cover passageways during the inspection. After further investigation, it is unclear if the plate did any relevant damage to the Head Cover or Runner, but this is an example of how an aging machine can potentially cause significant damage to machine components of high precision, ultimately, causing an unplanned outage.

Figure 5-215: Runner Cover Balance Plate, Piece Missing

Figure 5-216: Head Cover, Runner Cover Balance Plate Steel Plate Found

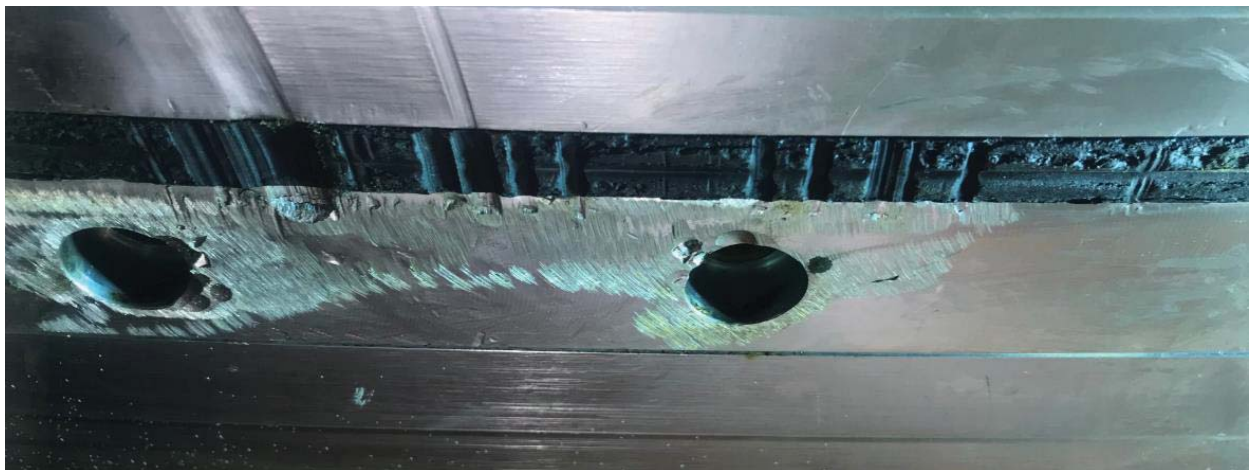
Figure 5-218: Head Cover, Wicket Gate Seals and Seal Retaining Plates (Damage)

The end seals were found to be highly deteriorated and in some cases damaged by debris or poor alignment of the Wicket Gates. The water passage surface of the Head Cover is overall in fair condition, but there were obvious signs of damage or abnormal wear. The lighter damage or imperfections were more than likely from the debris or maintenance over the years; however, in some locations it was apparent that the misalignment in the Wicket Gates caused the gates to contact the water passage surface, causing significant surface damage.

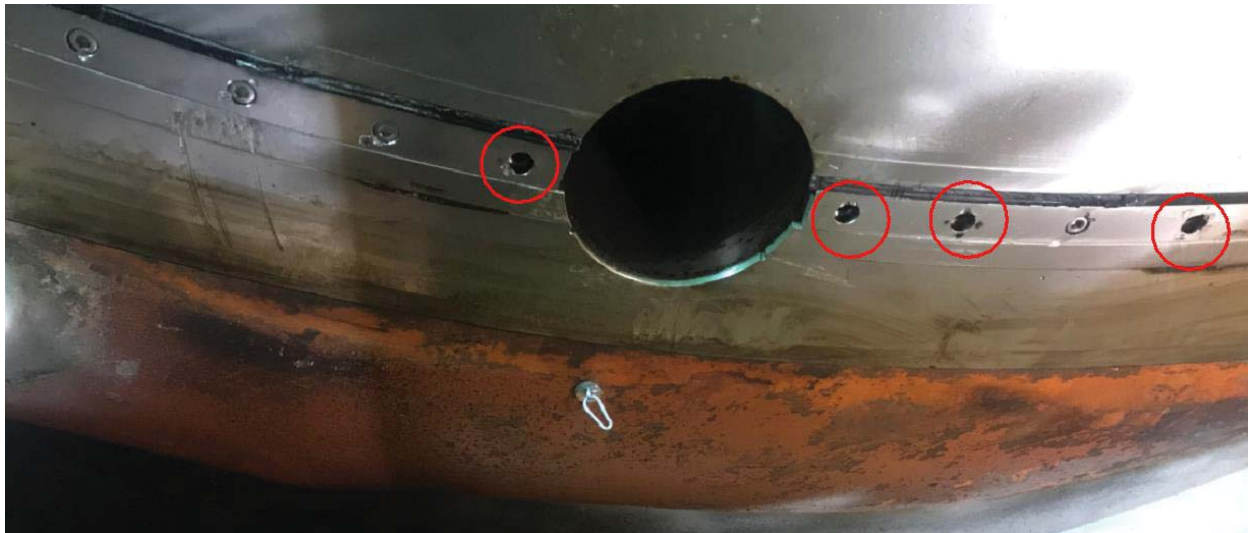
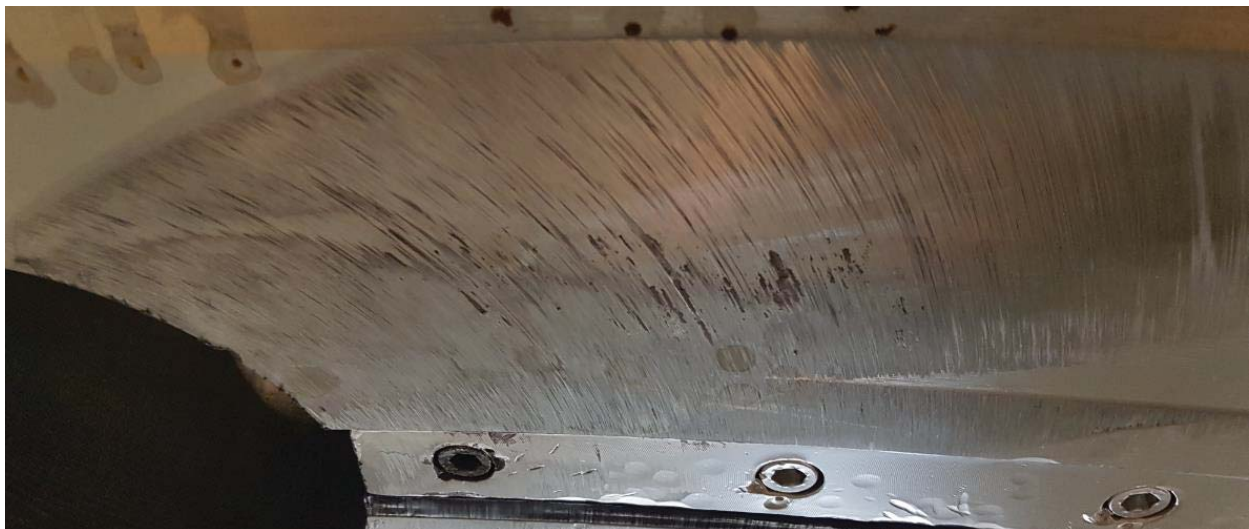
Figure 5-219: Head Cover, Seal Retaining Plates (Missing Screws)

Figure 5-220: Head Cover, Water Passage Surface Damage

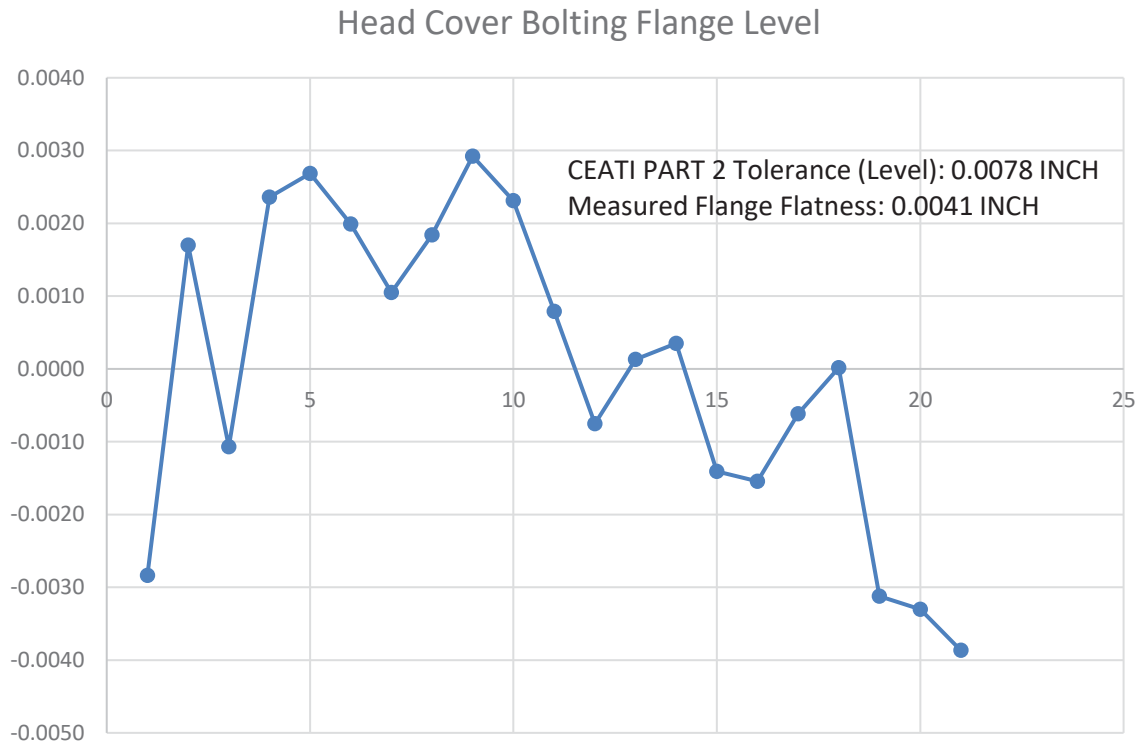
Shown in Figure 5-224 is a graph of the points taken on the bolting flange of the Head Cover. This feature is important because this surface mates with the Stay Ring Flange, which can influence the level reading of the Distributor assembly. Using the tolerance of the new machine standard set by CEATI Part 2, the data revealed

Figure 5-224: Head Cover, Bolting Flange Level/Flatness

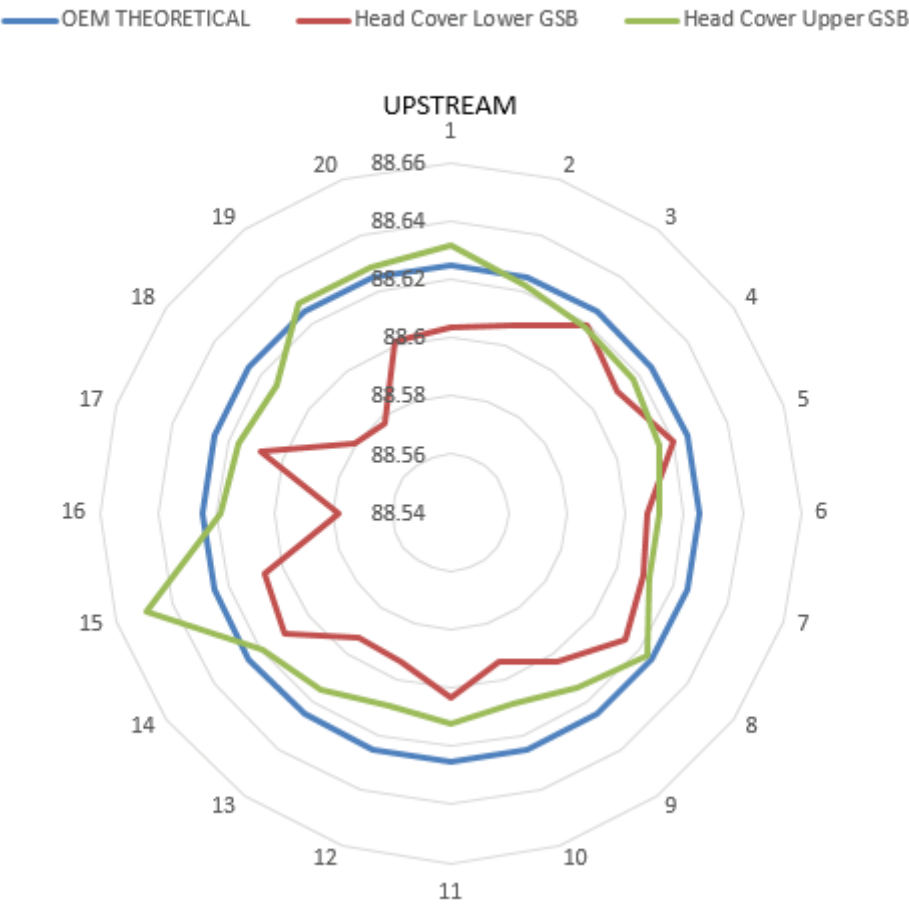
The Gate Stem Bore alignment is shown in Figure 5-227. The plot revealed that the alignment of the Upper and Intermediate Bushings were not concentric to each other; however, the bores had to be compared to the Bottom Ring Gate Stem Bores for a complete analysis of the system. It was obvious from the data that the concentricity between the Upper and Intermediate Bores of the Head Cover were not concentric to each other individually in a range of 0.010 inch to 0.056 inch. This value was concerning because it indicated that line boring of the bores together was required. Line boring is a very tedious and time consuming operation, requiring large precision boring equipment to machine the upper bore the entire length of the Wicket Gate to the lower bushing of the Bottom Ring. A comprehensive summary of the Gate Stem Bore alignment and recommendations is in Section 5.23.

Figure 5-227: Head Cover, Gate Stem Bore Alignment

- The Gate Stem Bores alignment and concentricity were still in question after the laser inspection mainly due to the amount of misalignment the laser data was suggesting. At first Voith believed this could be due to the fact the Head Cover was measured in the free-state rather than in its operational state, in which it is bolted and doweled to the Stay Ring Flange. It was Voith's opinion that the GSB data points may have been somewhat misleading due to the Head Cover "springing" back into a normal, relaxed shape after being removed from the Stay Ring, causing the questionable data. Therefore, Voith recommended installing the Head Cover back into its position on the Stay Ring and bolting and doweled it into place. This would force the part back into the shape it has during operation. From there, Voith asked NLH to measure all of the GSB at once, using a wire micrometer, including the Bottom Ring GSB. This measurement would provide an improved data set and a complete view of all of the GSB together. This was critical for determining if line boring of the GSB was required.
