Re: Application for Capital Expenditures for the Life Extension of Bay d'Espoir Unit 7 – Redacted

Please find enclosed Newfoundland and Labrador Hydro's ("Hydro") application for the capital expenditures required for the life extension of Unit 7 of the Bay d'Espoir Hydroelectric Generating Facility ("Bay d'Espoir Unit 7").

Engineering Report
Mechanical Engineering
Bay D'Espoir Unit 7 Condition Assessment Condition
Report

Bay d'Espoir – Newfoundland and Labrador Hydro		
Unit 7 Refurbishment Report Project Report	TFS7000	
	PDM Doc ID:	Doc. Revision:
	2-10066279	-

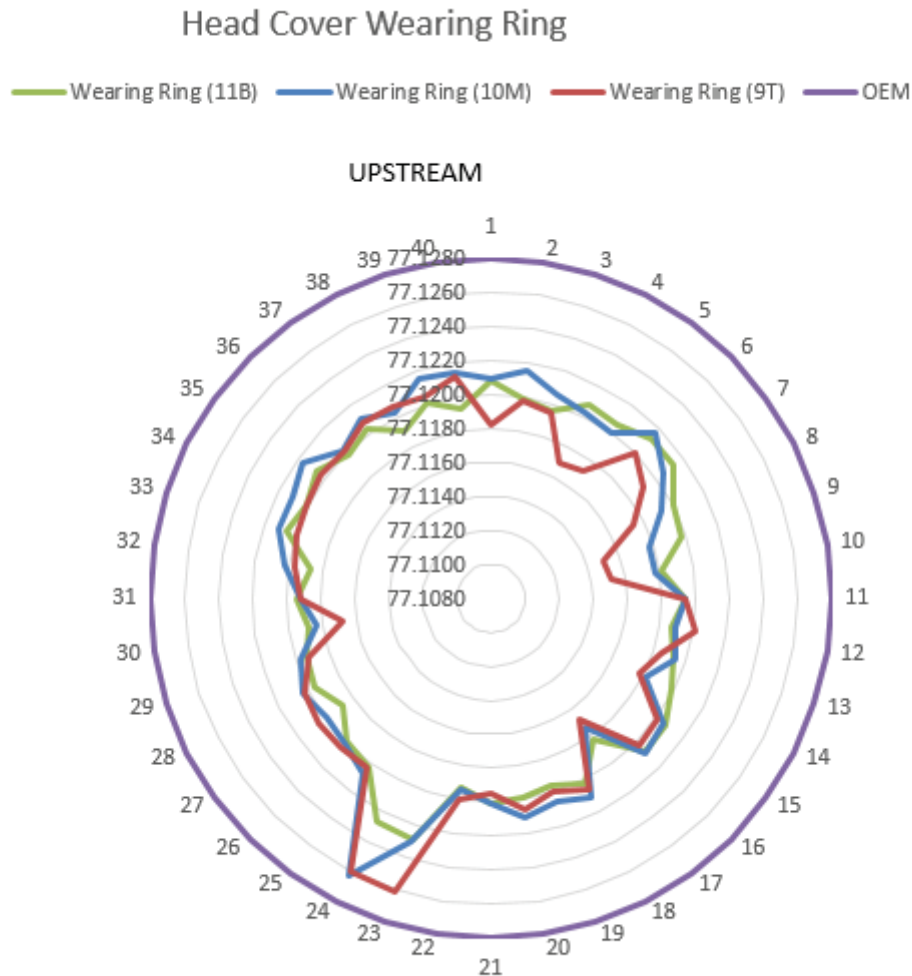
The Head Cover Wearing Ring data points are plotted in Figure 5-228. For the most part, the roundness of the ring data points recorded averages 0.0048 inch, which is somewhat expected considering the age and condition of the machine. A closer look at the plot reveals that the Wearing Ring has slightly changed into an elliptical shape, which is similar to the rest of the stationary components. This information was used and accounted for during the analysis of the Wearing Ring machining discussed in Section 5.25.

Figure 5-228: Head Cover, Wearing Ring

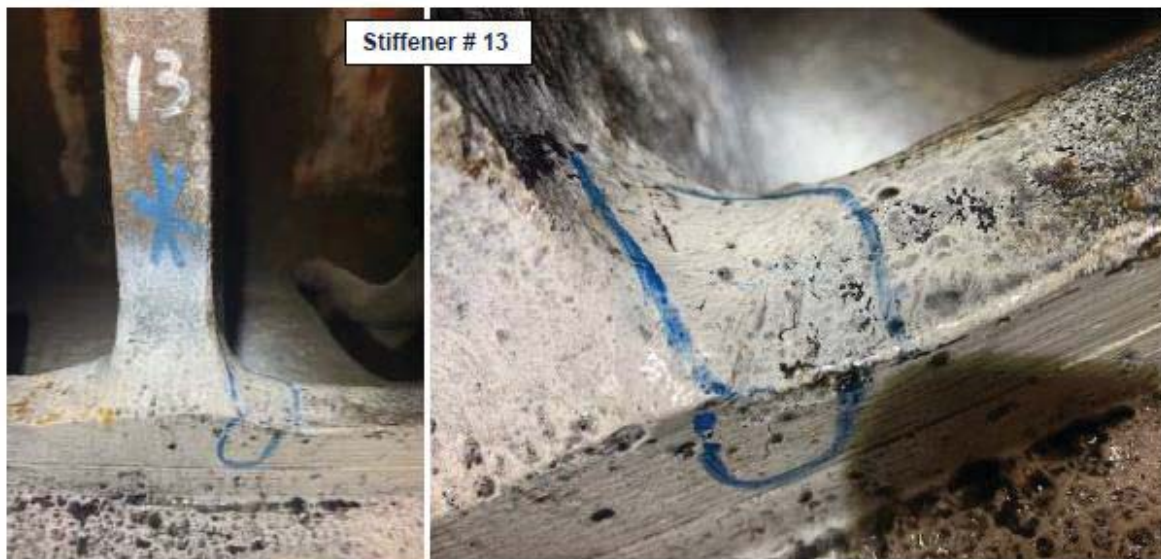
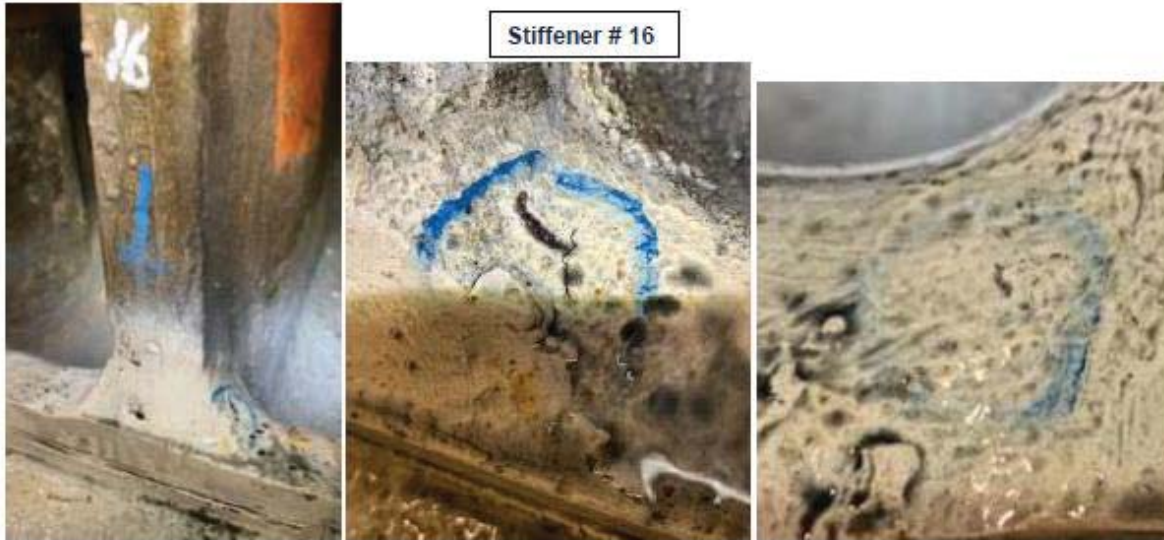
that connect the outer flange to the inner wall of the Head Cover. These were small cracks found around the ends of the joint. A comprehensive NDE report, with results and notes, is located in the Appendix.

Figure 5-230: Head Cover, Small Stiffener Cracks

Figure 5-231: Head Cover, Small Stiffener Cracks

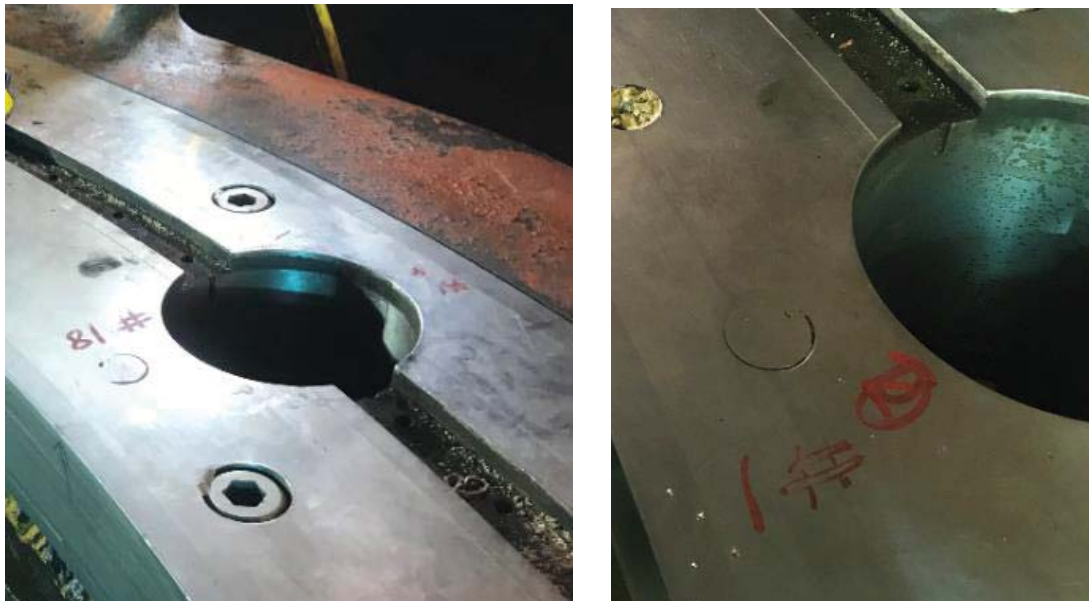
Figure 5-236: Bottom Ring, Gate Stem Bores

The bushings for the Gate Stem Bores were already removed during the inspection, revealing the open bores of the Bottom Ring. The bushings of the Bottom Ring had the same wear pattern as those mentioned in Section 5.21.2.3 of the Head Cover. Within that section, Figure 5-227 provides proof of misalignment of the Wicket Gate Stem Bores between the Head Cover and the Bottom Ring. Overall the open Gate Stem Bores were found to be in good condition and no issue was foreseen by installing the planned upgraded greaseless bushing. The Seal Retaining Plates and Seals were also removed prior to the inspection, but like the bushing, the Seal Retaining Plates and Seals were found to be in similar condition as the Head Cover Seal Retaining Plates. Shown in Figure 5-220, the Head Cover Seal Retaining Plates showed signs of debris wear and damage from the Wicket Gate contact. The Bottom Ring Seal Retaining Plates also showed these same signs of damage. The groove where the Seal Retaining Plates and Seal are located was found to be dirty with debris and light corrosion was present, but there were no signs damage or indications that required attention at the time of the 2019 maintenance outage.

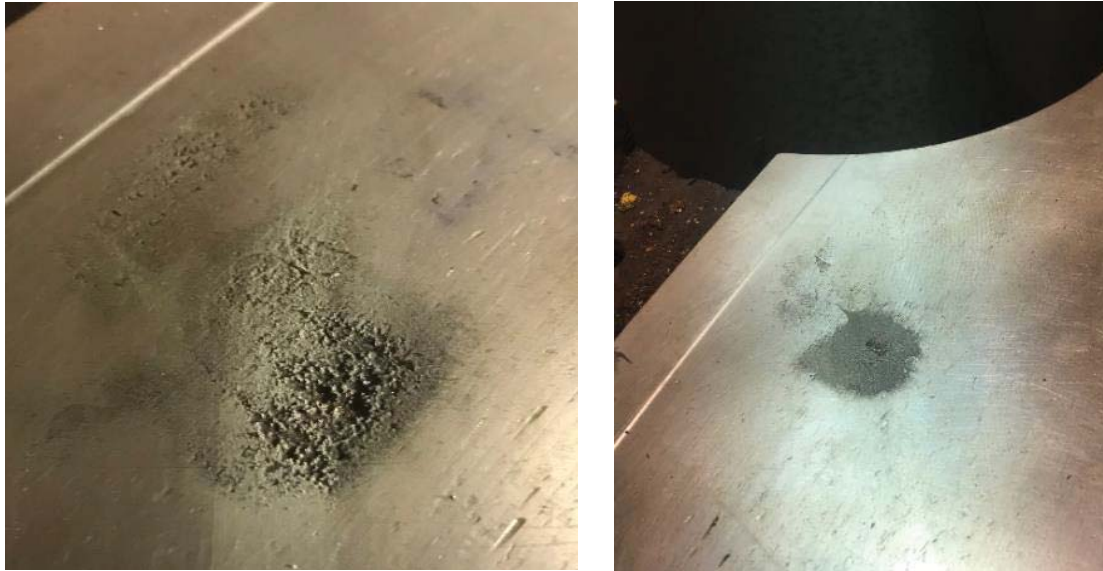
The Water Passage Surface, which consists of a stainless steel overlay, was found to be in good condition considering the age and service hours on the machine. The surface had light to moderate scratches present with signs of cavitation located next to each GSB. The cavitation was light in the nature, but did occur in the same location around the Bottom Ring.

Figure 5-239: Bottom Ring, Water Passage Surface Cavitation

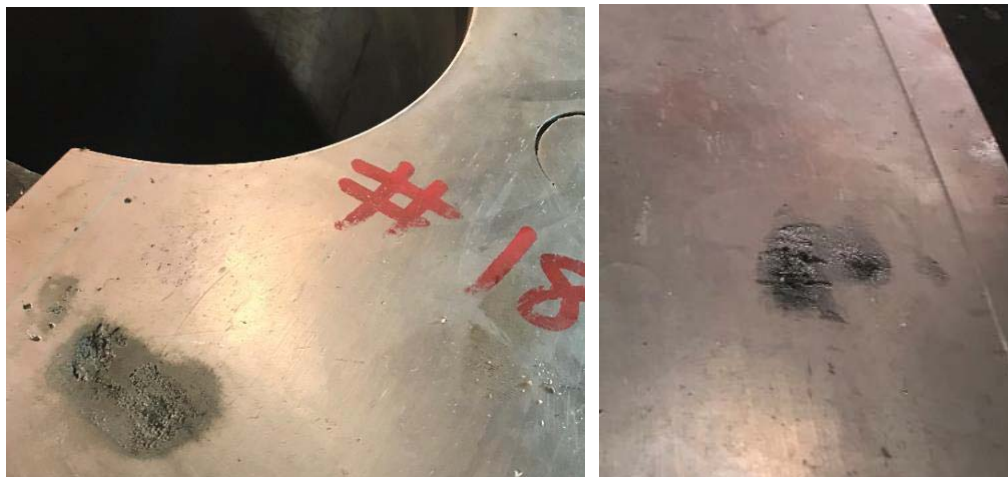
Figure 5-240: Bottom Ring, Water Passage Surface Cavitation

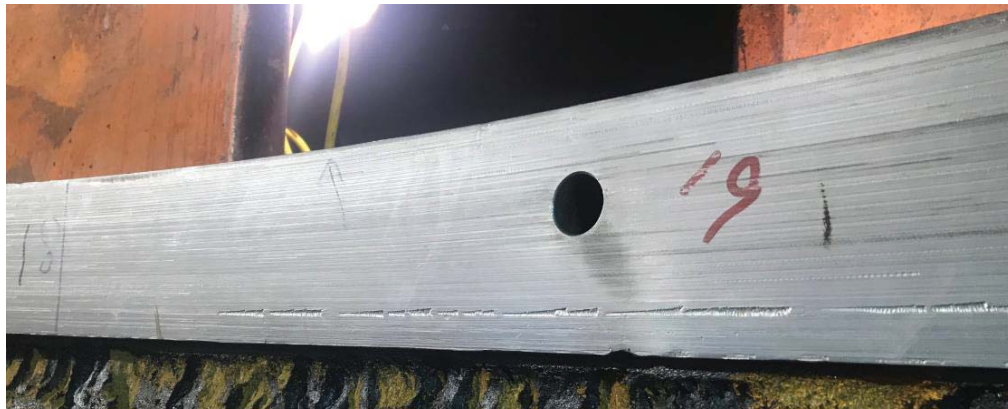
The Bottom Ring Wearing Ring condition was very similar to the Runner Band Wearing Ring discussed in Section 5.9.2.5. Both of these rings work in conjunction with one another during operation, creating the tight seal between the stationary wearing ring (Bottom Ring) and the rotating Wearing Ring of the Runner (Band). The Bottom Ring Wearing Ring had many visible scratches, dents, and some material missing. It is difficult to know what came into contact with the seal surface, and when it happened. Although, it is safe to assume that

at some point in time small debris contacted the seal surfaces during operation; in fact, it is even possible that the rotating Runner came into contact with the stationary Wearing Ring of the Bottom Ring.

Figure 5-241: Bottom Ring, Wearing Ring Damage

- **Voith Recommendation:**
 - As expected the Wearing Ring of the Bottom Ring was going to require machining to improve the global roundness and clearance of the Runner radial seal clearance. Therefore, Voith recommended machining the Wearing Ring to a known size to establish a larger RSC.

- **Outcome:**
 - NLH followed the Voith recommendation to machine the Wearing Ring. A complete timeline, summary of events/discussions, and outcome is provided in Section 5.25, Wearing Ring Machining.

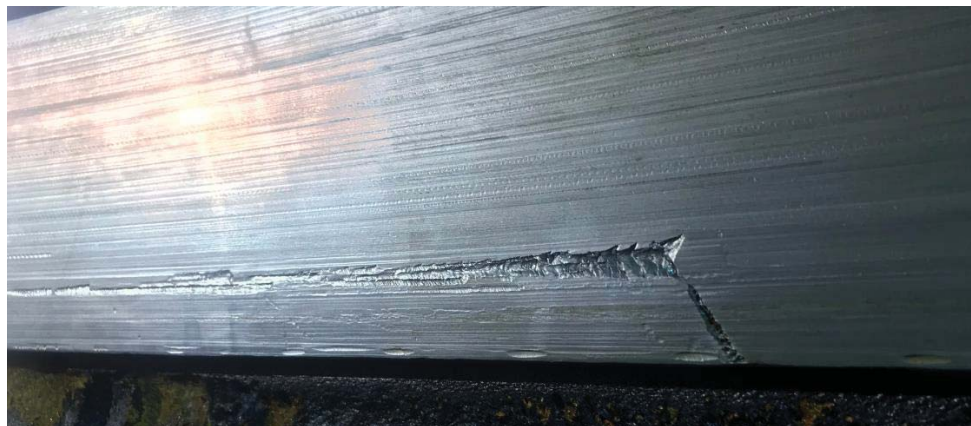
Figure 5-242: Bottom Ring, Wearing Ring Damage

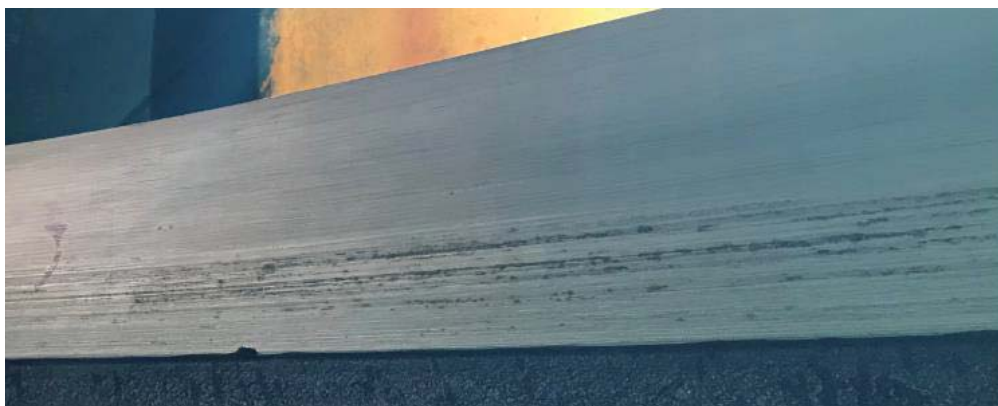
Figure 5-243: Bottom Ring, Wearing Ring Damage

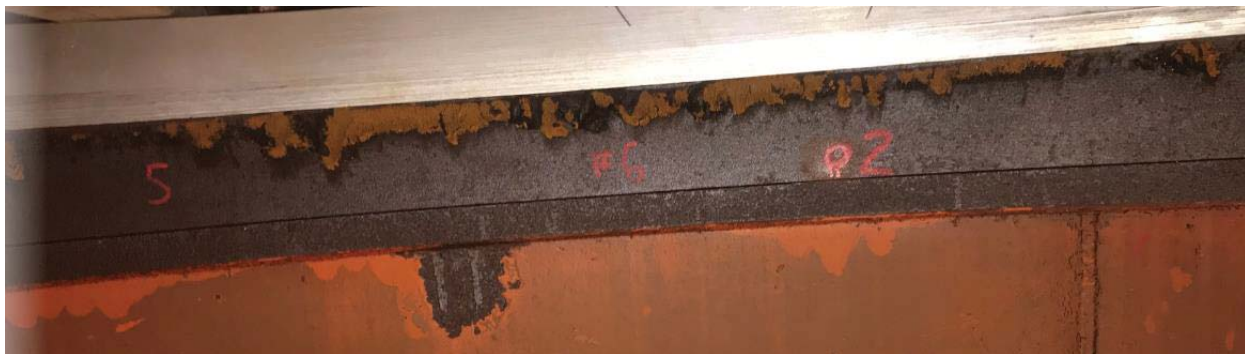
The inner diameter surface directly under the Wearing Ring had significant cavitation damage in the axis perpendicular to the upstream/downstream axis. The source of this cavitation is more than likely a direct result of the change in RSC seal clearance in that area. The increased flow rate and velocity of water past the seal created an environment for cavitation to form, causing significant damage to the inner diameter surface of the Bottom Ring.

Figure 5-246: Bottom Ring, Cavitation Damage

- Voith recommended cleaning and filling the eroded area found underneath the Bottom Ring Wearing Ring with a high strength epoxy to fix the cavitation damage. The area would be blasted to near white metal, then short pieces of a round steel bar would be added to the deeper area to create a framework to ensure the epoxy properly adheres. The Epoxy could be applied to the area once the framework is established until flush with the non-effected area, after which the epoxy was coated with a two-part, anti-cavitation paint. The complete repair procedure, BDES-2TFV04-0800-10052132-REV-, can be referenced in the Appendix.

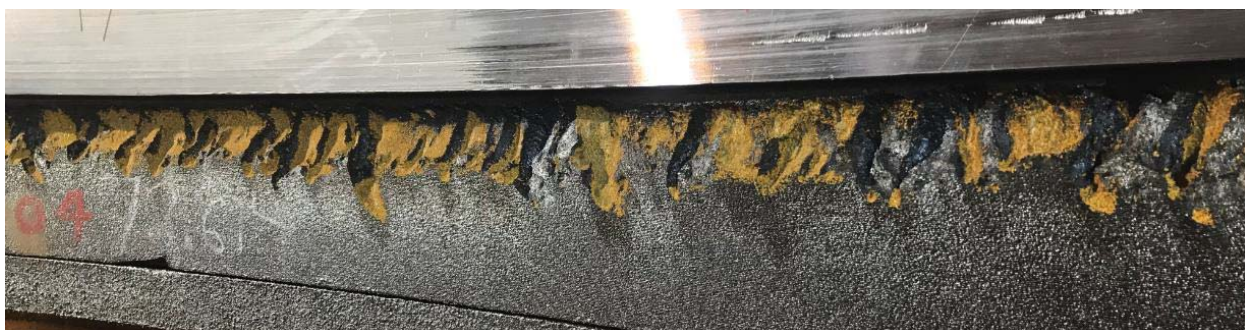
Figure 5-247: Bottom Ring, Cavitation Damage

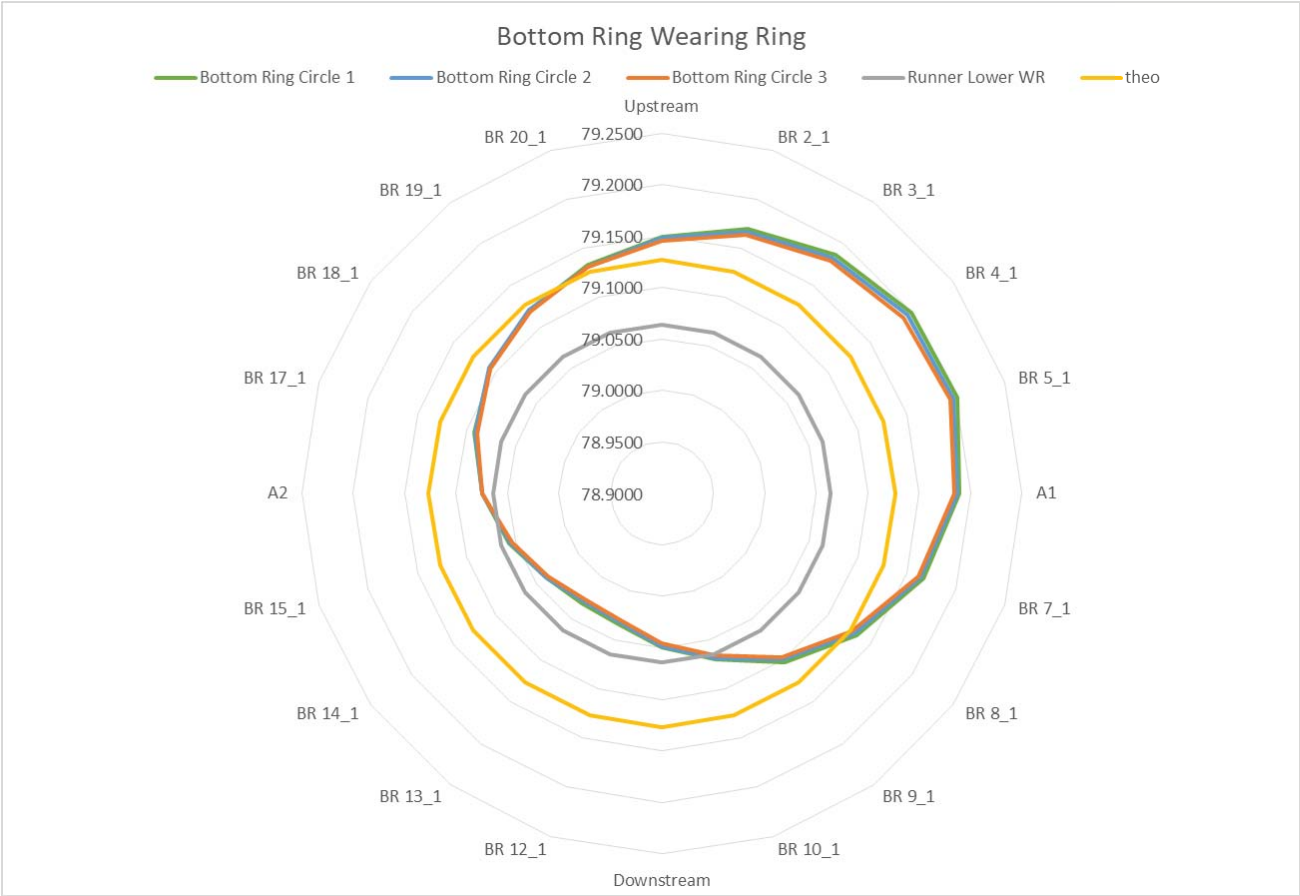
Figure 5-251: Bottom Ring, Wearing Ring Shape versus OEM

Figure 5-251 shows a circle graph representing the data points taken on the Wearing Ring during the laser inspection. The points are plotted starting in the upstream direction and going clockwise around the Wearing Ring. To provide an accurate representation of the Wearing Ring condition, three circles were created on the ring: top, middle, and bottom. The graph shows the OEM theoretical Wearing Ring design versus the as-found condition. As expected, and one of the main reasons for the 2019 maintenance outage, the Wearing Ring was found to be distorted in shape.

The Wearing Ring was originally machined as a perfect circle; however, the Wearing Ring has been forced into a different shape due to the movement/growth of the stationary components around the Bottom Ring. This change in shape has caused the RSC between the Runner and Wearing Ring to change. The circularity average found during the inspection was 0.052 inch. The standard set by CEATI is 5 percent of the RSC ($0.045(\text{RSC}) \times 0.05\% = 0.00225$ inch), not to exceed 0.06mm (0.0024 inch). Therefore, the as-found condition of the circularity was much higher than allowed by CEATI.

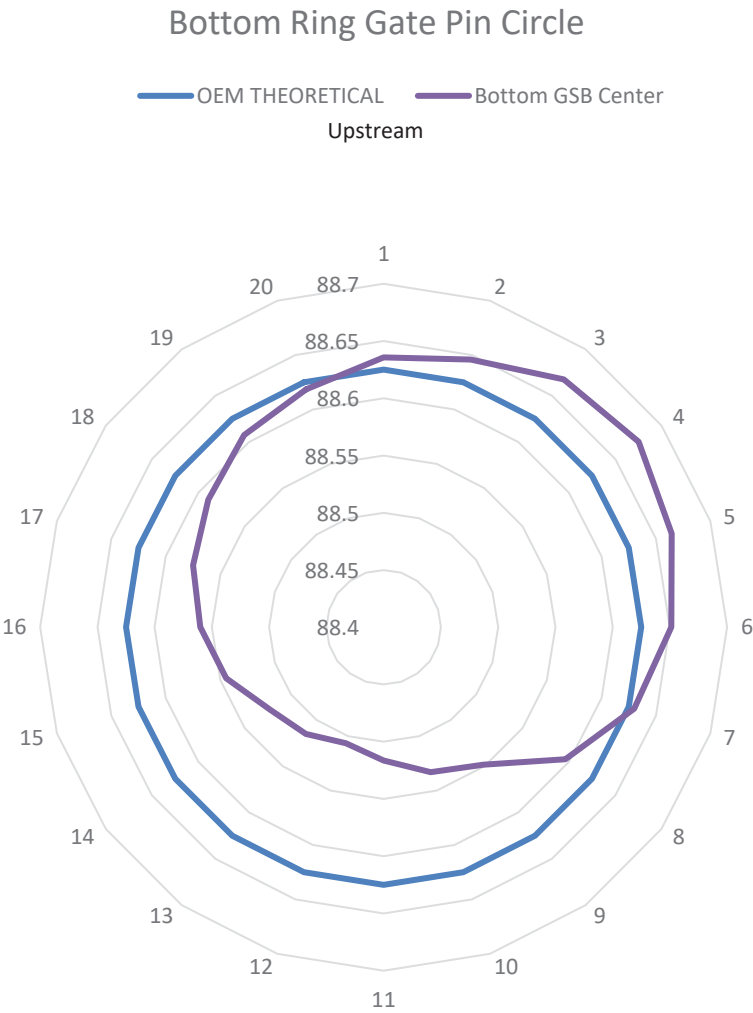
Figure 5-252: Bottom Ring, Wearing Ring Gate Pin Circle versus OEM

The Gate Pin Circle, which is the circle created by the center of all of the Gate Stem Bores, is shown in Figure 5-252. This circle was created by taking laser points on each of the individual GSB and defining a cylinder from each. From there the software used the mid-point of each cylinder to create a best fit circle.

The data revealed a significant shift in the position of the Bottom Ring GSB. The plot in Figure 5-252 shows that the GSB locations and Gate Pin Circle have taken on the same shape and shifted as to what was found in laser inspection of the Wearing Ring; this was visualized in Figure 5-253. The black circles of the plot

- The as-found condition of Bottom Ring Gate Pin Circle was concerning to Voith because of the potential need for line boring all of the bores. The line boring procedure is very time consuming and expensive. Voith recommended installing the Head Cover back into position and measure the bores of the Bottom Ring in conjunction with the Head Cover GSB to determine if line boring was absolutely required. This method is the most accurate when determining the position of all of the bores relative to each other. Voith could determine if line boring is required with this information.

- **Outcome:**
 - NLH followed VH recommendation and reinstall the Head Cover and wire measure the Gate Stem Bores together to ensure the proper Gate Stem alignment and to potentially rule out line boring. The results of this recommendation are located in Section 5.23, Gate Stem Bore alignment.

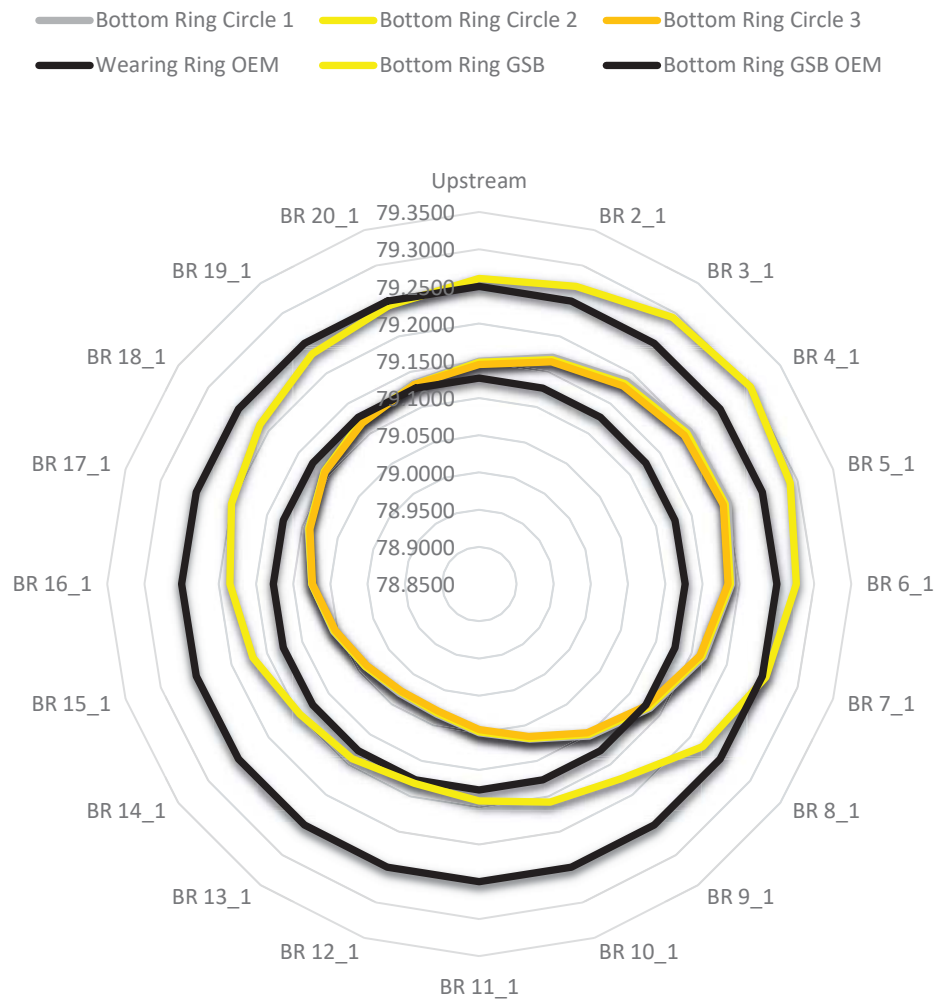
Figure 5-253: Bottom Ring, Wearing Ring Compared to Gate Pin Circle (Not to scale)

represent the OEM intent for the Wearing Ring and Gate Pin circles. The orange and yellow circle reflect the as-found results of the laser inspection, which are distorted from OEM.

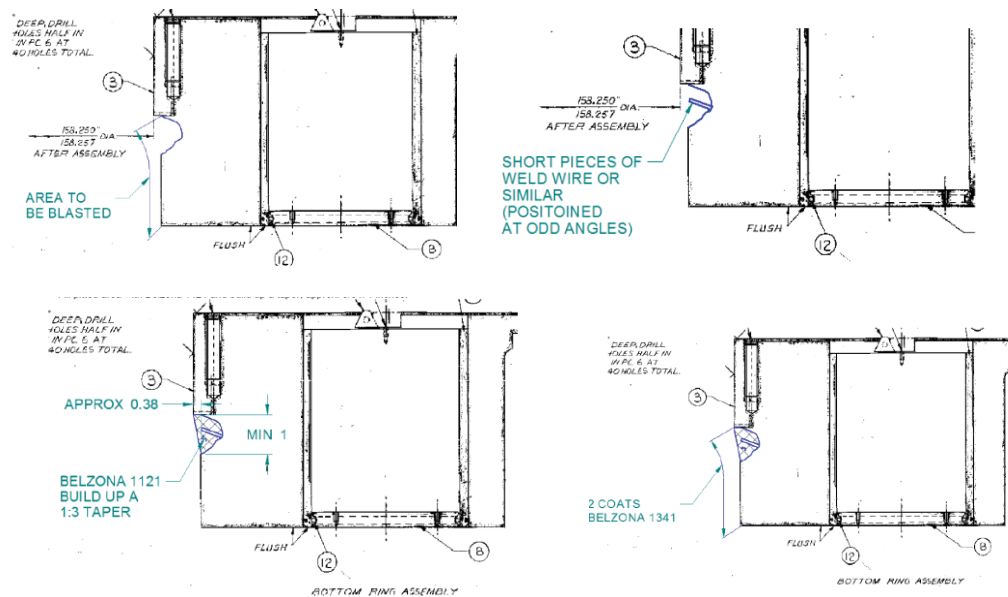
Figure 5-255: Bottom Ring, Cavitation Repair

- **Outcome:**
 - NLH performed the repairs recommended by Voith to prevent further cavitation damage and preserve the condition of the Bottom Ring.
- **Voith Recommendation:**

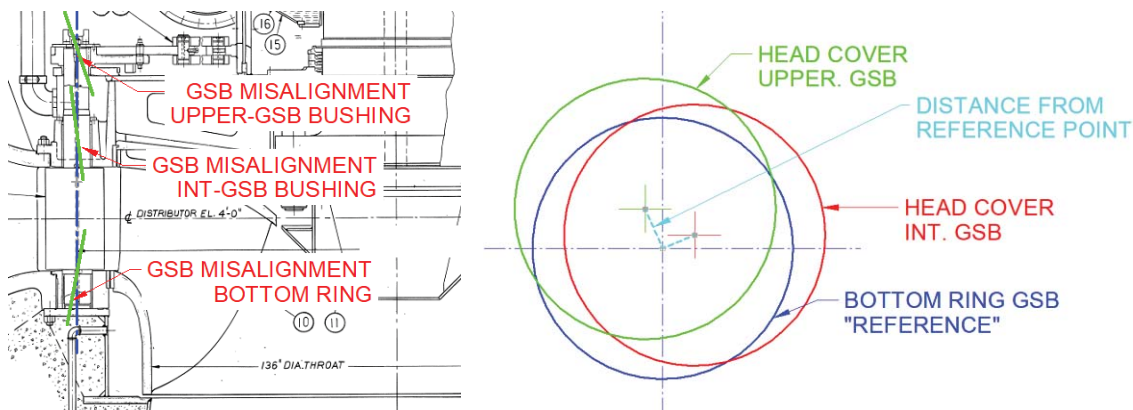
Figure 5-257: Example of Gate Stem Bore Axis Misalignment

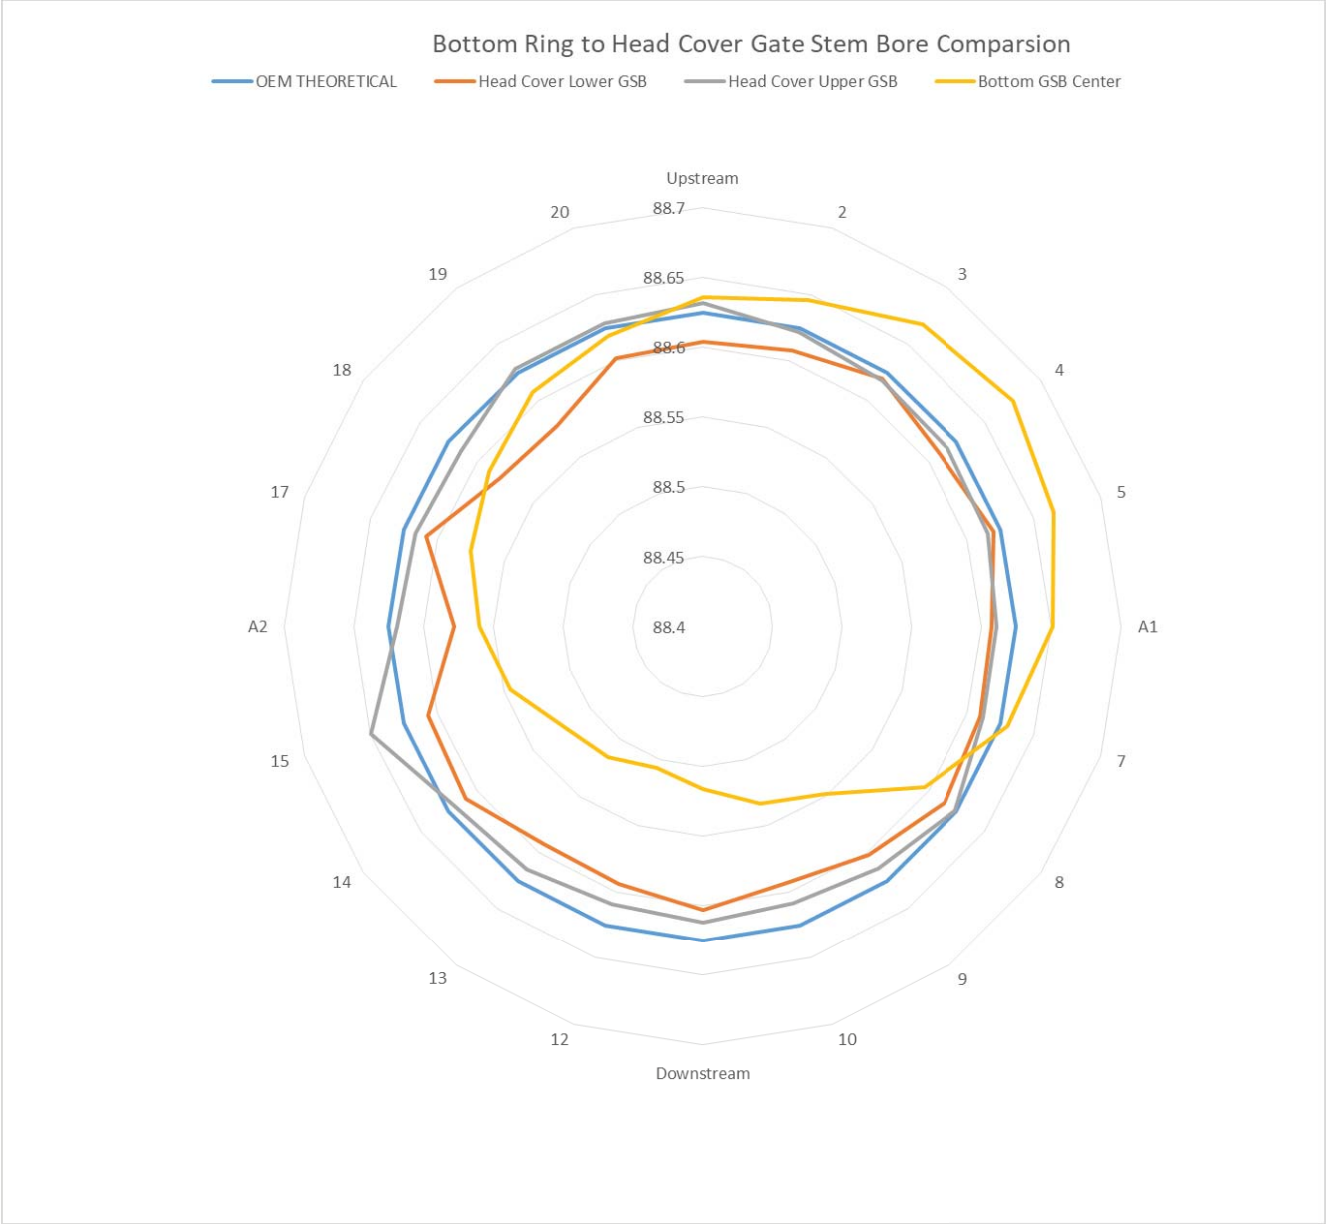
Figure 5-258: GSB Alignment: Laser Inspection Results Graph

The planned concentricity tolerance zone is typically a function of the size of the Gate Stems, design bushing clearances, expected loads (forces), and overall size and dimensions of the other Distributor components. The design concentricity tolerance was unclear at the time of the 2019 maintenance outage from the drawings that were available; however, using modern design principles, which were not much different than the era of when Unit 7 was designed. This assembled tolerance range for concentricity was determined to be in a range 0.006 to 0.010 inch.

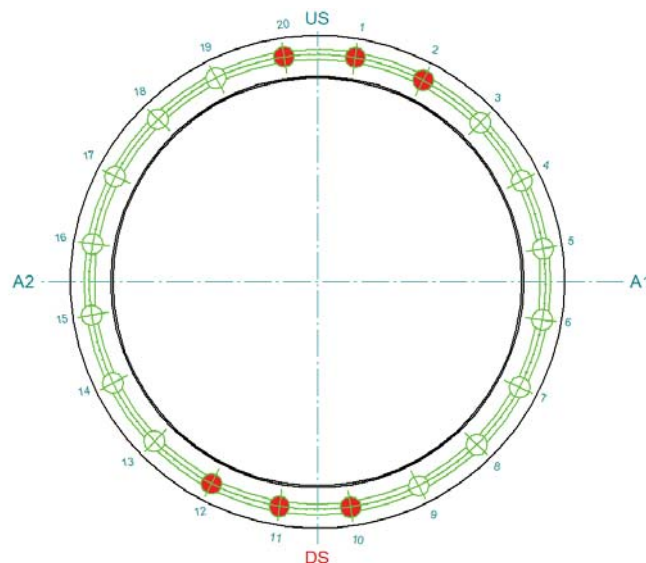
Figure 5-264: Bushing Clearance Evaluation (Affected Gate Stem Bores Only)

The calculation revealed that six upper bushings required machining to allow for the appropriate clearance. The gates affected were numbers one, two, ten, eleven, twelve, and twenty. Voith provided information to NLH for their review and approval prior to machining. Once the group collectively discussed the results and understood the calculations performed, NLH provided approval for Voith to machine the selected Upper Bushings. The calculation results of the impacted gates are shown in the table of Figure 5-264. A comprehensive collection of all of the measurements, discussions, and calculations are included in the Appendix.

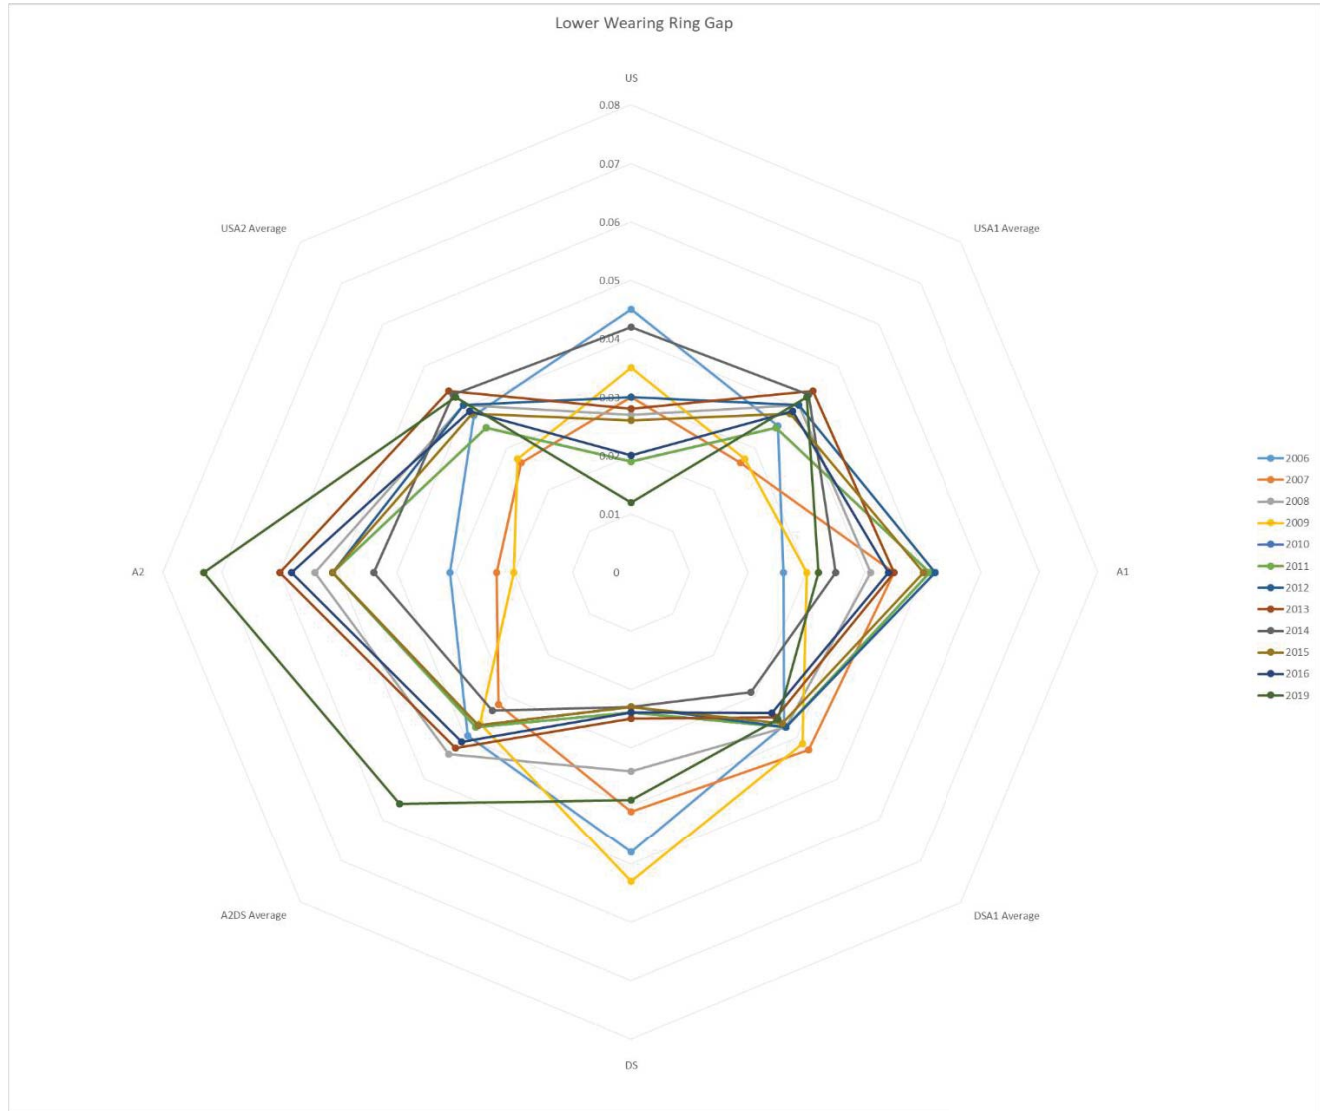
Figure 5-269: NLH Lower Wearing Ring Radial Seal Clearance over 14 Years

The main reason and motivation for the 2019 maintenance outage was to restore the Lower Primary Seal Clearances between the Runner Band Wearing Ring and the Bottom Ring Wearing to OEM tolerance. Since 2006, NLH has measured significant changes in the radial seal clearance between the stationary and rotating parts of the turbine. Figure 5-269 and 5-270 show that the clearance was somewhat symmetrical in 2006 and, as time has passed, the clearances have changed. These radial seal clearance changes varied depending upon which axis was being evaluated.

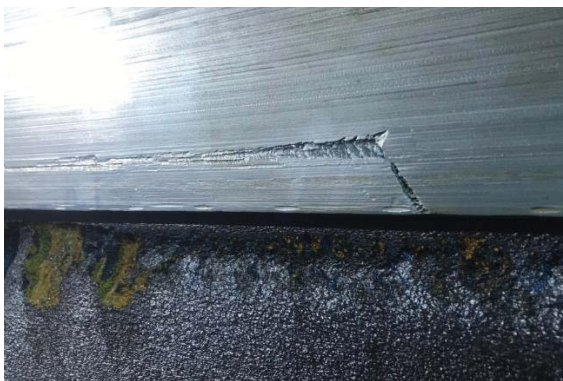
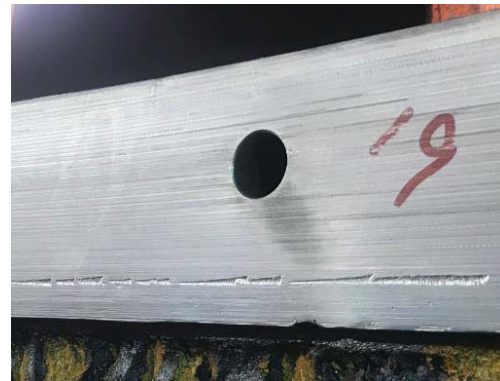
Figure 5-271: Bottom Ring Wearing Ring Condition (Lower)

At the time of the Wearing Ring visual inspection, the entire Unit 7 machine was already disassembled and other tasks were being performed on all of the other components and subsystems of the machine. A thorough visual inspection had already been completed on all of the other components at this point. Each ring had varying levels of damage and deformation. The exact time and cause of damage is difficult to determine, but it was safe to assume the Runner contacted either debris or the stationary Wearing Rings at some point during its service life. Below are images of the condition of the Wearing Rings. While not critical to the machining process of the Wearing Ring, it is noteworthy to point out the cavitation damage again on the Bottom Ring. This damage is described in detail in Section 5.22, but is mentioned in this section and was considered during the analysis of the data and recommendations.

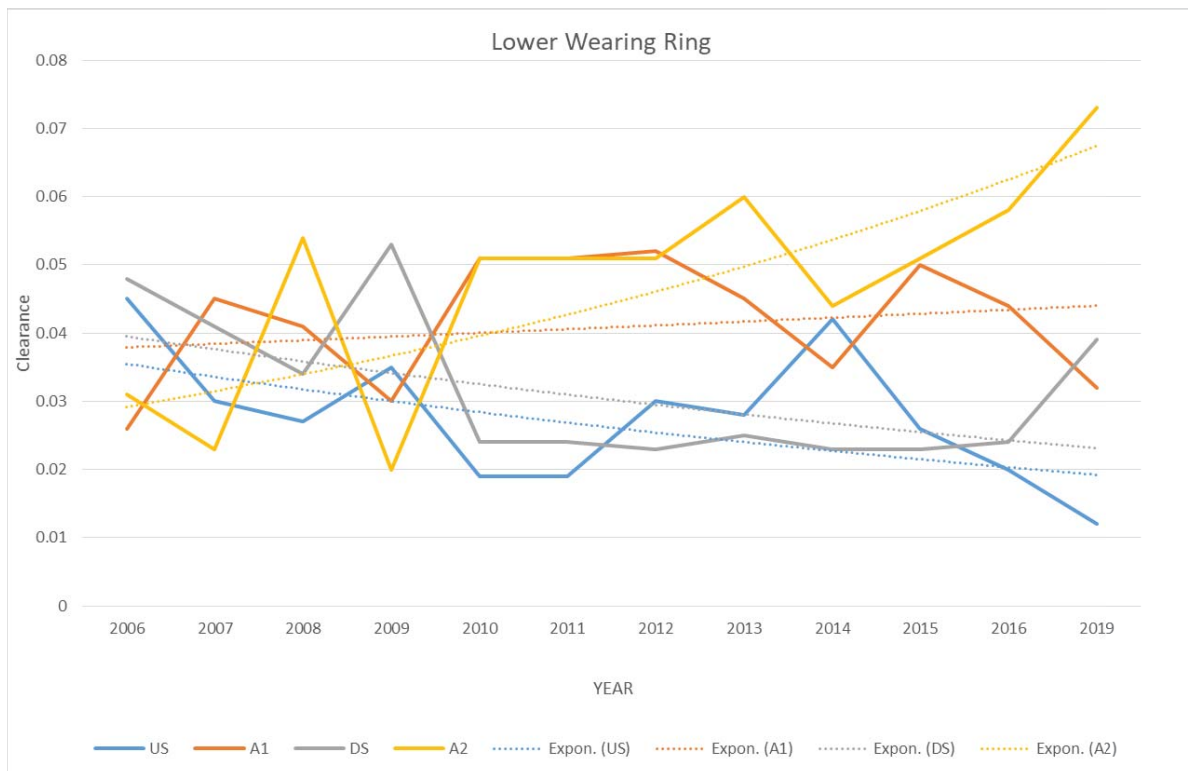
Figure 5-275: Lower Wearing Ring Radial Seal Clearance Change, (Clearance in Inches)

attempt to predict when the RSC of the Wearing Ring would reach the intervention and critical limits of the CEATI Part 5 Maintenance Standard. In the case of Unit 7, the value was 0.25 of nominal (minimum) RSC and up to 1.5 times the nominal RSC for the maximum intervention limit. The critical limit set by CEATI Part 5 for the Unit 7 machine was 0.1 times the nominal RSC; this is the limit in which the machine should be placed out of service. Figures 5-275 and 5-276 show the actual growth and shrinkage of the clearance for both the Lower and Upper Wearing Rings from 2006 to 2019. Voith developed models to understand the change and predict intervention and critical moments in the future. The change in either axis was approximately 0.0015 to 0.004 inch per year regardless of which model was used, whether linear, exponential, or average.

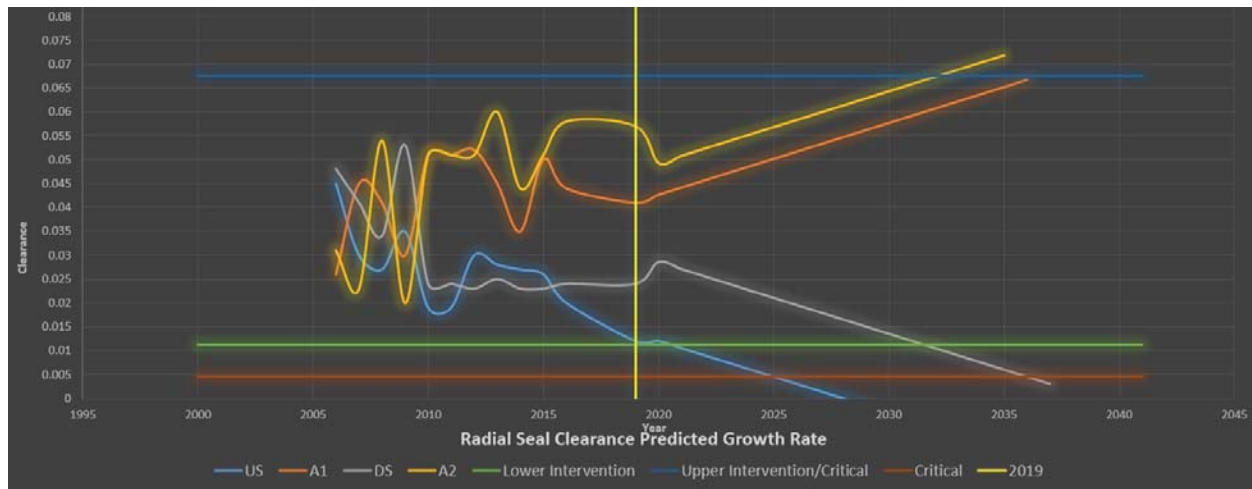
Figure 5-277: Predicted Growth Rate of Radial Seal Clearance (Clearance in Inches)

The graph in Figure 5-277 shows that the upstream clearance of the Runner was approaching the intervention limit of CEATI Part 5; therefore, the 2019 maintenance outage timing was appropriate and in accordance with when the machine should be placed out of service prior to reaching the critical limit. With this analysis and timeline determined, Voith was able to propose a new diameter to machine the lower Wearing Ring to in order to safely operate the machine until the next major outage in five years.

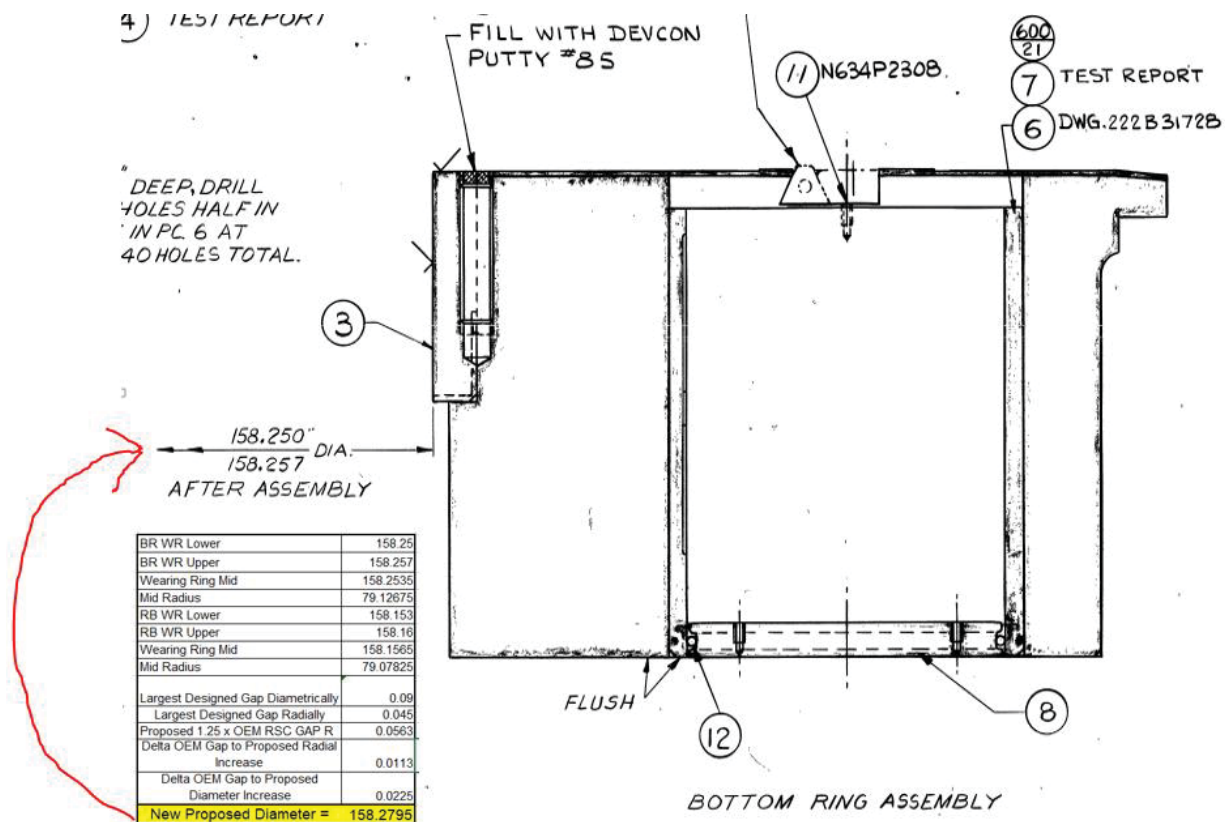
Figure 5-278: Voith Recommended New Diameter

The recommended 1.25 times the OEM RSC was a compromise between impacting the machine's performance and the rate of deformation of the embedded parts. If the Wearing Ring was machined to OEM RSC, the gap at certain locations could return to its current size in as little as five years or sooner. Increasing the RSC slightly past OEM would provide more clearance, especially if alignment issues develop with the machine over time or the rate of deformation increasing, and provide NLH more time to investigate the cause of the deformation and possible remedies.

To reiterate, this recommendation was a compromise between many factors that can impact the machine's performance and lifespan and that no standard guideline (e.g., CEATI) existed for this situation. Additionally, some of the same logic and principles were applied on previous Bay d'Espoir Wearing Ring issues; in fact, the diameters were increased even more than what Voith recommended for the Unit 7 machine in some previous cases.

NLH should increase the radial seal clearance (RSC) to 1.25 times the OEM value, which is 0.05625 inch, rather than the OEM of 0.045 inch. This will improve the global roundness of the Lower Wearing Ring and increase the clearance between the Runner and Wearing Ring. Currently, the gap measures a minimum of 0.012 inch in the upstream direction and a maximum of 0.060 inch in the A2 direction. Machining the Wearing Ring to the proposed diameter will not “clean” or create a perfect circle, in fact, in the locations of the larger gap (A2), the boring bar will not even touch the surface, which is acceptable.

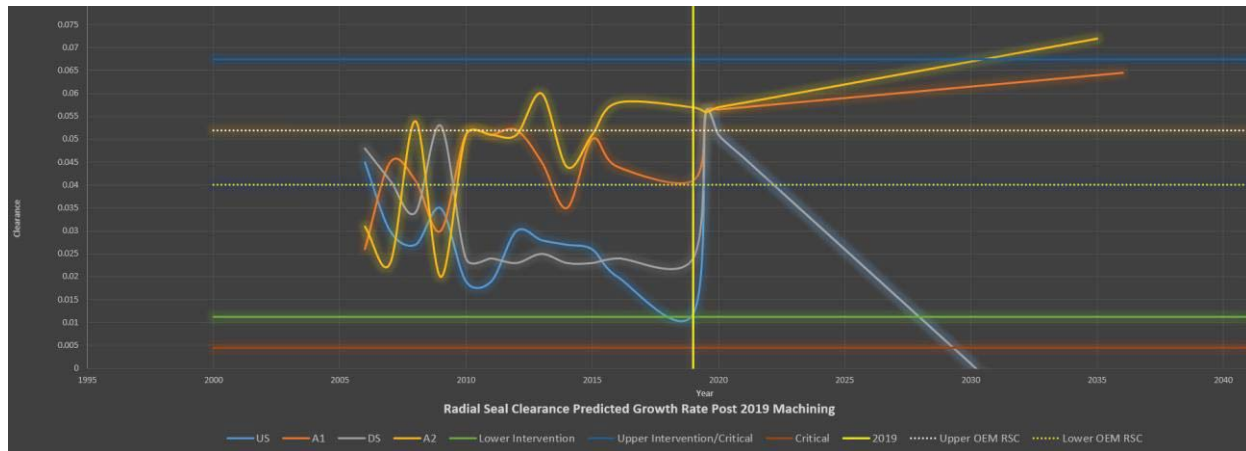
Figure 5-284: Predicted Growth Rate and Timeline of Radial Seal Clearance after Machining (Clearance in Inches)

Figure 5-284 is a graph that shows the 14-year change in the Radial Seal Clearance, the new 2019 RSC clearance, and the predicted rate of change of the next 15 years. This rate of change is using the 0.002 to 0.003 inch change per year used during the pre-machining analysis. While no absolute logic or mathematical model exists to predict the RSC phenomenon, the graph reveals that the RSC could be approaching, if not

surpassing, the intervention limit referenced in the CEATI Part 5 maintenance standard in as little as five years. The change in RSC could also approach the critical limit after the ten year mark past the 2019 commissioning, if the growth rate continues at the same rate. Moving beyond the 2019 Maintenance Outage, NLH should plan to continue to monitor the RSC at appropriate intervals. The RSC should be measured and recorded at least once a year; however, if other opportunities present themselves NLH should take advantage and measure the RSC.
