Re: Application for Capital Expenditures for the Life Extension of Bay d'Espoir Unit 7 – Redacted

Please find enclosed Newfoundland and Labrador Hydro's ("Hydro") application for the capital expenditures required for the life extension of Unit 7 of the Bay d'Espoir Hydroelectric Generating Facility ("Bay d'Espoir Unit 7").

Engineering Report
Mechanical Engineering
Bay D'Espoir Unit 7 Condition Assessment Condition
Report

Bay d'Espoir – Newfoundland and Labrador Hydro		
Unit 7 Refurbishment Report Project Report	TFS7000	
	PDM Doc ID:	Doc. Revision:
	2-10066279	-

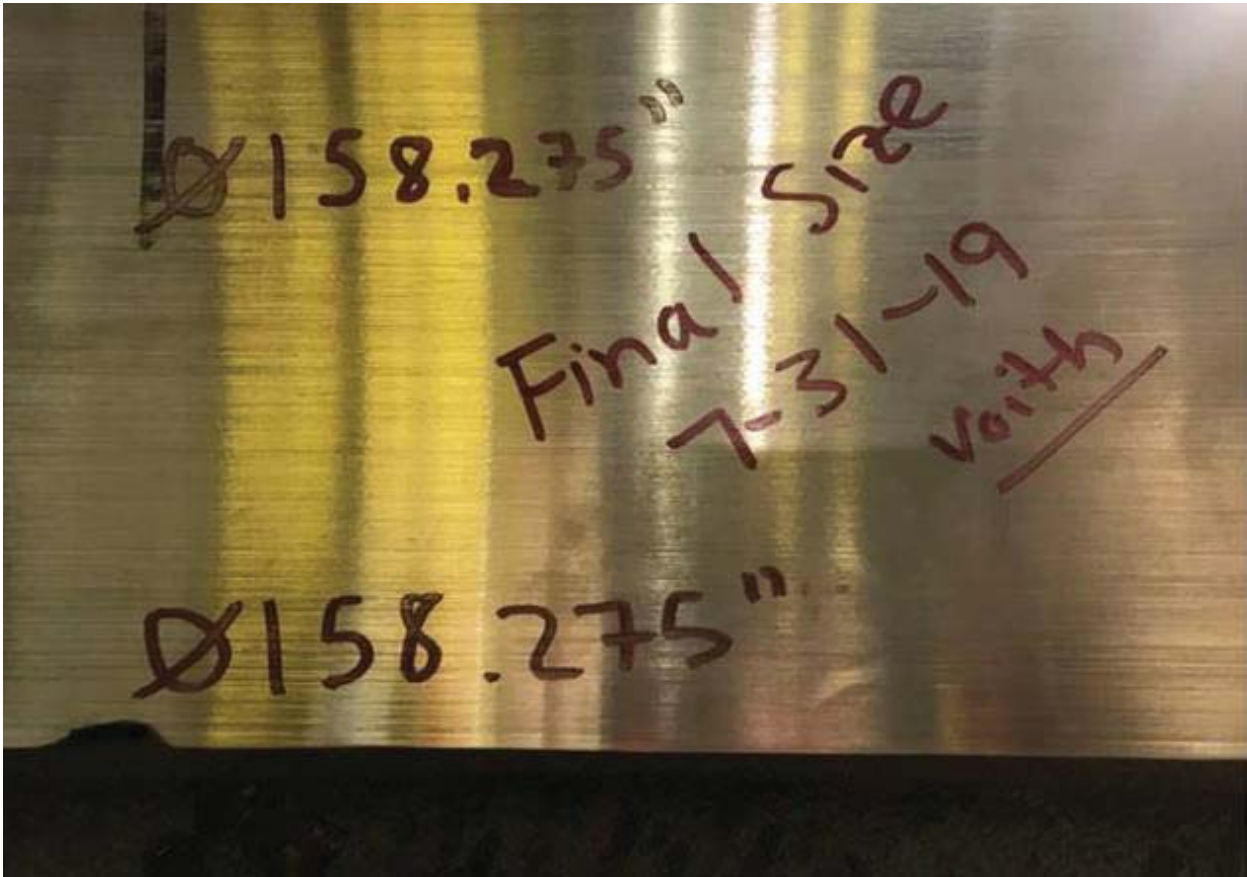
Figure 5-285: Final Bottom Ring Wearing Dimension – (Two Location)

The machining of the Bay d'Espoir Bottom Ring Wearing Ring was completed on July 31, 2019. The final diameter shown in Figure 5-285 was recorded in four locations, top and bottom, on the Wearing Ring to 158.275 inches. The diameter is slightly less than the maximum Voith proposed, which was 158.2795 inches. With the slight risk going over proposed size, and with the logic that taking an additional cut would not net significant gain, Voith decided to remain a few thousandths of an inch under the max size. As the figures revealed, and as expected, the Wearing Ring did not machine clean; meaning, the final diameter was not large enough to cut the as-found elliptical shape of the Wearing Ring; however, Voith was confident that the new global roundness and runouts recorded would not have changed enough to warrant the additional cut. The machining of the Wearing Ring opened up new surface material of the OEM welds of the rings. These welds were located where the ring quarters were originally welded together. There were four welds. Of the four, three were easy to see visually and a 4th spot was NDE inspected assuming the welds were all equally spaced. To ensure the machining process did not reveal surface imperfection across the weld, Voith recommended NDE be performed on the welds. NLH performed the recommended examination on the welds after removal of the Voith Boring Machine; no indications were found. The NDE reports are located in the Appendix of this report.

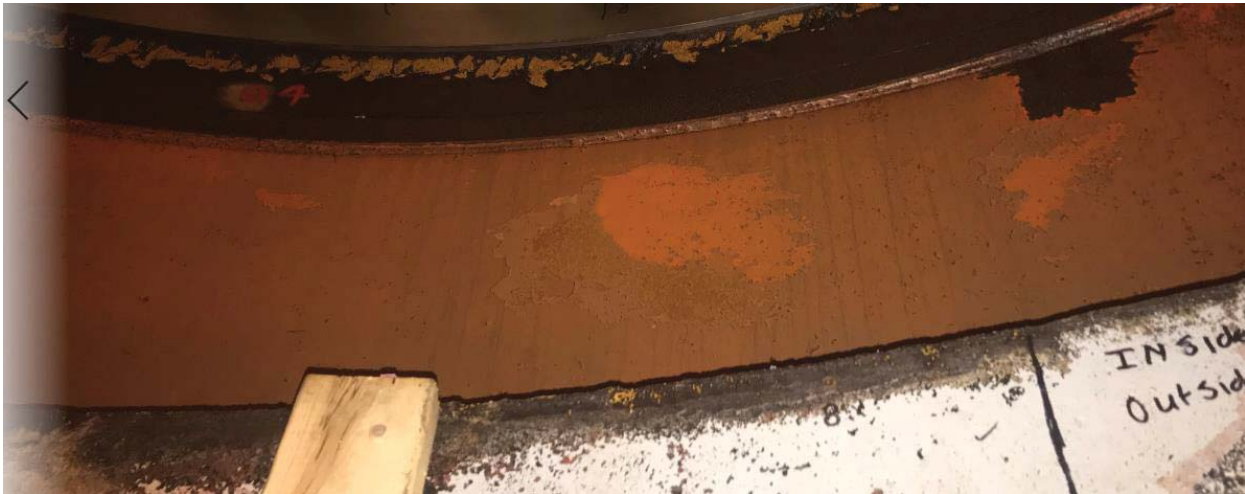
Figure 5-290: Discharge Ring, Rust and Corrosion

The Discharge Ring was visually inspected by Voith engineering for any obvious signs of damage, cracking, and any indications that the ring may require repair prior to placing the unit back into to service. The inspection of the Discharge Ring revealed that the ring was in good condition considering the age and service life of the machine. The original OEM orange paint was still present and in fair condition. There was some light rust and corrosion present, but this was limited to the upper and lower main plates of the Discharge Ring. There were no indications or signs of cracks or damage found on the Discharge Ring. The Voith Hydro Field Services team inspected the Discharge Ring by the means of tapping the structure of the Discharge Ring with a hammer and listening for different tones, indicating voids behind the steel. After a thorough inspection VH did not detect any voids behind the steel structure of the Discharge Ring.

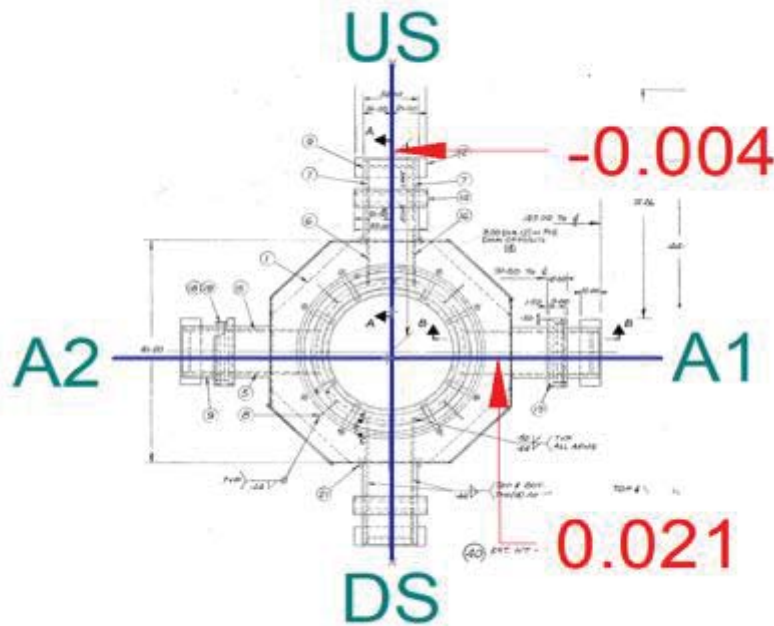
Figure 6-2: Unit 7 Verticality, First Move to Adjust Verticality

- Unit verticality was 0.0929 mm/m compared to the CEATI tolerance of 0.0600 mm/m.
- Runout at the Turbine Guide Bearing was 0.002 inch in both the Upstream/Downstream and A2/A1 axis.
- Voith recommended moving the Main Bracket down 0.004 inch in US/DS direction and up 0.021 inch in the A2/A1 direction (NLH performed the recommended move).

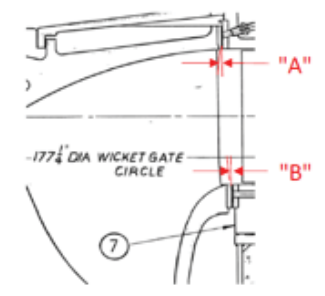
Figure 6-6: Final Results of Unit 7 Concentricity

- The move to improve the concentricity was successful, resulting in Air Gap and Radial Seal Clearance within CEATI Part 2 Erection Standard. The results of the move are highlighted in green in Figure 6-6.
- With the rotation checks and measurements completed, NLH continued assembly of the final parts of the Unit 7 machine in preparation for commissioning.

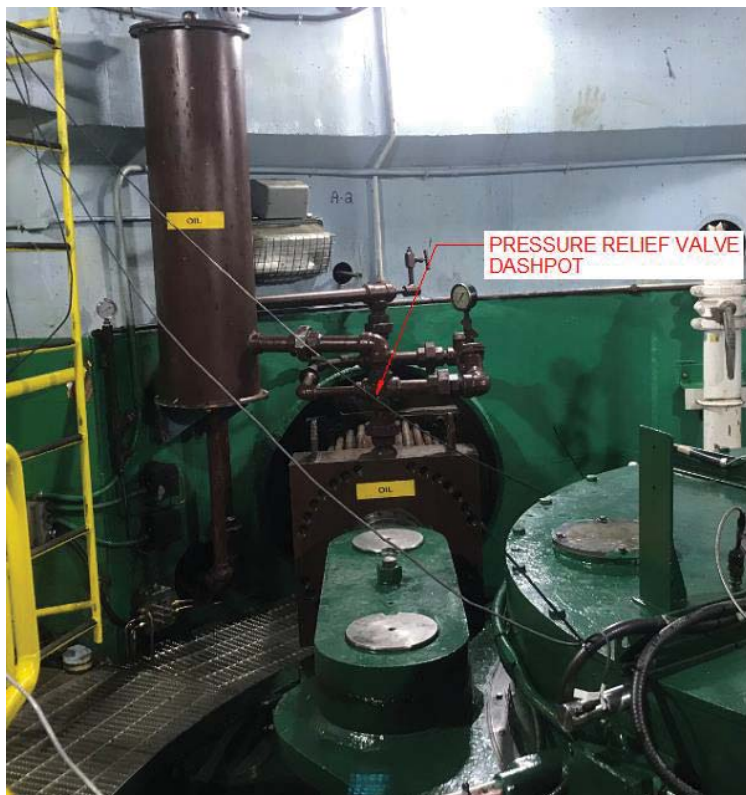
Figure 8-2: Pressure Relief Valve Dashpot

There was no Voith Hydro scope planned for the Dashpot and Operating Servomotor (see Figure 8-1) for the 2019 Maintenance outage.

Recommendation: During the next major outage, NLH should plan to thoroughly inspect, repair (if necessary), and paint the Dashpot and Operating Servomotor.

- **Rehabilitation Expected:**
 - Immediately ship the components to qualified rehabilitation supplier.
 - Non-destructive examination.
 - Unknown repairs.
 - New seals.
 - Possible machining.
 - Paint.
