**Re: Allowance for Unforeseen Items Account – TL219 and TL203 Storm Damage Repairs –
Final Report**

TL219 and TL203 Storm Damage Recovery

Final Report

March 10, 2022

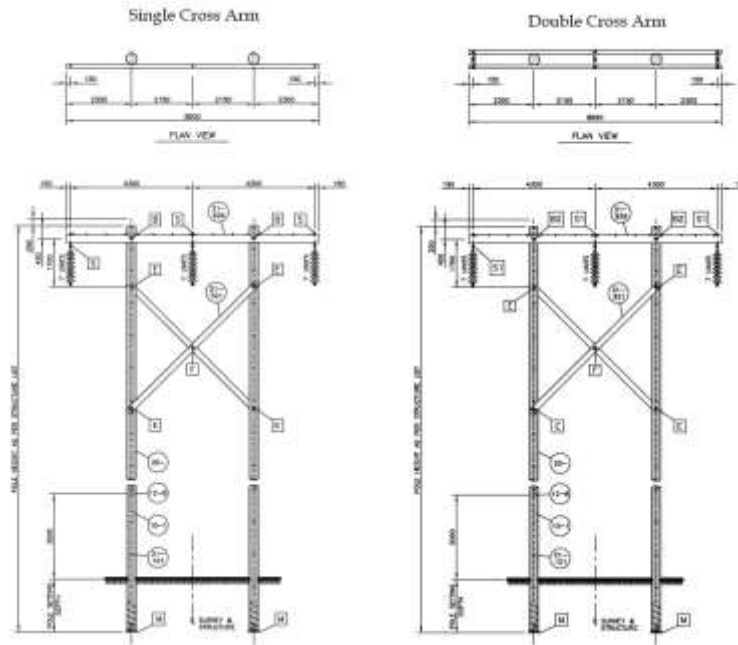
Figure 11: 138 kV H-frame Structure Design

10 The existing tangent structures were designed using a single dimensional wood crossarm configuration
11 supported by class 4 poles. As Hydro no longer uses class 4 poles for transmission infrastructure, the
12 existing structures were replaced with class 2 poles, increasing reliability of the structures as per current
13 standards. In addition, a double dimensional wood crossarm was utilized instead of a single crossarm to
14 increase the structures ability to resist future unbalanced loading. Figure 11 illustrates the design
15 difference between the existing structure and the new structure. The more robust material components
16 utilized during the repair effort provide a significant increase in structure capacity. Refer to Figure 12–
17 Figure 14 for photos showing repair work.
