Re: Holyrood Thermal Generating Station Unit 1 – Root Cause Investigation Report

Holyrood Thermal Generating Station Root Cause Investigation

Unit 1 – Cold Reheat Piping Support Failure

December 2021

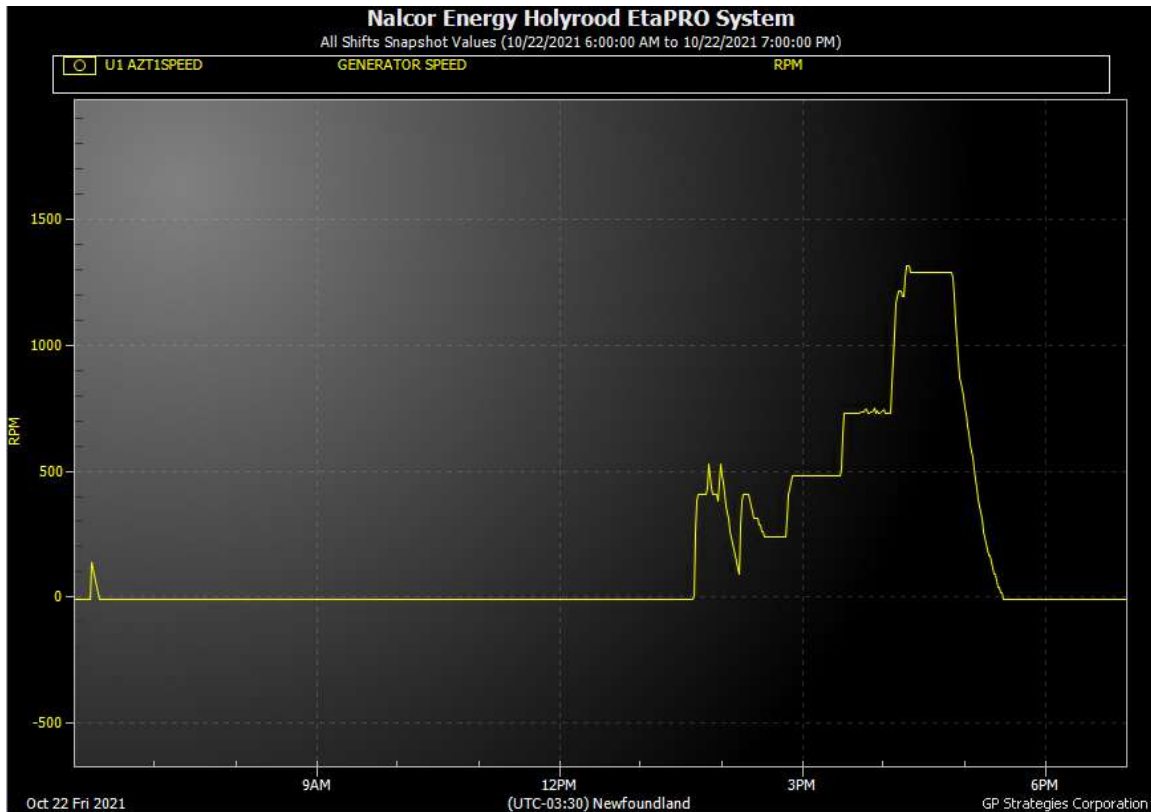
Figure 3: Holyrood Unit 1 Turbine Speed during Turbine Roll (October 22, 2021)

7 The initial setpoint of 250 rpm overshoot above 500 rpm (refer to Figure 3 and Table 2) The operator
8 modified the setpoints to try to achieve 250 rpm before continuing to the next speed setpoints, and
9 continued to enter lower setpoints to achieve desired speeds. The setpoint vs. actual speed issue
10 appeared to normalize at the 1300 rpm setpoint.

11 The standard operating procedure does not require an operator to adjust the turbine speed setpoint to
12 achieve a desired speed.

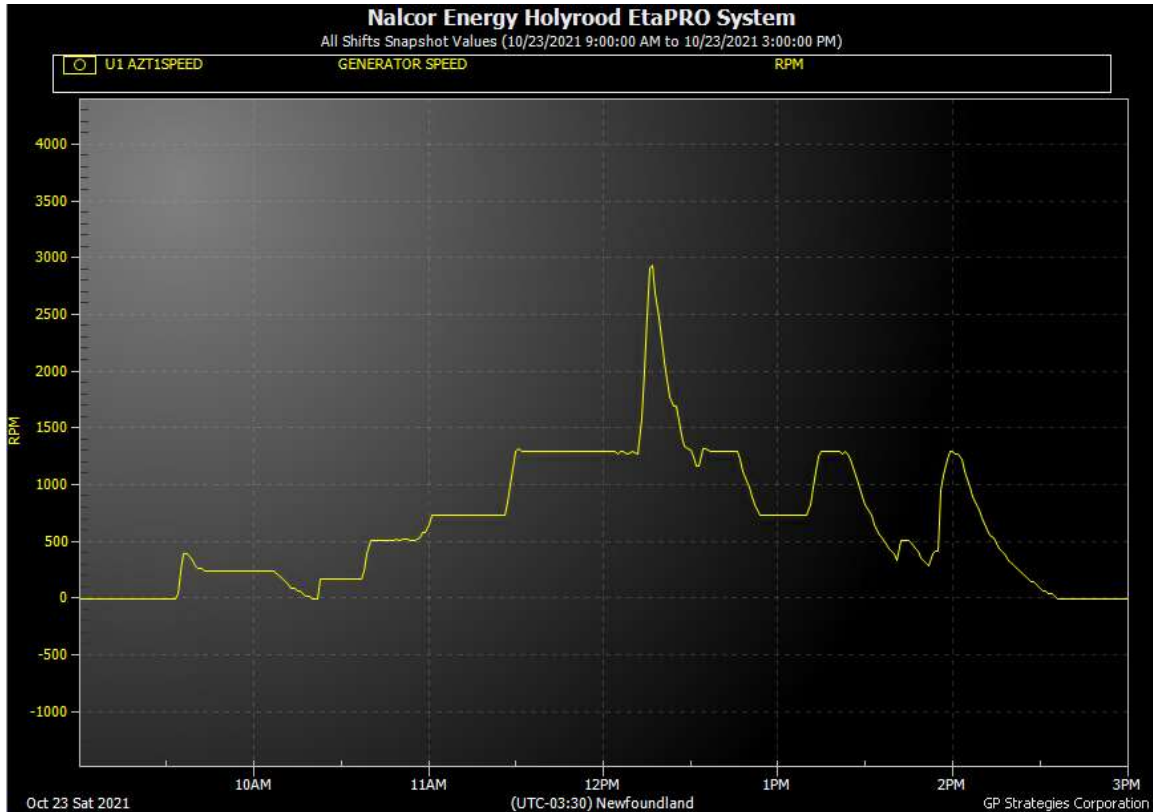
Figure 4: Holyrood Unit 1 Turbine Speed during Turbine Roll (October 23, 2021)

- 1 On Saturday, October 23, 2021, at 0935 hrs, Holyrood operations started rolling the turbine. GE’s
- 2 controls engineer was present. The operator logs do not have enough detail regarding the setpoints
- 3 used, but it is visible in Figure 4 that turbine initially accelerated to nearly 400 rpm. GE’s controls
- 4 engineer report (Appendix C) states that the unit accelerated to a few hundred rpm on reset. While
- 5 ramping the speed towards 3000 rpm, operations experienced a drop in hydraulic pressure (as low as
- 6 5872kPA) and decided to trip the turbine. Operations reset the turbine and reengaged it at 1300 rpm.

- 7 The GE controls engineer attempted to improve speed control by changing the control curve of the MSV
- 8 pilot valve, but was unsuccessful, so he suggested that the MSV valve might be leaking too much steam
- 9 across the seat. Upon investigation and review of the MSV overhaul work, GE mechanical team did not
- 10 think the valve could be leaking a significant amount of steam, but GE suggested the installation of a
- 11 shim in the MSV actuator to increase the spring tension and make sure the valve is closed.

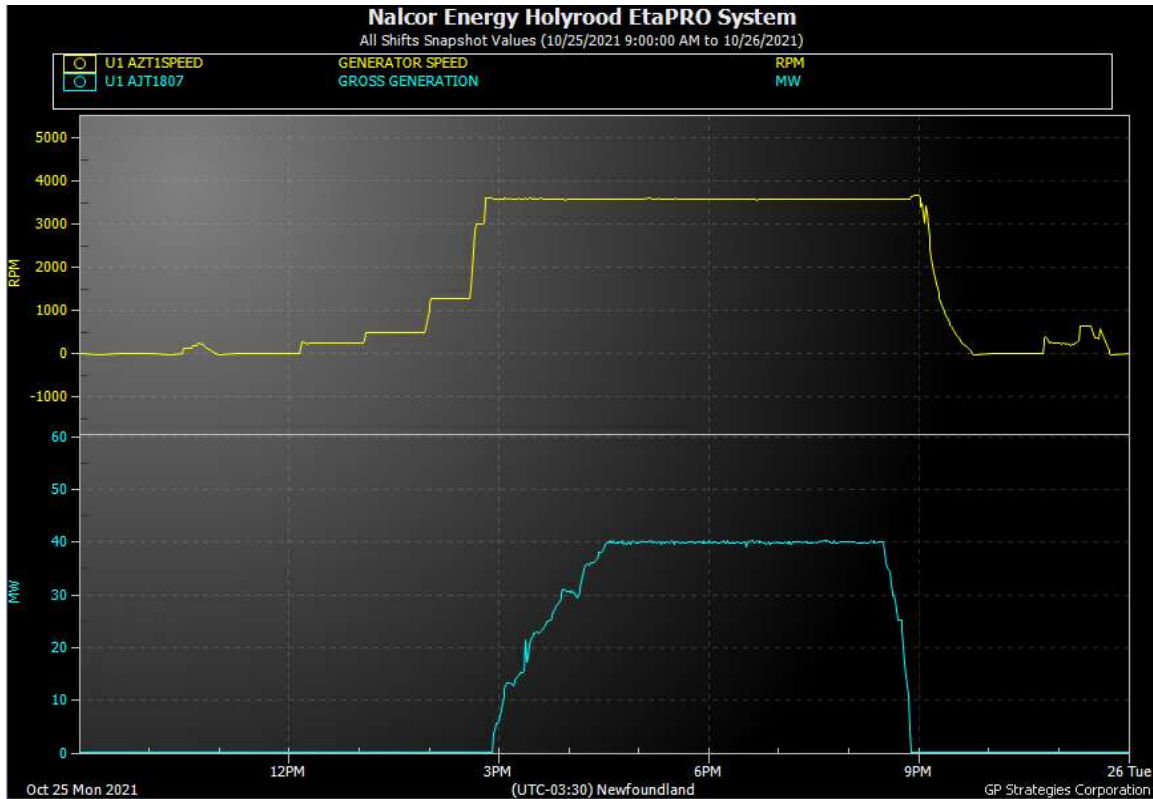
Figure 5: Holyrood Unit 1 Turbine Speed during Turbine Roll (October 25, 2021) and Gross Generation

1 Shortly after 1200 hrs, Holyrood operations team started to roll the turbine to 250 rpm. The turbine
2 overshot the speed setpoint by less than 40 rpm but it returned to the desired value without any change
3 in setpoint (refer to Appendix C) to see the data recorded by GE. Figure 5 shows the recorded speed in
4 EtaPRO®). Similarly, the turbine overshot by even smaller margins at the 500, 1300, 3000, and 3600 rpm
5 setpoints. There were no issues with the acceleration of the turbine or any other turbine parameters.
6 Operations synchronized the generator to the power grid at approximately 1500 hrs.

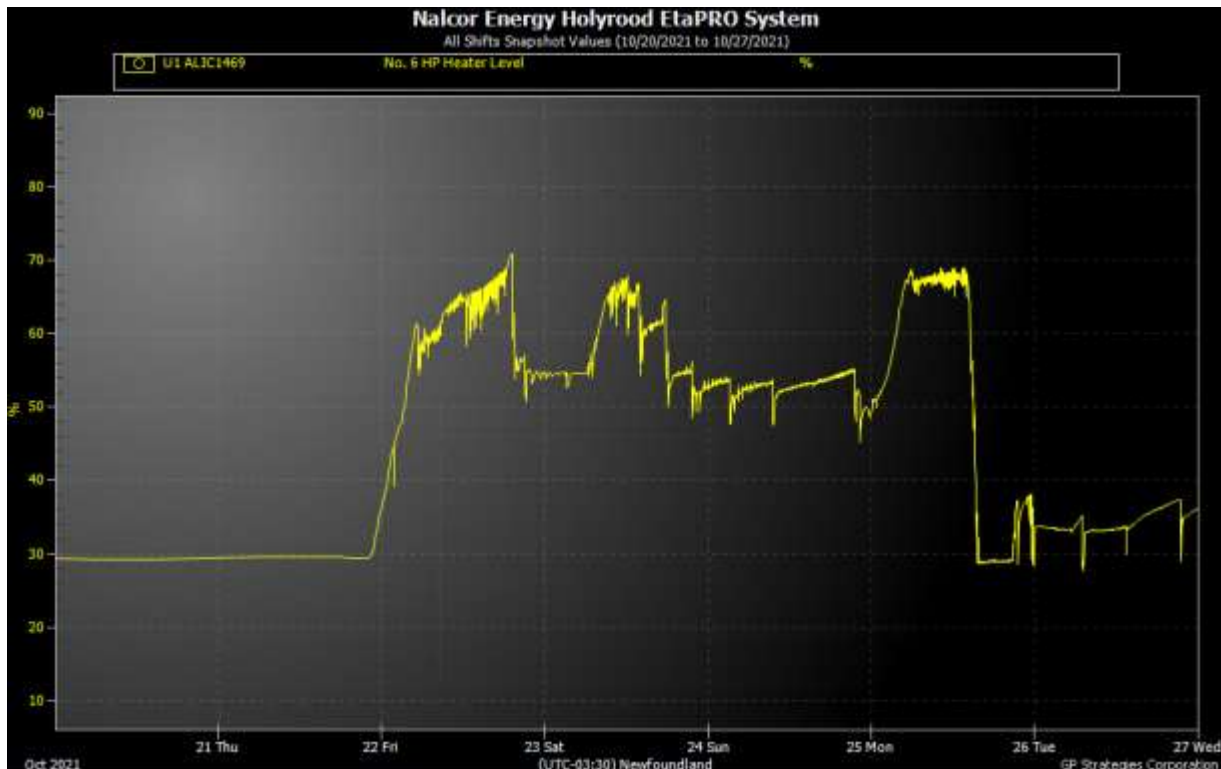
Figure 6: Holyrood Unit 1 No. 6 HP Heater Level (October 20, 2021 to October 27, 2021)

12 From October 20, 2021 to October 27, 2021, the level of water in the No. 6 HP heater remained below
13 70% (see Figure 6). The check valve was inspected on November 24 and was functioning properly.
14 Therefore, water ingress from the No. 6 HP heater was not possible.

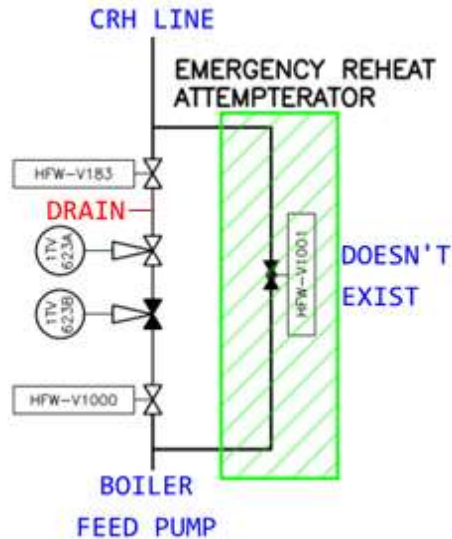
Figure 7: Holyrood Unit 1 Emergency Reheat Attenuator Spray Valves

11 During the implementation of the work protection permit for the annual Unit 1 outage, valve HFW-V183
12 was locked on May 27, 2021 with no operation (remain closed, step 93). On October 16, 2021, following
13 completion of the annual outage work, operations completed the reverse switching order of the work
14 permit. Step 7 of the reverse switching order mandates that valve HFW-V183 be unlocked with no
15 operation, (i.e. remain closed). However, on Tuesday, October 26, 2021, a Holyrood employee found the
16 manual block valve HFW-V183 in the open position. An entry in the shift supervisor log on October 28,
17 2021, confirms that the valve was open.

18 In addition to the open manual valves, there is an outstanding work order (1446407) on the pneumatic
19 block valve (TV-623B). An issue with the valve was identified in November 2019 and investigated in
20 February 2020 (work order 1426742). Parts to complete the work were ordered in 2021, but they have
21 not been received and, due to the historical use of the reheat spray and the fact that the manual block
22 valve is supposed to be closed, the work is classified as low priority.

11 The test determined that valves 1TV-623A and 1TV-623B were leaking significantly and injecting water
12 into the CRH line. All manual block valves were closed after the test.

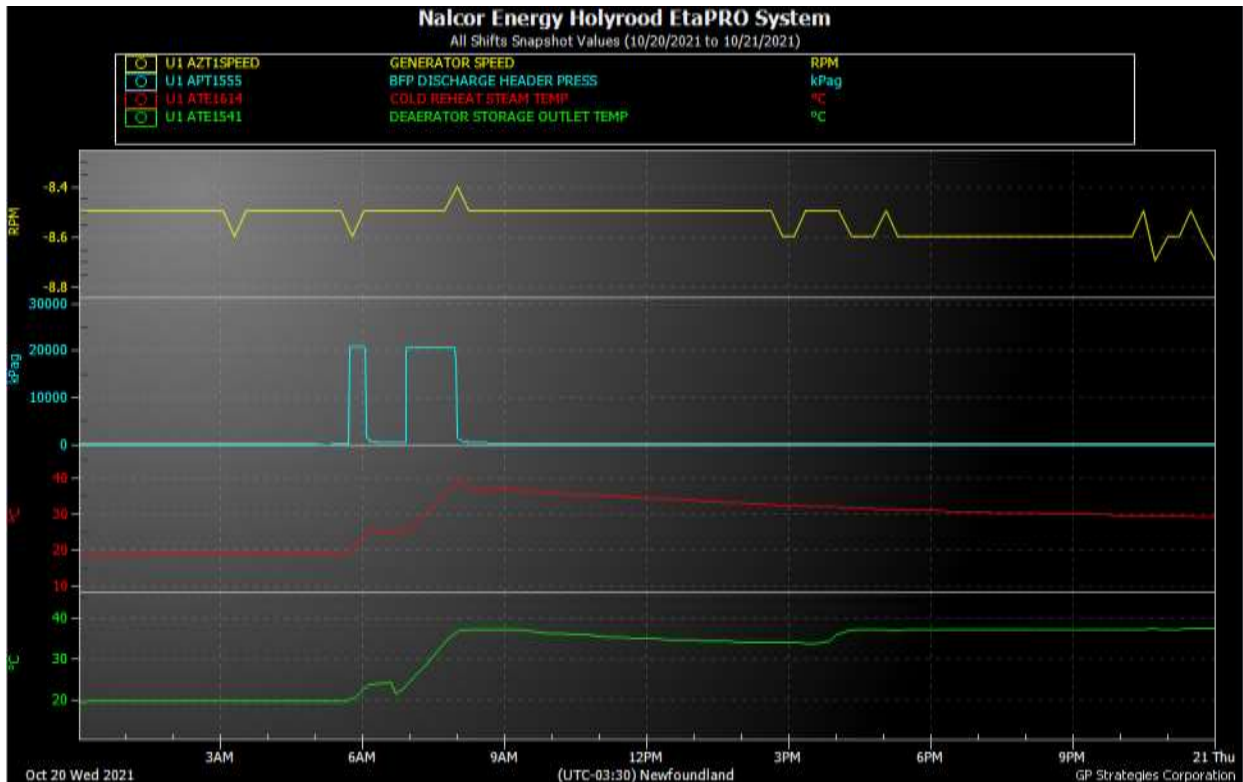
Figure 8: Temperature in CRH Line following Feedwater Temperature – No Steam in Turbine

13 Further analysis of temperature and pressure readings indicate that water was sprayed into the CRH line
14 as early as October 20, 2021. Figure 8 shows that the temperature in the CRH line started to climb and
15 roughly match the temperature of the boiler feedwater when the boiler feed pump was operating. On
16 October 20, 2021, there was no steam being admitted to the turbine. The temperature change in the

- 1 CRH line should not have been this significant. This and several other similar occasions are observed
- 2 throughout October 22, 2021 to October 25, 2021 (see Appendix F). This also confirms that saturated
- 3 steam/water was being introduced to the CRH line via the attemperator spray.
- 4 As a result, the attemperator spray was deemed the source of water hammer issue in the CRH line.

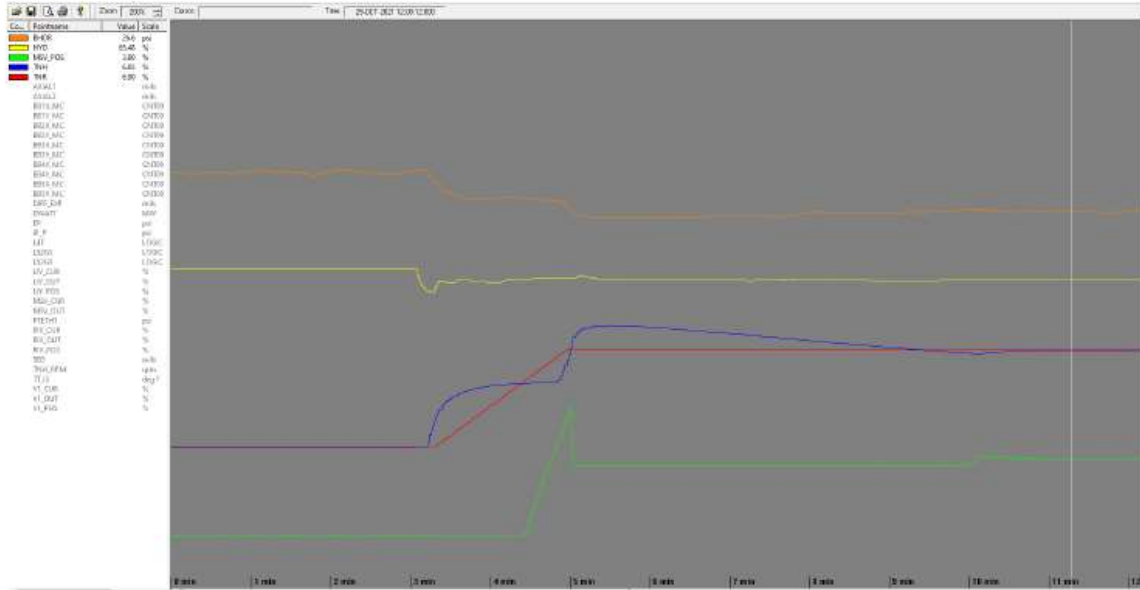
Reset and 6.9% Speed Hold – Speed (Blue) over shot reference about 20RPM.

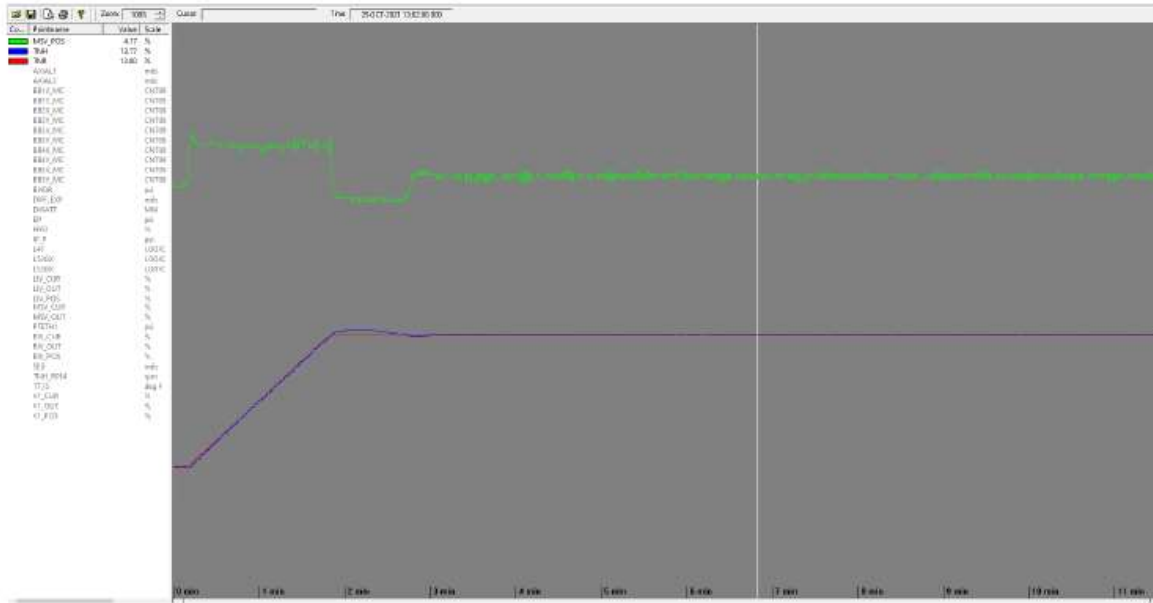
Speed Hold at 13.80% - Speed (Blue) over shot reference less than 10RPM.

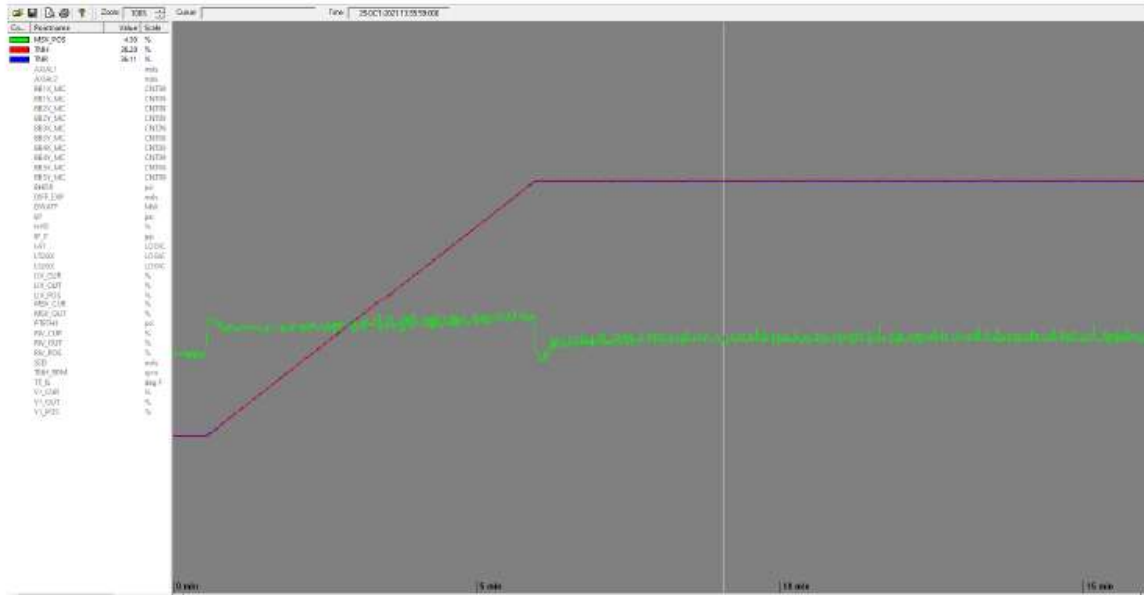
Speed Hold at 36.11% - Speed (Blue) over shot reference less than 10RPM.

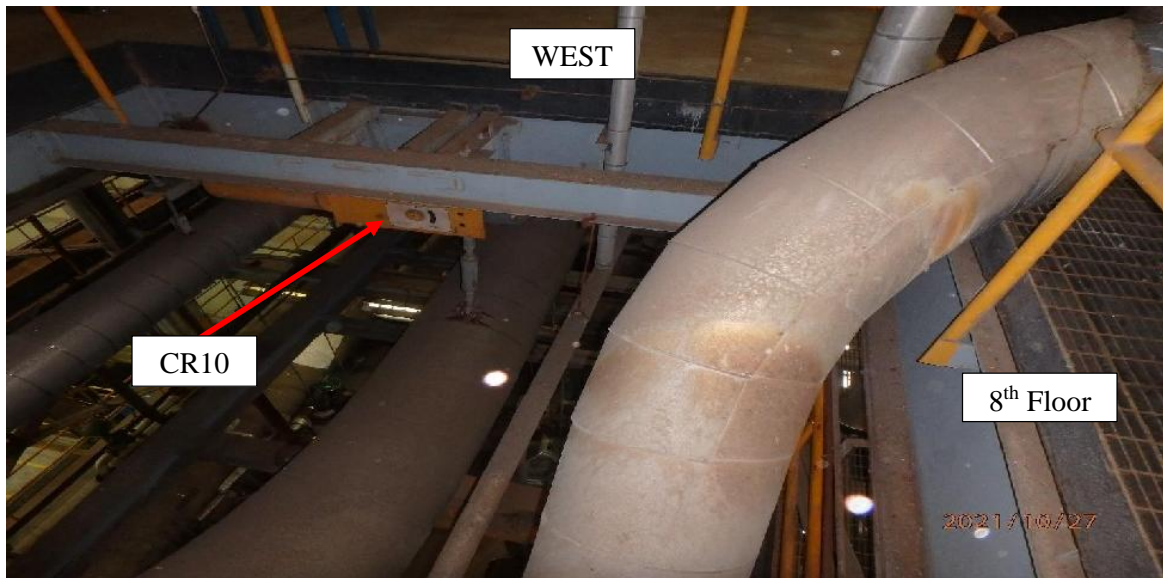
Location 1

Hanger CR10 (located below the 8th floor) appears to be out of plum, no signs of further damage from the point of access.

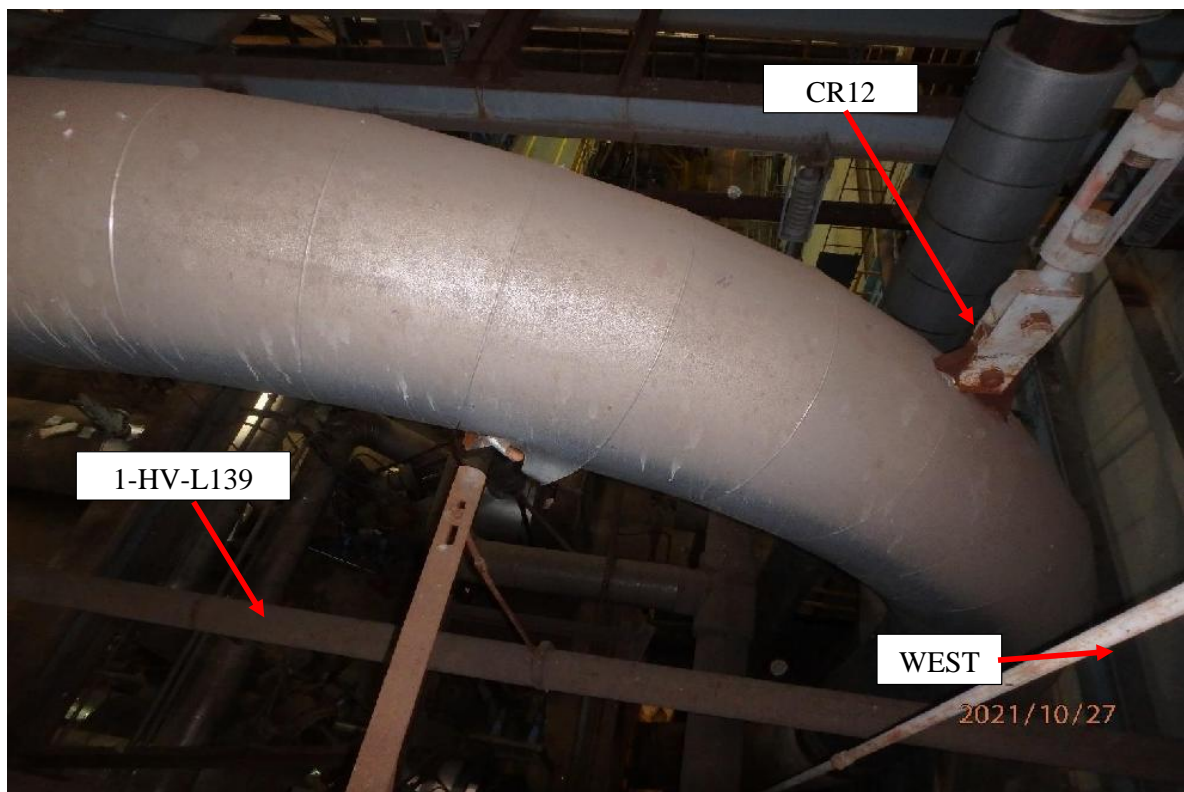
Location 2

CRH pipe contacted pipe hanger support for line # 1-HV-L139 causing damage to insulation. Also, hanger rod noted as being distorted (7th floor at grating level)

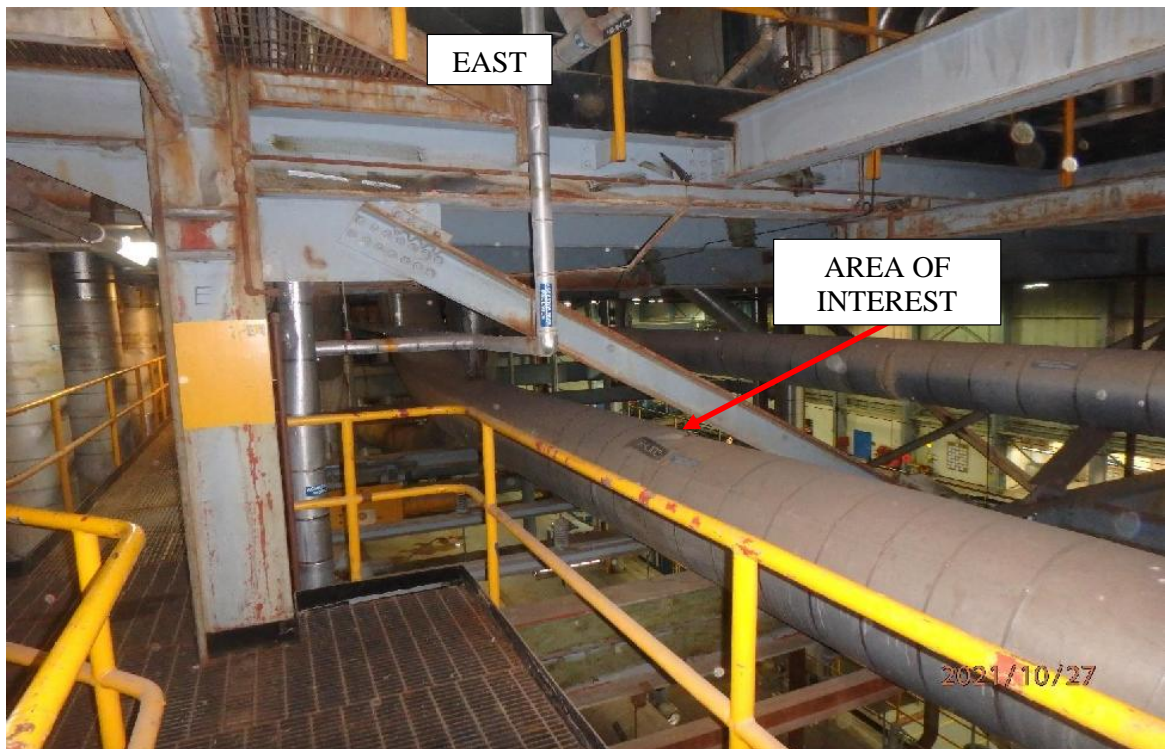
Location 3

CRH pipe contacted cross member at column 7-E4 resulting in damage to insulation. No visible sign of damage to cross member from current access.

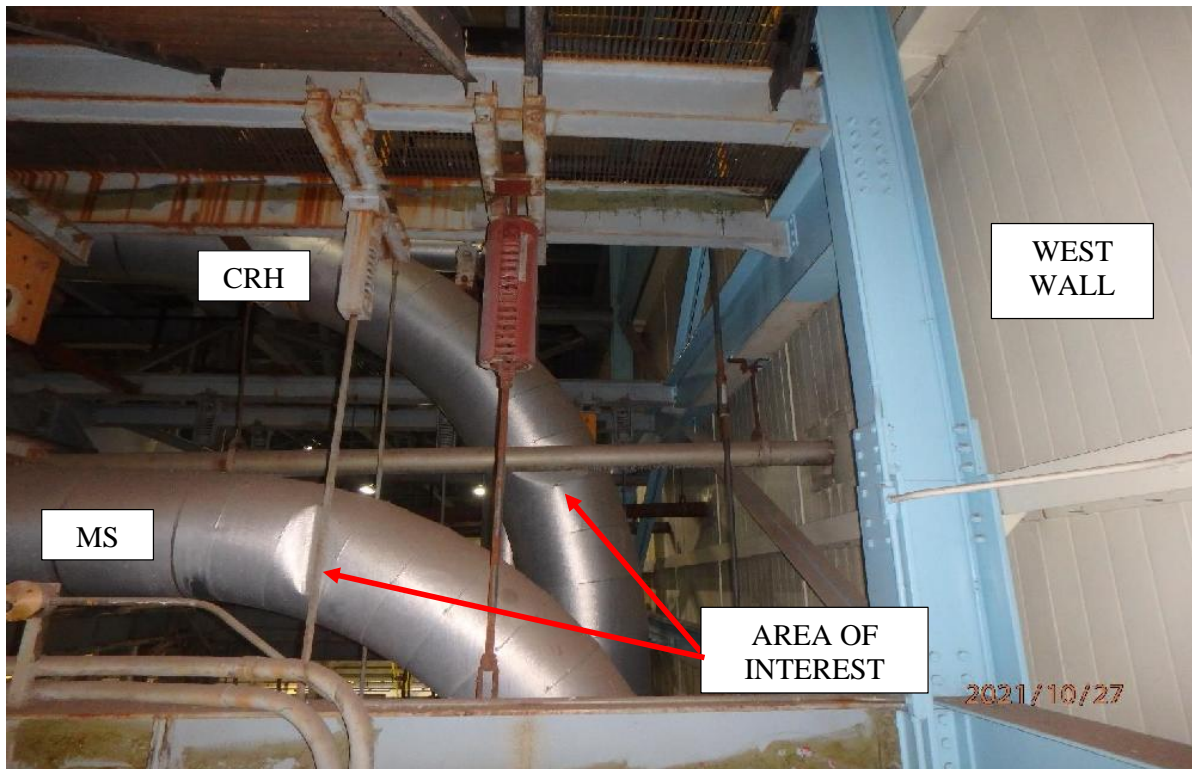
Location 4

CRH Pipe contacted line # 1-HV-L139 between the 6th & 7th floor next to West wall causing damage to insulation. Also, hanger rod for #6 HP Heater Bypass piping contacted main steam line, perhaps as a result of cold reheat pipe making contact with #6 HP Heater inlet valve gear box.

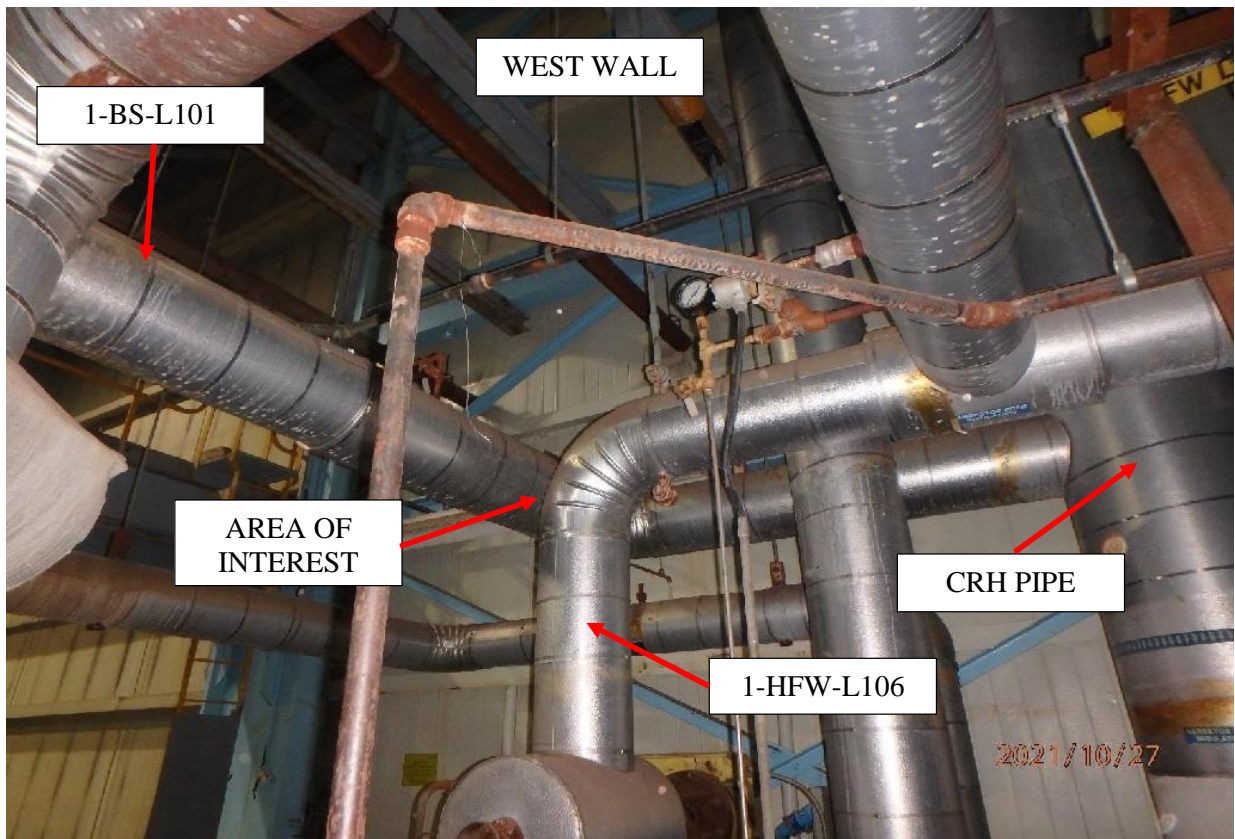
Location 5

Line # 1-BS-L101 contacted line # 1-HFW-L106 resulting in damage to insulation on BS line (5th floor).

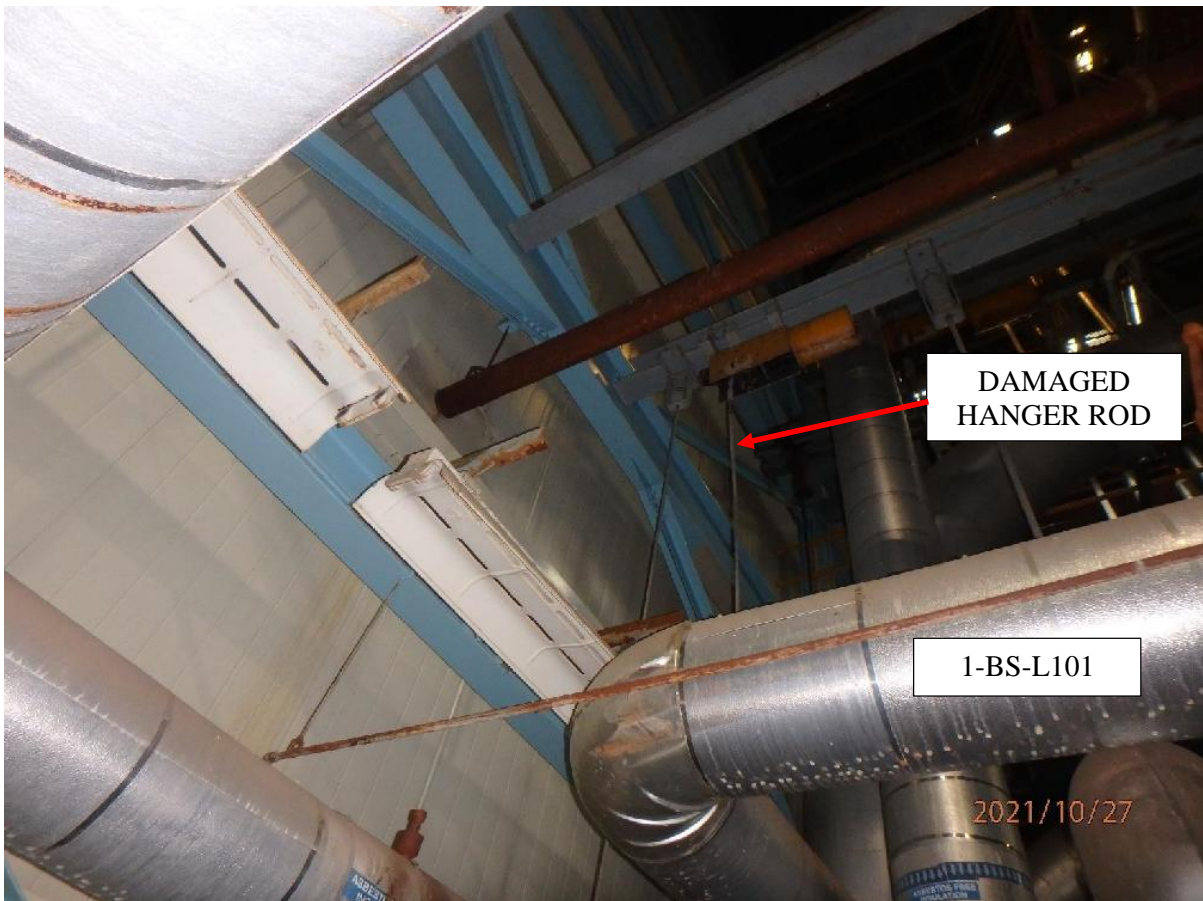
Location 6

Line # 1-BS-101 hanger rod at West wall distorted (5th floor).

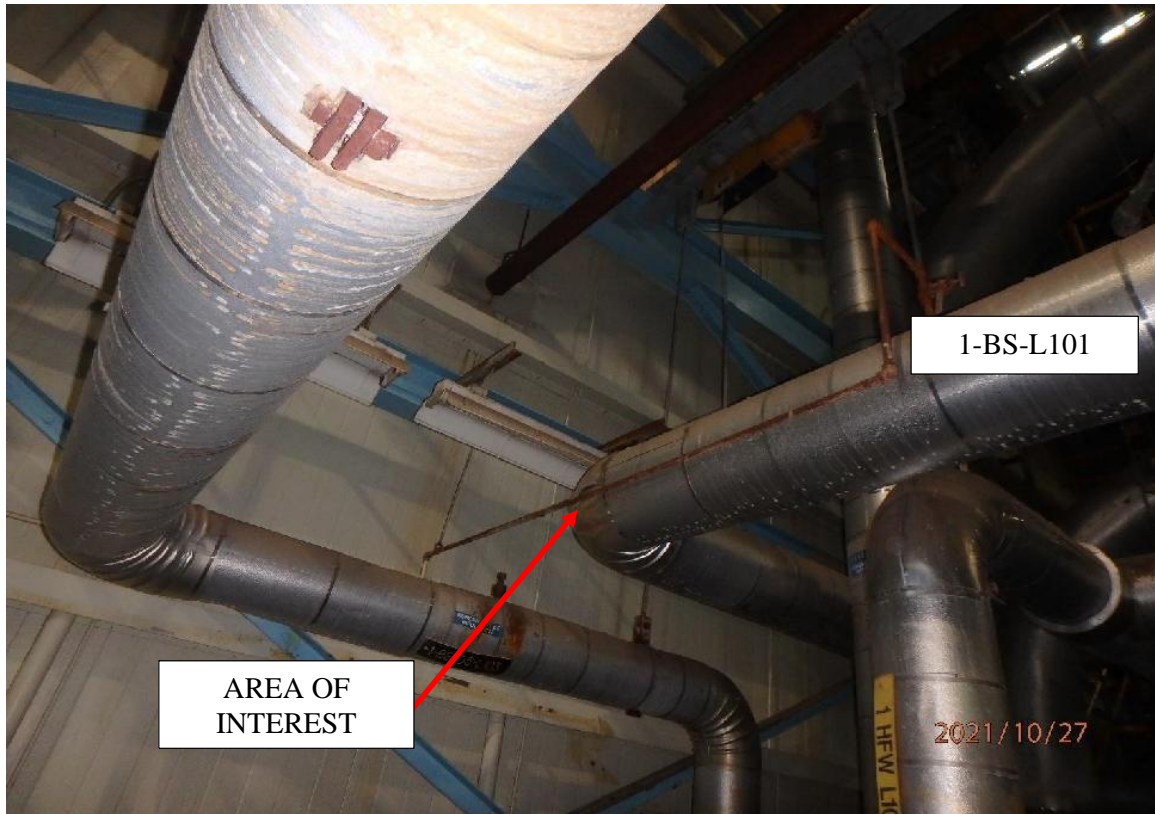
Location 7

1/2" line exiting line # 1-BS-L101 and going to transmitter PT 1466 appears to have contacted insulation and shifted the hanger (5th floor)

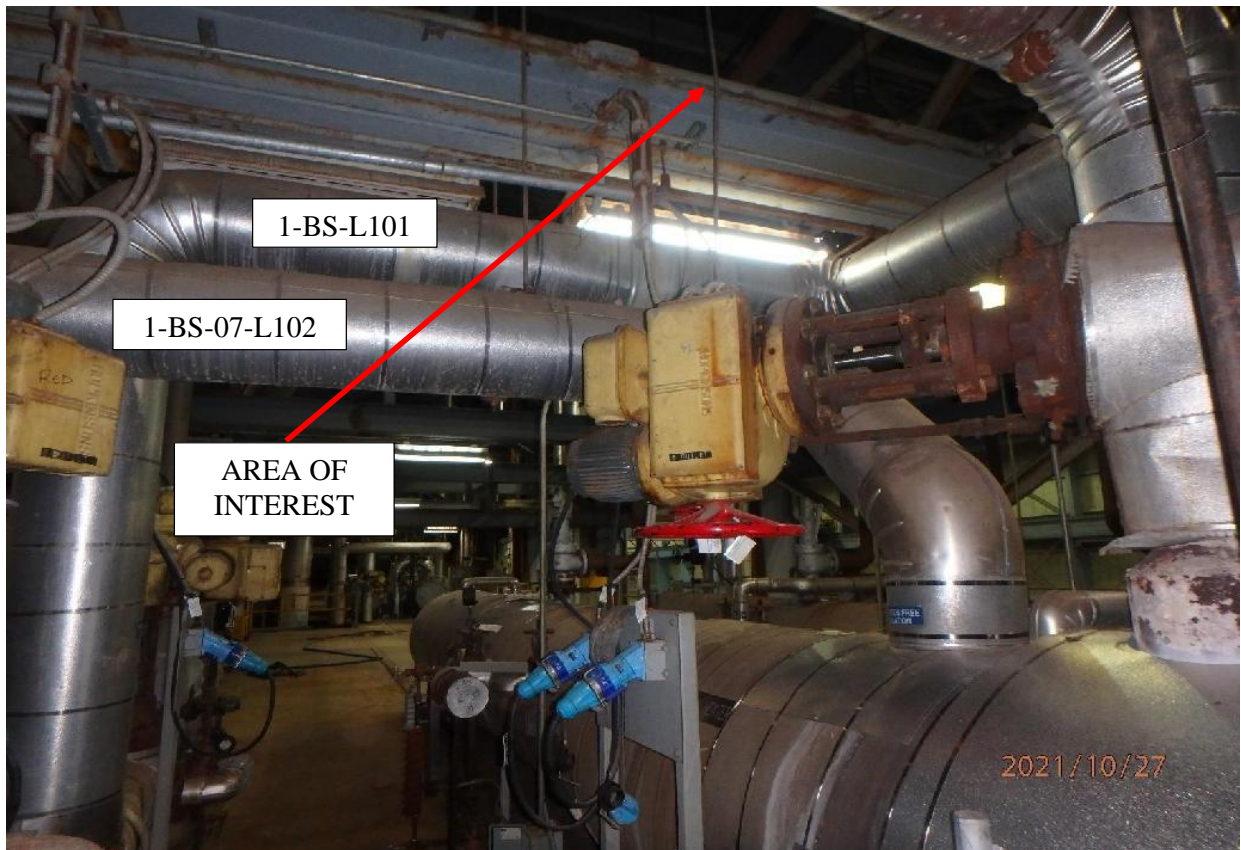
Location 8

Pipe hanger rod for line # 1-BS-07-L102 appears to be distorted above #5 HP Heater (5th floor)

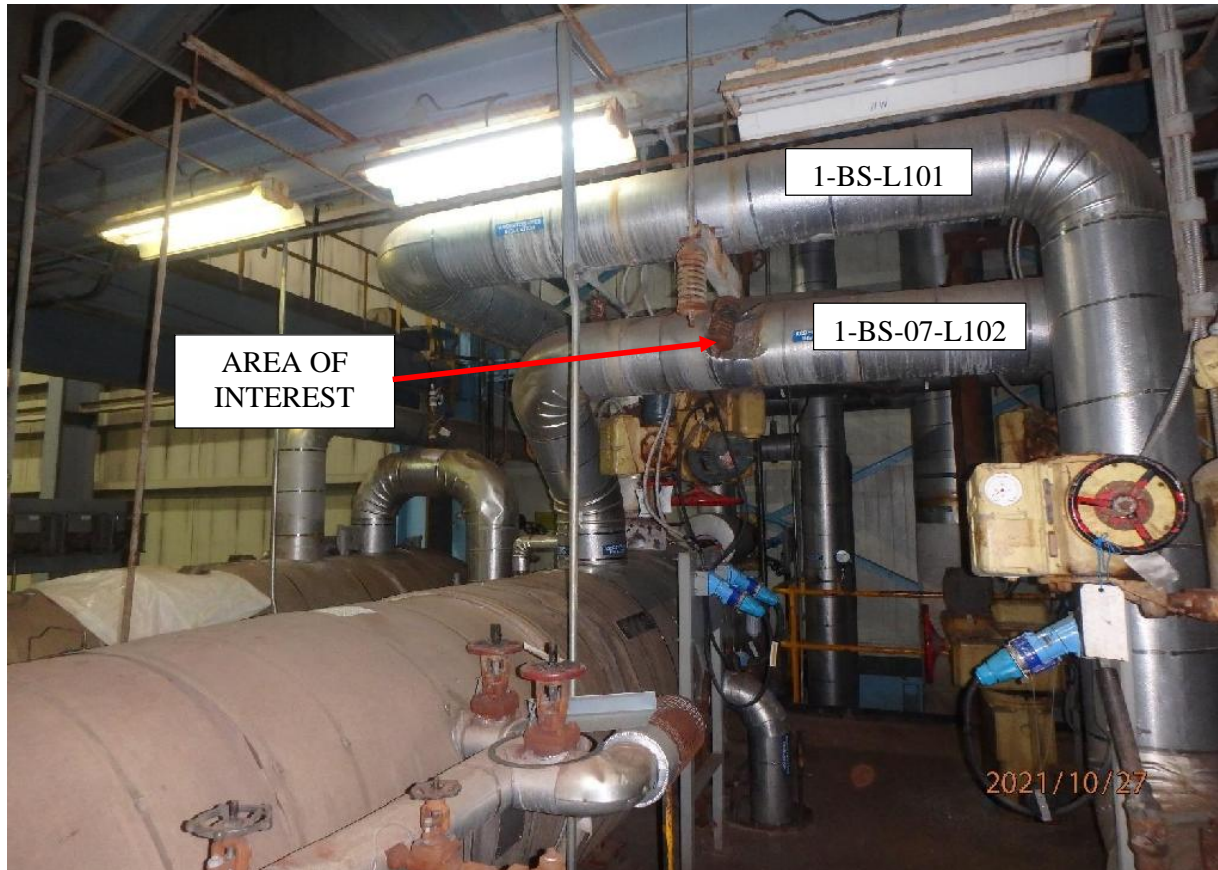
Location 9

Line # 1-BS-07-L102 insulation damaged from being struck by Line # 1-BS-L101 hanger above #5 HP Heater (5th floor).

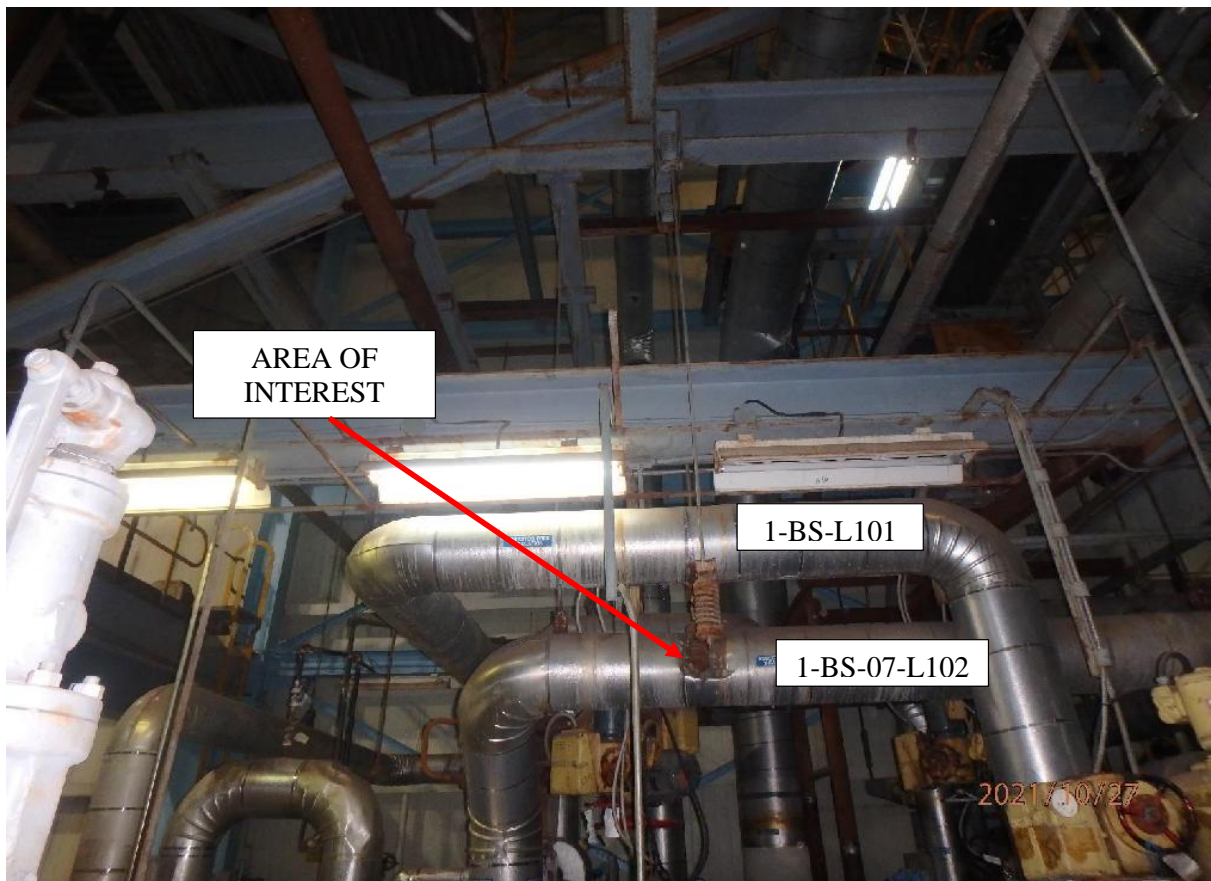
Location 10

Line # 1-BS-L101 hanger damaged from contacting line #1-BS-07-L102 above #5 HP Heater (5th floor).

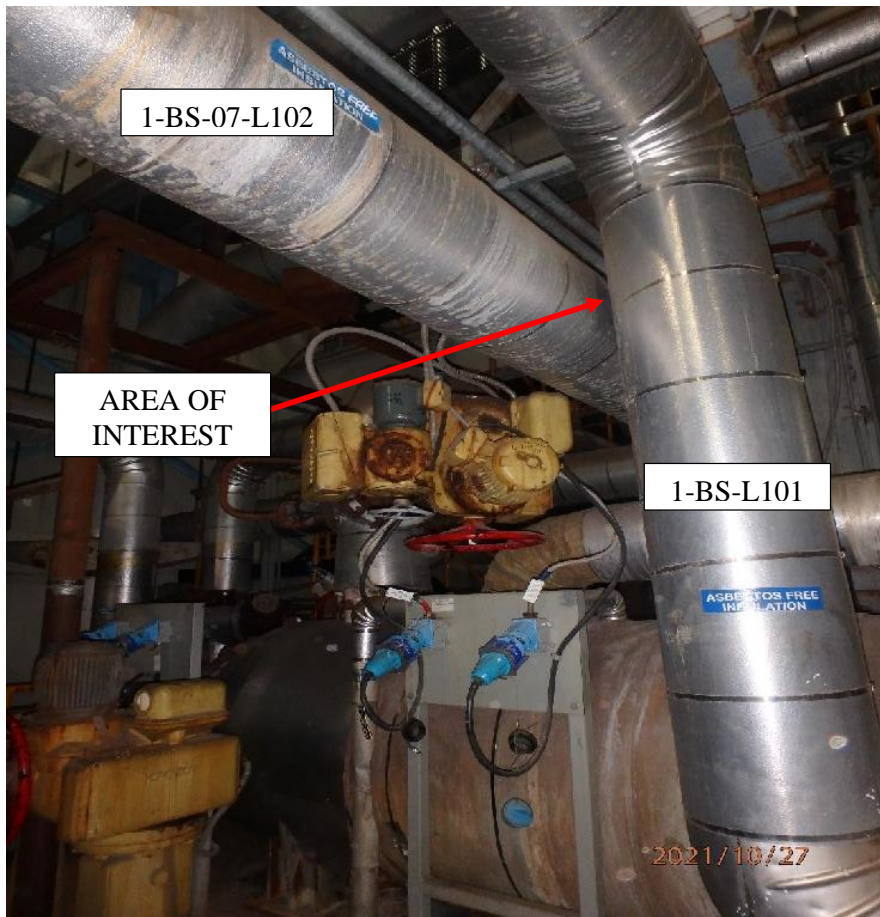
Location 11

Line # 1-BS-L101 contacted line # 1-BS-07-L102 above #6 HP Heater (5th floor).

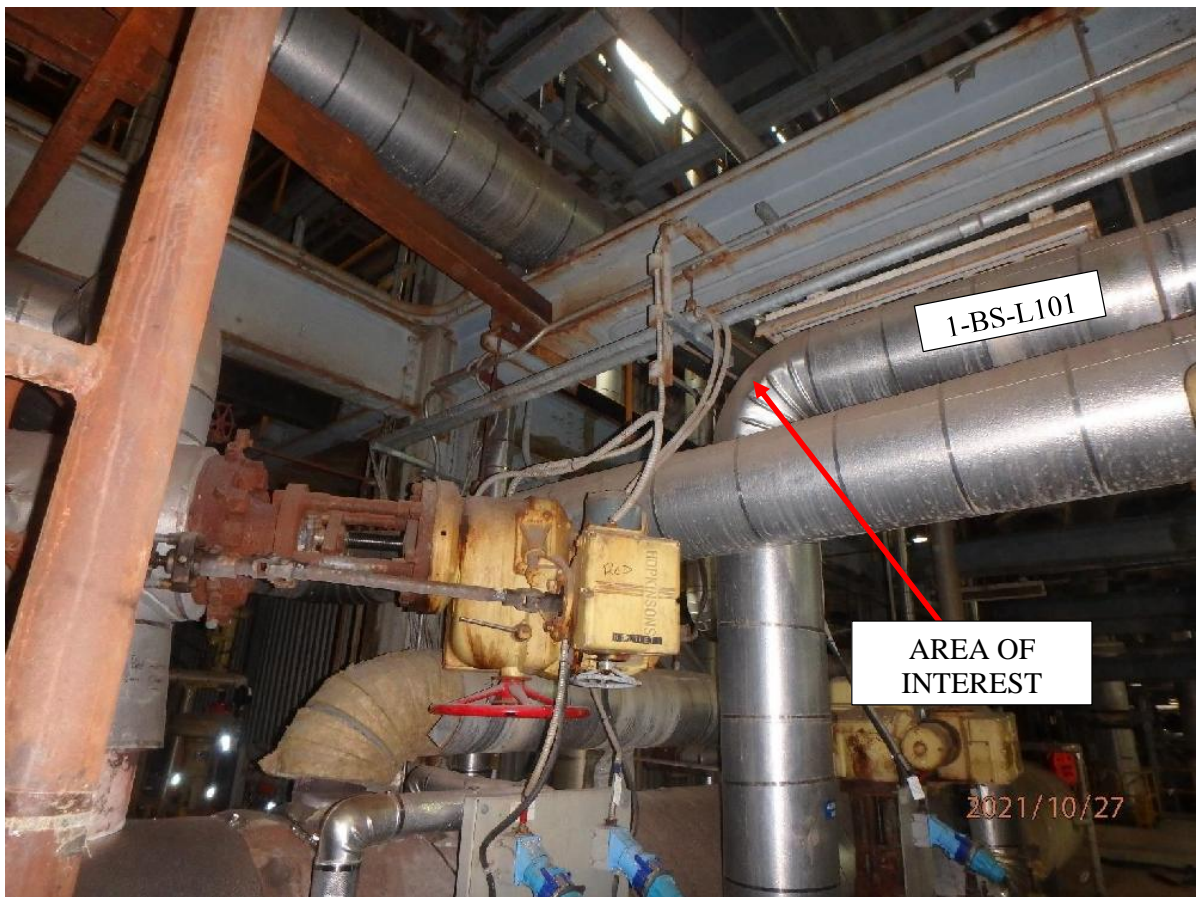
Location 12

Line # 1-BS-L101 contacted conduit support bracket above #6 HP Heater and electrical cables being pinned between piping and column (5th floor).

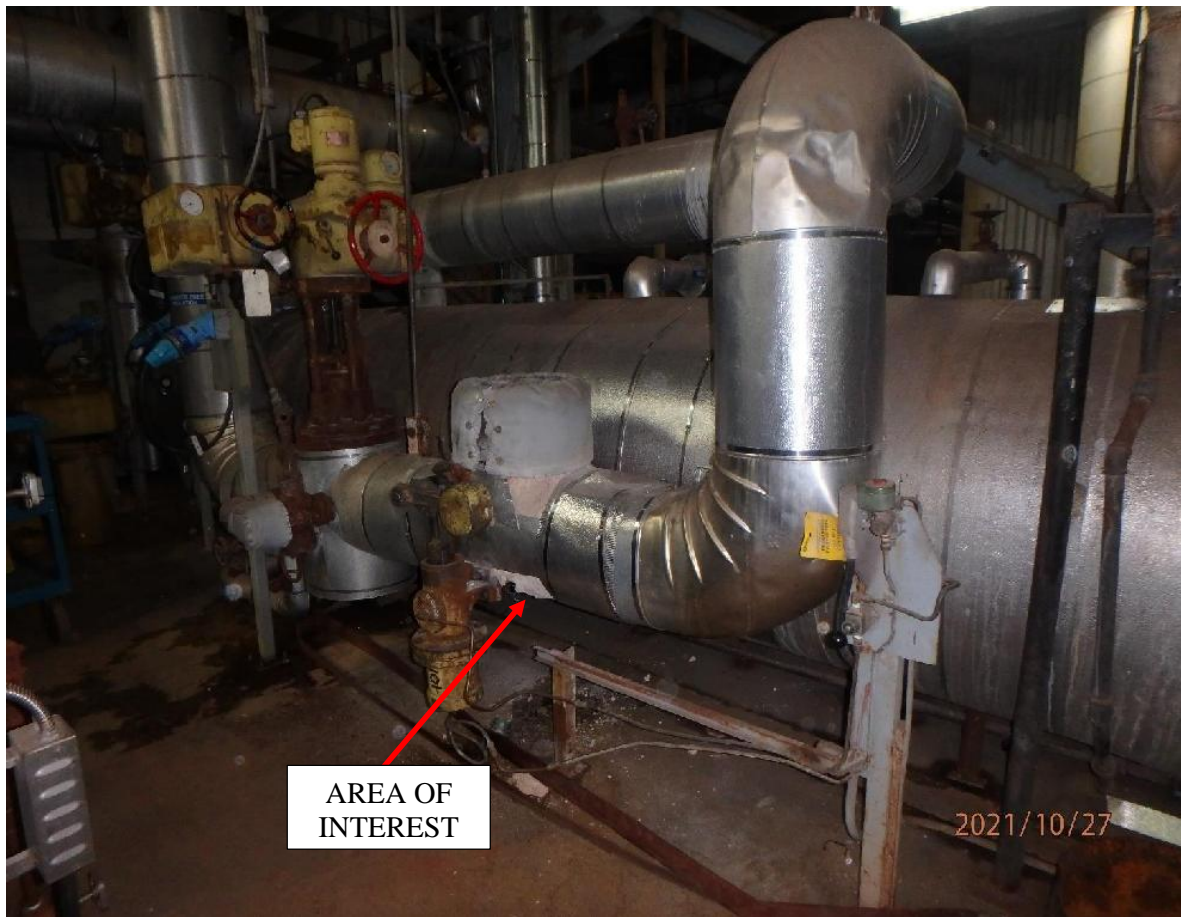
Location 13

Line # 1-BS-L101 valve insulation damaged along side of #6 HP Heater (5th floor).

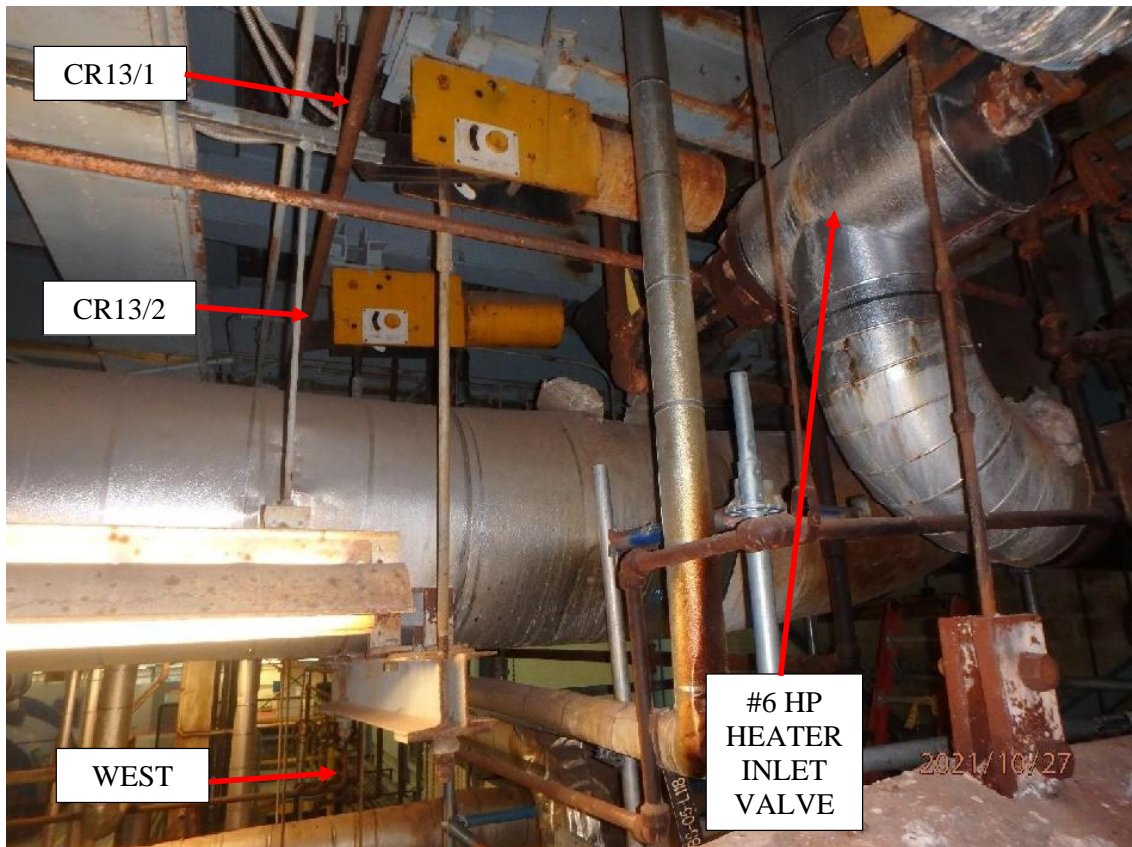
Location 14

CRH Hangers CR13/1 & CR13/2 appear to be distorted, as well I-Beam flange distorted at CR13/2 (4th floor).
