Re: Holyrood Thermal Generating Station Unit 1 – Root Cause Investigation Report

Holyrood Thermal Generating Station Root Cause Investigation

Unit 1 – Cold Reheat Piping Support Failure

December 2021

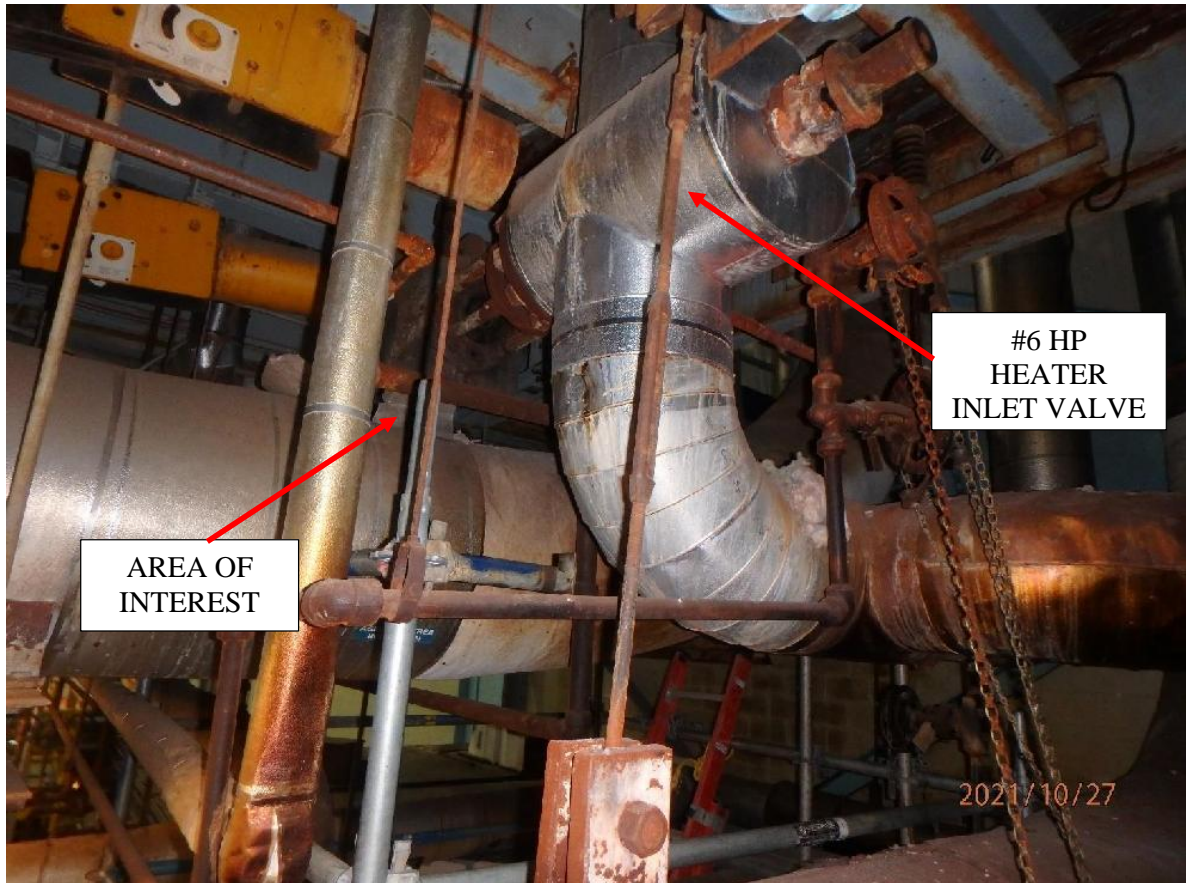
Location 15

CRH pipe contacted #6 HP Heater bypass valve gear box resulting in damaged insulation (4th floor).

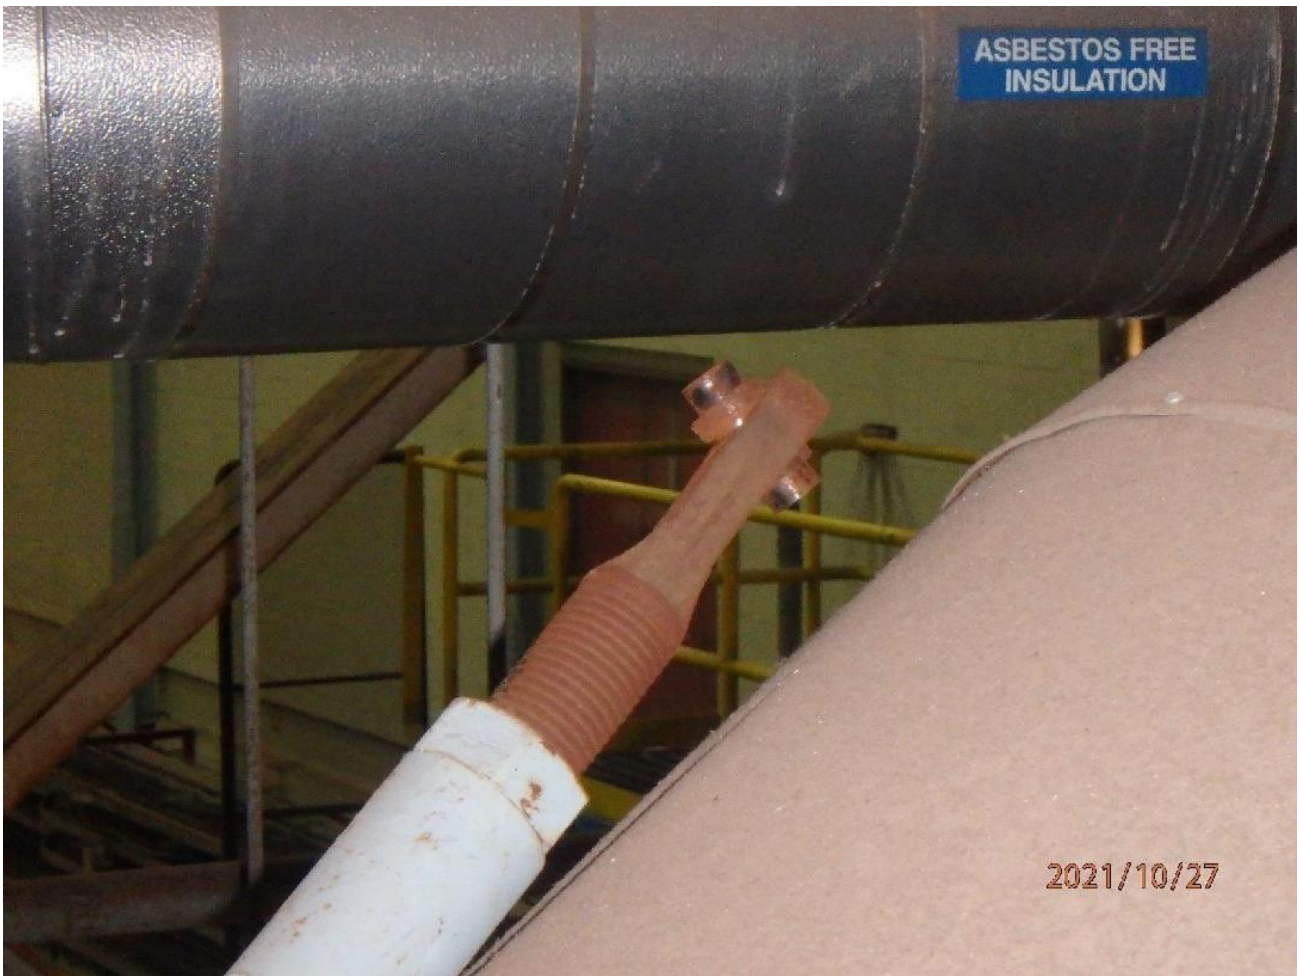
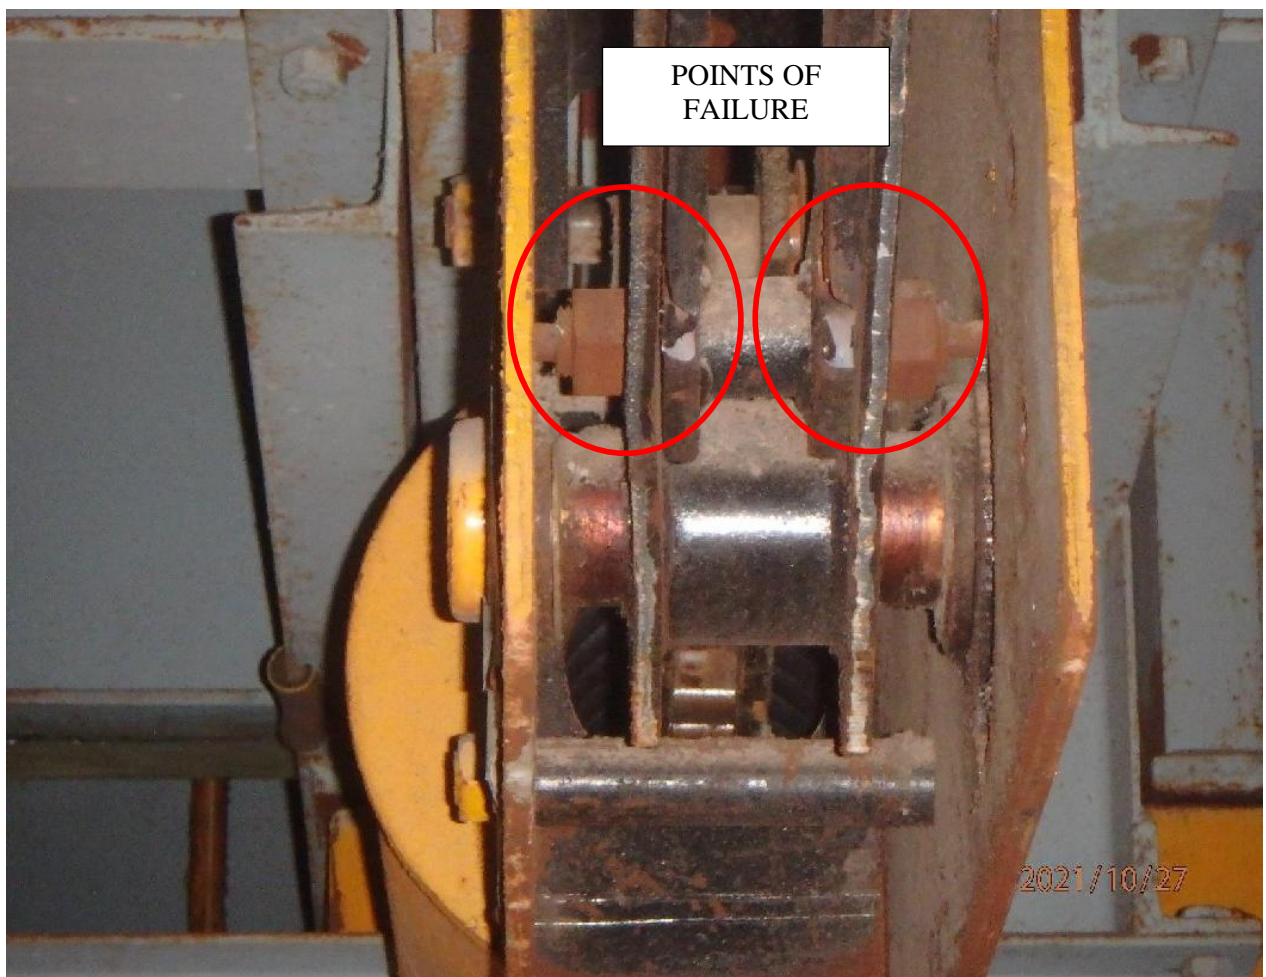
CRH Hanger CR14 failure (4th floor).

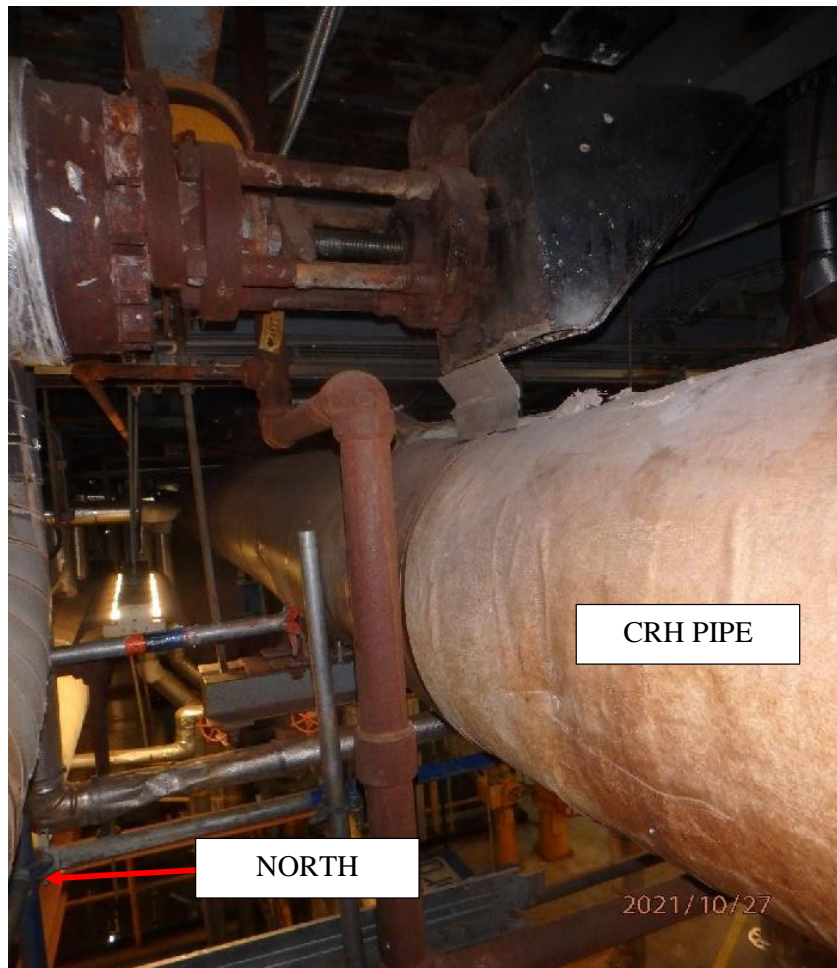
Location 17

CRH pipe contacted line # 1-HV-L125 (4th floor).

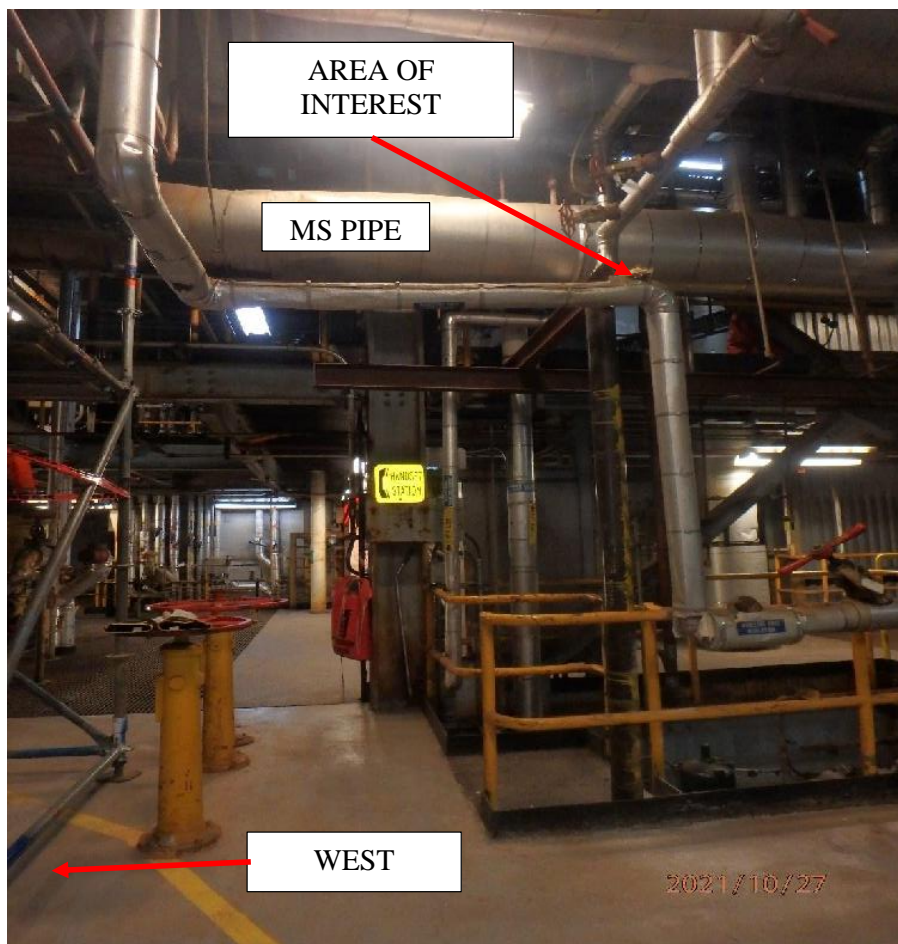
Location 18

Line # 1-HFW-L111 contacted support resulting in damaged insulation (3rd floor).

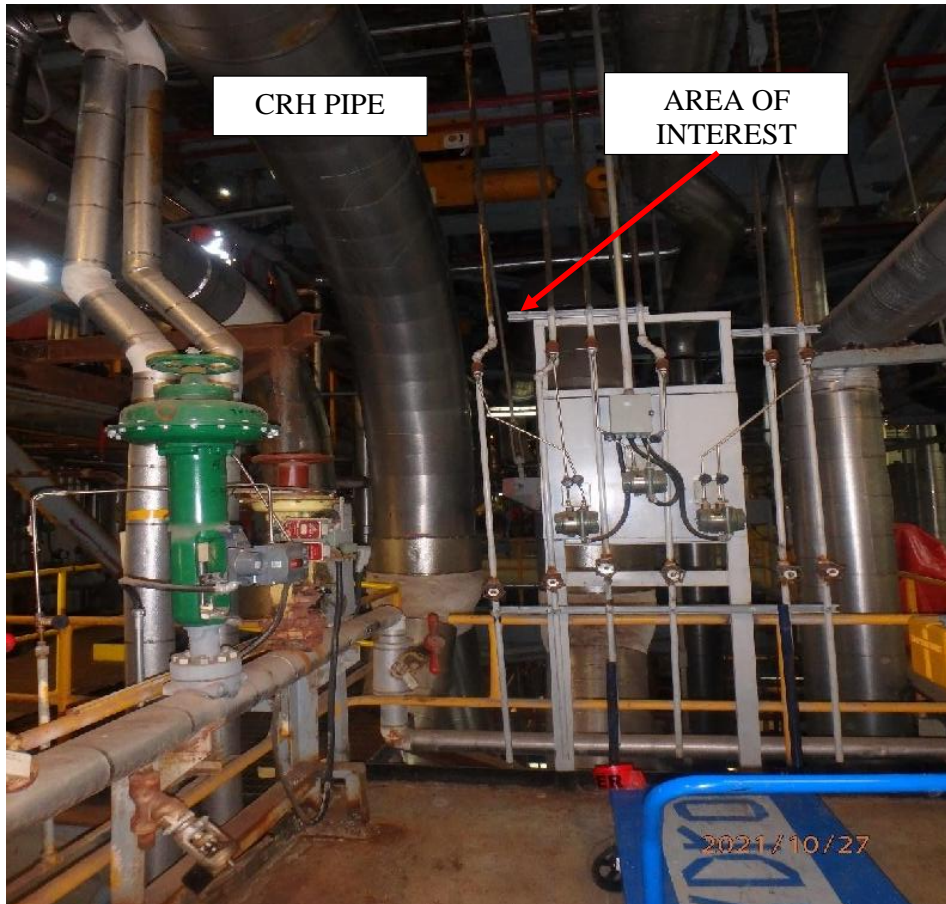
Location 19

#6 HP Heater level LT 1469 line removed from bracket and hanger rods distorted (3rd floor).

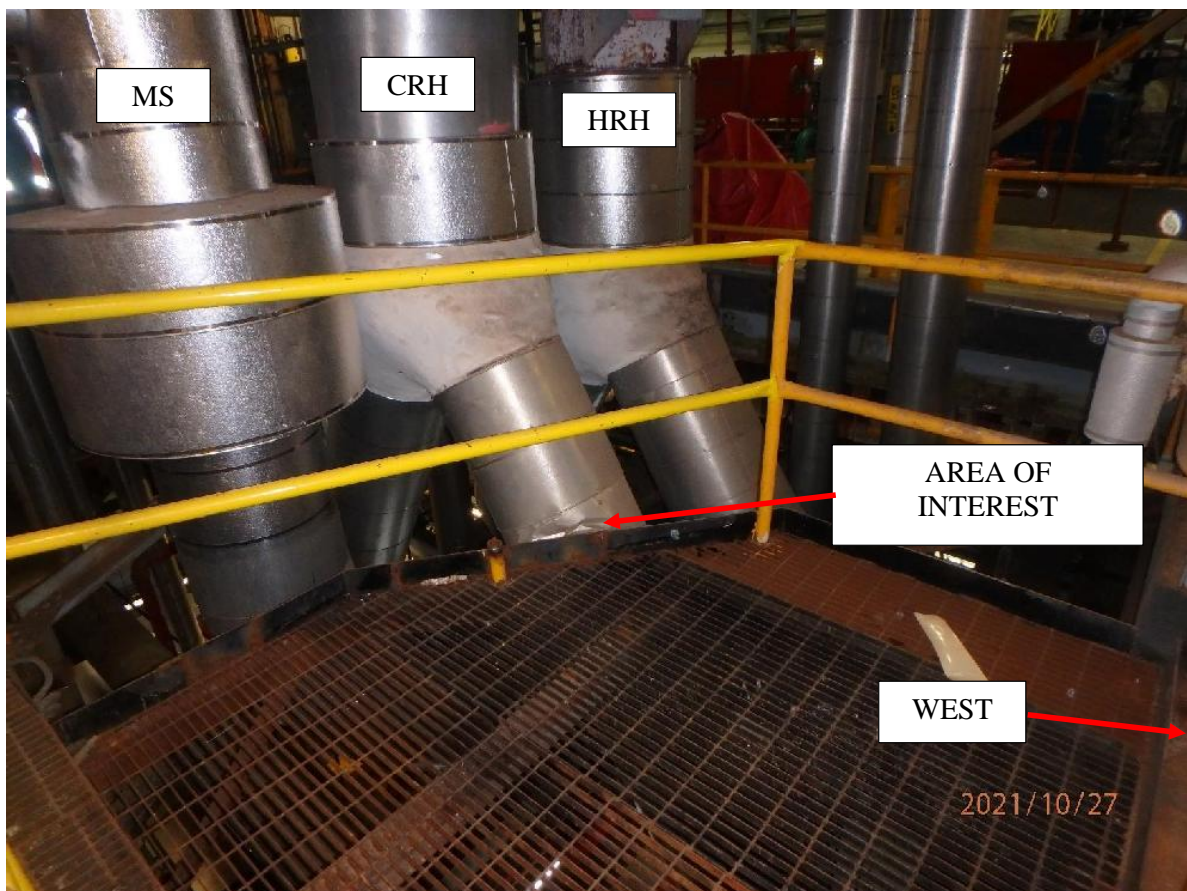
Location 20

West CRH pipe contacted access deck causing distortion to structural steel (3rd floor).

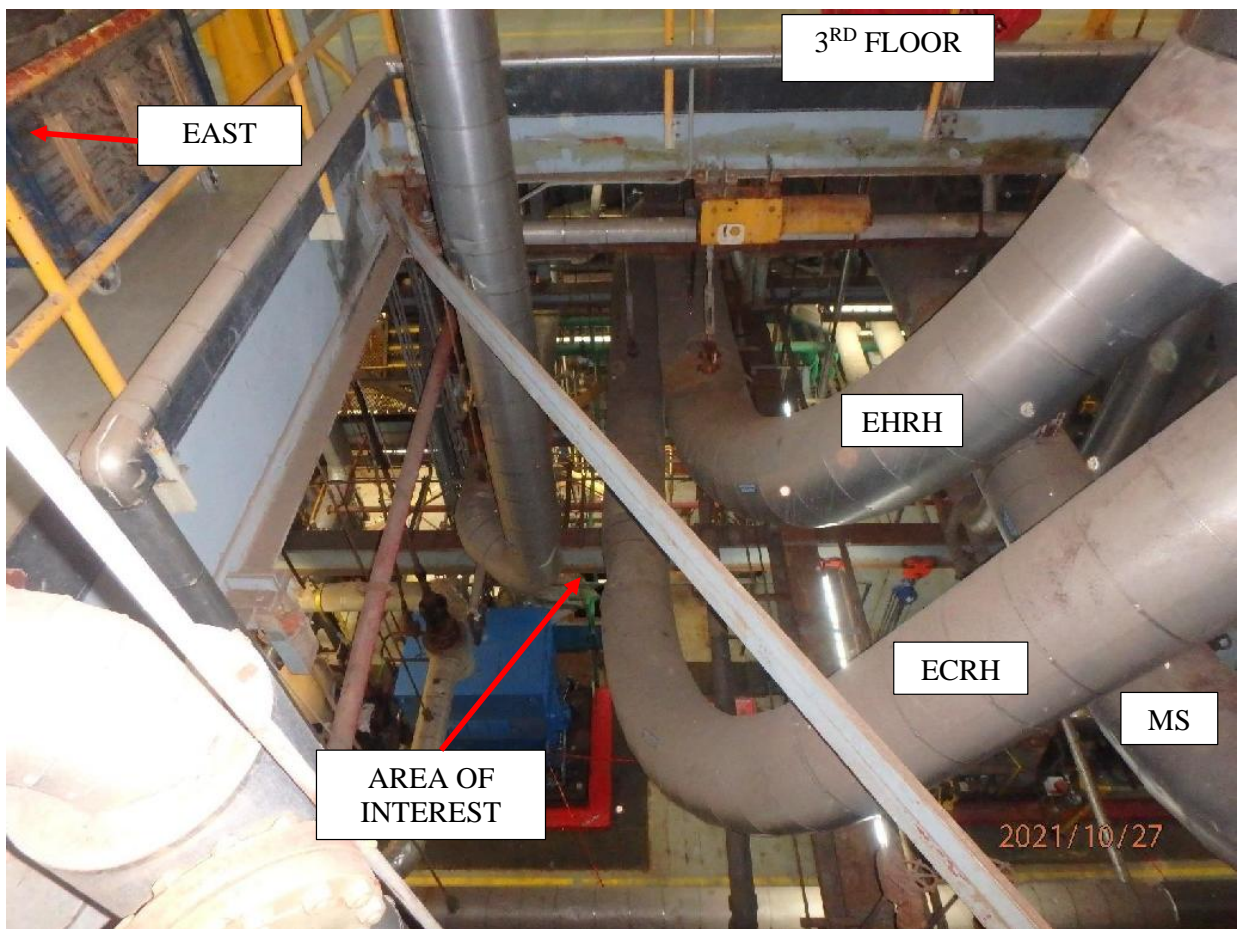
Location 21

East CRH pipe contacted line # 1-BS-02-L104 causing damage to insulation (2nd floor).

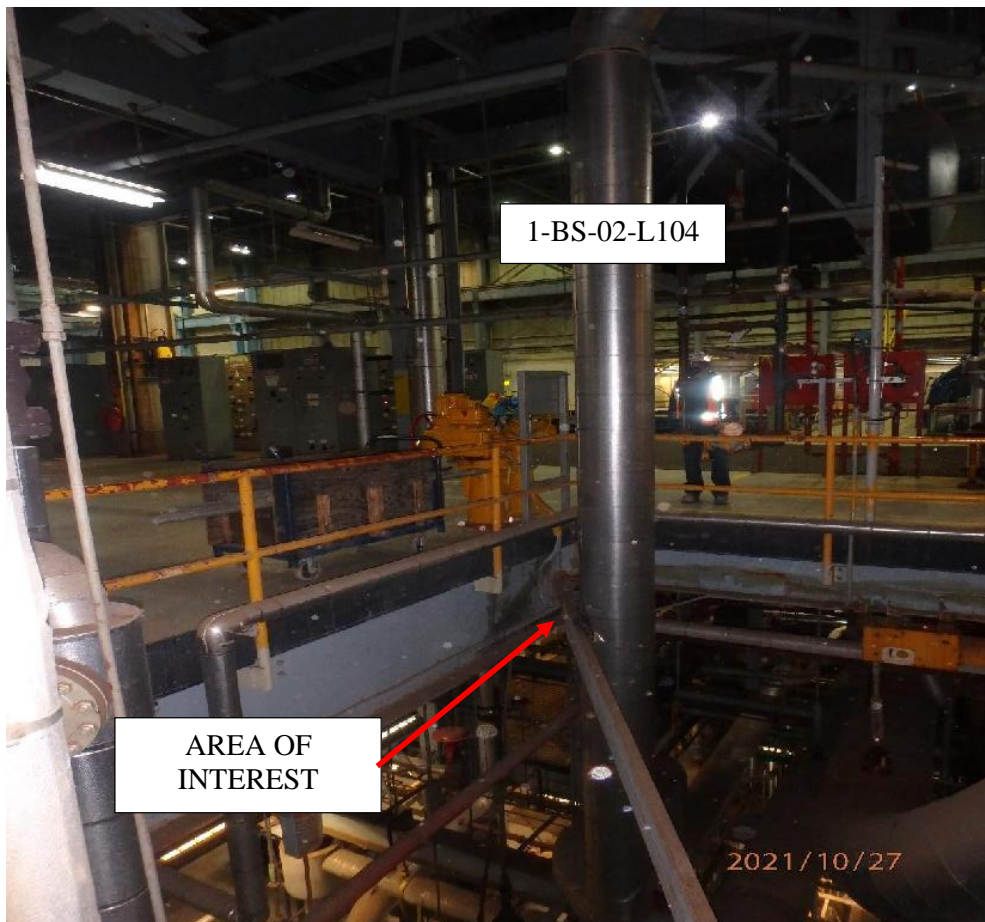
Location 22

Line # 1-BS-02-L104 contacted cross member causing distortion and damage to insulation (3rd floor).

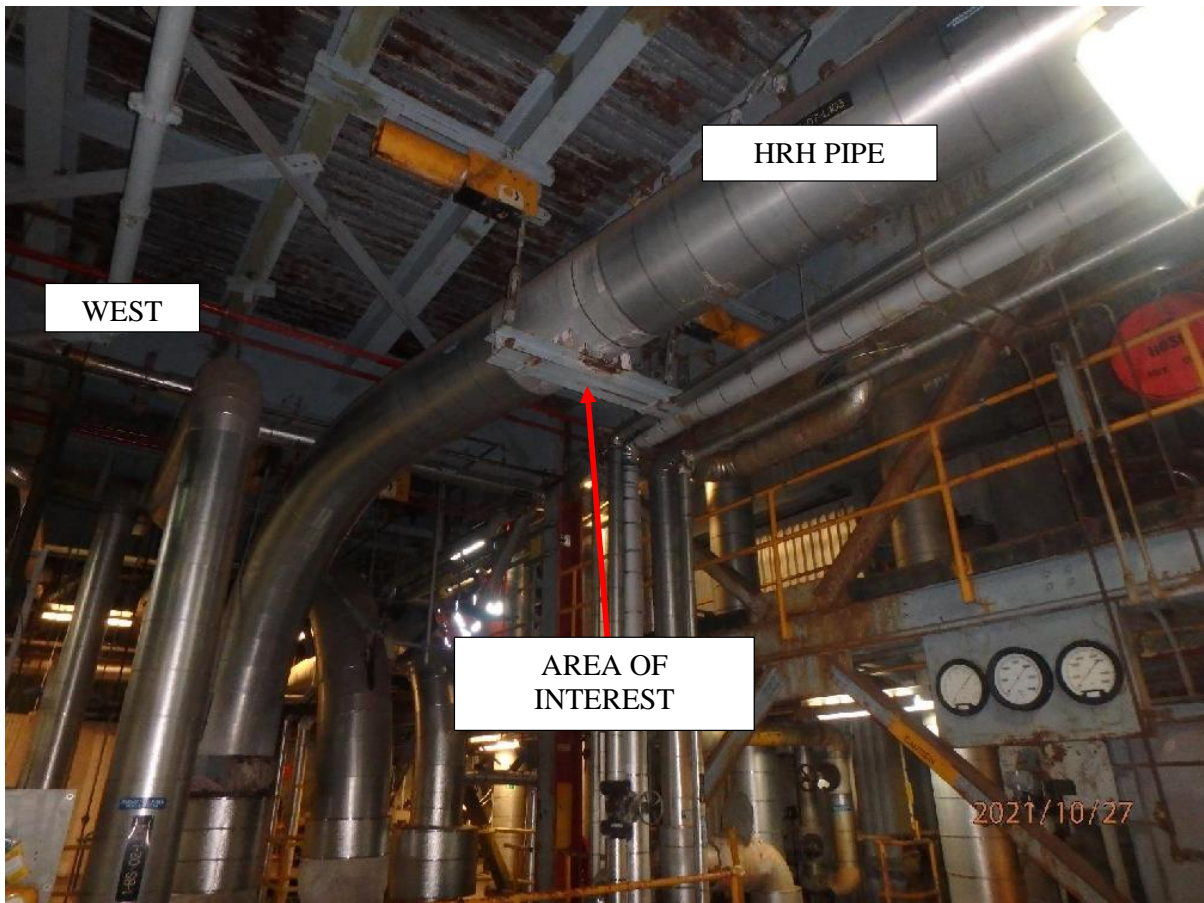
Location 23

HRH pipe hanger offset and rods not plum (3rd floor).

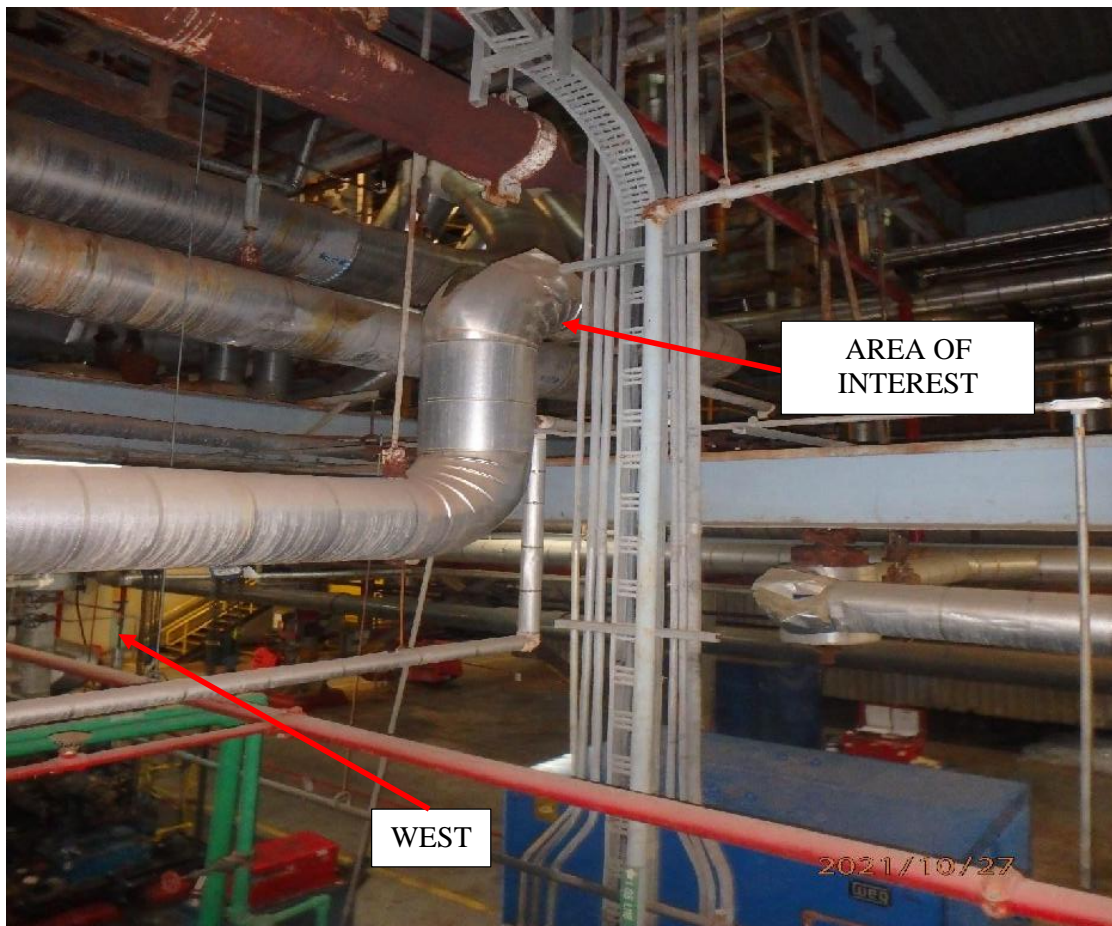
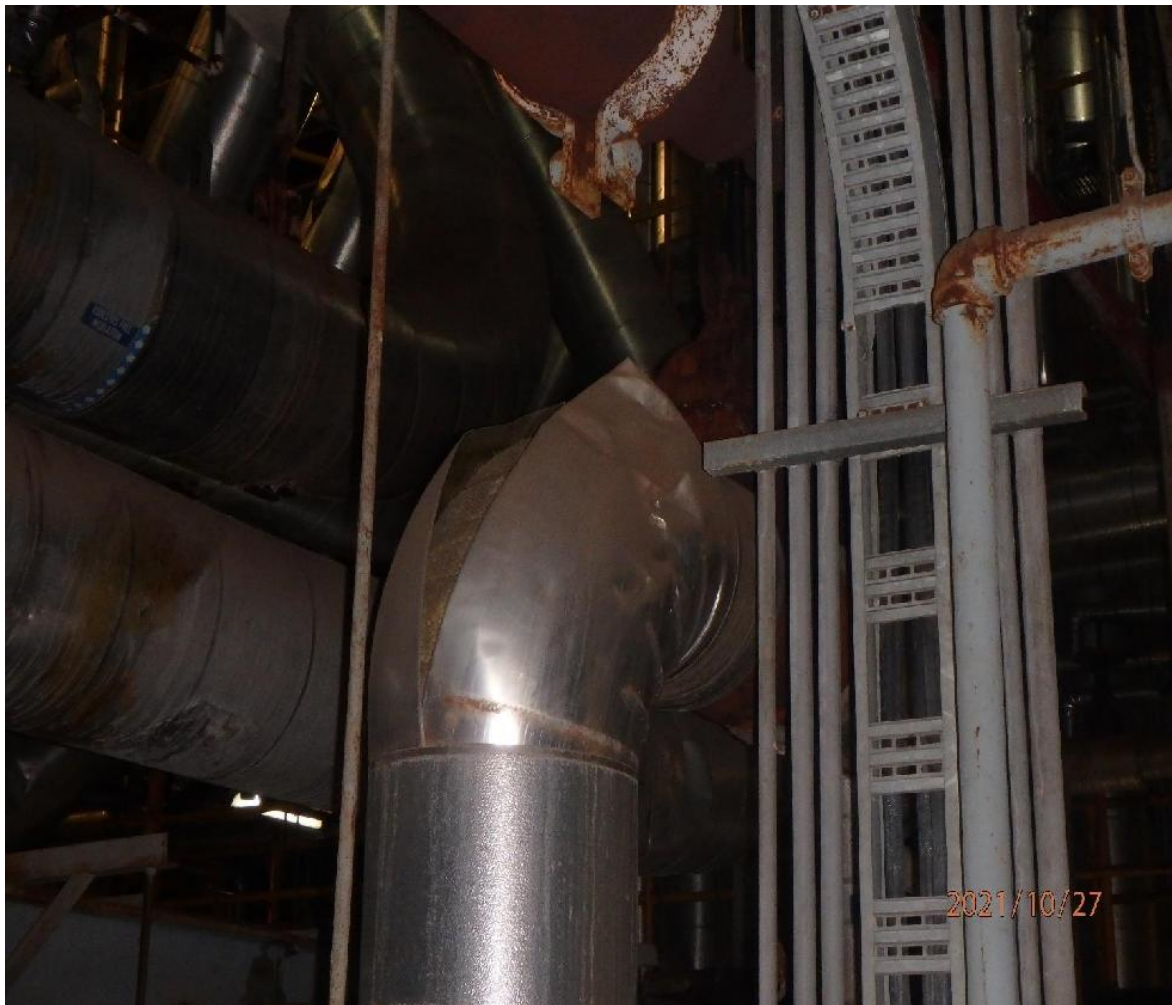
Location 24

Line # 1-BS-02-L104 contacted cable tray support bracket resulting in damage to insulation (2nd floor).

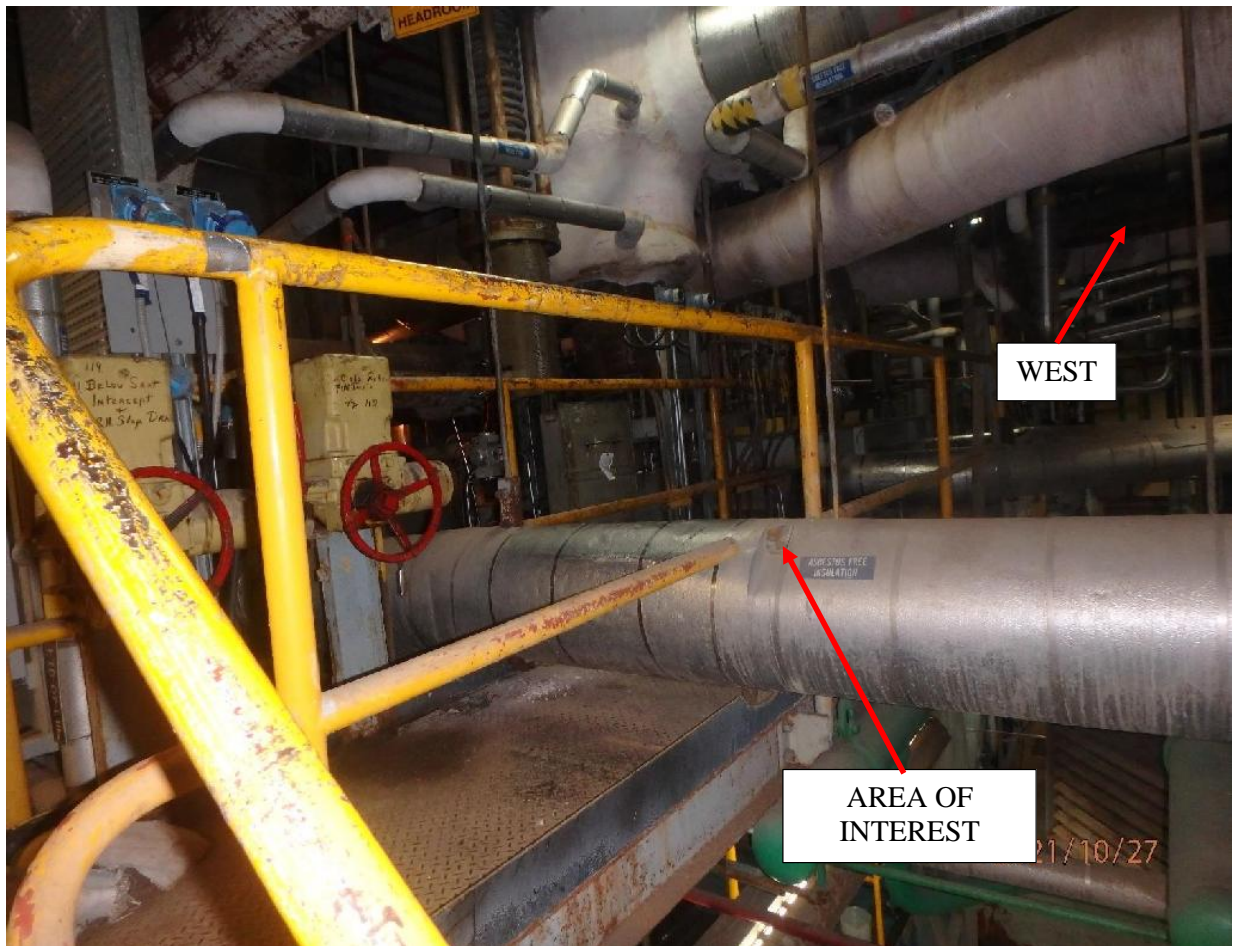
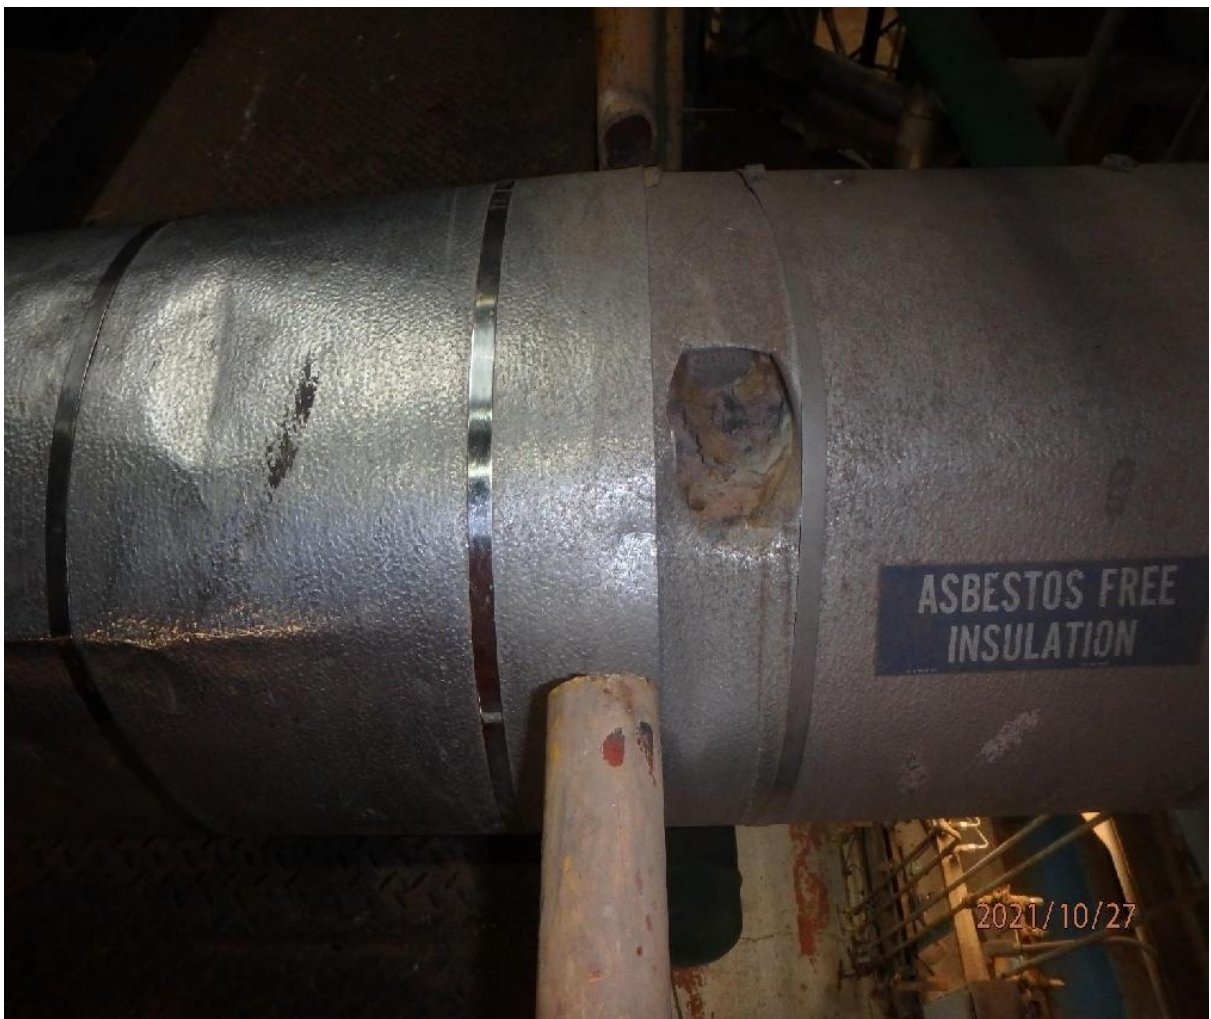
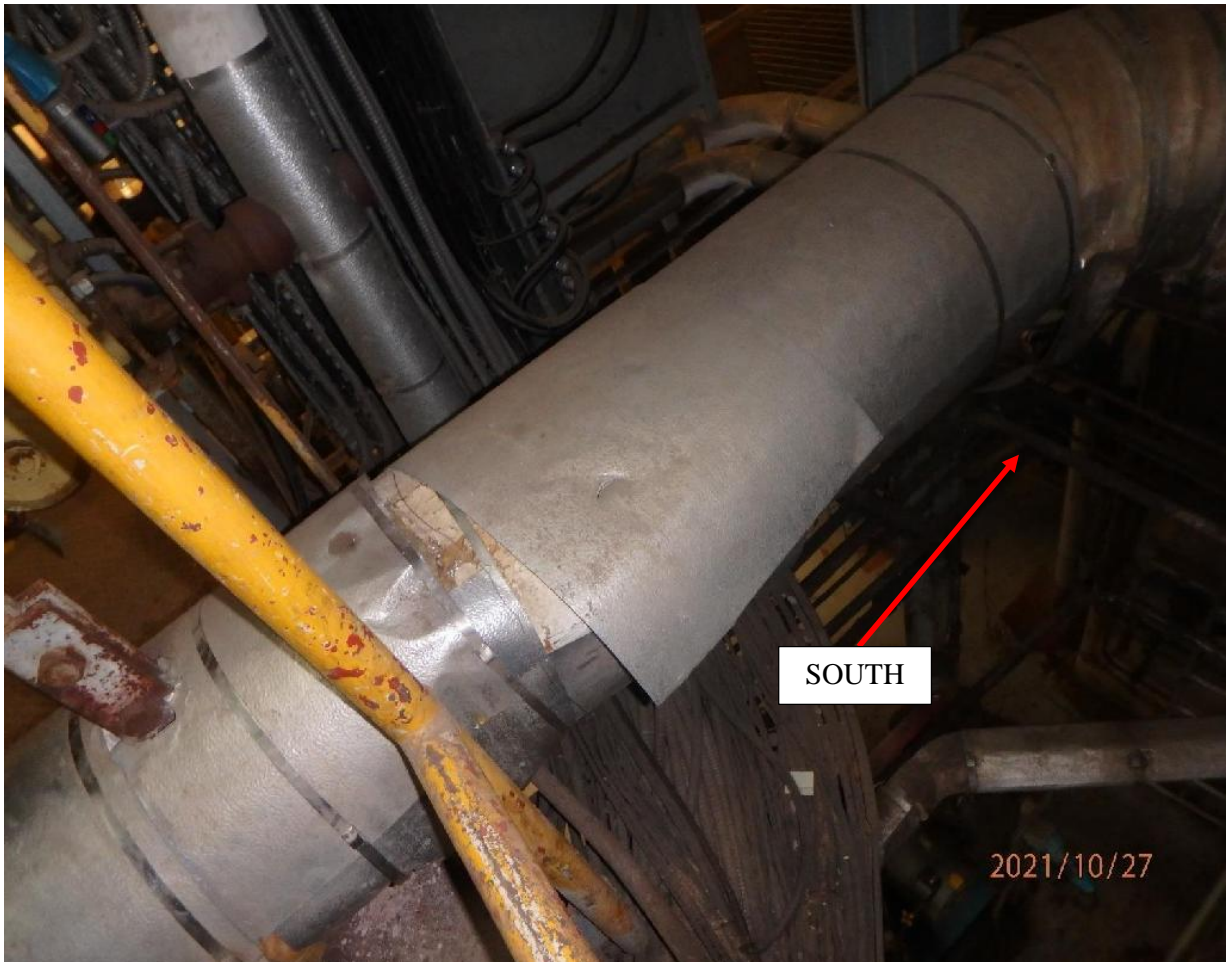
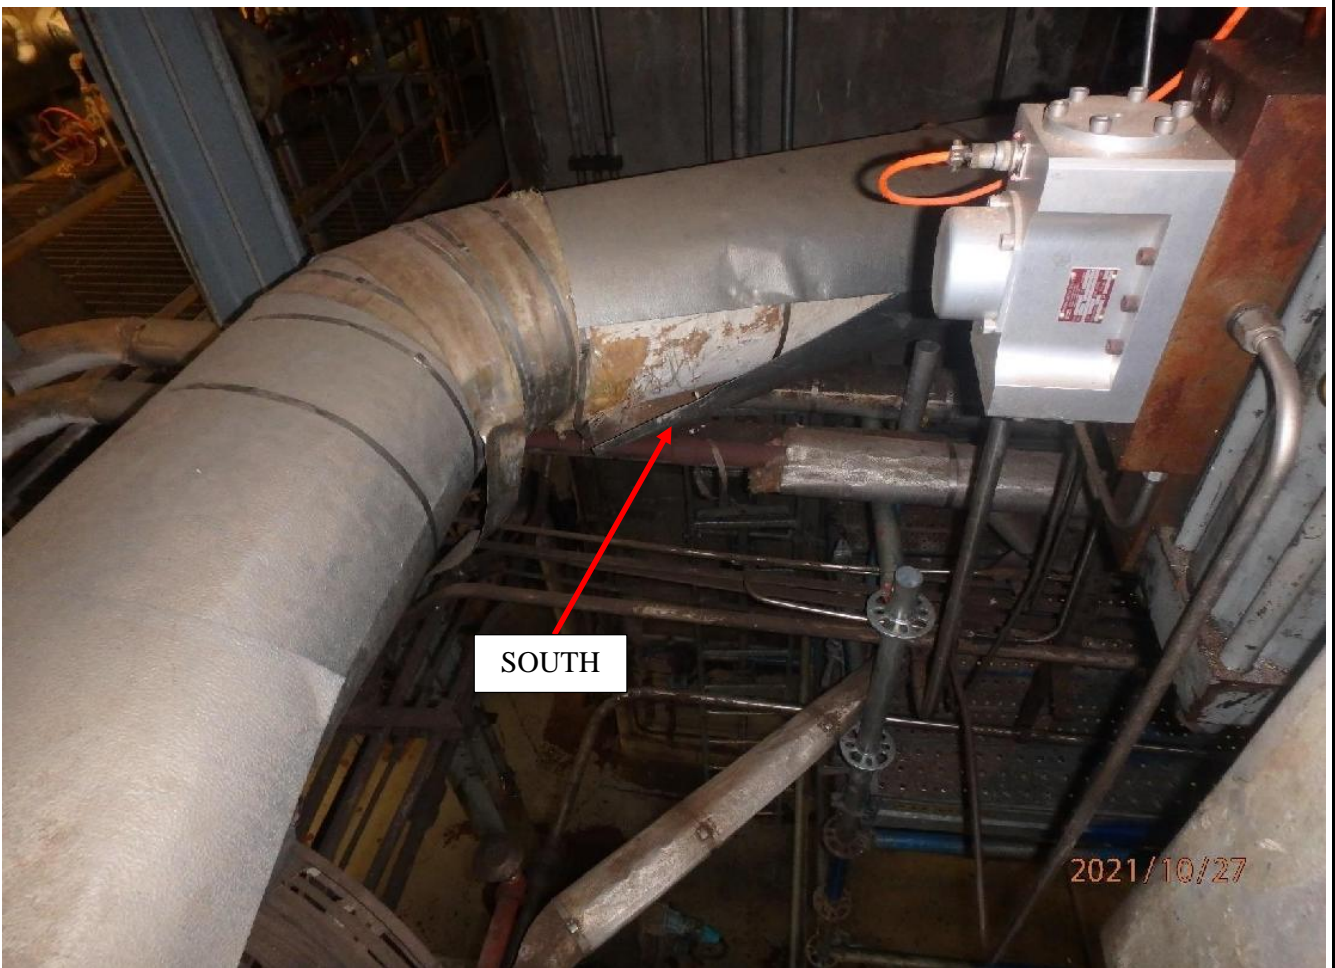
Location 25

Line # 1-BS-02-L-104 contacted handrail resulting in damage to insulation (2nd floor).

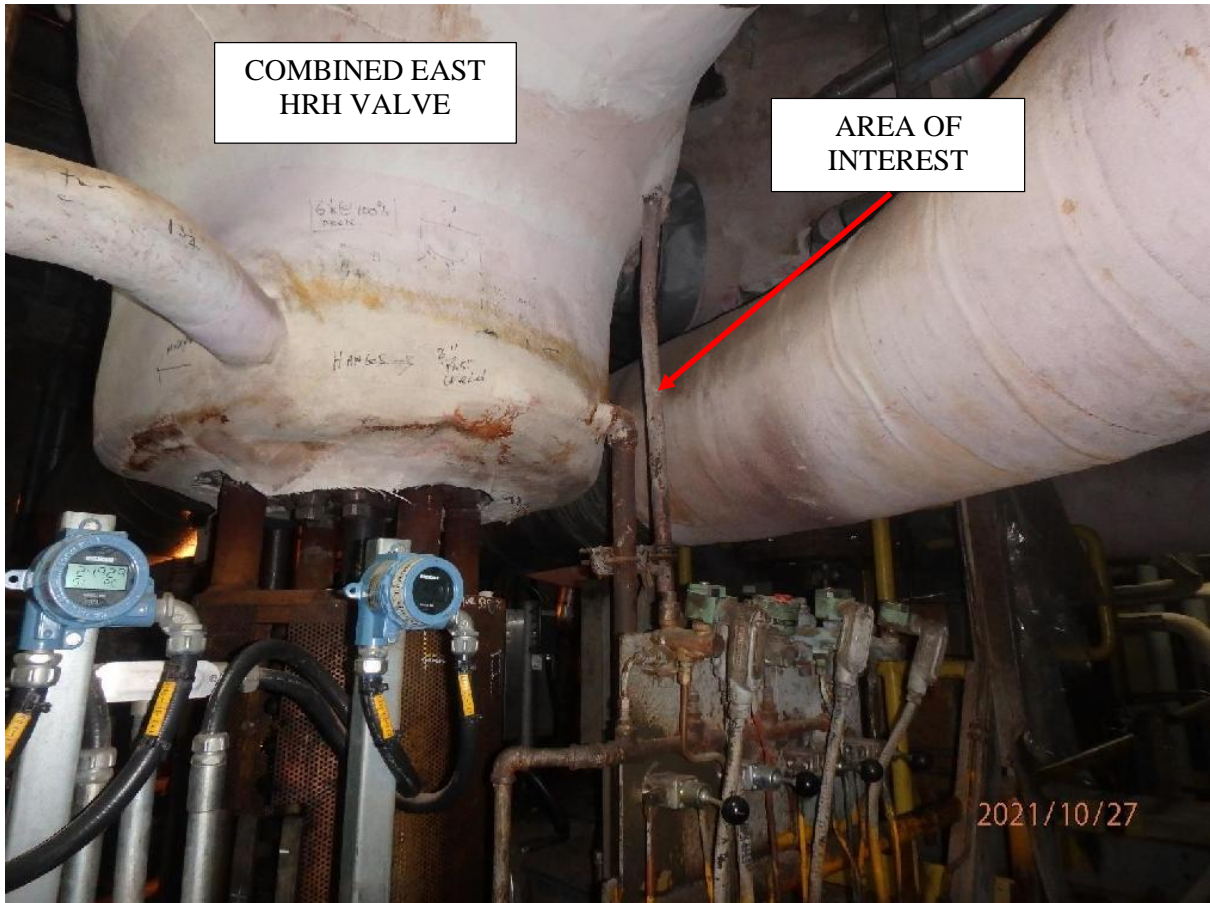
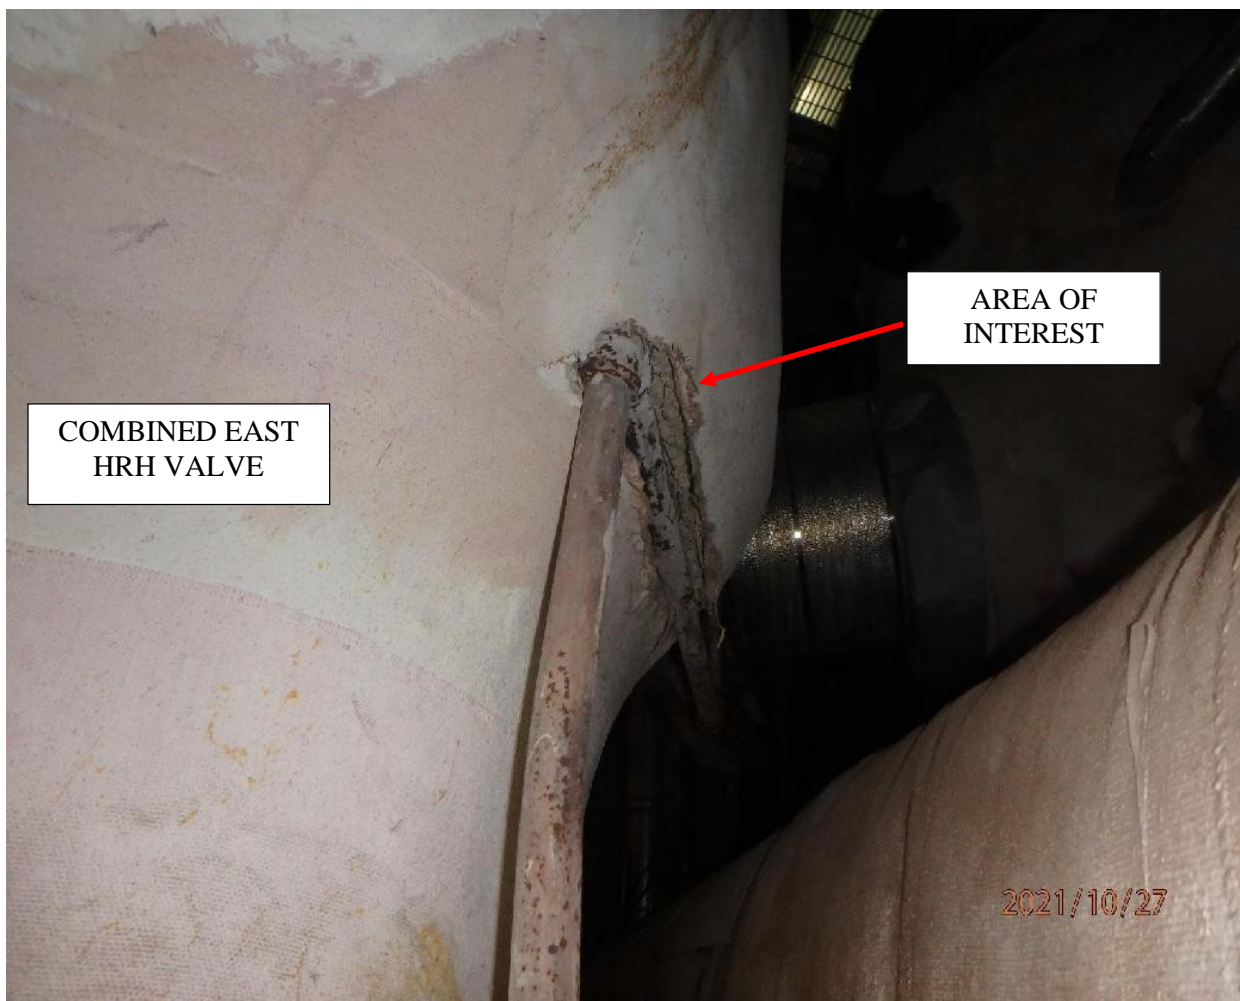
Location 26

East CRH pipe appeared to have contacted drain line causing distortion and insulation damage (2nd floor).
