Re: Holyrood Thermal Generating Station Unit 1 – Root Cause Investigation Report

Holyrood Thermal Generating Station Root Cause Investigation

Unit 1 – Cold Reheat Piping Support Failure

December 2021

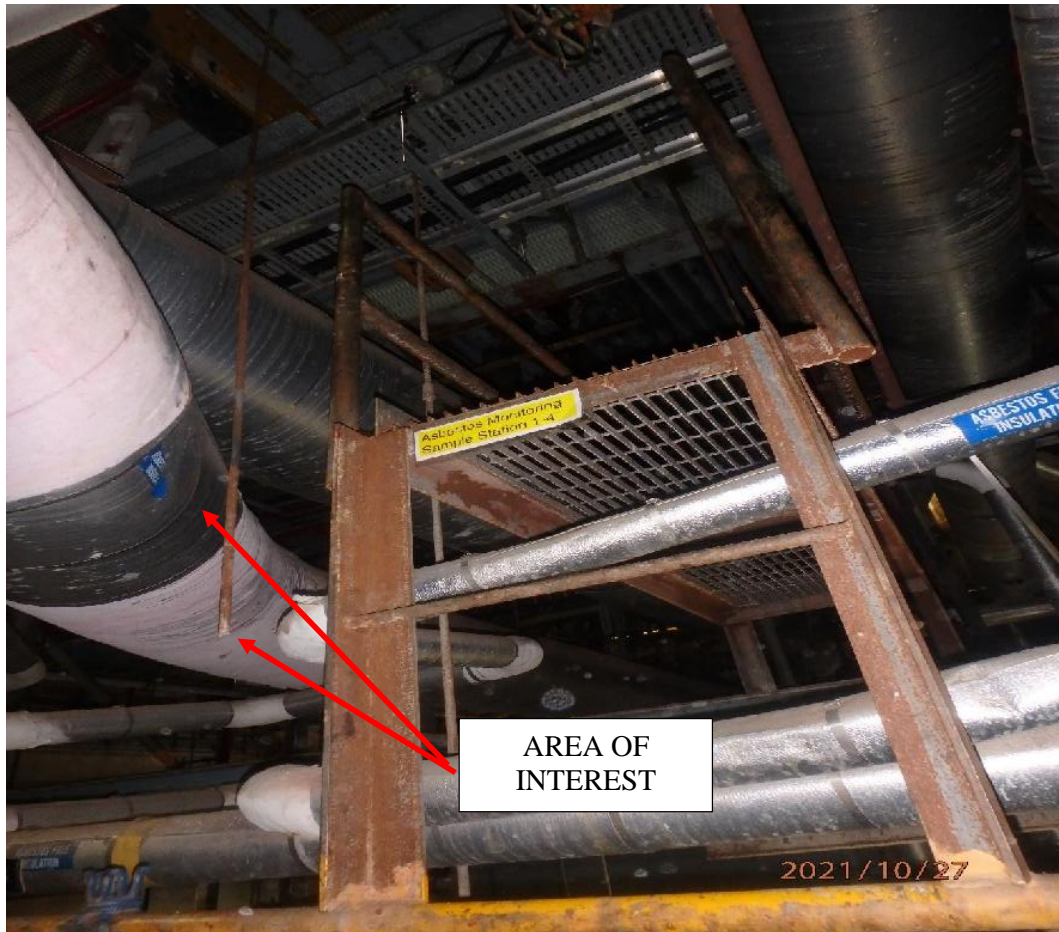
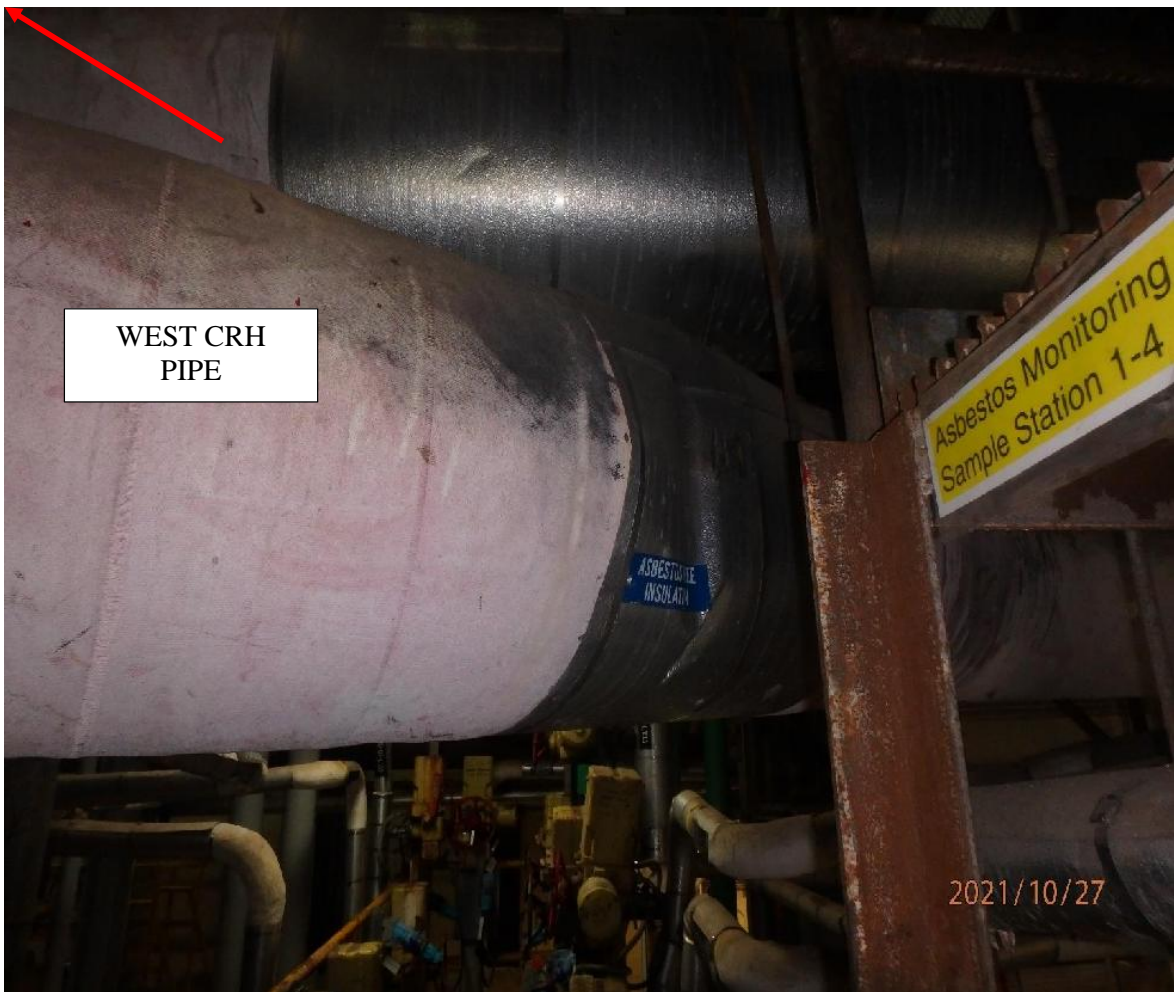
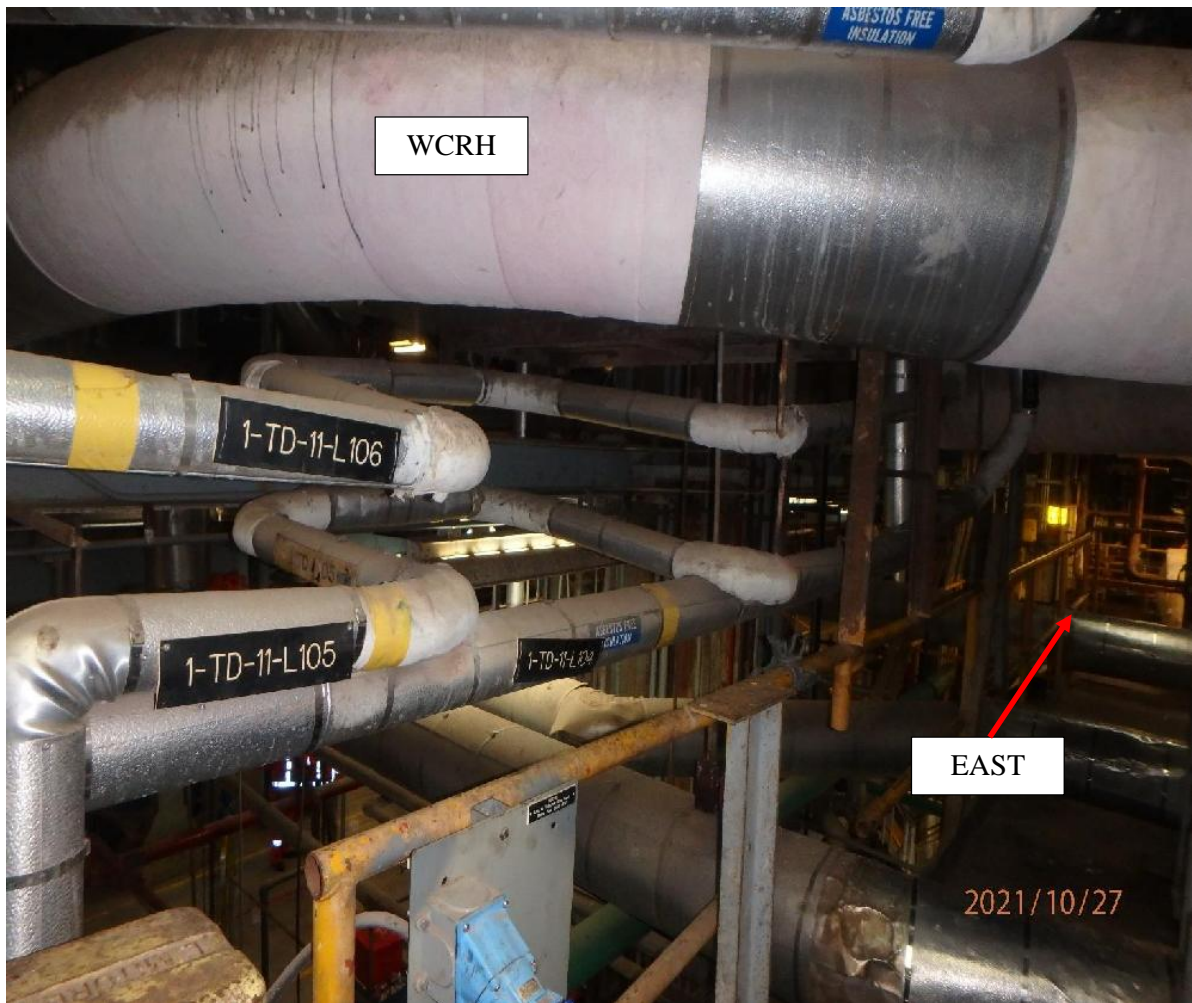
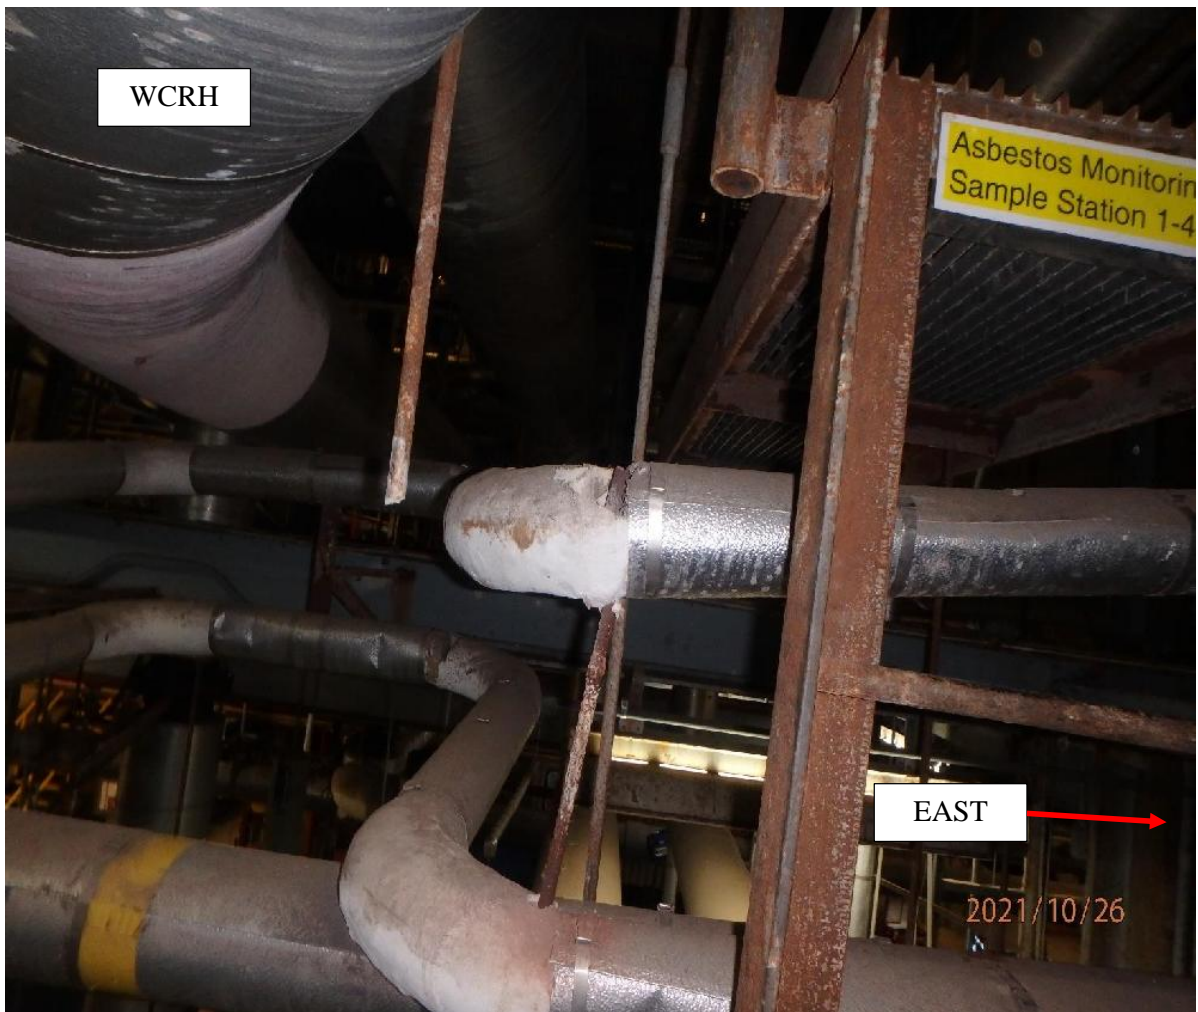
Location 27

West CRH pipe contacted line #'s 1-TD-11-L105 & L106 hanger rods and walkway resulting in broken hanger rods and damaged insulation (2nd floor).

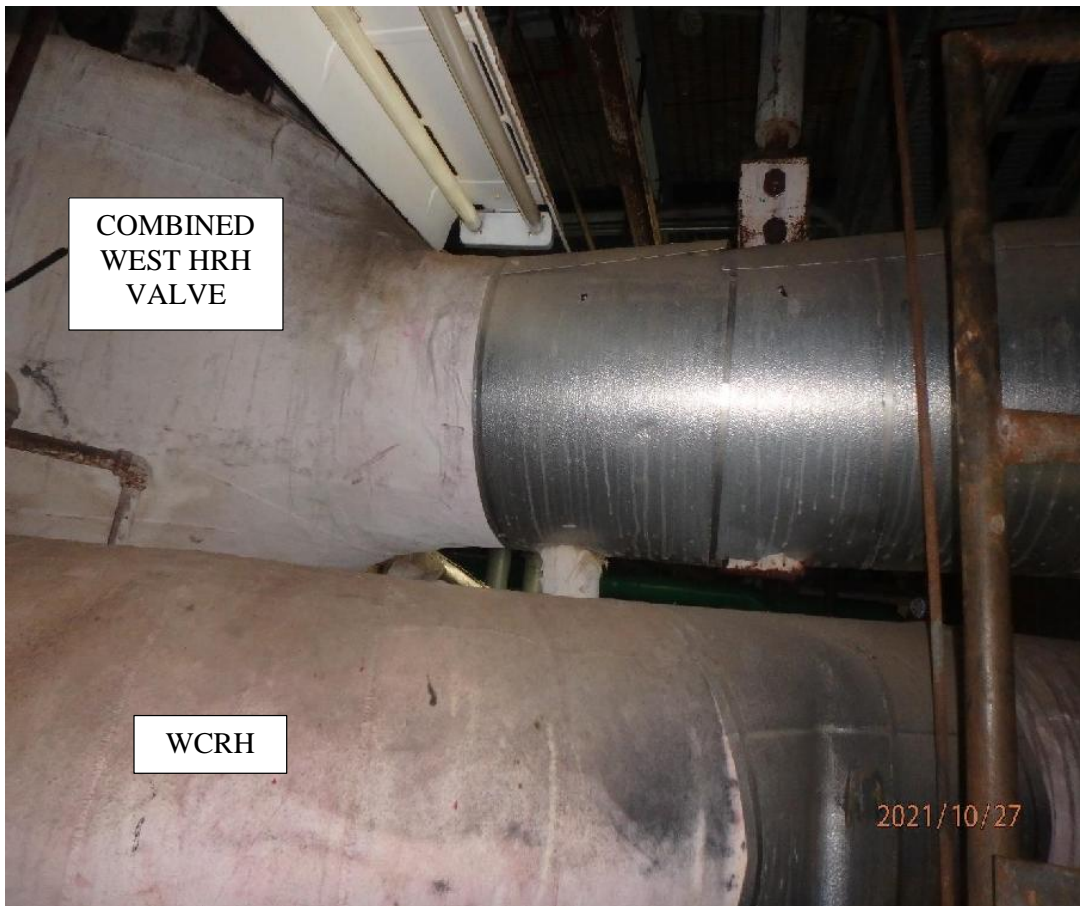
Location 28

West CRH pipe contacted West HRH pipe and drain lines (2nd floor).

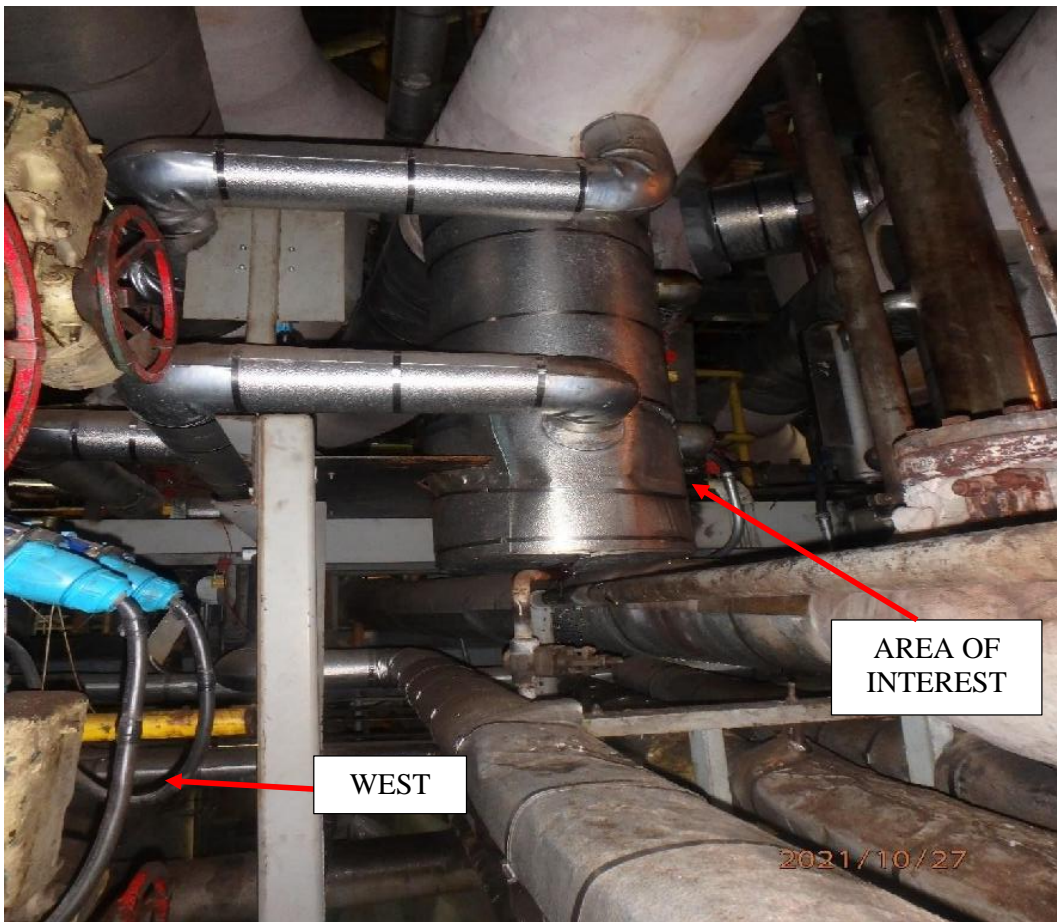
Location 29

West CRH condensate drain pot leak (2nd floor under turbine).

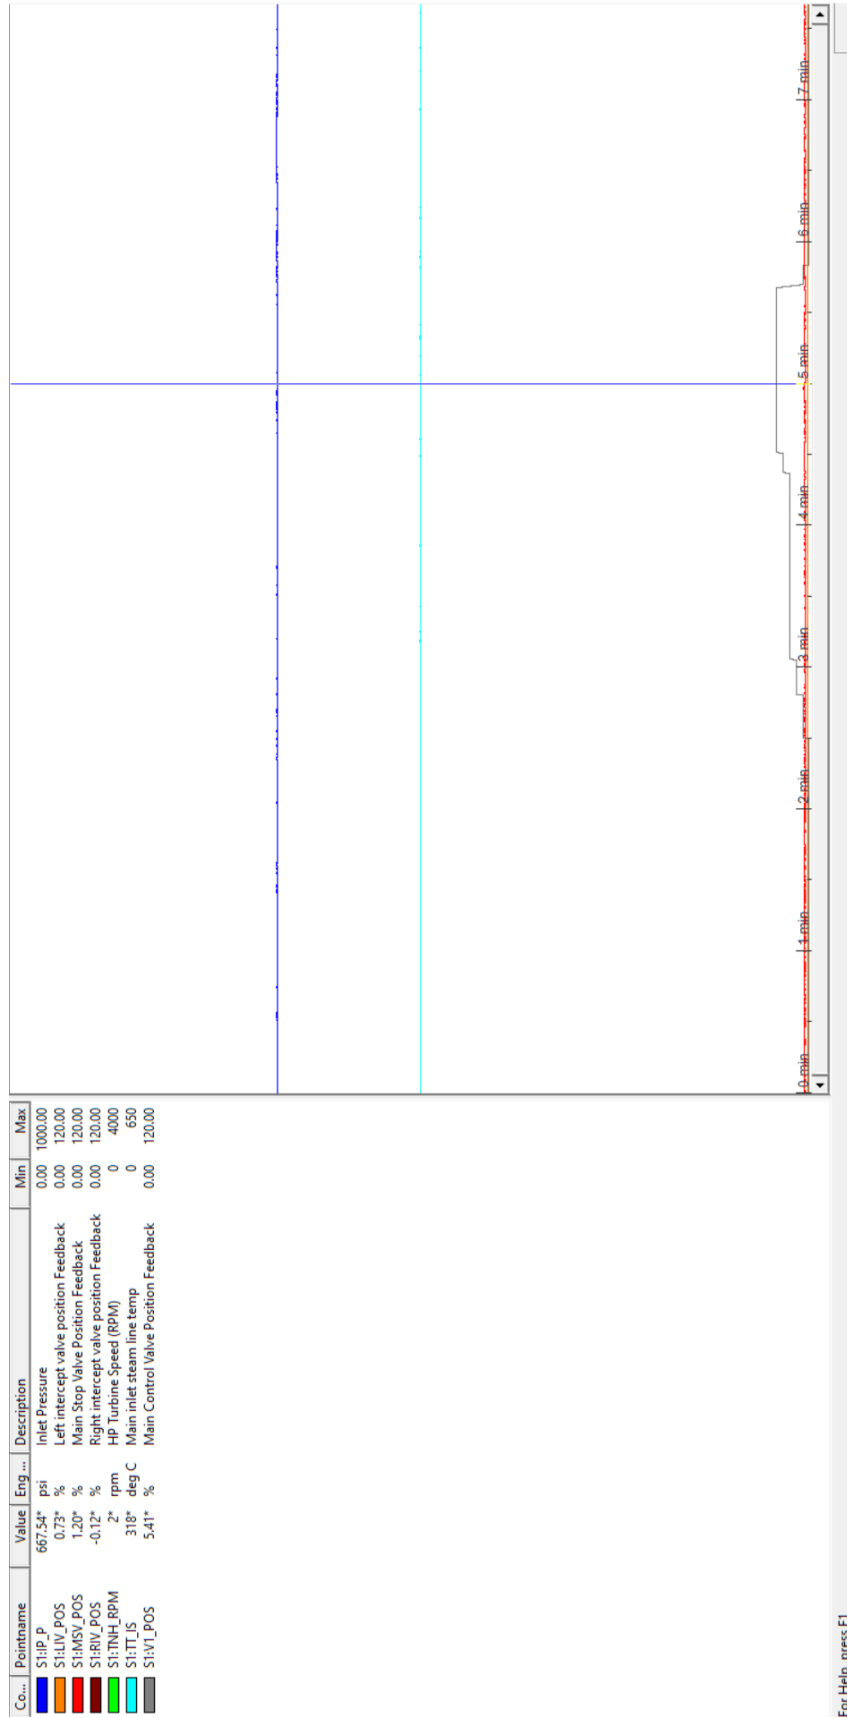
Figure 1: Step 0 – Main Stop Valve Steam Seal Test

Checked Inlet Pressure and Turbine speed for any indication of Steam Leak, confirmed no steam leak by observing delta inlet pressure of Zero (0) psi

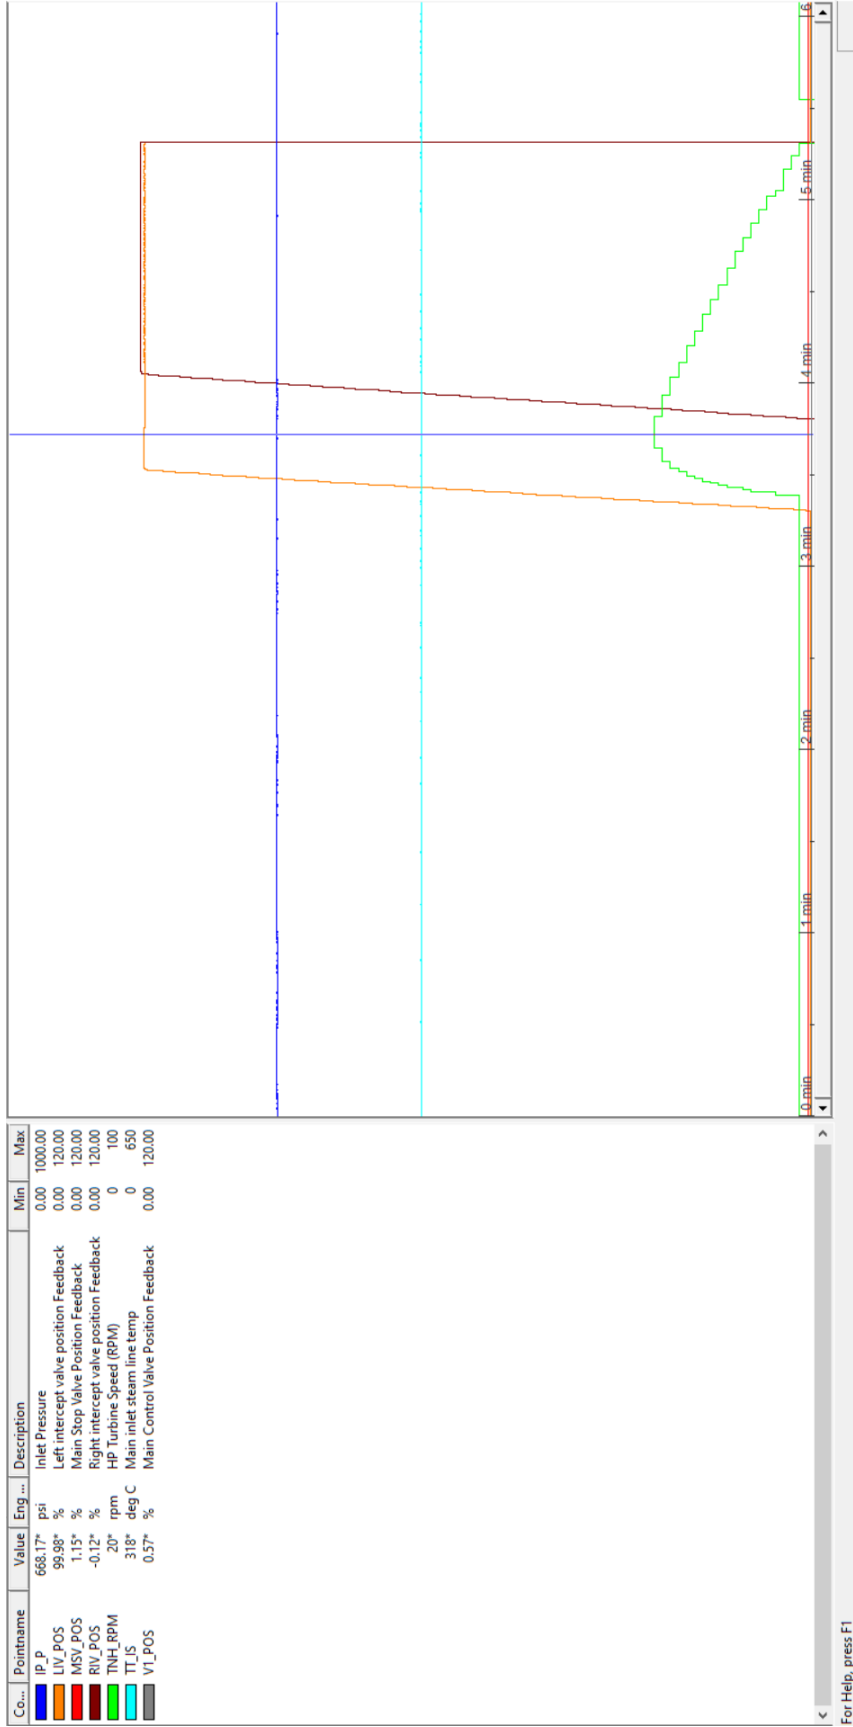
Figure 3: Step 1 – Manually Open LIV then RIV Step 1

Checked Inlet Pressure and Turbine speed for any indication of Steam Leak, confirmed no steam leak by observing delta inlet pressure of Zero (0) psi

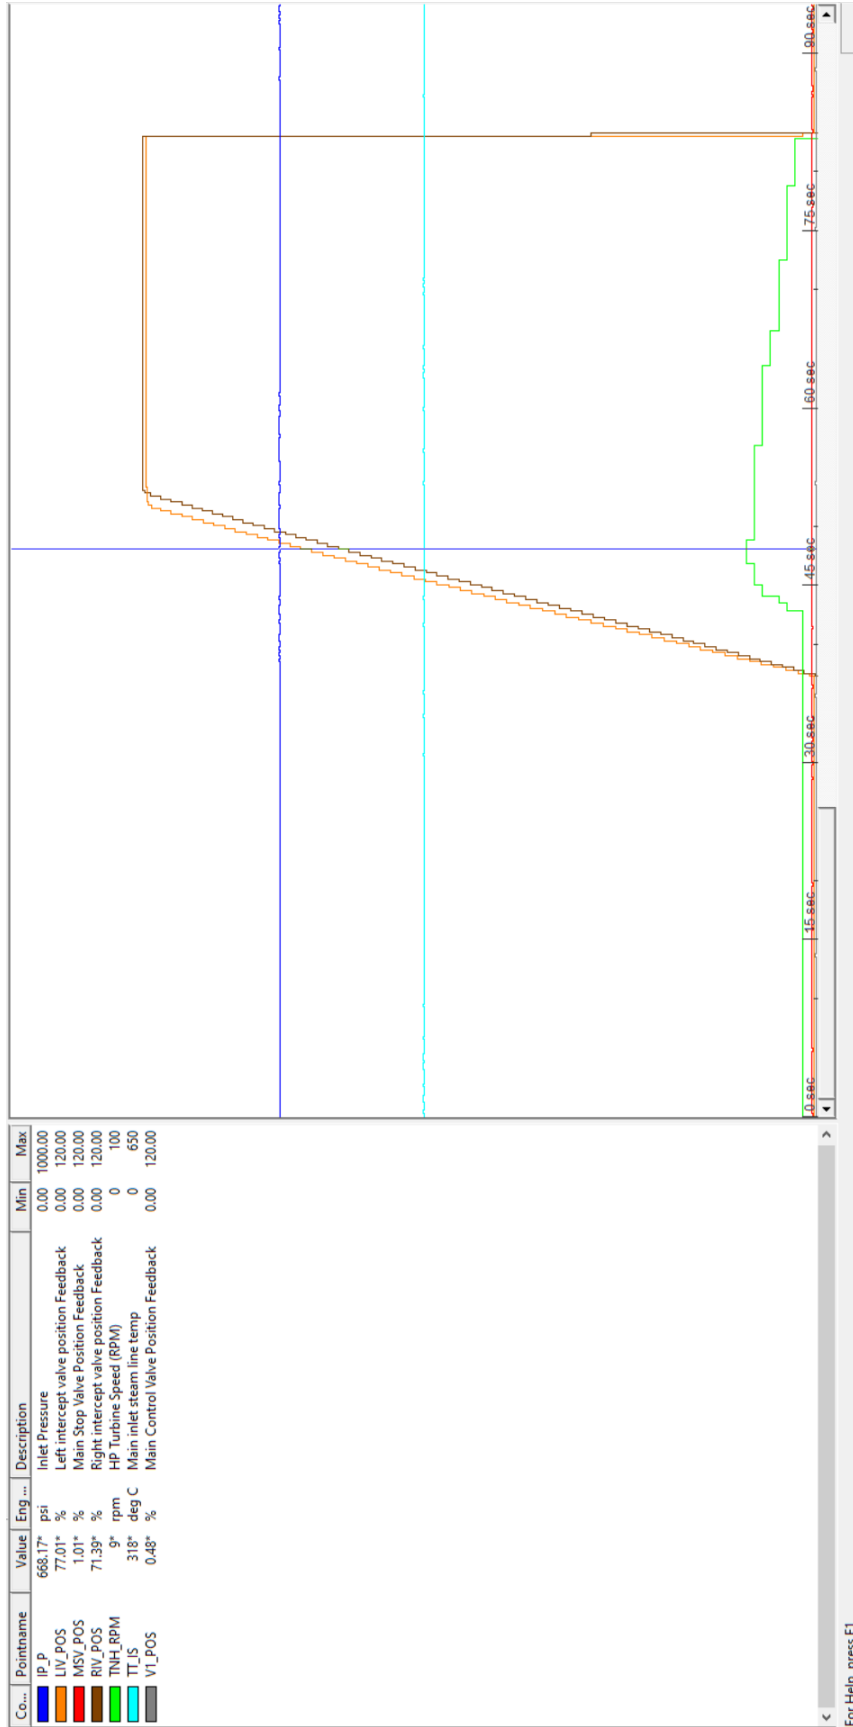
Figure 5: Step 2 – Automatically Open LIV and RIV

Checked Inlet Pressure and Turbine speed for any indication of Steam Leak, confirmed no steam leak by observing delta inlet pressure of Zero (0) psi

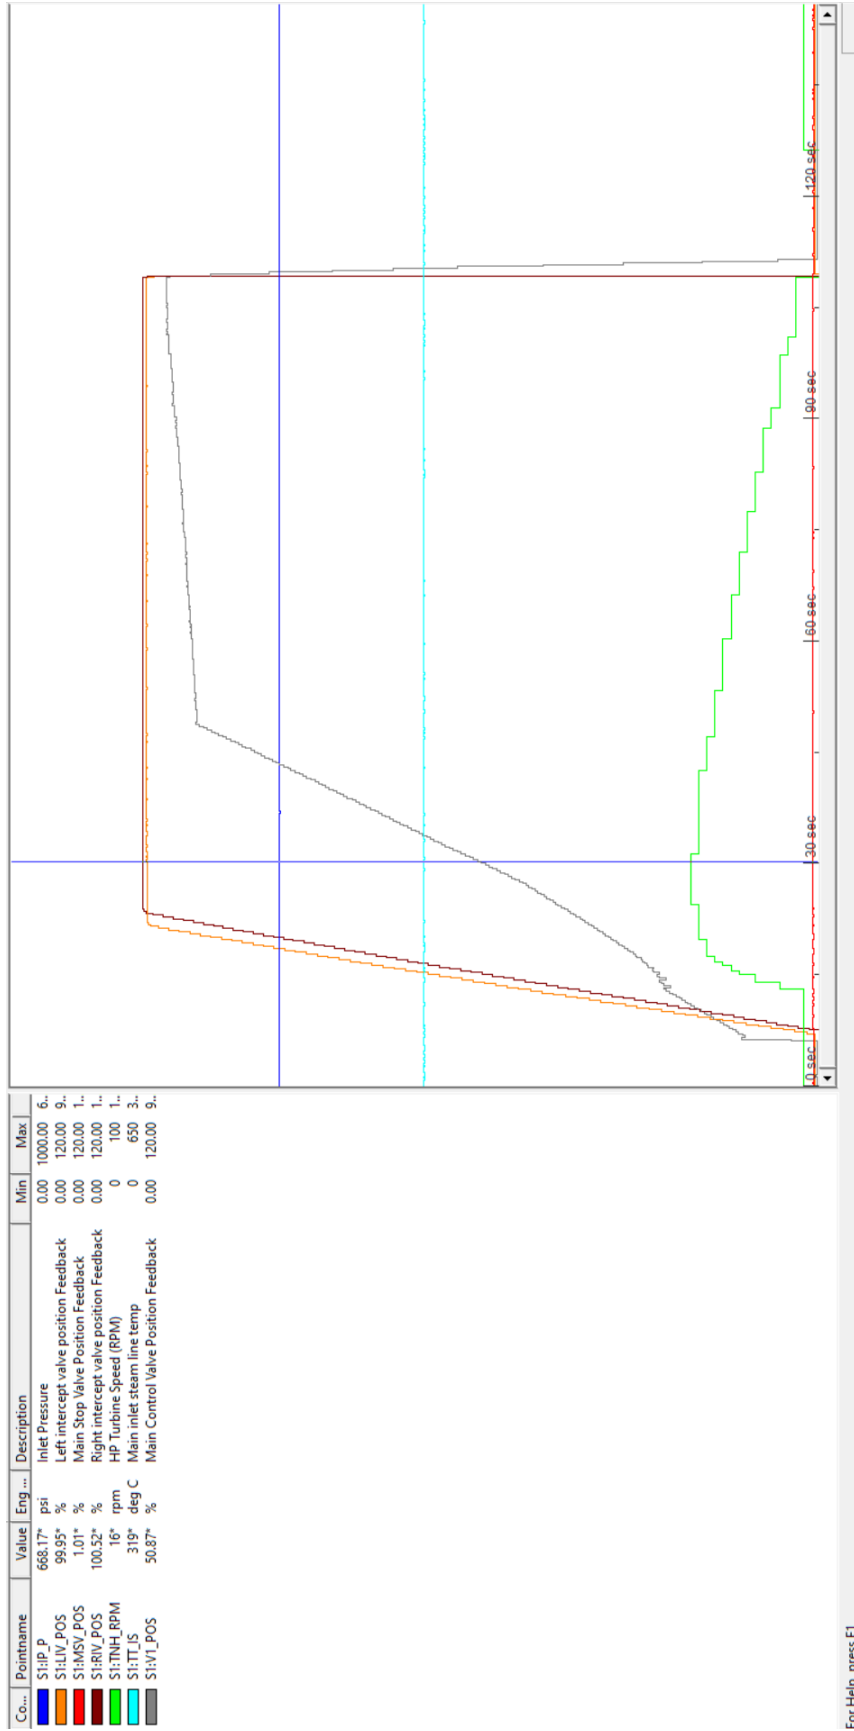
Figure 7: Step 3 – Normal Operation - All Valves on Auto Mode

Checked Inlet Pressure and Turbine speed for any indication of Steam Leak, confirmed no steam leak by observing delta inlet pressure of Zero (0) psi between valves and at MCV 50% where Turbine Speed at 16 RPM

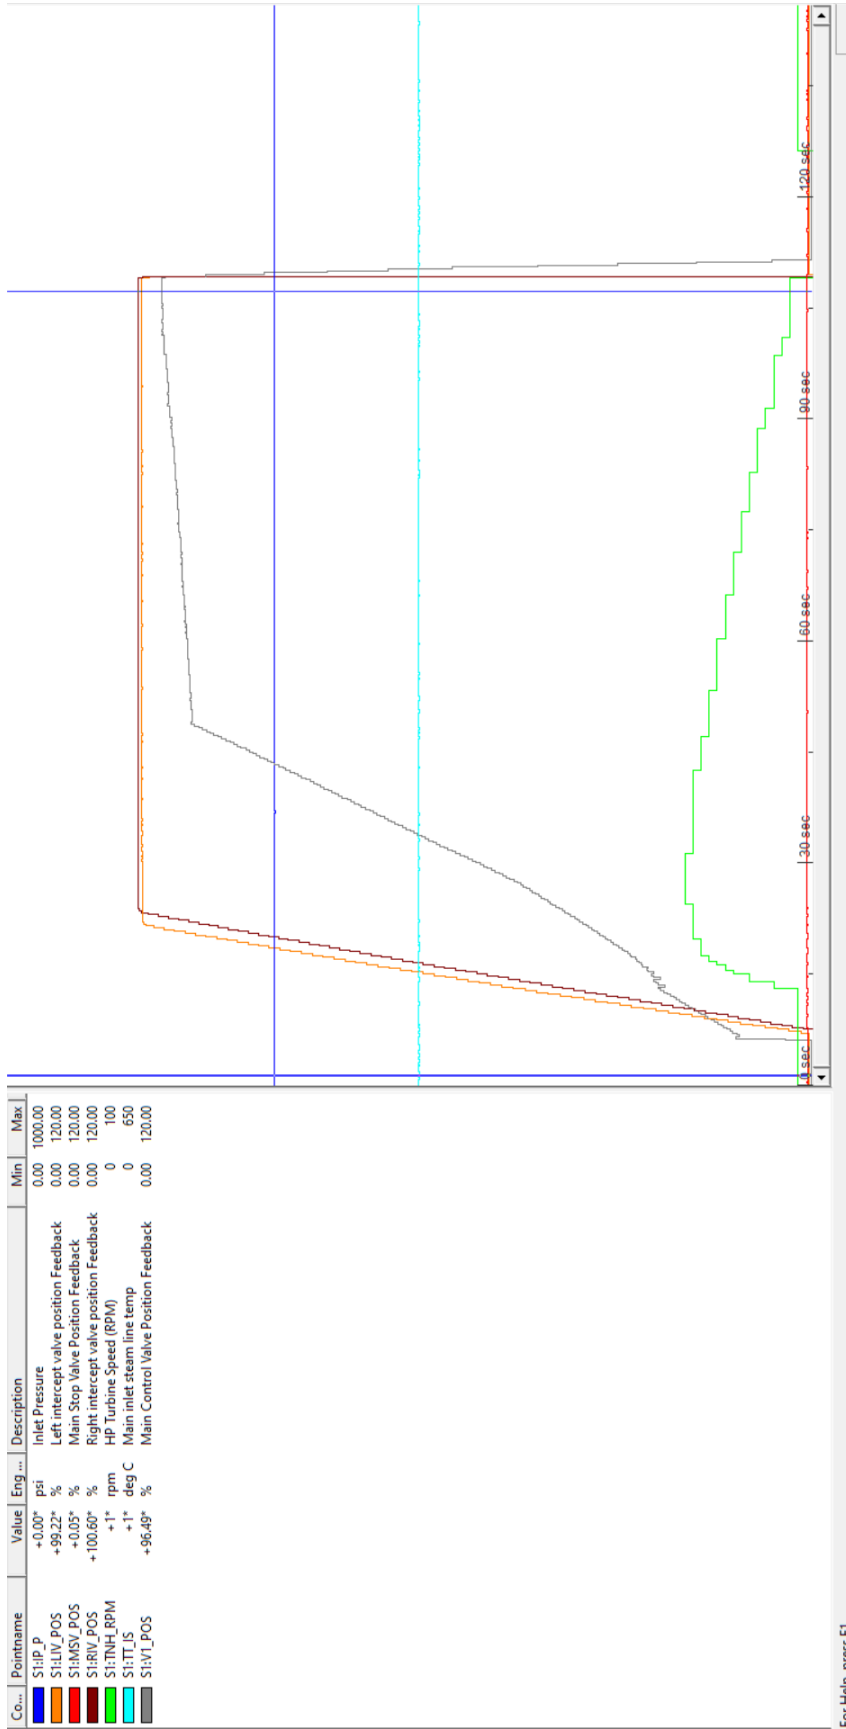
Figure 9: Step 3 – Normal Operation - MCV Valve Full Open - No Change in inlet pressure

Checked Inlet Pressure and Turbine speed for any indication of Steam Leak, confirmed no steam leak by observing delta inlet pressure of zero (0) psi between valves and at MCV 100% where Turbine Speed settled down to 3 RPM

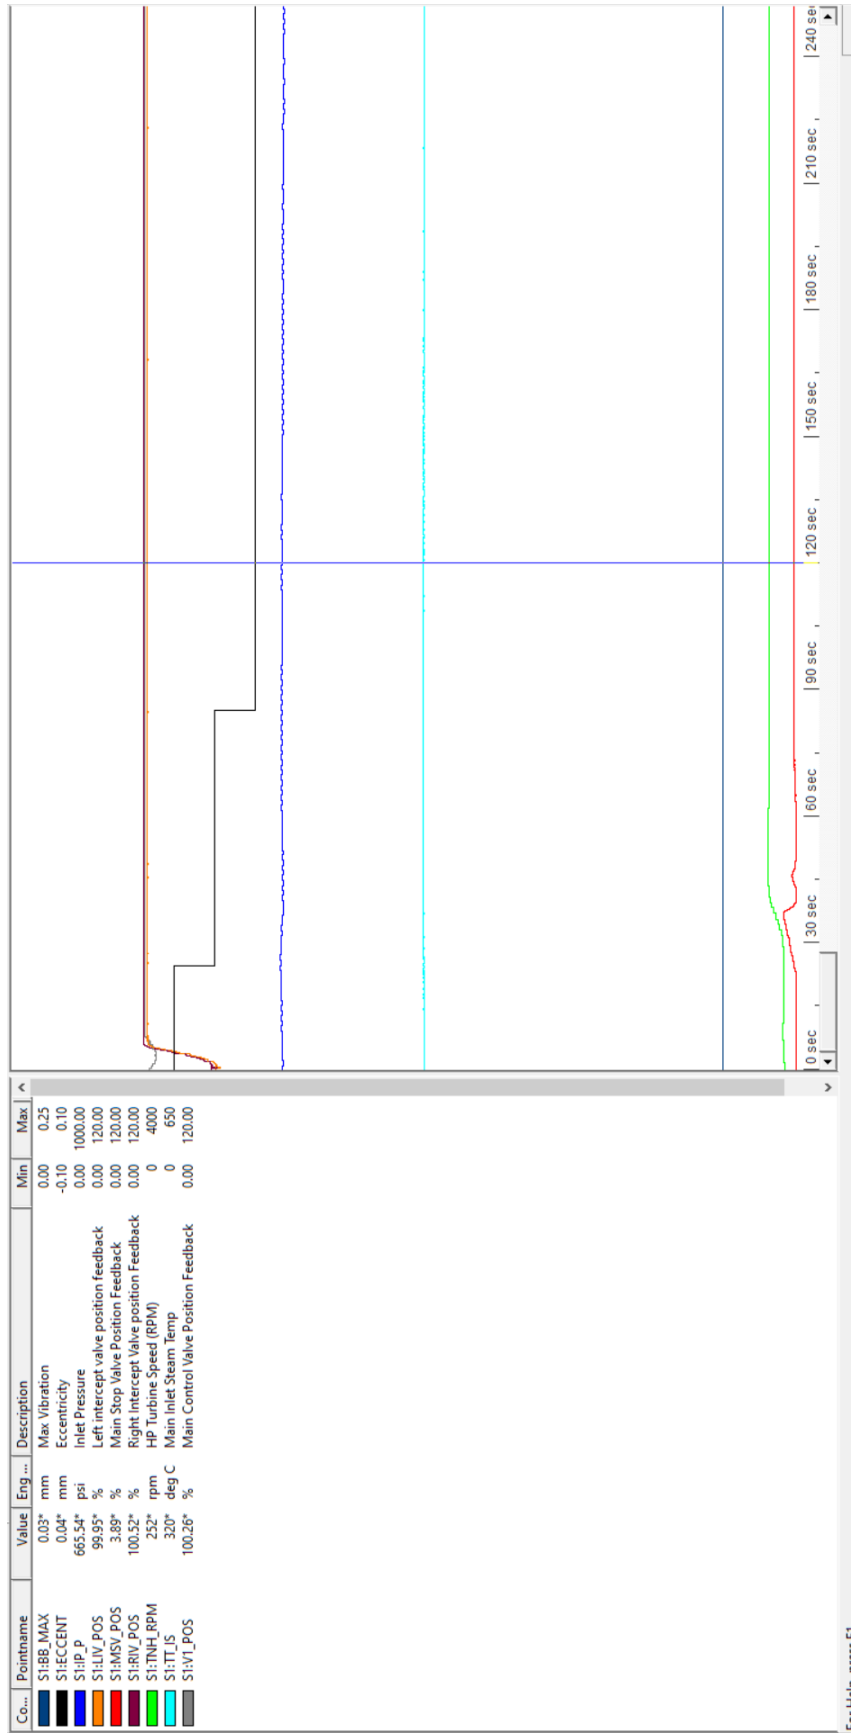
Unit Ramp to 250 RPM Data

Unit ramped up from turning gear speed of 2 RPM to 252 RPM smoothly with minimal overshooting speed of 261 RPM that quickly settled down to controlled 252 RPM, Main Stop Valve was stable and controlling smoothly the speed.

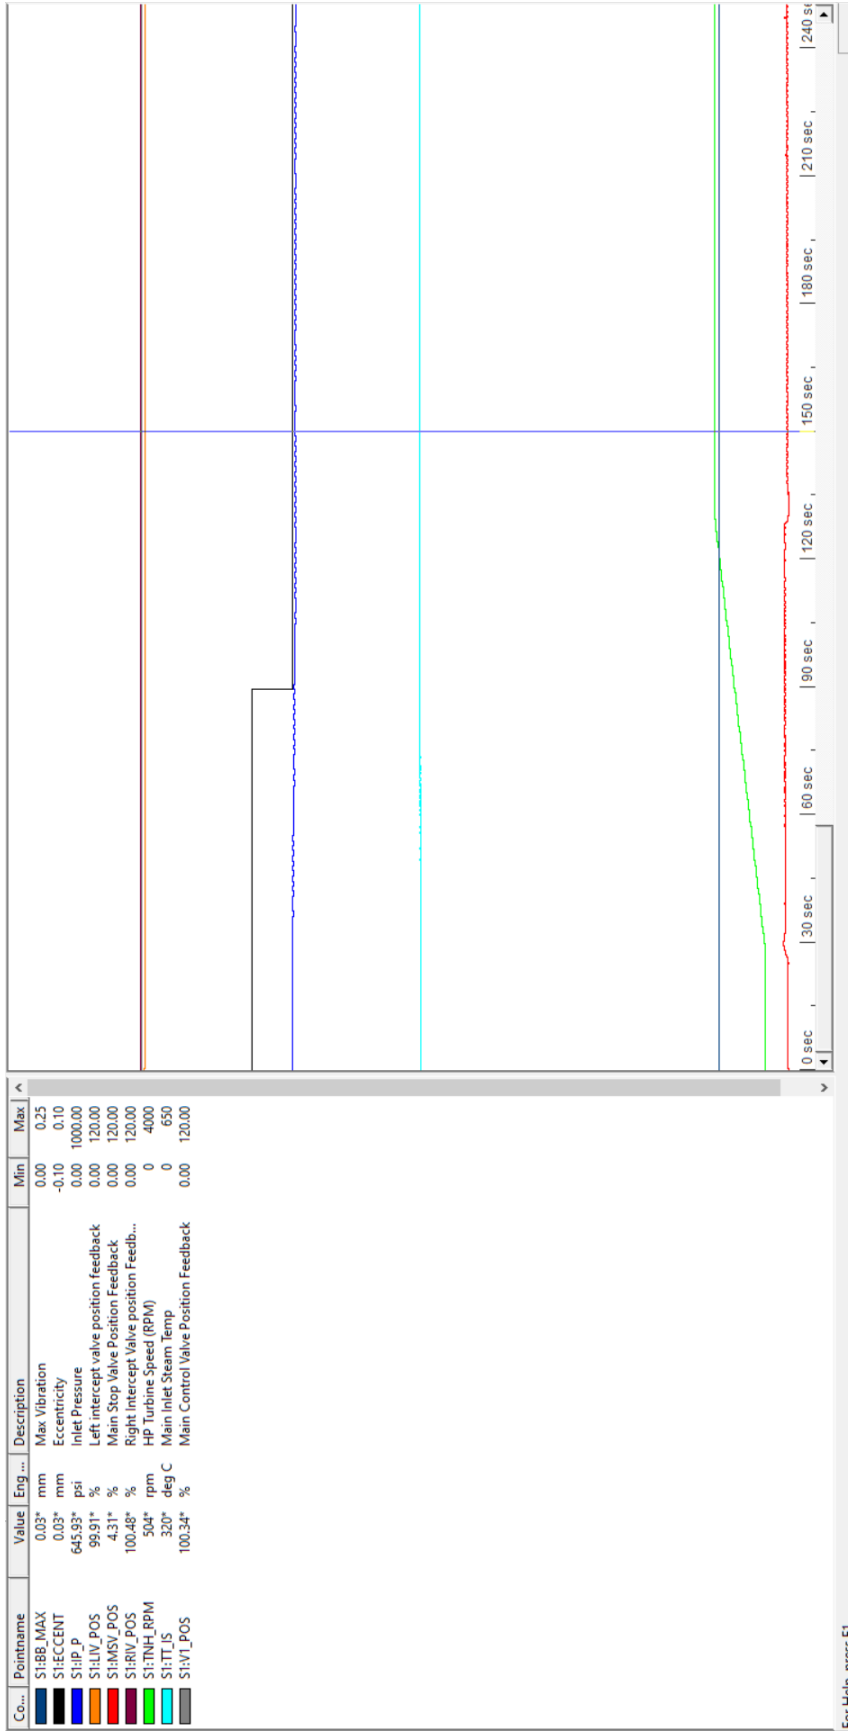
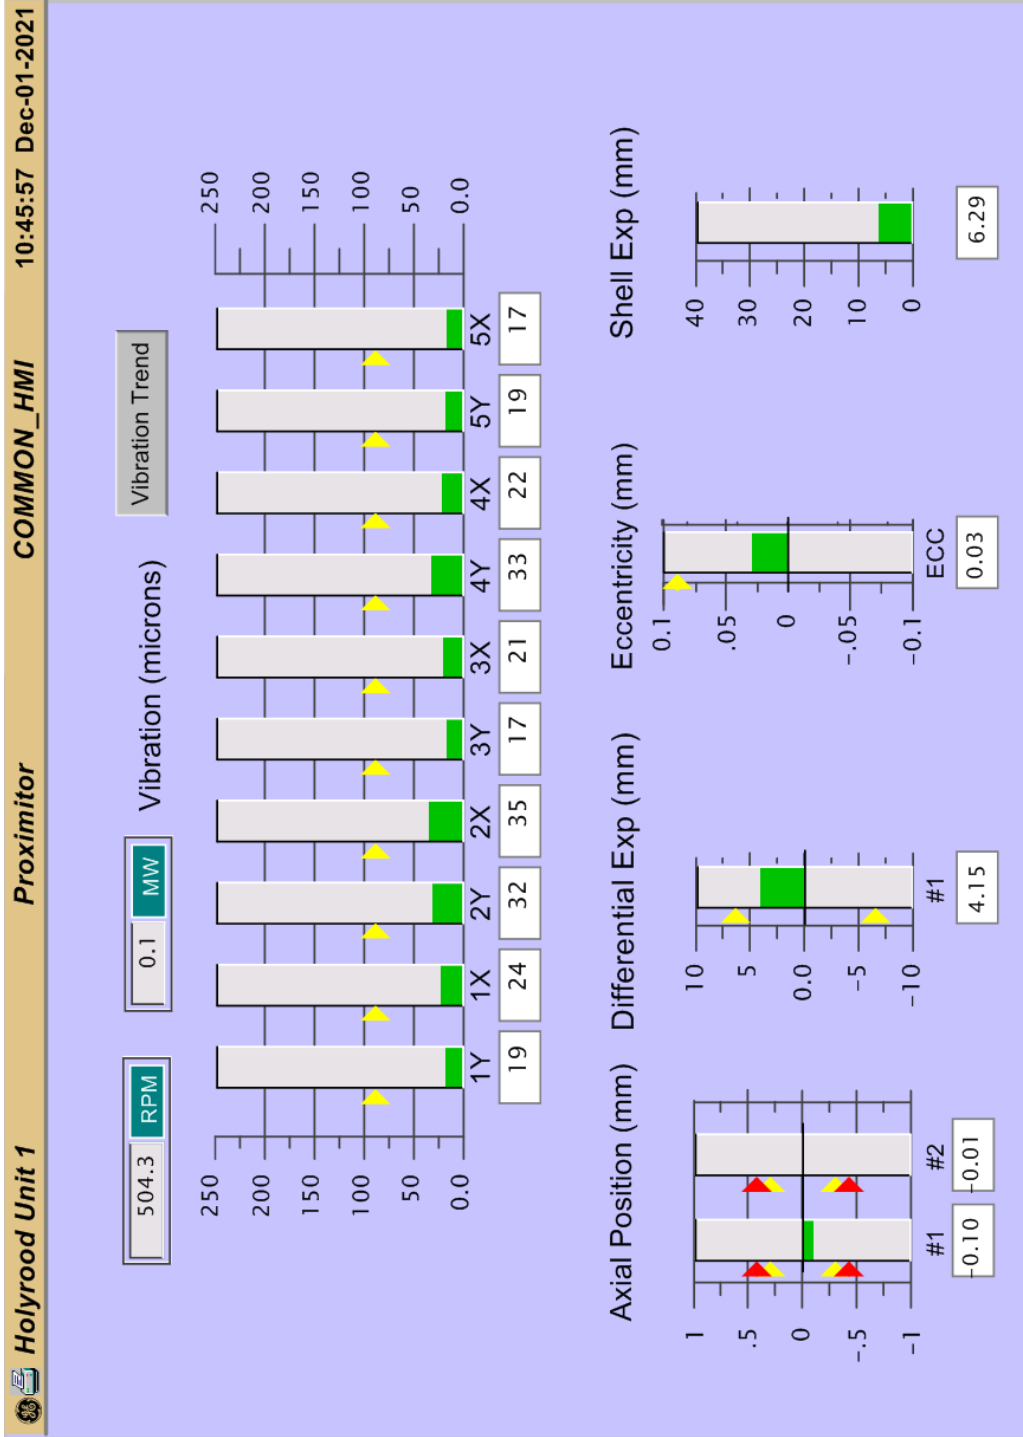
Unit Ramp to 500 RPM Data

Unit ramped up from 252 RPM to 504 RPM smoothly with no overshooting and kept controlling at 504 RPM, Main Stop Valve was stable and controlling smoothly the speed.

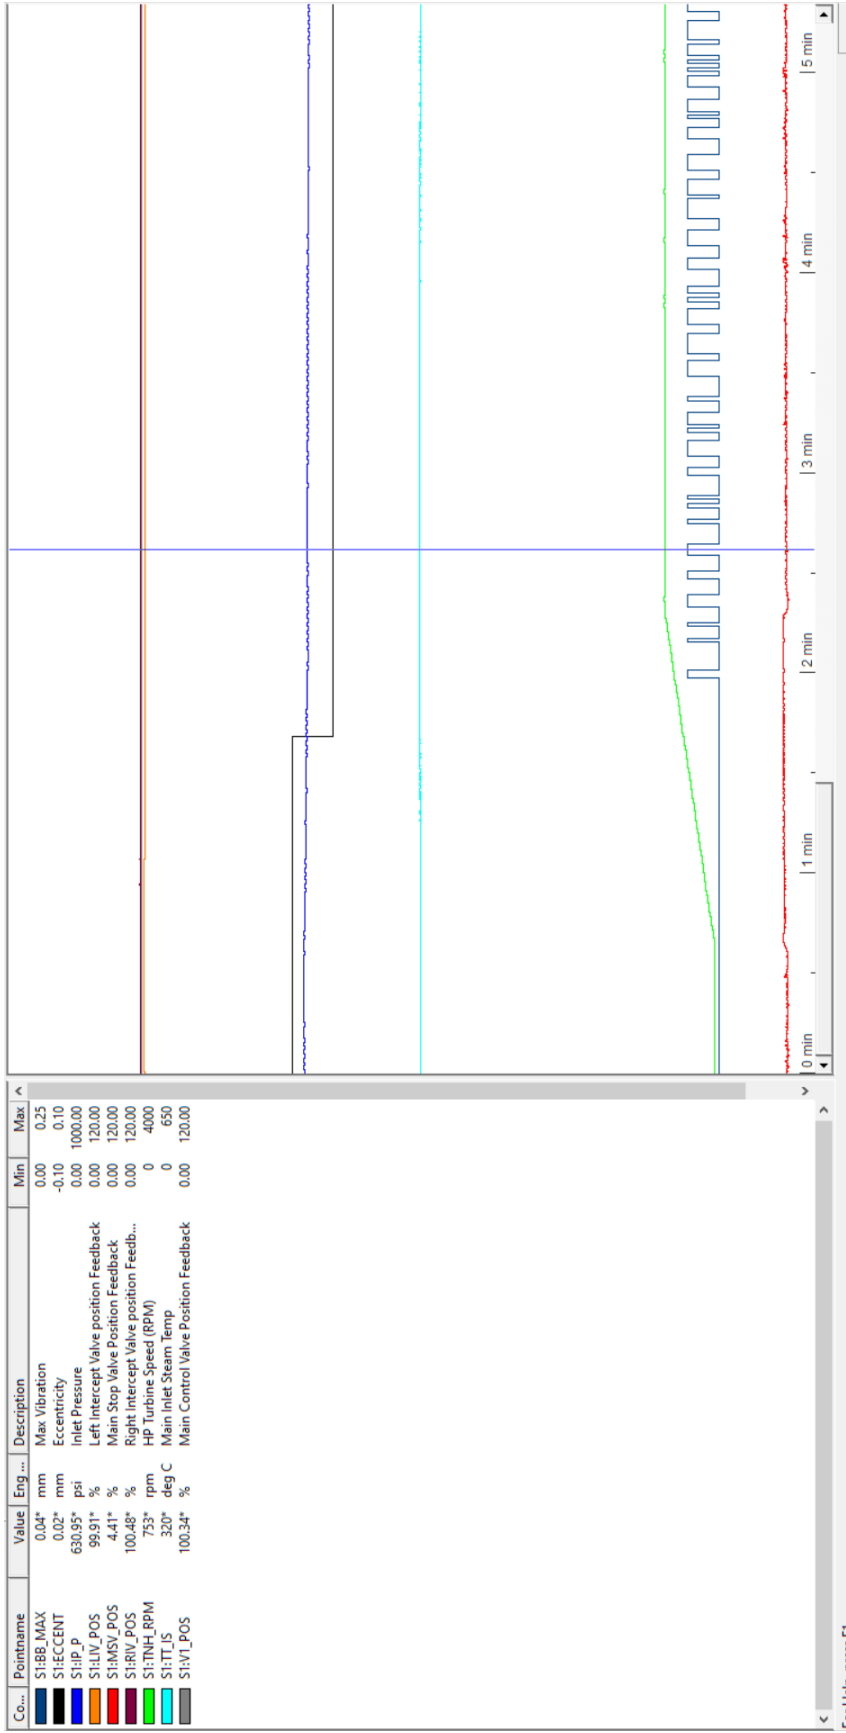
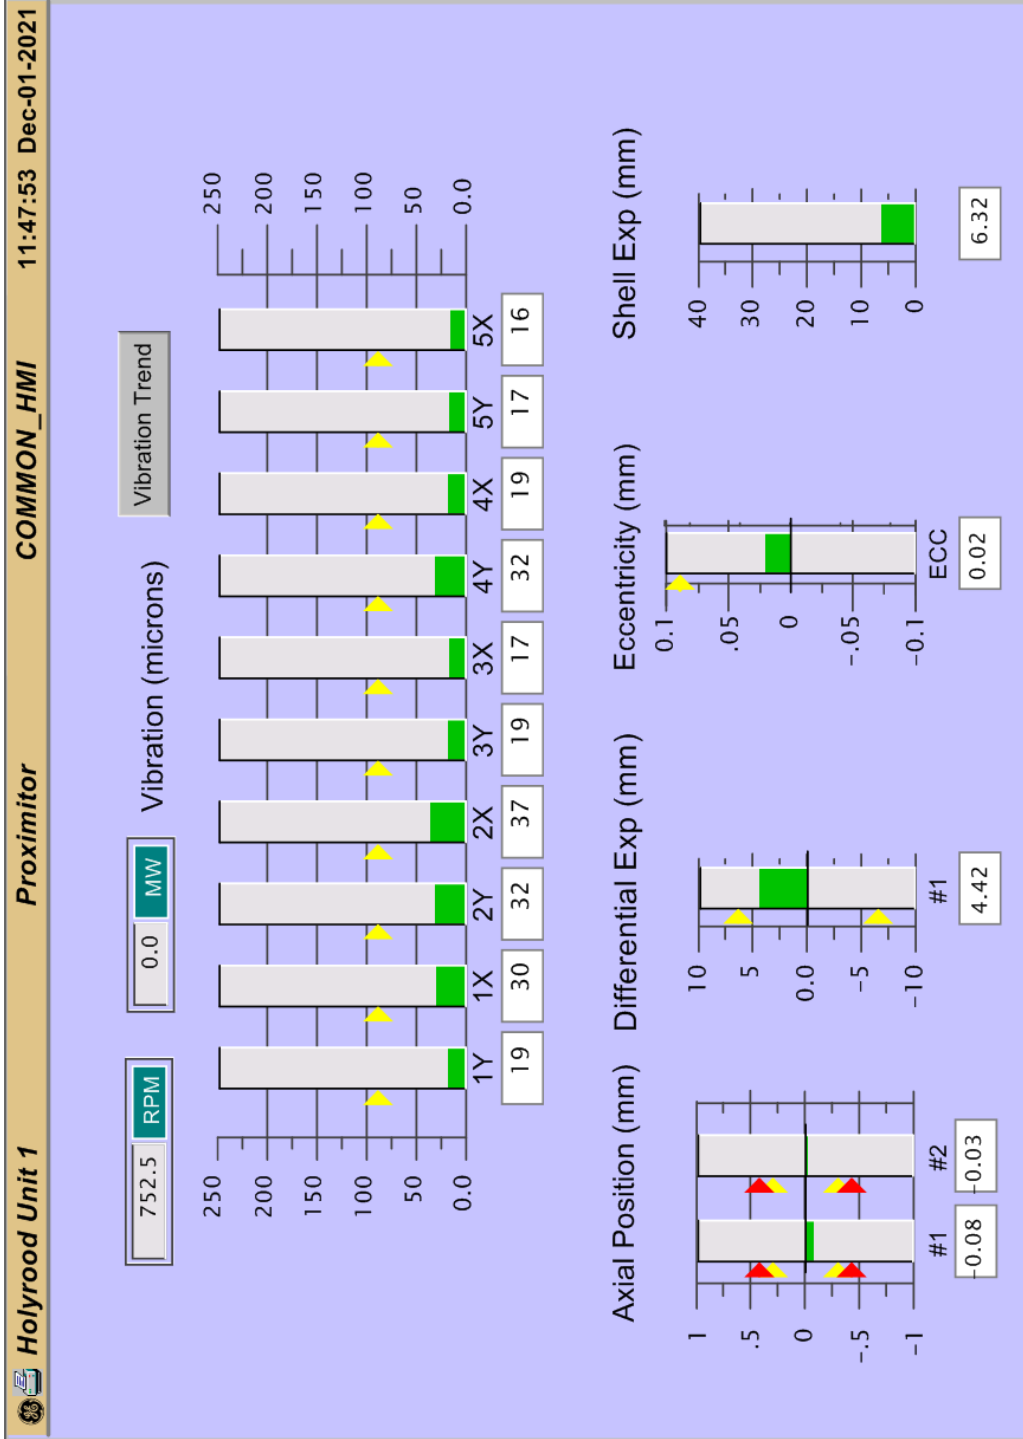
Unit Ramp to 750 RPM Data

Unit ramped up from 504 RPM to 753 RPM smoothly with no overshooting and kept controlling at 703 RPM, Main Stop Valve was stable and controlling smoothly the speed.
