Re: Holyrood Thermal Generating Station Unit 1 – Root Cause Investigation Report

Holyrood Thermal Generating Station Root Cause Investigation

Unit 1 – Cold Reheat Piping Support Failure

December 2021

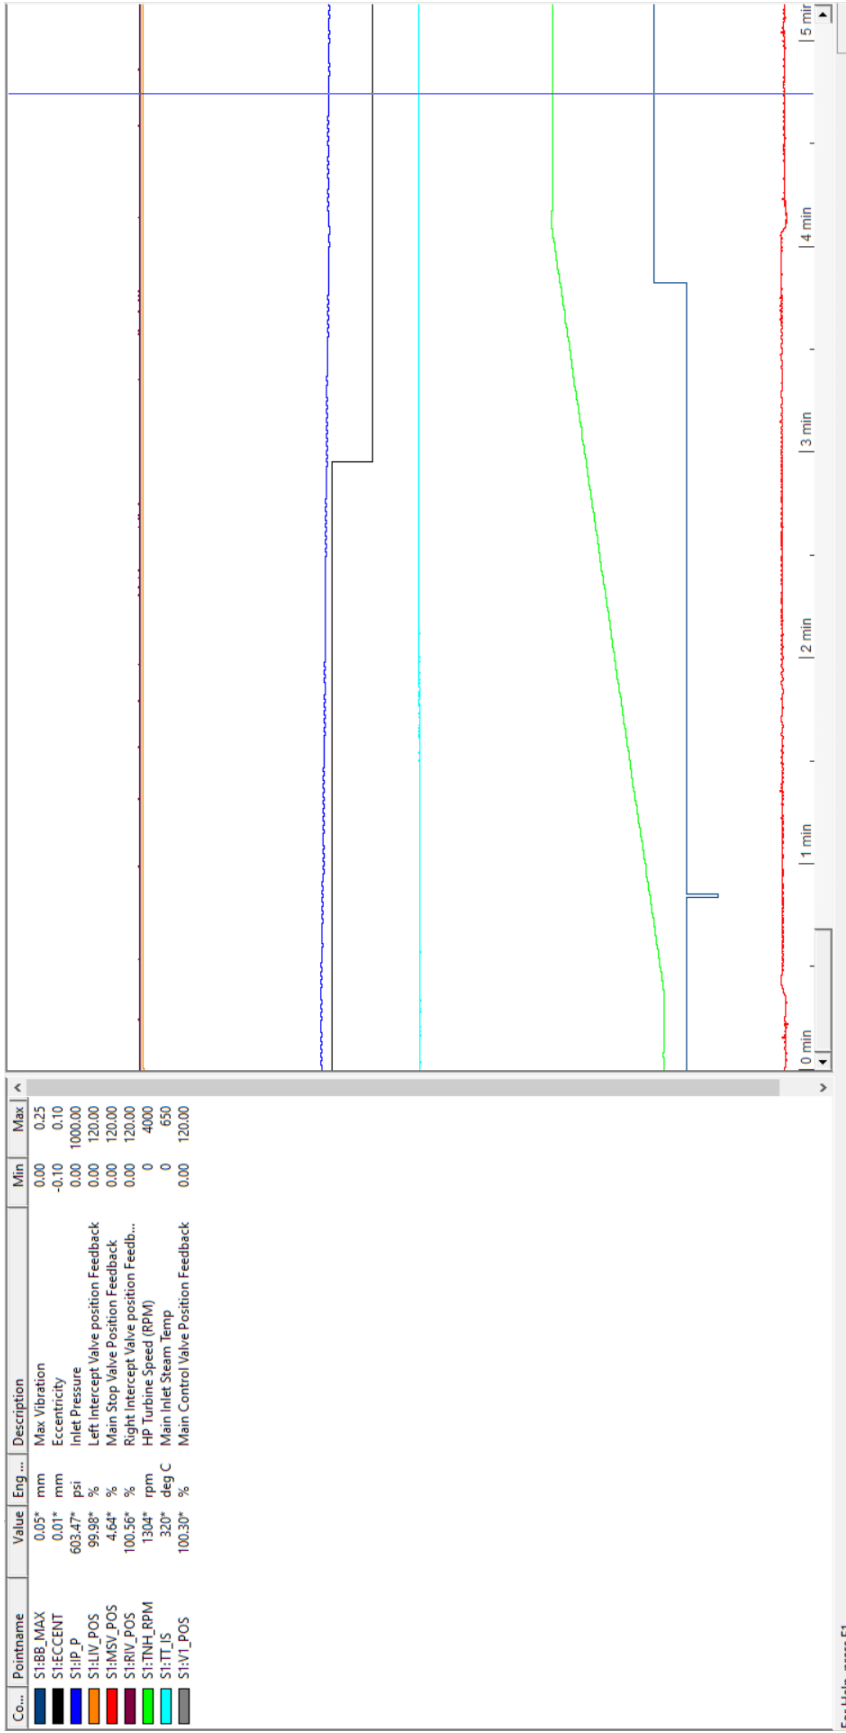
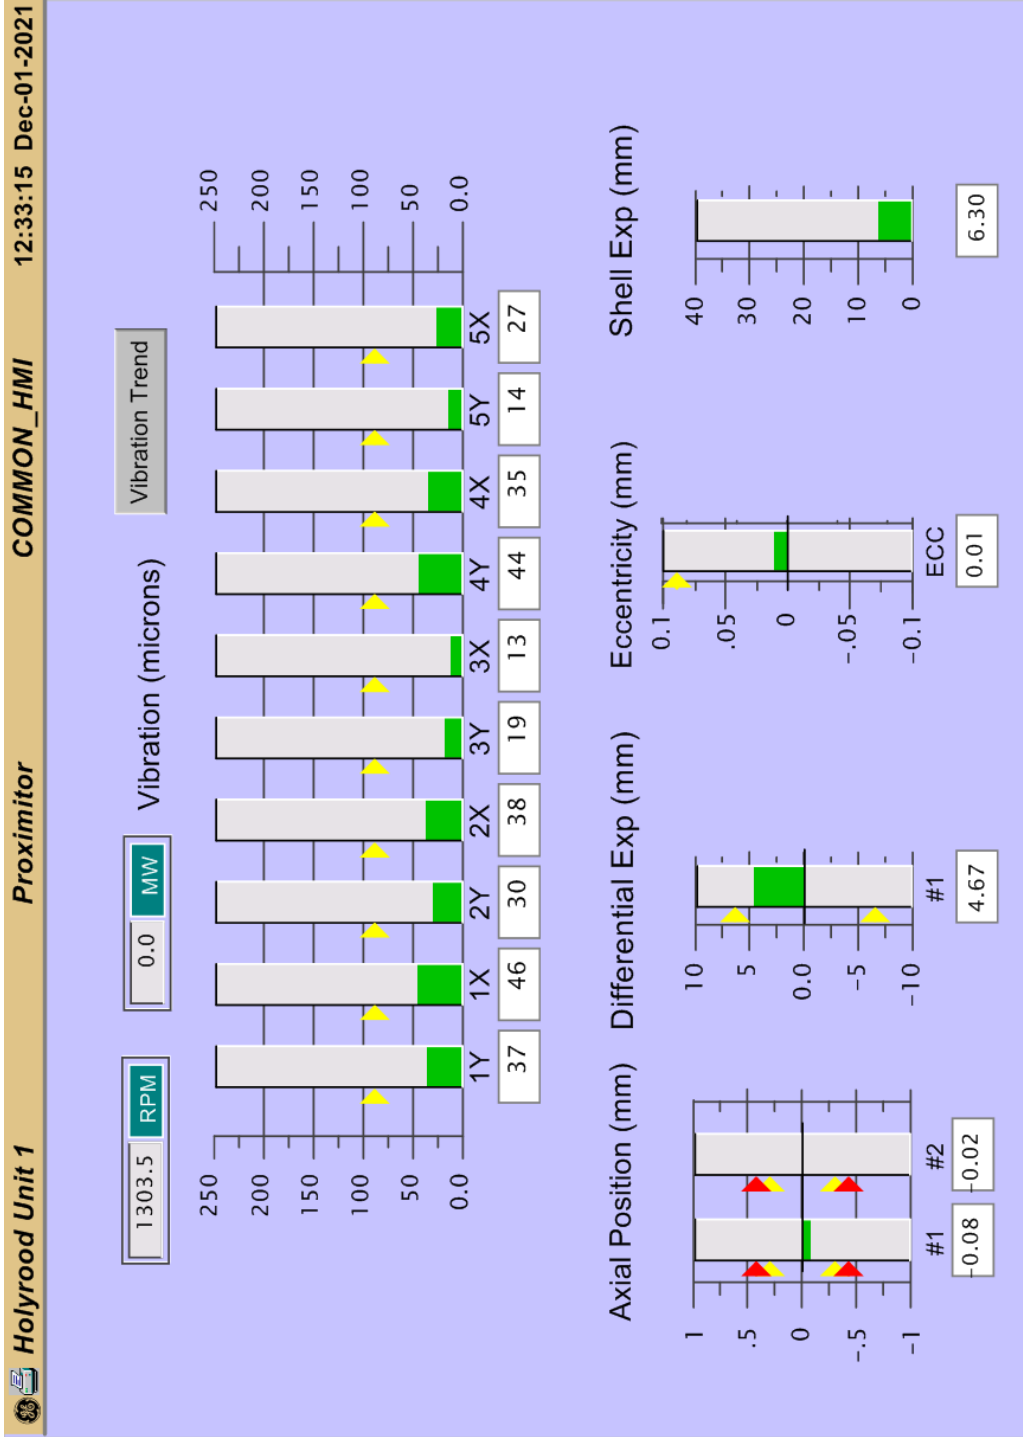
Unit Ramp to 1300 RPM Data

Unit ramped up from 753 RPM to 1304 RPM smoothly with minimal overshooting speed of 1308 RPM that quickly settled down to controlled 1304 RPM, Main Stop Valve was stable and controlling smoothly the speed.

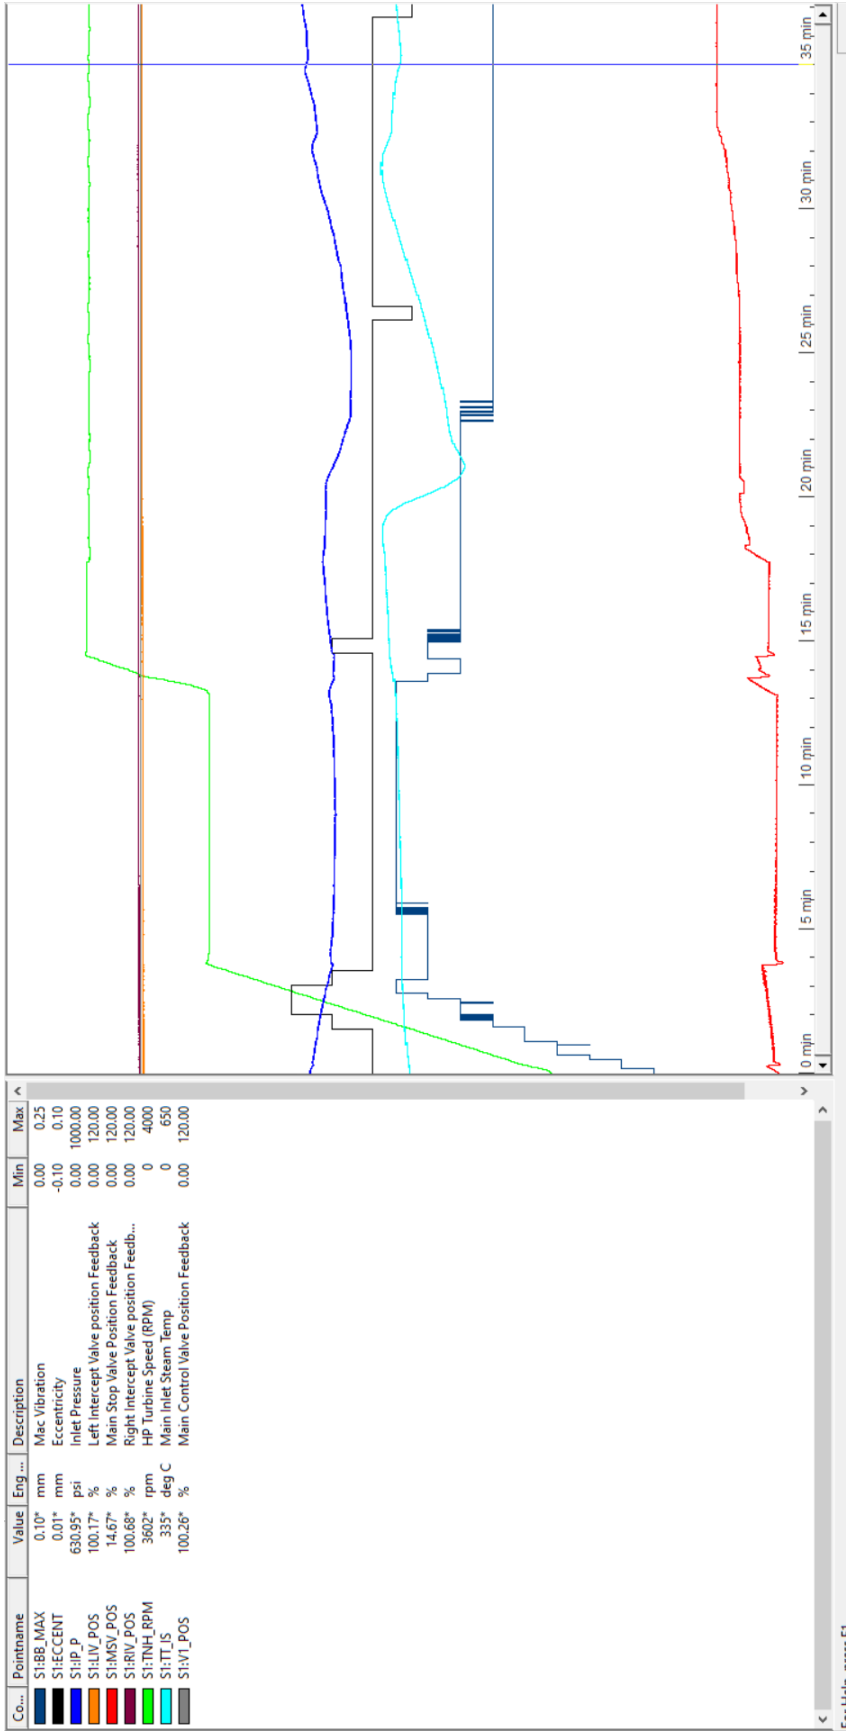
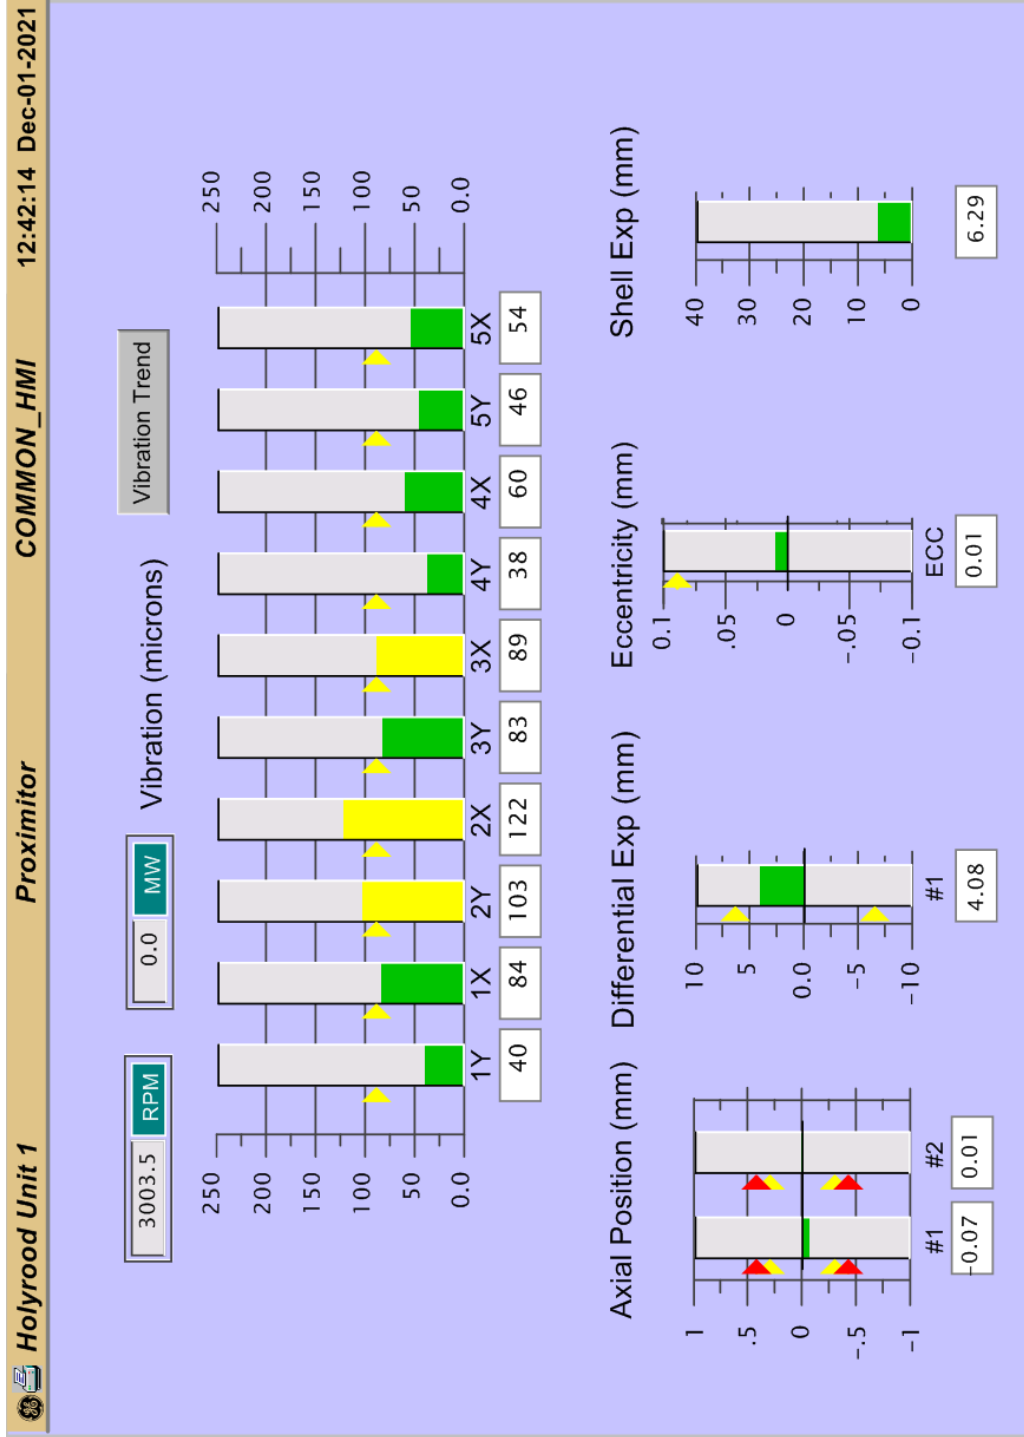
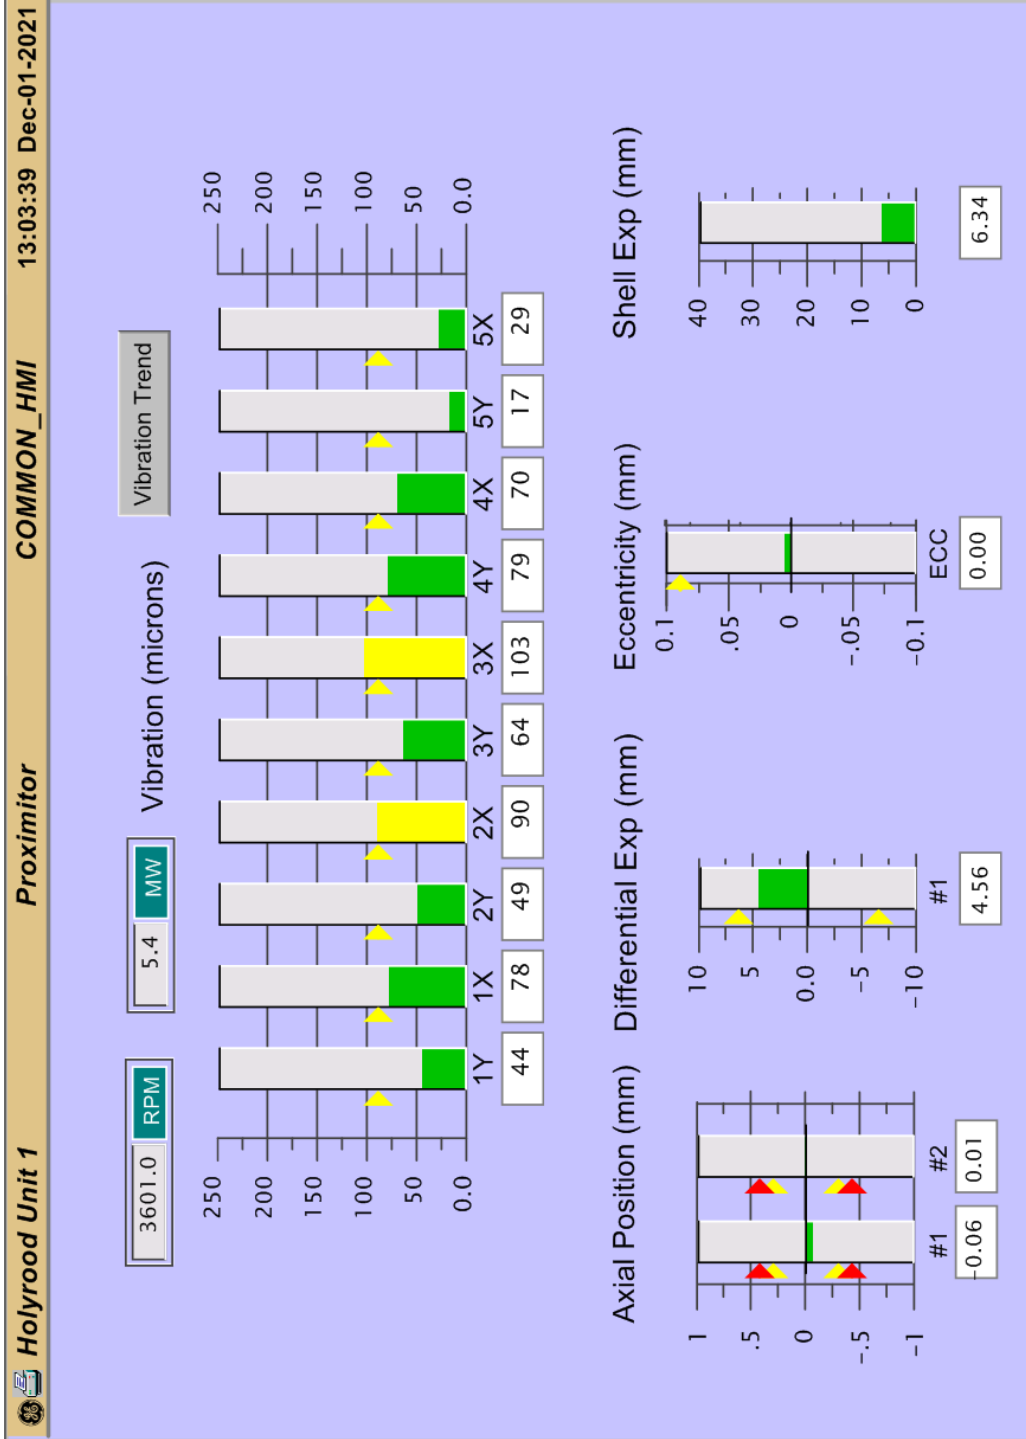
Unit Ramp to Synchronise Speed Data

Unit ramped up from 1304 RPM to Synchronise speed of 3602 RPM smoothly with minimal overshooting speed of 3620 RPM that quickly settled down to controlled 3614 RPM, Main Stop Valve was stable and controlling smoothly the speed.

Maximum Vibration during critical speed of 2600 RPM and during acceleration from 3000 RPM to 3450 RPM was 130 Microns that settled down to 100 Microns

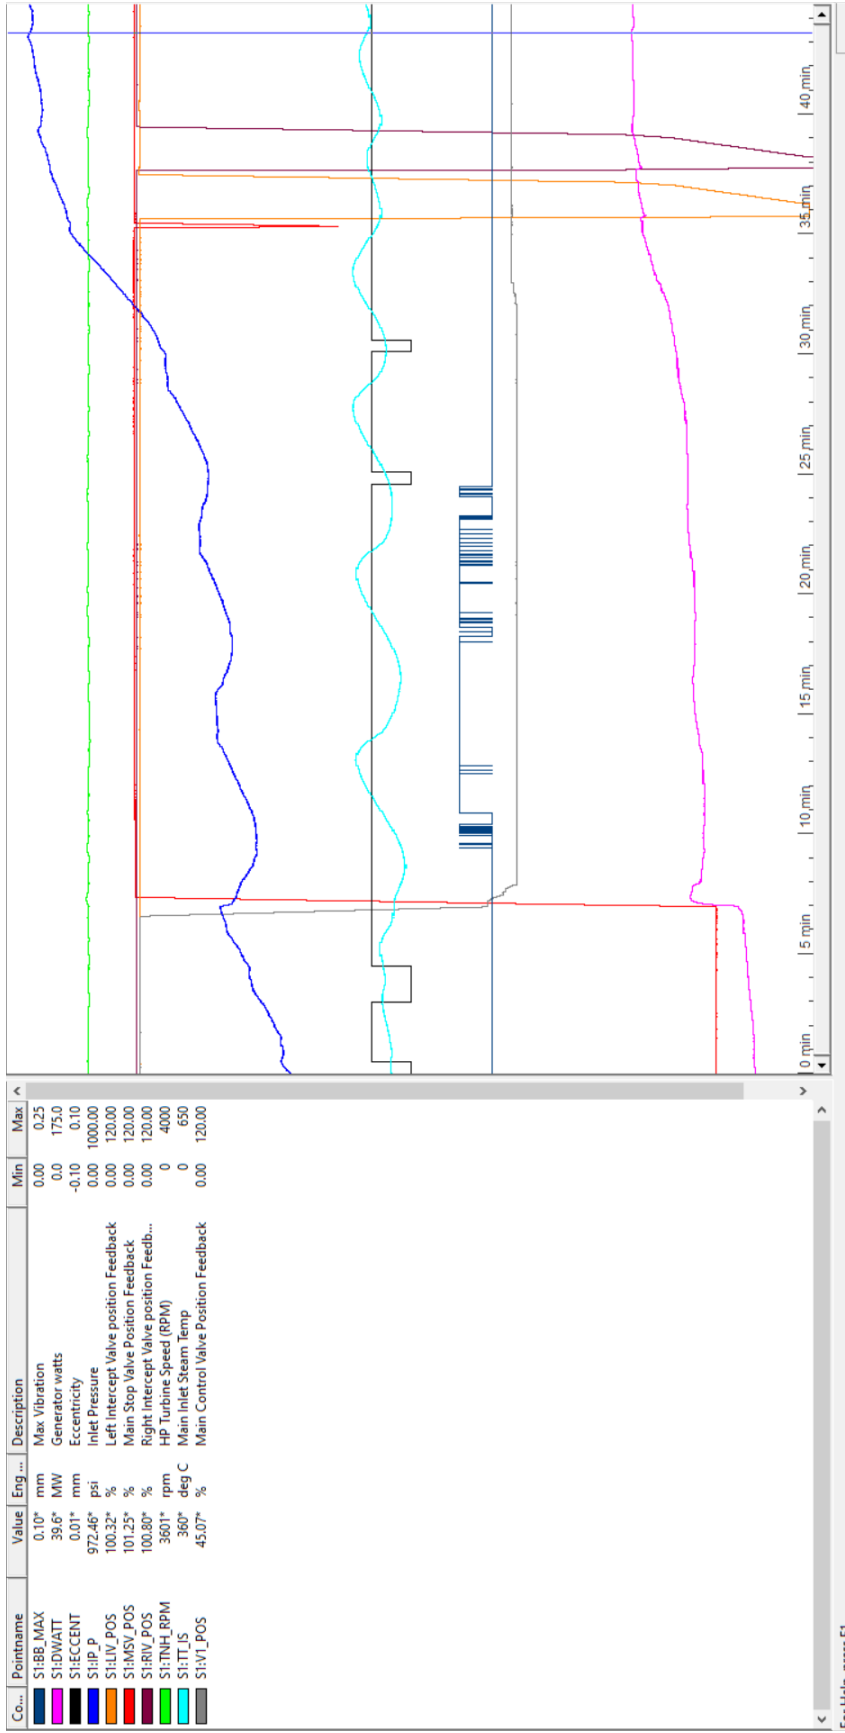
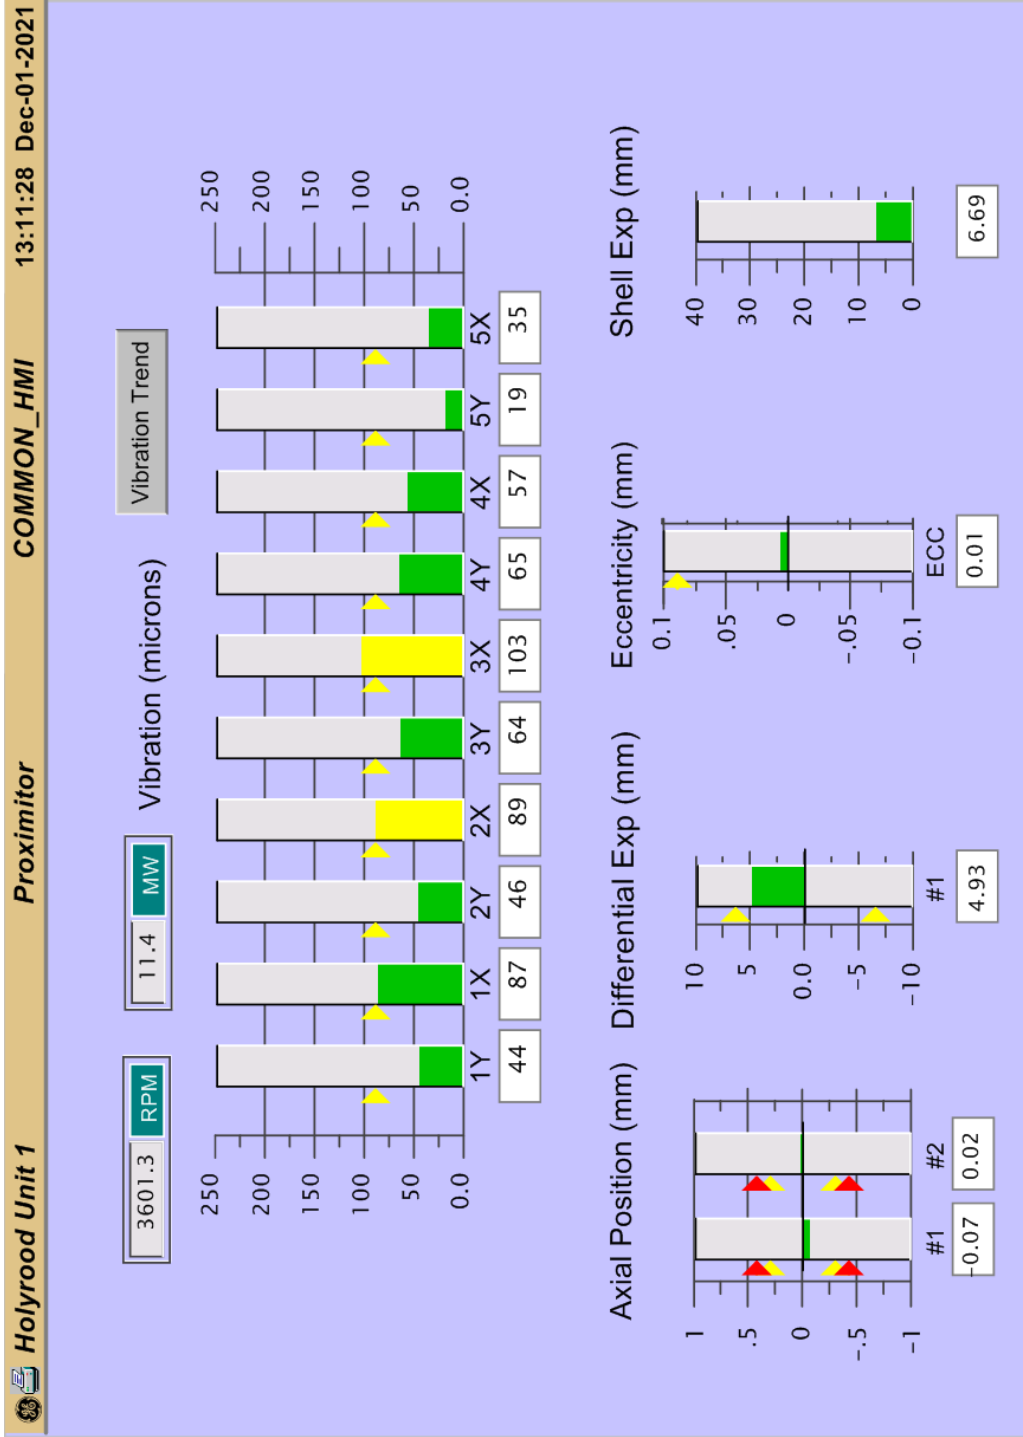
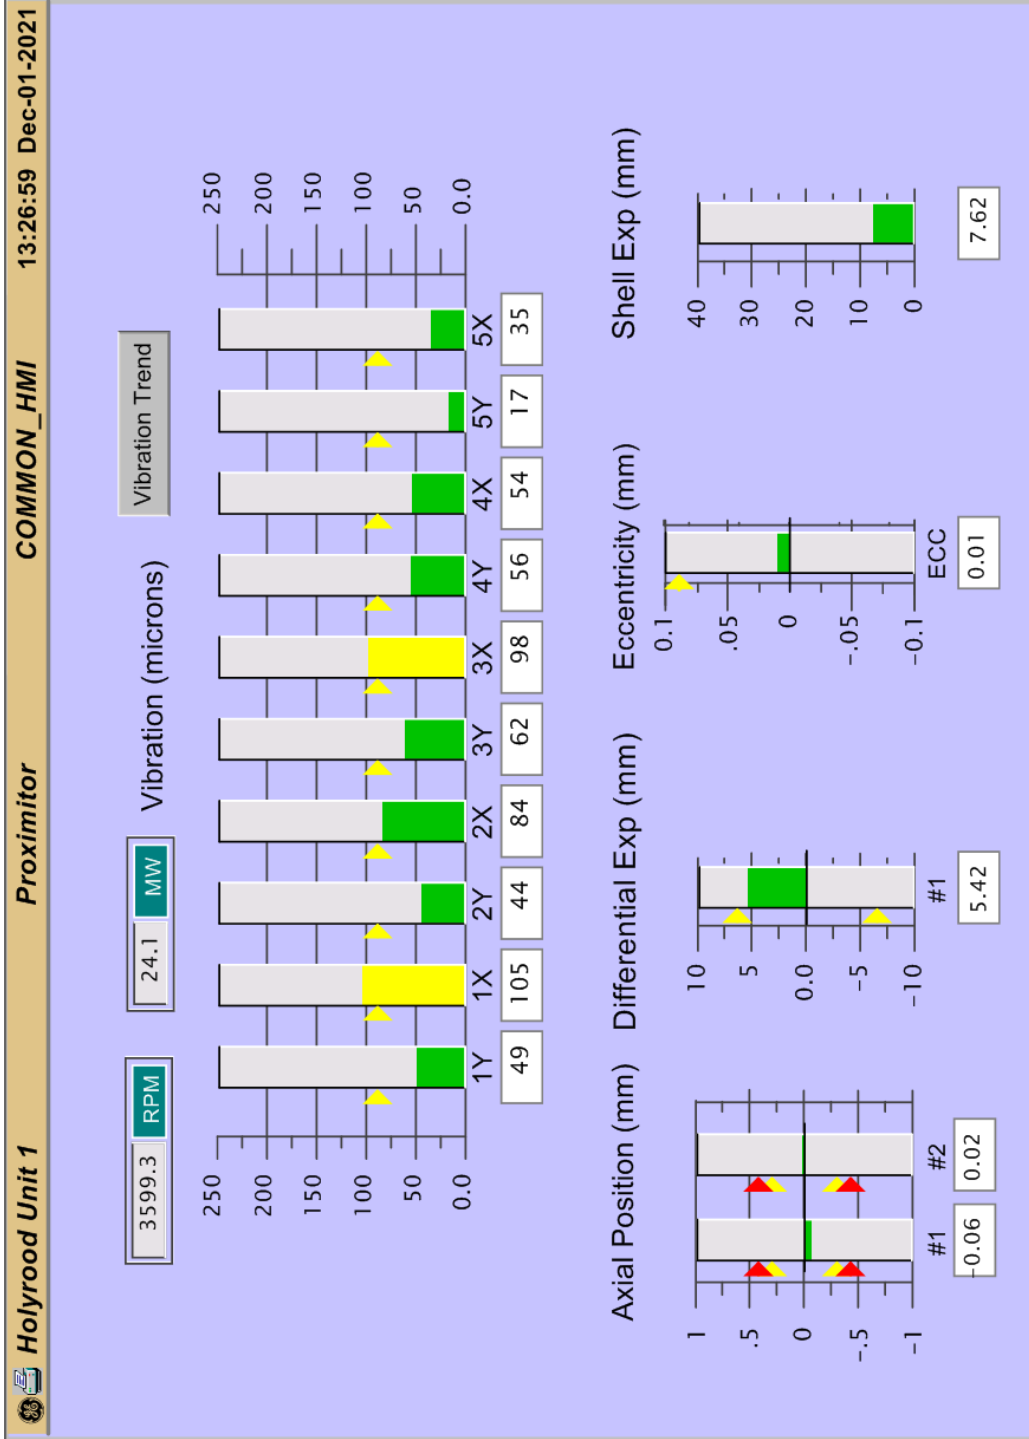
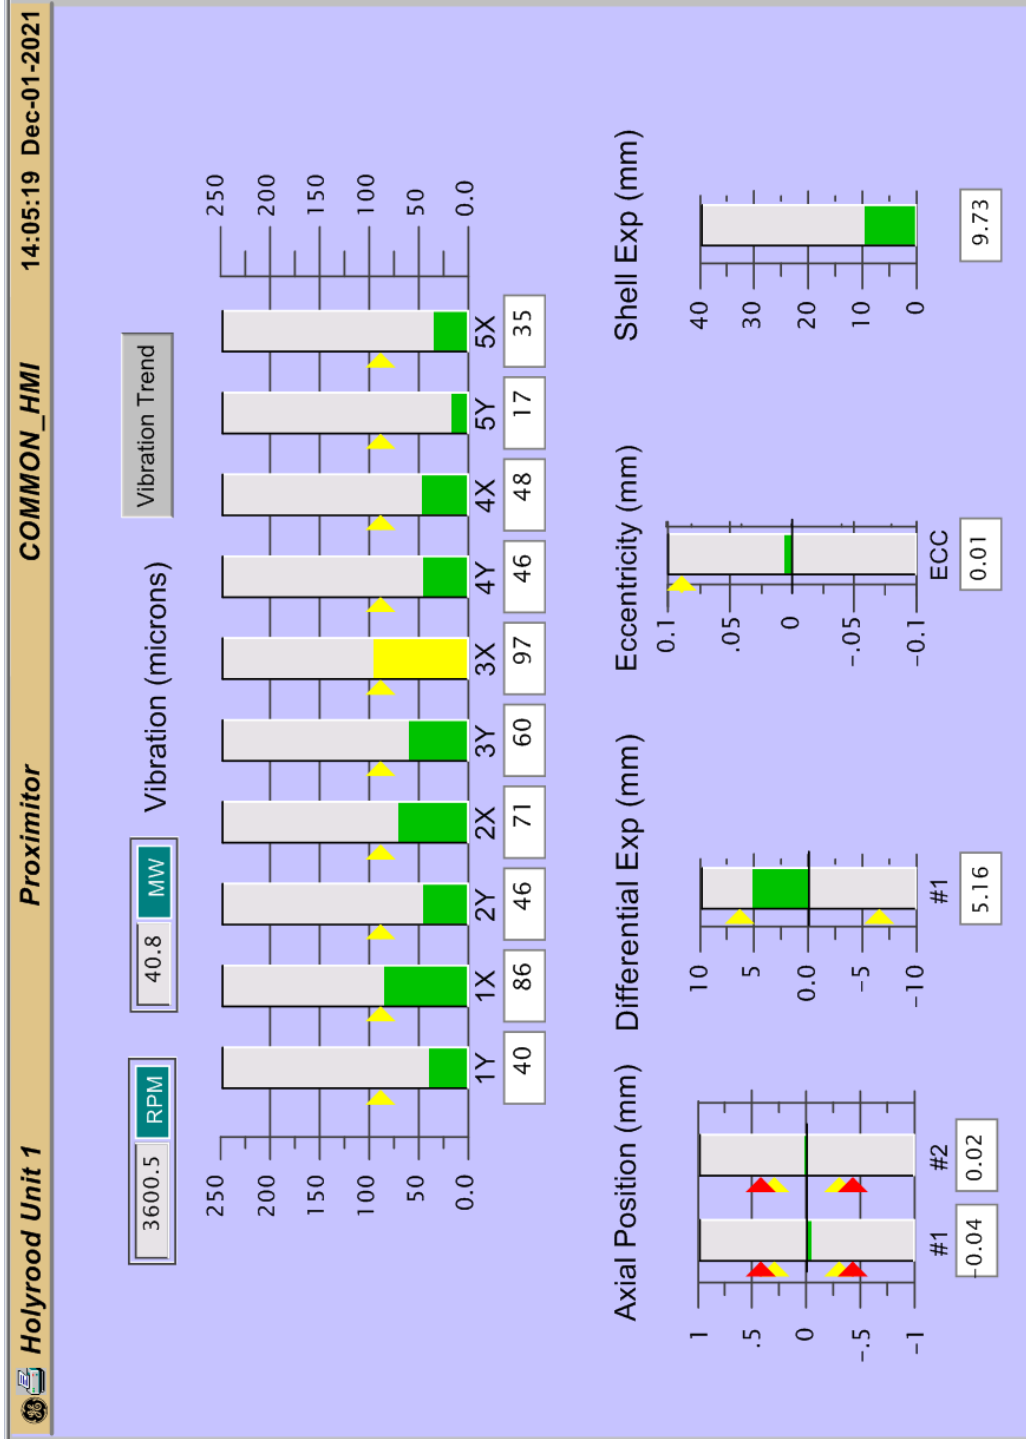
Unit Loading to 40 MW Data and Valve Test

Unit was synchronized and loaded to 40 MW where Valve Test and on-line ETD test successfully completed.

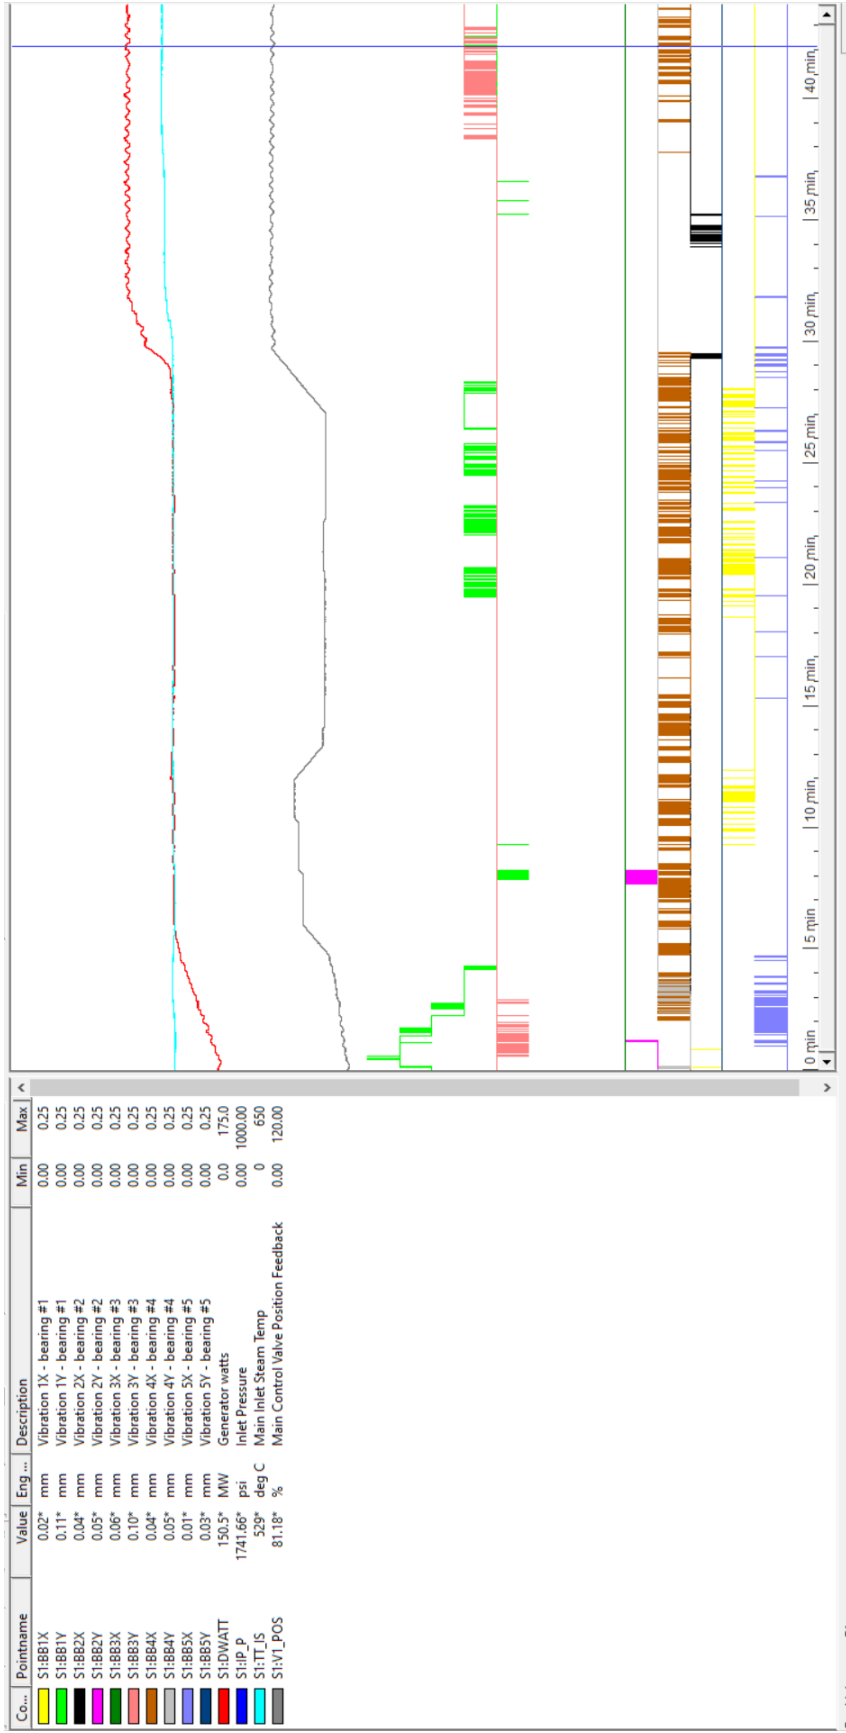
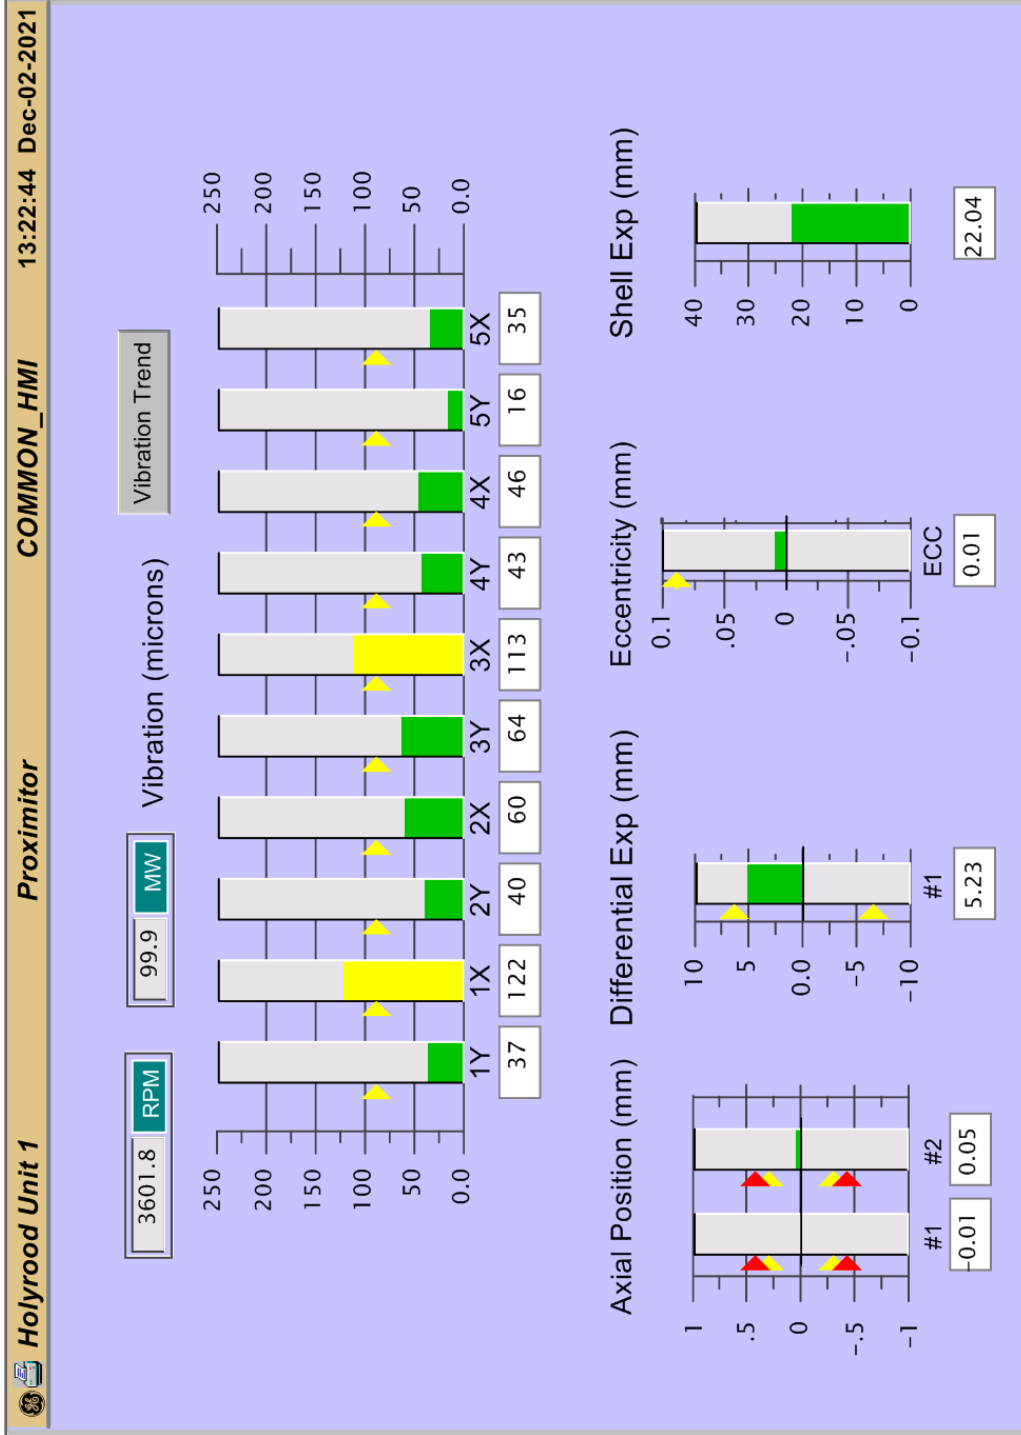
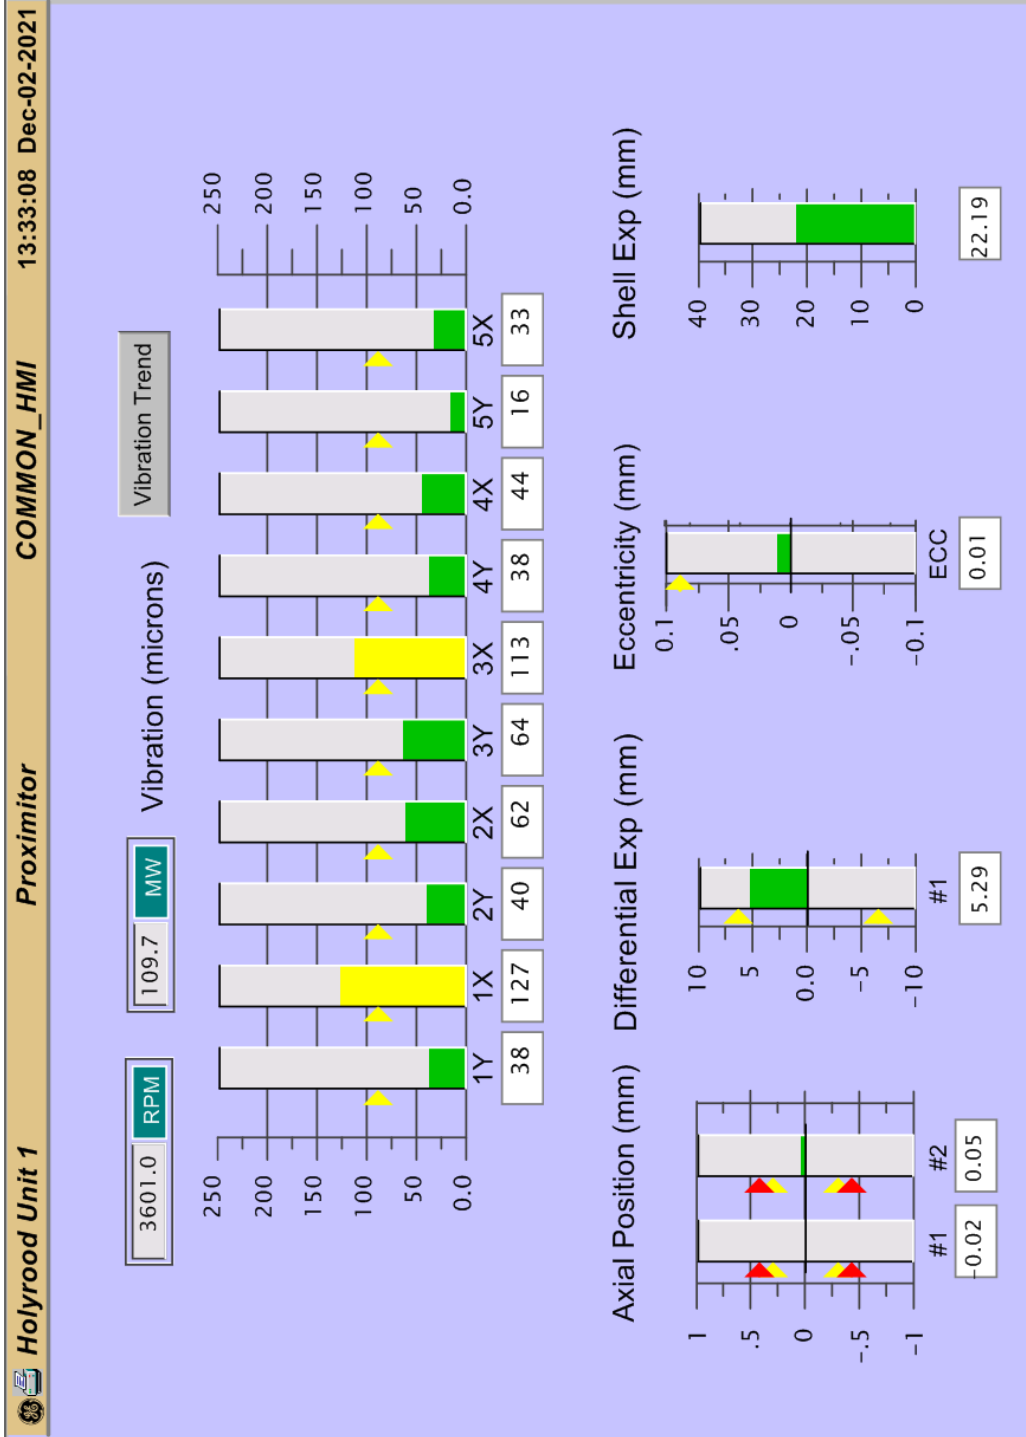
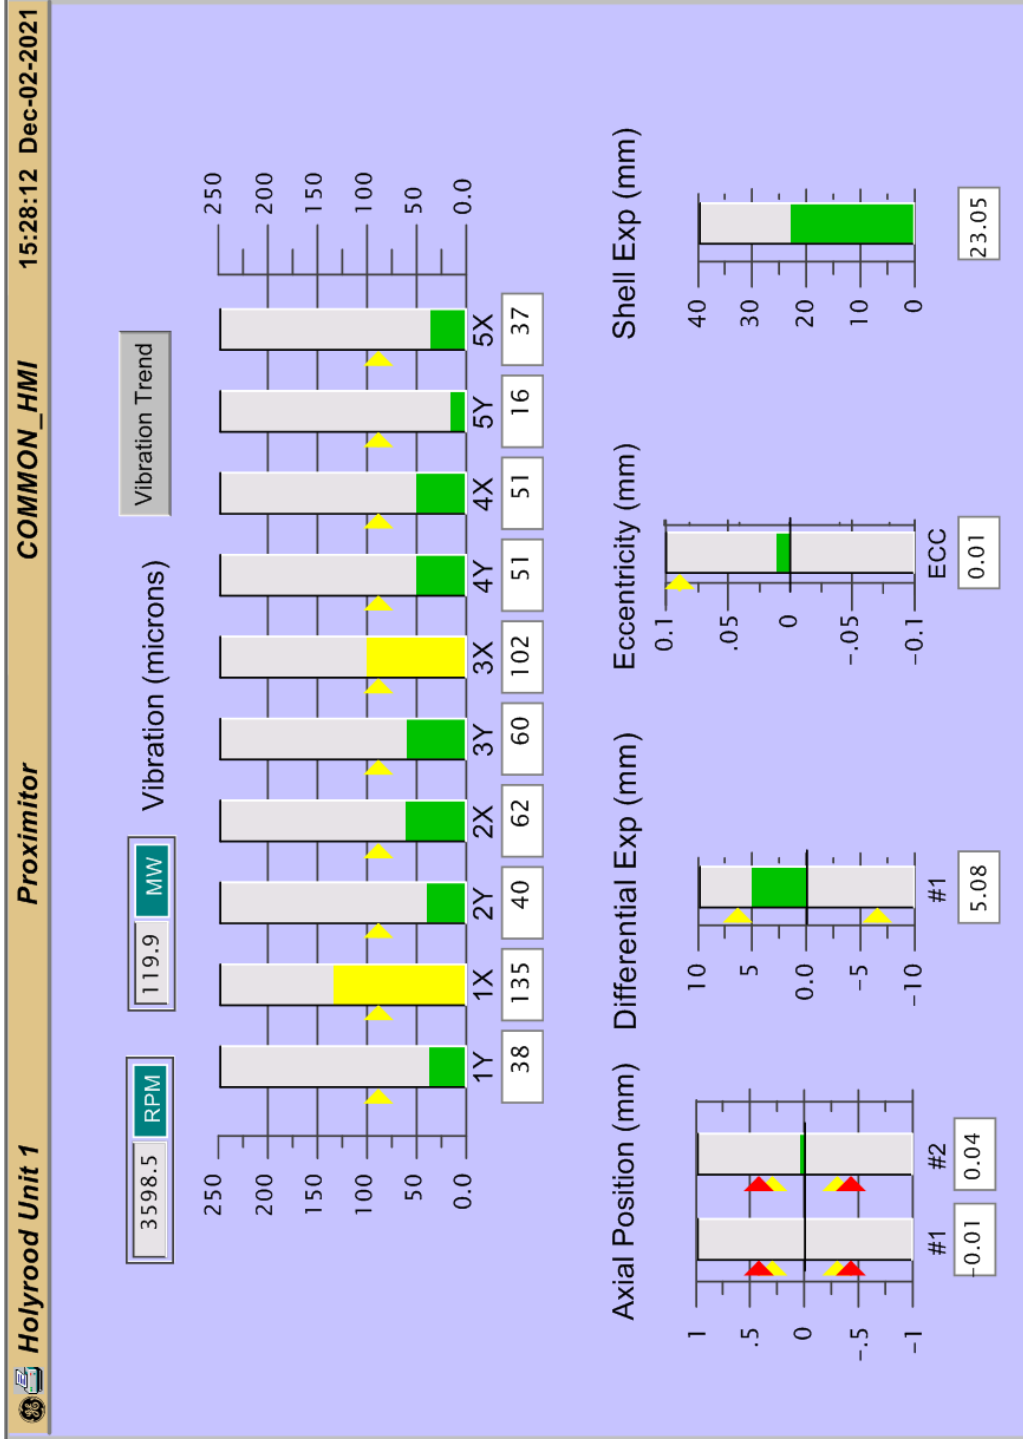
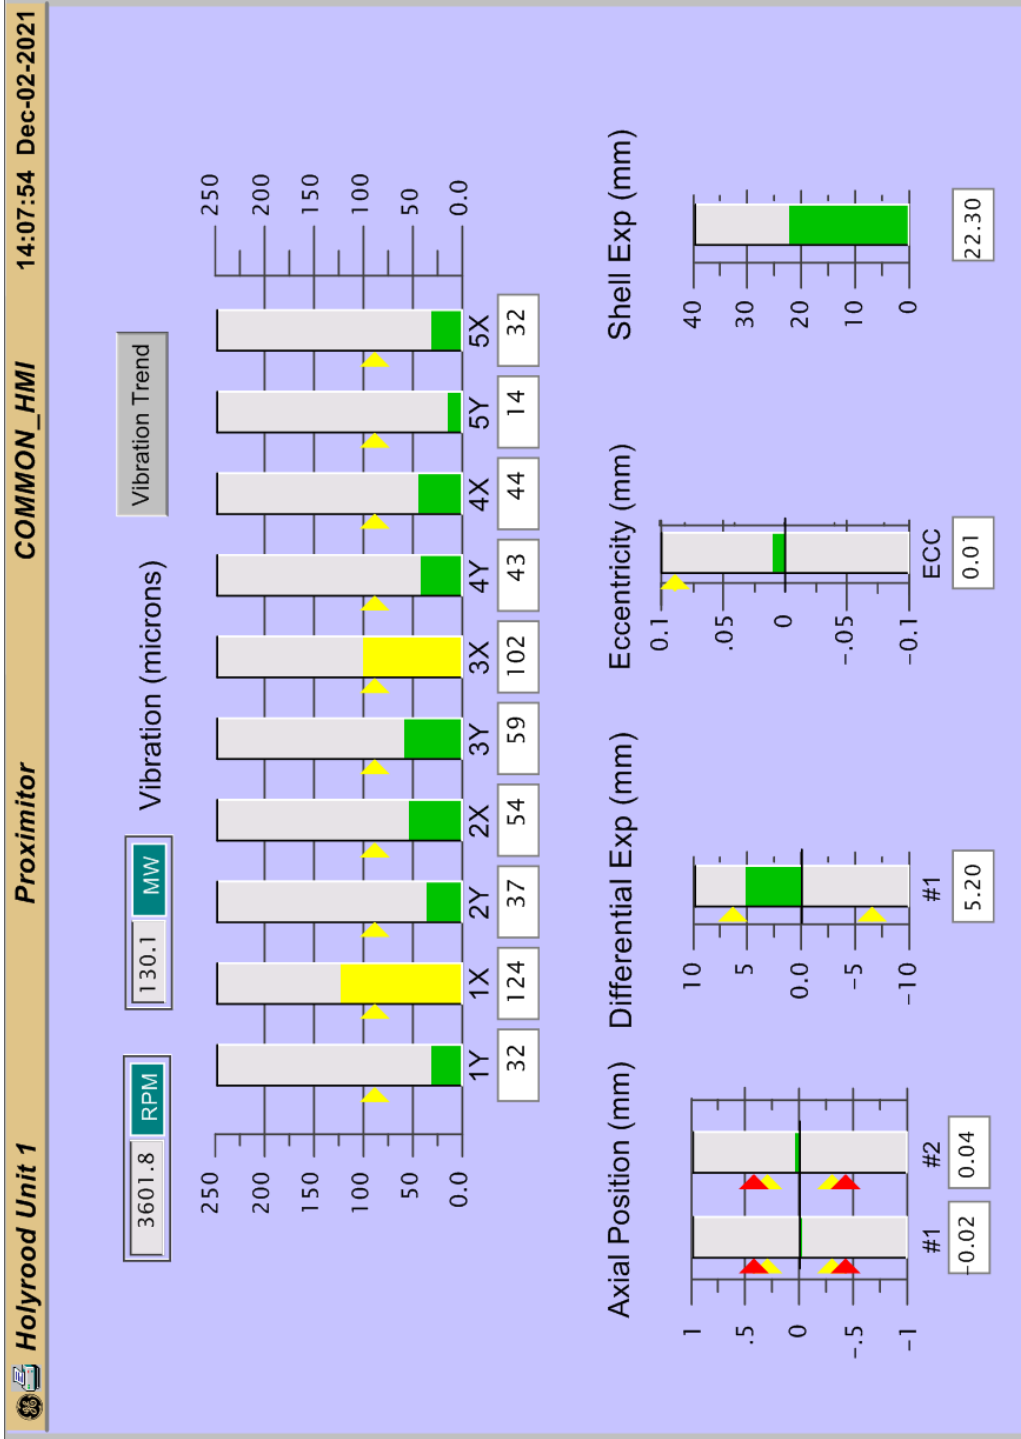
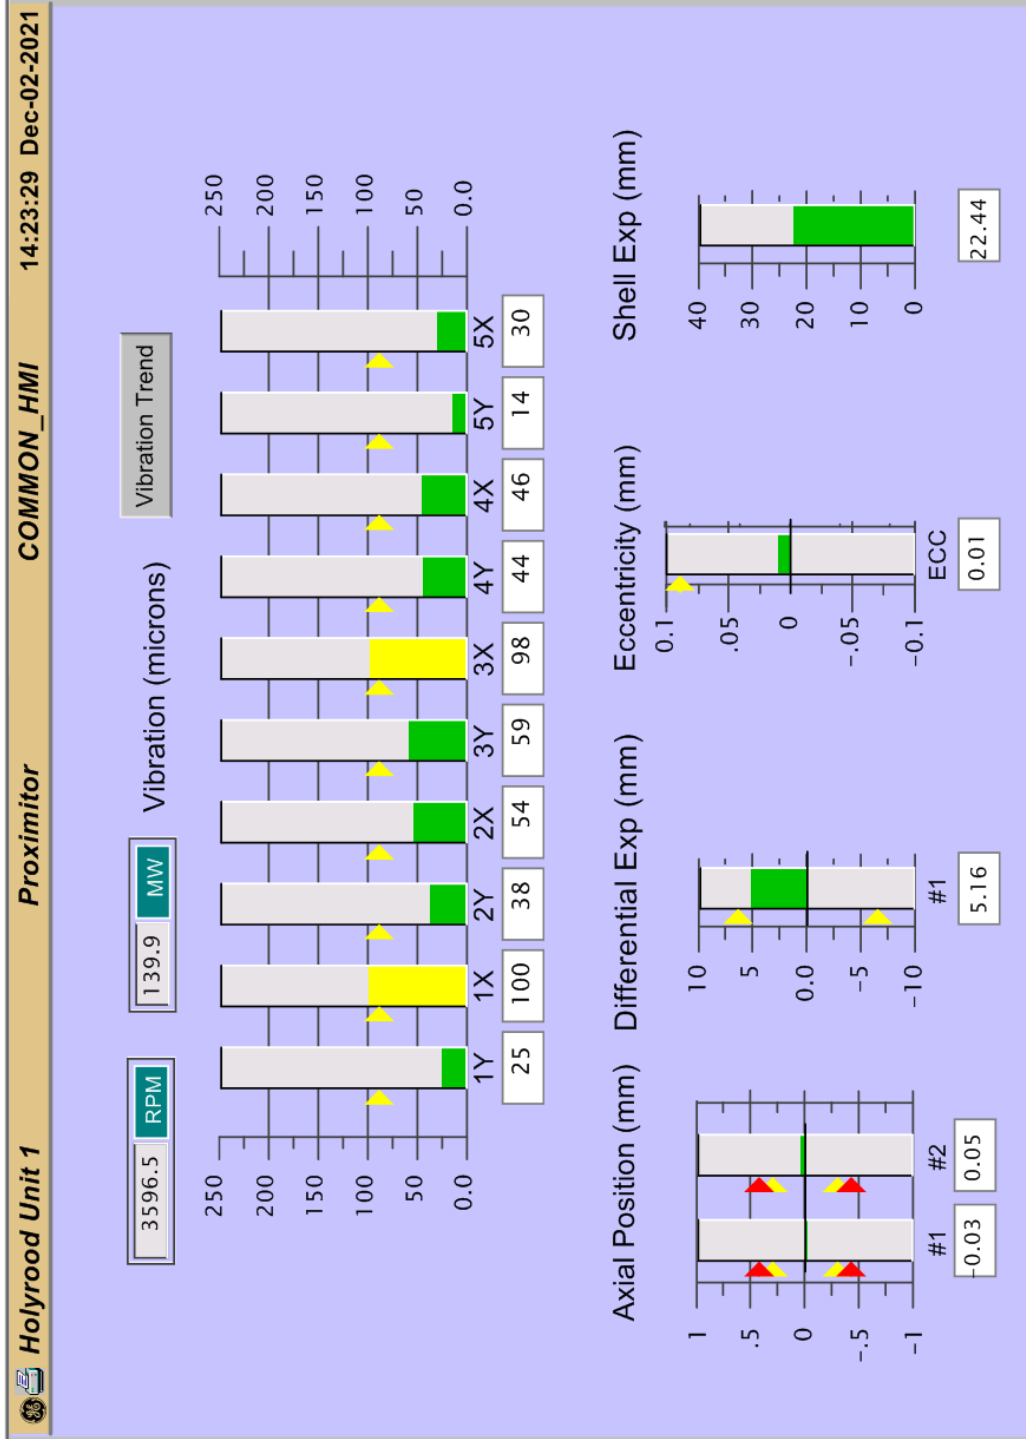
Unit Loading to 150 MW Data

Max vibration was noticed around 130 MW on Bearing #1 of 130 Microns

It is highly recommended to upgrade the control system to gain the power of Triple Module Redundancy which will improve unit reliability and availability, as well as allow access to high-speed trends and data & event logger. Such upgrade will facilitate more decisive troubleshooting in case of any incidents or trips.

It is highly recommended installing NTP and reference all HMI's and Controllers to it, to maintain one clock for the whole plant, it was noticed that events were logged with different timestamp on the Unit Control than DCS which creates confusion when troubleshooting an incident or a trip.
