Re: 2019–2020 Winter Readiness Planning Report – Further Update – Bay d’Espoir Terminal Station General Electric Dead Tank Circuit Breaker Failure Report

Bay d'Espoir Terminal Station General Electric Dead Tank Circuit Breaker Failure Report

February 14, 2020

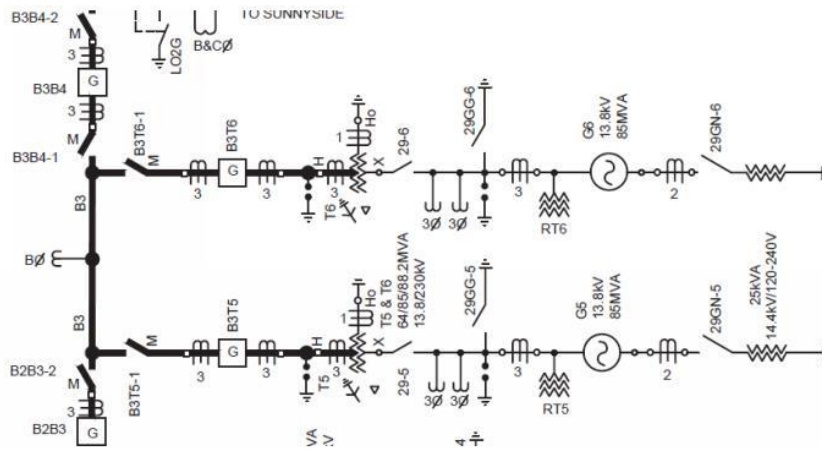
Figure 1-1: Configuration of Interconnection of Breaker B3T6 and Disconnect Switch B3T6-1 in BDE TS#1

Breaker B3T6 failed on 8/24/2019 at the time of operation of the B3T6-1 disconnect switch. Figure 1-1 shows the single line diagram of the interconnection of Generators 5 and 6 in BDE TS#1. In a meeting with the manufacturer of the breaker, GE, the transients created during disconnect switch operation as well as the role of particles inside the breaker in reducing the effective withstand capability of the breaker have been discussed. NL Hydro requested Hatch to carry out a study to recreate the switching transients created during disconnect switch operation. As all the breakers at BDE have now been replaced with the GE dead tank design which are prone to generating particles inside the breaker, one objective of the study is to investigate ways to minimize the transients generated during disconnect switch operation.

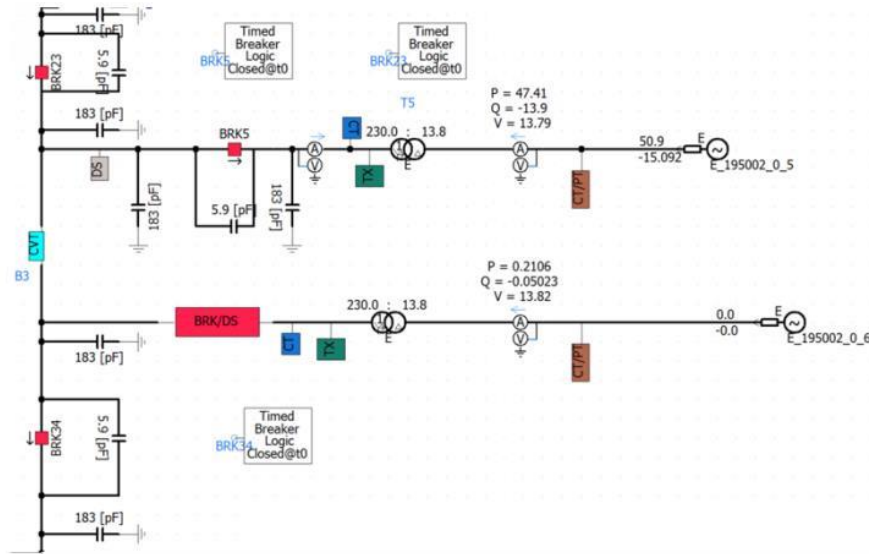
Figure 2-3: Schematic of Developed Model in PSCAD

The PSCAD model of the BDE TSs #1 and #2 is developed based on the model provided in PSSE software. The main focus of the study is bus B3 in BDE TS1, where G5 and G6 are connected to B3, as shown in Figure 2-3.

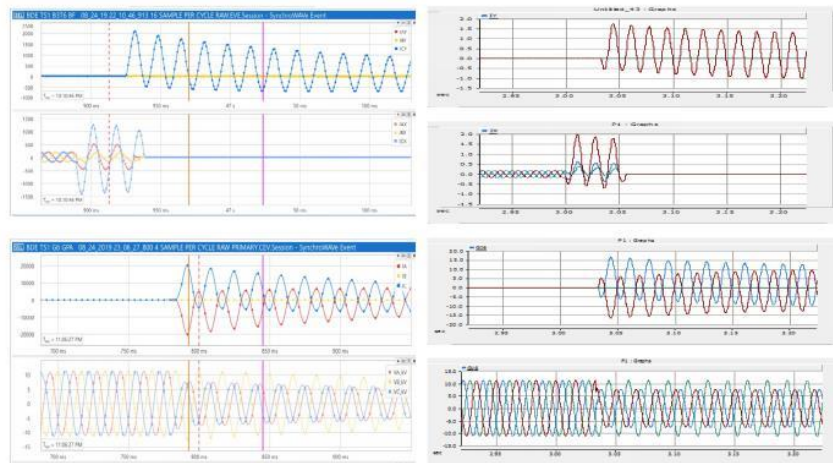
Figure 2-4: Simulation of Fault Event in the Developed Model in PSCAD

Using the developed PSCAD model and based on the received fault trace data, the fault events are recreated. Figure 2-4 depicts the comparison between actual fault traces obtained from relays and the recreated fault event using PSCAD model. As it can be seen, PACAD simulations are able to fairly accurately recreate the fault scenario.

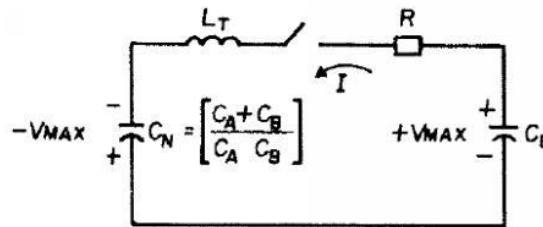
Figure 2-5: Approximate Equivalent Circuit¹

To investigate the main cause of the flashovers in more detail, a study is conducted using an approximate equivalent model of the circuit. In doing so, an approximate equivalent of the system from breaker connection point all the way up to the bus (B3) is developed considering all the capacitance and inductance values of the equipment. This is to investigate the impact of the induced effect during occurrence of a disturbance in the system. It is assumed that the capacitive, inductive and resistive elements of the circuit can be approximated on both sides of the disconnect switch, as shown in Figure 2-5. In this circuit, C_N and C_E are the equivalent capacitance values on each side of the disconnect switch, L_T is the equivalent loop inductance and R is the arc resistance value.

During disconnect switch is opening, capacitors are left with a trapped charge. In the worst case scenario, the voltage on one side of the switch will be equal to +Vmax and the voltage on the other side will be -Vmax. Because of arcing of the disconnect switch, this trapped charge will be dissipated in the circuit creating transient currents and voltages across the elements. These transient voltage and current components have high frequencies, in the order of hundreds of kHz to MHz ranges. If this transient voltage that appears across the bushings of the breaker is higher than its withstand capability, a flashover may occur causing the breaker to fail.

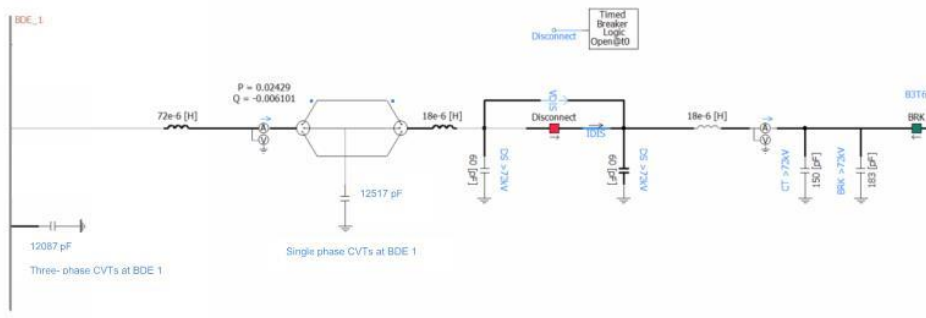
Figure 2-7: Approximate Equivalent Circuit of BDE TS#1 and TS#2

Figure 2-7 shows the approximate equivalent circuit of the circuit connections from the breaker B3T6 up to the main bus. This event is perceived as a local event, thus it is mainly impacted by the equipment in the vicinity of the disconnect switch. For the capacitances of

It should be noted that this is an approximate equivalent of the actual circuit and may not exactly match the real world phenomena. The magnitude of the transient voltage depends on many complex factors including the capacitance values and the maximum trapped charge in the capacitors during disconnect switch arcing.

Using the approximate equivalent circuit shown in Figure 2-7, the arcing of the disconnect switch during its opening operation is simulated, assuming that capacitors on phase C of the circuit are charged to their maximum voltage level (1.4 pu is assumed in this case) and the other two phases are charged to 50% (when one phase is at peak value, the other two phases are at 50% of their peak) of the maximum voltage level of phase C. These assumptions are made based on the fact that the fault events have happened on the C phase and also, based on the fault trace data, at the time the fault happened phase C was at its maximum magnitude, as seen in Figure 2-8.

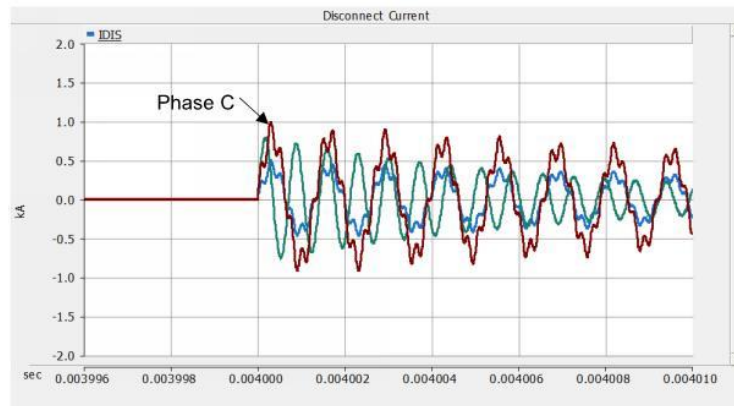
Figure 2-10: Transient Current through Disconnect Switch

The simulation results show a transient voltage of up to almost 800 kV at the breaker terminals. This is an approximate value which depends on various parameters used in the simulation model. With more accurate data, a more realistic estimation can be obtained. The transient voltage at the breaker terminal and the current through the disconnect switch are shown in Figure 2-9 and Figure 2-10. The frequency of this transient voltage is in the order of 0.7 MHz.

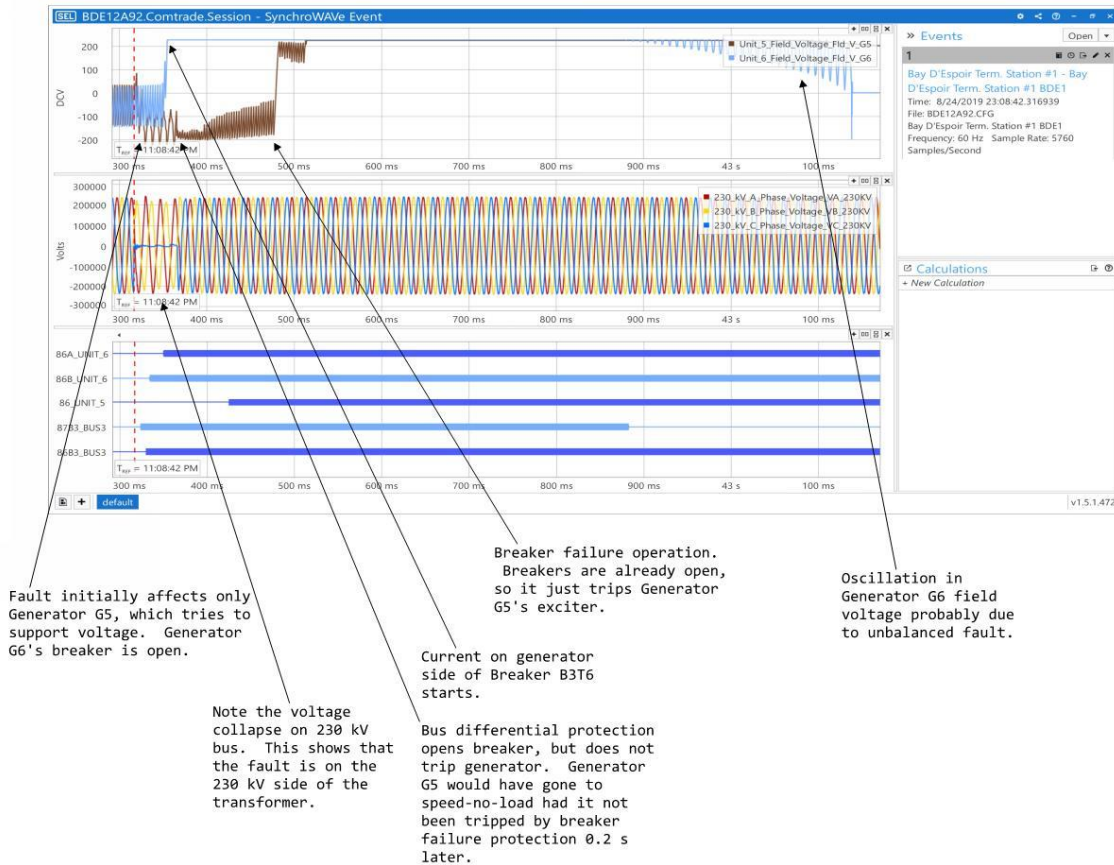
TRIP VIEWED FROM DFR
 (Only has field voltages from generators.)
