1 Q. Please identify what Hydro considers to be the complete project description and
2 justification filed with the Board for the replacement of the Come By Chance T1 and
3 T2 High Voltage Bushings (H1, H2, H3), and please identify by what process Hydro
4 considers these capital expenditures to have been approved by the Board, including
5 the applicable reference thereto in an order of the Board. Please include with your
6 response copies of all filings referred to in the response.

A REPORT TO
THE BOARD OF COMMISSIONERS OF PUBLIC UTILITIES

Upgrade Power Transformers

July 2014

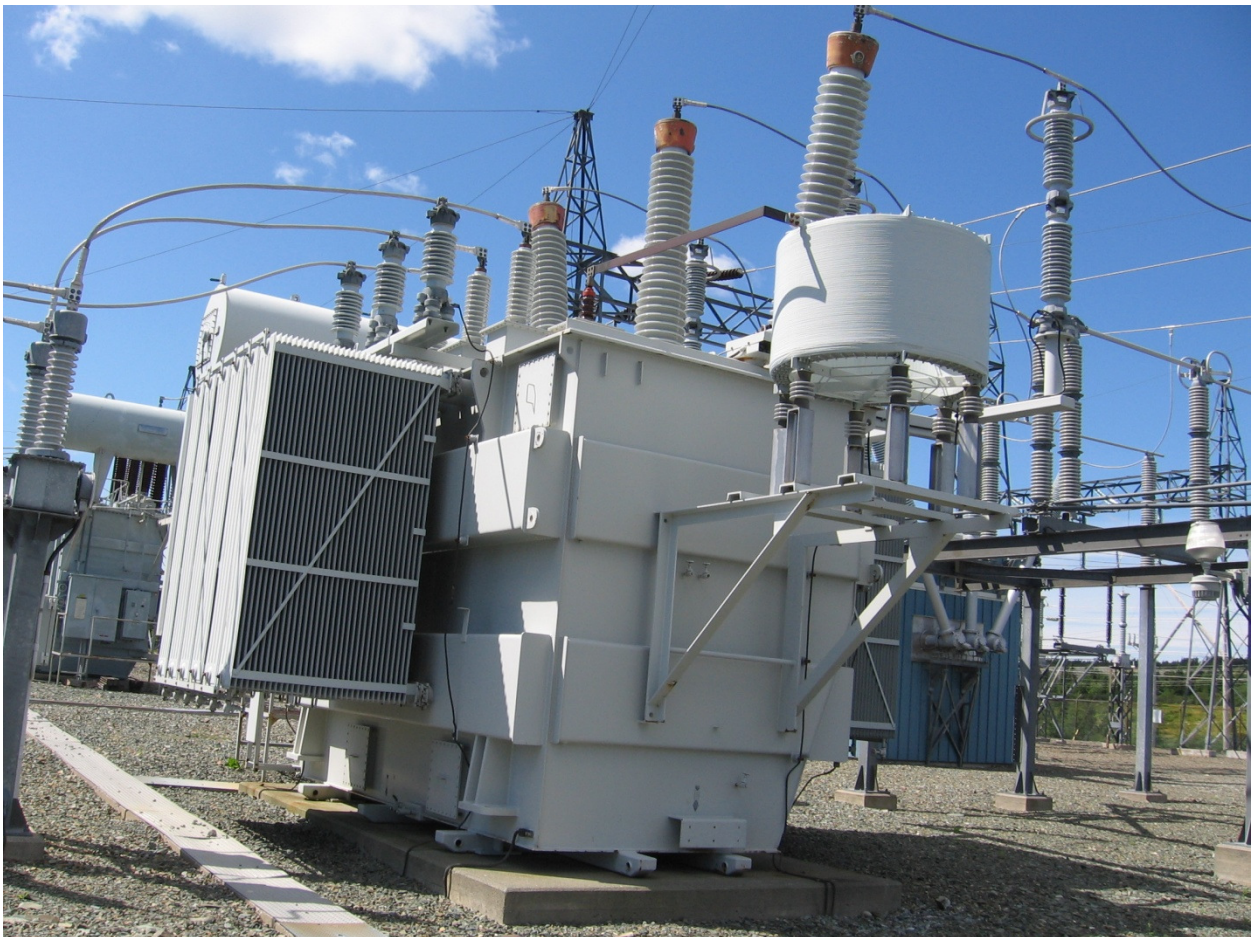
transformers are referred to as step up transformers. These transformers step up the voltage for power transmission from the generation source voltage to the line voltage. A higher transmission voltage yields a lower transmission current and much smaller transmission line losses. Reducing the transmission current allows the transmission line to be a smaller size and weight. Lower current also reduces the amount of power loss during transmission. At a terminal station or a substation, step down power transformers are used to convert the voltage down to a distribution voltage level suitable for delivery to end users. Figure 1 shows a picture of a 75 MVA, 230/66 kV power transformer at Hardwoods Terminal Station.

Figure 1: Power Transformer T4 at Hardwoods Terminal Station

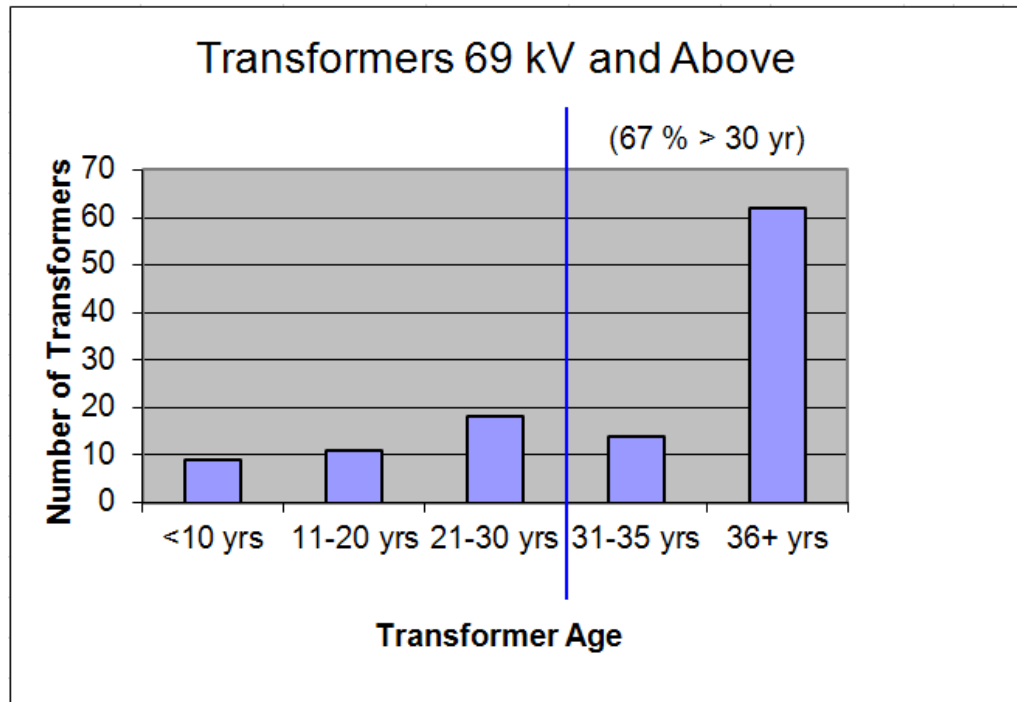
Of Hydro’s transformer fleet, 67% are greater than 30 years of age and 30 units are 45 years old or older. Figure 2 shows the age distribution for Hydro’s transformers rated 66 kV and greater.

Figure 2: Transformer Age Distribution (66 kV and above)

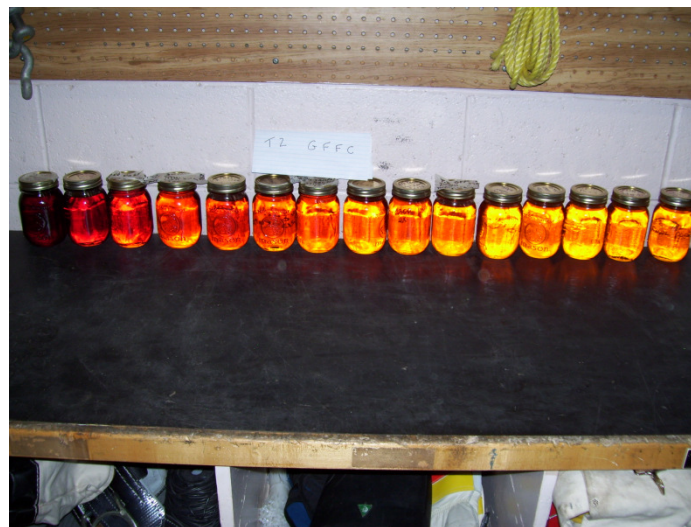
Oil quality data has previously shown the acidity on several units to be outside the accepted guideline as stated by Institute of Electrical and Electronic Engineers (IEEE) Standard 637-1985³. Hydro decided the most cost effective way to rejuvenate this oil was to reclaim the power transformer oil. This reclaiming process brings aged oil back to within oil quality parameters similar to new oil. Figure 3 shows how transformer oil has a visual change in oil color as it is reclaimed from start to finish. Table 2 outlines the work completed in this area to date. In 2005 an in-house transformer ranking tool was developed (see Appendix A) to prioritize units for reclamation based upon oil quality values and criticality within the Island Interconnected System. As per the guideline for PCB Regulations, all transformer oil that is 2mg/kg and greater will be reclaimed on site, with the reclamation unit located next to the transformer.

Figure 3: Reclaimed Oil – Start to Finish (left to right)

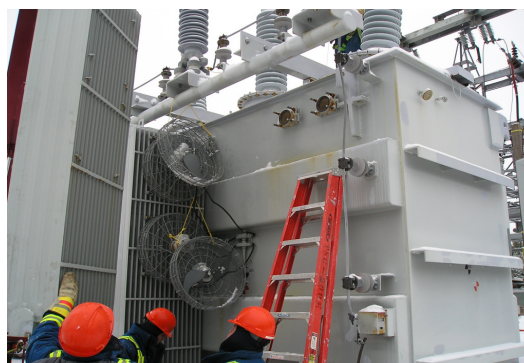
Historically, radiators were manufactured from painted carbon steel. Newfoundland and Labrador's environmental conditions have resulted in high corrosion levels causing damage beyond repair. In some cases corrosion damage resulted in oil leaks. Figure 4 shows radiators that were replaced at Bottom Waters Terminal Station. A list of the completed transformer radiators replacements in recent years is shown in Table 3.

Figure 4: Radiators being replaced at Bottom Waters Terminal Station

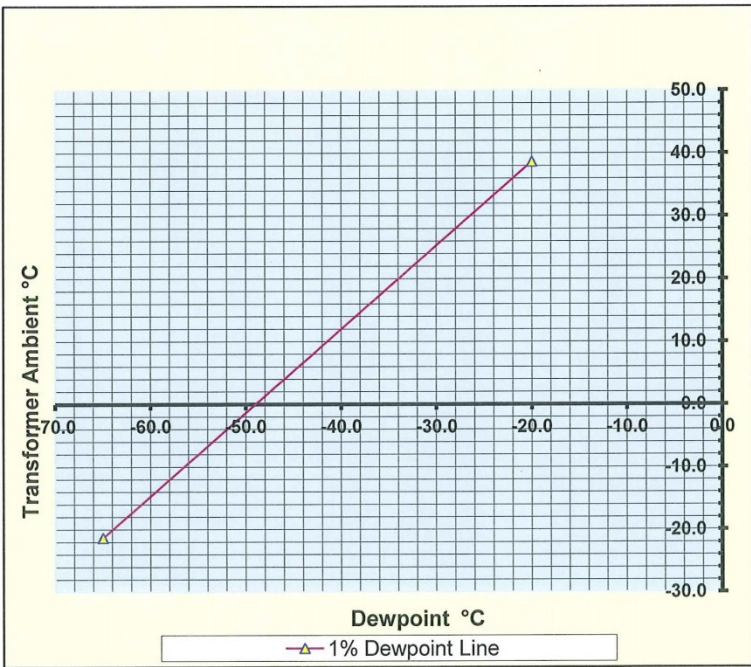
Figure 1

Job Number	<input type="text"/>
Tester	<input type="text"/>
Moister %	<input type="text"/>
Transformer Pressure psi	<input type="text"/>
Transformer Dewpoint °C	<input type="text"/>
Transformer Ambient °C	<input type="text"/>

After completion of work and the transformer is air tight, apply 3 psi of dry air (see Bill of material) pressure to the transformer. Let stand for 24 hours to assure quality of work. If at any point during the 24 hour period the pressure drops below 3 psi then check for leaks. After holding 3 psi for 24 hours conduct a Dew Point test. If the Dew Point test results are satisfactory (values are under the 1% dew point line shown in figure 1 attached) then begin vacuum filling.
