*Board Order No. P.U. 3(2014)*  
*Investigation and Hearing into Supply Issues and Power Outages on the*  
*Island Interconnected System*

## **NEWFOUNDLAND AND LABRADOR HYDRO**

### **A Review of Supply Disruptions and Rotating Outages: January 2-8, 2014 Volume I**

# **A REVIEW OF SUPPLY DISRUPTIONS AND ROTATING OUTAGES: JANUARY 2-8, 2014**

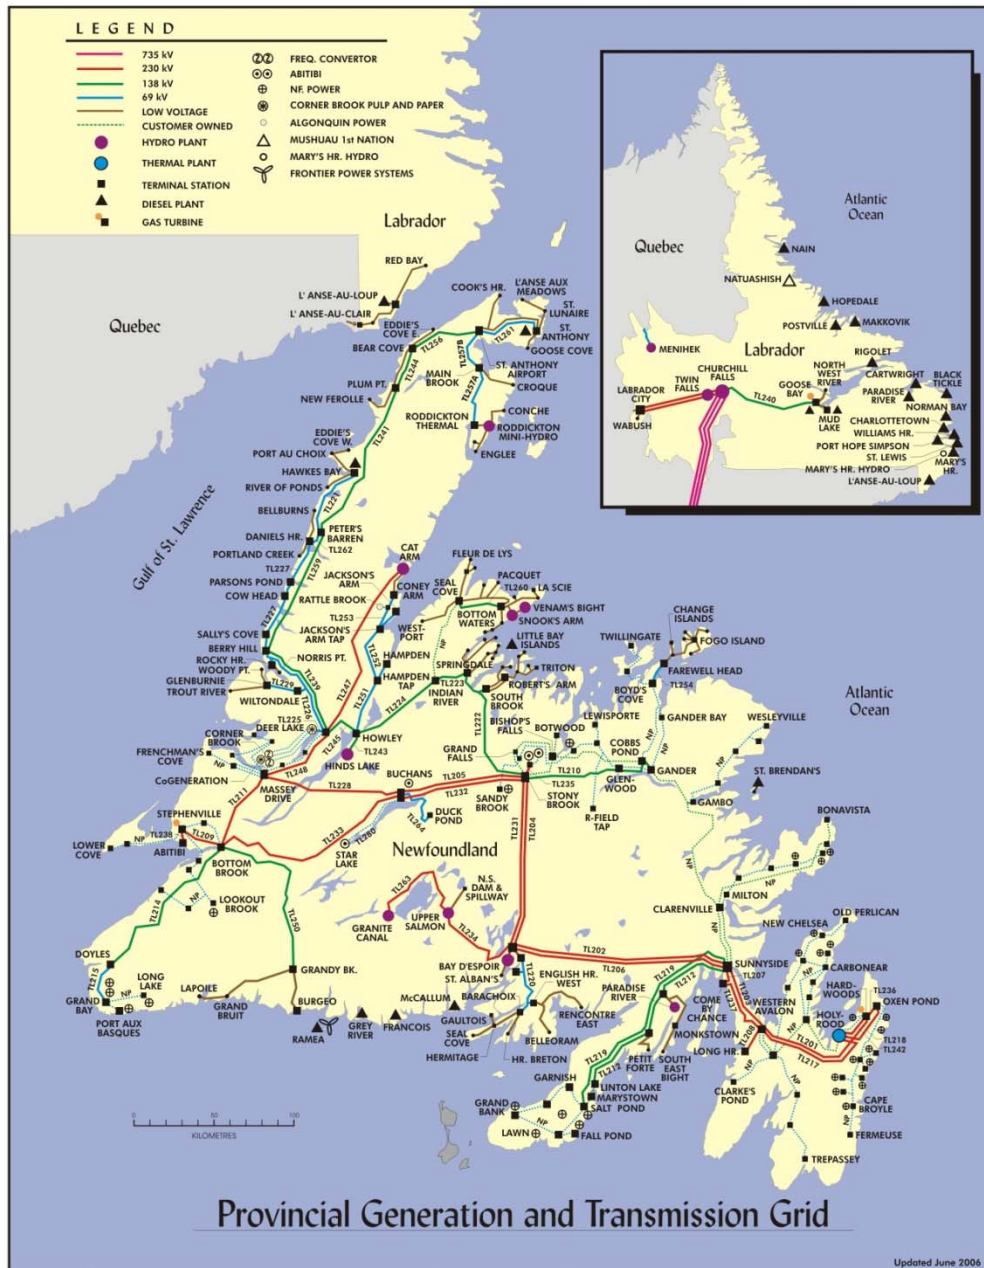
19 The Island Interconnected System is primarily characterized by large hydroelectric generation  
20 capability located off the Avalon Peninsula with two parallel 230 kV lines bringing energy to the  
21 Avalon Peninsula where demand is concentrated, and a large oil-fired thermal generating plant  
22 on the Avalon Peninsula. Figure 3.1 below presents a visual overview of Hydro’s generation and  
23 transmission infrastructure both on the island of Newfoundland and in Labrador.

**FIGURE 3.1: Hydro's Generation and Transmission Infrastructure**
