Re: Newfoundland and Labrador Hydro - The Board's Investigation and Hearing into Supply Issues and Power Outages on the Island Interconnected System – Rolling 12 Month Performance of Hydro's Generating Units

Quarterly Report on Performance of Generating Units
For the Quarter ended June 30, 2018

A Report to the Board of Commissioners of Public Utilities

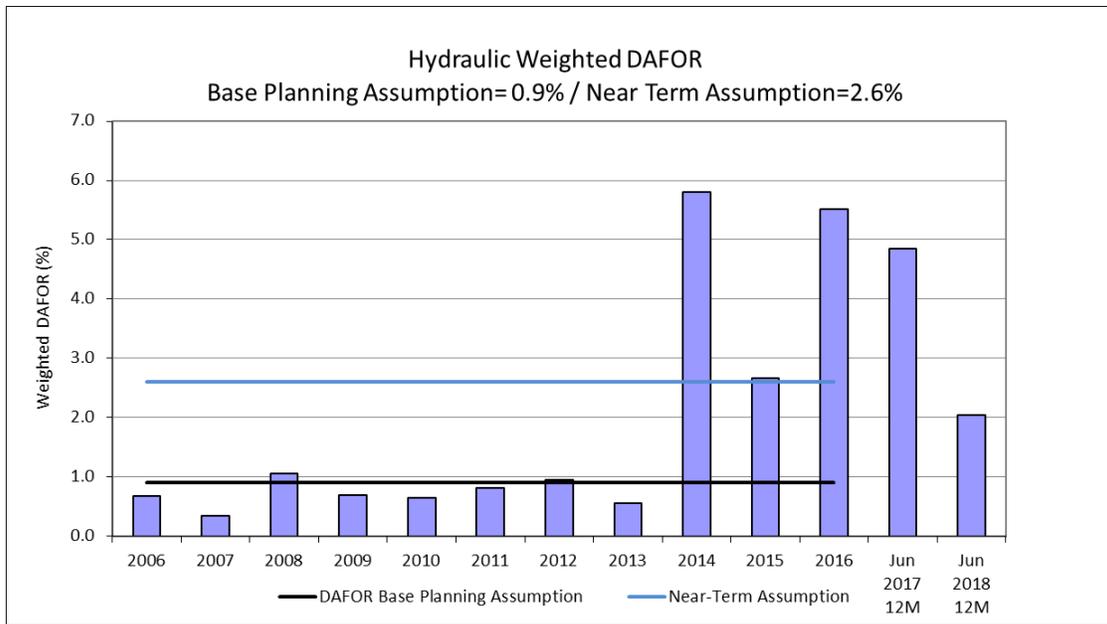
Figure 1: Hydraulic Weighted DAFOR

1 Considering the individual units’ performance, the assumed Hydro generation base planning
 2 DAFOR was materially exceeded for Bay d’Espoir Unit 1 and Bay d’Espoir Unit 2. Also, there
 3 were exceedances compared to base planning assumption for Bay d’Espoir Unit 7 for the
 4 current period.

6 The Bay d’Espoir Unit 1 DAFOR of 8.67% and Unit 2 DAFOR of 12.41%, exceeded the base
 7 planning assumption of 0.9% and the near-term assumption of 3.9% for an individual Bay
 8 d’Espoir unit. This was due to Units 1 and 2 being removed from service on November 4, 2017
 9 as a result of a leak in Penstock 1, which provides water to both units. A consultant was
 10 engaged in the process to provide engineering analysis and recommendations to return the
 11 penstock to reliable service. Extensive inspection and testing was completed, which resulted in
 12 the damaged section being replaced. All additional suspect areas were also cleaned and
 13 refurbished and additional backfill was placed over a section of the ruptured area as this had
 14 been part of the approved capital plan resulting from the 2016 leak. Findings from the final

23
24 Note that the data for 2006 to 2016 in Figure 1, Figure 2, and Figure 3 are annual numbers
25 (January 1 to December 31), while the data for 2017 and 2018 are 12-month rolling numbers
26 (July 1 to June 30 for each year).

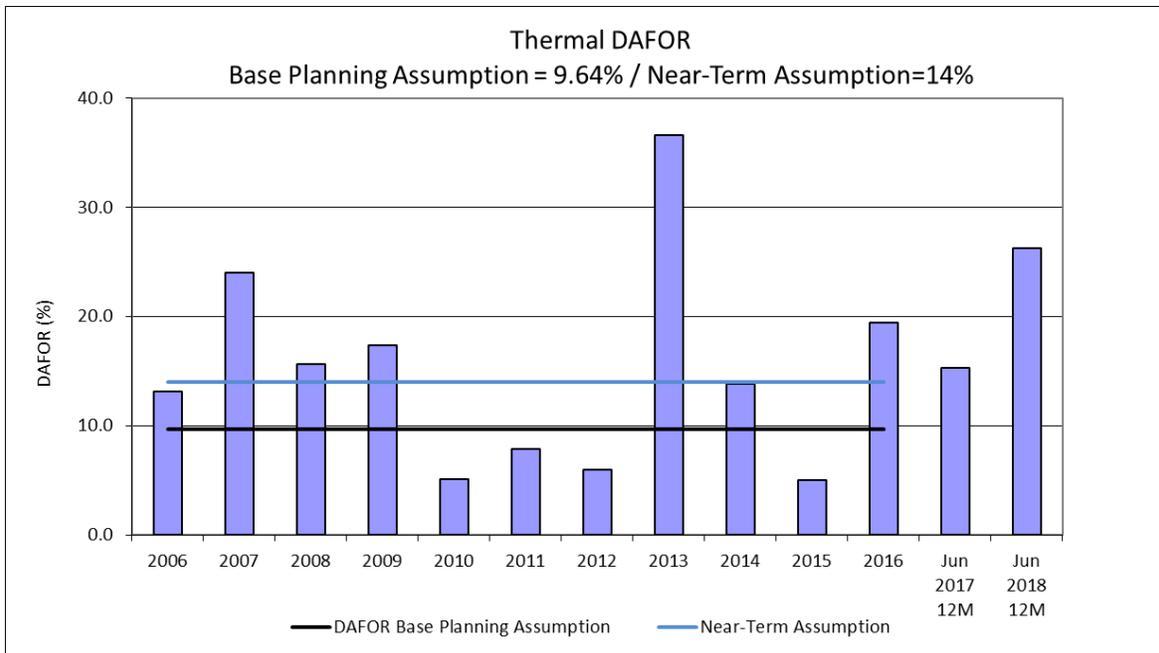
Figure 2: Thermal DAFOR

1 For the 12-month period ending June 31, 2018, the weighted DAFOR of 26.22% for all thermal
 2 units is above the assumed Hydro generation base planning DAFOR value of 9.64%, and the
 3 near-term assumption of 14.00%.⁷ Unit 1 DAFOR was 32.30% and Unit 2 DAFOR was 26.62%.
 4 The performance for both Units 1 and 2 was above the base planning assumption of 9.64% and
 5 the near-term assumption of 15% (Unit 1) and 10% (Unit 2). Unit 3 DAFOR was 16.60%, which
 6 is above the base planning assumption of 9.64% but below the near-term assumption of 18.0%.

4
5 For the Holyrood thermal units, the forced outage rate of the current period ending June 2018
6 is 26.22%, which is above the base planning assumption of 9.64%, the sensitivity of 11.64%, and
7 above the near-term planning assumption of 14.00%⁴. This is primarily caused by an airflow
8 derating on Unit 1 and Unit 2 that continued in 2017 and 2018 and an extended forced outage
9 on Unit 1 in February 2018.

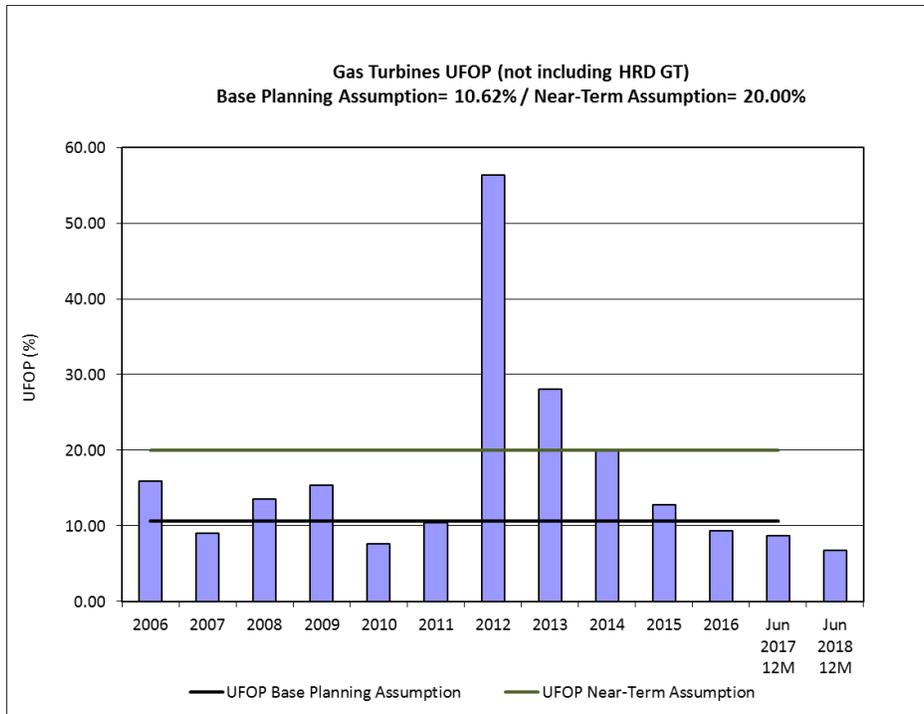
Figure 3: Gas Turbine UFOP – HWD/HVY/SVL Units

1 On September 16, 2017, the Happy Valley gas turbine tripped when attempting a black start of
2 the unit to support an unplanned outage in the Happy Valley area. Hydro's investigation found
3 that the cause of the trip was related to the operation of a voltage protection relay in the
4 terminal station. Upon review of the relevant procedures, drawings and settings it was
5 determined that a setting change was required to the protection relay. The setting was
6 changed and the unit was returned to service on September 21, 2017. During the investigation,
7 it was found that prior to the trip the power turbine had developed higher than normal
8 vibration, though it was not the cause of the trip. Further investigation of the higher than
9 normal vibration found the source to be a high temperature exhaust gas leak from the power
10 turbine. Repairs were made and vibration levels returned to normal on October 7, 2017.

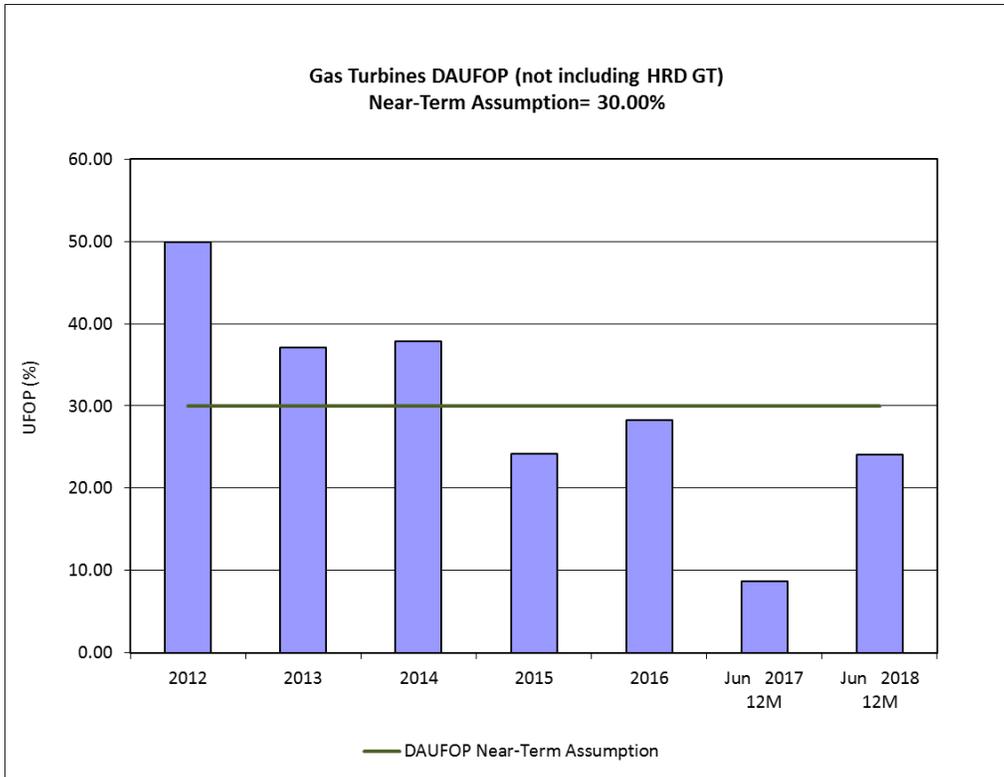
Figure 5: Gas Turbine DAUFOP – HWD/HVY/SVL Units

1 The Stephenville gas turbine DAUFOP for the period was impacted by the unavailability of End A
2 as a result of an exhaust bellows failure at Hardwoods gas turbine End A on December 28, 2017.
3 End A was unavailable at this time due to issues with the power turbine rear bearing which
4 requires the bearing to be replaced. Hydro decided to remove the bellows from End A at
5 Stephenville and install it at Hardwoods End A to return that Unit to full capacity. It is currently
6 expected that the Stephenville gas turbine will be returned to full capacity in August 2018.
7
8 The Hardwoods gas turbine DAUFOP for the period is impacted by the unavailability of End A
9 due to an exhaust bellows failure on May 28, 2018. End A remains unavailable with a planned
10 return to service at the end of July 2018.
