**Re: *Reliability and Resource Adequacy Study Review – Analysis of Recommendations, Mitigations, and Enhancements of the Labrador-Island Link***

Appendix A: Summary of Labrador-Island Link Investigation and Haldar Report Recommendations

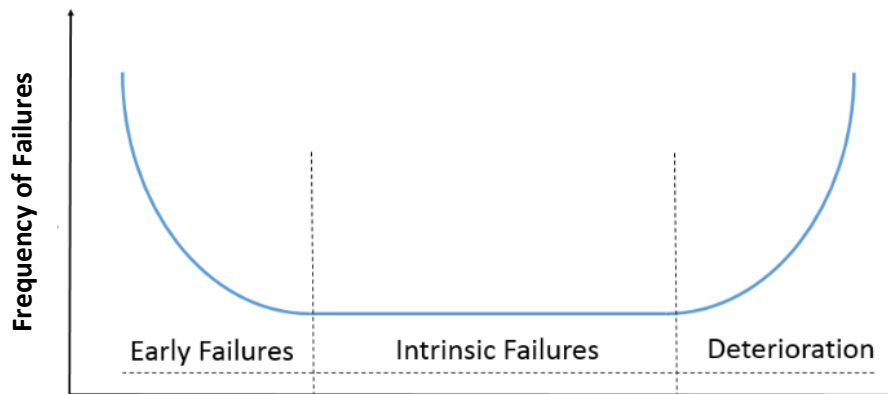
9 As shown in Figure 1, the bathtub curve has three regions—the first region represents the early years of  
10 an asset's life and has a decreasing failure rate due to early failures that are found and corrected  
11 contributing to improved reliability. The middle is a constant, lower instance of failure rate due to the  
12 normalized frequency of expected failures, and the last region represents the later years of an asset's  
13 useful life and shows an increasing failure rate due to age and end-of-life failures. The first region or  
14 early years of a utility asset’s lifecycle is generally several years long, while the middle period can often  
15 be decades long, as is the case for the LIL.

Figure 1: Bathtub Curve<sup>13</sup>
