Re: Application for Approval of Capital Expenditures for Section Replacement and Weld Refurbishment for Bay d'Espoir Hydroelectric Generating Facility Penstock 1

Attachment 1

Kleinschmidt Cost Opinion Memo

Penstock Lining Assessment and Opinion of Probable
Construction Costs, 2024 Update

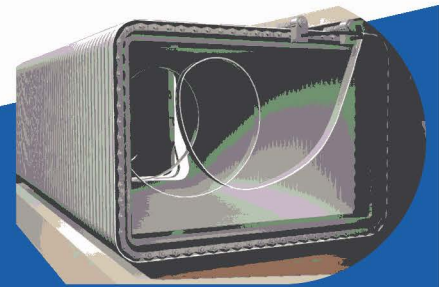
SPR™ | 32" - 200+"

SPR™ renews large diameter, round and non-round shaped pipelines. The PVC is wound by a traversing machine that forms the liner while traveling the pipe segment.
