**Re: Charlottetown Generator Failure – Allowance for Unforeseen Items Final Report**

# Charlottetown Diesel Generator Failure

## Final Report

A report to the Board of Commissioners of Public Utilities

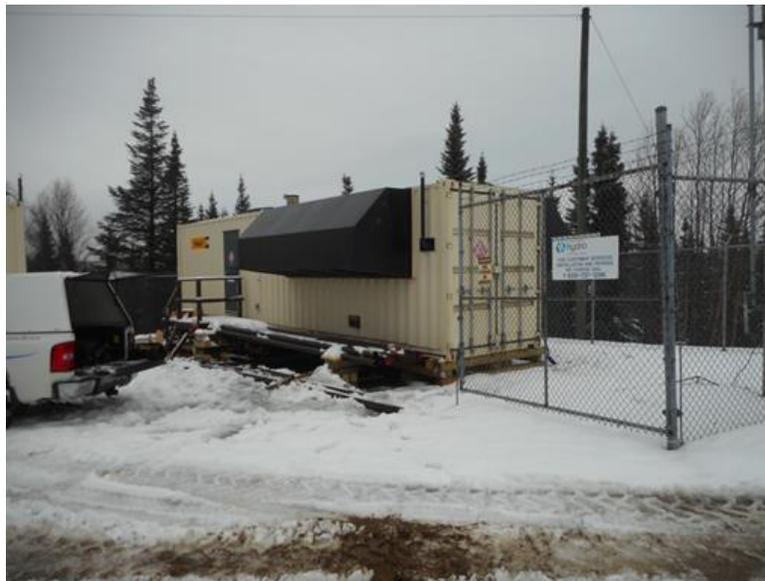
Figure 1: Unit 2102

1 Diesel generating stations are designed such that firm power<sup>4</sup> can be delivered in the event of failure of  
2 the largest generating unit. As such, the forecasted peak load can be met during the failure of a genset;  
3 however, all remaining units are required to be in service to meet that load. As a result of the failure of  
4 the generator on Unit 2102, adequate firm supply was not available to serve the load of both towns,  
5 including the shrimp plant.<sup>5</sup> While the shrimp plant is operating, two units are required to be online. As  
6 such, without a functioning third unit, an outage to either of the two remaining units would have  
7 resulted in customer outages. Unit 2102 is shown in Figure 1.
