**Re: Approval of Capital Expenditures Supplemental to Newfoundland Power Inc.'s  
(the "Company") 2017 Capital Budget Application – Rose Blanche Hydroelectric  
Plant**

6. Schedule C to this Application is a report titled *Rose Blanche Hydro Plant Turbine No.1 Refurbishment*, which details the results of the assessment of the damage to Turbine No. 1 and provides estimates of the expenditures necessary to return the turbine to service.

8. Schedule D to this Application is a report titled *Rose Blanche Hydro Plant Rockfall Remediation*, which provides a detailed assessment of the results of the rockfall and provides estimates of the expenditures necessary to return the Plant site to a safe condition.

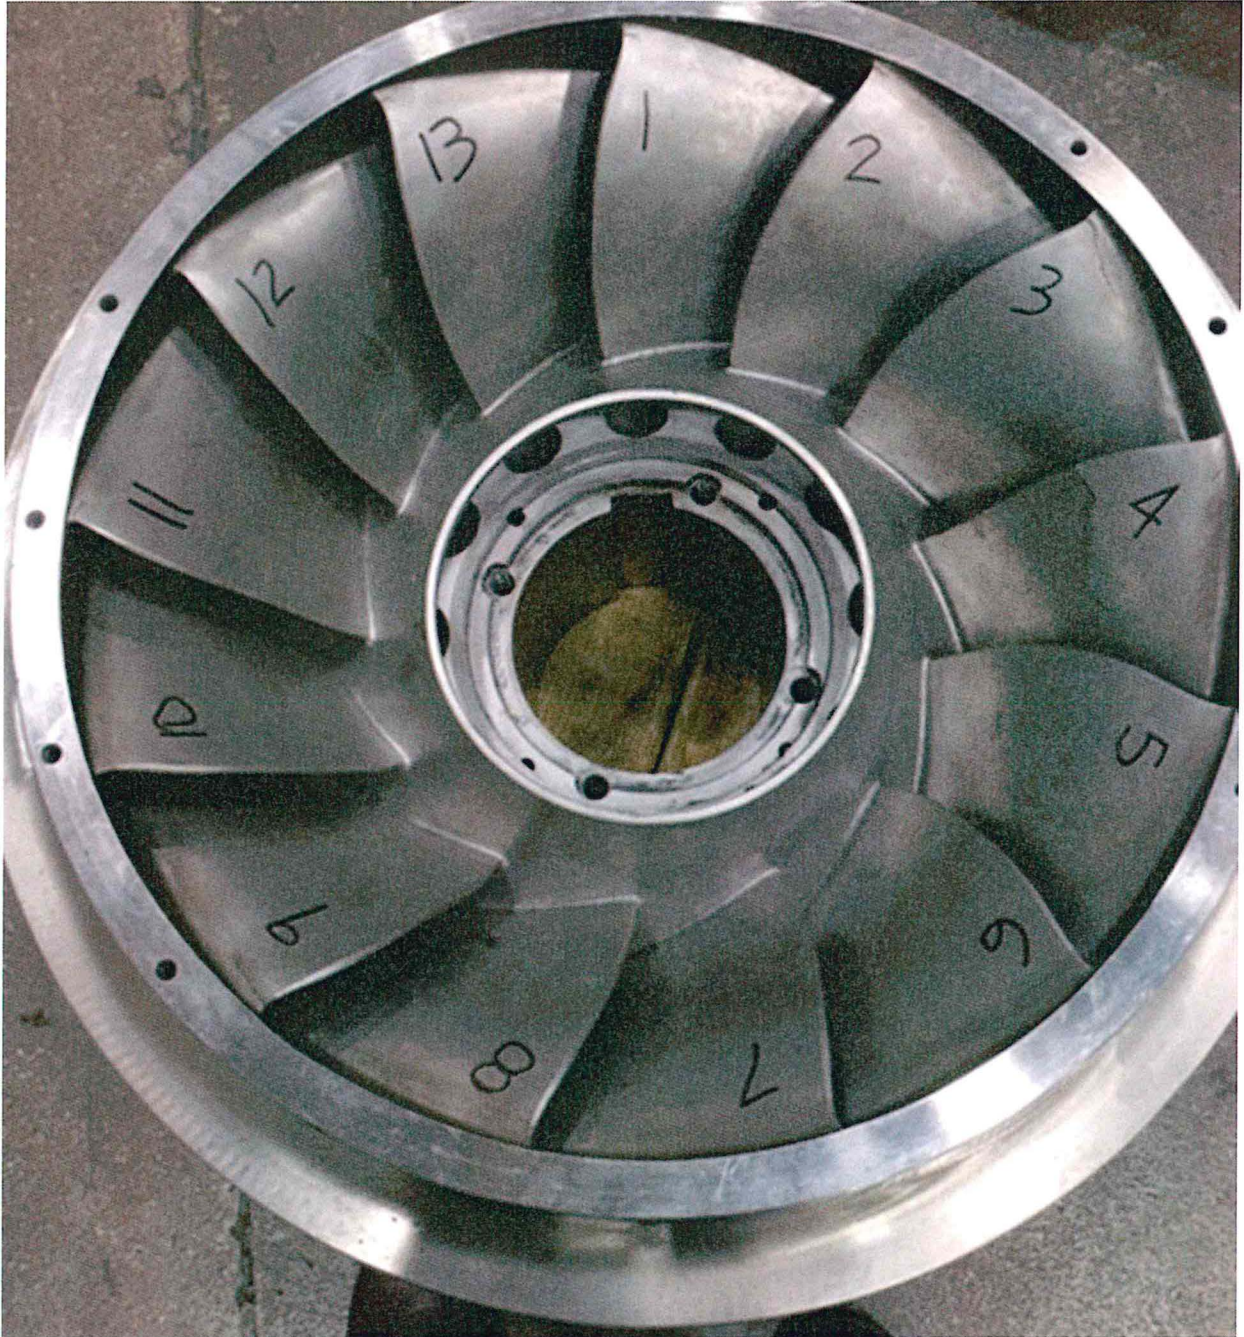
**FIGURE 1 – BUCKET IDENTIFICATION PATTERN**

Upon arrival at AH, the runner buckets were sequentially numbered 1-13 in a clockwise direction beginning at the shaft key way (Figure 1 below). A long crack was immediately noted in the middle of the discharge section of bucket #4. Major deformation of the key way was also observed.

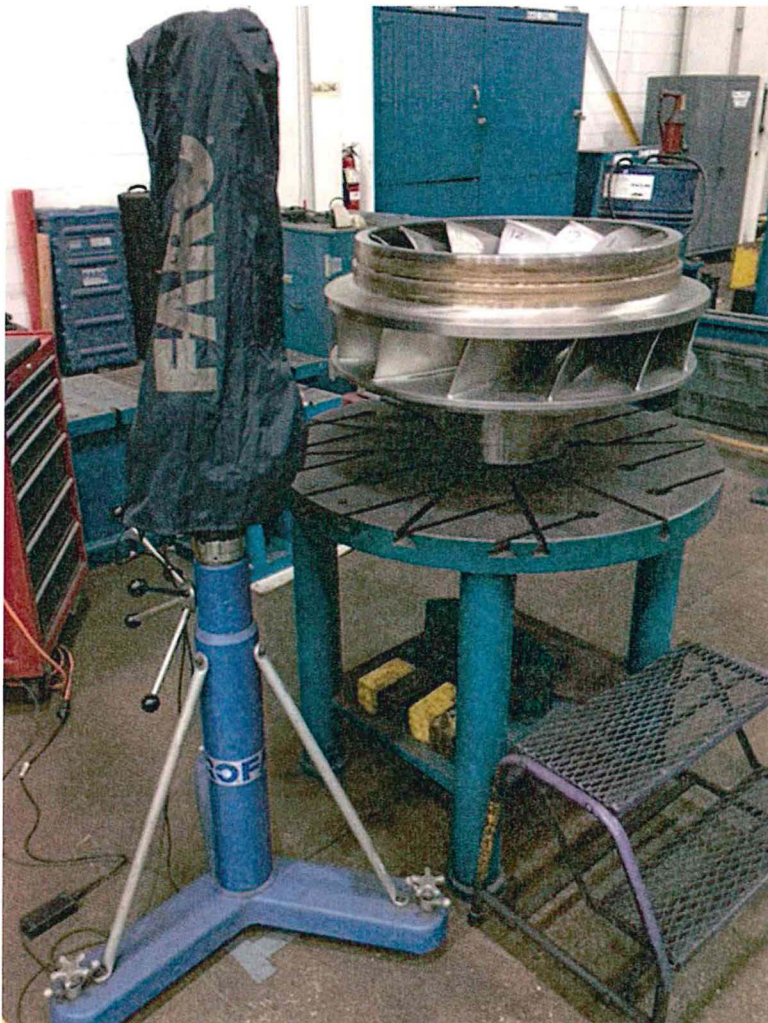
**FIGURE 2 – RUNNER SET UP IN FARO ARM WORK STATION**

All of the shaft bore run outs exceed industry standards. This is assumed by AH to be a direct result of the visually distorted keyway. At datum A the run out is .0047" (.12mm), at datum B the run out is .0078" (.20mm) and at datum C the run out is .0093" (.24mm)

The bottom plane of the band and the top plane of the crown are parallel within .003" (.08mm) which is in line with original equipment manufacturer tolerances.

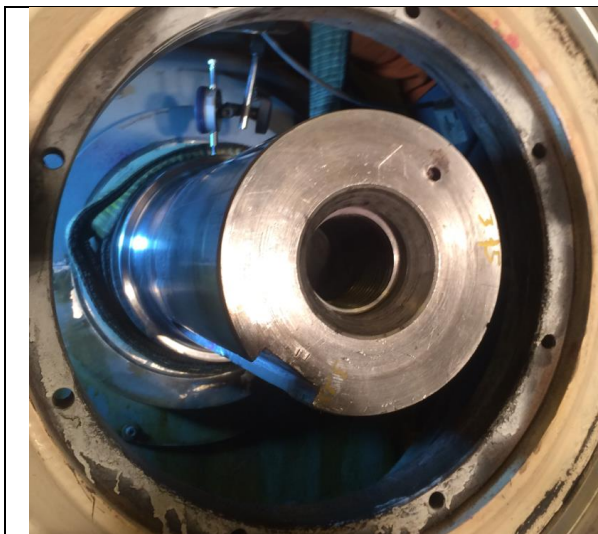
The total indicator runout measured on the seal fit was 0.004 mils and at the end of the shaft was 0.017 mils.

Dial indicator on the shaft seal bushing fit

Dial indicator at the end of the shaft

This may be an indication of some shaft bending but will need further verification.

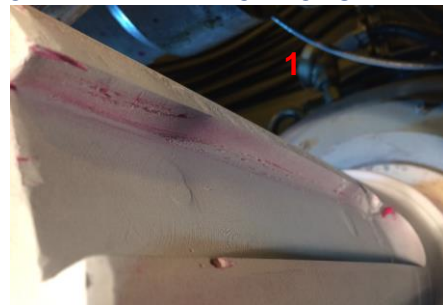
1. Area where keyway was damaged showed some tool marks but no relevant indications with dye penetrant.
2. Area on opposite side of keyway showed some tooling marks but no relevant indications with dye penetrant.
3. Area on back end of shaft where hub came loose and spun around causing non relevant indications due to surface flaking from mating surfaces.

**NO RELEVANT INDICATIONS WERE FOUND AT TIME OF INSPECTION.**

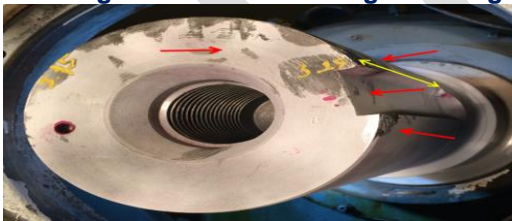
**RESULTS: Shear wave and longitudinal ultrasonic testing were utilized to inspect the end of the # 1 turbine shaft around the keyway after it was damaged.**

Longitudinal 0 degree inspection was performed from the end of the shaft as well as around the keyway to determine if any cracking had occurred transverse or parallel to the shaft keyway. Shear wave inspection was also performed around the keyway from multiple directions to detect any subsurface cracking not detectable using the 0 degree.

Red arrows show areas for 0 degree inspection and yellow arrow shows the area for the shear wave inspection.

**NO RELEVANT INDICATIONS WERE FOUND AT TIME OF INSPECTION.**

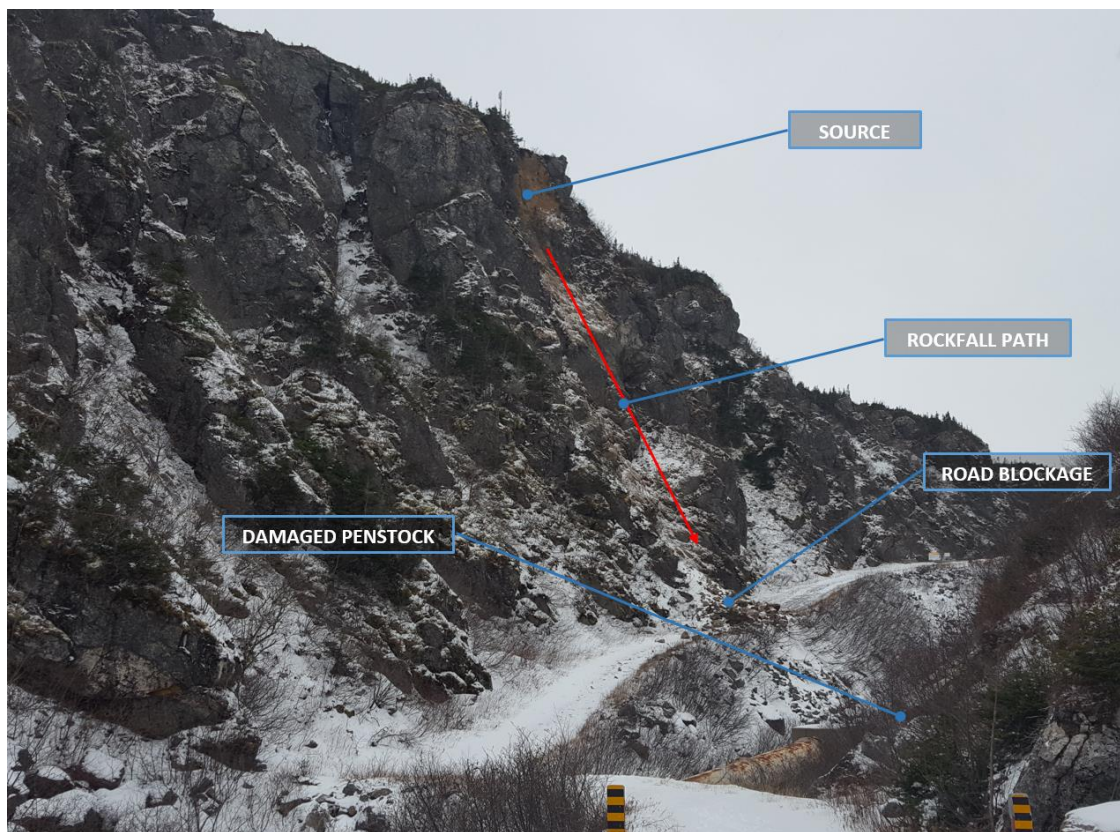
Figure 2 – Rockfall Path

It is estimated that approximately 500 to 1,000 tonnes of rock material were displaced in the fall, including stones as large as 5 tonnes. The source and path of the rockfall are shown on Figure 2.

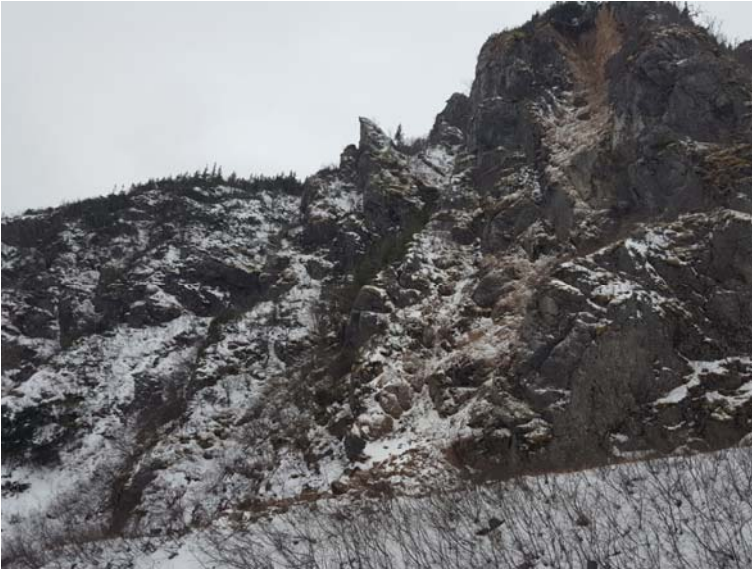
**Photo 7** – Fall zone showing trace of detritus.

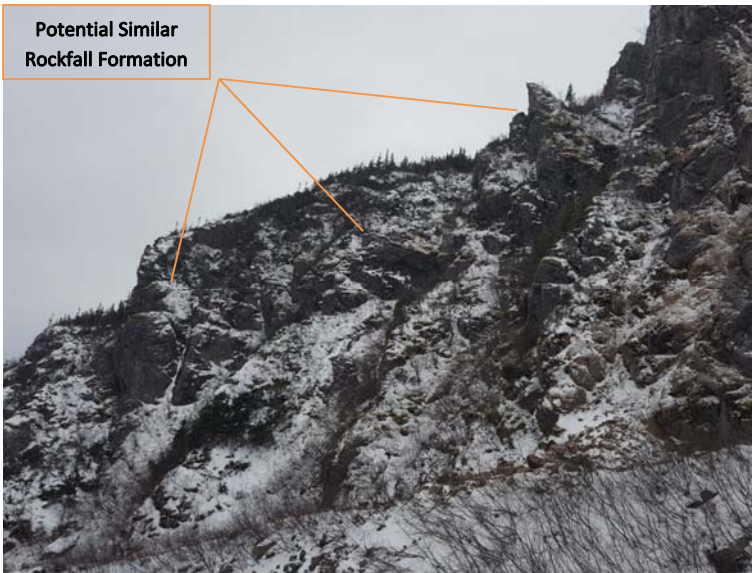
**Photo 9** – Similar slope structures near the access road.

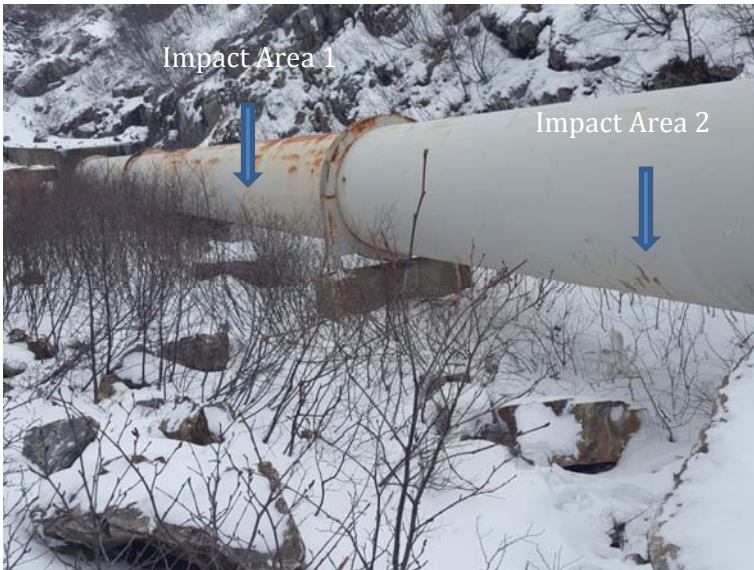
**Photo 11** - Impact Area 1 and 2.

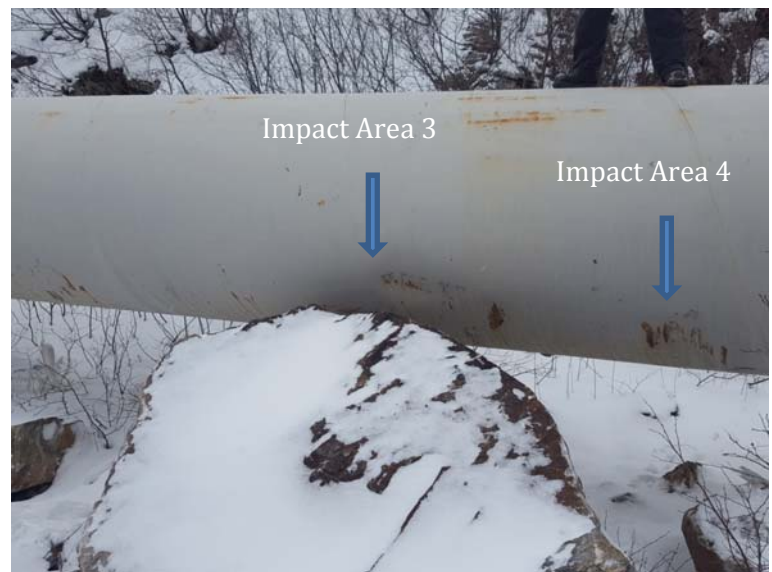
**Photo 12** - Impact Areas 3 and 4.

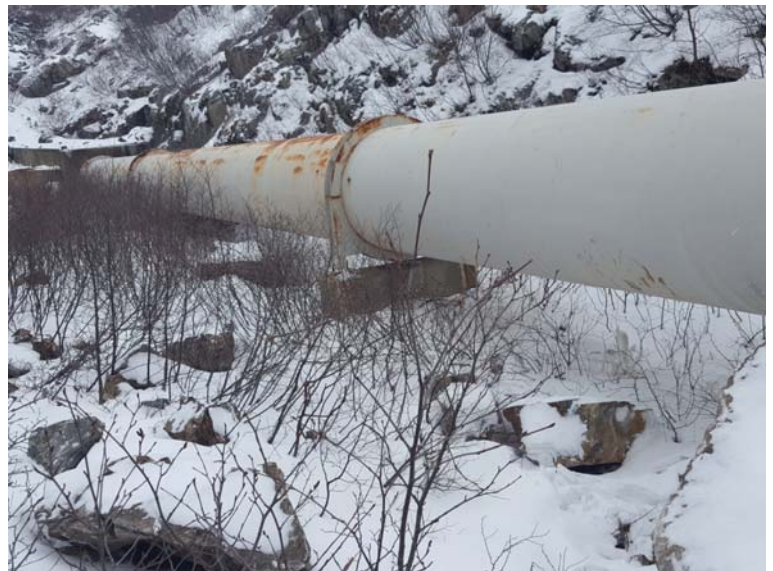
**Photo 14** – Impact Area 1 and 2.

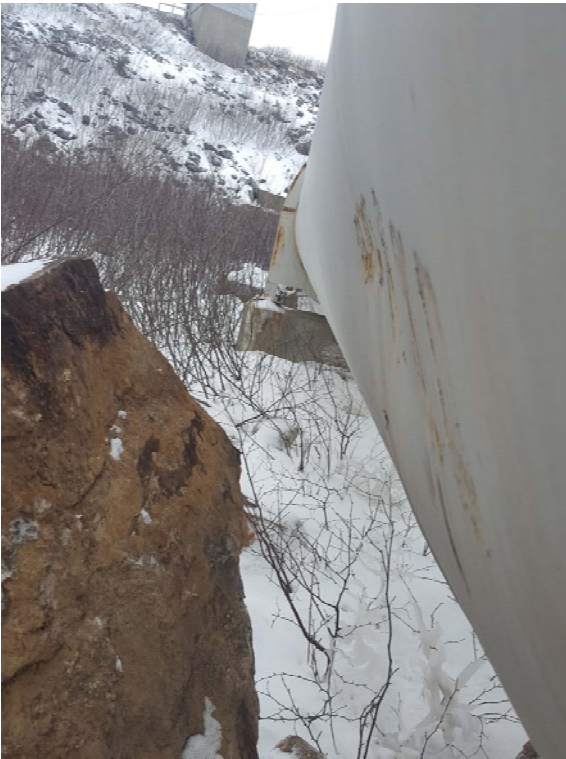
**Photo 17** – Impact Area 3, indentation.

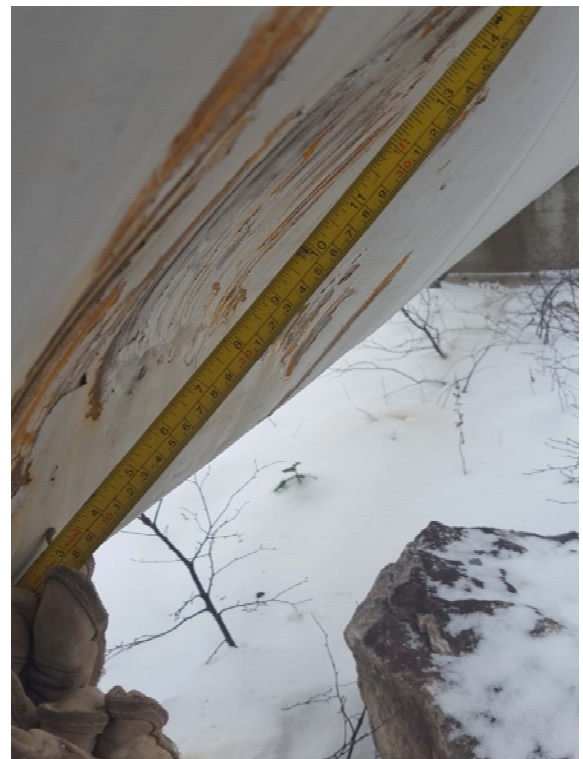
**Photo 18** – Size of Impact Area 4.

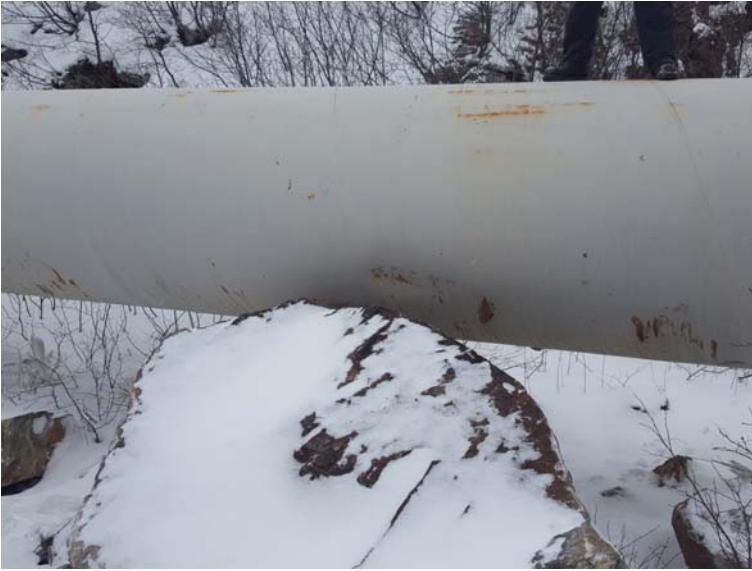
**Photo 19** – Impact Area 2, 3 and 4.

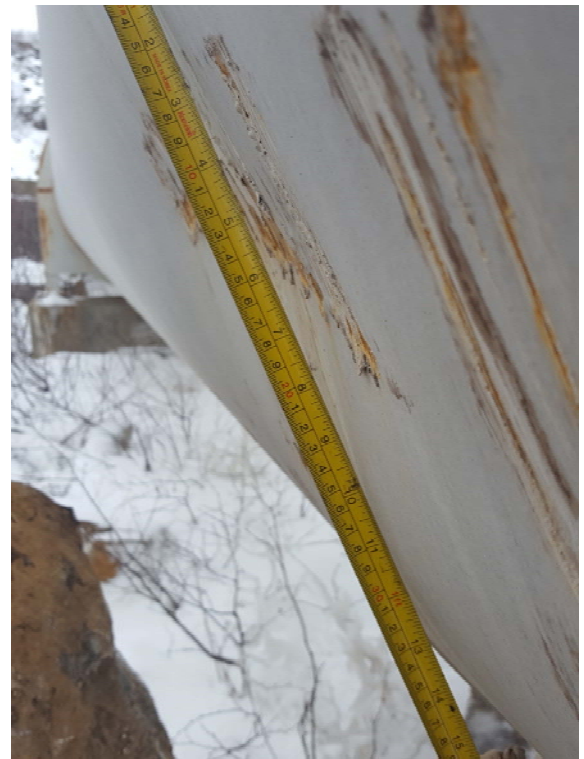
**Photo 20** – Impact Area 3.

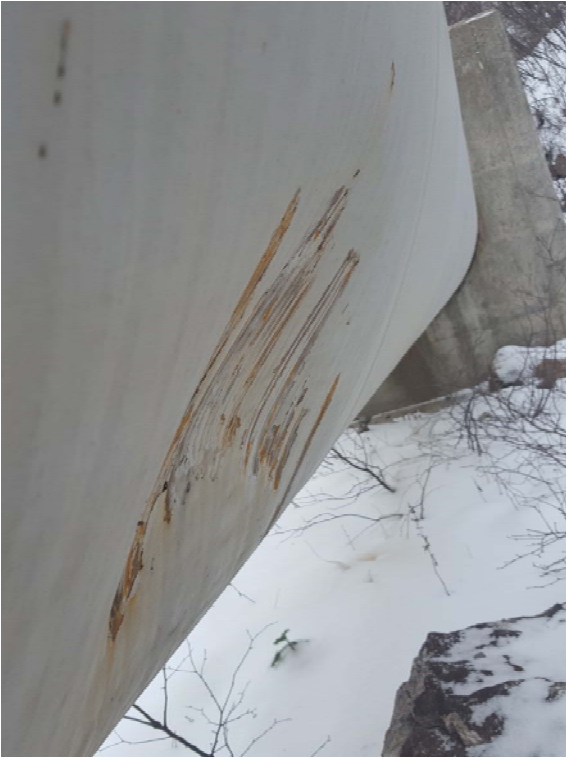
**Photo 21** – Impact Area 4 indentation.
